**NATIONAL TRANSPORTATION SAFETY BOARD  
OFFICE OF AVIATION SAFETY**

OPERATIONS FACTUAL REPORT  
WPR18MA087

Operator: Papillon Airways, Inc.  
Location: Peach Springs, Arizona  
Date: February 10, 2018  
Time: 1719 mountain standard time  
Aircraft: Airbus Helicopters EC130 B4

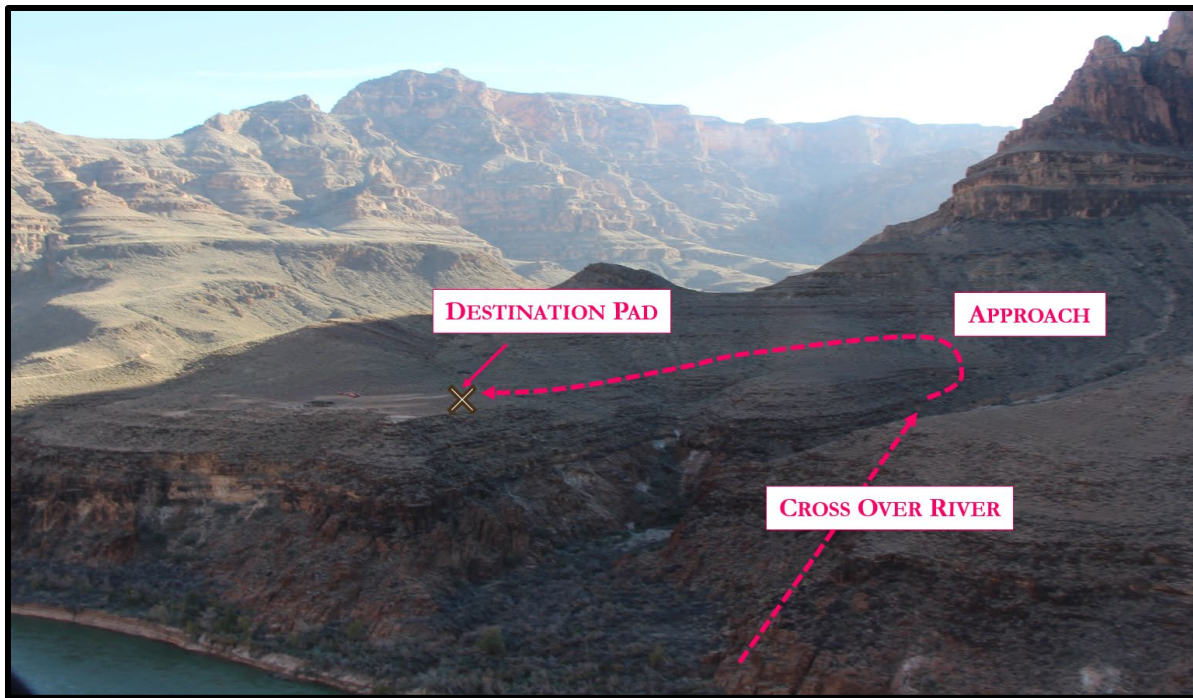
*Figure 05: Pilot's Planned Approach to the Landing Pad*

The pilot stated that he would normally maneuver the helicopter at 200-300 feet agl as he crossed the river. He stated that he would configure his approach depending on the wind and the ground speed.

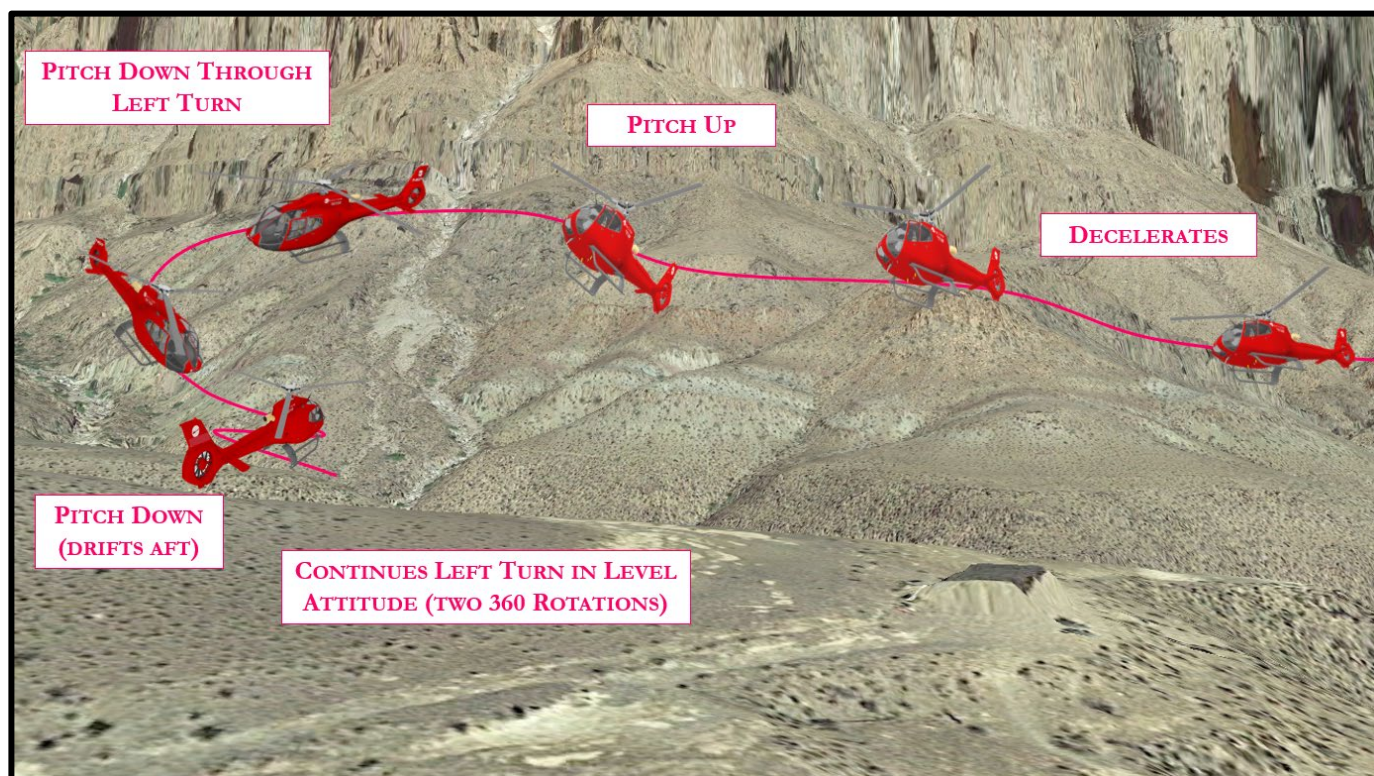
Figure 06: Visual Representation of the Witness's Observations

A witness, who was also a Papillon pilot, stated that he observed the accident helicopter cross over the river and assumed the pilot was planning on landing on the west pads. The helicopter began to decelerate and then pitched to an estimated 15° nose-up attitude. As the helicopter began a left turn toward the pads, the pitch-attitude transitioned to a nose-level attitude and continued to a nose-low attitude. The helicopter began to drift aft which appeared to be from the wind, and it looked as though the pilot was attempting to gain airspeed. The left turn continued, and the nose assumed a level-attitude. The turn continued 360° and then began to descend in a level pitch attitude. The helicopter made a second 360° rotation and collided

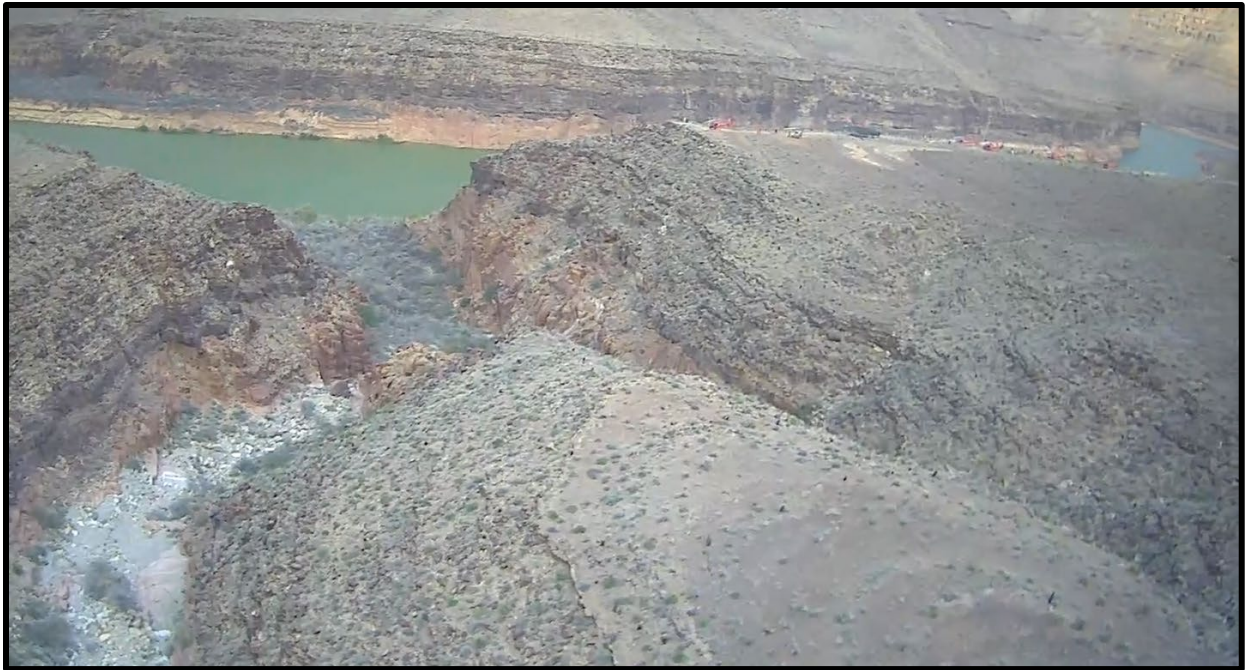
*Figure 13: Forward View from Helicopter 23 After Experiencing the Wind Vane Event*

The helicopter entered into the canyon and while he was turning toward the landing zone, the helicopter's heading shifted rapidly. The tail swung around rapidly, feeling like a strong wind was pushing on the tail akin to a wind vane. With the major shift, he was immediately concerned with the helicopter's rate of descent and noted that the airspeed indicator showed 45 to 50 kts with a descent rate of about 400 feet per minute.

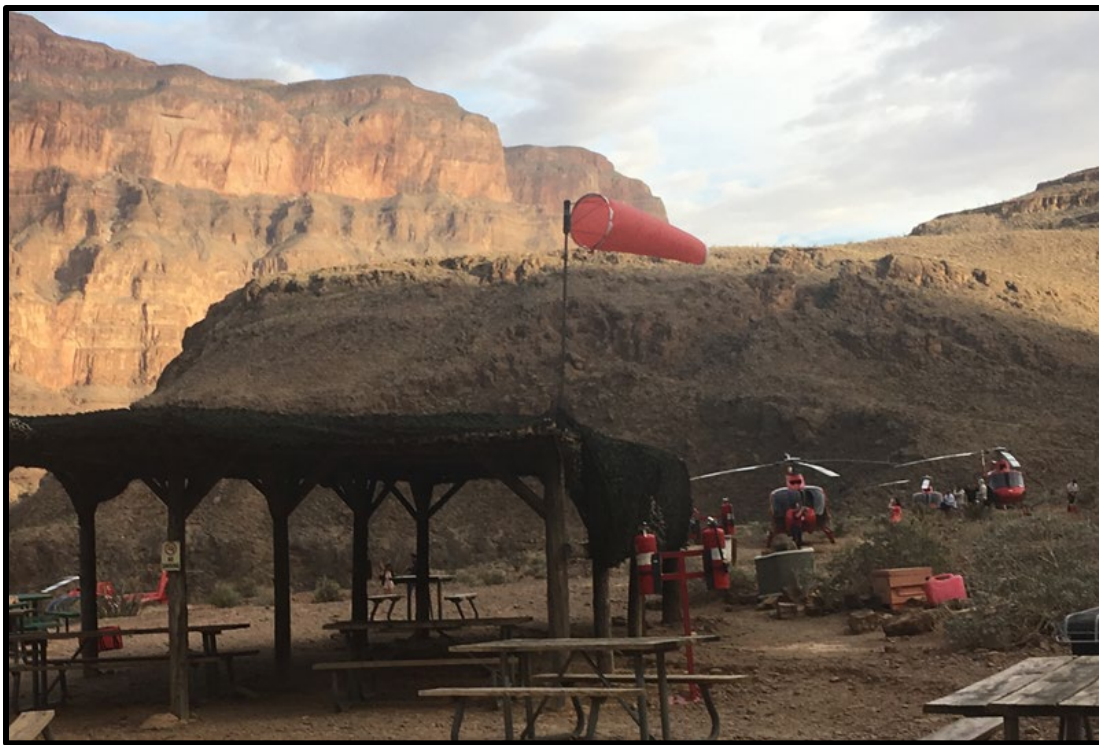
Figure 24: Picture Showing the Wind from the North-Northwest Several Minutes Prior to the Accident

<sup>44</sup> Because this windsock fully extended at 15 kts and was located near the landing pad where helicopters are arriving and departing (potentially creating a local “artificial” wind), there are concerns with using these observations for creating an accurate quantitative measurement of the local wind condition at the landing pad.

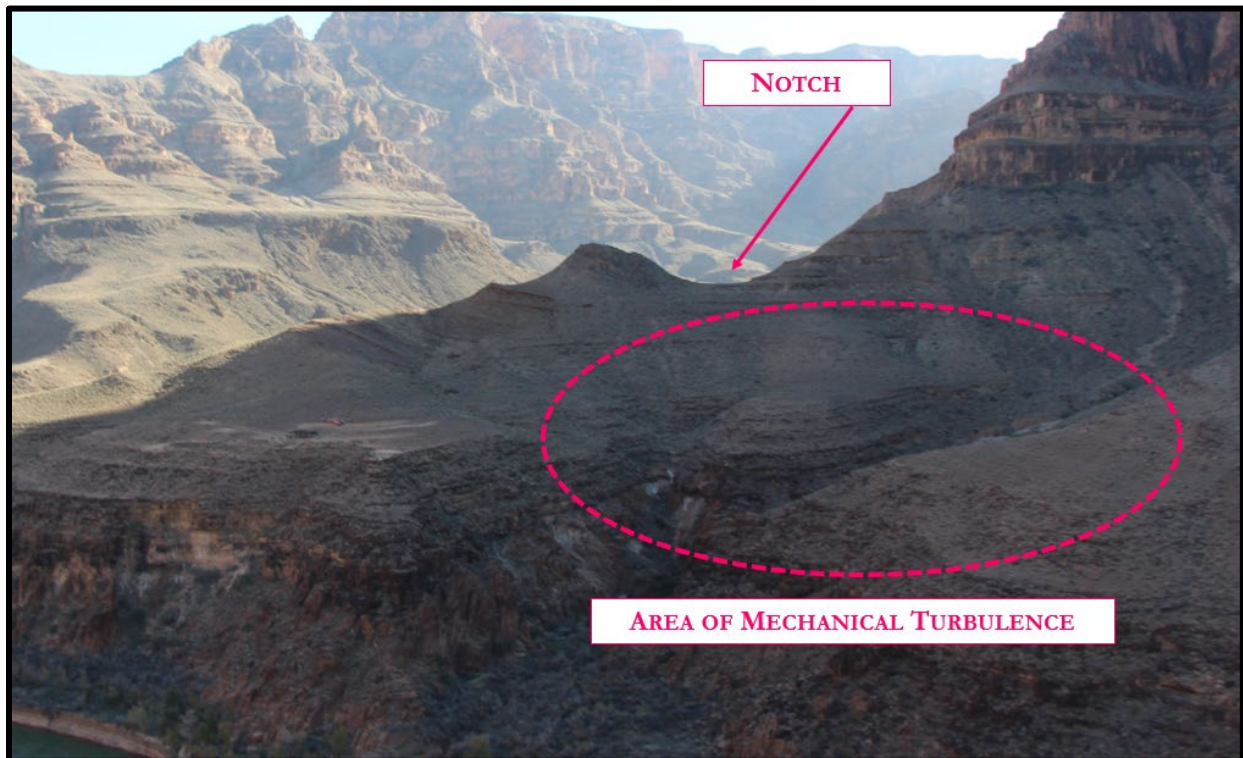
*Figure 37: Area that Pilots Reported Experiencing Turbulence*

Numerous Papillon pilots stated that the wind at Quartermaster was not predictable. Specifically, that the wind direction can change while the pilot is flying the approach. Pilots additionally remarked that the terrain characteristics in the canyon adjacent to the west pads create mechanical turbulence<sup>59</sup>. A few pilots added that they have experienced a swirl-type turbulence in that area where the helicopter will sink.
