**SURVIVAL FACTORS SPECIALIST'S FACTUAL REPORT**

| Airplane | : | Airbus Helicopters EC130 B4 [N155GC] |
| Location | : | Peach Springs, AZ |
| NTSB # | : | WPR18MA087 |

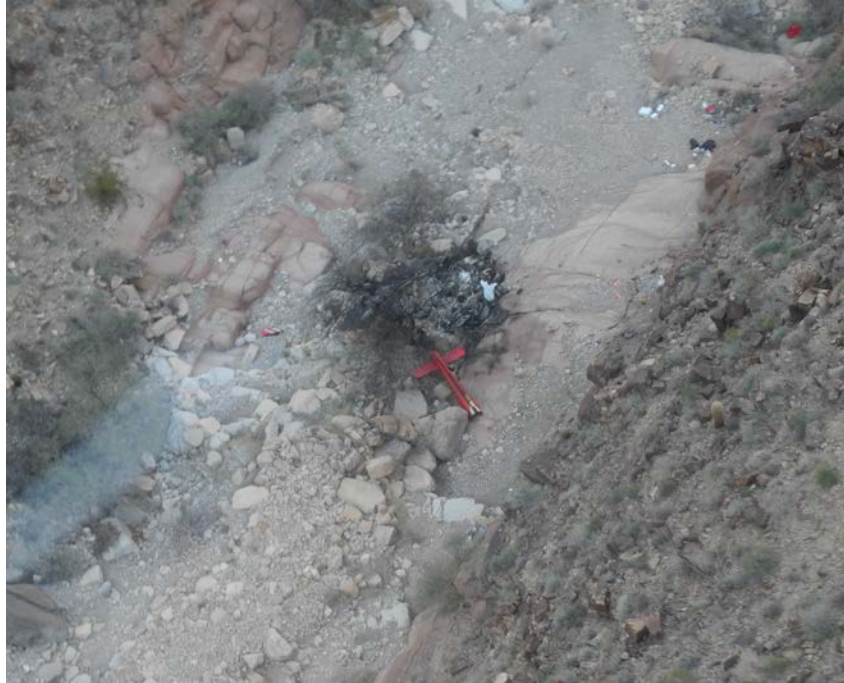
The helicopter came to rest on rocky terrain in a ravine approximately 800 feet from the Quartermaster landing zone. There was an immediate postcrash fire which consumed the entire helicopter except for the tail boom (with fenestron), which remained unburned.

**Photo 1. Overhead view of accident site.**

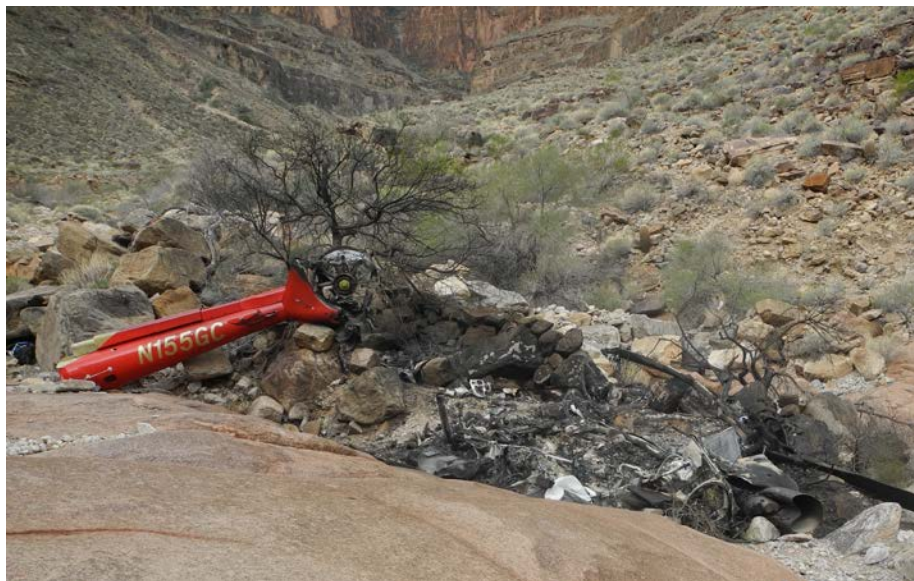
**Photo 2. View of the accident site facing south (away from Colorado River).**

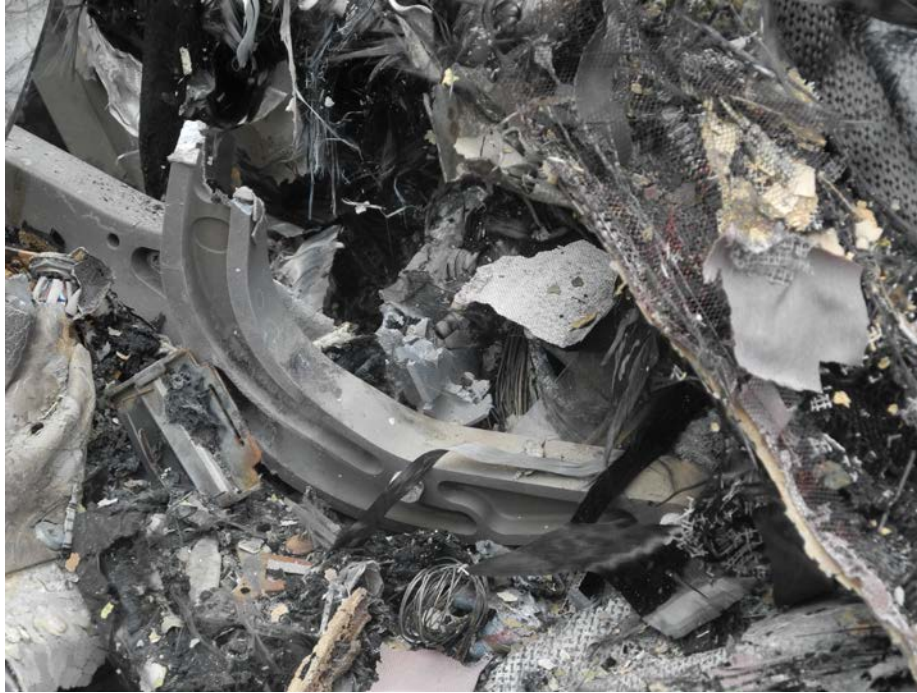
The NTSB's airworthiness group responded to the accident site and documented the portions of seats and restraint systems that could be identified. All of the seats were heavily fire damaged. The bottom portion of the pilot seat aluminum frame was found in its normally installed location. The left aluminum frame webs were not fractured and were still attached to remnant floor track and airframe. The right aluminum frame was melted.

**Photo 4. Pilot seat's left frame.**

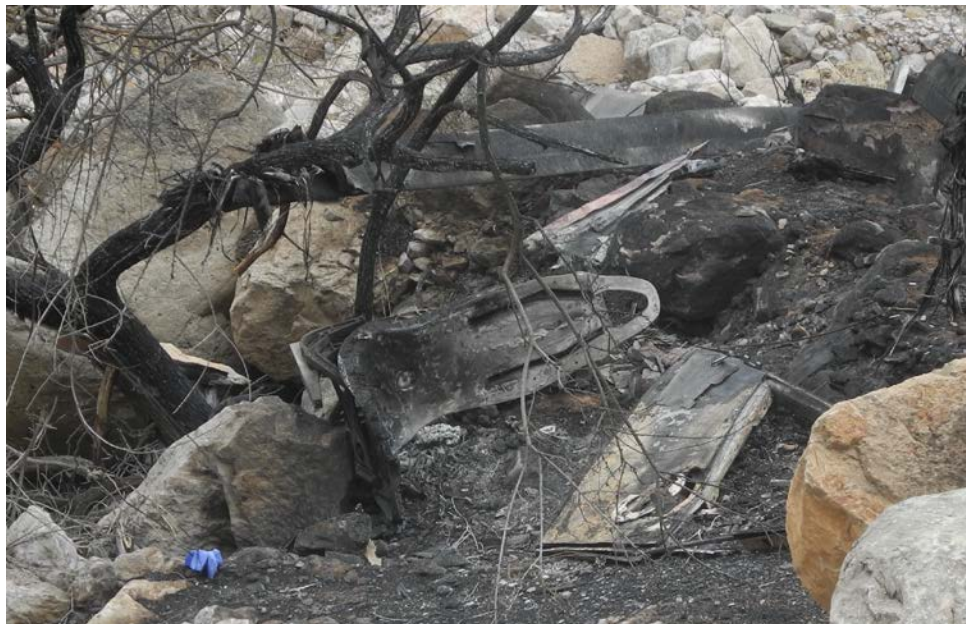
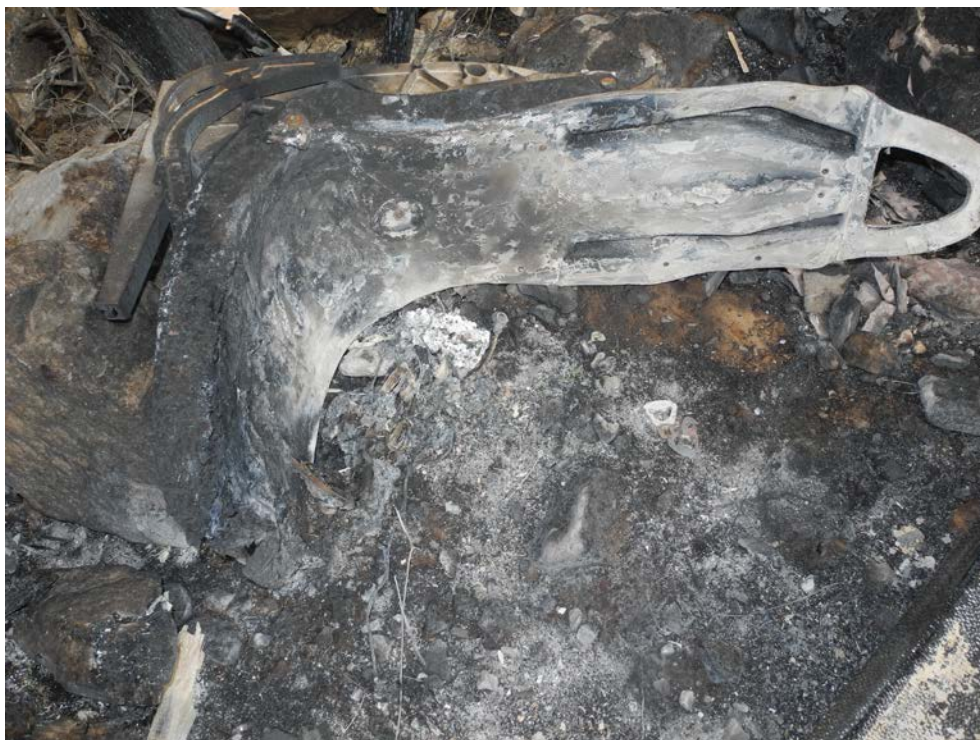
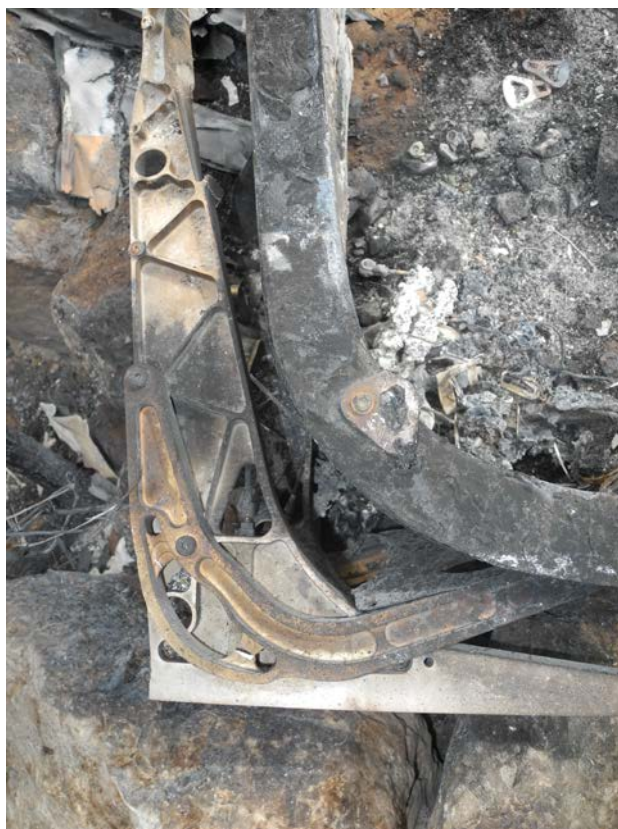
One seat was found to the front right of the wreckage, over a line of boulders and adjacent to a small tree. (see photos 5, 6, and 7.) The carbon fiber seat was mostly whole but was thermally damaged. Both left and right seat frames had separated from the floor track. The left side webs were not fractured but the right side webs were both fractured. The right-side vertical track's forward end was fractured and missing and thermally damaged, but the right side of the seat was displaced partially down vertical track.

**Photo 5. Thermally damaged seat found near a small tree.**

**Photo 6. Close-up of the thermally damaged seat found near a small tree.**

**Photo 7. Right-side seat frame from seat found near small tree.**

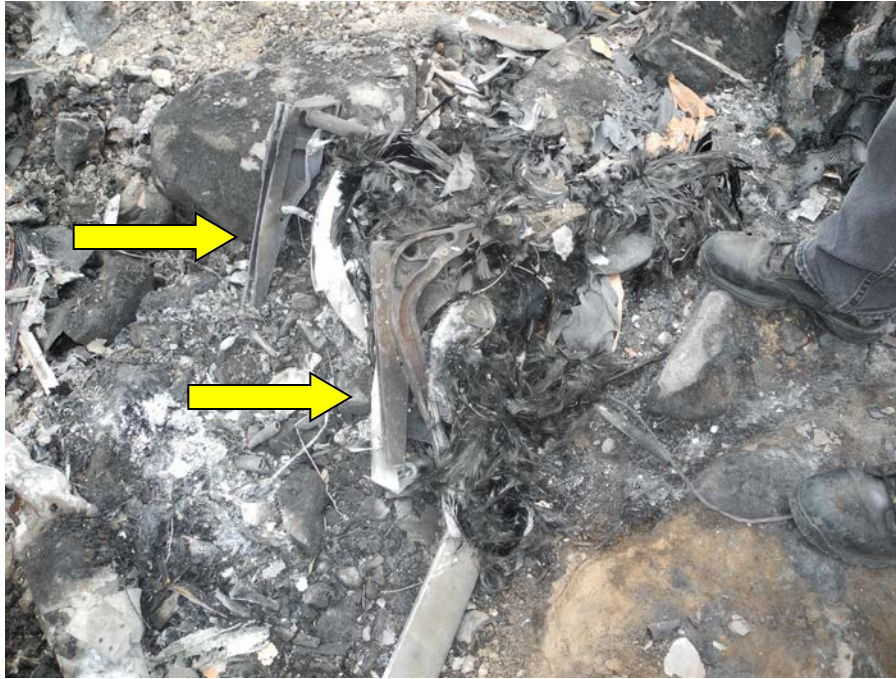
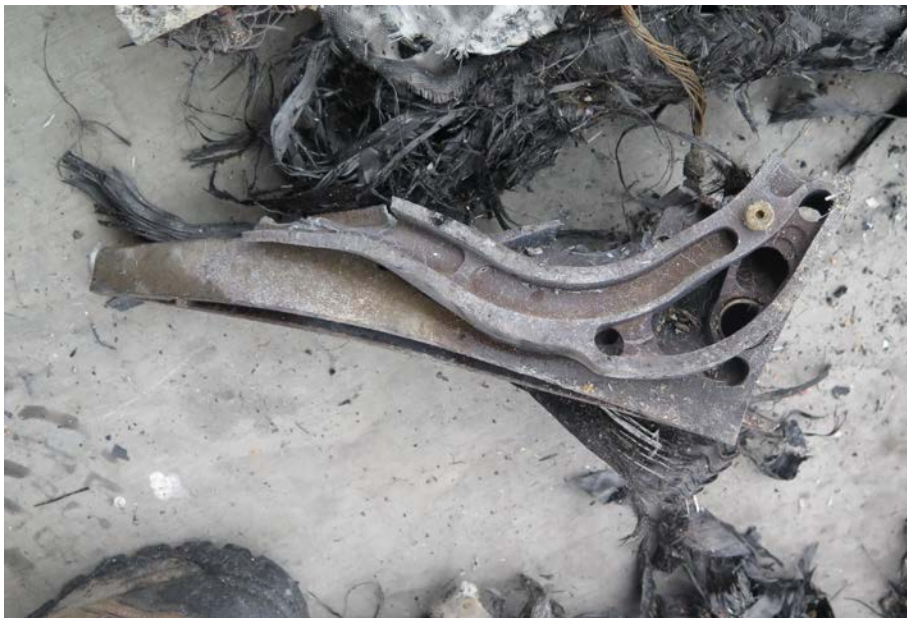
Another seat frame was found immediately to the front-right of the helicopter. Remnant loose carbon fiber pieces from the seat were attached to both left and right aluminum frames. The right-side webs were both fractured. The left side aft web was partially fractured and the front web was fully fractured. Both left and right frames had separated from the floor track. (see photos 8 and 9.)

**Photo 8. Thermally damaged seat found immediately to the front right of the helicopter (left and right frames visible).**

**Photo 9. Left frame of seat found immediately to front right of helicopter (front web was fractured; aft web was partially fractured).**

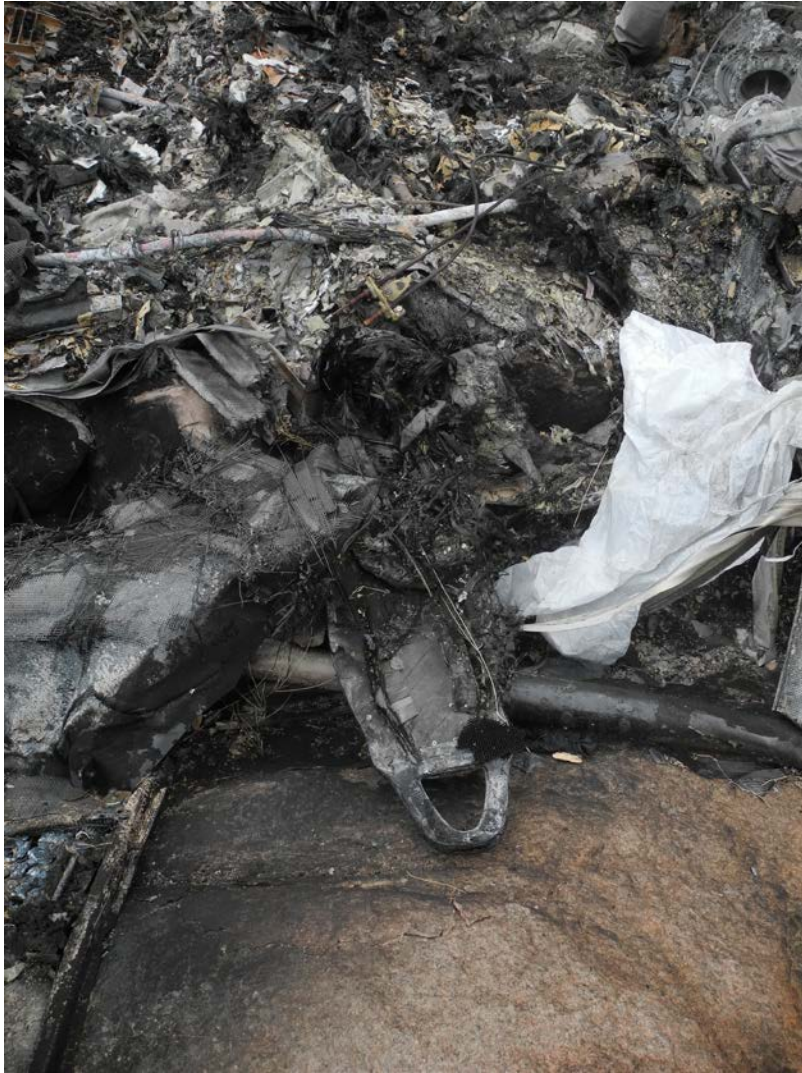
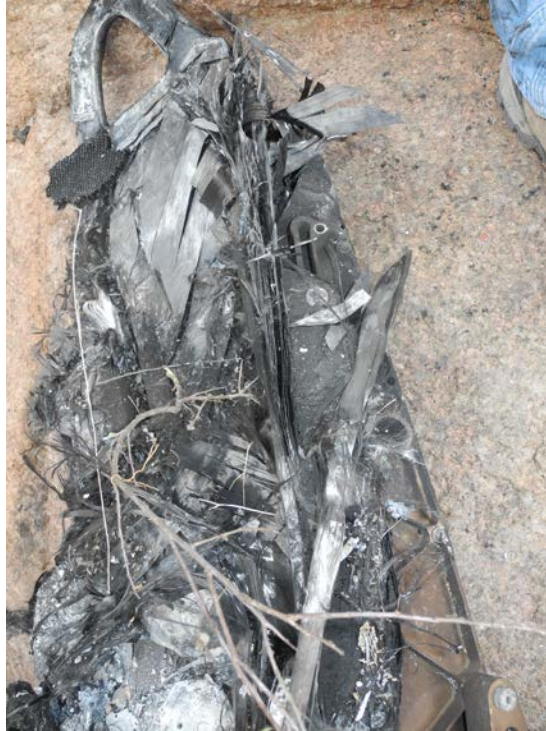
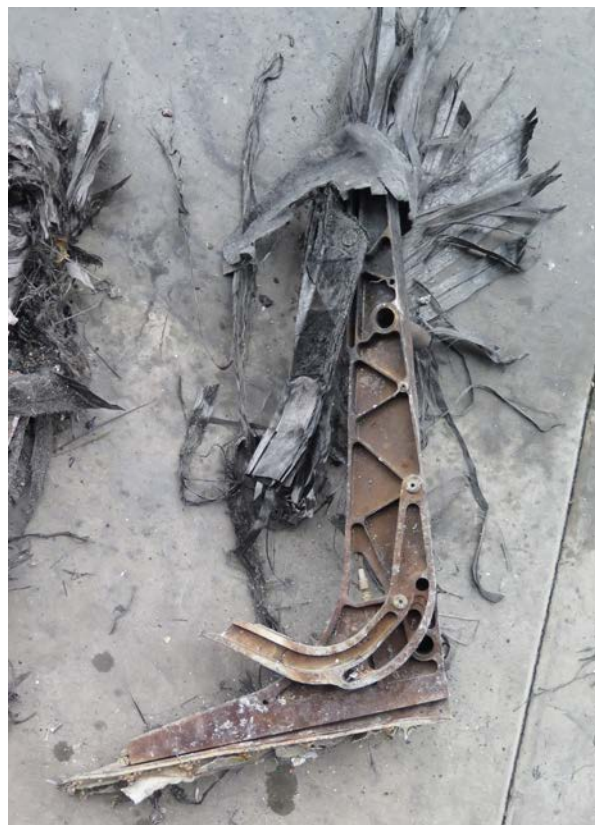
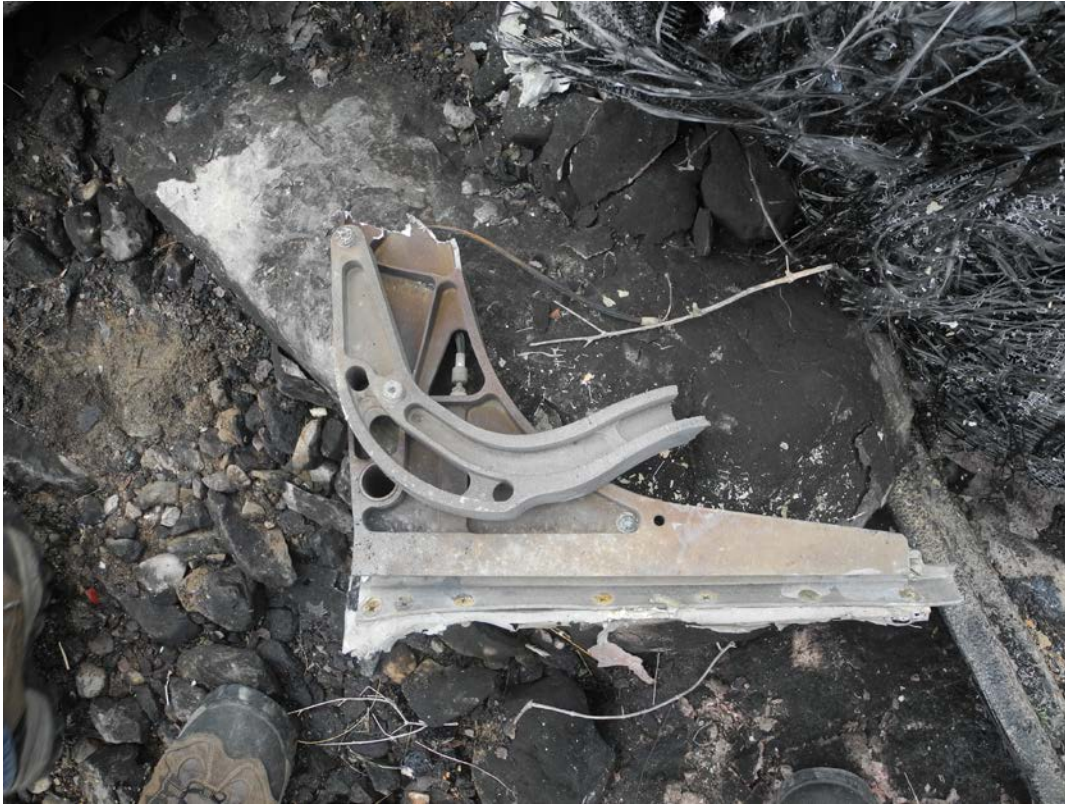
The aft left seat was found immediately behind the pilot seat. (see photos 10, 11, and 12.) The carbon fiber seat was mostly whole but thermally damaged. Remnant seat track and airframe was attached to the left frame. Both webs on the left side were intact. The left side of the seat was about 3.5 inches down the vertical track (along which the seat strokes) but the seat was loose and could be moved by hand. The right side of the frame was fractured along the vertical track but both webs remained intact. All pieces exhibited thermal damage.

**Photo 10. Aft left seat.**

**Photo 11. Left frame of aft left seat.**

**Photo 12. Left frame of aft left seat.**

**Photo 13. Right frame of aft left seat.**

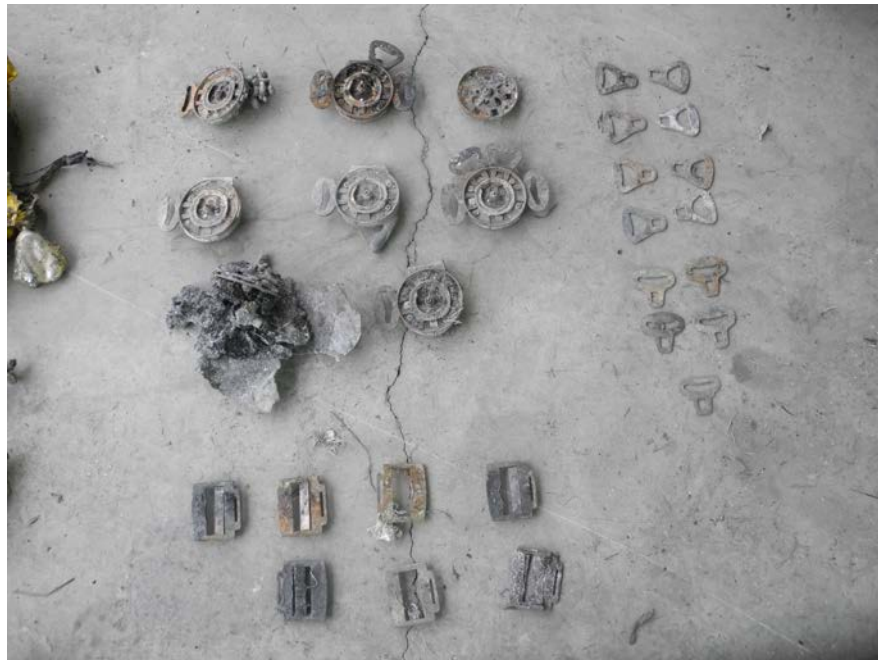
Each seat was equipped with a 4-point Pacific Scientific rotary buckle restraint. All eight rotary buckles were recovered. Seven were found loose in the wreckage and one was stuck within resolidified metal. Thirteen loose insert tabs were identified. One buckle had all four tabs inserted, while another buckle had three tabs inserted.<sup>2</sup> (see photo 15.)

**Photo 15. Rotary seatbelt buckles, insert tabs, and adjusters identified in the wreckage.**

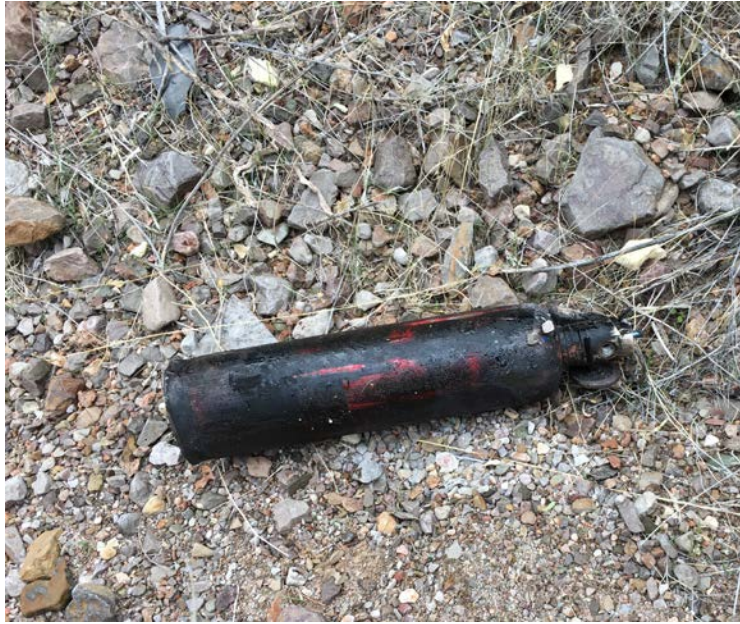
A charred fire extinguisher was found in the wreckage. It was normally stowed in a bracket on the floor between the pilot seat and passenger seat #1. (see photo 17.) Portions of several burned or partially burned life vests were found near the wreckage.

**Photo 16. Burned fire extinguisher found in the wreckage.**
