## RECORD OF COMMUNICATION

**Date: September 12, 2018**  
**Person Contacted: Mr. Ray Lawrence (ULPower Engines Representative)**  
**NTSB Accident Number: WPR18TA223**

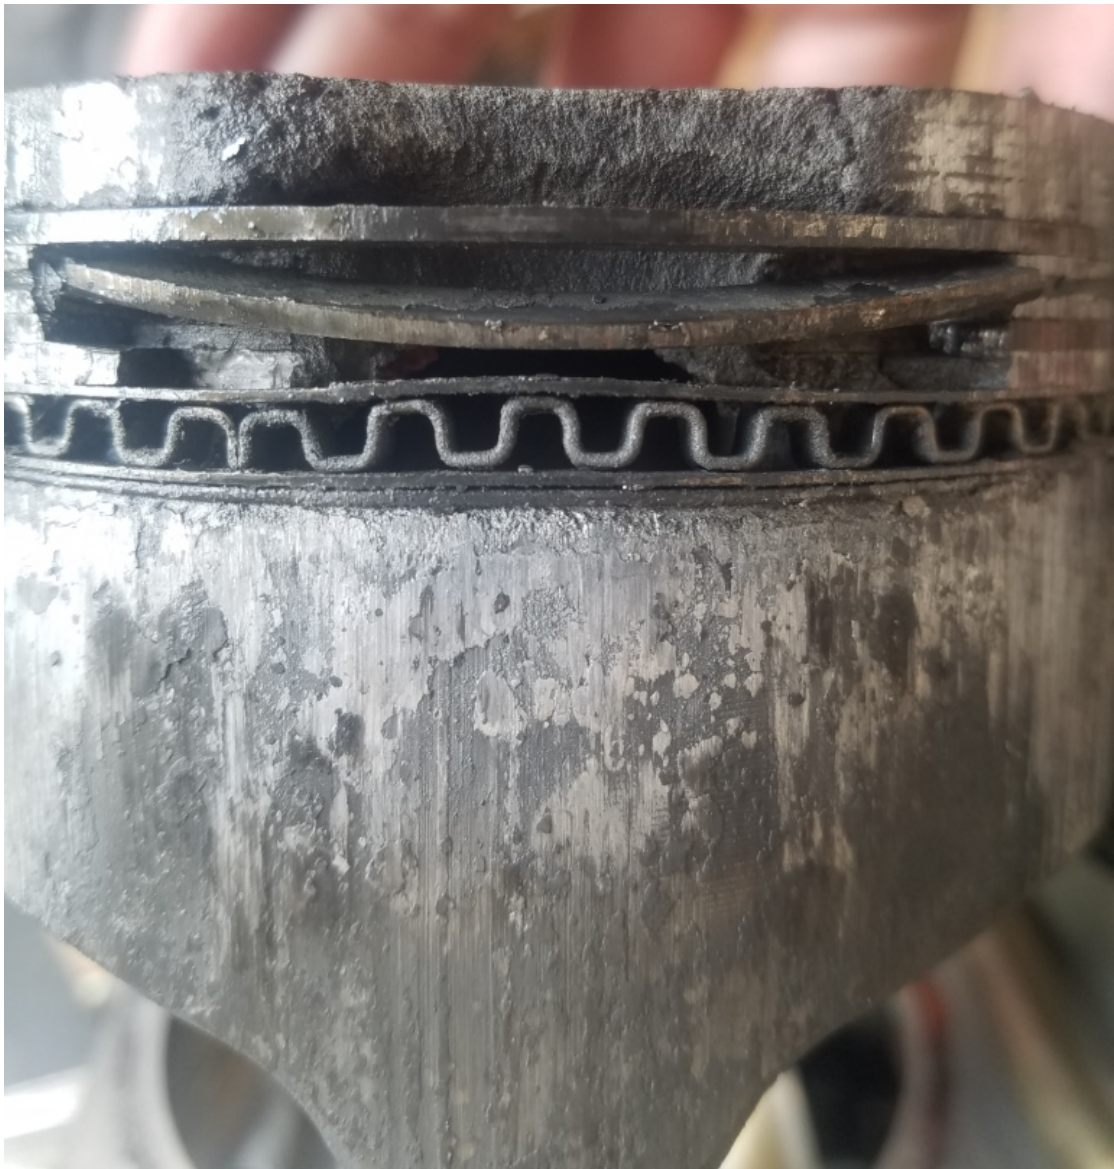
I have inspected this engine this week and found that the probable cause of failure was detonation, probably caused by the use of fuel with a lower than recommended octane rating.

I am including pictures of the affected piston, showing severe erosion.

This would have allowed the crankcase to become pressurized, forcing the engine oil out through the crankcase vent and exhaust valve. The erosion is present in #1 piston and an excessive amount of oil was present in #1 exhaust pipe, to support this opinion.

**Figure 1 - Damaged Piston**

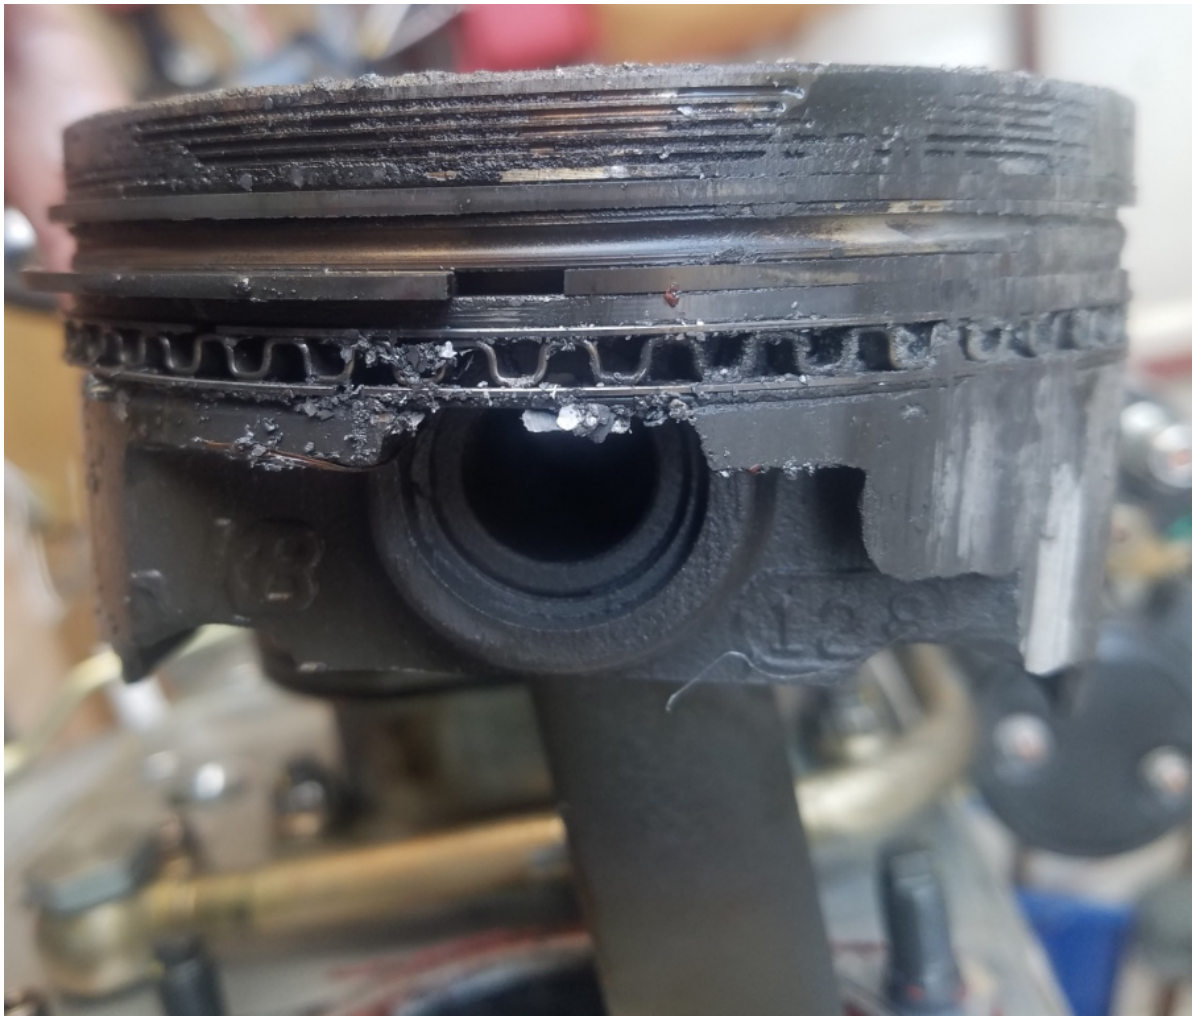
**Figure 2 - Damaged Piston**

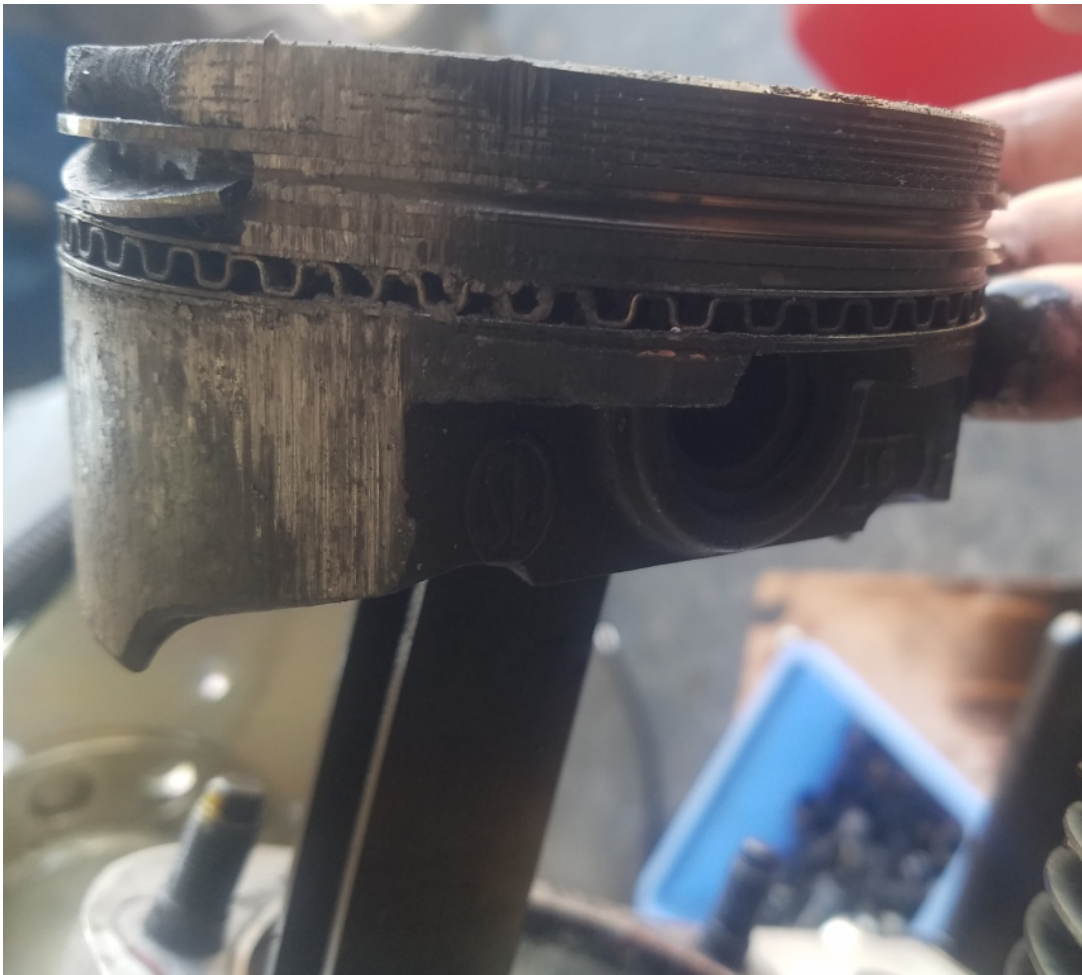
**Figure 3 - Damaged Piston**

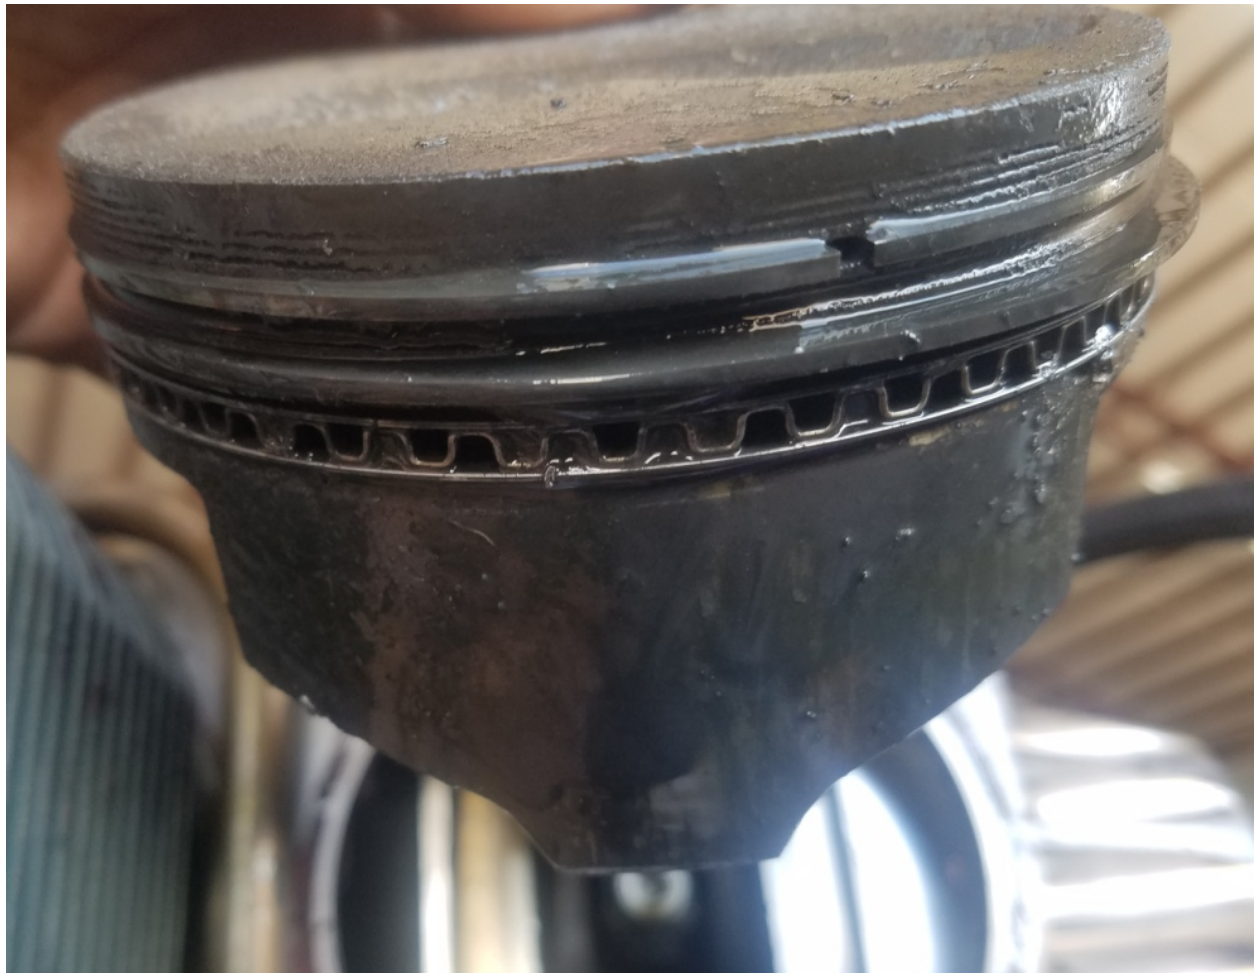
**Figure 4 - Damaged Piston**
