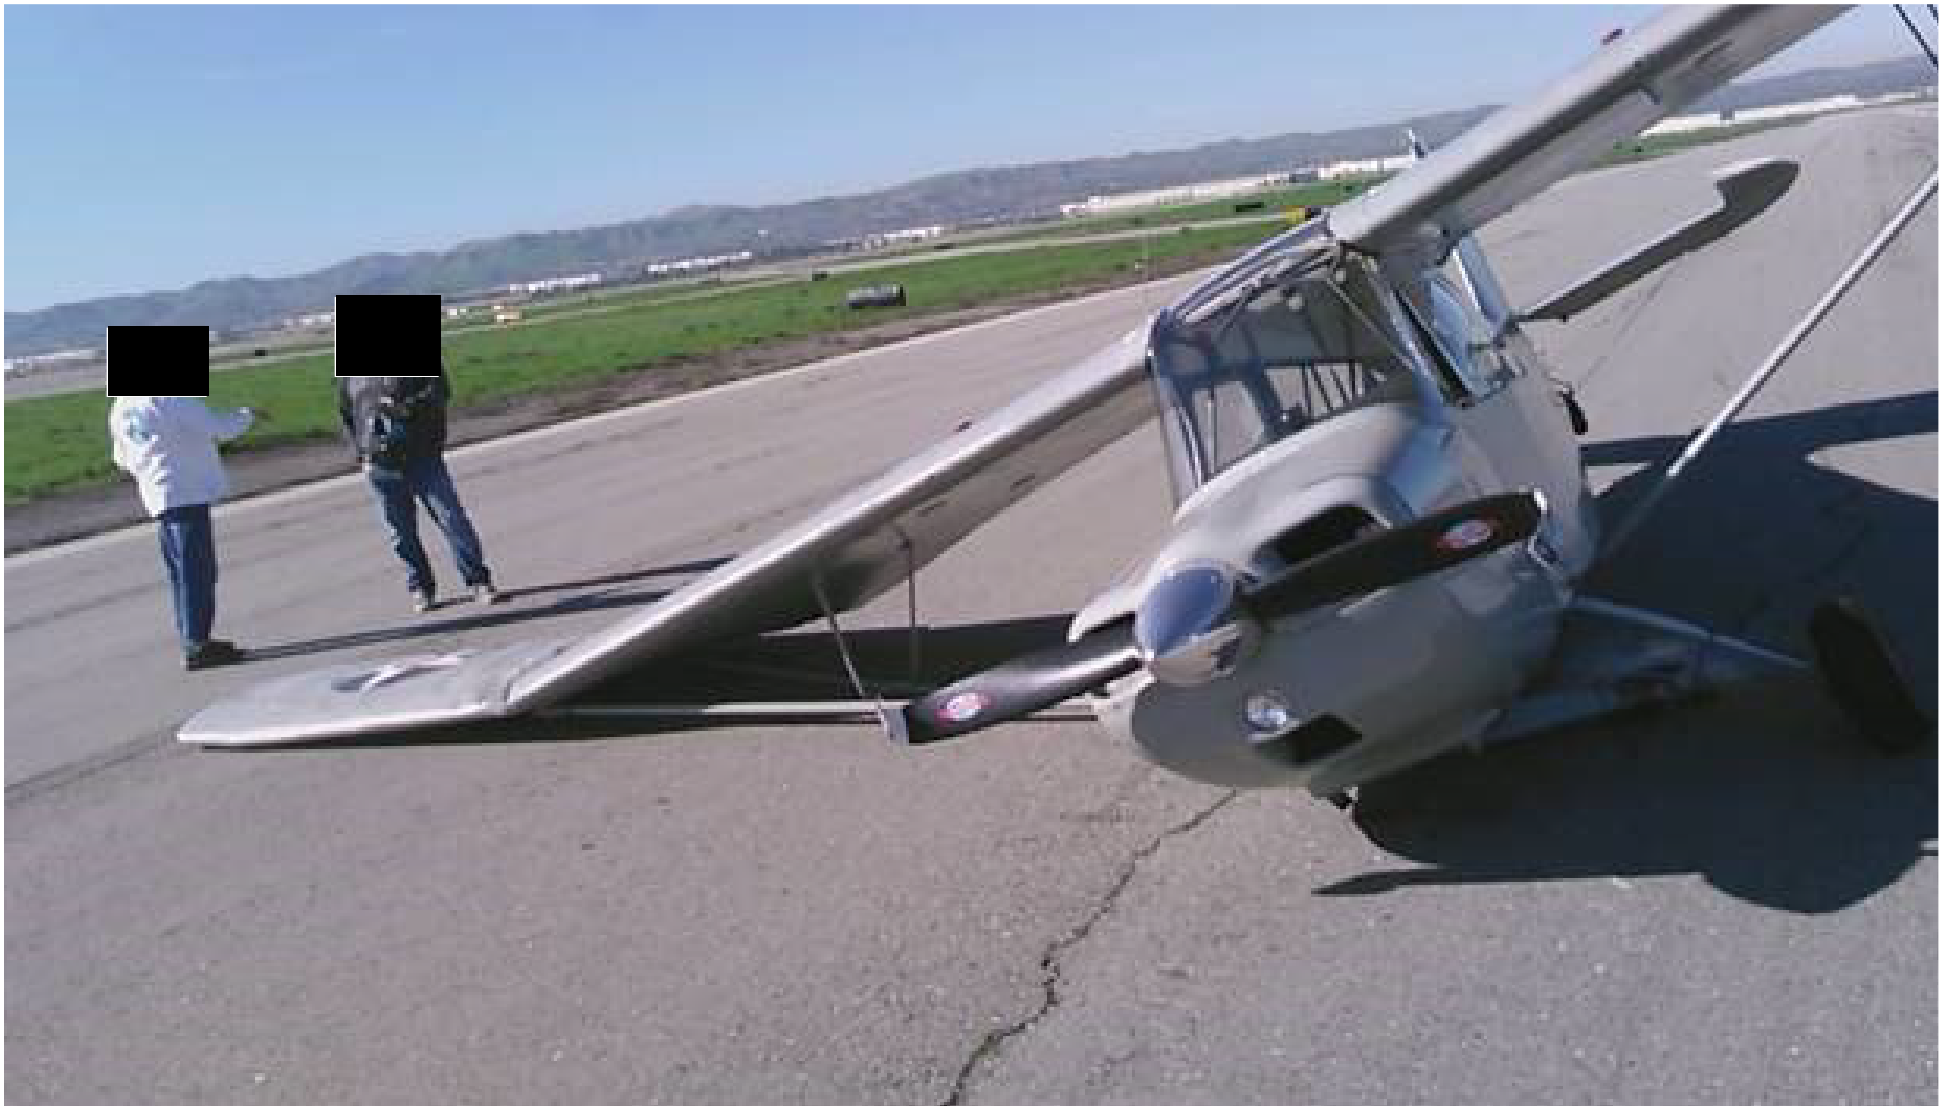
**Photo 1 – Damage to the Right Wing and Collapsed Landing Gear (Photo Provided by Airport Manager)**
