## **WITNESS STATEMENT**

**Date: October 5, 2018**  
**Person Contacted: Fabian Salazar (Air Safety Investigator, NTSB)**  
**NTSB Accident Number: WPR19FA001**

RE: aircraft accident, N7997M, Beech Bonanza, October 01, 2018, Brackett Field (KPOC), La Verne, California.

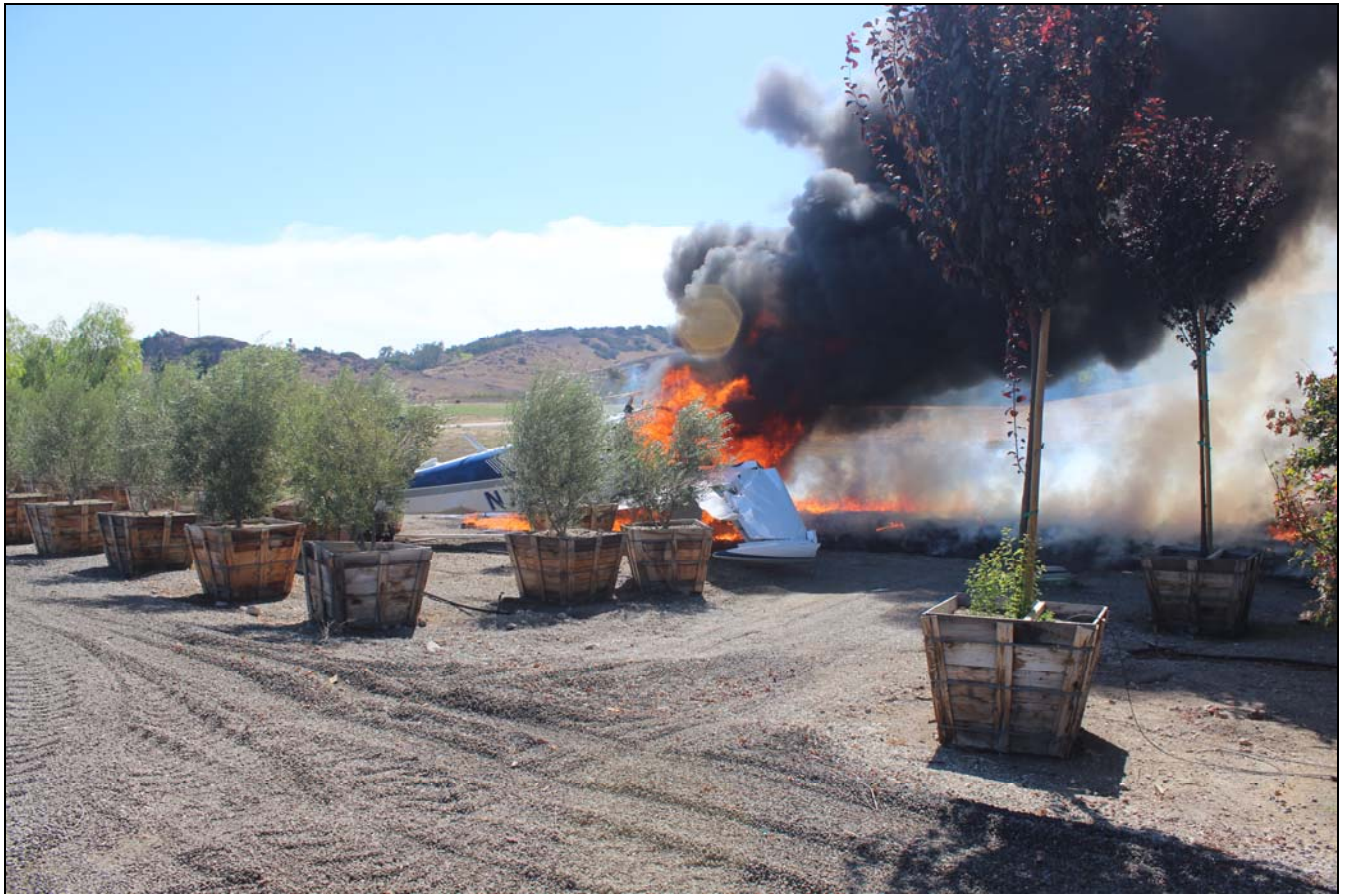
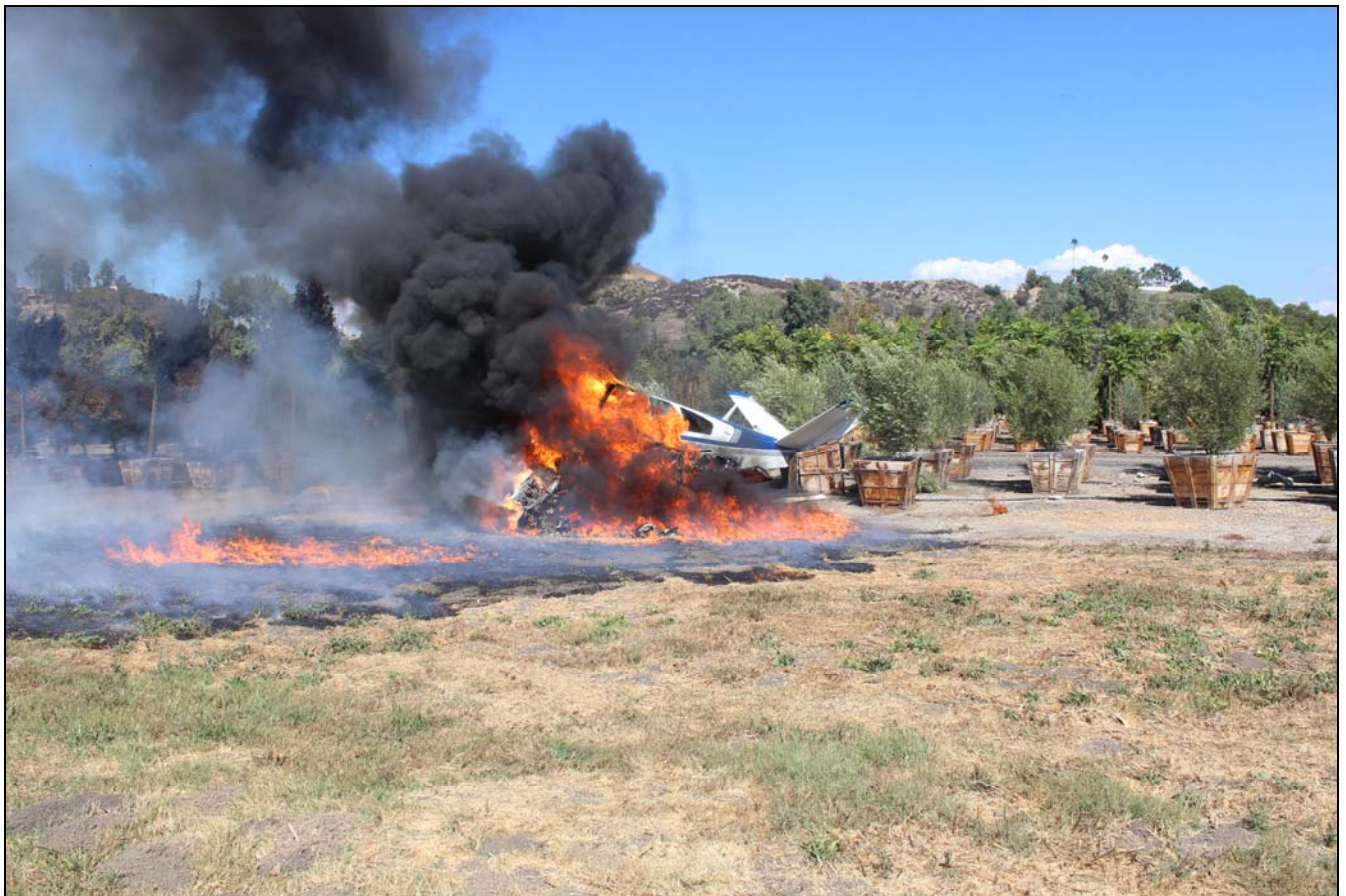
As I stated earlier, at the time of this accident I was actively engaged documenting the previous day's accident. I had my camera in its tether harness, and when I arrived at the Bonanza accident I instinctively started to photograph the site. I have included these photos (attached) for your file.

I can say I knew the subject aircraft had collided with the trees due to the sound I heard. I have heard this distinct sound hundreds of times during the recovery process of previous accident aircraft while being dragged across trees and brush. Additionally, I visualized tree branches on the ground in-line with the aircraft energy path.
