## Air Safety Investigations Aircraft Incident/Accident Technical Report

| Aircraft Incident/<br>Accident Information | Year: 1966 | Make: Beechcraft | Model: V35 |
| Air Safety Investigator: Jennifer D. Barclay | | Report #: ASI-18-DC | Report date: 02-01-19 |

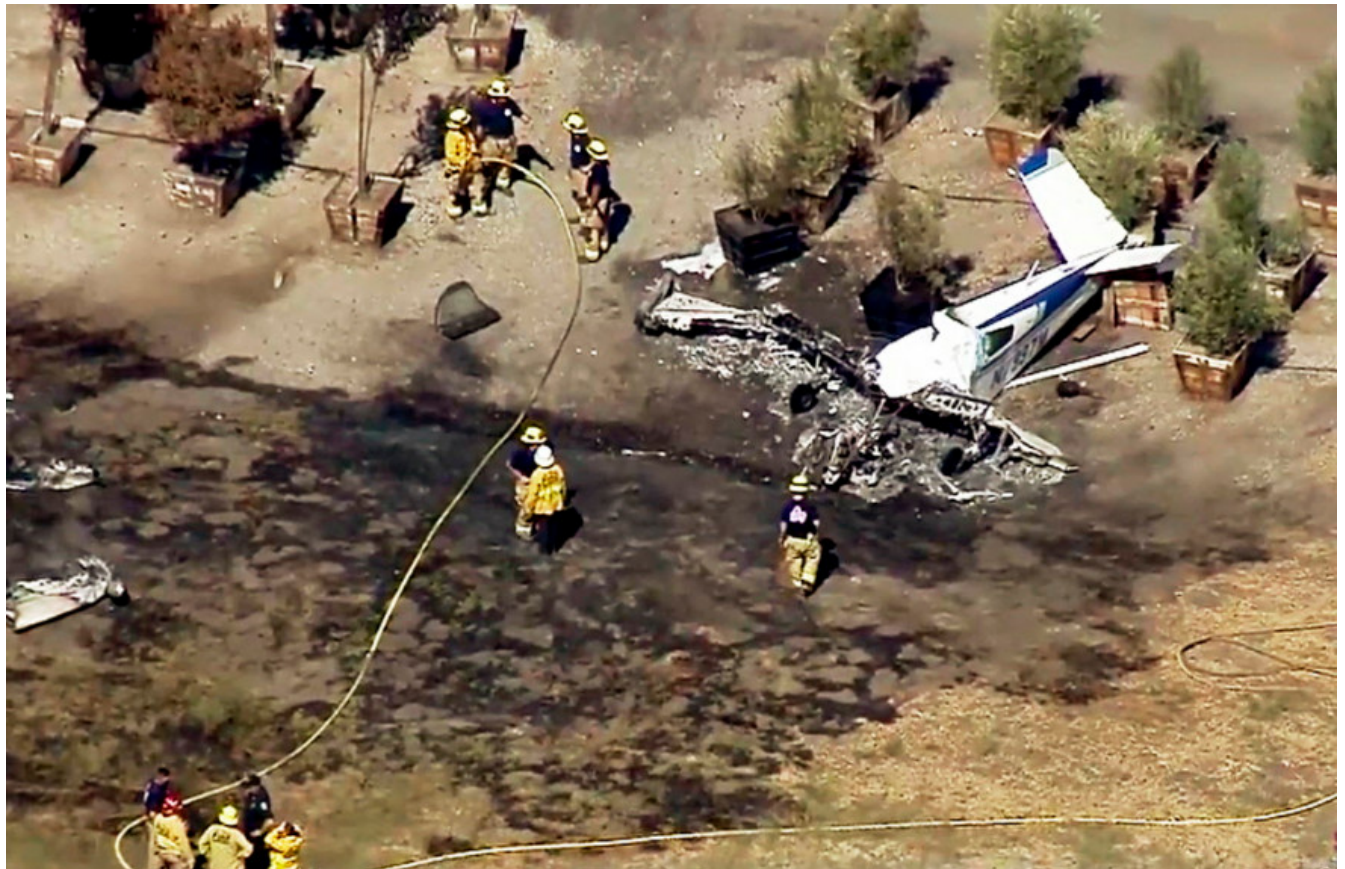
The aircraft struck a tree approximately 50' in height about 900' from the approach end of runway 8R, and about 185' left of the runway centerline. According to witnesses, the aircraft was in a left bank and nose low attitude prior to impact. The inboard wings and forward fuselage were consumed by a post impact fire.

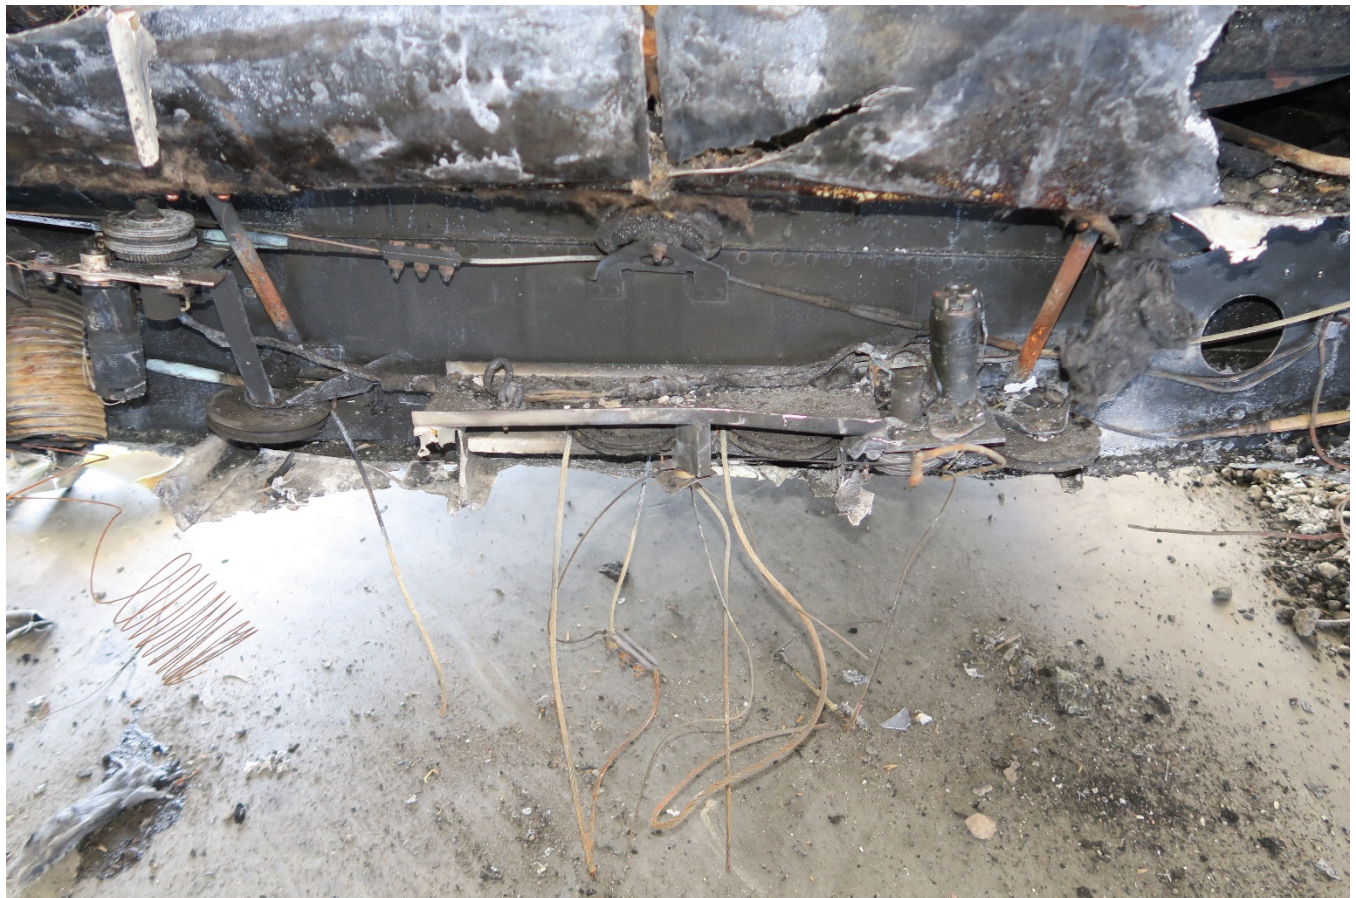
Aileron control cable continuity was established from the bellcranks to the wing root where the cables were cut by recovery personnel. Ruddervator control cable continuity was established from the control surface to the aft spar. The area forward of the aft spar, including the cockpit was destroyed by the post impact fire. The right flap actuator was not located in the wreckage. The left flap actuator indicated flap deployment to approximately ten degrees.

Aft Wing Spar, ASI-18-DC-042 Wreckage Exam

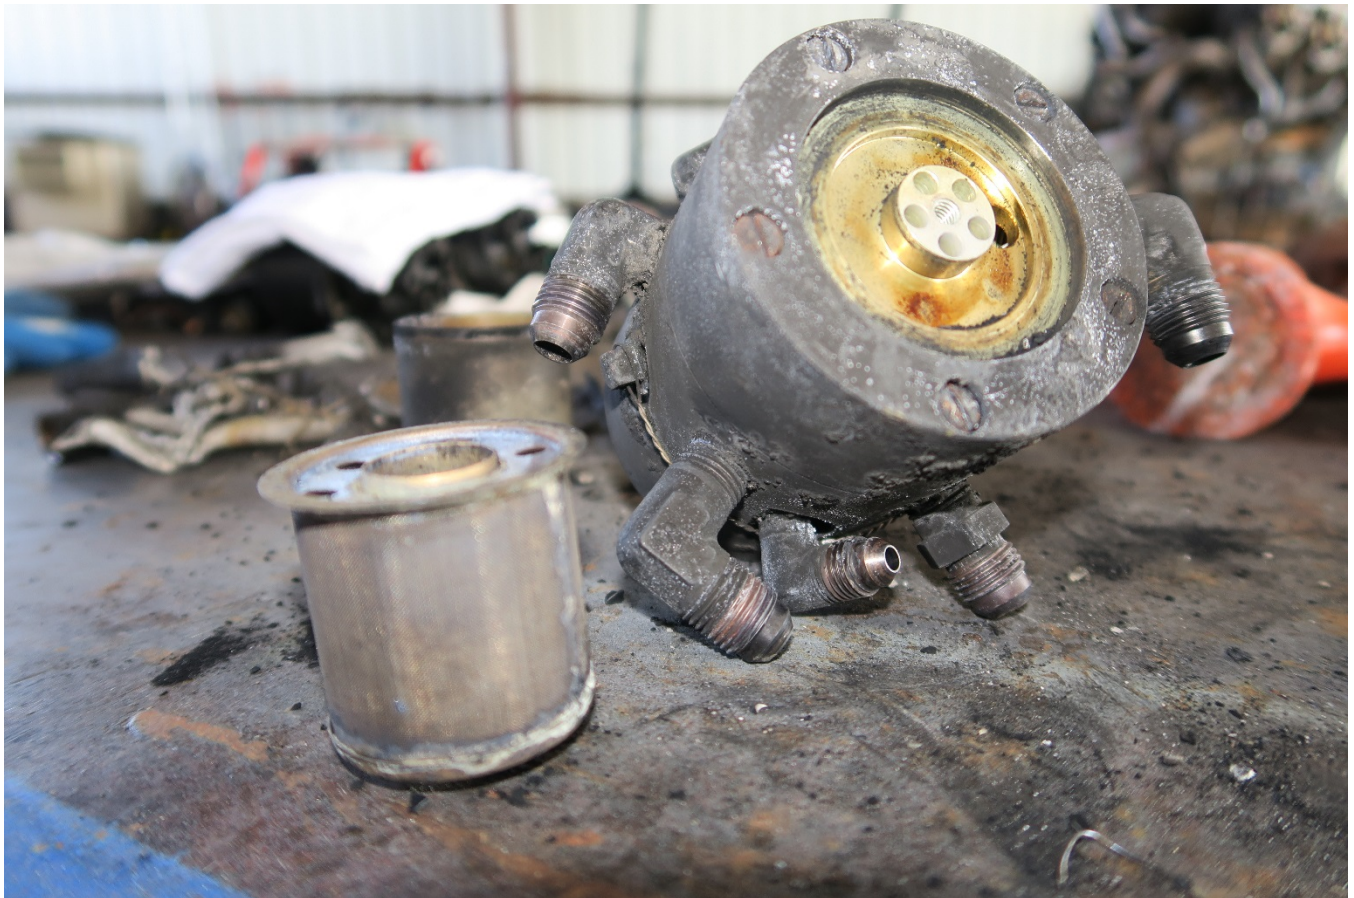
The fuel selector mounting bracket fractured on impact. The fuel selector valve was thermally damaged and all 'B' nuts were secure. The fuel selector valve was found in the OFF position. The valve was tested in each position by blowing air through the outlet port. No fuel remained in the strainer and soot was found in the screen.

Fuel Selector Valve, ASI-18-DC-053 Wreckage Exam

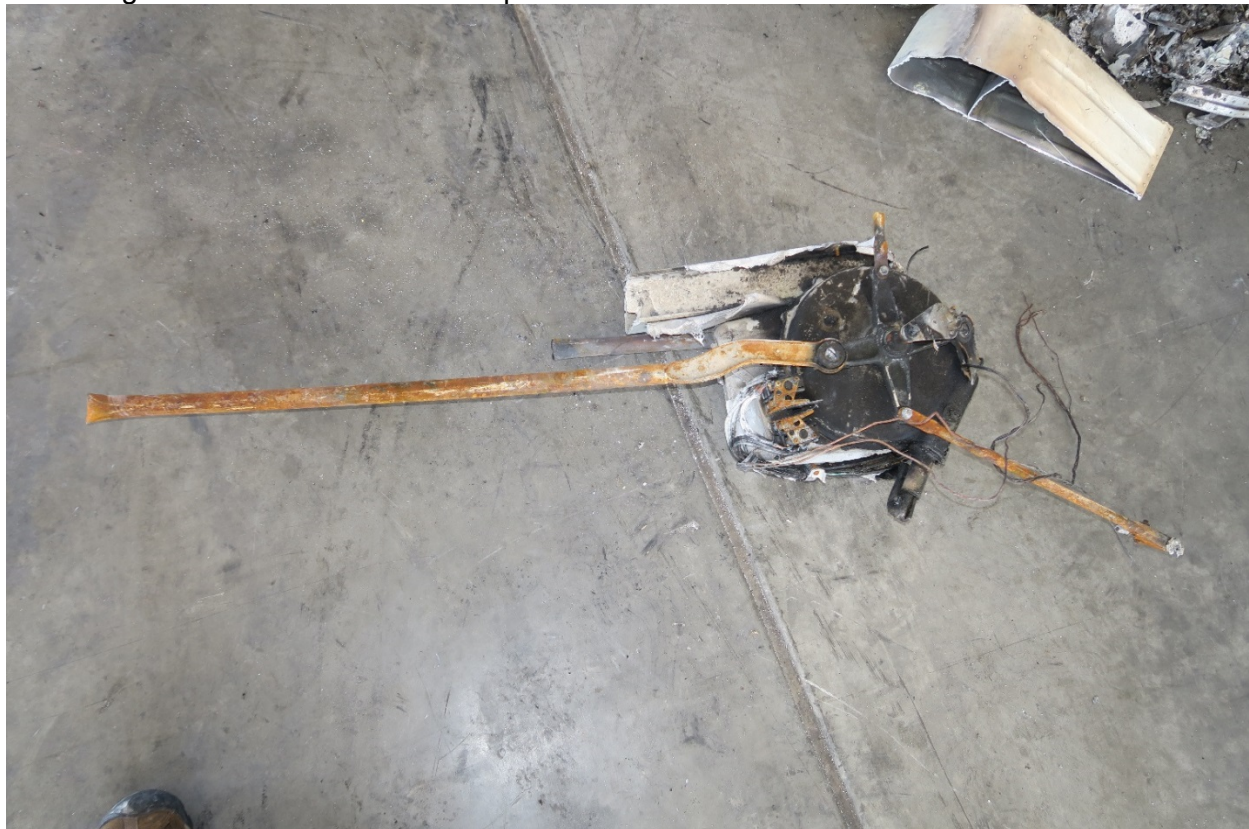
The position of the landing gear actuator arms indicated the gear was extended. The push/pull rods from the gearbox were fractured on impact.

Landing Gear Retract Gearbox, ASI-18-DC-040 Wreckage Exam

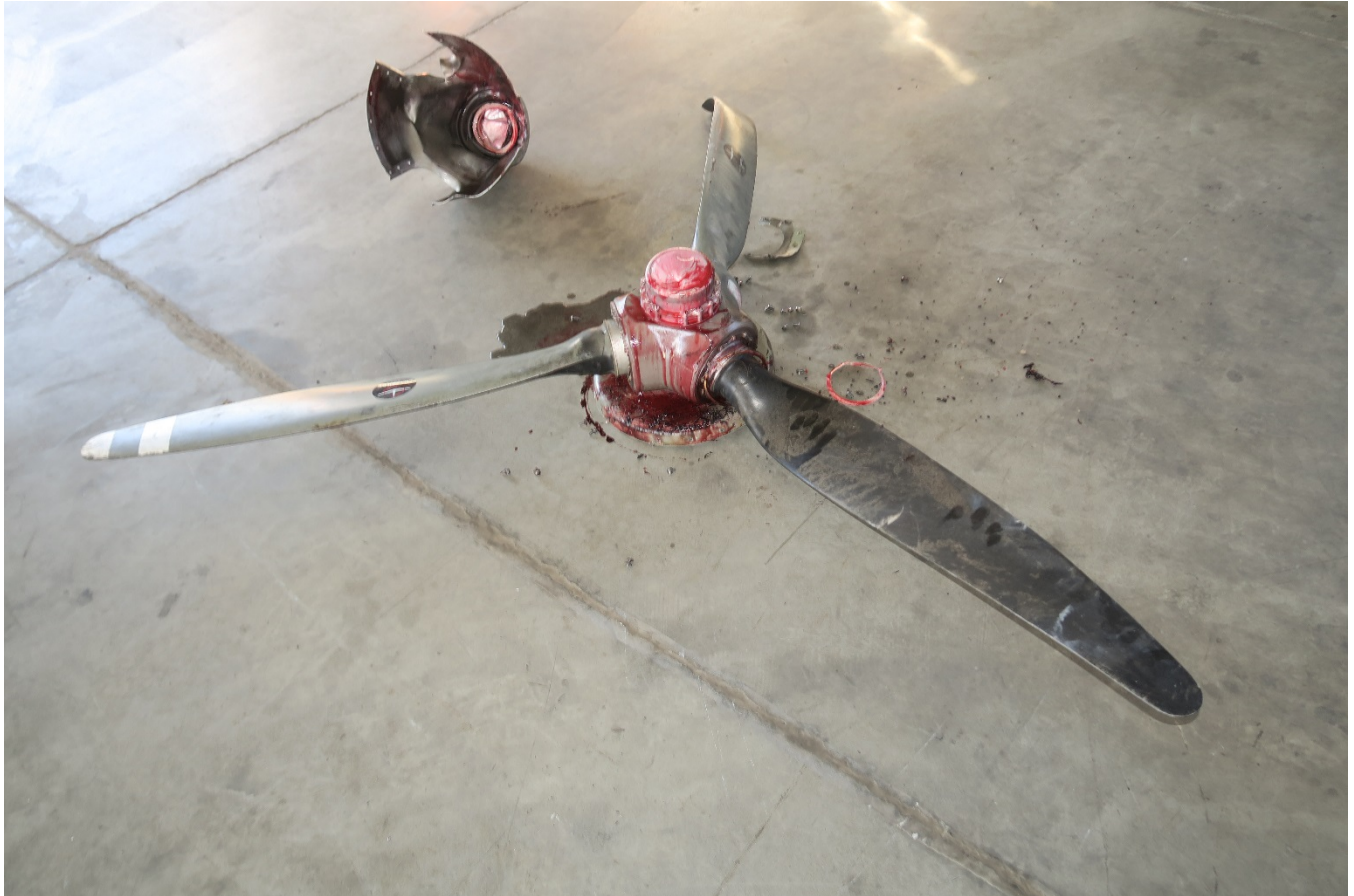
The propeller was separated from the engine at impact. Blade one was bent slightly aft at the tip and was found loose in the hub. Blade two was bent aft at the root and exhibited leading edge burnishing; the blade was loose in the hub. Blade three was straight with minimal damage. The propeller exhibited signatures of low power rotational impact.

Propeller, ASI-18-DC-062 Wreckage Exam
