## **NATIONAL TRANSPORTATION SAFETY BOARD**

# **ACCIDENT SITE, AIRFRAME, AND ENGINE EXAMINATION SUMMARY**

**WPR19FA001**

| Aircraft: | Beech V35, N7997M |

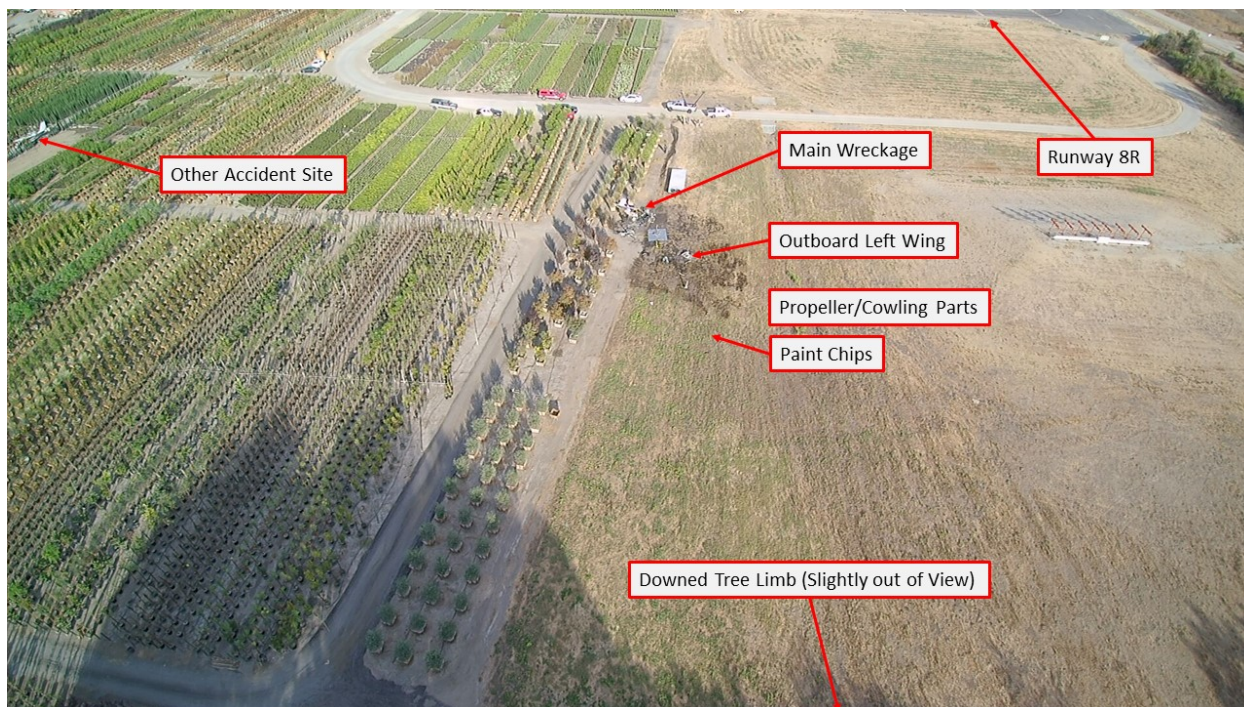
Figure 1: Accident site overview. Image courtesy of the La Verne Fire Department.

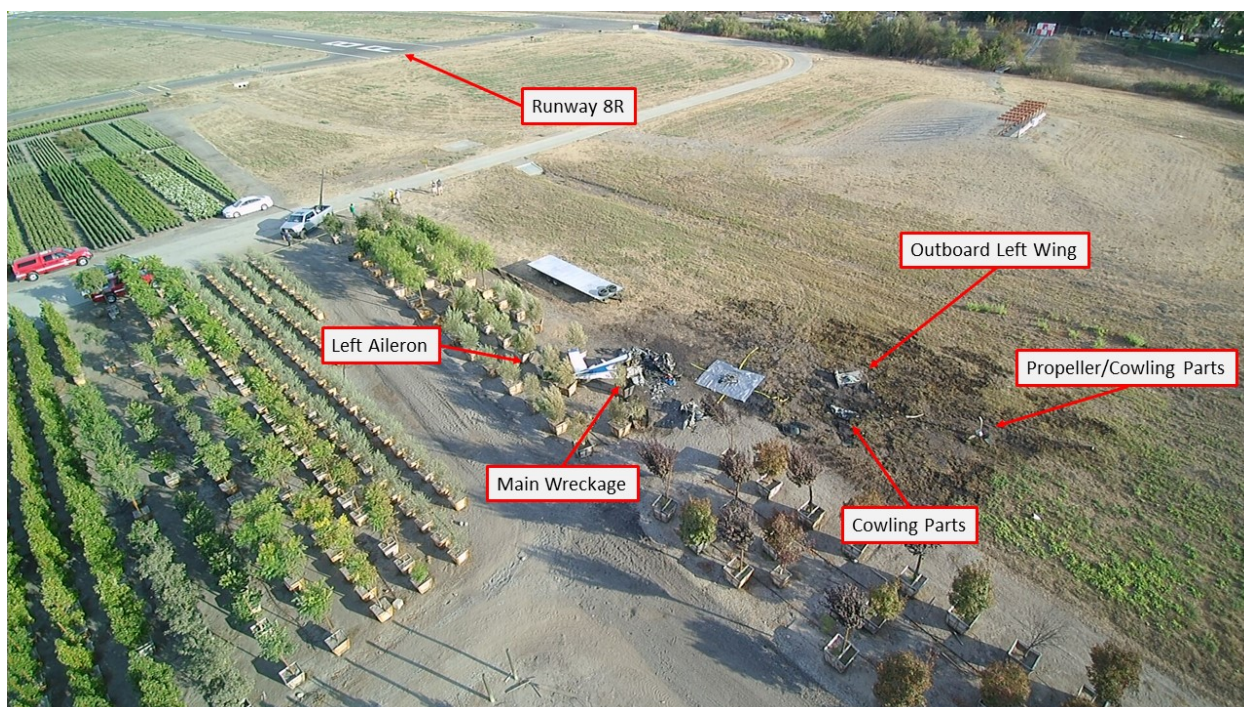
Figure 2: Accident site overview. Image courtesy of the La Verne Fire Department.

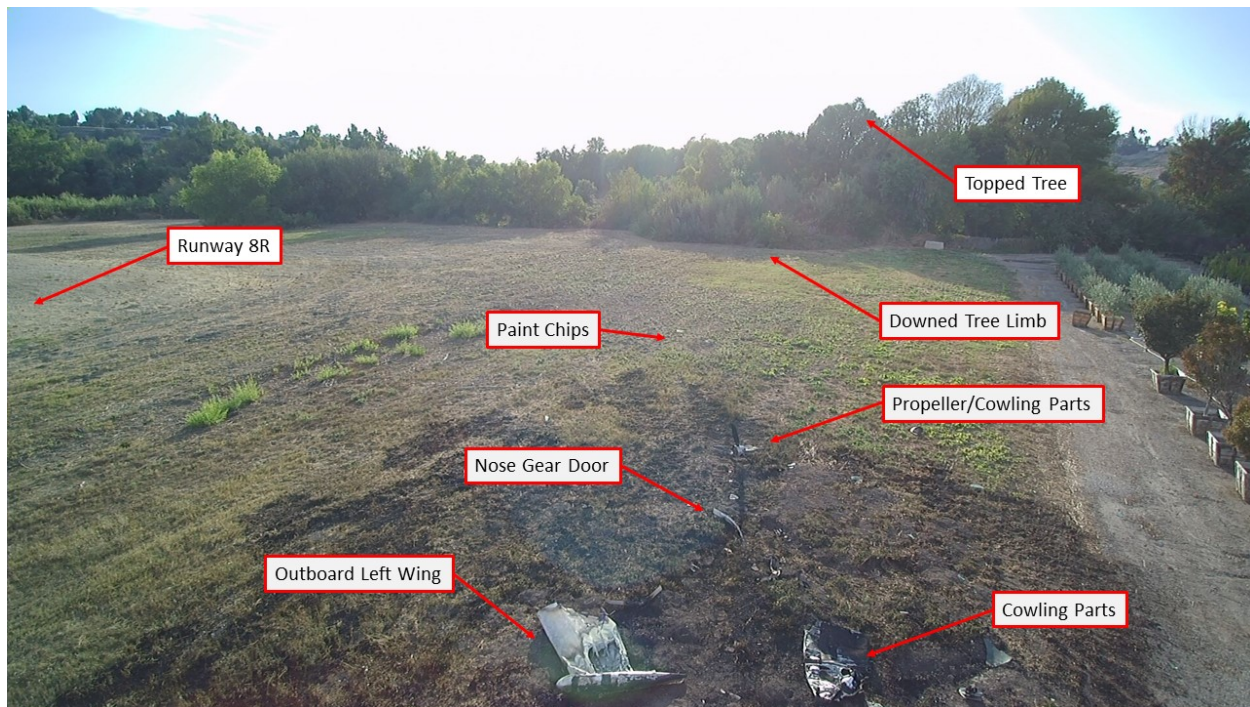
**Figure 3: Accident site overview. Image courtesy of the La Verne Fire Department.**

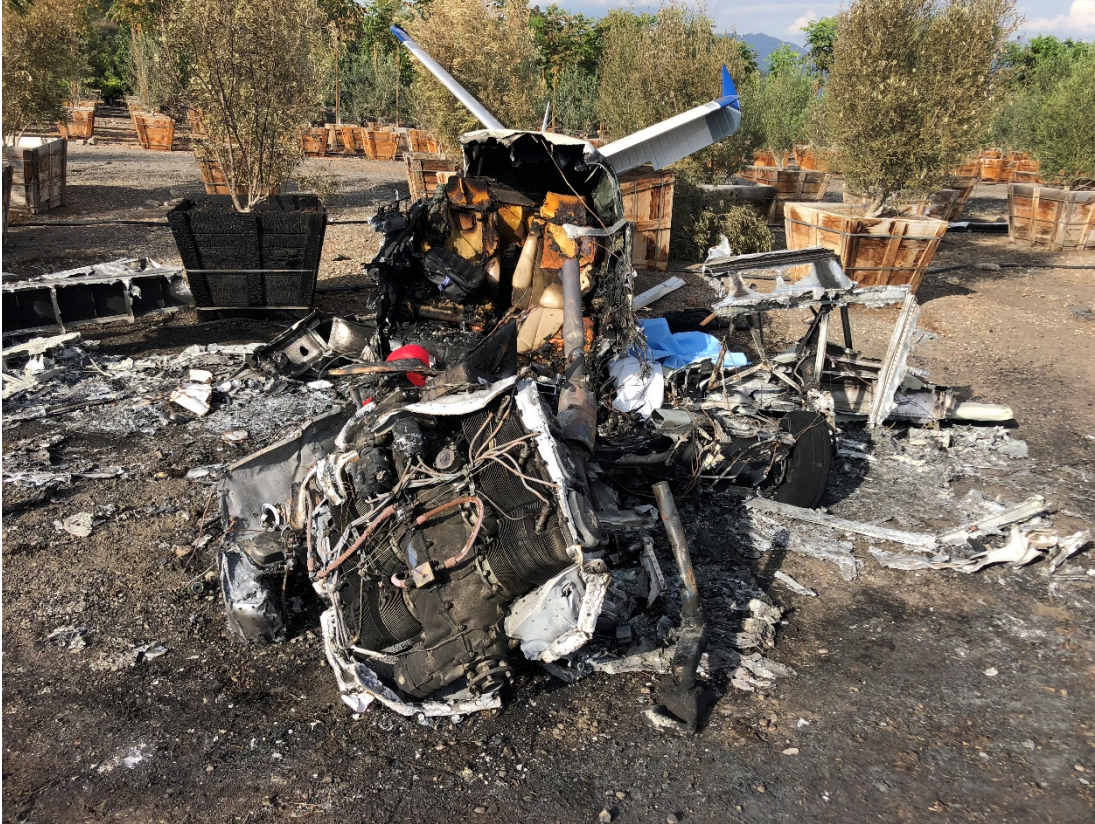
**Figure 4: View of the main wreckage.**

The left wing remained attached to the fuselage and exhibited fire damage. The flap remained attached to the wing structure and appeared to be in the “up” position. The left main landing gear appeared to be in the extended position. A majority of the wing structure was consumed by fire. The outboard part of the left wing that was separated was fire damaged. The tip tank remained attached to the wing structure. The leading edge of the wing just inboard of the tip tank was buckled / bent and the tip tank appeared to be displaced/bent slightly inboard. The aileron was separated and exhibited bending and buckling throughout its span.

The right wing remained attached to the fuselage and was fire damaged. The wing structure was mostly consumed by fire. Remains of the flap and aileron were observed. The tip tank was partially attached to the wing. The right main landing gear appeared to be in the extended position.
