# Continental Motors

## ENGINE EXAMINATION REPORT

| ENGINE MODEL | IO-520-BA |
| FILE NUMBER | 18-216 |

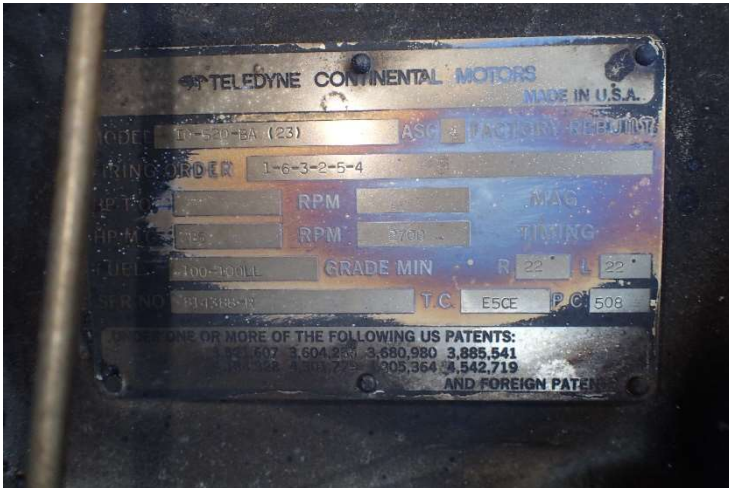
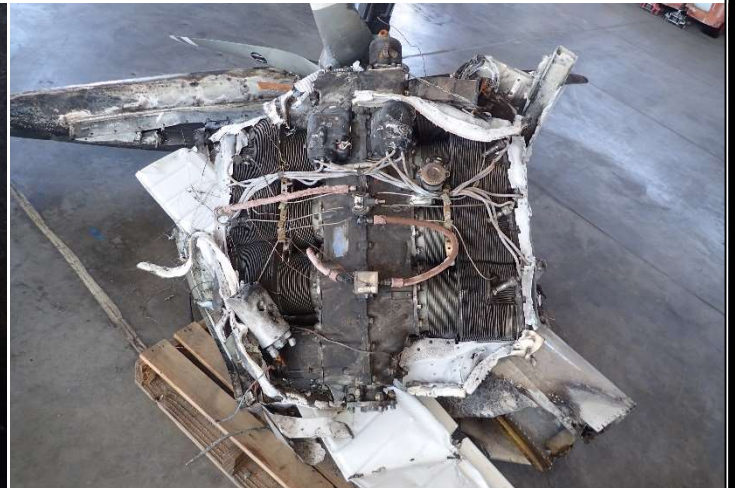
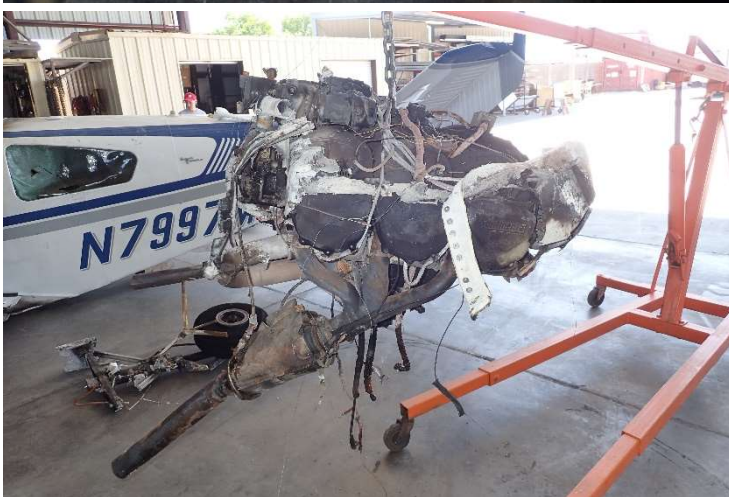
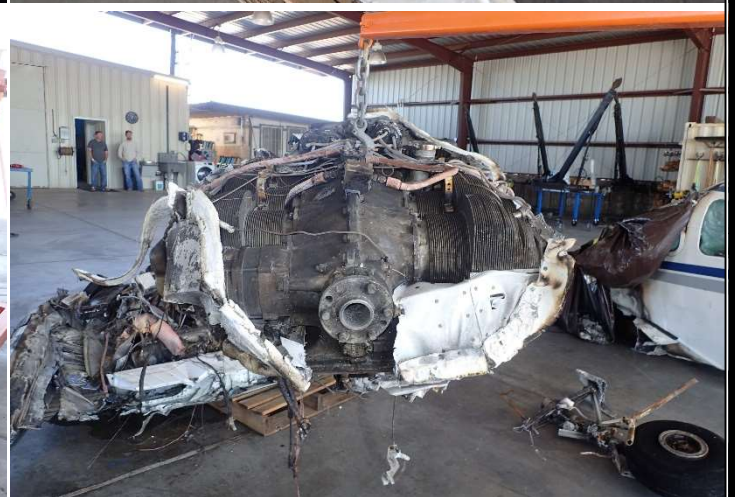
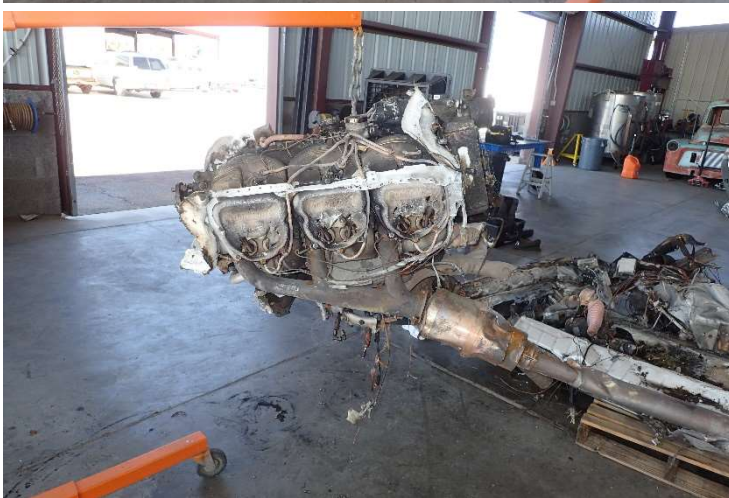
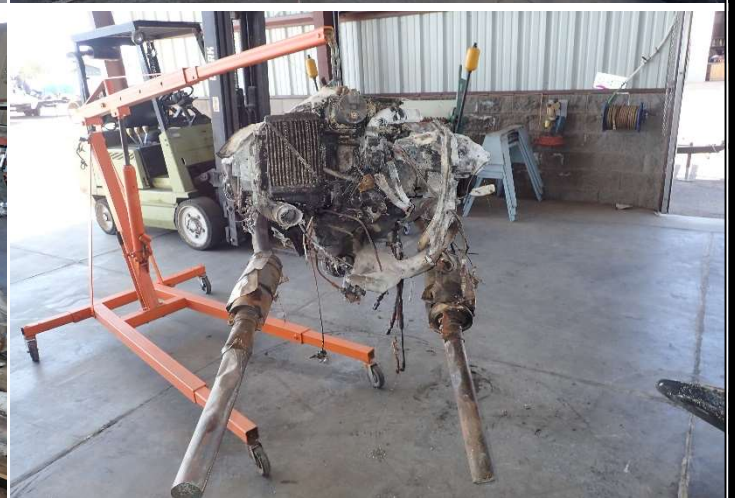
The engine remained partially attached to the airframe and displayed impact damage and a significant amount of thermal damage. The crankcase remained intact and displayed thermal damage signatures; there were no signs of a catastrophic engine failure with the crankcase. The propeller flange remained attached to the rest of the crankshaft and displayed impact damage signatures to the propeller flange. The propeller had broken free from the propeller flange; the propeller studs had pulled out of the propeller hub and remained with the propeller flange. The propeller displayed impact damage signatures. All six cylinders remained attached to their cylinder bays and displayed thermal and impact damage signatures.

Both of the magnetos remained attached to their installation point and displayed thermal damage signatures. The ignition harness remained attached to both of the magnetos and to the spark plugs; the harness leads displayed a significant amount of thermal damage signatures. All of the ignition leads were severely burned. All of the spark plugs remained installed in their cylinders and displayed varying amounts of thermal damage signatures.

The fuel pump remained attached to its installation point and displayed impact damage signature and a significant amount of thermal damage signatures. The throttle and metering assembly remained attached to its installation point and displayed a significant amount impact and thermal damage signatures. The manifold valve remained attached to its installation point and displayed thermal damage signatures.

The induction system displayed a significant amount of thermal damage signatures with the most damage occurring to the rear induction tubes and risers. The exhaust system remained attached to the engine and displayed impact damage signatures.

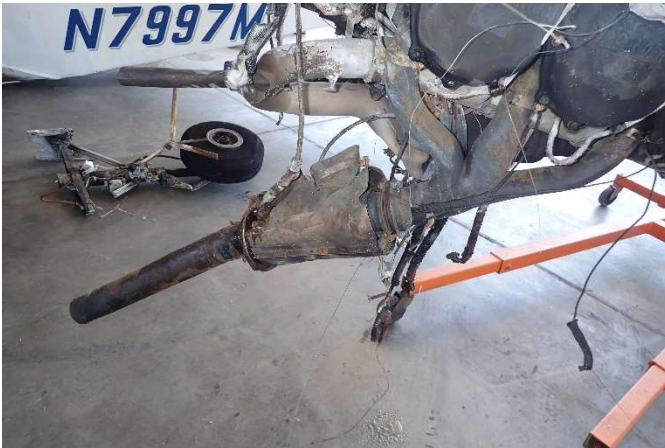
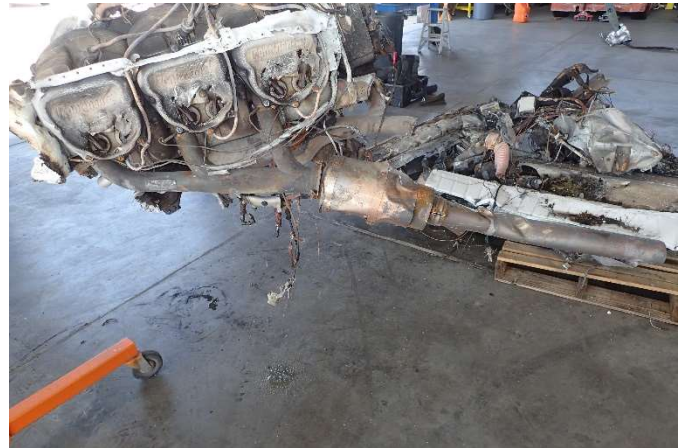
#### EXHAUST SYSTEM

The exhaust system remained attached to the engine and displayed impact damage signatures. The cabin heat exchanger shield was removed, and the exhaust was visually inspected; there were no signs of exhaust leaks anywhere in the exhaust system.

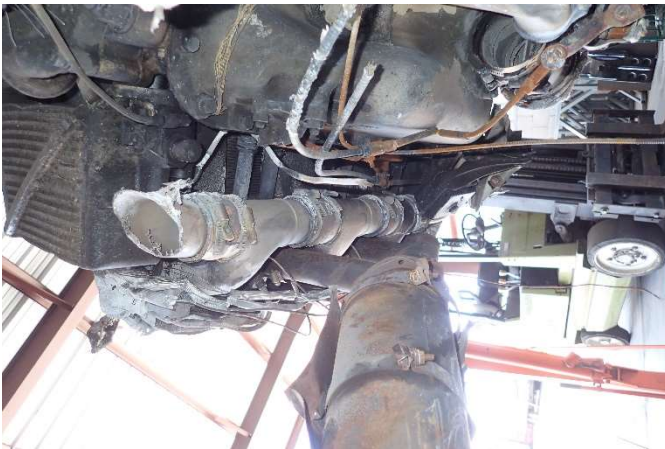
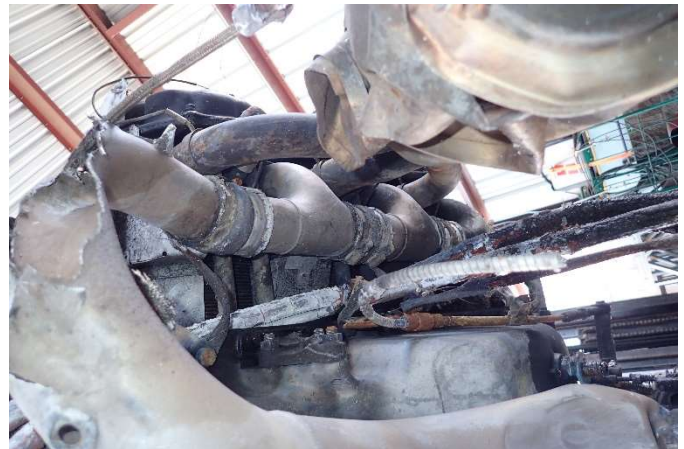
#### INDUCTION SYSTEM

The majority of the induction system remained attached to the engine and displayed varying amounts of thermal damage and impact damage. Most of the damage occurred to the rear portions of the induction system. There were no signs of induction leaks or blockages noted. There were no anomalies noted.

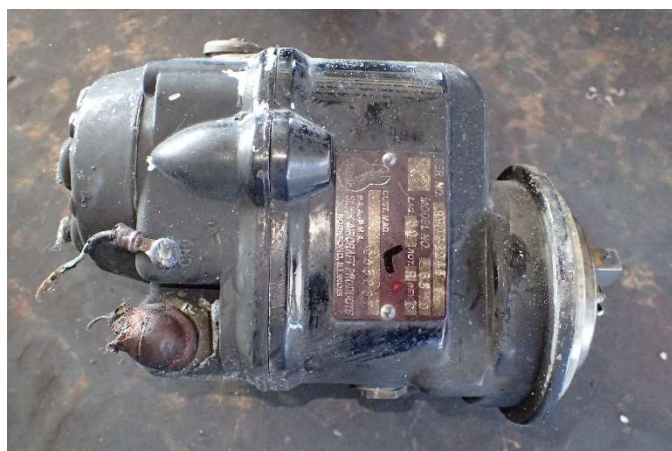
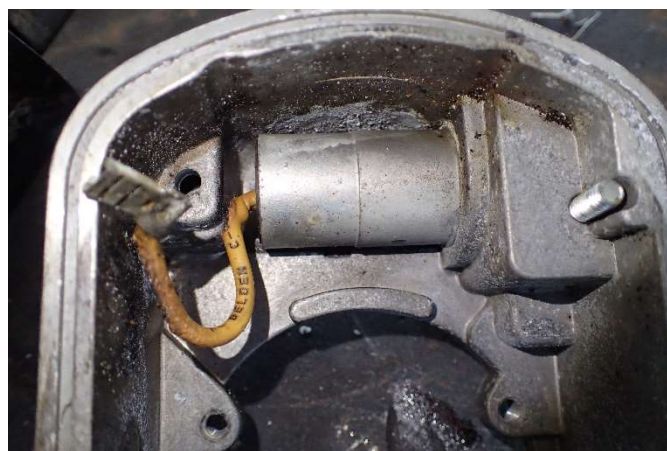
## LEFT MAGNETO

The magneto remained attached to its installation point and displayed thermal damage signatures. The magneto was removed, and it was noted that the drive shaft was capable of rotation and the impulse coupling was capable of operation. During impulse coupling operation it was noted that the magneto was capable of producing a spark on all six posts in the correct order. The magneto was partially disassembled, and it displayed thermal damage signatures and normal operating signatures.

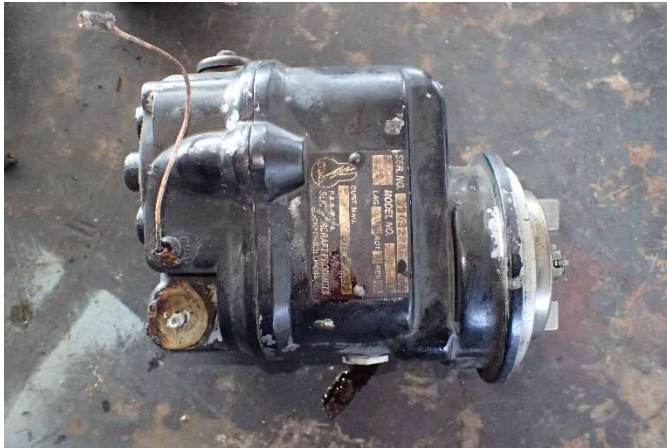
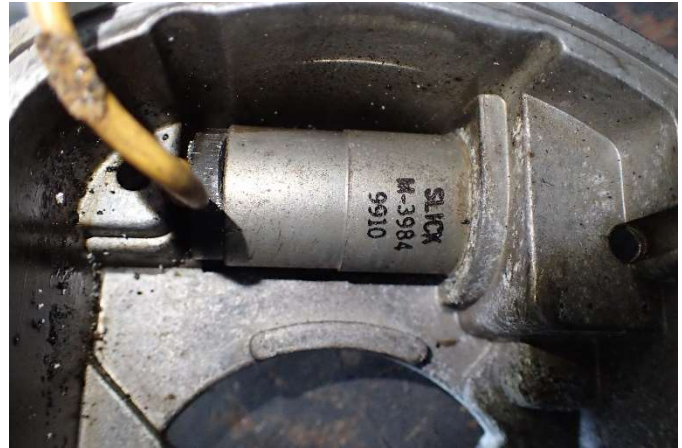
RIGHT  
MAGNETO

The magneto remained attached to its installation point and displayed thermal damage signatures. The magneto was removed, and it was noted that the drive shaft was capable of rotation and the impulse coupling operated normally. It was noted that the magneto was unable to produce a spark. The magneto was partially disassembled, and it was noted that the capacitor and wire displayed a significant amount of thermal damage; the rest of the components displayed minor thermal damage and normal operating signatures. The top housing and capacitor was replaced with the capacitor and top housing from the left magneto. It was noted that after replacing the capacitor and top housing the magneto was capable of producing a spark on all six posts in the correct order.

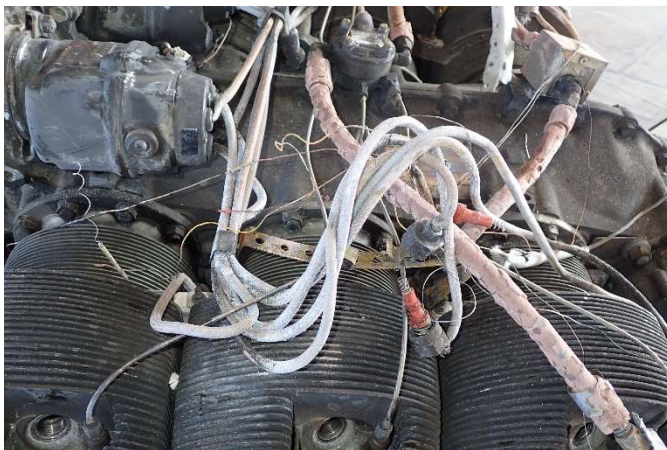
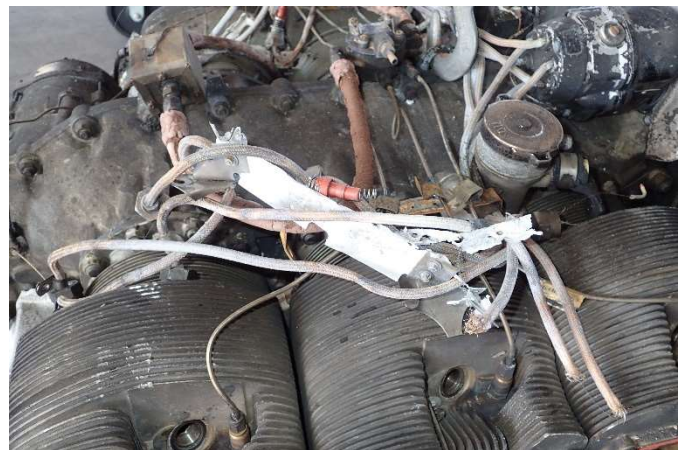
## IGNITION HARNESS

The ignition harness remained attached to the engine and displayed a significant amount thermal and impact damage signatures. There were no anomalies noted with the ignition harness.

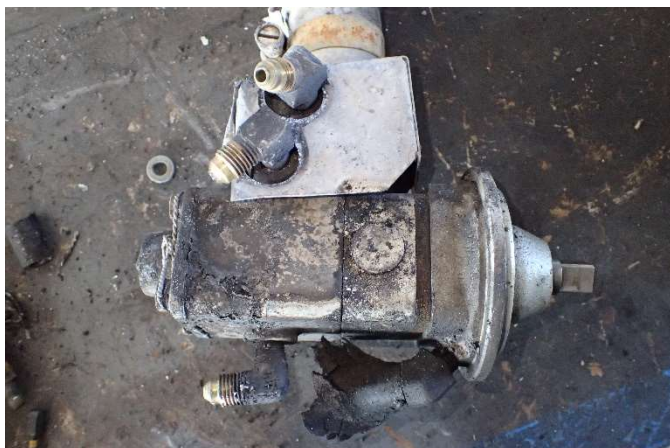
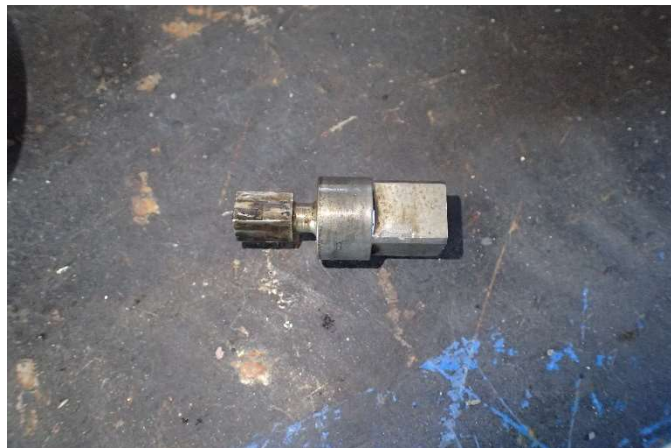
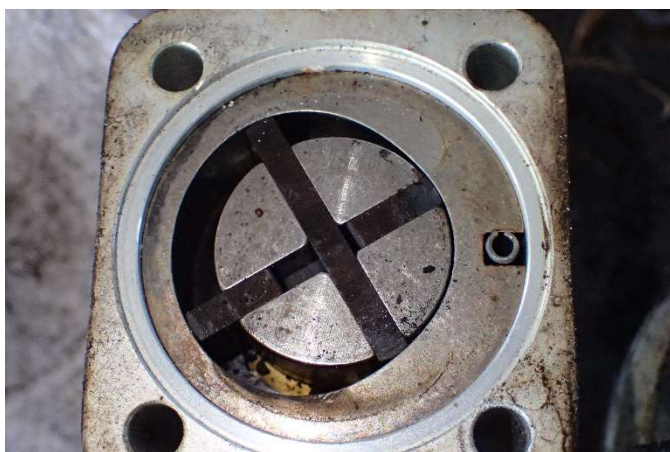
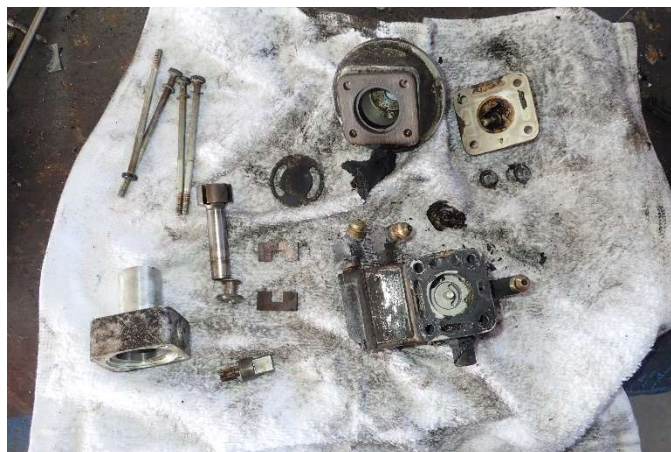
## FUEL PUMP

The fuel pump remained attached to its installation point and displayed impact and thermal damage signatures. The fuel return AN fitting had broken free from the fuel pump; the remaining AN fittings remained attached to the fuel pump; it was noted that all of the B-nuts were loose which is consistent with the thermal damage. The fuel pump was removed, and it was noted that the drive coupling was intact, and the drive shaft was capable of rotation with some noticeable resistance. The fuel pump was disassembled, and the internal components were visually inspected; the components displayed thermal damage signatures, impact damage signatures, and normal operating signatures. There were no anomalies noted with the fuel pump.

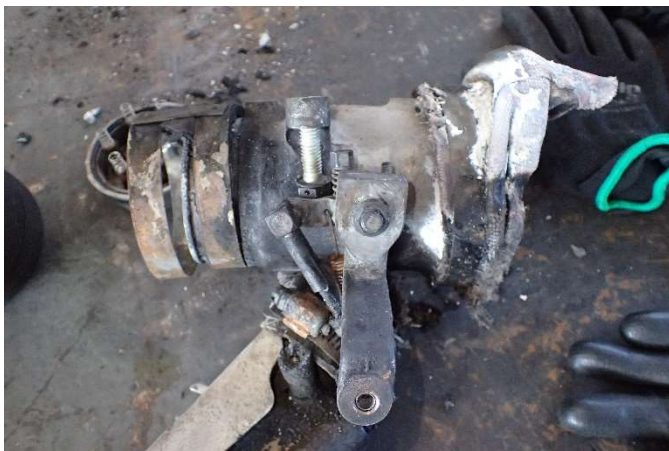
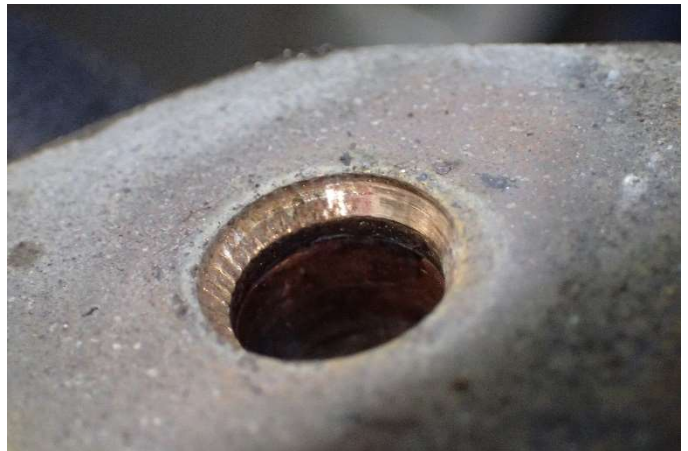
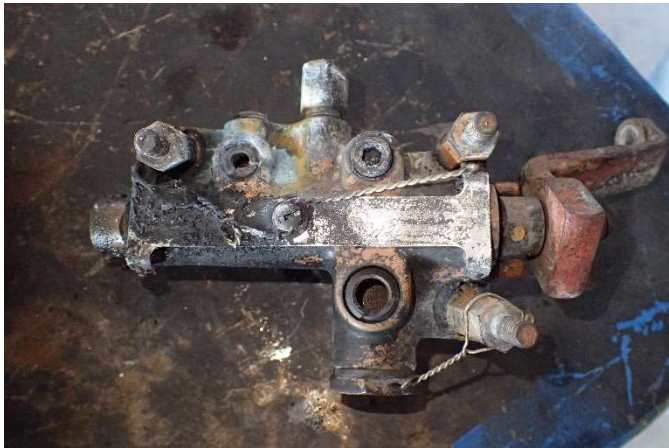
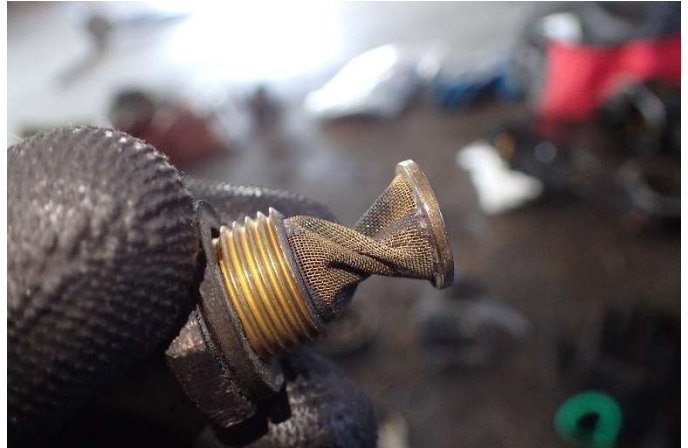
## THROTTLE BODY METERING UNIT

The throttle and metering assembly displayed a significant amount of impact damage signatures and thermal damage signatures. The assembly was removed, and it was noted that the throttle control arm was capable of moving freely around the throttle control shaft. The control arm was remove and it was noted that damage to the knurls was consistent with impact damage. The metering assembly was disassembled, and the components were visually inspected. The fuel inlet screen was twisted; there were no contaminates notes within the screen. The mixture and throttle cams displayed thermal damage and normal operating signatures. The metering plug displayed normal operating signatures.

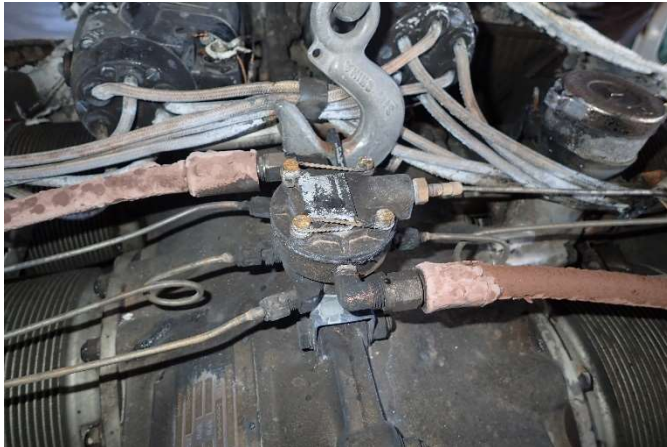
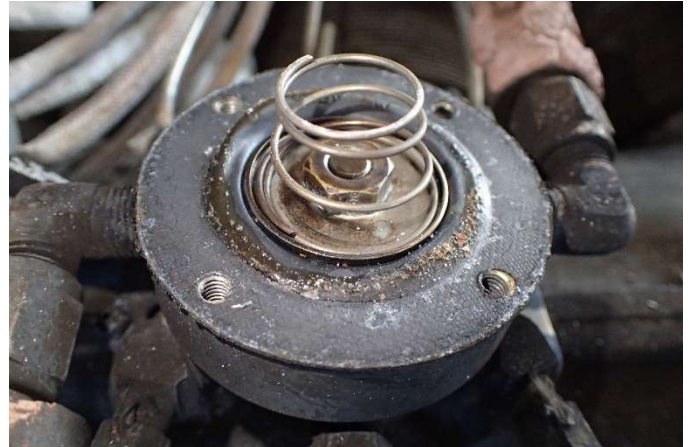
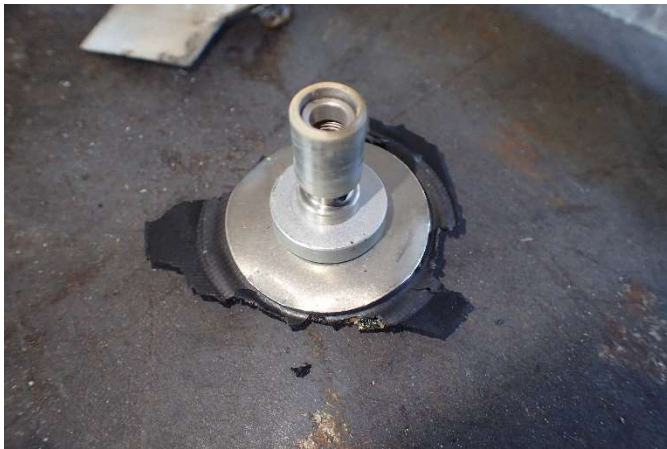
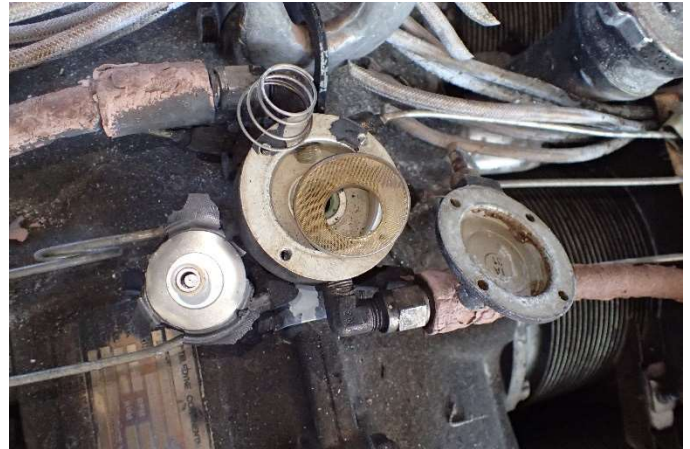
## FUEL MANIFOLD VALVE

The fuel manifold valve remained attached to its installation point and displayed thermal damage signatures. The valve was disassembled, and the internal components were visually inspected. The components displayed thermal damage signatures and normal operating signatures. There were no anomalies noted.

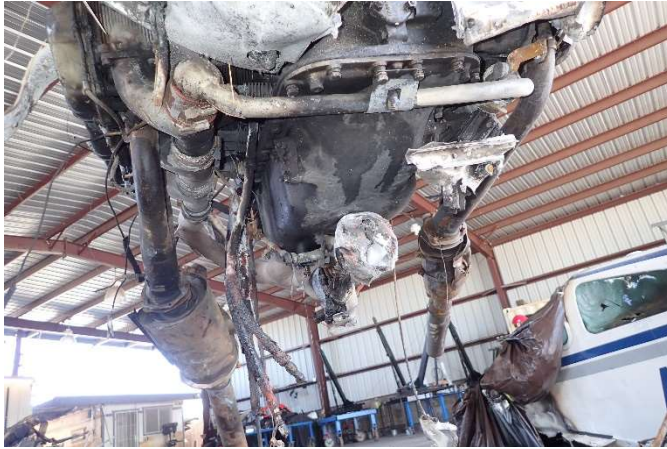
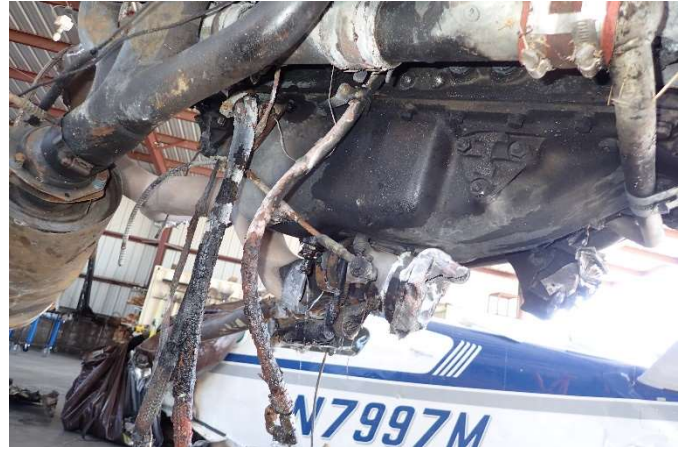
### OIL SUMP

The oil sump remained intact and displayed some impact and thermal damage signatures. There were no anomalies noted.

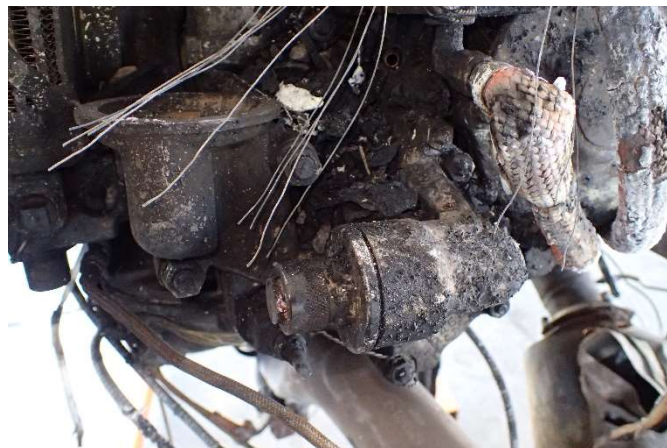
### OIL PUMP

The oil pump remained attached to its installation point and displayed thermal and impact damage signatures. There were no anomalies noted.

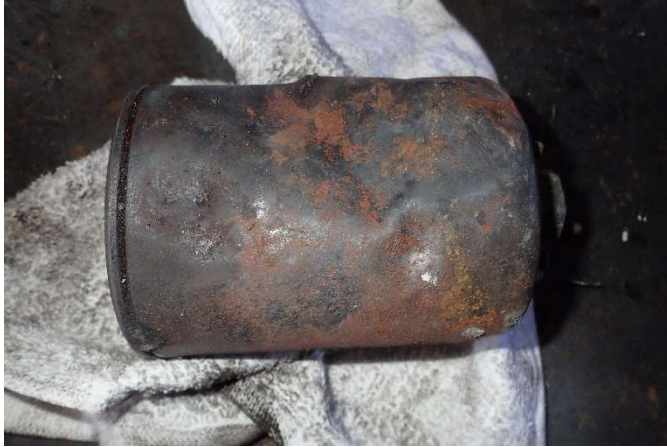
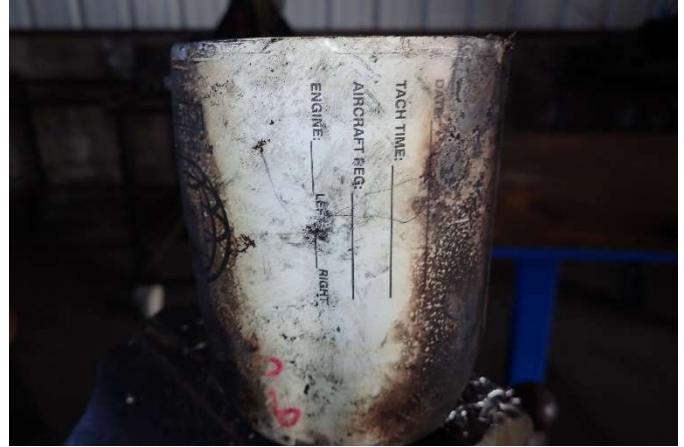
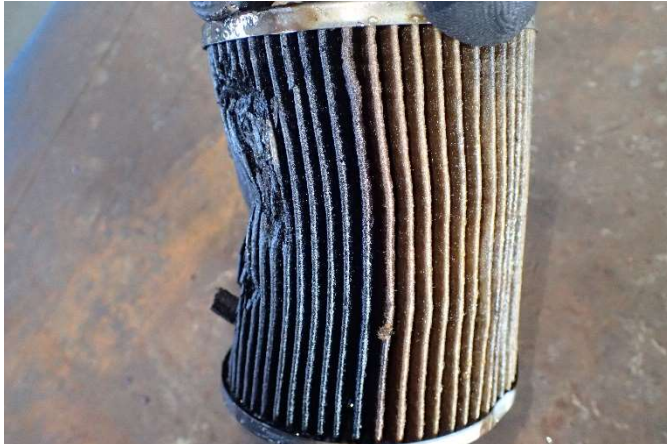
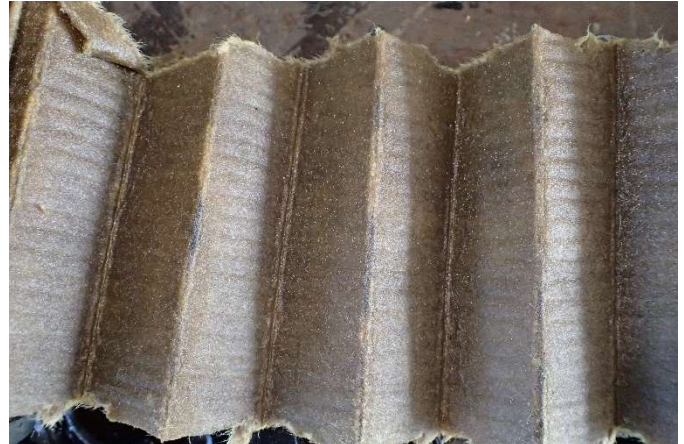
## OIL FILTER

The oil filter had broken free from the oil filter adapter and displayed impact and thermal damage signatures. The oil filter housing was cut open and the filter pleats were inspected; there was no metal noted within the filter pleats. There were no anomalies noted.

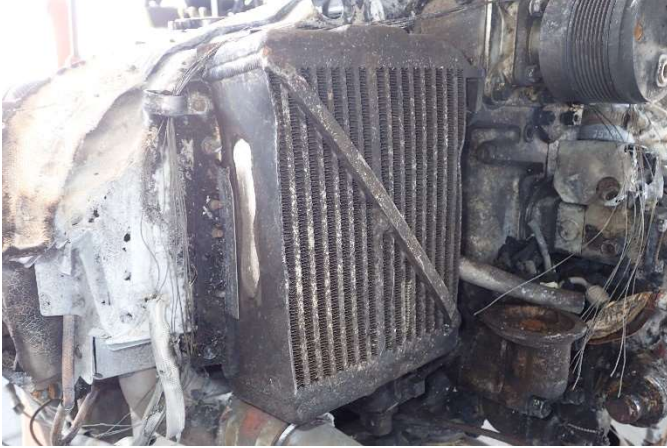
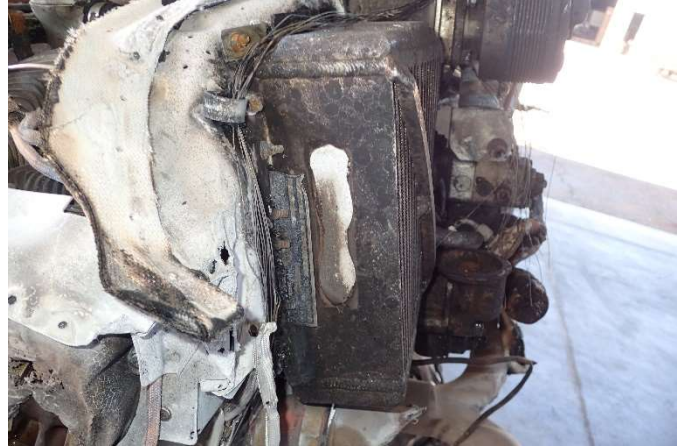
## OIL COOLER

The oil cooler remained attached to its installation point and displayed thermal damage signatures. There were no anomalies noted with the oil cooler.

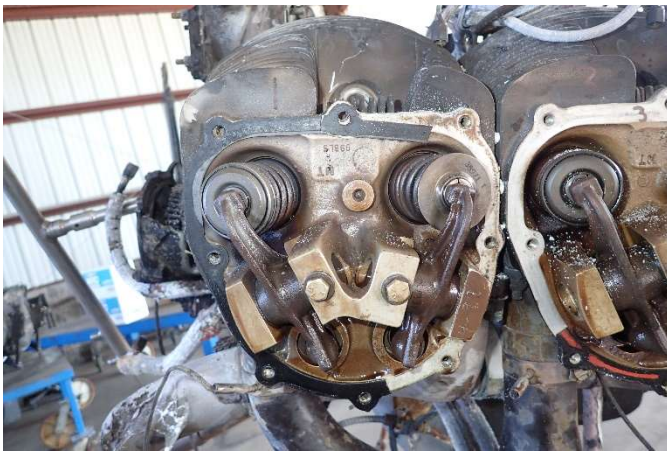
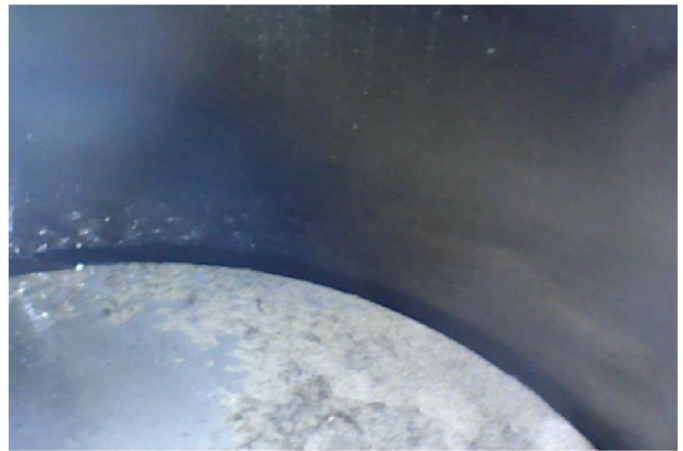
## CYLINDERS

All of the cylinders remained attached to their cylinder bays and displayed varying amounts of impact and thermal damage signatures. During crankshaft rotation it was noted that all of the cylinders displayed good thumb compression and suction and all of the rocker arms and valves operated normally. The cylinders were inspected using a lighted borescope and the pistons, cylinder bore, and valve heads displayed normal operating and combustion signatures. All of the overhead components (valves, springs, and rocker arms) displayed minor thermal damage signatures, and normal operating and lubrication signatures. There were no anomalies noted with any of the cylinders.

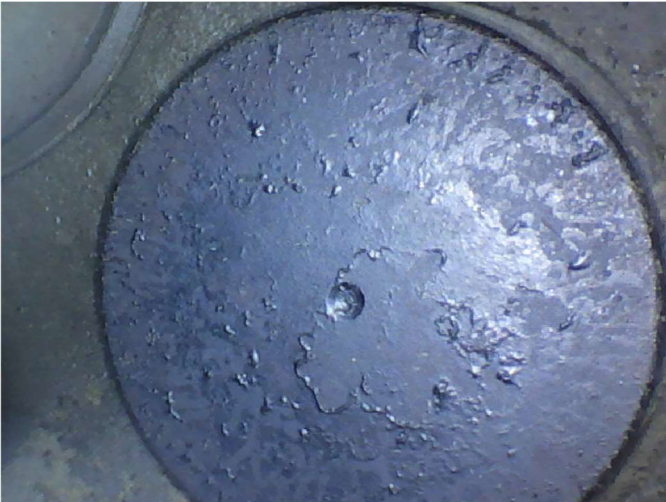
#1 Exhaust Valve

The valve heads were inspected using a lighted borescope; the valve heads displayed normal operating and combustion signatures. The valves operated normally during crankshaft rotation. There were no anomalies noted.

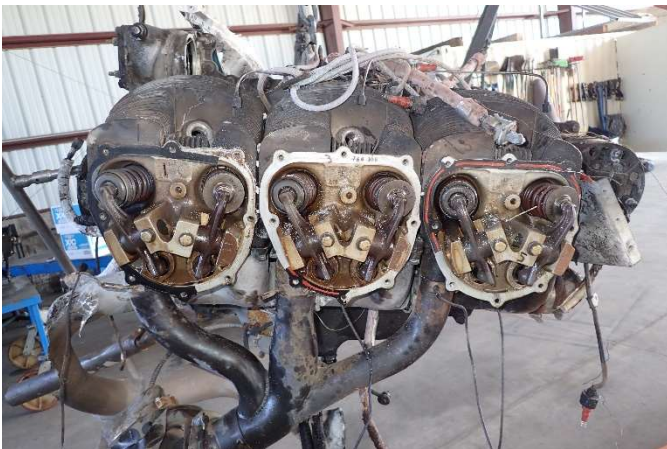
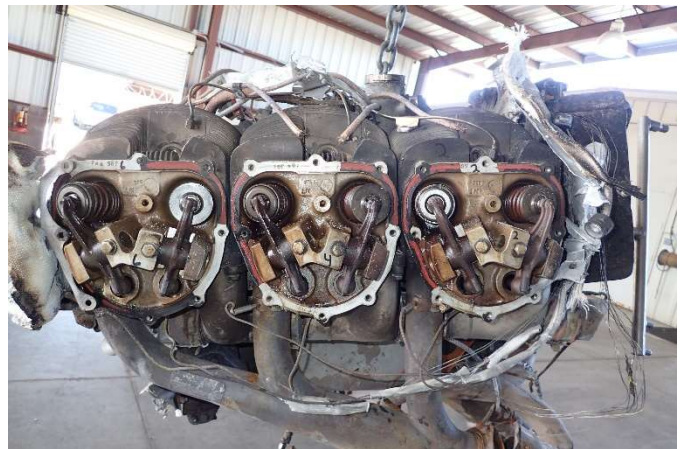
## ROCKER ARMS AND SHAFTS

All of the rocker arms remained attached to their installation points and displayed minor thermal damage signatures. During crankshaft rotation all of the rocker arms operated normally.

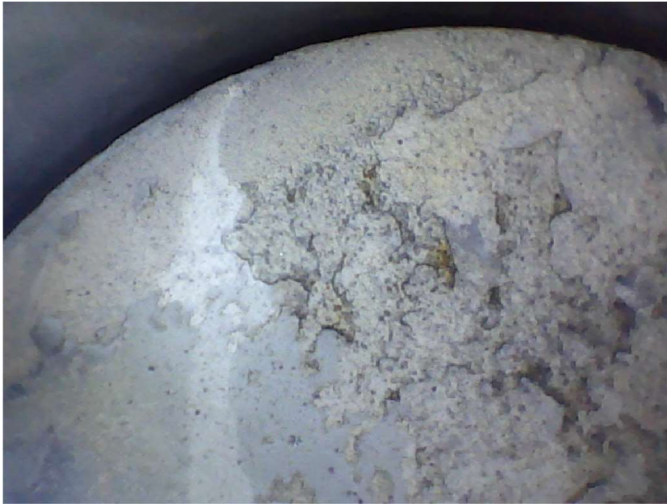
#1 Piston

All of the pistons faces were inspected using a lighted borescope. The piston faces displayed normal operating and combustion signatures. During crankshaft rotation all of the pistons operated normally.

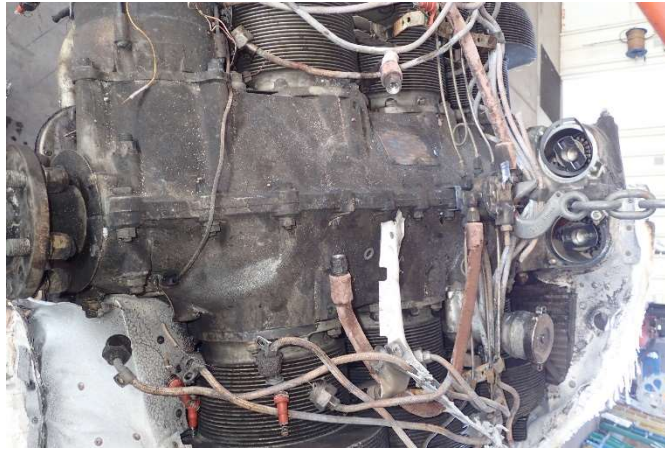
The crankcase remained intact and displayed thermal damage signatures. There were no signs of a catastrophic engine failure. There were no anomalies noted with the crankcase.

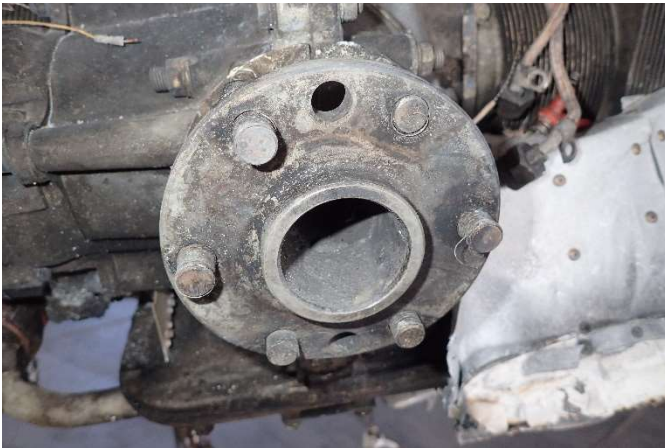
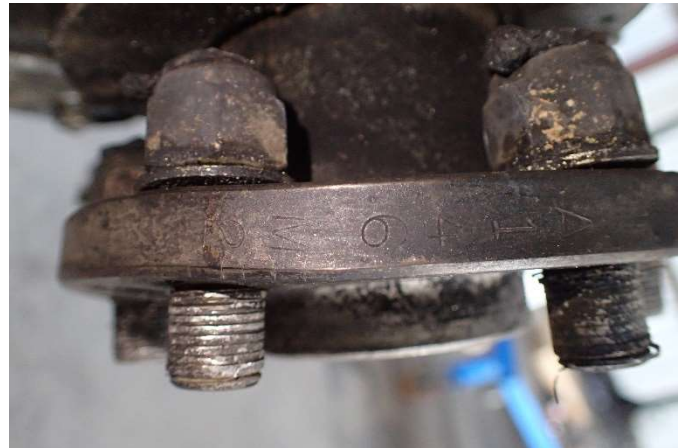
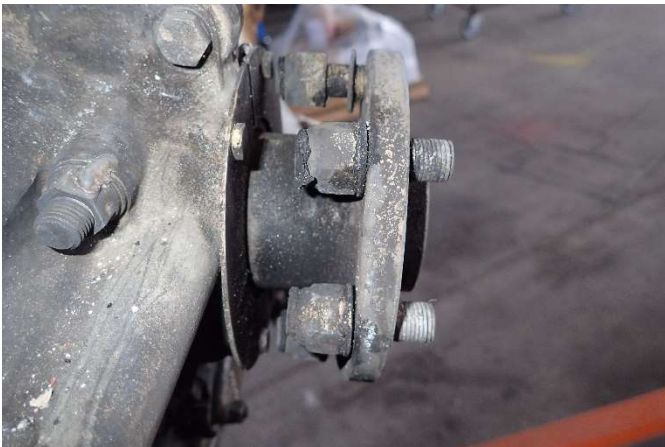
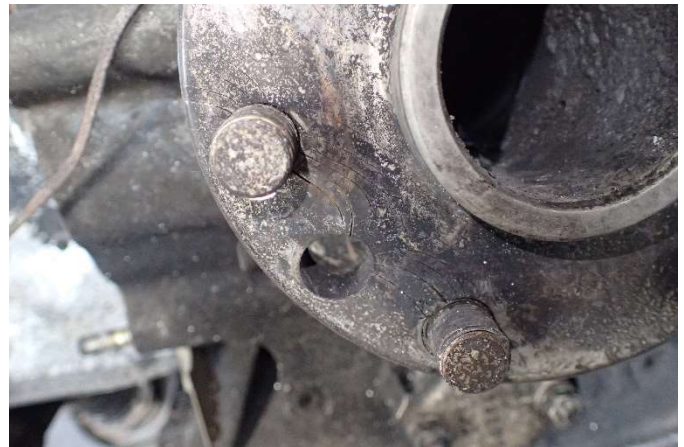
## CRANKSHAFT

The propeller flange remained attached to the rest of the crankshaft and displayed impact damage signatures in the forms of bending deformation and cracks in the propeller flange. The crankshaft was rotated from the rear of the crankshaft using a hand tool; continuity was established between the crankshaft, camshaft, connecting rods, and associated components. There were no anomalies noted.

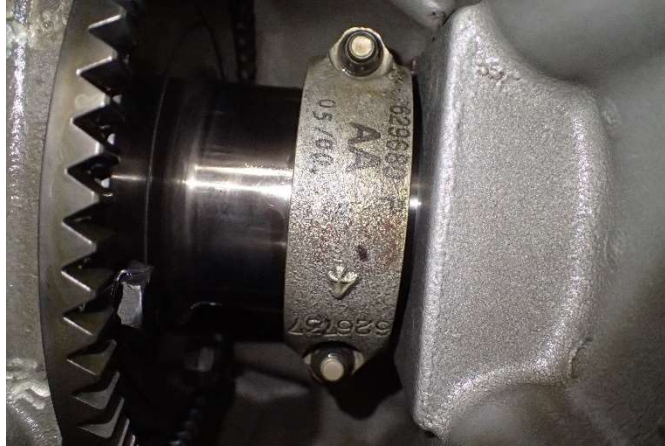
## TRANSFER COLLAR

The transfer collar remained attached to its installation point and was undamaged. There were no anomalies noted with the transfer collar.

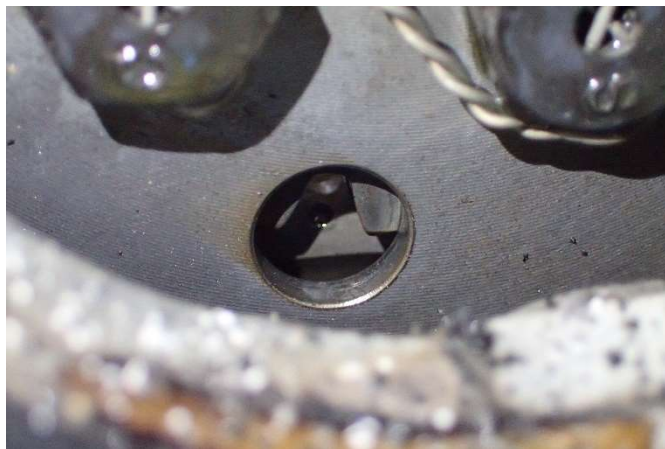
## INTERNAL TIMING

The internal timing was verified to be correct.

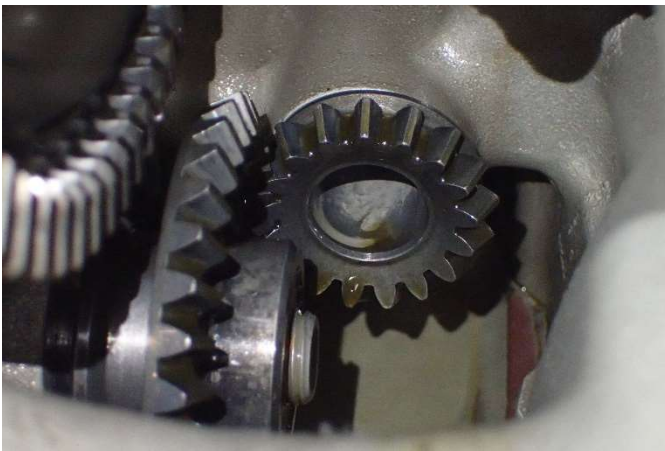
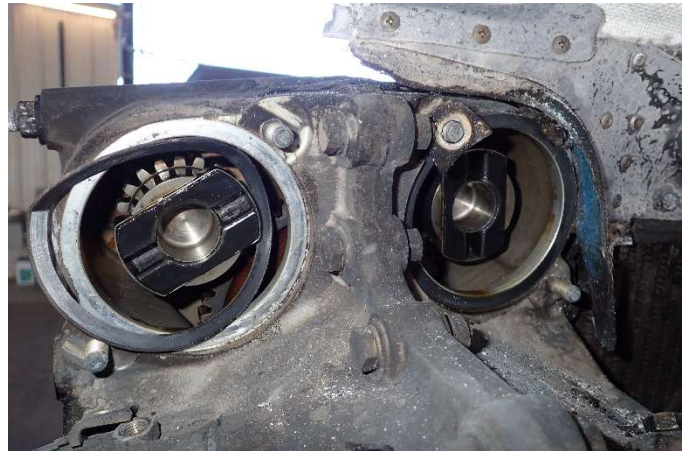
The accessory drive gears remained installed and displayed normal operating signatures. There were no anomalies noted.

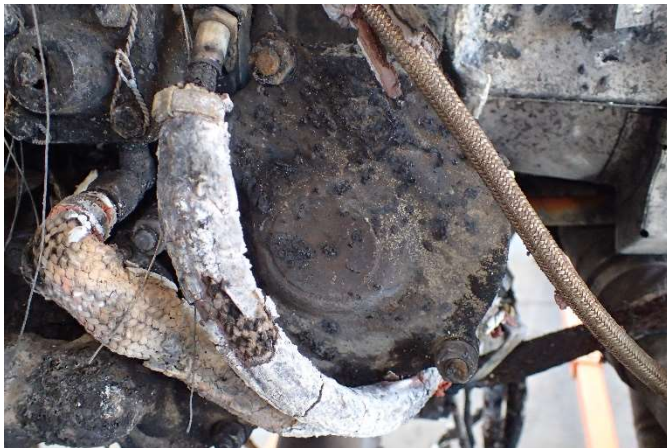
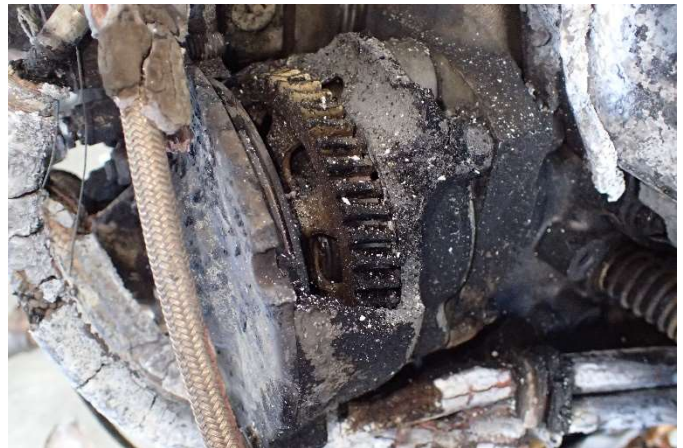
### STARTER ADAPTER

The starter remained attached to a portion of the starter adapter; however, the starter attach flange had broken free from the rest of the starter adapter. The starter displayed thermal damage signatures. There were no anomalies noted.

The starter adapter remained attached to the engine and displayed a significant amount of impact damage and thermal damage; a large portion of the adapter had broken free from the rest of the starter adapter. There were no anomalies noted with the adapter.

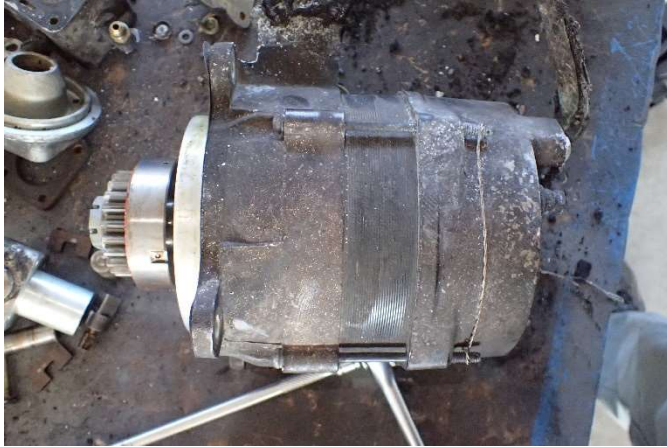
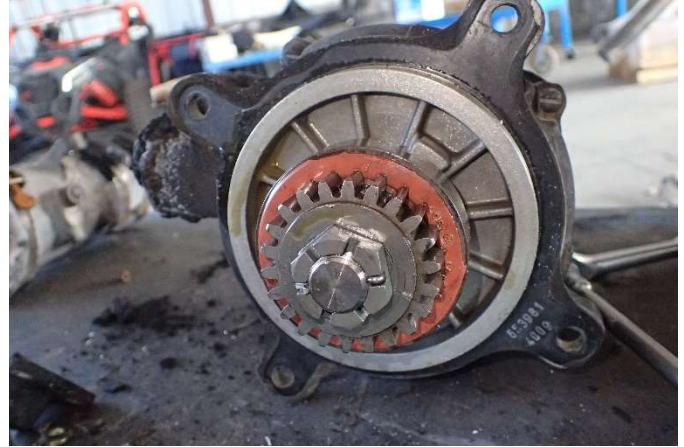
## ALTERNATOR

The alternator remained attached to its installation point and displayed thermal damage signatures. The alternator was removed, and it was noted that the drive coupling remained intact and was undamaged. The alternator drive was capable of rotation; there were no anomalies noted.

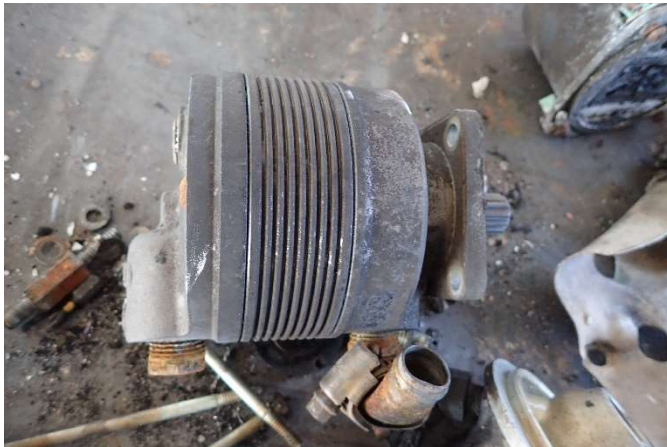
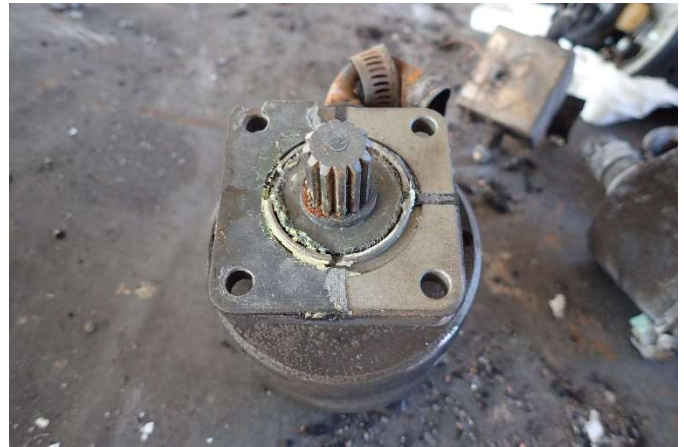
## VACUUM PUMP

The vacuum pump remained attached to its installation point and displayed thermal damage signatures. The vacuum pump was removed, and it was noted that the drive coupling displayed thermal damage signatures. There were no anomalies noted.

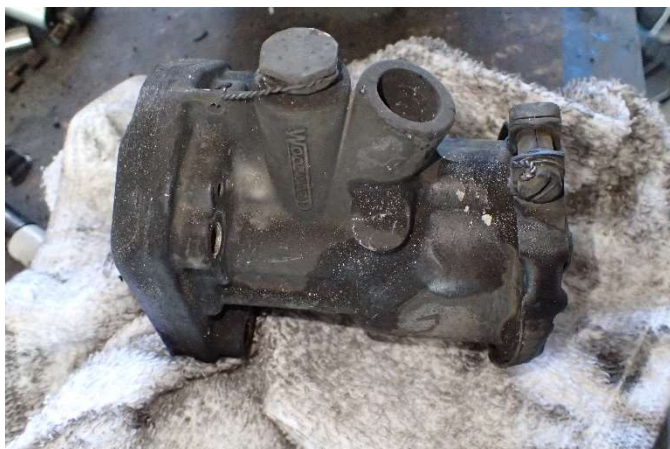
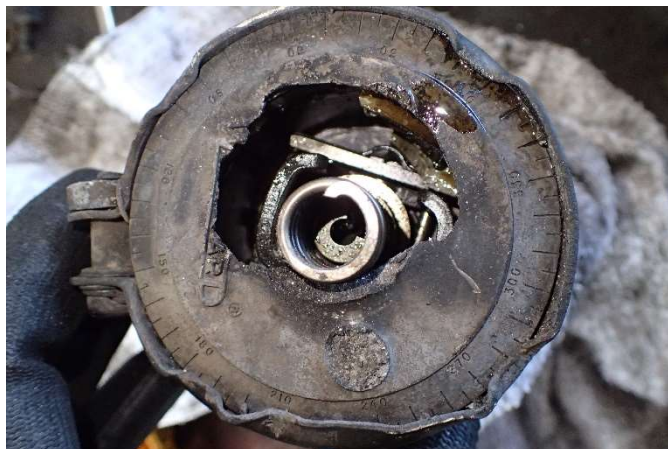
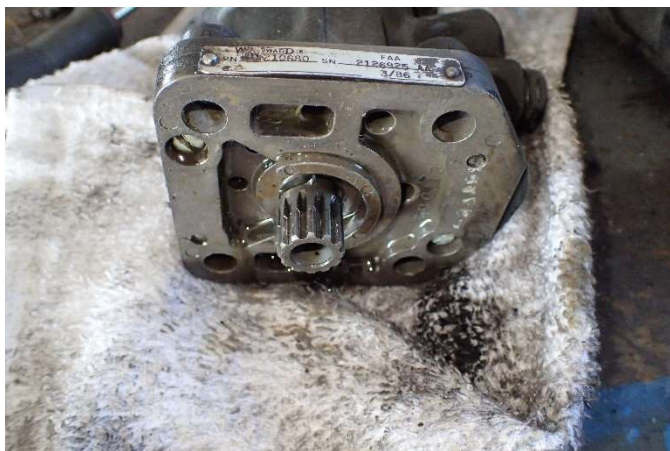
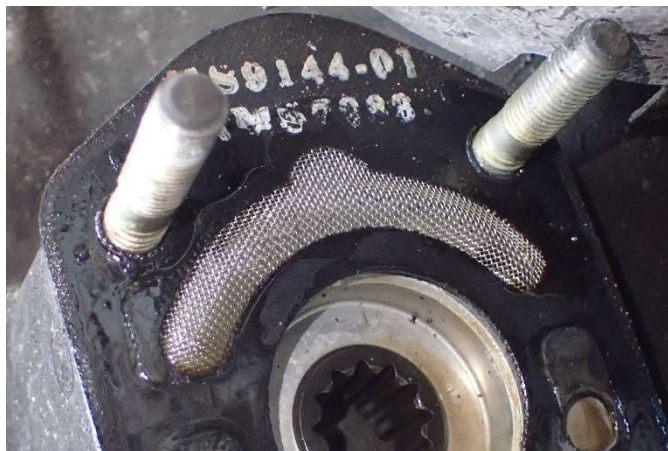
| PROPELLER GOVERNOR | Manufacturer: Woodward | P/N: D210680 | S/N: 2126925 |
|---|---|---|---|
| Condition: | The governor remained attached to its installation point and displayed impact damage signatures. The governor was removed, and it was noted that the gasket screen was clear of contaminants. The governor drive was capable of rotation and was capable of pumping oil. The flyweights were visible through the impact damage to the top of the governor and they were noted to be installed and intact. There were no anomalies noted. | | |
