# NATIONAL TRANSPORTATION SAFETY BOARD

## MATERIALS LABORATORY FACTUAL REPORT

Report No. 18-105

Place : Guthrie Center, Iowa  
Date : November 18, 2018  
Vehicle : Piper PA-28-236  
NTSB No. : WPR19FA022  
Investigator : Elliott Simpson, AS-WPR

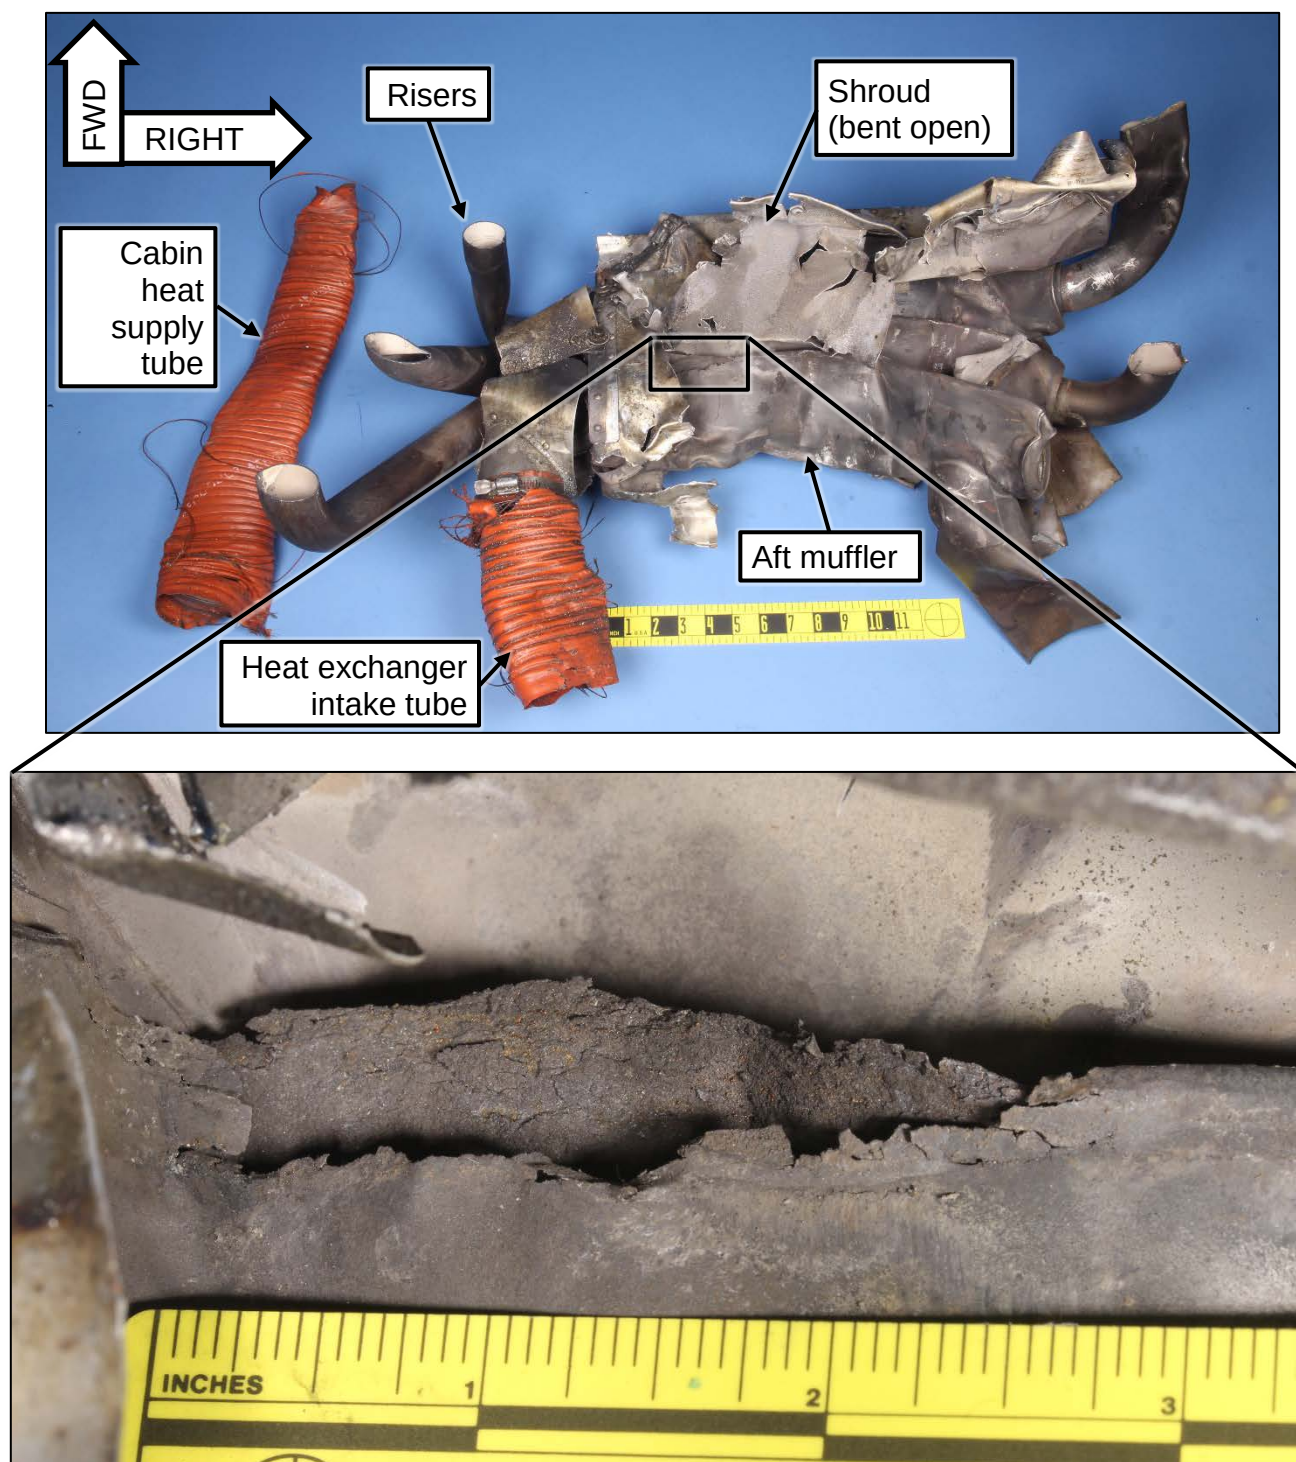
An overall view of the submitted components is shown in figure 1. The shroud and mufflers were crushed, and the upper side of the shroud was bent forward, partially exposing the mufflers. The right aft riser was not included with the submitted components, and the remaining risers were bent and crushed. The aft muffler had multiple cracks including a longitudinal crack at the forward upper side of the aft muffler as shown in figure 1.

Figure 1. Overall view of the submitted components (upper image) with a closer view of an open crack at the upper forward side of the aft muffler (lower image).

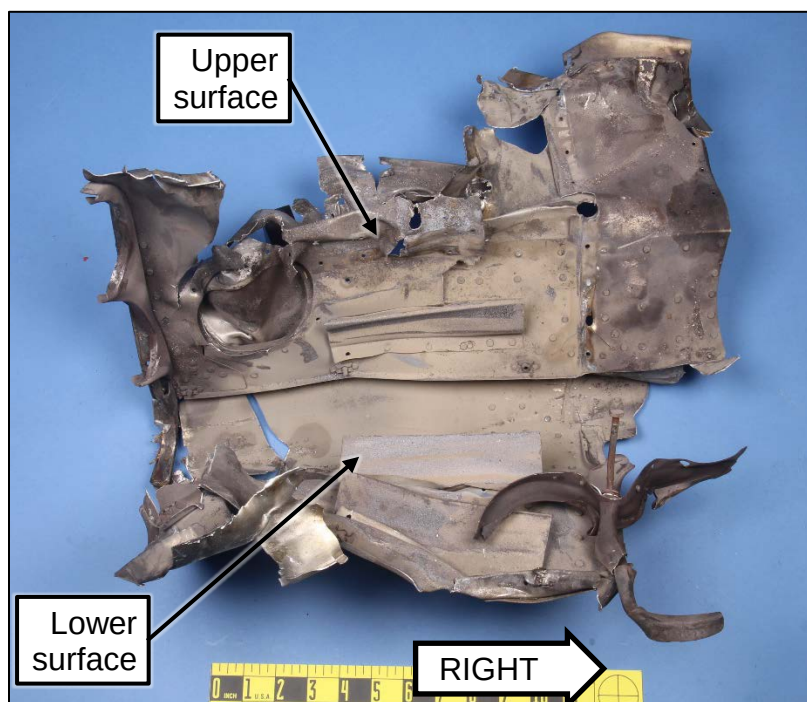
The heat exchanger shroud was disassembled from the mufflers and pried open to expose the interior surface. Tan deposits were observed covering the interior surface of the shroud as shown in figure 2.

Figure 2. Interior surface of the heat exchanger shroud after disassembly. Tan deposits were observed on the interior surfaces.

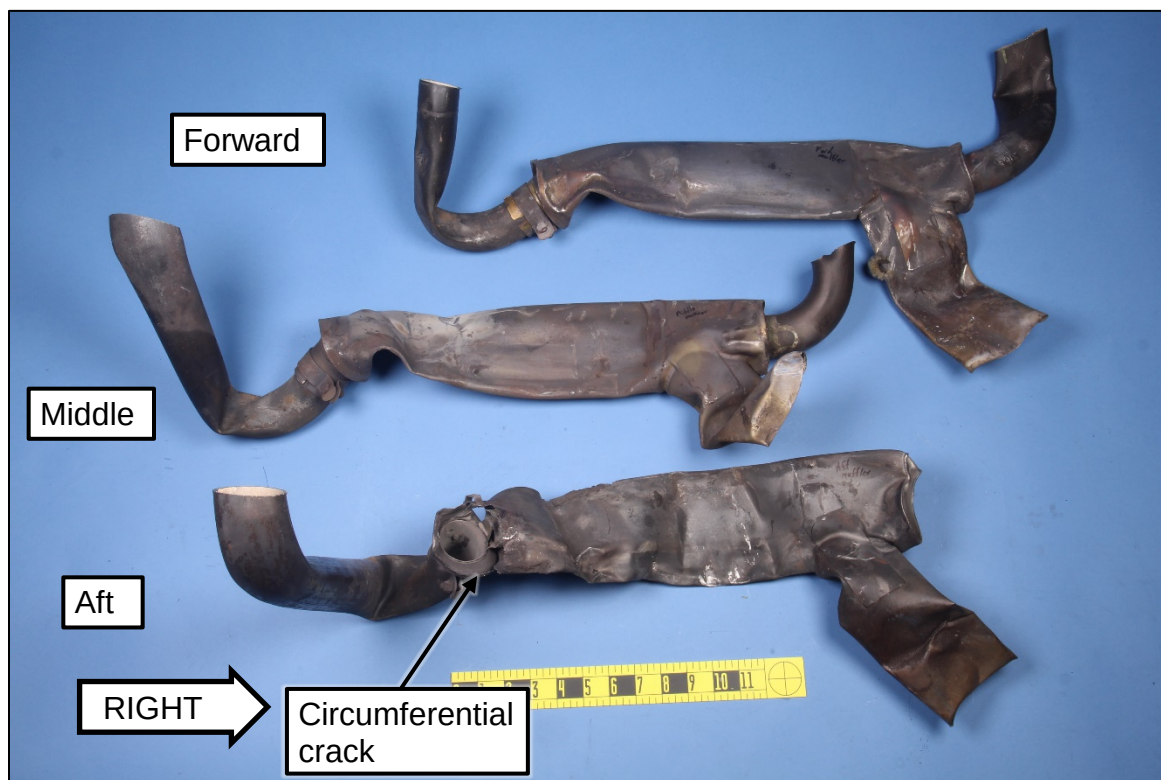
An overall view of the mufflers after the shroud was removed is shown in figure 3. The forward and middle mufflers were crushed but appeared intact. No visual evidence of cracks or perforations through the muffler wall was observed in the forward or middle muffler.

The aft muffler was also crushed, and multiple cracks and perforations through the muffler wall were observed at the left end of the muffler. A circumferential crack extended around approximately  $\frac{3}{4}$  of the circumference of the muffler adjacent to the left end face as indicated in figure 3. At the upper forward side shown in figure 1, a longitudinal crack extended 2.75 inches at the location of a longitudinal seam weld. The crack was gaped open as shown, and portions of wall material were missing at the crack opening. On the lower side of the aft muffler (see figures 4 and 5), perforations and another longitudinal

Figure 3. Overall view of the upper surfaces of the forward, middle, and aft mufflers from the heat exchanger system.

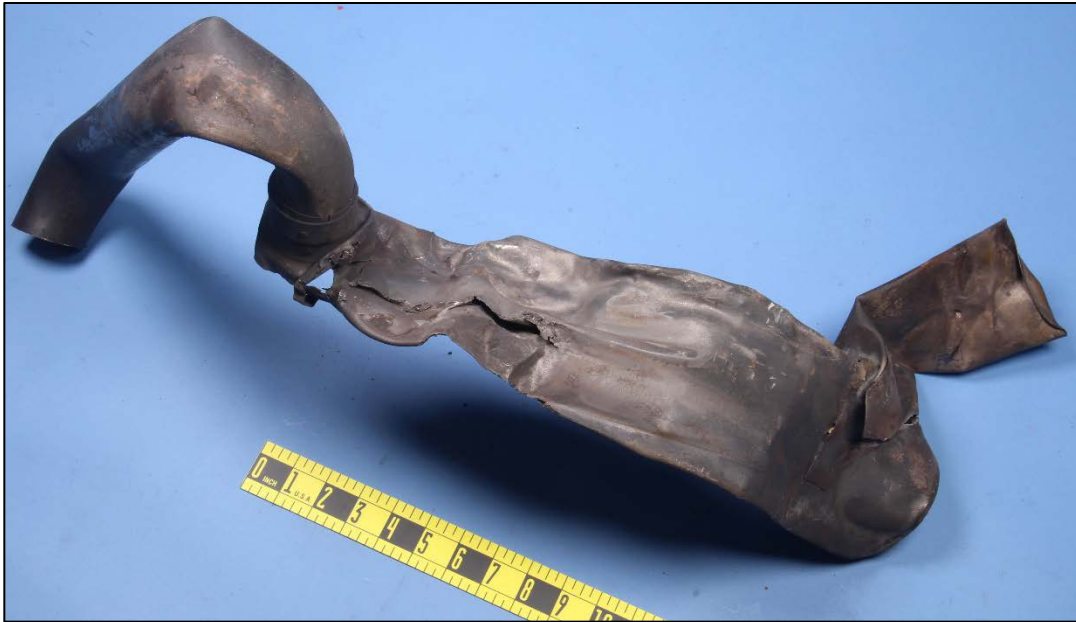
crack were observed. The muffler wall was crushed and folded at the location of the crack on the lower side of the muffler.

Figure 4. Overall view of the lower surface of the aft muffler.

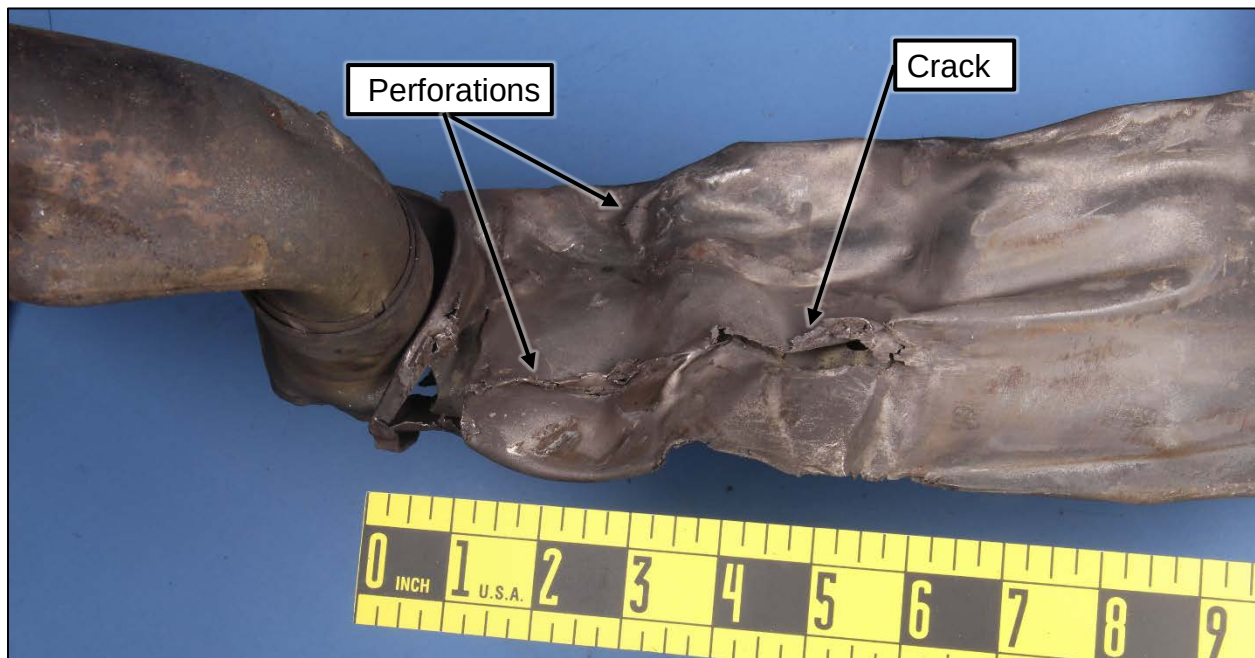
The cracks and perforations in the wall at the lower side of the aft muffler were generally associated with wrinkles, folds, and deformation on the muffler wall. Sliding contact marks on the lower surface were also observed associated with the longitudinal crack opening on the lower side. Oxidized fracture surfaces were observed adjacent to the interior surfaces of the perforations and cracks, and light gray fracture features were generally observed adjacent to the exterior surface.

Figure 5. Close view of cracks and perforations on the lower left side of the aft muffler.

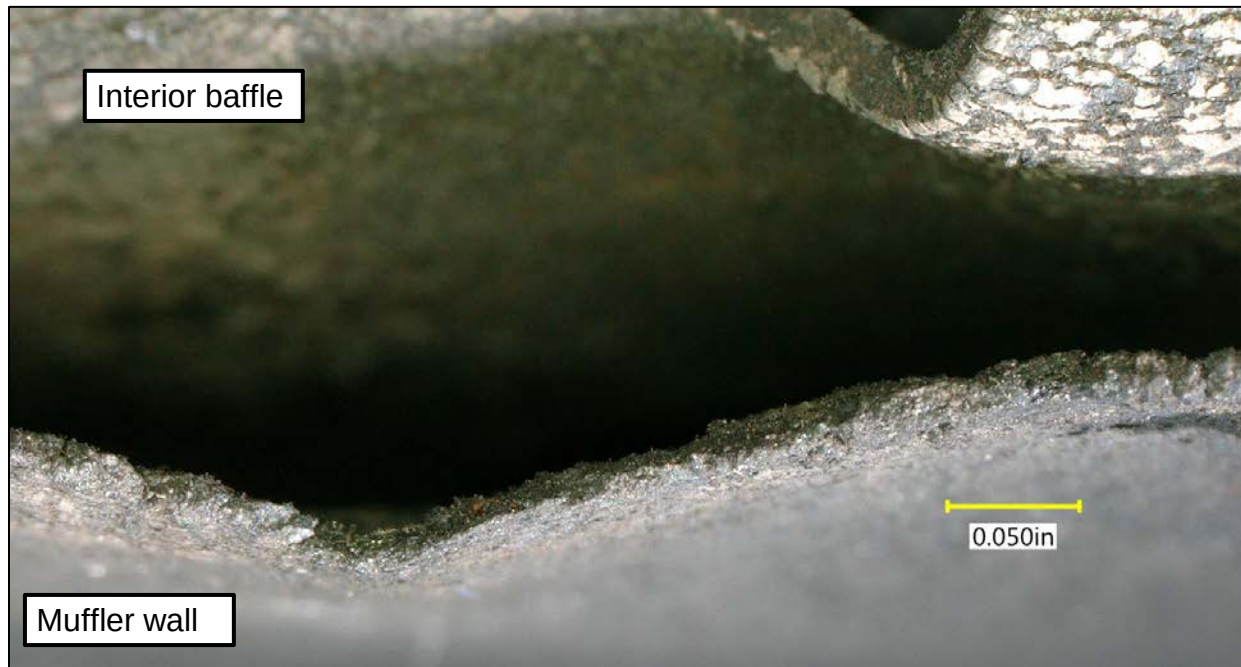
The fracture features for cracks and perforations on the aft muffler were examined closely using an optical stereomicroscope. A magnified optical image of the longitudinal crack fracture surface at the upper forward side of the aft muffler wall is shown in figure 6. The fracture surface was oxidized with dark-colored deposits on the surface consistent with a preexisting crack.

Figure 6. Close view of the oxidized fracture surface associated with the longitudinal crack at the upper forward side of the aft muffler (see figure 1).

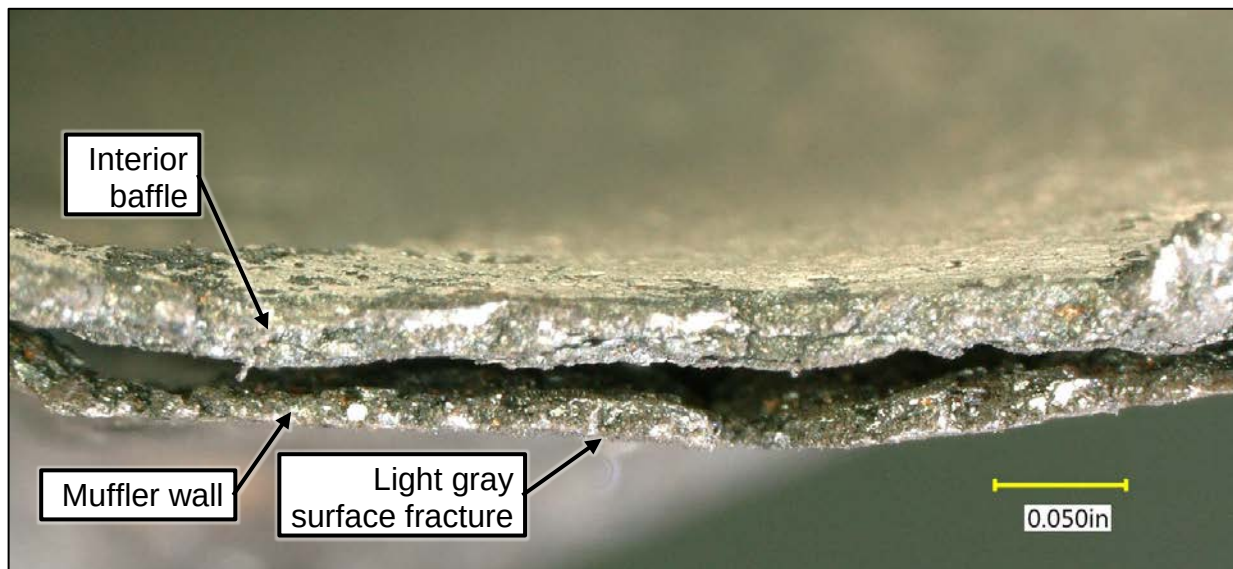
A close view of the muffler wall fracture features associated with the circumferential crack at the left end of the aft muffler is shown in figure 7. The fracture surface had dark oxidation and deposits across much of the thickness, but a thin portion of the fracture at the exterior surface was in a slightly different fracture plane and had a light gray appearance consistent with final fracture at impact.

Figure 7. Fracture features associated with the transverse fracture at the left side of the aft muffler.

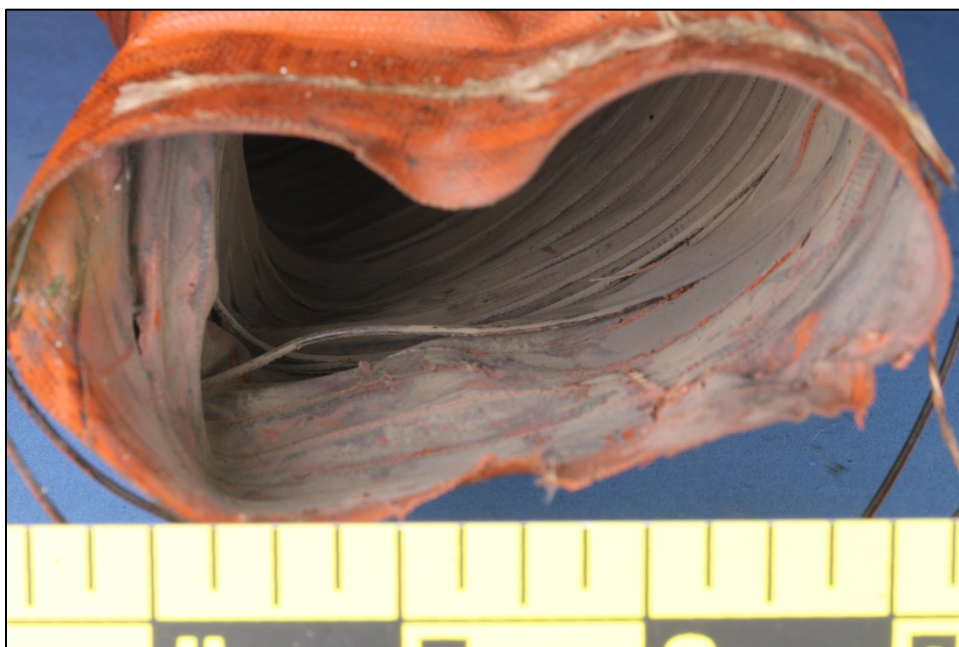
Tan deposits were observed coating the interior surface of the cabin heat supply tube as shown in figure 8. A sample of the tan deposit was scraped from the interior using a scalpel to facilitate compositional analysis of the deposit using energy dispersive x-ray spectroscopy (EDS). The sample was placed on an aluminum stub coated with carbon tape. For comparison, a sample was collected from the interior surface of the heat exchanger intake tube and was also placed on the coated aluminum stub. Resulting EDS spectra for the two samples are shown in figure 9. The tan deposit had high peaks of lead and bromine, consistent with exhaust deposits. The sample collected from the intake tube interior surface had a high peak of silicon with no peaks of lead or bromine.

Figure 8. Tan deposits on interior of the cabin heat supply tube.

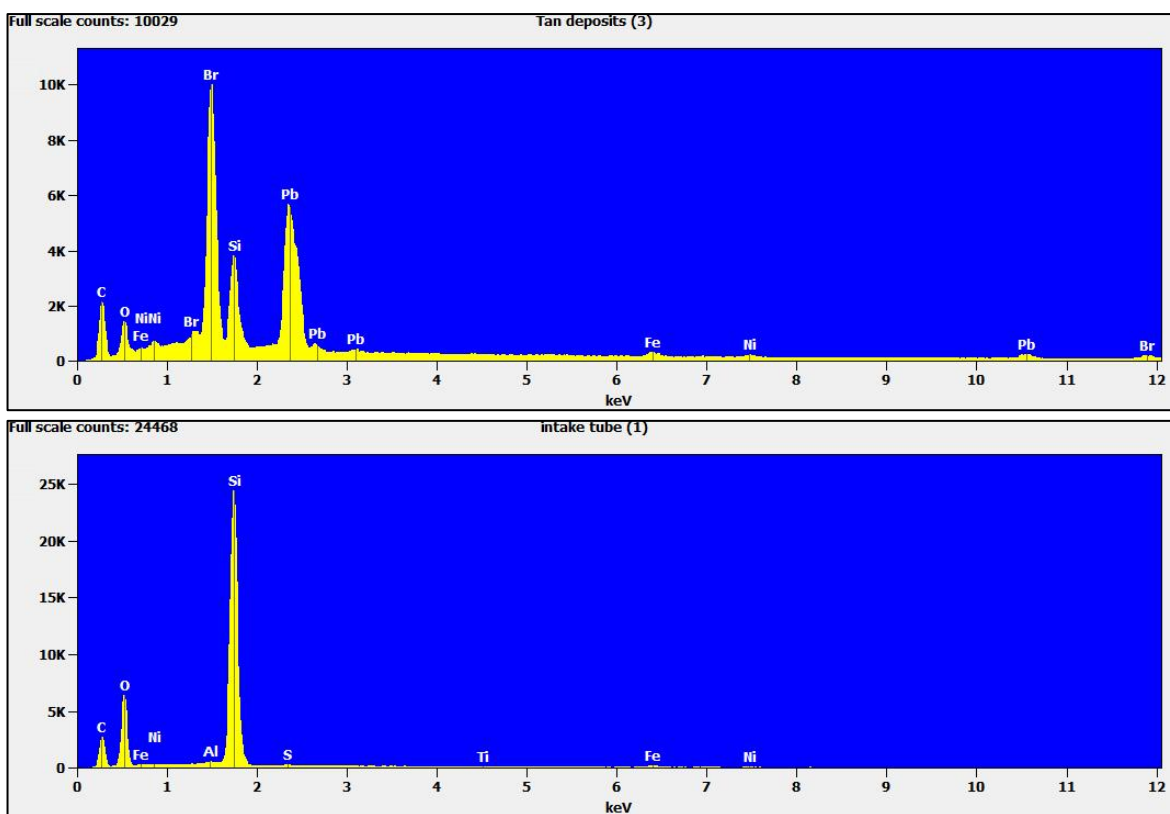
Figure 9. EDS spectra of the tan deposits from the cabin heat supply tube (upper spectrum) and of the heat exchanger intake tube interior surface (lower spectrum).
