## **NATIONAL TRANSPORTATION SAFETY BOARD**

# **AIRFRAME AND ENGINE EXAMINATION**

**WPR19FA022**

Location: Guthrie Center, Iowa  
Date: November 9, 2018  
Aircraft: Piper PA 28-236, Registration N91770, S/N 28-7911174  
NTSB IIC: Elliott Simpson

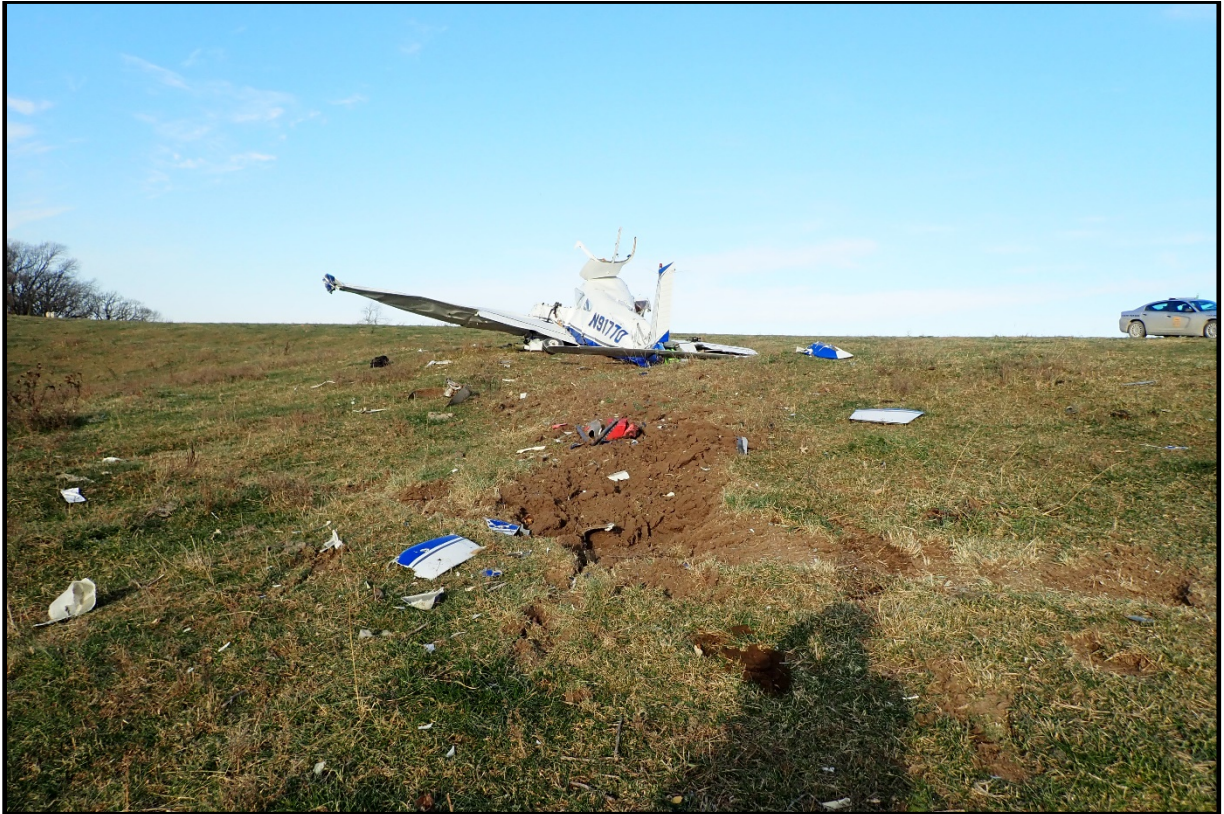
The airplane was located in an area composed of rolling hills and pastures, at an elevation of 1,200 ft, 6 miles southwest of Guthrie County Regional Airport (KGCT). The main wreckage, which included the cabin, both wings and the empennage, had come to rest facing uphill on a heading of about 270° magnetic (Photo 1). The first identified point of impact was located about 25 ft southeast and was composed of three 18-inch-long by 8-inch-wide divots, the spatial dimensions of which matched the main landing and nose gear (Photo 1). The nose gear-scissor leg was found impaled in the soil just beyond the center divot, and a few feet further the soil had cratered leaving a 15-inch-deep by 4-ft-wide hole. Two matching linear impact marks, the total length of which matched the airplanes wingspan, stemmed from either side of the crater at an orientation of about 320 ° (Photo 2). Red lens fragments were present at the tip of the northwest mark, and a complete green lens was located just beyond the tip of the southeast mark.

Photo 1 – Main Wreckage

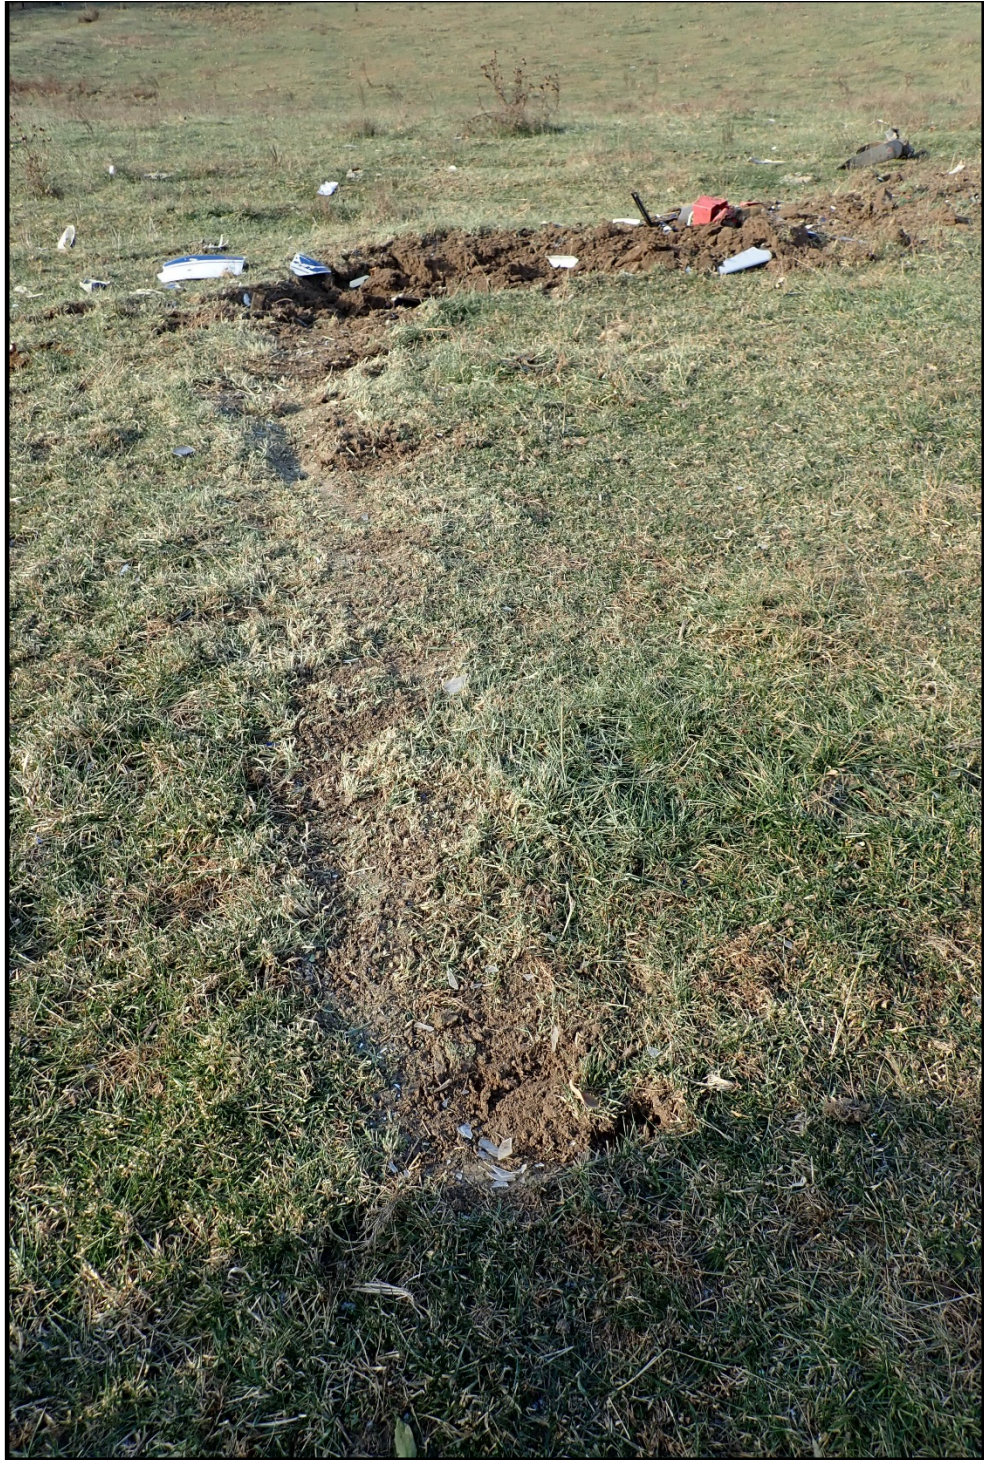
Photo 2 – Wing Marks

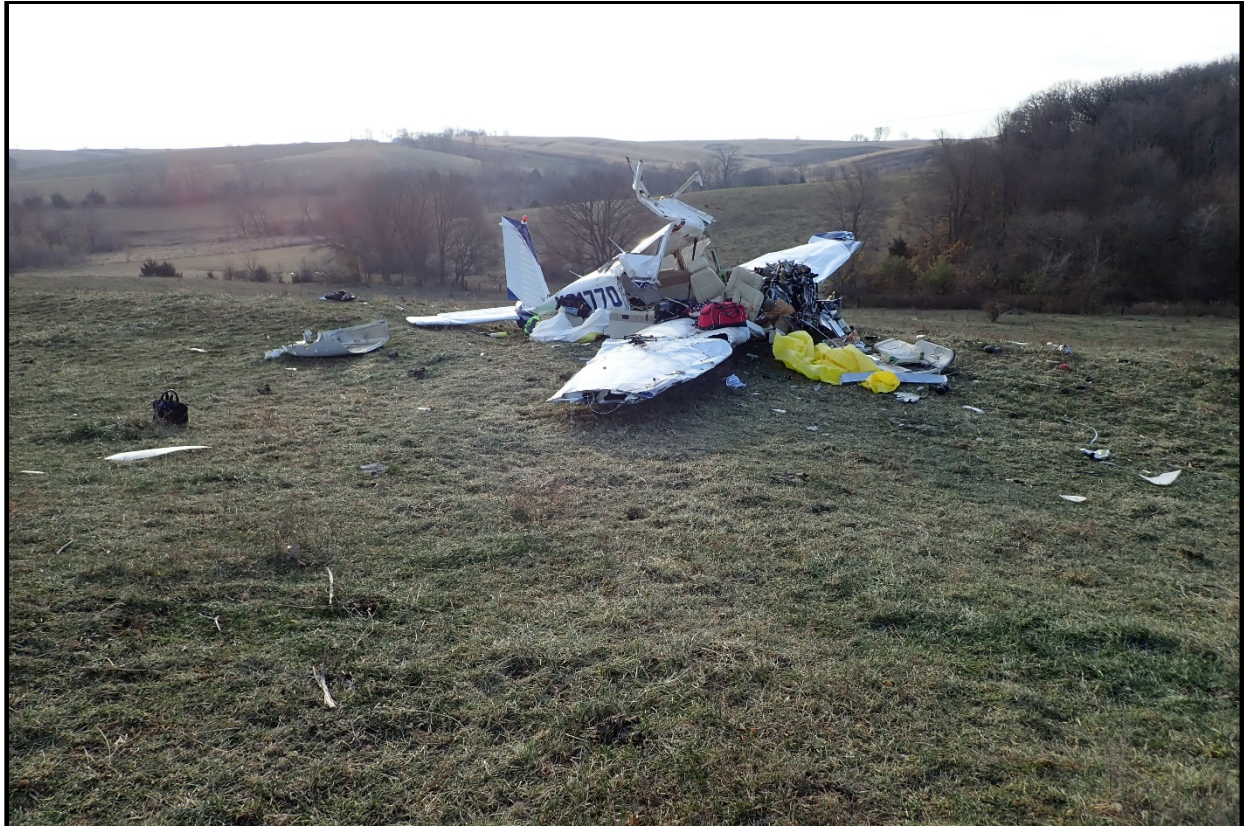
The fuselage sustained crush damage from the nose through to the leading edge of the vertical stabilizer (Photo 3). The flight controls, instrument panel, and avionics were heavily fragmented and compressed (Photo 4). The firewall had folded underneath the instrument panel, which was obscuring the engine. The right side of the cabin walls, along with the cabin roof had peeled back, exposing the aft seats and baggage area. The ignition switch key was in place, and the switch was in the “BOTH” position. The engine primer knob was in the closed and locked position.

Photo 3 – Main Wreckage

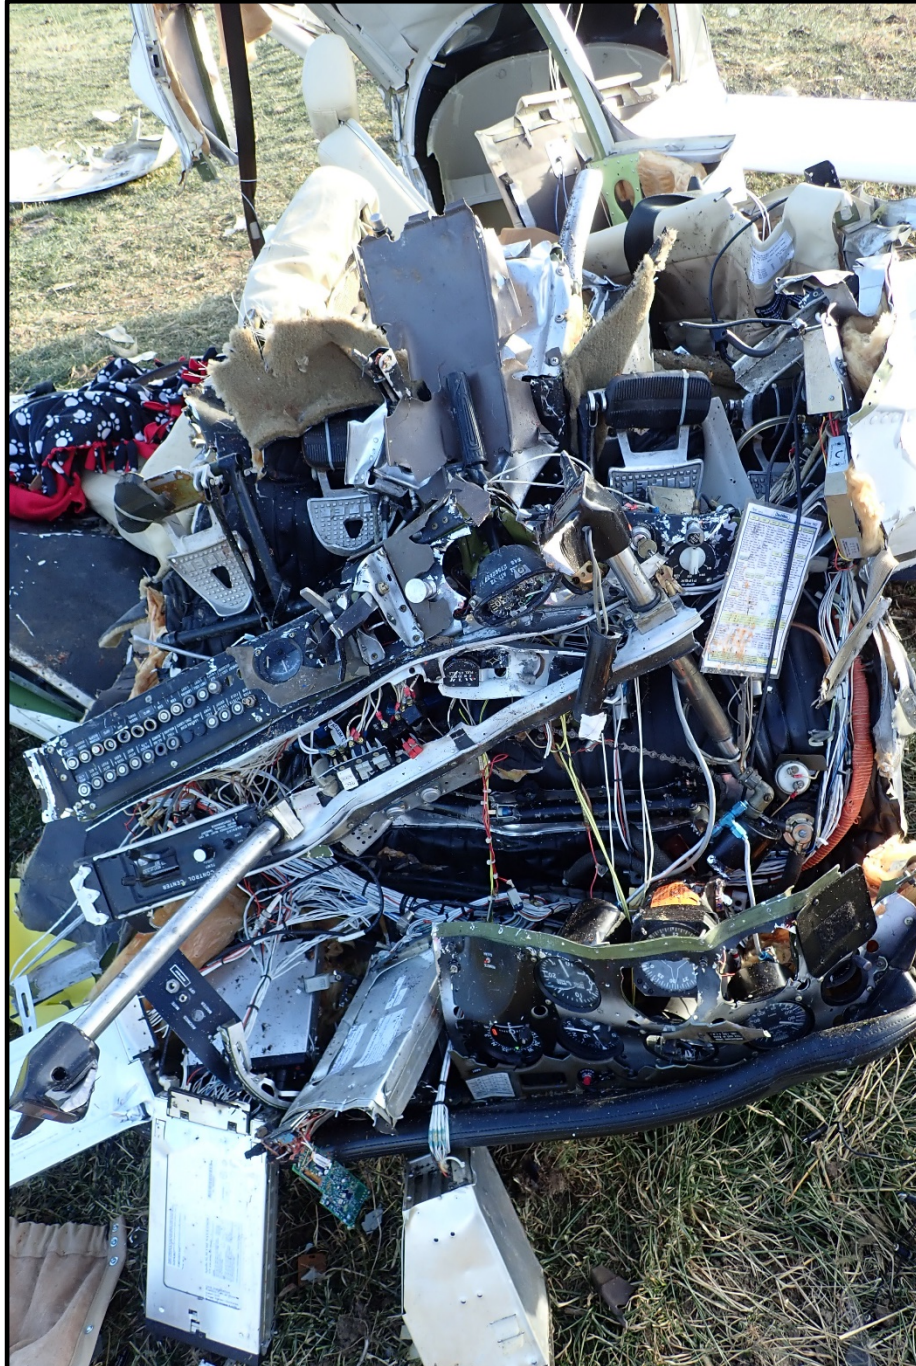
Photo 4 – Instrument Panel and Cabin Flight Controls

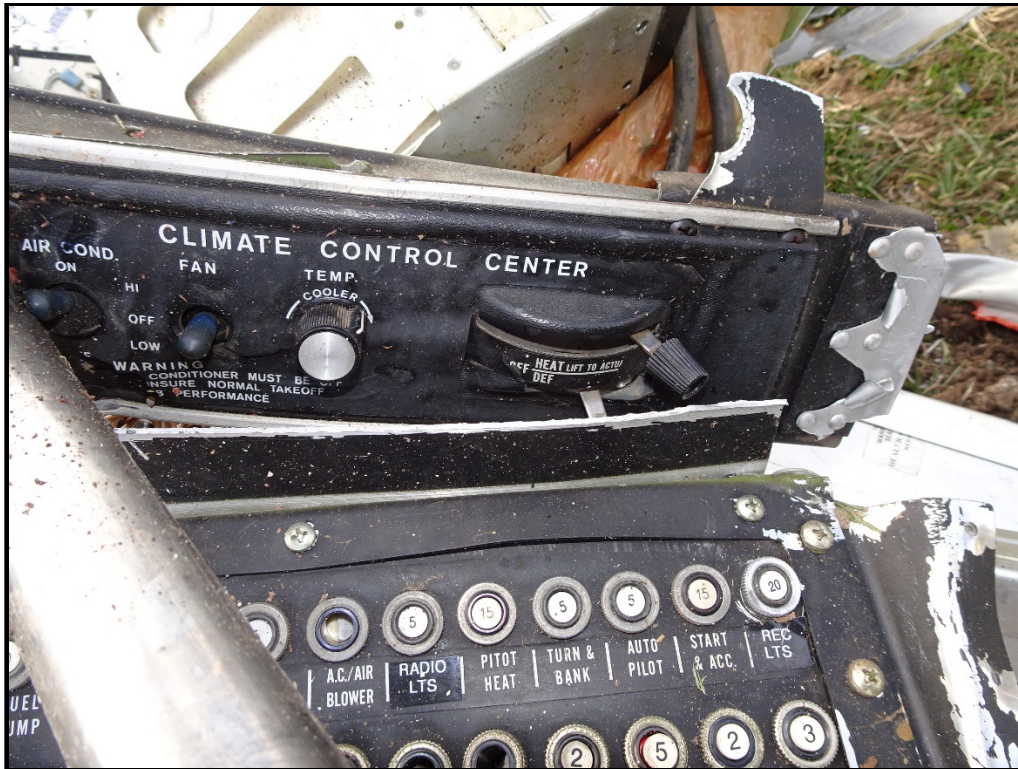
The cabin heat control was in the “ON” position, the “DEF” control was about 1/3 short of the on position (Photo 5).

Photo 5 – Cabin Heat Control

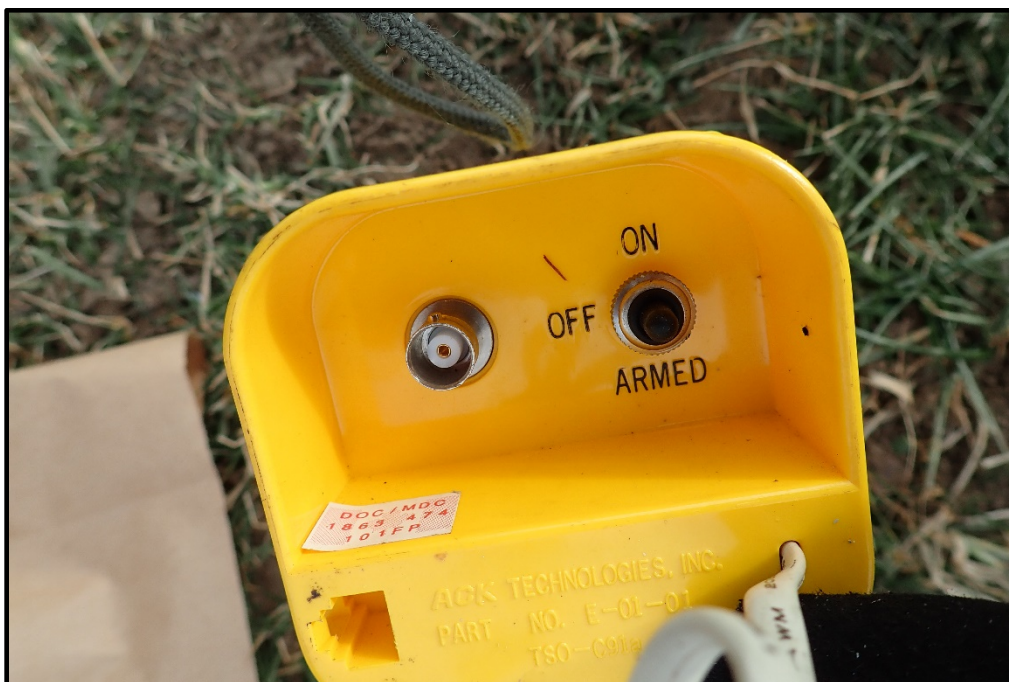
Three bags, totaling about 78 lbs in weight, were located both on the ground adjacent to the baggage area and on the right wing. The ELT remained mounted to the airframe behind the baggage hold. It was still connected to the antenna cable, and the ELT power switch was found in the “OFF” position (Photo 6). The rear baggage access panel for the ELT was intact, and there was no indication that the ELT had been accessed by first response personnel.

Photo 6 – ELT

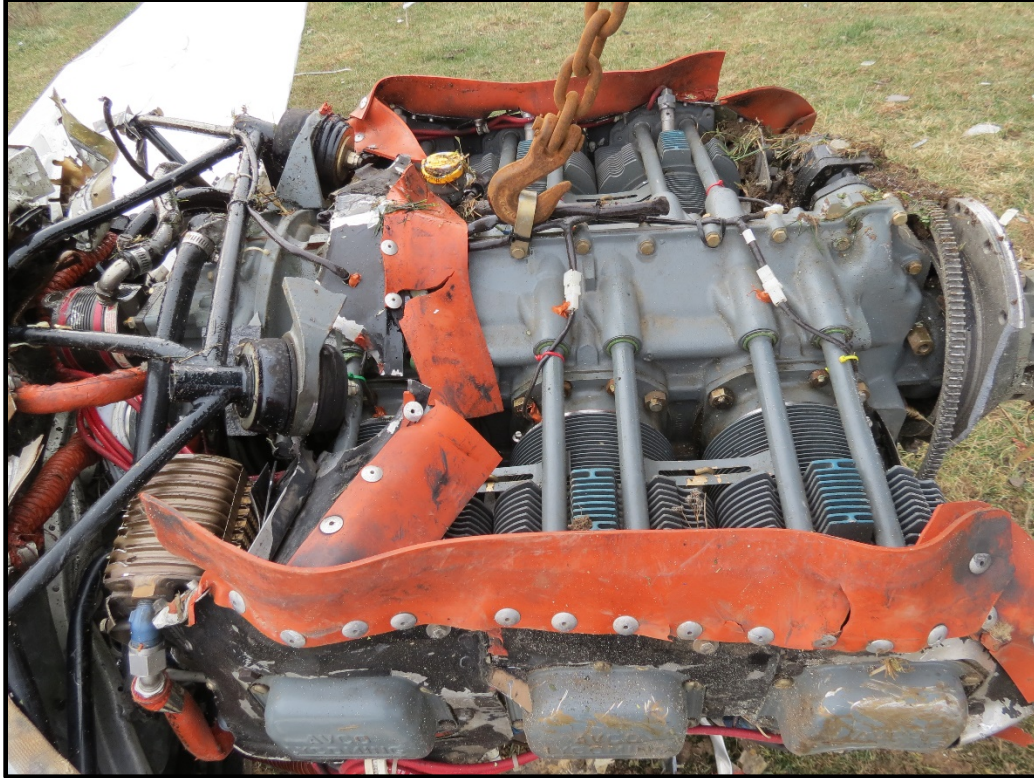
The engine was removed from the airframe by the team and, examined while being suspended by a tractor loader (Photo 7).

Photo 7 – Engine

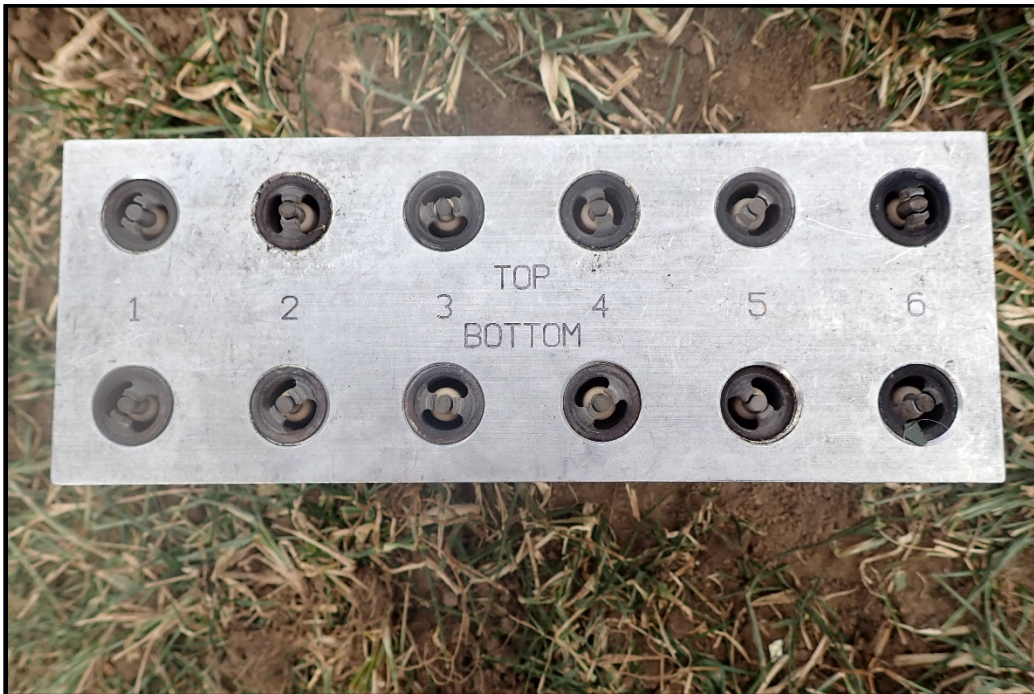
The spark plugs were removed and examined. All appeared undamaged, except for the lower plug of cylinder 1, the electrode of which was slightly offset. All plug electrodes were coated in light grey deposits (Photo 8) and exhibited “normal” to “worn out – normal” wear signatures when compared to the Champion AV-27 Aviation Check-A-Plug chart.

Photo 8 – Spark Plugs

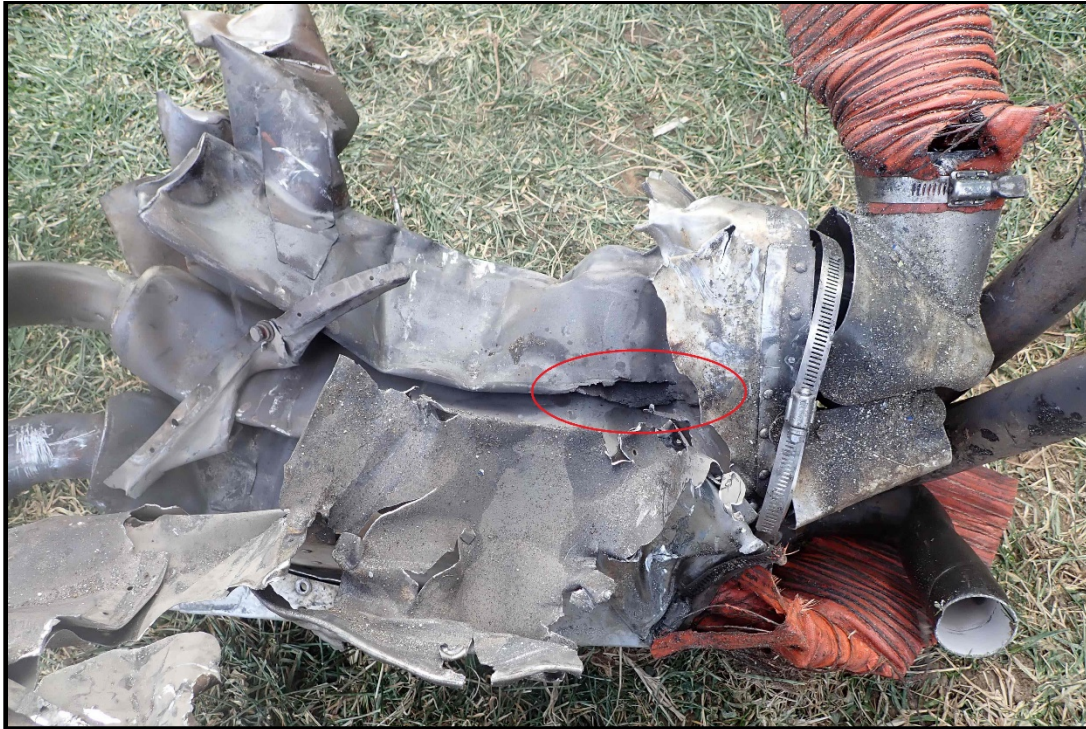
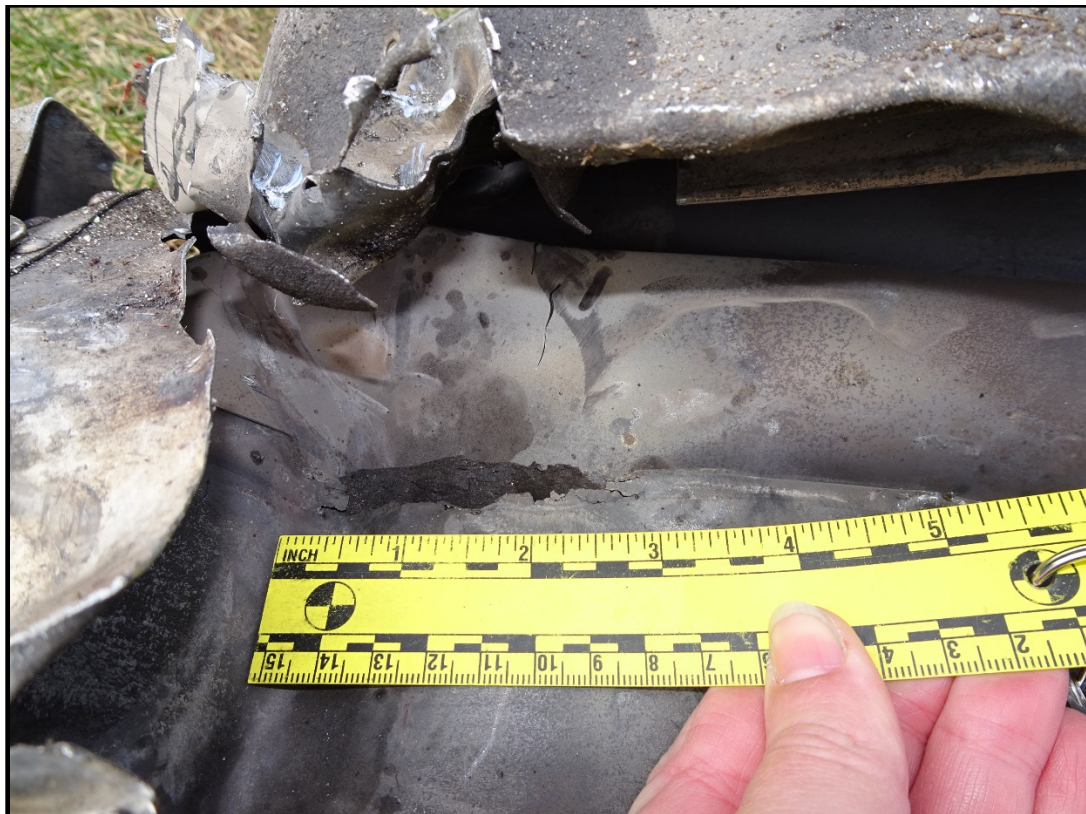
The exhaust muffler assembly was cut from the engine down-pipes to facilitate examination. The rear muffler exhibited a two-inch-long lateral hole to its outer surface (Photo 9,10). The metal on the edges of the hole were thinned and coated in black deposits. Similar metal thinning was observed at the intersection of the muffler inlet and the muffler seam (Photo 11). The inner surface of the heat shroud was coated in tan deposits; similar deposits were also present on the inner surface of the scat tube leading from the shroud to the cabin heat mixing valve (Photo 12).

Photo 9 – Exhaust Muffler System with Hole Circled

Photo 10 – Aft Exhaust Muffler

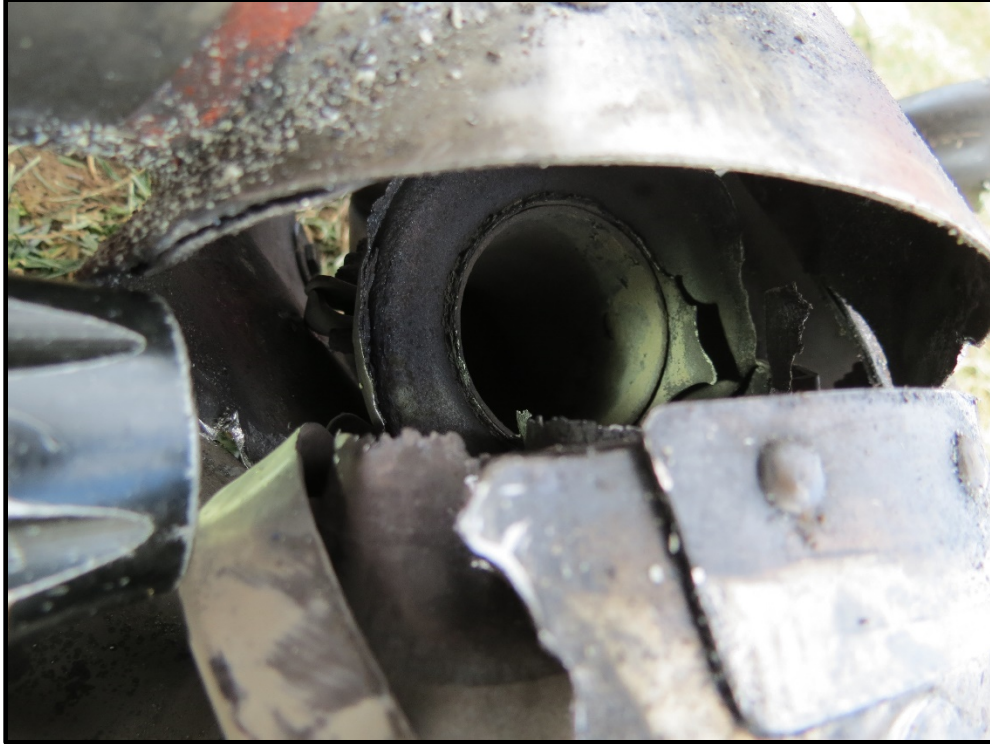
Photo 11 – Exhaust Muffler End

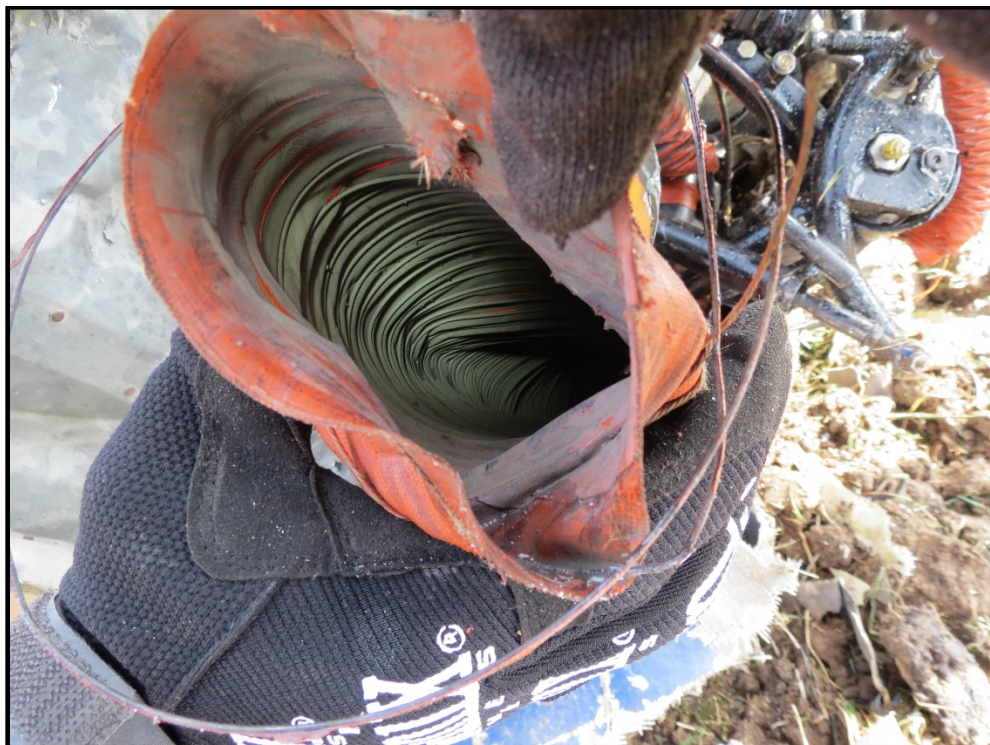
Photo 12 – Cabin Heat Tube
