## **NATIONAL TRANSPORTATION SAFETY BOARD**

# **ACCIDENT SITE EXAMINATION SUMMARY**

**WPR19FA025**

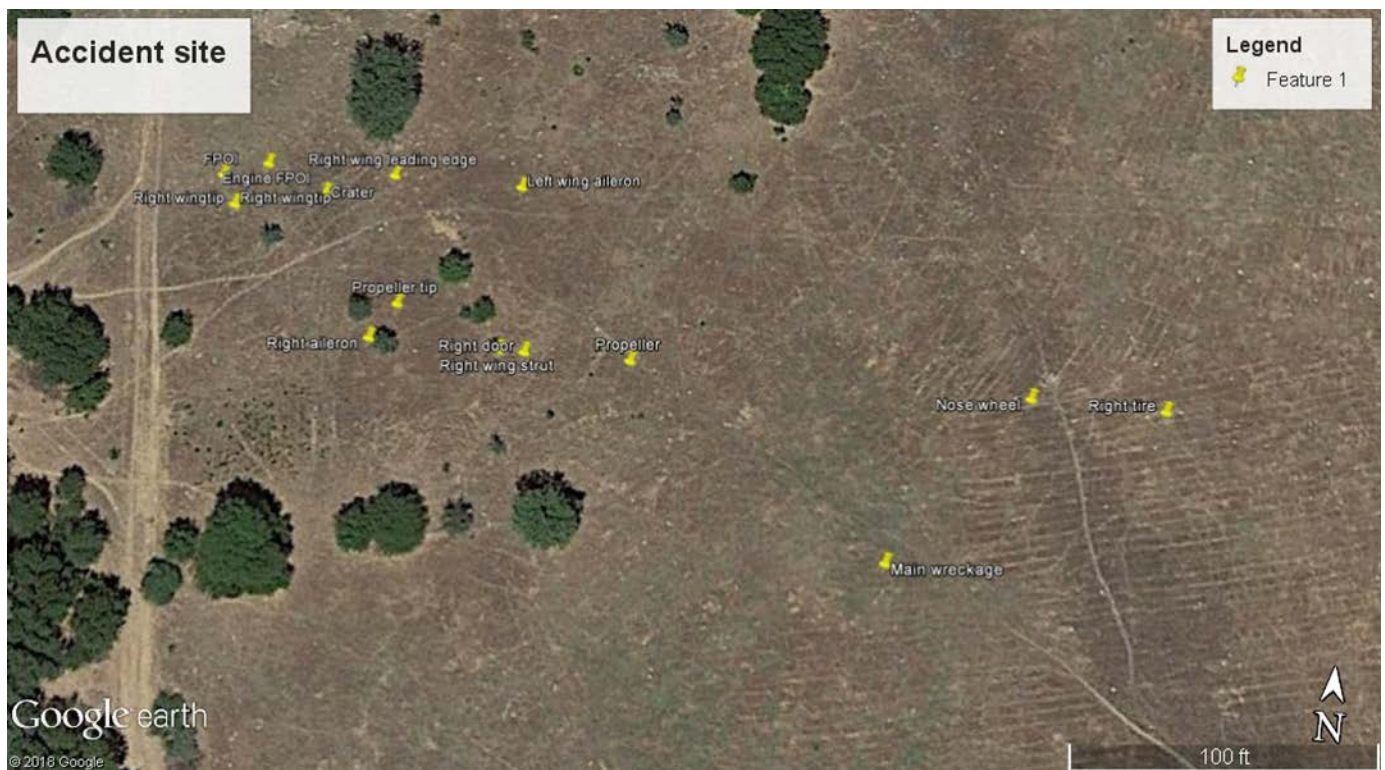
Figure 1. Accident site

The wreckage was spread along a 275 ft-long debris path through a dry grassy terrain on an approximate heading of 115° magnetic.

The first point of impact (FPOI) was a ground scar about 12 inches (in) long which contained a piece of a right-wing structure indicating that the right wing impacted the ground first. The right wingtip was located 18 ft from the FPOI. About 11 ft to the right of the FPOI, the ground scar

containing an engine rocker cover piece indicated the area where the engine initially impacted the ground.

The ground scar extended about 38 ft into a large area of disturbed dirt. The impact crater measured about 74 in in length, 14 inches in width and 7 in in depth. The right-wing leading edge was located 62 ft from the FPOI. The left-wing aileron was located about 108 ft from the FPOI. A part of the right aileron was located about 82 ft from the FPOI. The right-wing strut was located about 45 ft east of the right aileron. A propeller blade tip was located about 81 ft from the FPOI. The propeller was located about 164 ft from the FPOI and 109 ft from the main wreckage.

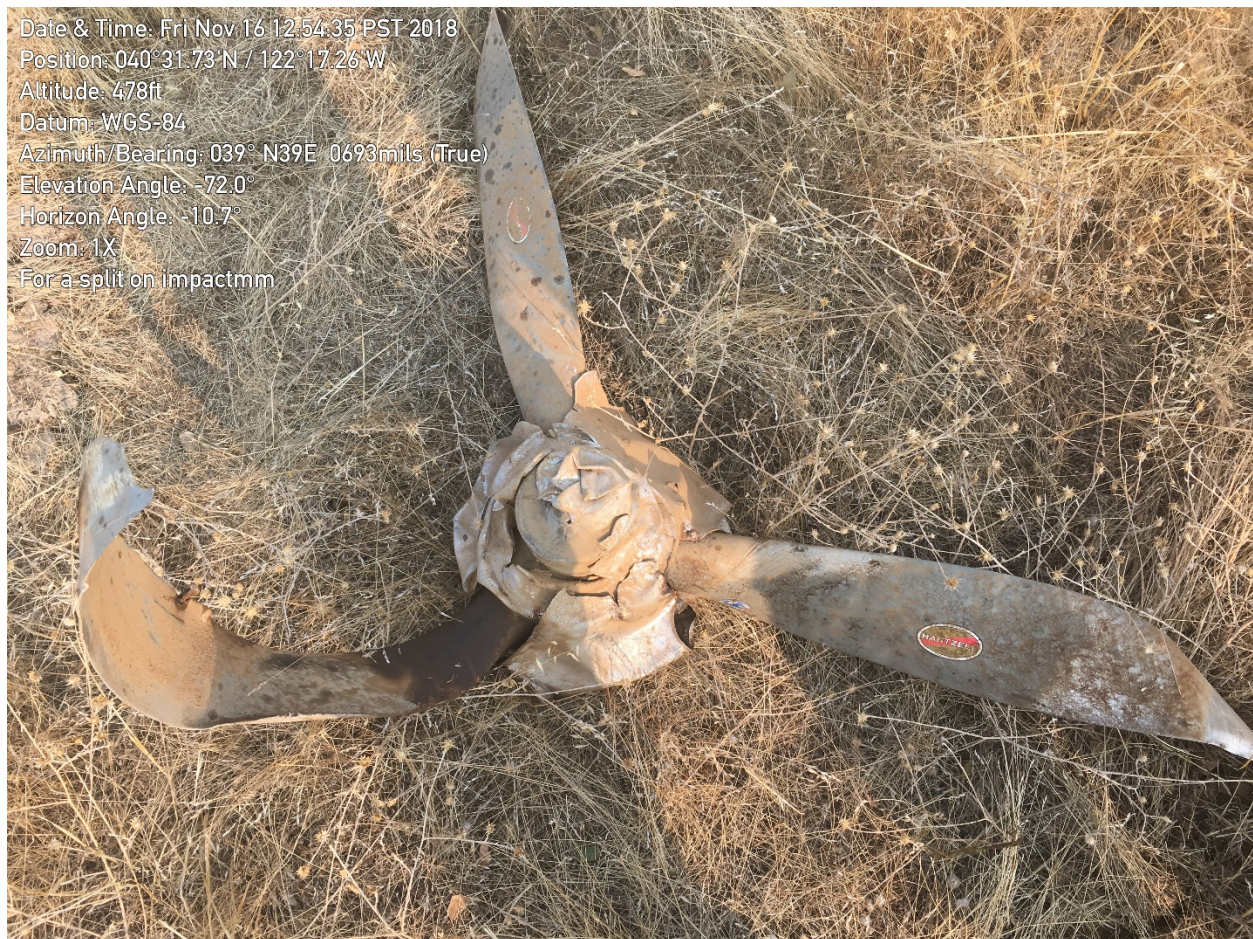
Figure 2. Propeller

All three blades remained attached to the propeller hub and all three blades were missing their respective blade tips. The propeller hub exhibited numerous impact signatures. One blade was bent backwards and contained a piece of an engine rocker arm imbedded in it. The area of the blade closest to the hub was covered with oil and dirt. The second blade exhibited twisting deformation about 1/3rd from the blade tip along with scratch marks throughout the blade length. The third blade exhibited slight twisting deformation with scratch marks. The propeller blades' signatures indicated that the engine was producing power on impact. Plexiglas, portions of engine cowling, instrumentation, and fuselage debris were scattered across the ground beginning at the first point of impact and extended to the main wreckage. The right door was located about

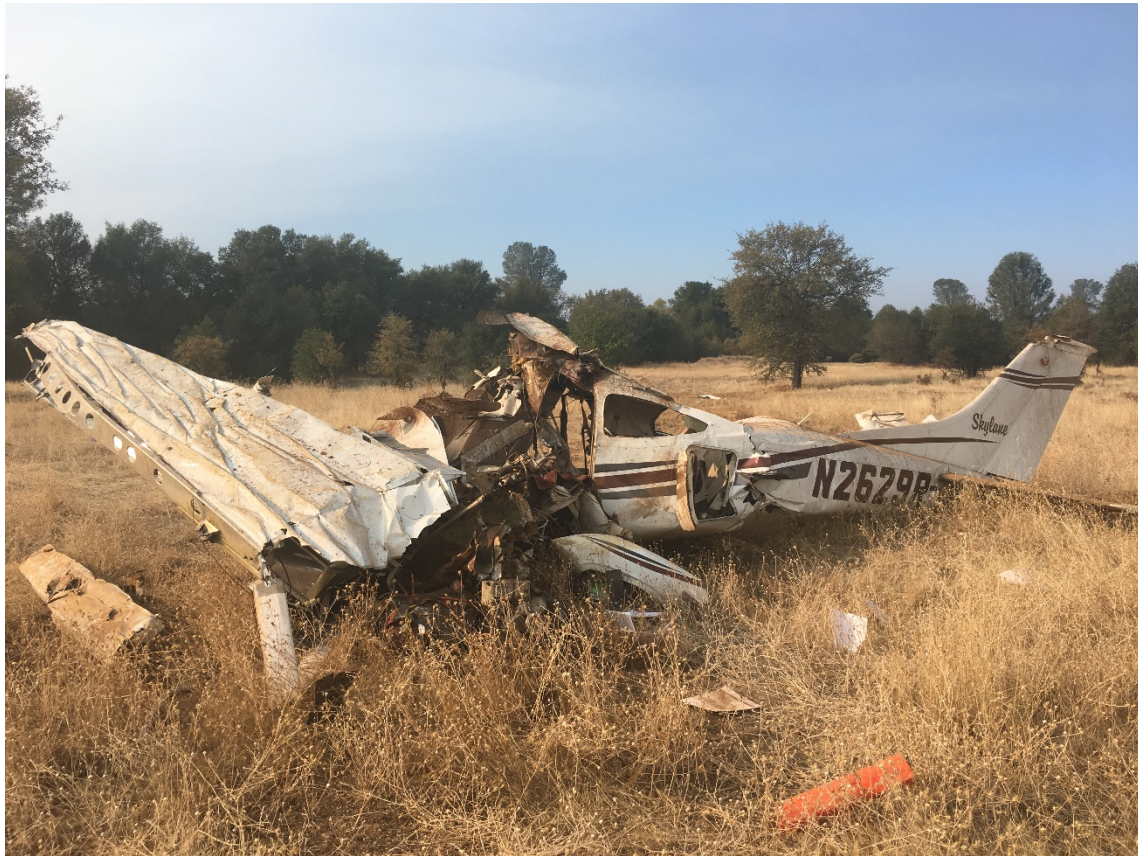
Figure 3. Main wreckage

The main wreckage consisted of the engine, both wings, cabin, fuselage and the empennage. The engine was separated from the firewall and no mounts were attached. The engine exhibited numerous impact signatures. The firewall and the instrument panel were crushed together and compressed downward. The instrument panel exhibited extensive damage. The carburetor heat lever was observed fully in. The throttle lever was observed  $\frac{3}{4}$  out. The master switch was on. The ignition key was in off position. Both front seats were found ejected from the airplane. Front seats were equipped with 3-point dual shoulder harness.

The left seat safety restraint buckles were found latched, the right seat safety restraint buckles were found not latched. The ELT was found in the off position and was in the grass about 20 ft left of the airplane. Both cabin doors were detached from the fuselage and located along the debris path.

The airplane was equipped with the aftermarket STOL kit that was installed on leading edge and wing tip of both wings. Both wings remained partially attached to the fuselage through cables except for aileron balance cable that was separated due to overstress. Both fuel tanks were breached in multiple locations, but the strong odor of fuel was present at the site. In addition, both wings had fuel splash marks on their surfaces indicated that there was fuel in fuel tanks. The right wing was crushed along its span, bent halfway upward and about 3.5 ft of the outboard wing was twisted backwards. Most of the aileron and flap remained attached to the wing. About

1 ft of the outboard wing aileron was found detached along with the wing tip. The leading edge with the STOL kit attached to it was separated from the wing.

The left wing exhibited crushing throughout its span. About 10 ft of the outboard wing was broken off and was resting on top of the inboard portion of the wing. The leading edge along the outboard wing was detached from the wing and crushed throughout its length. The leading edge along the inboard portion of the wing remained attached to the wing and exhibited forward impact damage.

About 1.5 ft of the left aileron remained attached to the wing; the rest of the aileron and flap was found detached. The top side of the empennage exhibited impact damage. The forward right side of the empennage was crushed inward. The vertical stabilizer, rudder, horizontal stabilizer and elevators remained attached to the empennage. The majority of the vertical stabilizer was mostly intact and exhibited minor impact damage. The top portion of the vertical stabilizer was impact damaged and broken off. The rudder was intact except the top portion that was damaged. The beacon light remained attached by the cable. The outboard piece of right horizontal stabilizer exhibited impact damage and was twisted and crushed inboard 90°. The right elevator remained attached to the horizontal stabilizer by its inboard hinge and exhibited wrinkling along its surface. The left horizontal stabilizer and elevator remained attached to the empennage and were intact.
