# Continental Motors

## ENGINE FIELD EXAMINATION REPORT

| ENGINE MODEL | IO-520F (83B) Converted by<br>Texas Skyways to O-520FTS |
| FILE NUMBER | 18-293 |

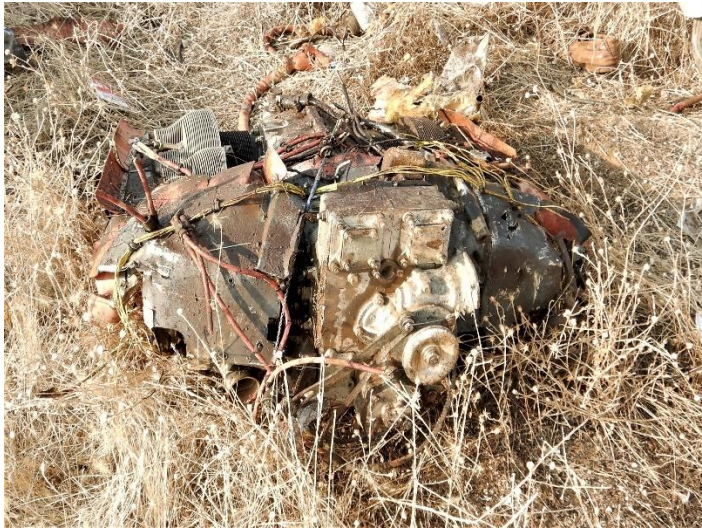
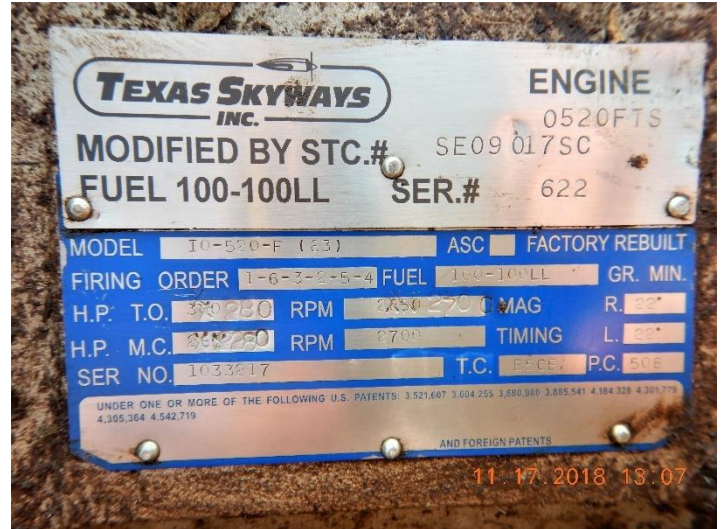
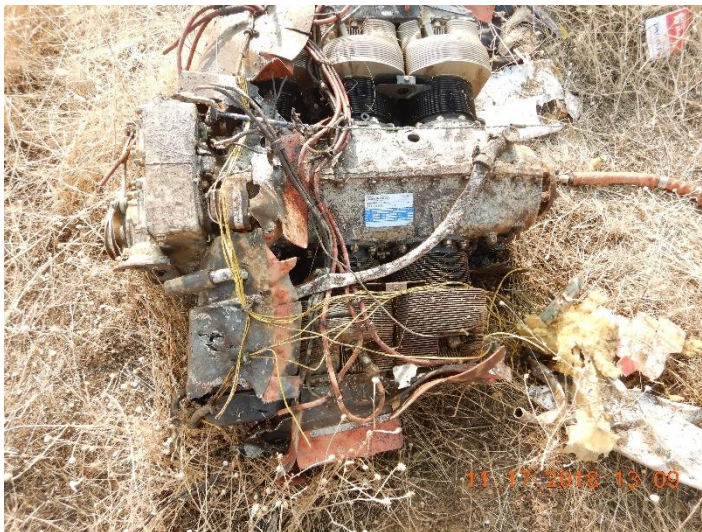
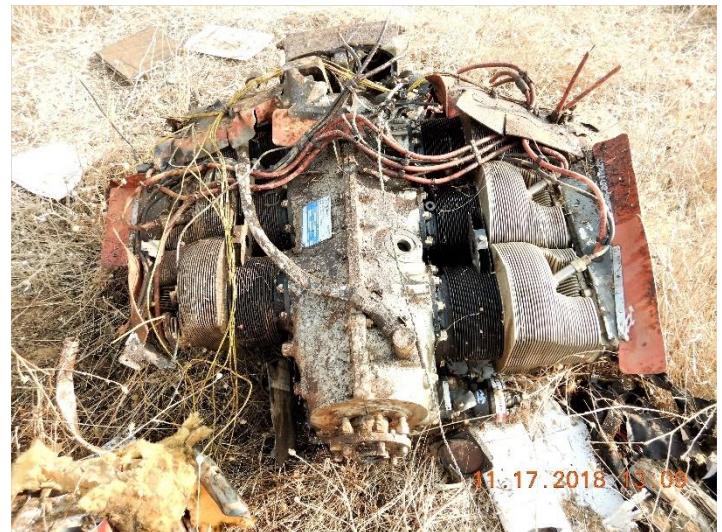
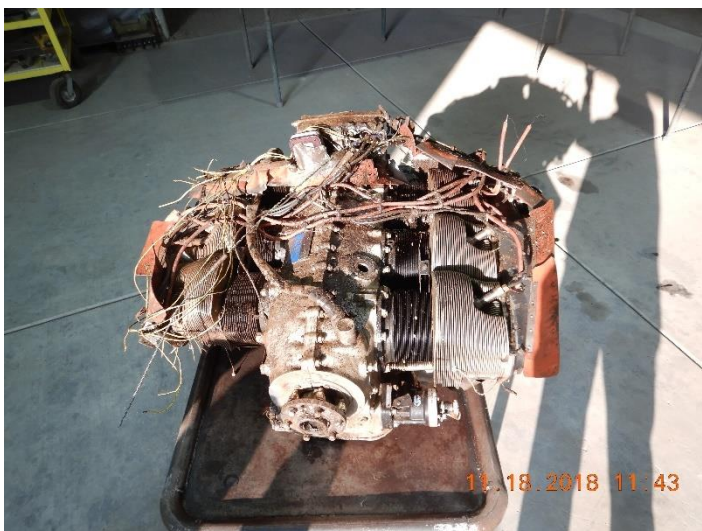
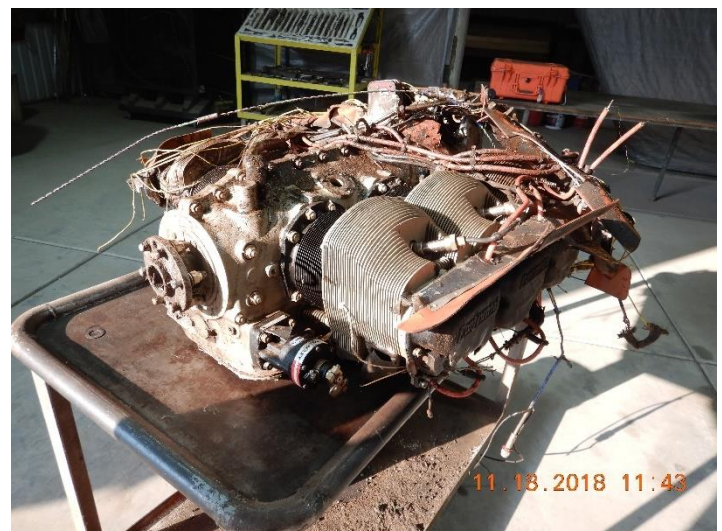
All six cylinders remained attached and the crankcase was intact. The engine mounts were broken by impact forces. The crankcase oil filler neck and oil rod and housing separated. The engine data plate was intact and indicated that the engine was a Continental Motors model IO-520-F (83B) serial number 1033217 which has been modified by Texas Skyways under STC SE-09017SC. This modification includes removing the fuel injection components and installing a carburetor which reduces the original 300 horsepower at 2850 RPM to an advertised horsepower of 280 at 2700 RPM. Texas Skyways also assigned a unique serial number 622 and model number O520FTS.

The # 5-cylinder rocker cover was impact damaged and the intake and exhaust push rod-tubes and pushrods separated. The lower portion of cylinder #5 separated. The rocker arms separated. A portion of one rocker arm was discovered in the leading edge of propeller blade C.

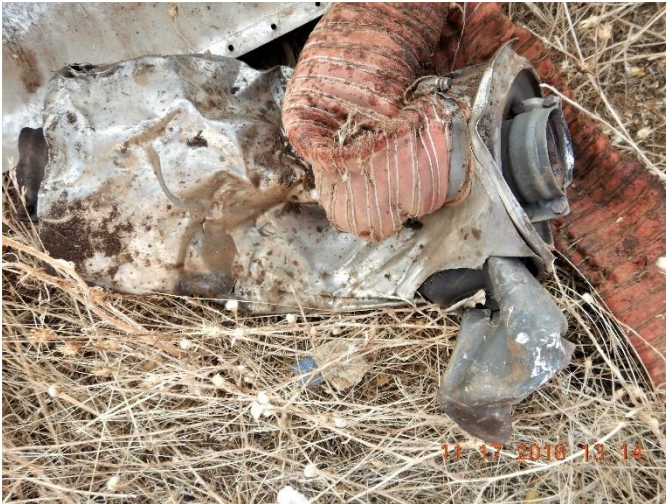
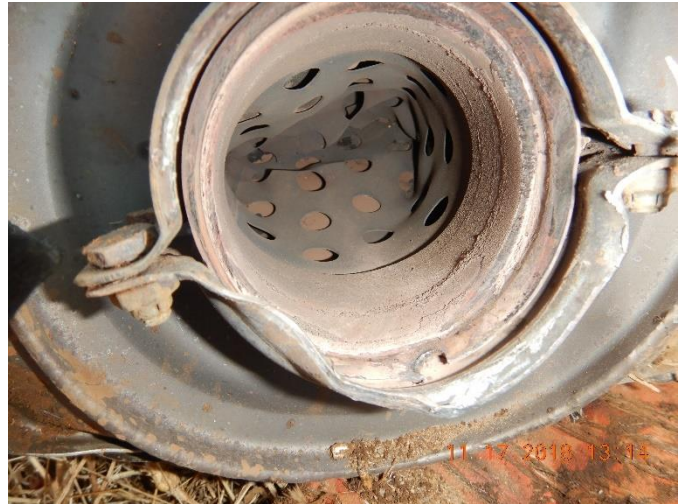
#### EXHAUST SYSTEM

Condition: The exhaust muffler separated but was recovered in the wreckage path. The muffler outer heat shield and muffler exterior were crushed by impact forces.

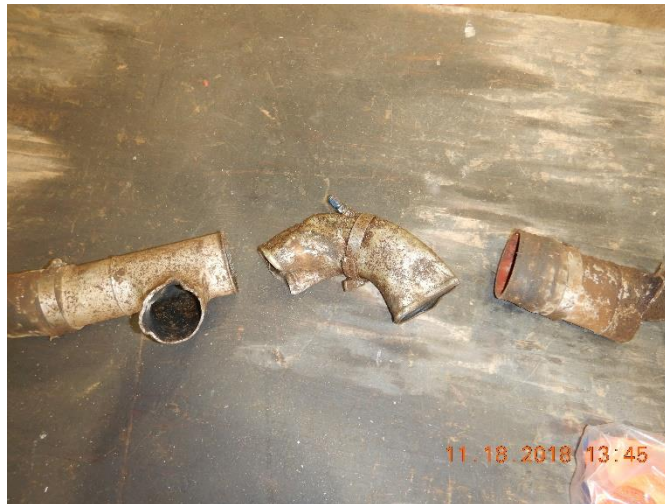
#### INDUCTION SYSTEM

Condition: Induction components separated at impact and were recovered along the debris path. All recovered induction components exhibited impact damage.

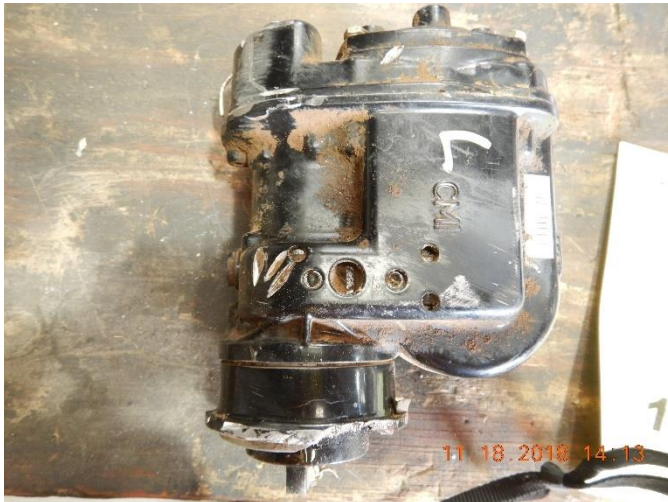
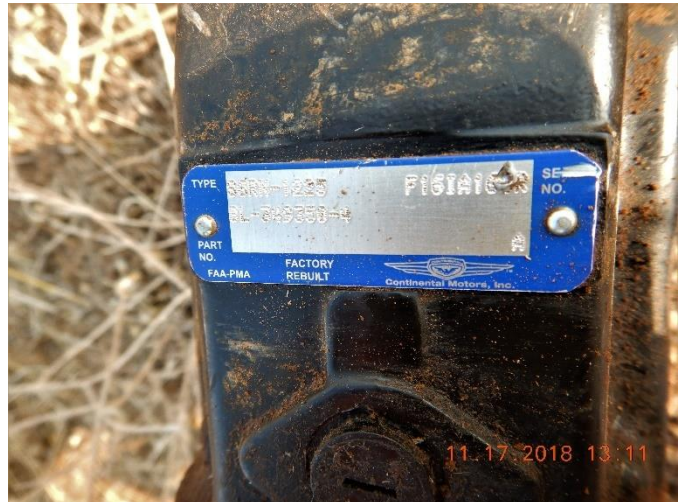
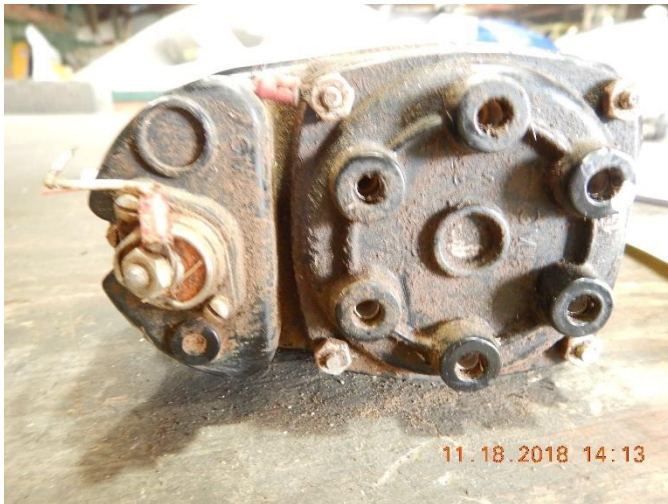
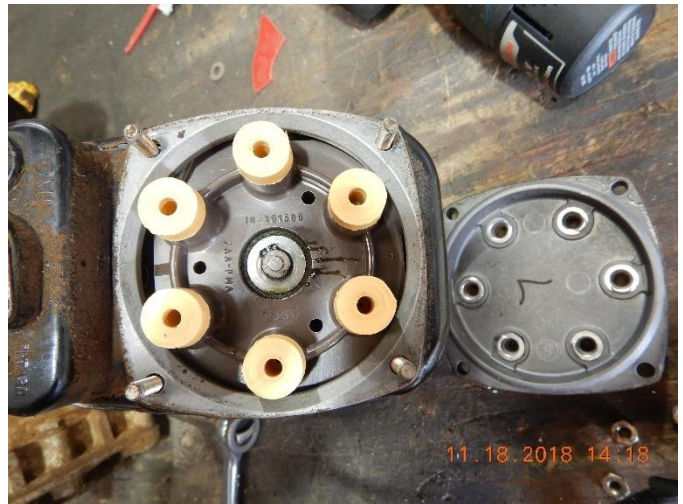
| LEFT MAGNETO | Manufacturer: CMI | M/N: S6RN-1225 | S/N: F161A166R |
|---|---|---|---|
| Condition: | The left magneto separated but was recovered from the wreckage path debris. A cotter pin was present in the drive coupling and the impulse coupling released normally when manually rotated. The cotter pin was removed from the magneto drive shaft to allow rotation of the magneto with an electric drill motor. The magneto produced spark at all terminals when manually rotated. | | |

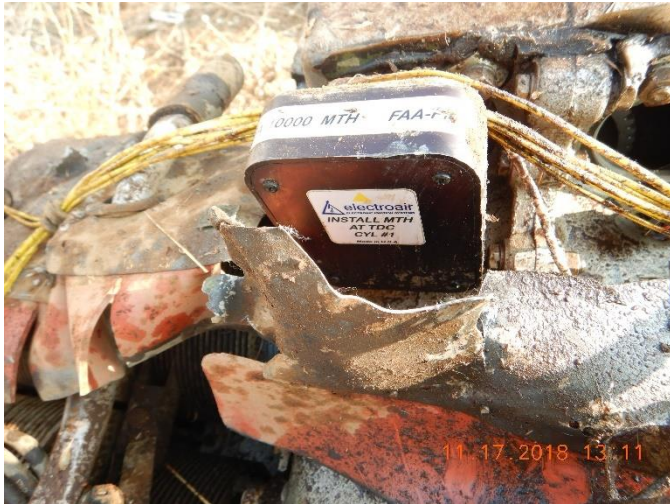
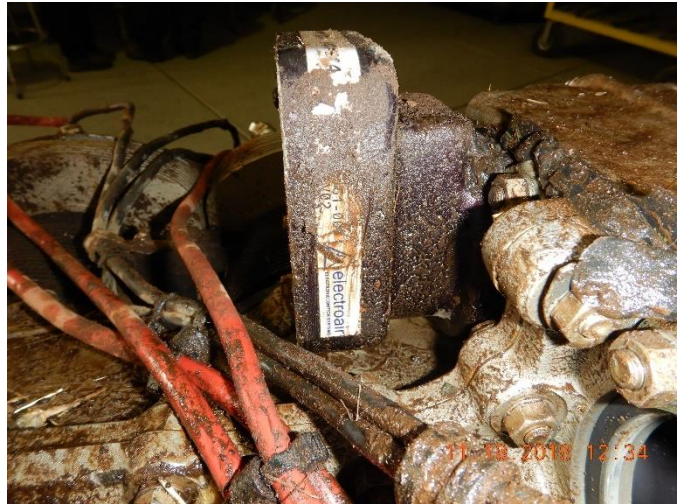
| RIGHT MAGNETO | Manufacturer: Electroair | P/N: Undetermined | S/N: 14-161-006<br>Rev 2 |

| Condition: | The original right magneto had been removed and an Electroair electronic ignition device was installed in its place. The broken electronic ignition module was impact damaged and could not be tested. | | |

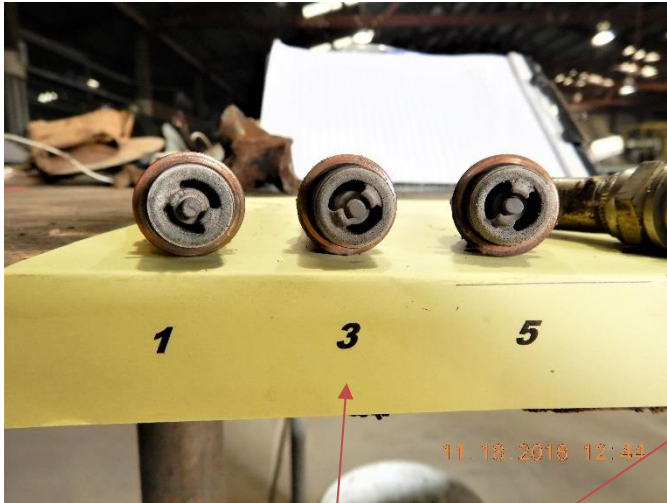
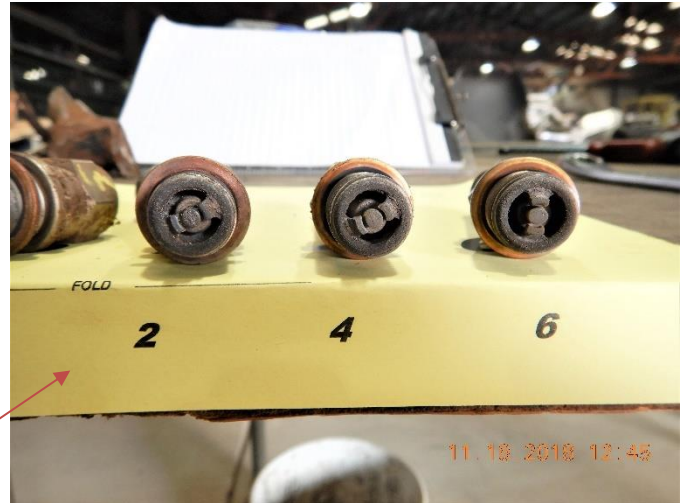
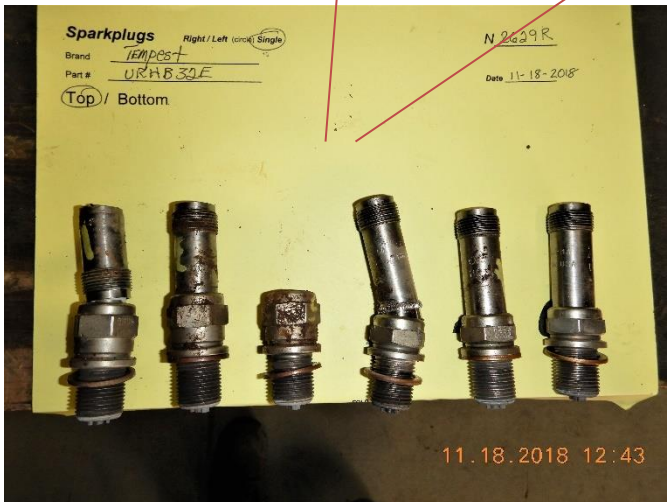
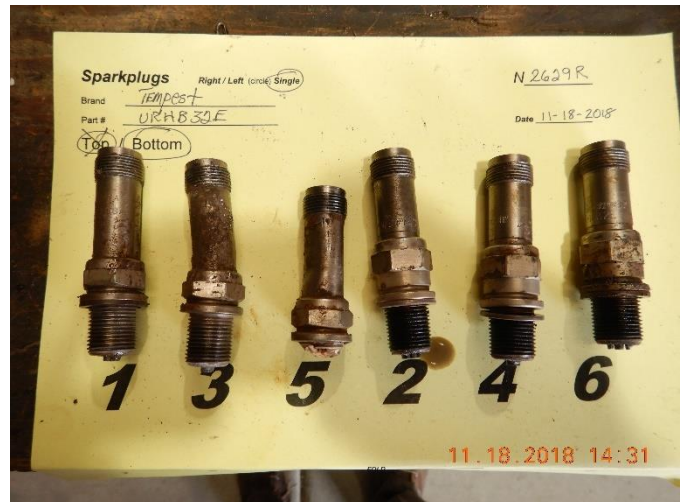
## SPARK PLUGS

**Condition:** The top sparkplugs were removed and inspected. Sparkplugs from cylinders 1, 2, and 5 exhibited impact damages. When compared to a Champion Spark Plug "Check-A-Plug" chart, the sparkplugs were "normal" in condition and color. The bottom sparkplugs were removed and inspected. The sparkplugs from cylinders 3 and 5 exhibited impact damaged. The threaded lower portion of sparkplug # 5 separated. The lower sparkplug from cylinder # 2 was oil fouled.

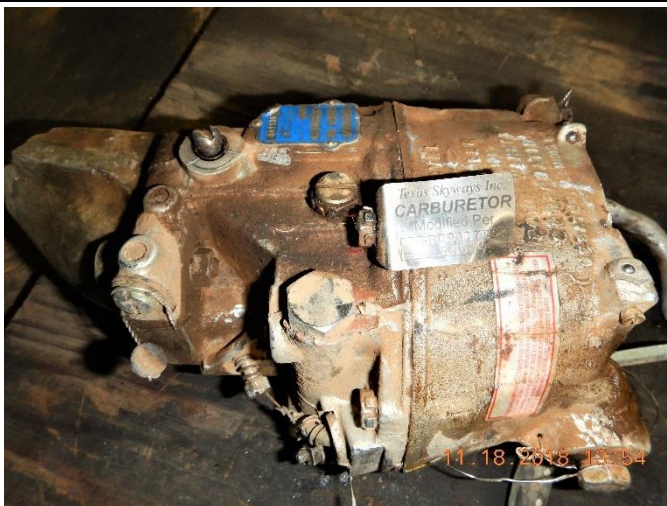
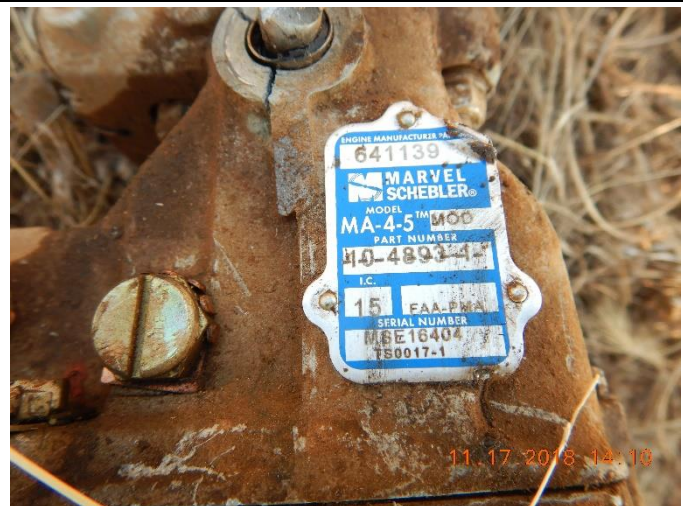
| Condition: | The carburetor exhibited impact damage and the mixture control arm and mixture adjustment screw were damaged. The carburetor was disassembled, and no fuel was present. The floats were intact and correctly operated the needle valve when manually lifted. The accelerator pump plunger was intact, but no fuel was present in the orifice. The fuel finger-screen was removed and inspected. No contamination was present. The throttle plate was in the full closed position. | | |

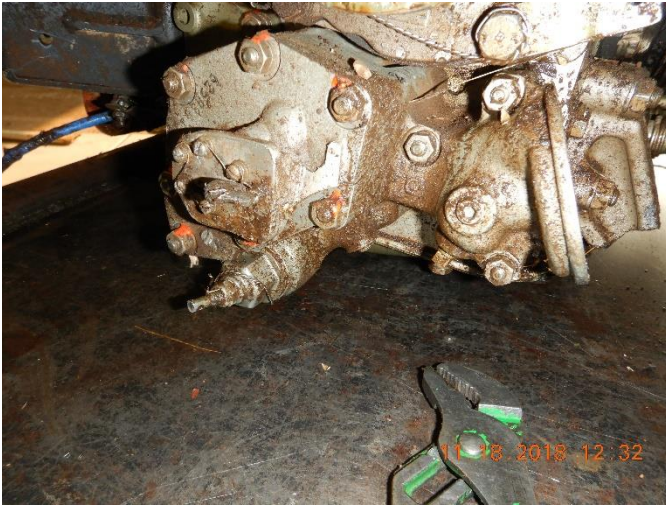
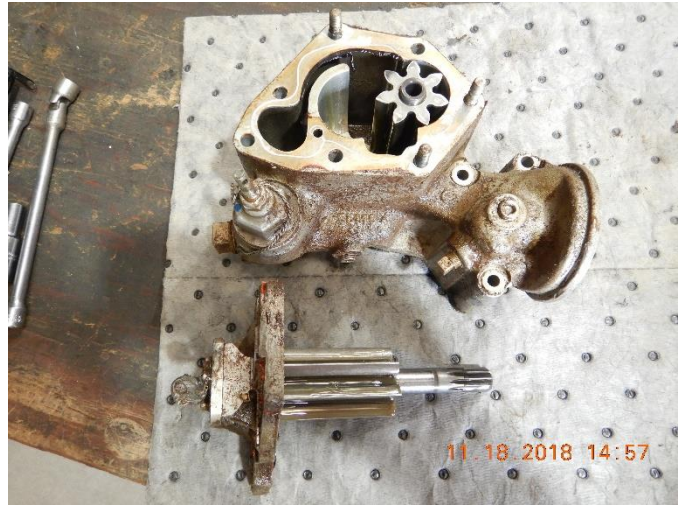
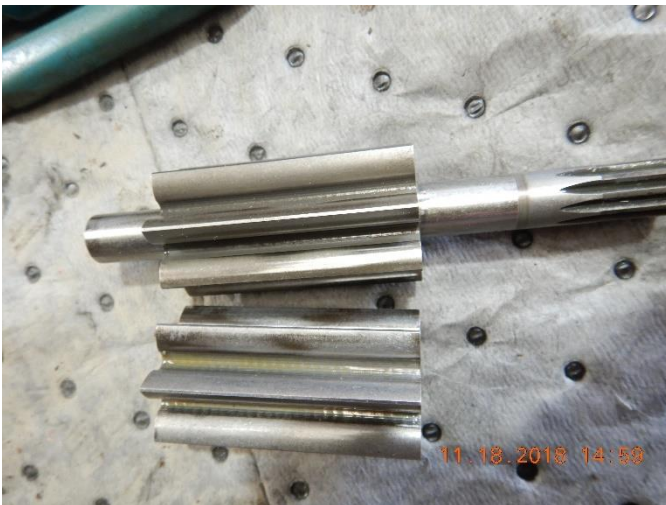
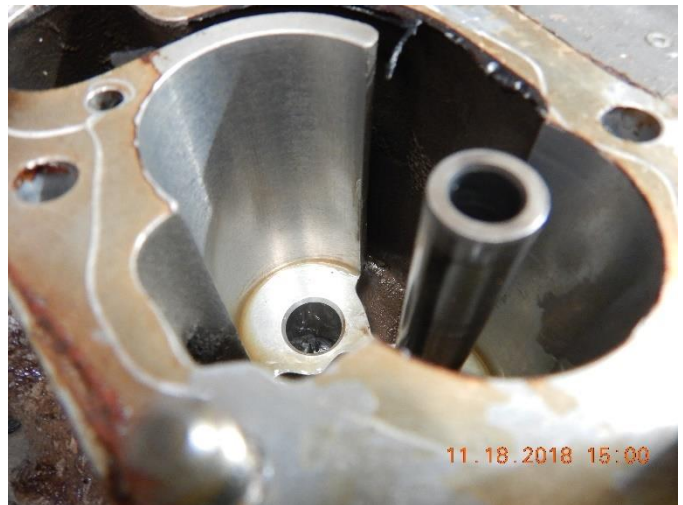
Condition: The engine oil sump which is located on the lower portion of the engine received impact damage. No oil remained in the oil sump.

Condition: The oil pump gears, shaft, and pump housing were intact and exhibited no damage.

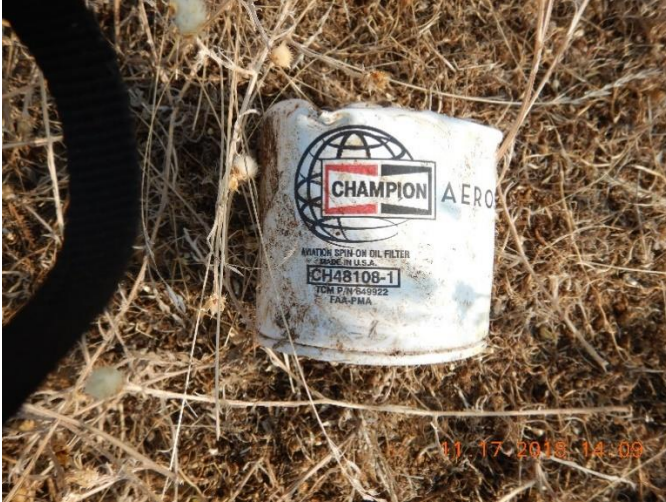
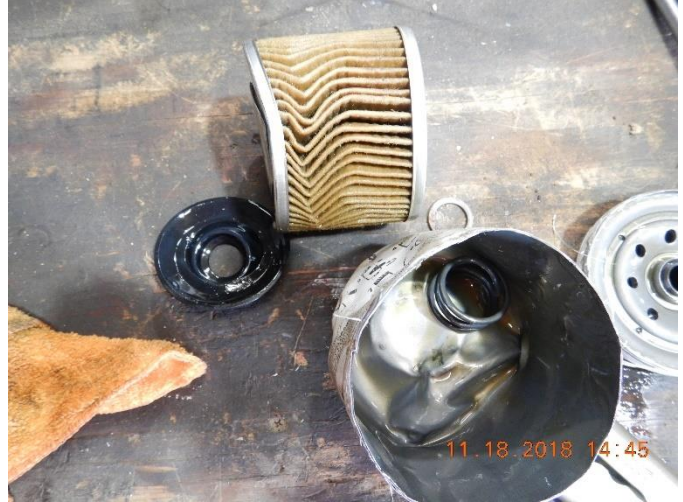
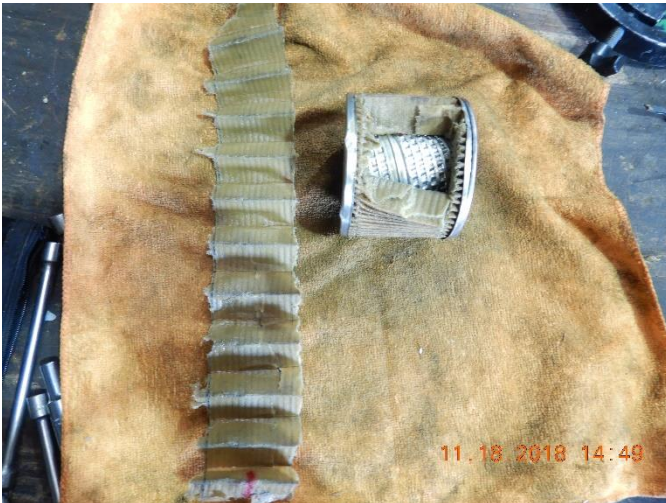
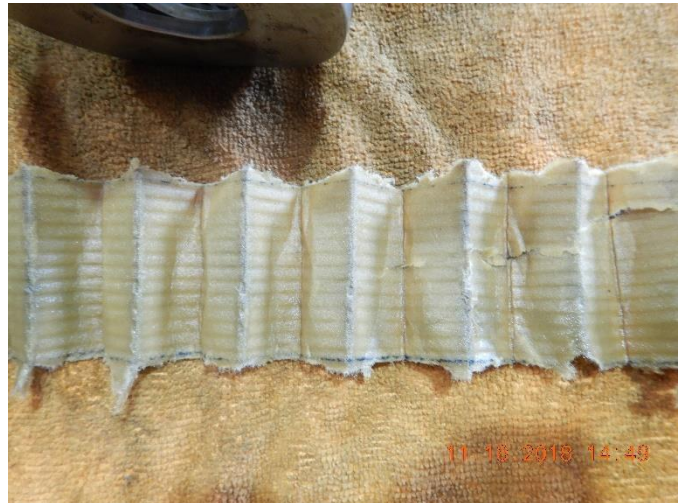
## OIL FILTER

The spin-on oil filter separated from the oil pump due to impact forces. The oil filter was cut open and inspected. Only a small amount of oil was present. The paper filter media was removed, and no contamination was present.

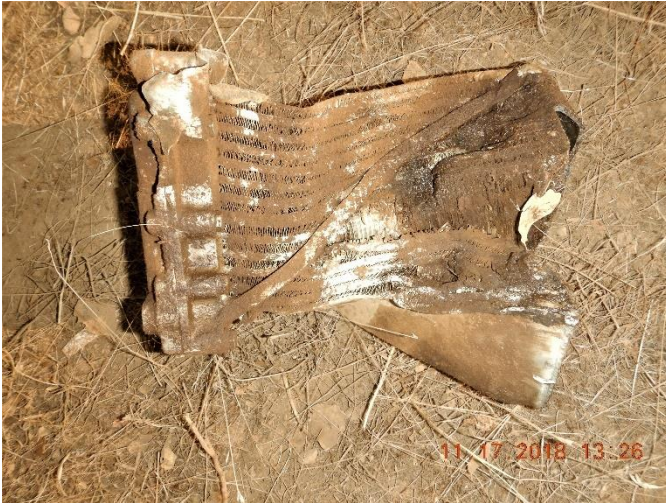
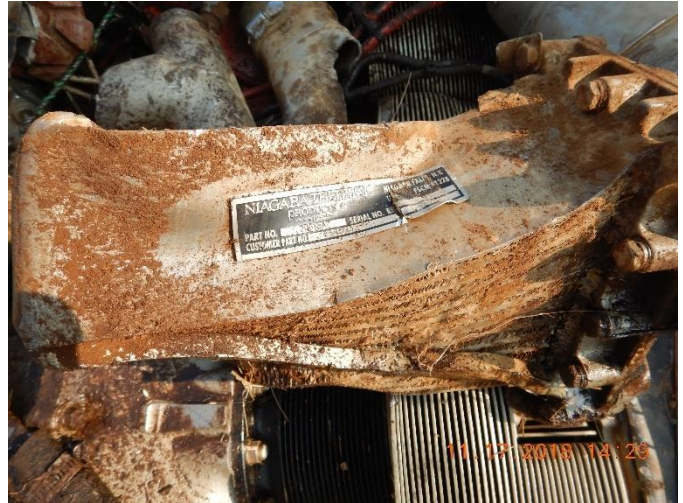
## OIL COOLER

The oil cooler separated from the engine during the impact sequence and exhibited impact damage.

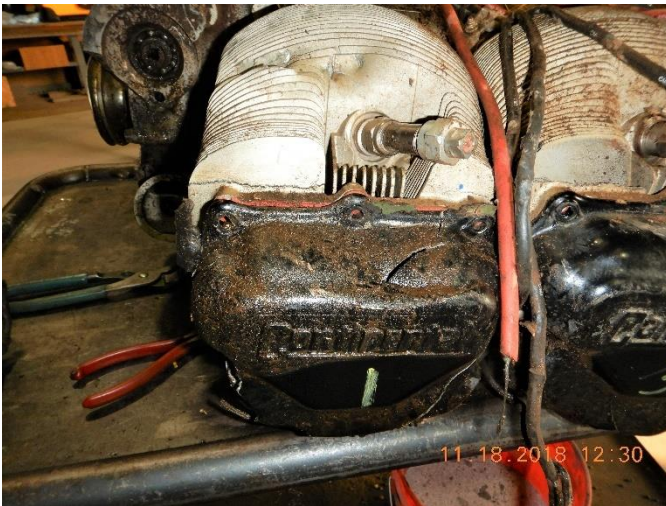
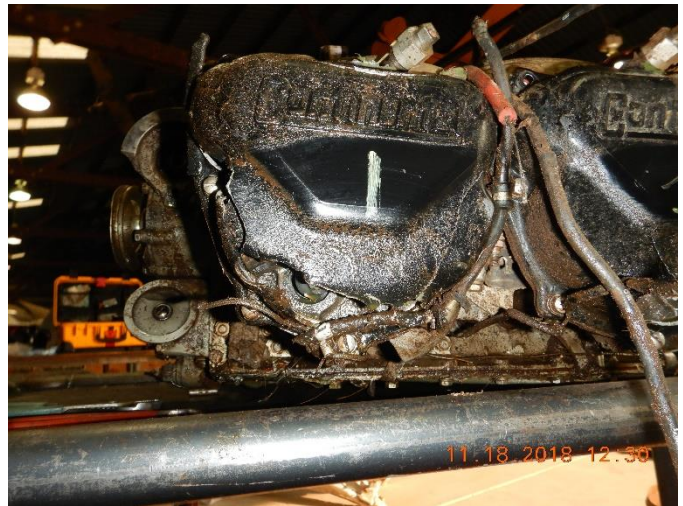
| CYLINDER #1 | P/N: 658552A4 | S/N: AC16JA340 | Head Date: Undetermined |

| Condition: | The cylinder was intact, but the rocker cover was broken due to impact forces. The top cooling fins were impact damaged. | | |

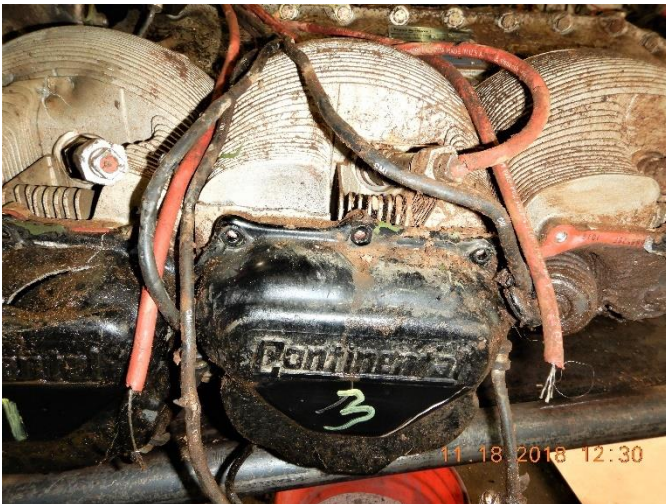
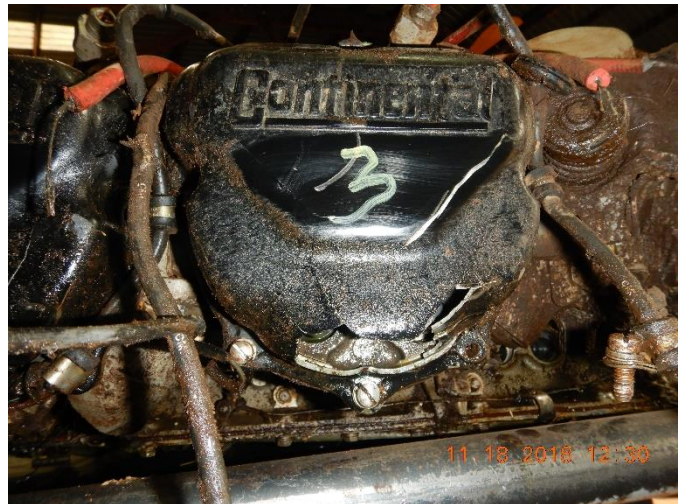
| CYLINDER #3 | P/N: 658552A4 | S/N: AC16JA526 | Head Date: Undetermined |

| Condition: | The cylinder was intact, but the rocker cover was broken due to impact forces. | | |

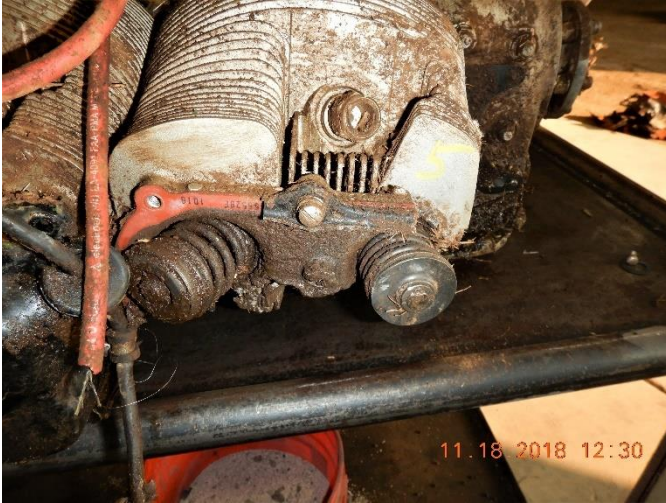
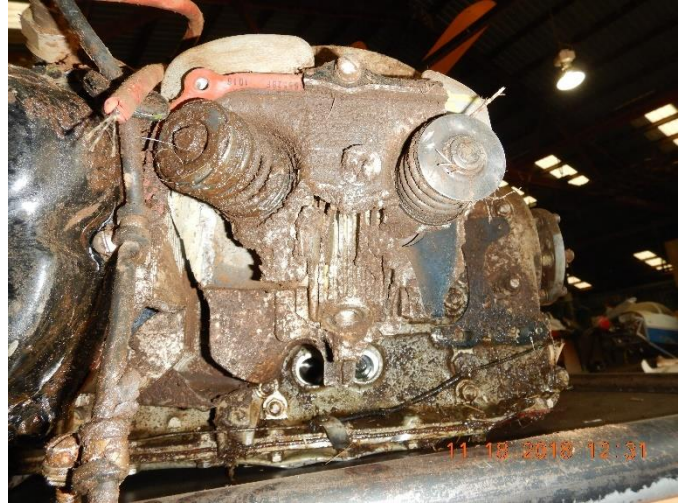
| <b>CYLINDER #5</b> | P/N: 658552A4 | S/N: AC16HD725 | Head Date: Undetermined |

**NOTE:** The engine was manually rotated and all cylinders except cylinder # 5 produced thumb compression. Cylinder # 5 was impact damaged and both pushrods separated leaving the intake valve partially open and damaged.

| Condition: | The rocker cover and the lower portion of the cylinder head separated. The rocker arms and pin separated. A broken section of a rocker arm was found imbedded in a propeller blade leading edge. See photos on page 19 of this report. | | |

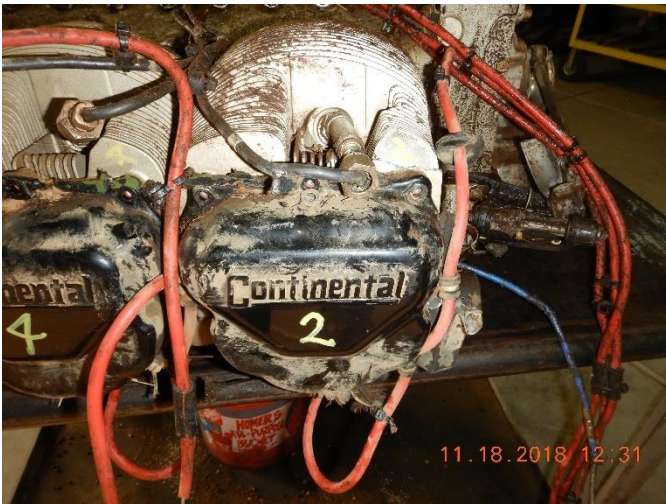
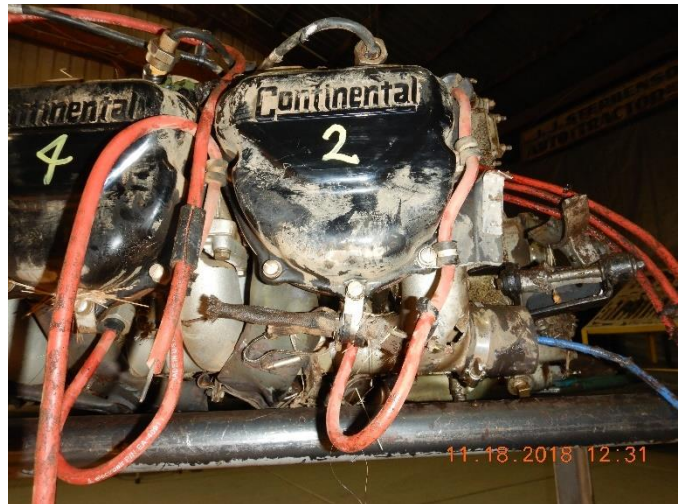
| <b>CYLINDER #2</b> | P/N: 658552A4 | S/N: AC16IA239 | Head Date: Undetermined |

| Condition: | The cylinder was intact with only minor impact damage to cooling fins. | | |

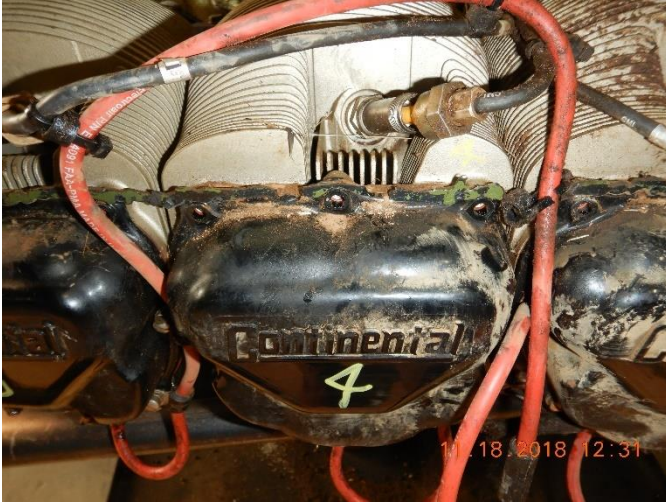
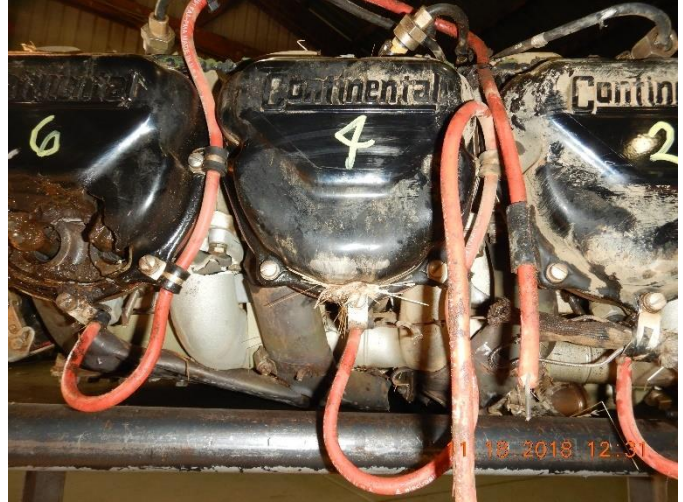
| CYLINDER #4 | P/N: 658552A4 | S/N:<br>AC16HD813 | Head Date: Undetermined |

| Condition: | The cylinder was intact with only minor impact damage to cooling fins. | | |

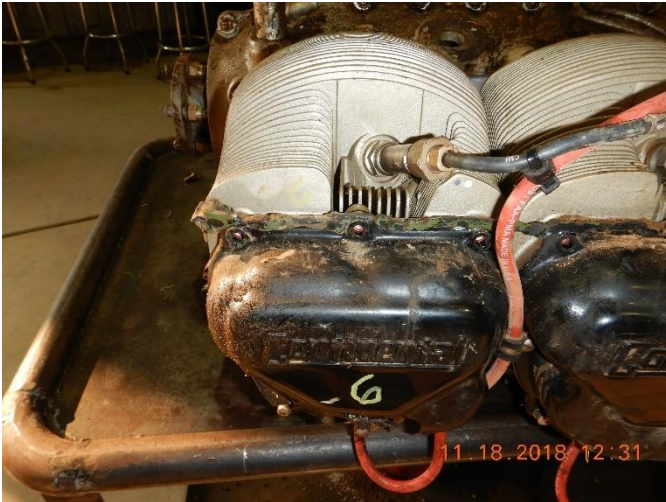
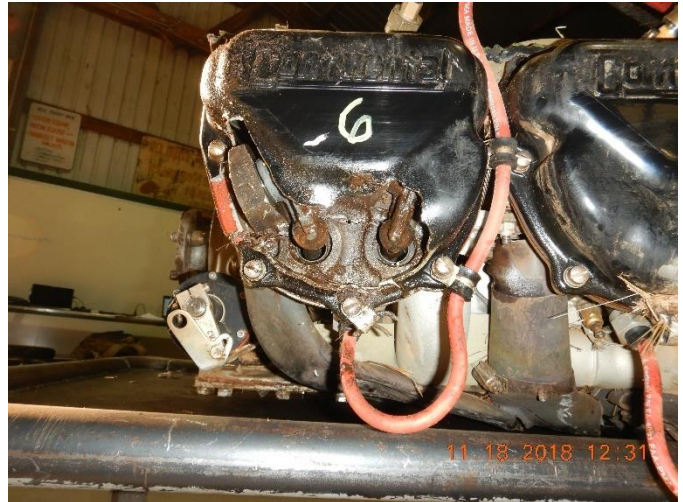
| CYLINDER #6 | P/N: 658552A4 | S/N:<br>AC16HC929 | Head Date: Undetermined |

| Condition: | The cylinder was intact, but the rocker cover received impact damage. | | |

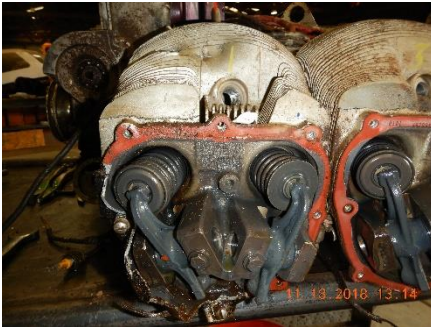
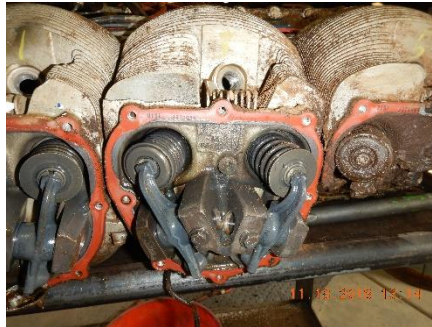
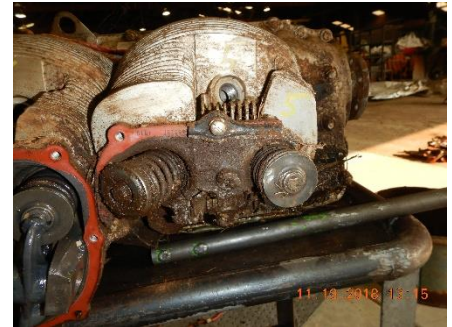
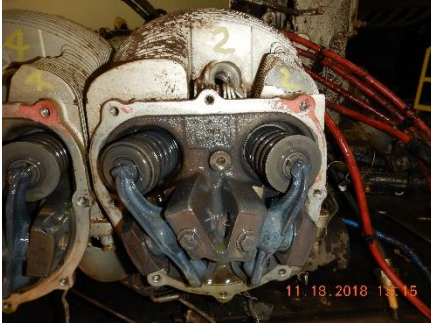
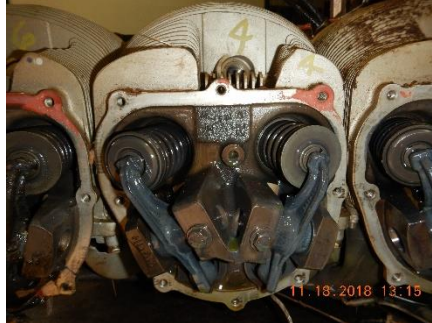
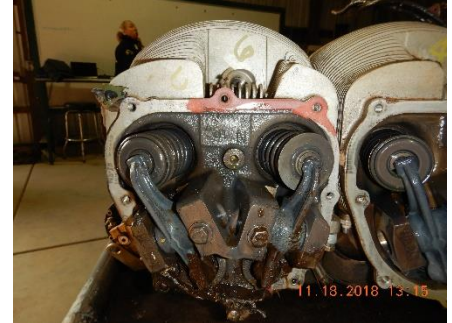
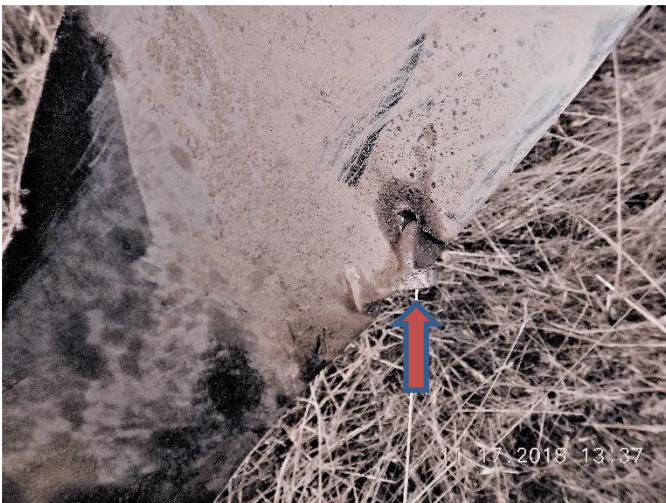
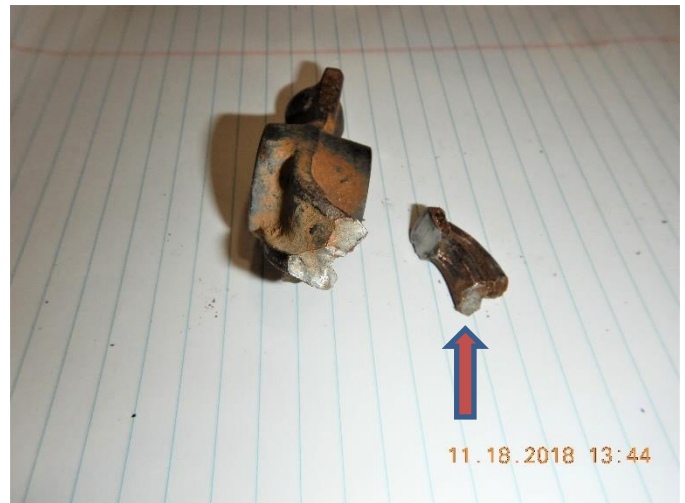
Condition: Valve faces were examined during the lighted borescope inspection. All valves exhibited normal combustion signatures. The intake valve stem on cylinder # 5 was bent and would not allow the valve to close normally.

Condition: Rocker covers were removed, and the engine was rotated manually. All rocker arms, valve springs and valves moved normally except cylinder # 5. Cylinder # 5 rocker arms separated, and the intake valve stem was bent due to impact forces.  
**NOTE: The # 5 intake rocker arm was recovered in the debris path. The top portion separated and was discovered embedded in the leading edge of blade C. See the red arrows below.**

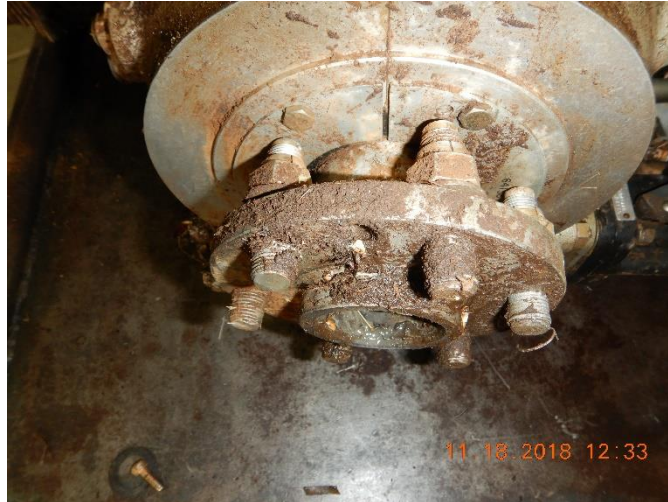
| Condition: | Crankshaft continuity was confirmed by manually rotating the crankshaft and noting that the accessory gears in the rear of the engine rotated normally. The propeller flange was impact damaged and the propeller separated due to impact forces. | | |

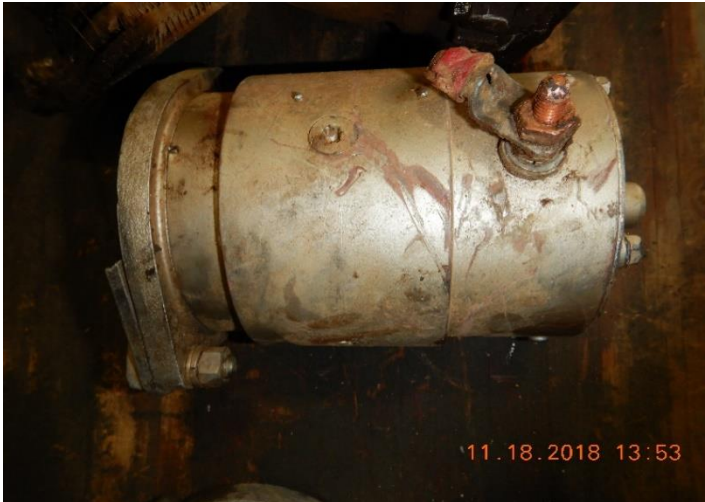
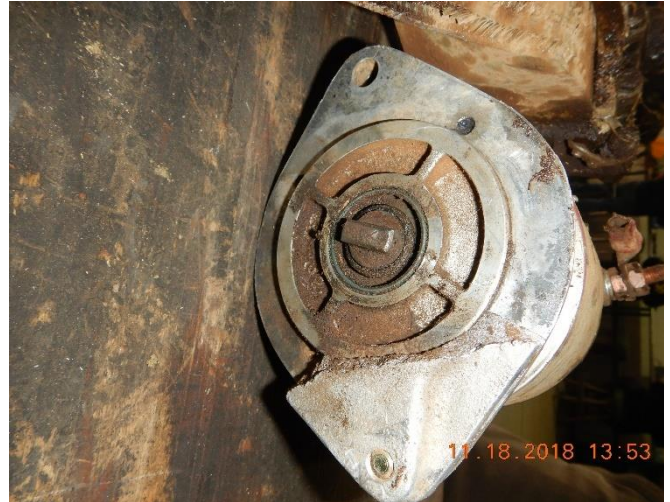
**STARTER**

No data plate was attached to the starter motor. The starter motor shaft rotated smoothly when manually manipulated.

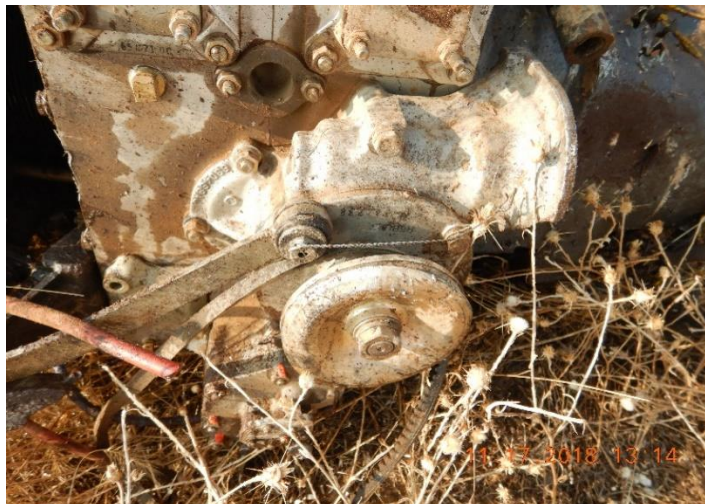
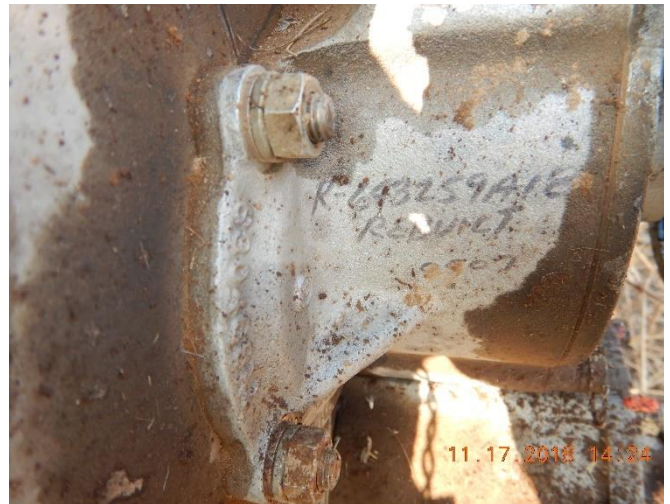
**STARTER ADAPTER**

The starter adapter remained attached to the rear of the crankcase. The PTO pulley was impact damaged and would not rotate.

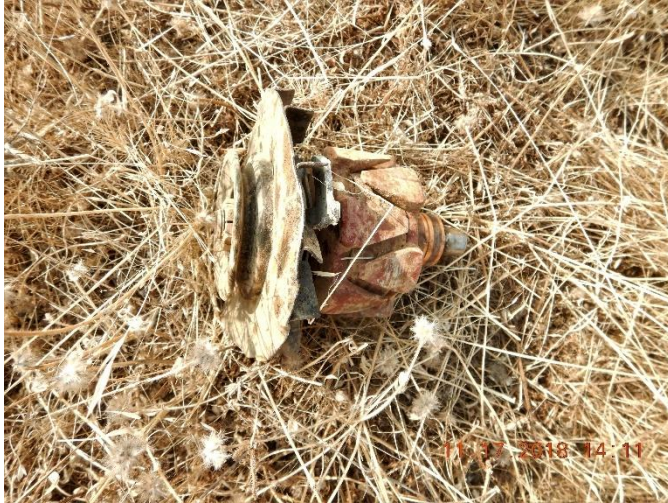
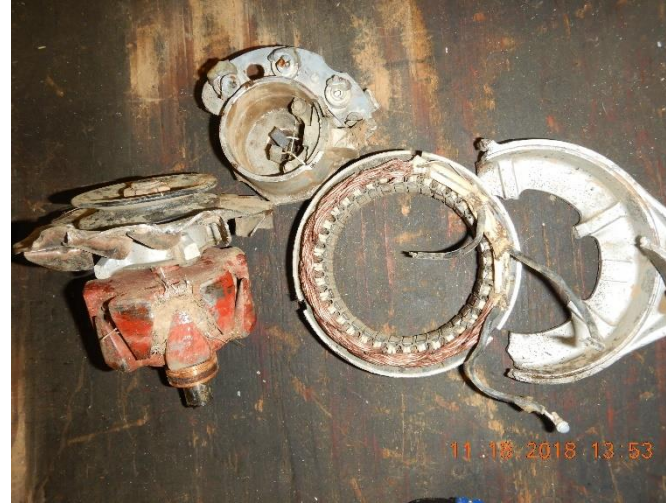
## ALTERNATOR

The alternator separated from the engine and fragments were discovered in the debris path. The data plate separated.

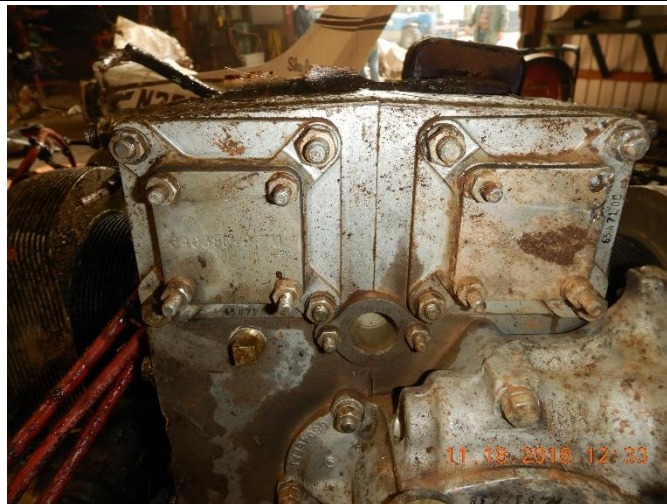
## VACUUM PUMP

No vacuum pump was installed on this engine

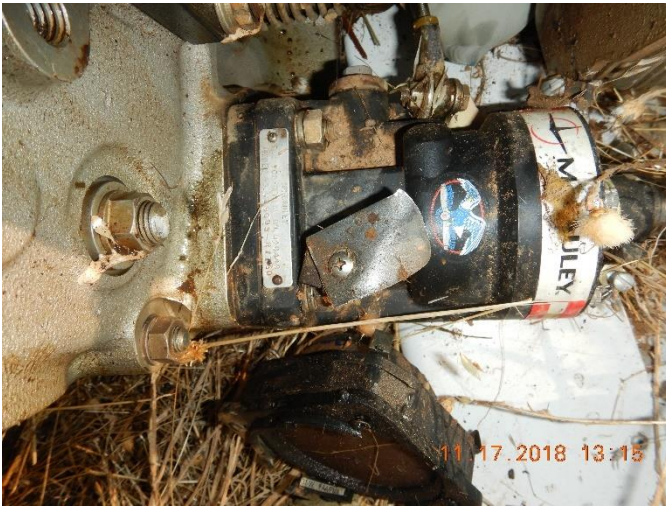
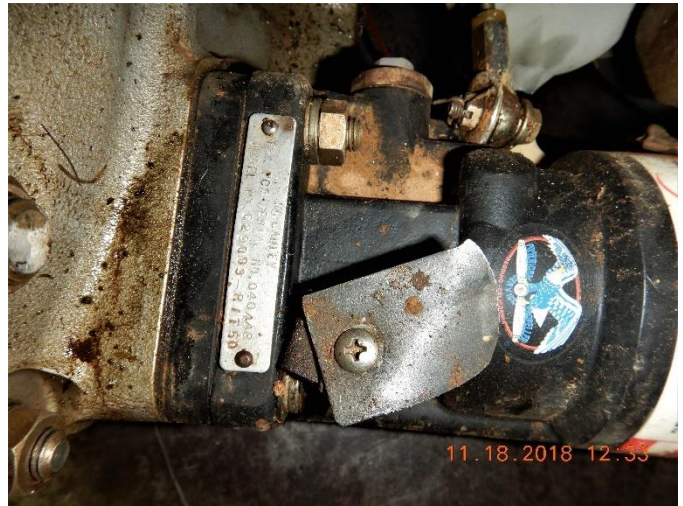
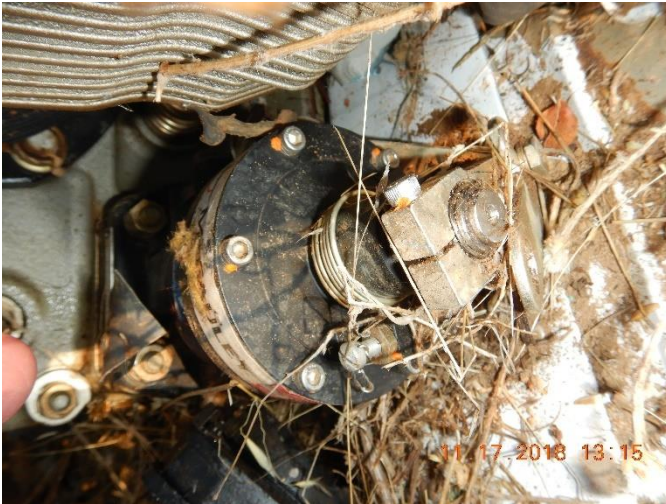
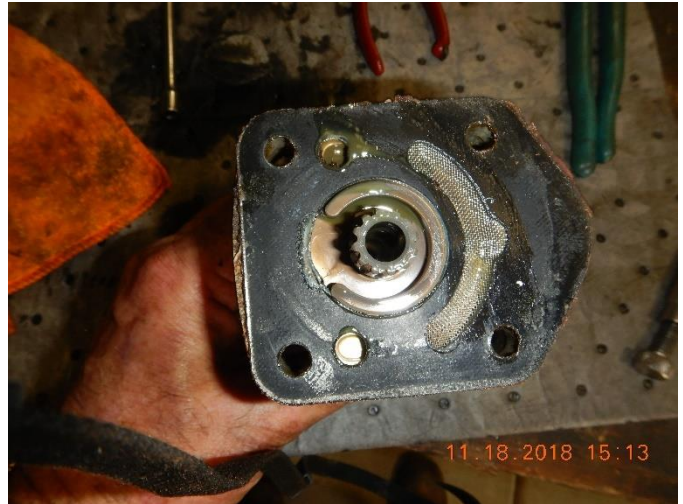
#### PROPELLER GOVERNOR

The propeller governor remained attached and the governor control arm remained attached. The mounting gasket screen was uncontaminated, and the pump shaft rotated smoothly when manipulated manually and oil was expelled.
