# Continental Motors

## ENGINE FIELD EXAMINATION REPORT

| ENGINE MODEL | IO-520F (83B) Converted by<br>Texas Skyways to O-520FTS |
| FILE NUMBER | 18-293 |

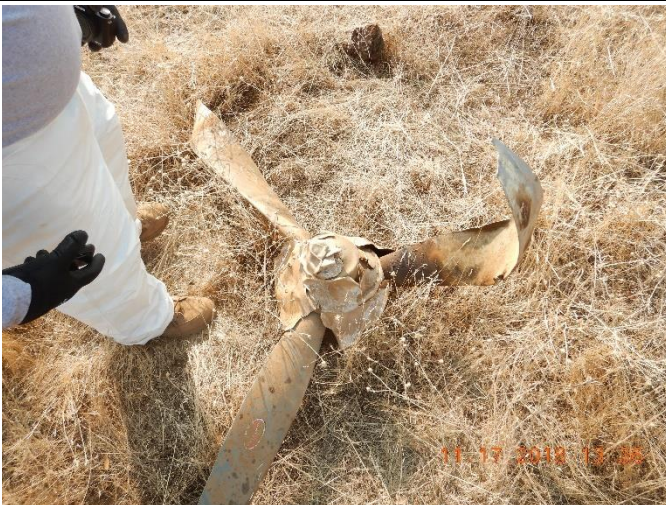
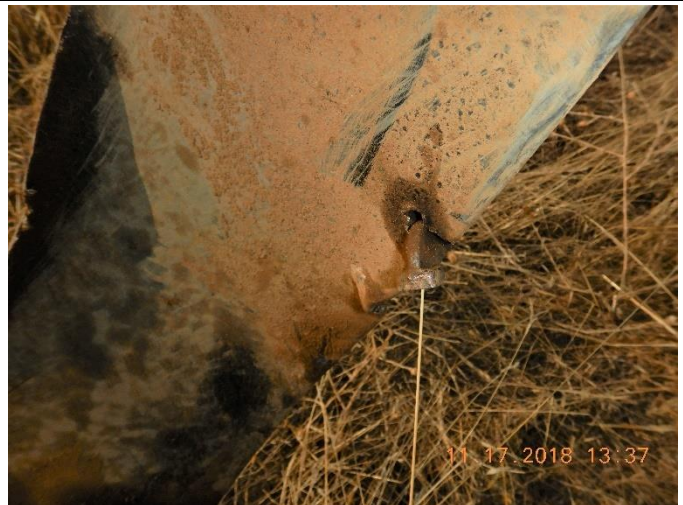
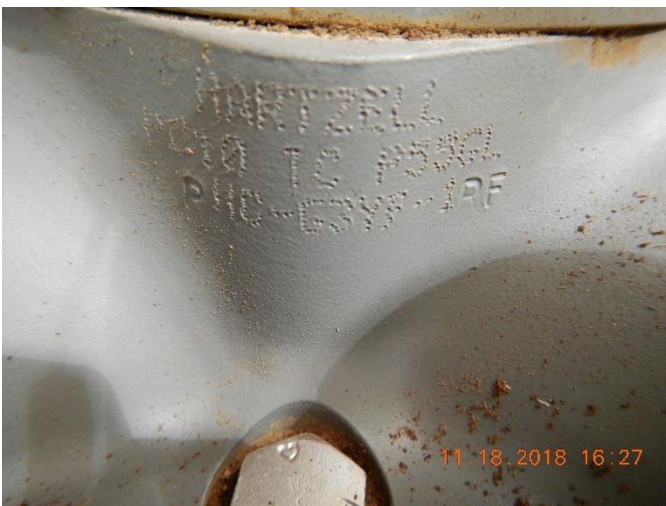
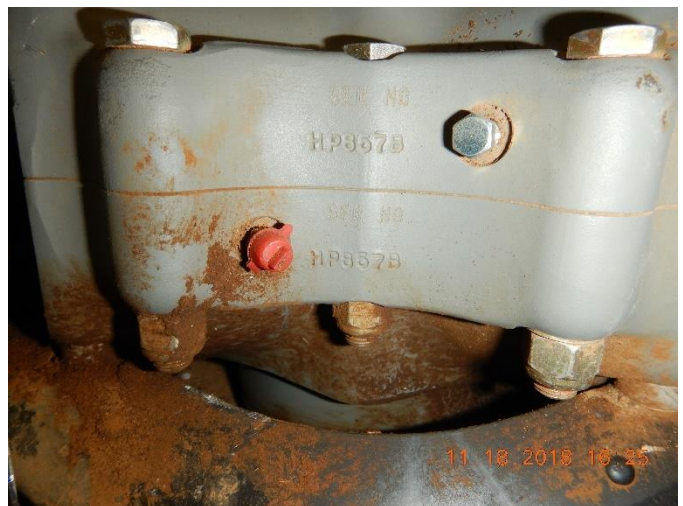
| Condition: | <p>The three-blade constant speed propeller separated from the engine crankshaft during the impact sequence. The spinner exhibited crush damage and was heavily damaged. Each propeller blade was marked with a letter A, B, or C to assist with photo identification. All three blades remained in the propeller hub and all exhibited cordwise scratching and gouging of the leading edges and tips. Blade A exhibited the least damage of the three blades. Blade A exhibited rearward bending and twisting beginning approximately 27" outboard of the blade root. Blade B exhibited rearward bending, twisting and paint transfer beginning approximately 20 inches outboard of the blade root. Blade C exhibited the most damage with rearward bending, twisting and paint transfer beginning approximately 12" outboard of the blade root. Heavy gouging of the leading edge and tip was present.</p> | | |
