## **NATIONAL TRANSPORTATION SAFETY BOARD**

# **ACCIDENT SITE / AIRFRAME / ENGINE EXAMINATION SUMMARY**

**WPR19FA042**

Location: Aberdeen, ID  
Date: December 17, 2018  
Aircraft: Piper PA-24-250, N6283P  
NTSB Investigator-in-Charge: Joshua Cawthra

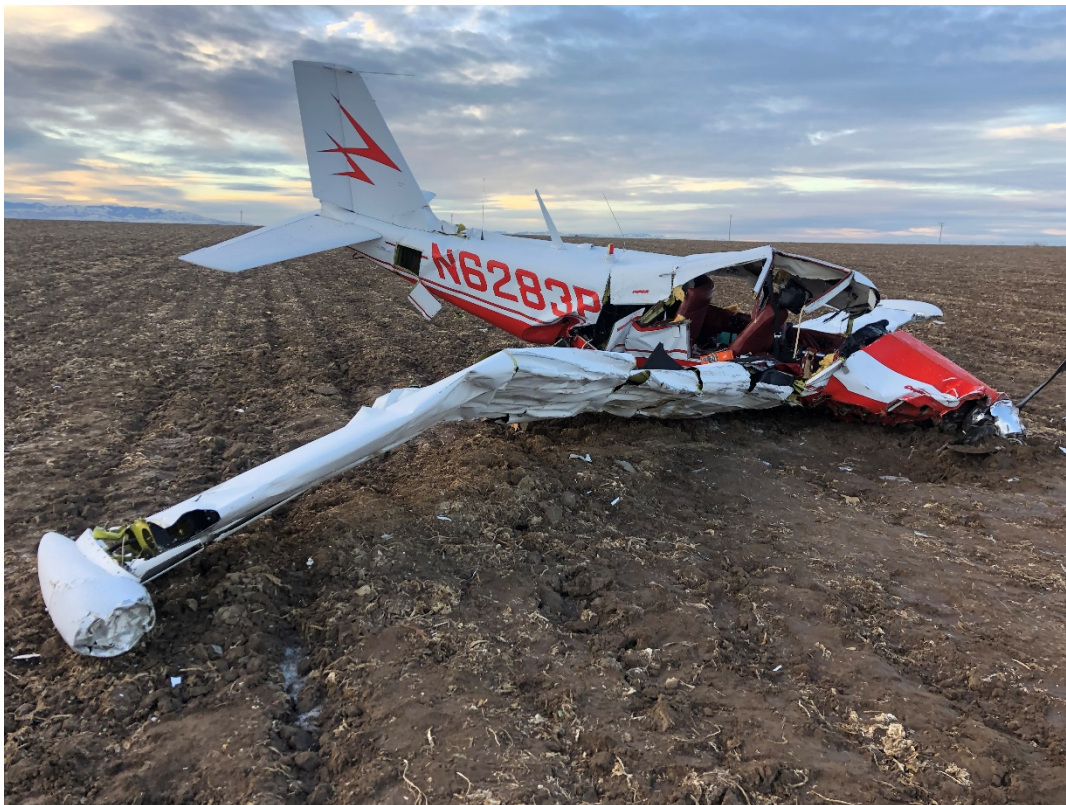
Examination of the accident site revealed that the airplane impacted open terrain about 1,850 ft west of the departure end of runway 25. Wreckage debris (windscreen plexiglass) was contained within about 50 feet of the main wreckage. The airplane came to rest upright on a heading of about 279° magnetic, at an altitude of 4,156 ft mean sea level. A ground impression consistent with the right-wing fuel tip tank was observed adjacent to the right-wing tip tank. In addition, an area of compressed dirt to the right of the fuselage/cowling area. All major structural components were located at the accident site. A scent of fuel was noticed at the accident site.

**Figure 1: View of the main wreckage.**

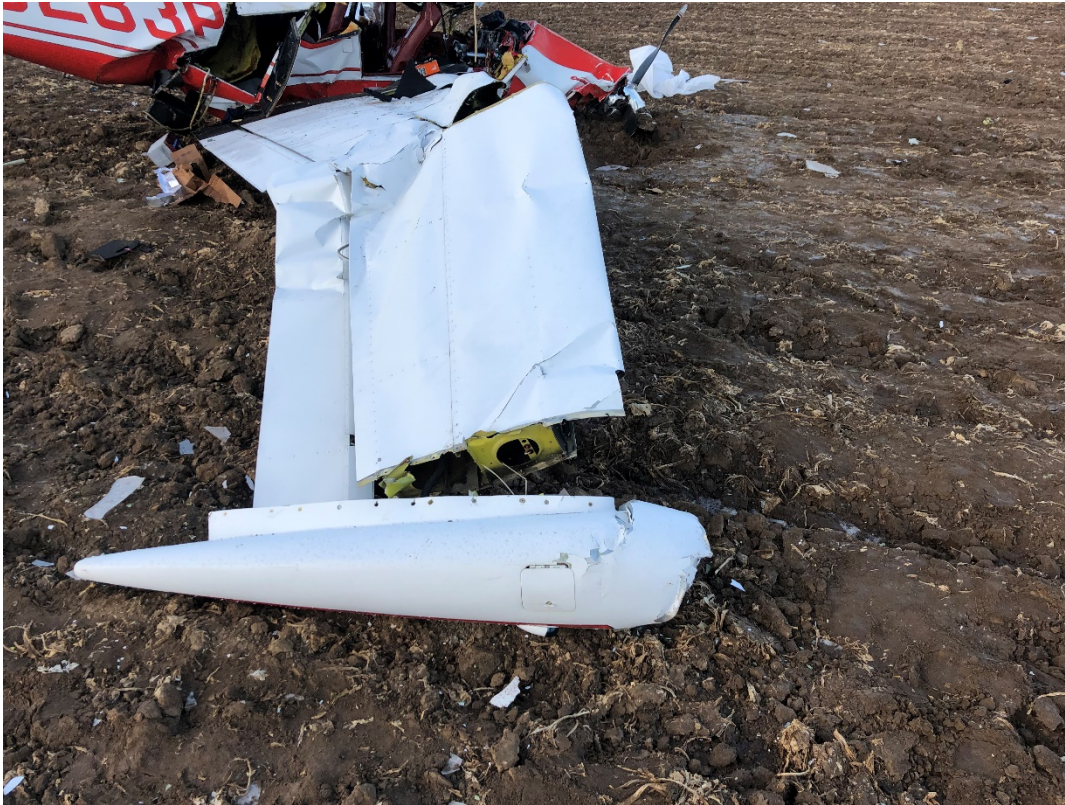
The right wing remained attached to the fuselage. The bottom side of the wing was compressed upward throughout its span. Multiple tears in the leading edge along with bending and buckling throughout was observed. The wing was downward about 67 inches inboard of the wing tip tank. The wing tip tank remained attached and exhibited an approximate 45° crush angle extending from the bottom of the tip tank to the top. The right flap and aileron remained attached via their mounts with the exception of the outboard aileron mount, which was separated. The flap was observed in the “up” position. Both the tip tank and main fuel tank fuel caps were observed in place and secure. Both the main fuel tank and tip fuel tank were breached. The right main landing gear was in the “up” position.

Figure 2: View of the right wing.

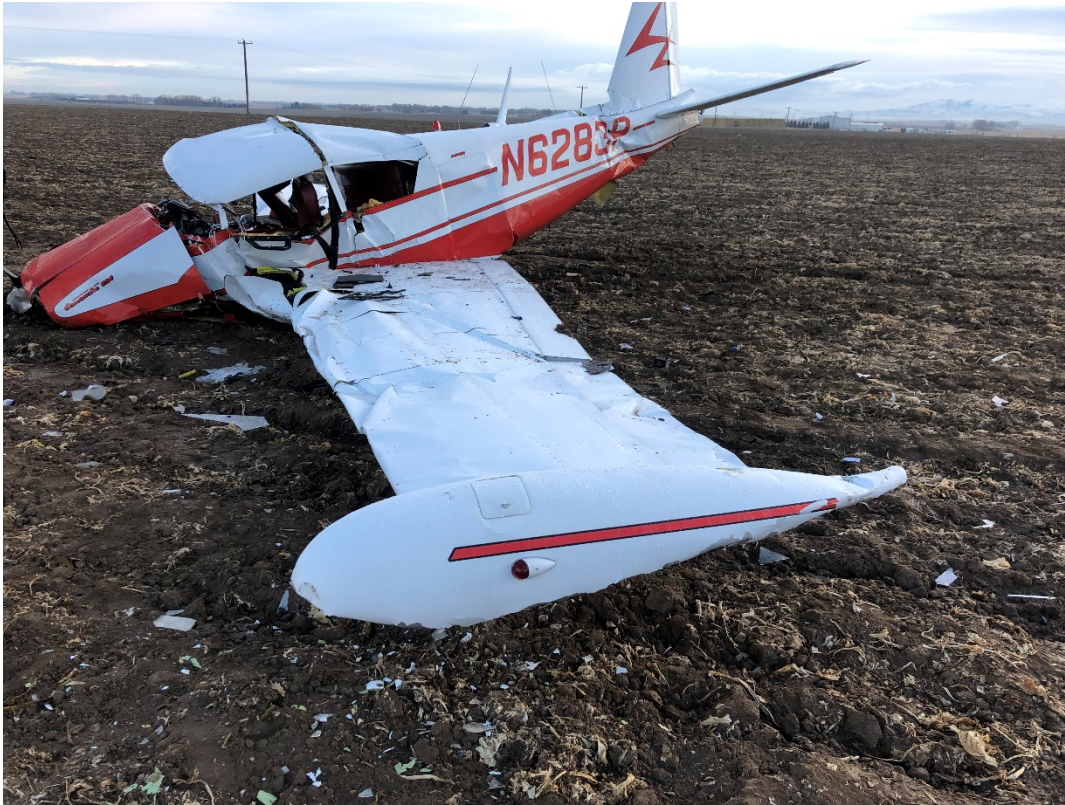
The left wing remained attached to the fuselage. The bottom side of the wing exhibited upward crushing throughout its span. The left-wing tip tank remained attached. The left flap and aileron remained attached via their mounts. The flap was observed in the “up” position. Both the tip tank and main fuel tank fuel caps were observed in place and secure. Both the main fuel tank and tip fuel tank were breached. The left main landing gear was in the “up” position.

**Figure 3: View of the left wing.**

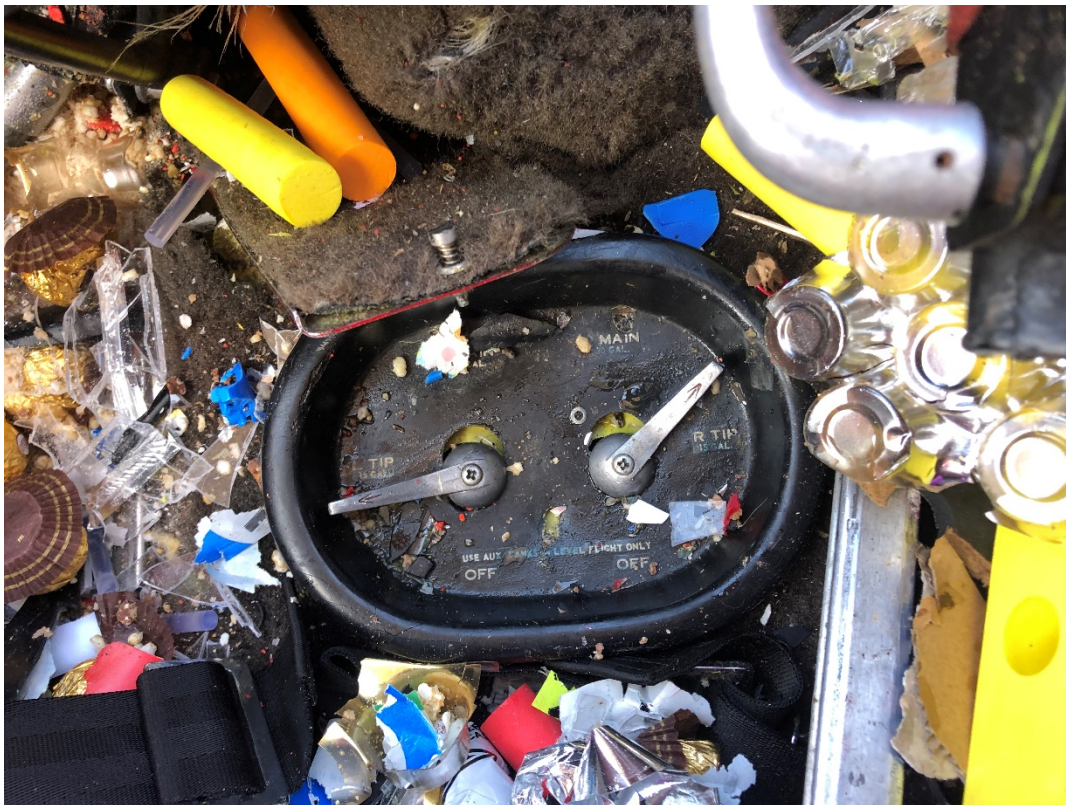
Fuel Selector Valves:

Left: Left Tip

Right: Between Right Main and Right Tip

Handles exhibited slight wear; all internal passages were free of obstructions.

Figure 4: View of the fuel selector valve handles.

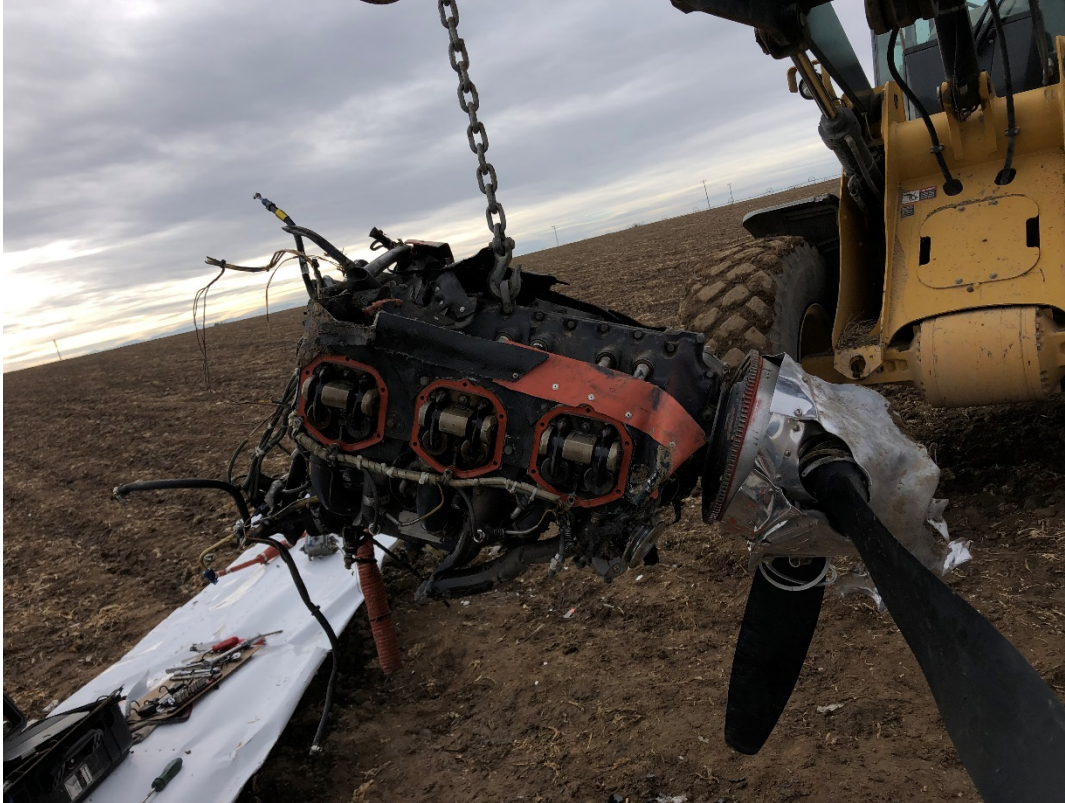
The engine remained attached to the fuselage via its mounts. The engine was cut away from the fuselage and suspended for further examination. The carburetor, magnetos, fuel pump, vacuum pump, oil filter, and starter were separated. The alternator and propeller governor remained attached. The upper spark plugs were removed, and the rocker box covers were removed. The engine crankshaft was rotated by hand using the propeller. Rotational continuity was established throughout the engine and valve train. Thumb compression and suction was established on all six cylinders. Equal movement of the intake and exhaust lifter arms was observed when the crankshaft was rotated.

**Figure 5: View of the engine and propeller assembly.**

The propeller remained attached to the crankshaft propeller flange. One of the three propeller blades was separated from hub and exhibited chordwise scuffing on the forward side of the blade. One of the two remaining propeller blades that remained attached to the hub was free to move within the hub, and exhibited chordwise polishing and leading-edge polishing, along with twisting in the opposite direction of rotation. The third propeller blade remained attached to the propeller hub and exhibited some chordwise scratching along with slight forward bending.

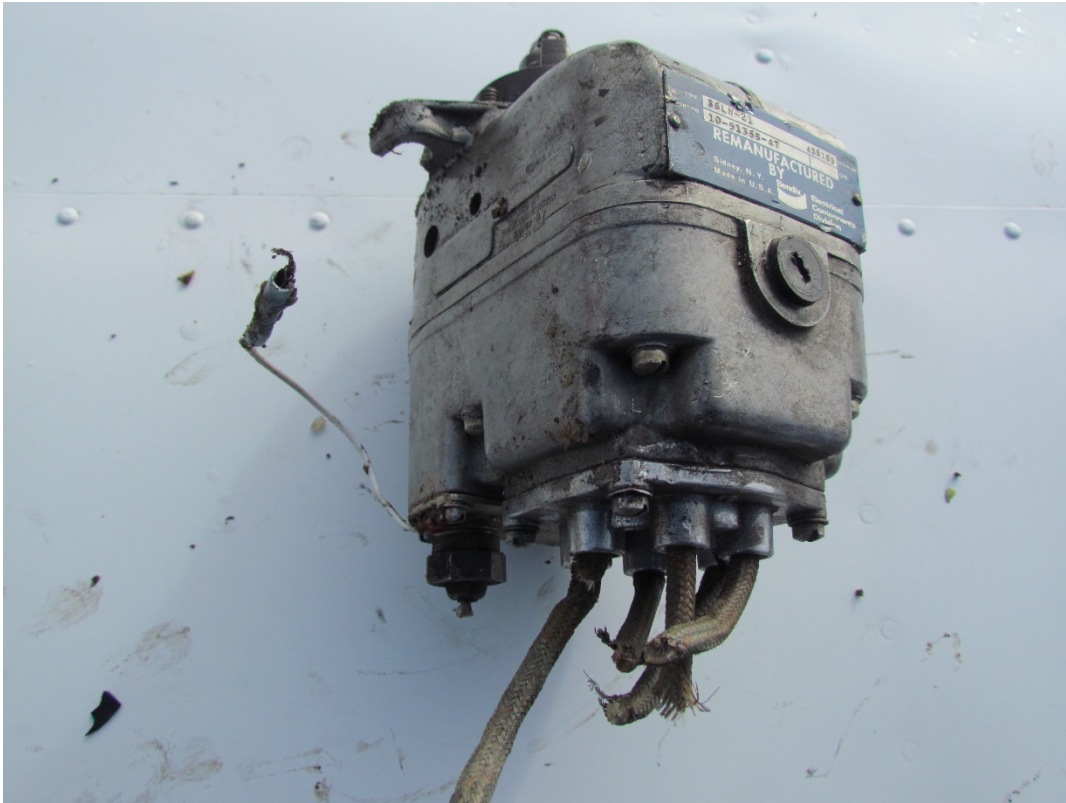
The left and right magnetos were retained for further examination.

**Figure 6: View of the right magneto. Photo courtesy of Lycoming Engines.**

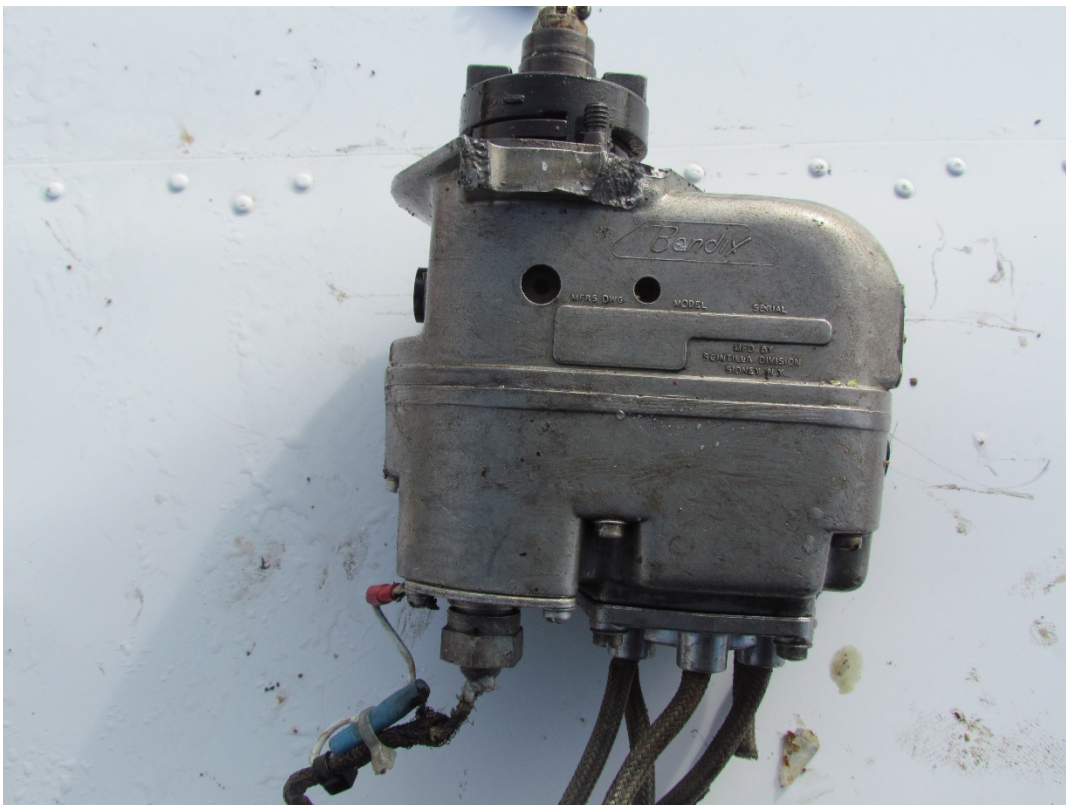
**Figure 7:View of the left magneto. Photo courtesy of Lycoming Engines.**
