## **NATIONAL TRANSPORTATION SAFETY BOARD**

# **AIRFRAME AND ENGINE EXAMINATION**

**WPR19FA080**

Location: Desert Hot Springs, California  
Date: February 5, 2019  
Aircraft: Cessna 172M, N20556, Serial # 1726139  
NTSB IIC: Michael Huhn

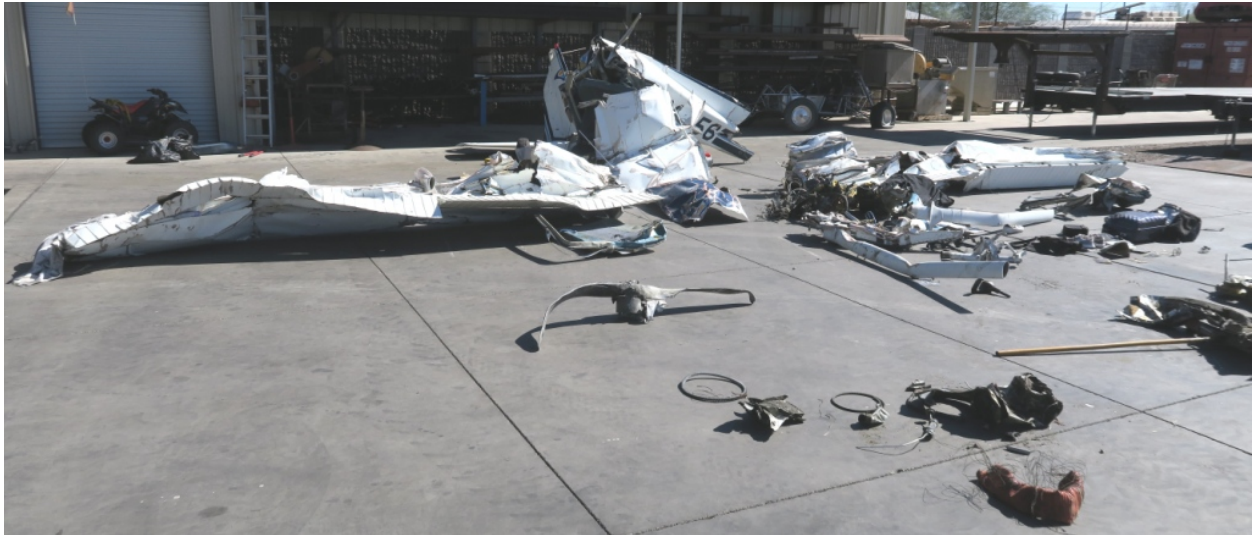
**Figure 1 - Wreckage Layout**

- On-scene information and overall damage patterns were consistent with the airplane impacting a very steep (approx. 70° + from the horizontal) terrain in an upright, approximately wings- and pitch- level attitude
- All primary components were located at the impact site

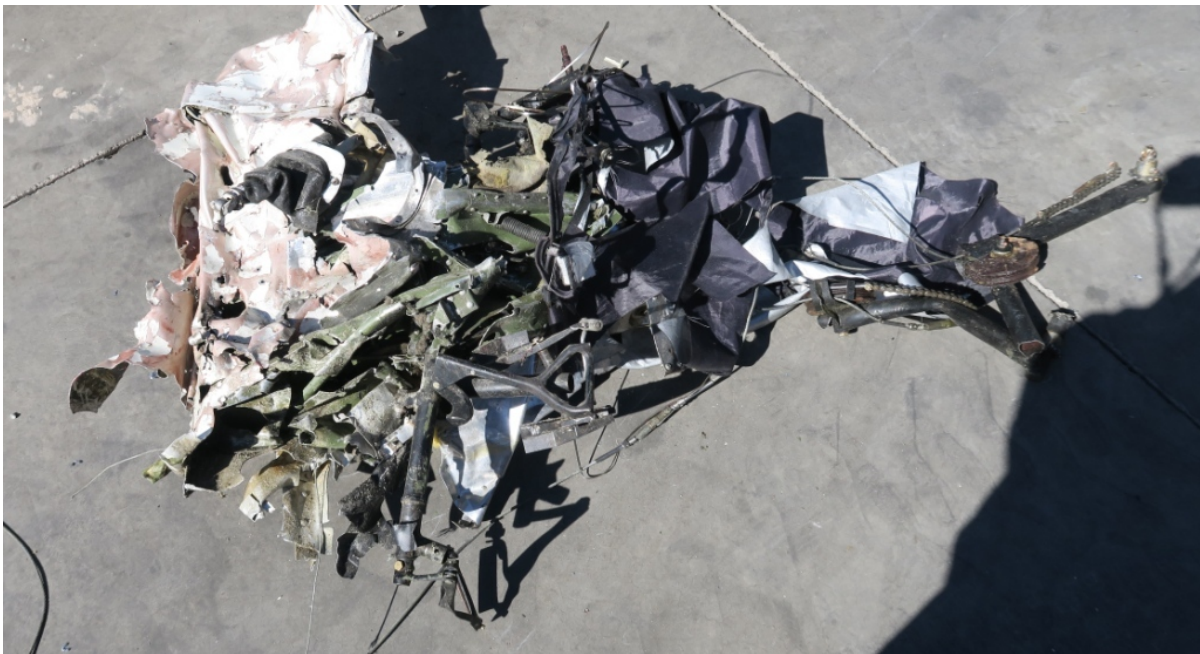
**Figure 2 - Cockpit Flight Controls**

- All flight controls were present and attached to their respective aerodynamic surfaces
- Control cable continuity was established for the ailerons, elevators, pitch trim, and rudder
- The pitch trim actuator was found in a position corresponding to tab 5° TEU
- The flaps were fully retracted
  - The flap actuator was found in the flaps retracted position
  - The flap position indicator registered 40° (full down)

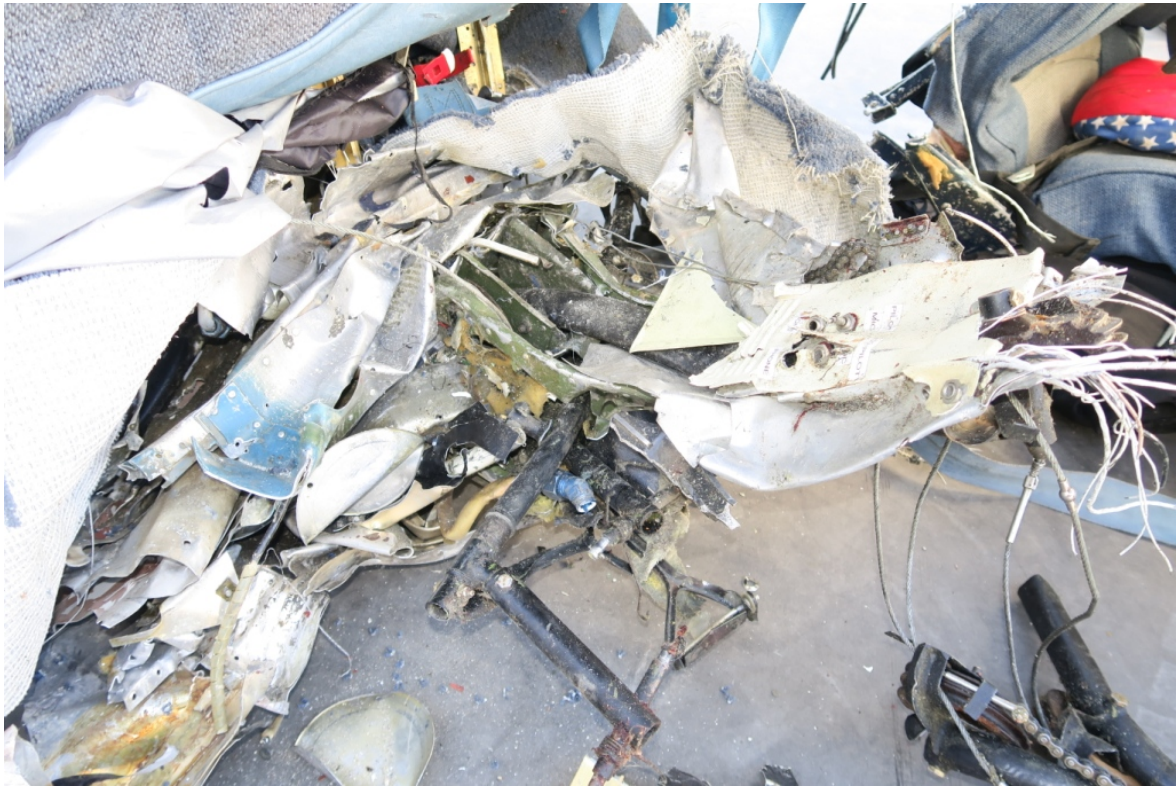
**Figure 3 - Cockpit / Cabin**

- The cockpit/cabin area was severely disrupted due to crushing and tearing
- The engine was pushed aft into the cabin
- The cabin floor, starting at the firewall, was crushed aft to the main gear attach points.

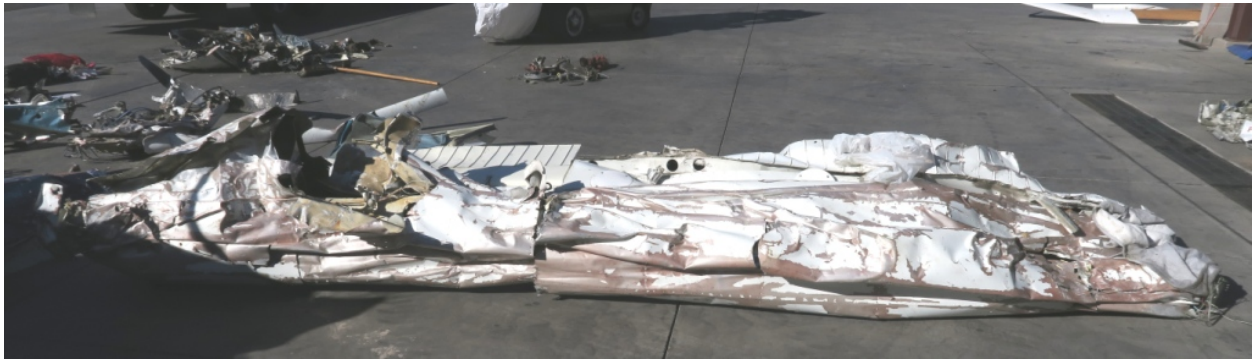
**Figure 5 - Left Wing**

- The outboard 3 ft of the left wing leading edge was crushed diagonally aft
  - The outboard end was crushed aft to the trailing edge
- The leading edges of both the left and right wings were crushed straight aft to approximately the mid-chord of each wing
- Both fuel caps remained securely fastened in their respective filler necks

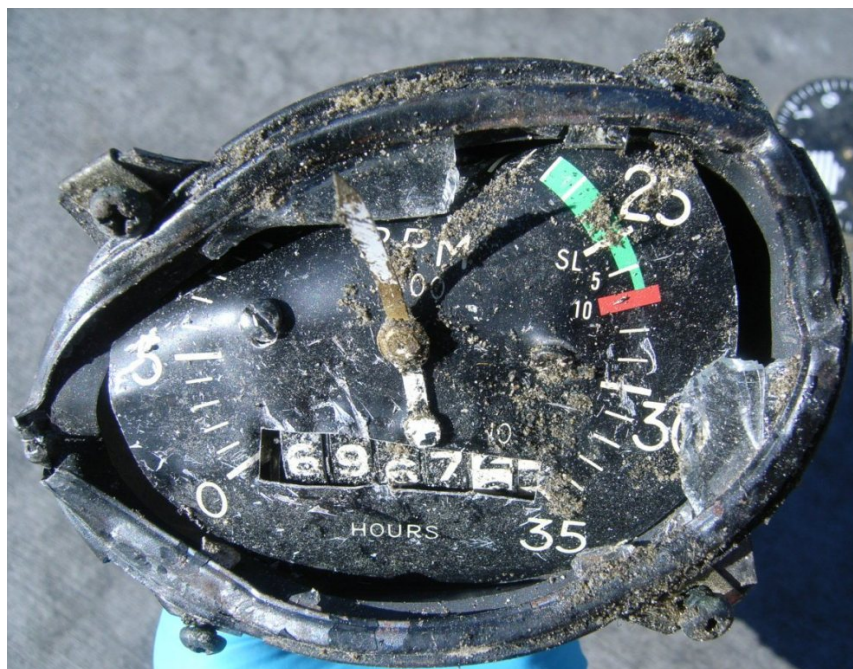
**Figure 7 - Tachometer**

- The tachometer registered 6967.2 hours, and the needle pointed to about 1,600 rpm
- The needles on the altimeter, airspeed indicator, and vertical speed indicator were absent

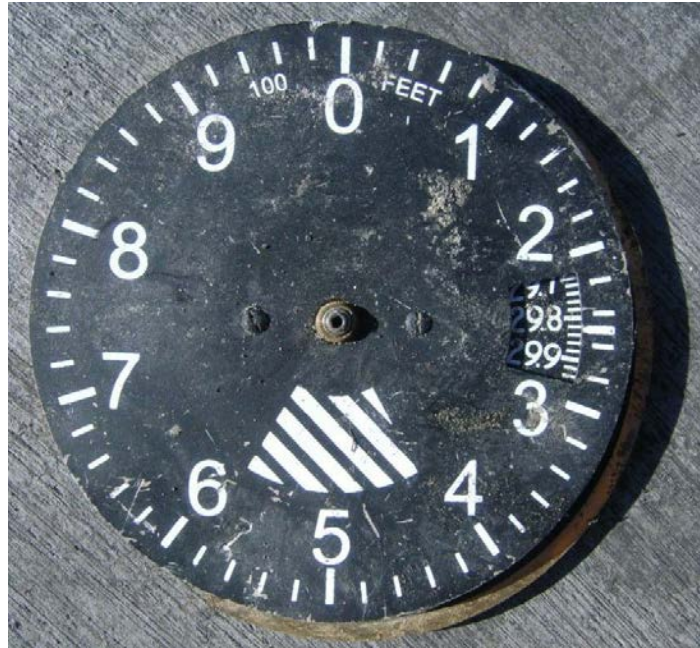
**Figure 8 - Altimeter Face**

- The altimeter Kollsman window was set to 29.82
- The front plate of the heading indicator was absent
- The airplane and ball on the turn coordinator were absent

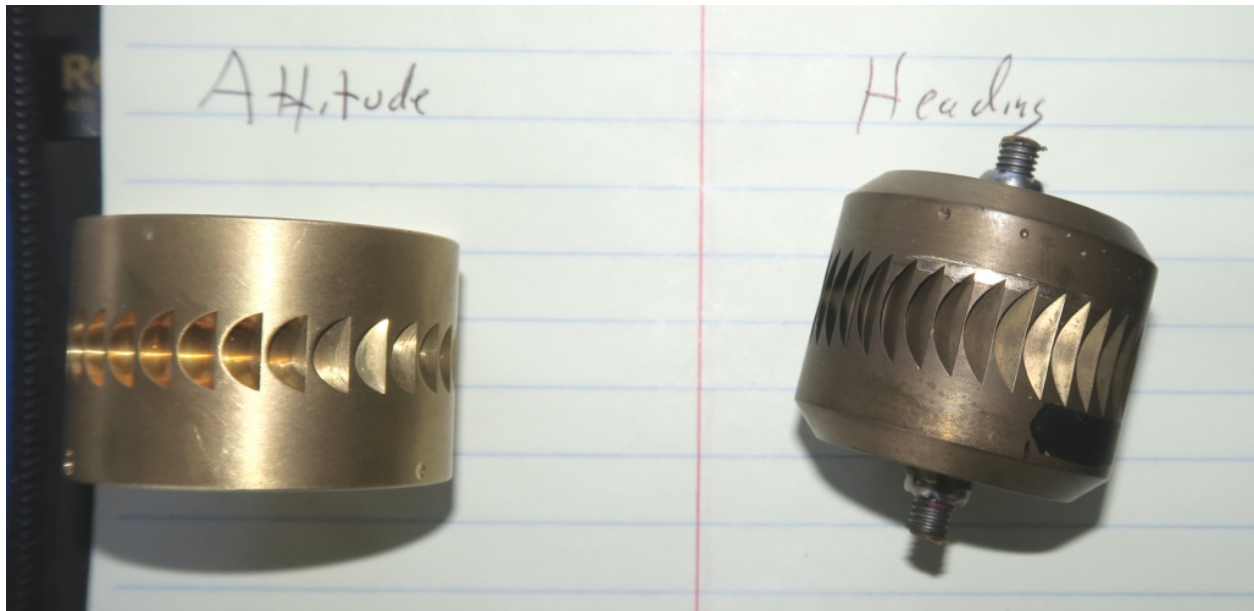
**Figure 10 - Rotors From Attitude and Directional Gyros**

- The attitude indicator gyro rotor was found offset inside the rotor housing
  - The rotor was free to rotate, but exhibited no rotational scoring
- The heading indicator gyro rotor was free to rotate, and exhibited rotational scoring

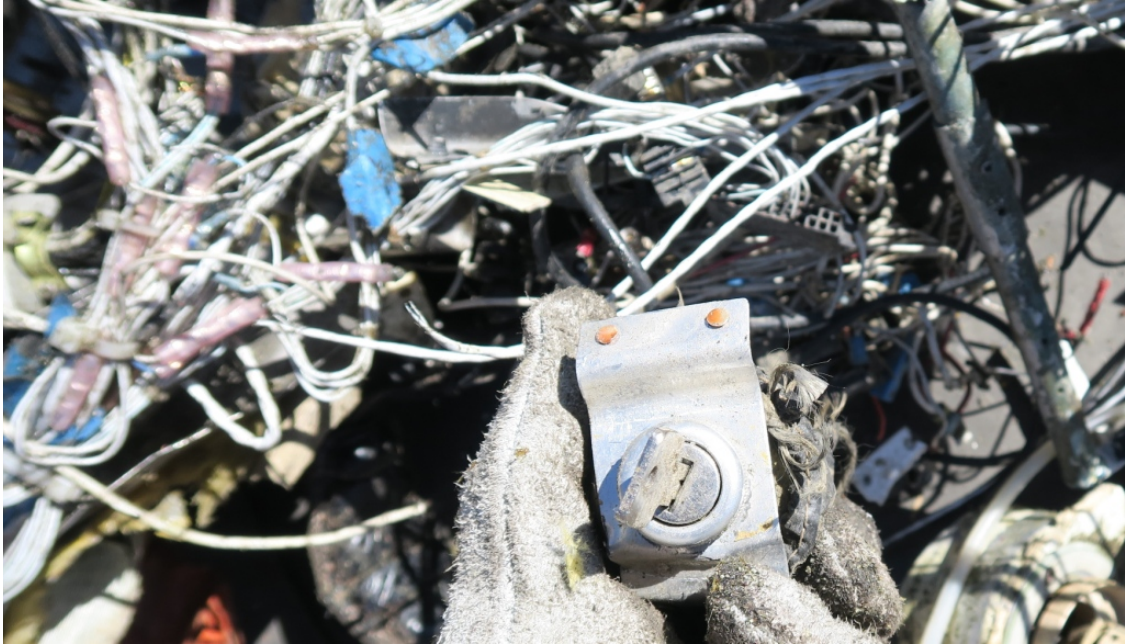
**Figure 12 - Ignition Switch**

- The positions of the electrical switches and circuit breakers were not observed/documented (due to damage)
- The key remained in the ignition switch and its orientation appeared consistent with being in the 'Both' position

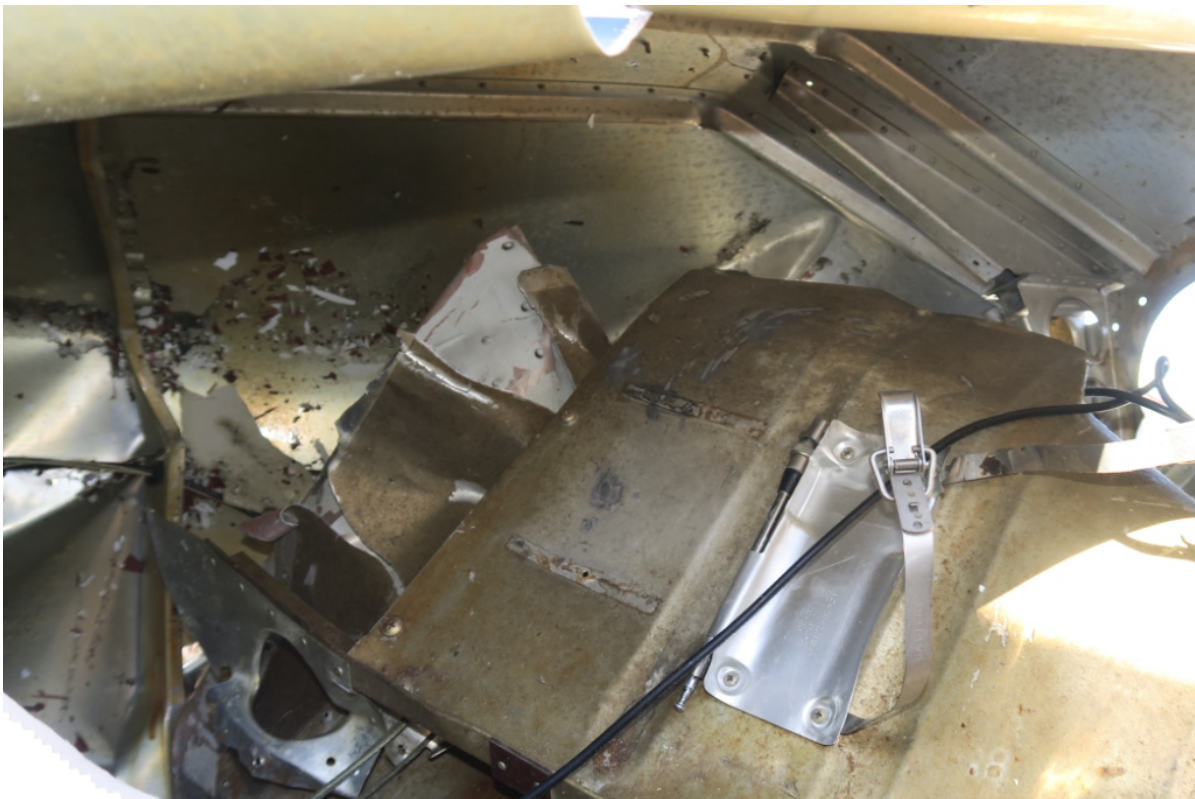
**Figure 13 - ELT Mounting Bracket**

- o The ELT was armed but had not activated
  - o The battery due date was 12/31/24
  - o The ELT had separated from its mounting holddown, but remained attached to its antenna
  - o The ELT battery case was fractured, and the holddown clamp was found in the released position
- A Flight school document found in the airplane indicated that the tachometer registered 6966 (sic) hrs when the airplane was released to the pilot

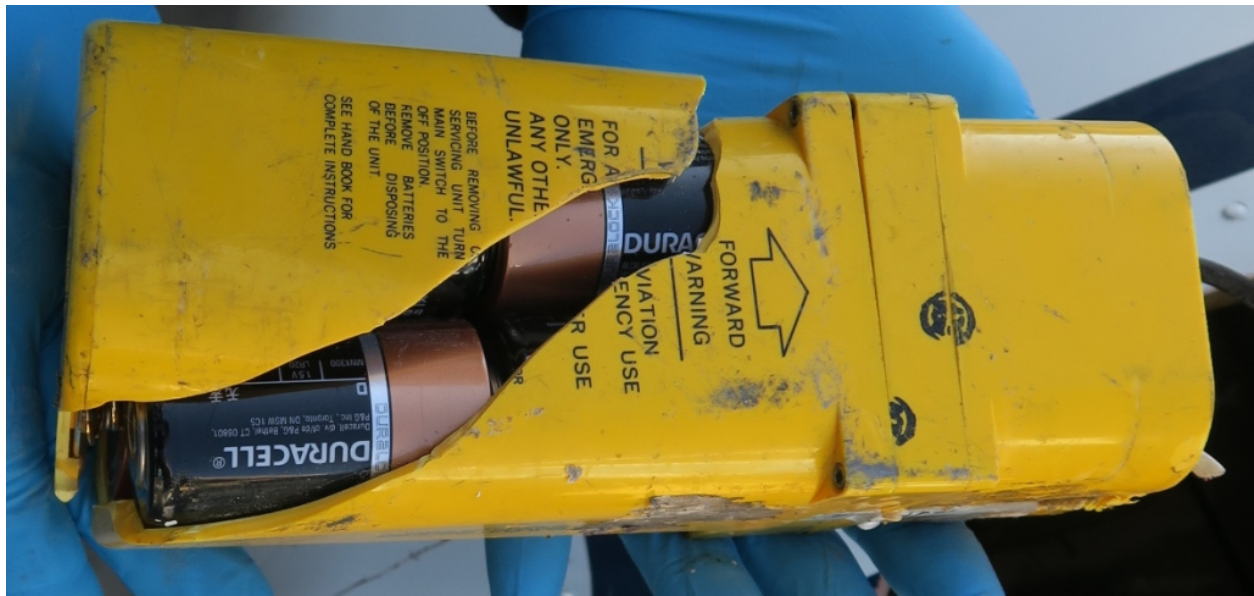
**Figure 14 - ELT**

- The strainer screen and bowl were clear of debris
- The ELT was an ACK Technologies model E-01, serial number 033768

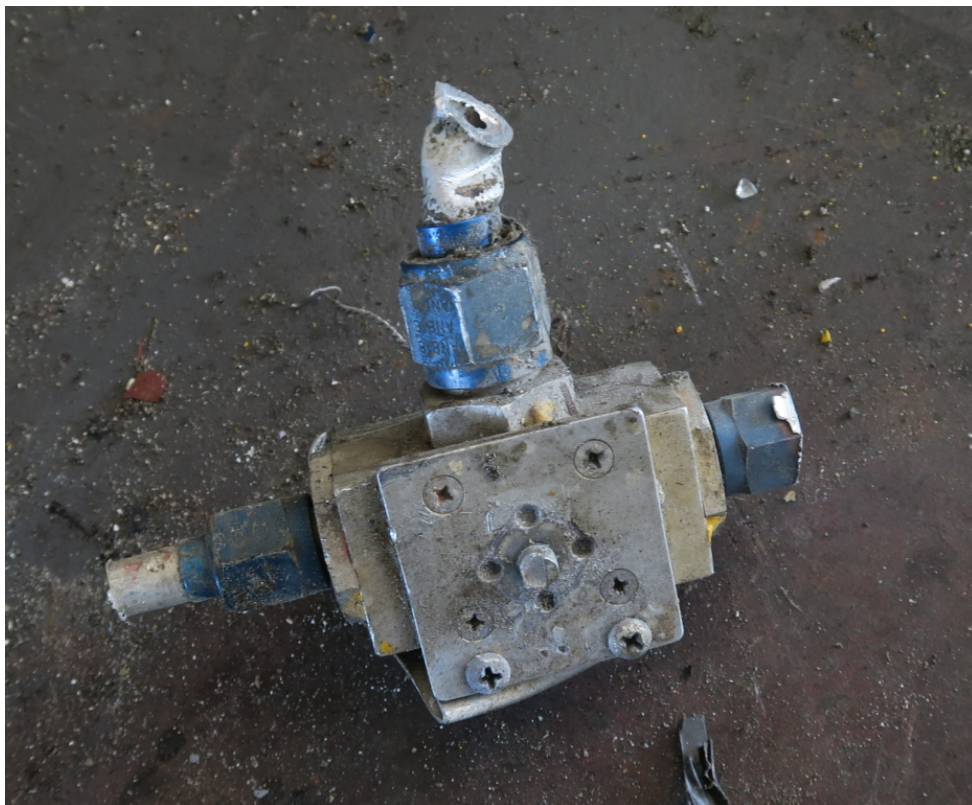
**Figure 15 - Fuel Selector Valve**

- The fuel selector handle and shaft were separated from the fuel selector valve.
  - The fuel selector valve was removed, and its setting (to the right tank) was determined by blowing air through the ports.

- The selector position was also confirmed by lining up the fractured shaft with the valve
- The fuel strainer bowl was fractured but the full assembly remained attached to the firewall

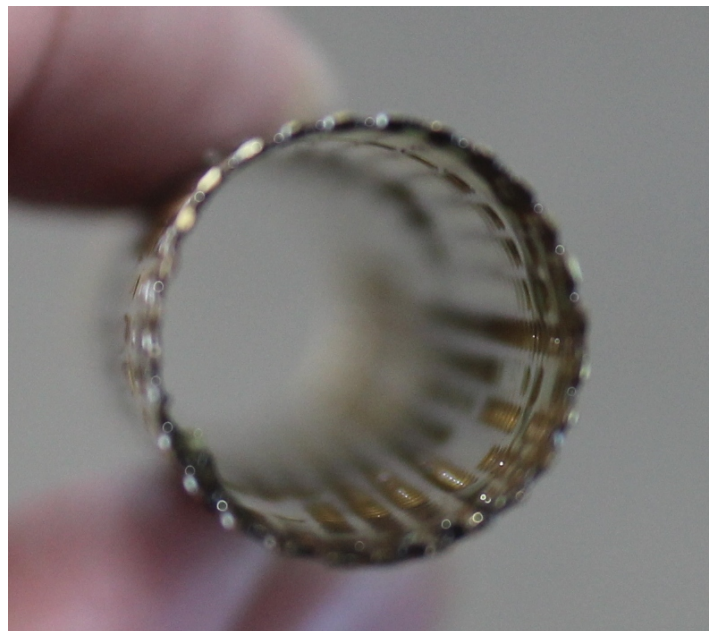
**Figure 25 - Oil Screen**

- The oil filter mounting pad casting was fracture-separated from the engine due to overload.
- The oil filter was crushed and remained attached to the mounting pad.
  - It was not removed from the pad for examination.
- The oil suction screen was found secure and uncontaminated by any pre-impact debris.
- There was no evidence observed of any pre-impact lubrication system contamination found during the examination.

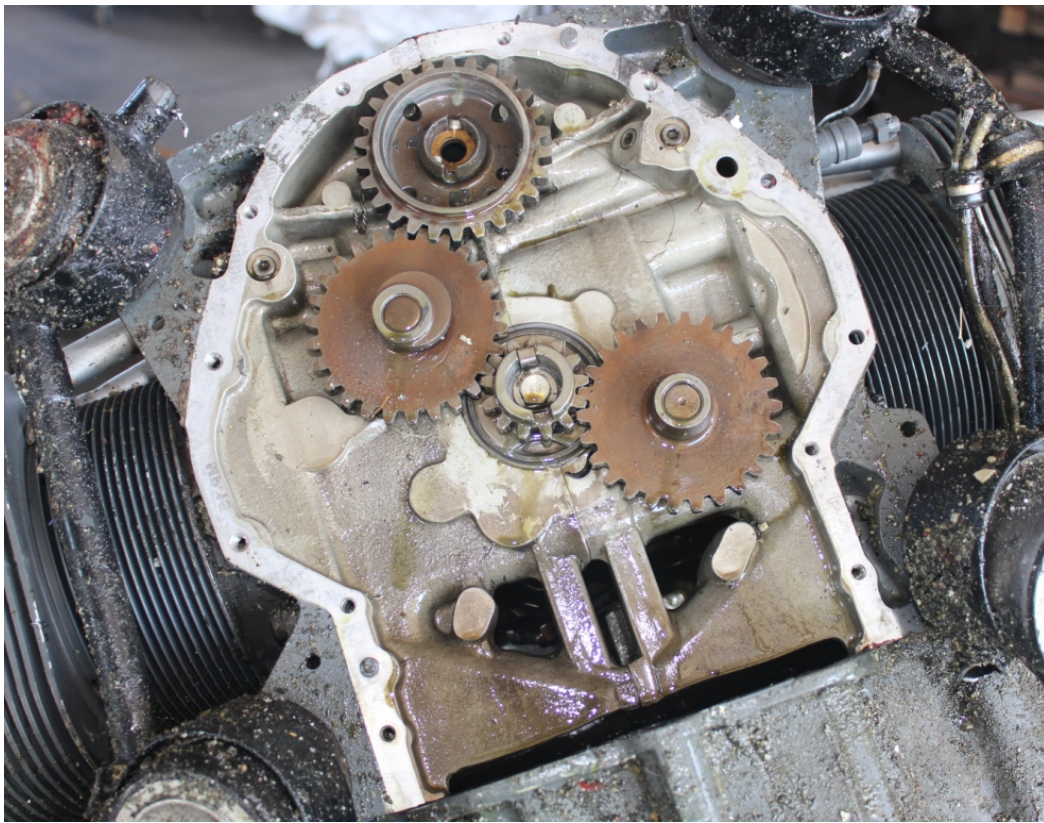
**Figure 27 - Accessory Case Drive Gears**

- The accessory case was removed.
- The accessory gears including the crankshaft gear, bolt, and dowel were intact and remained undamaged by any pre-impact malfunction.
- The camshaft gear was manually rotated using a drive tool and normal "lift action" and mechanical continuity was observed at each rocker assembly.
- The rear-mounted vacuum pump remained attached to the mounting pad.

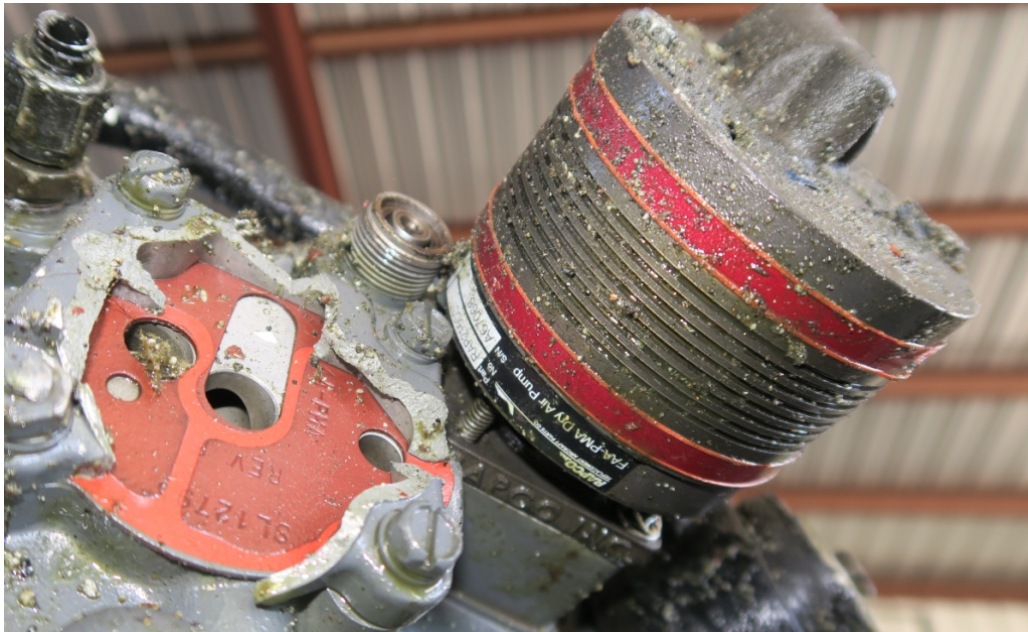
**Figure 28 - Vacuum Pump (in situ)**

- o One of the 4 holddown nuts was absent; there was no evidence that the nut had been removed by impact
  - o The remaining 3 nuts were secure
  - o RAPCO model RAP215CC, sn A67068
- The pump was removed, examined and photographed.
  - o The drive shaft was intact.
  - o The rotor was fractured into multiple pieces
  - o One vane was fractured.

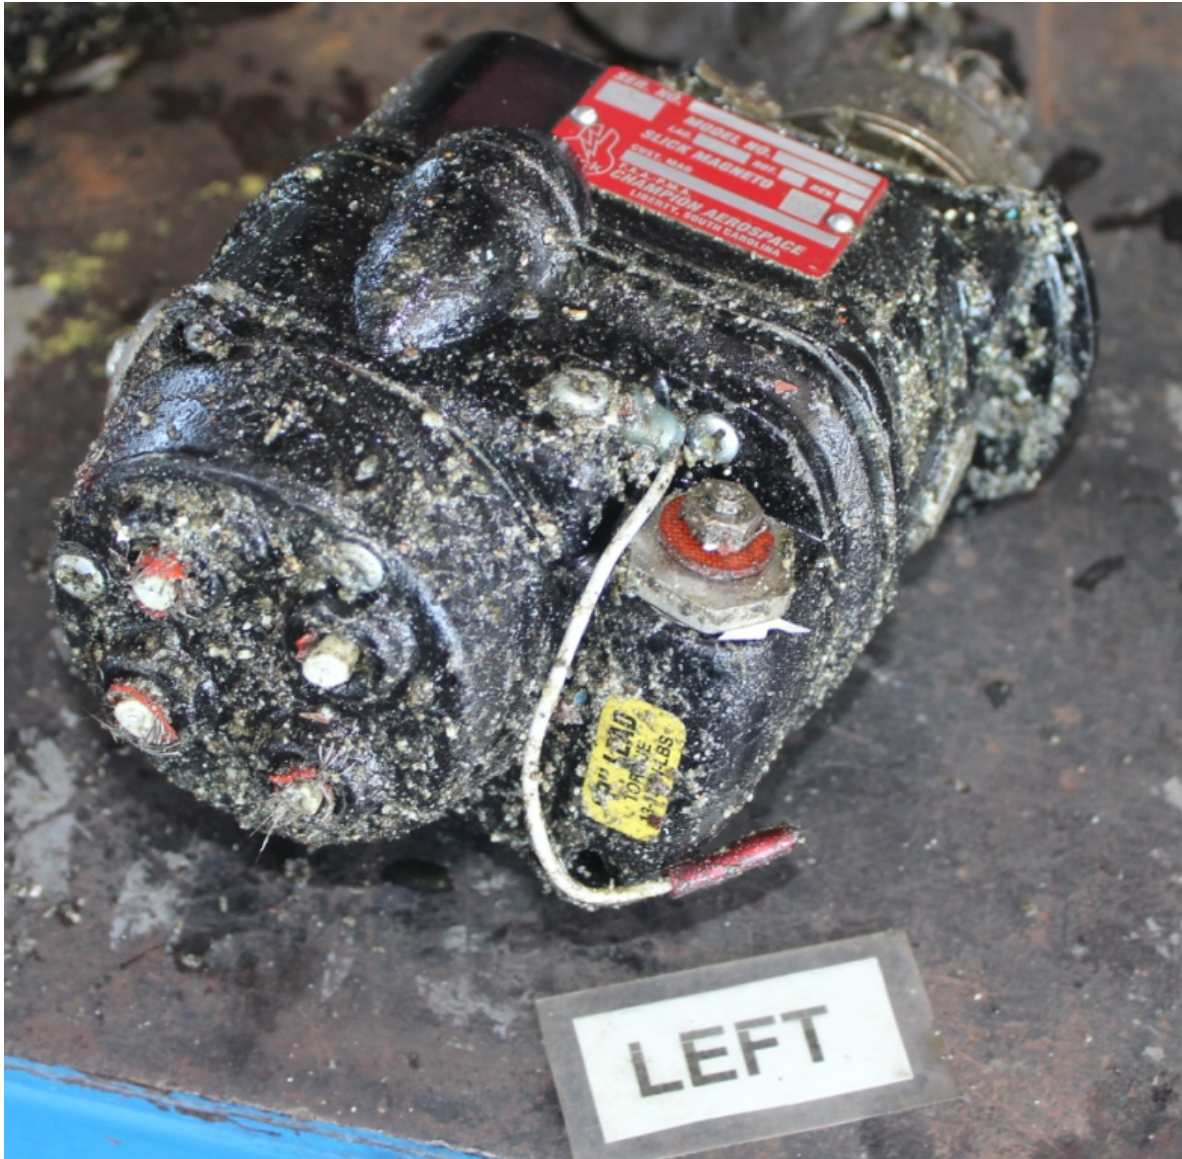
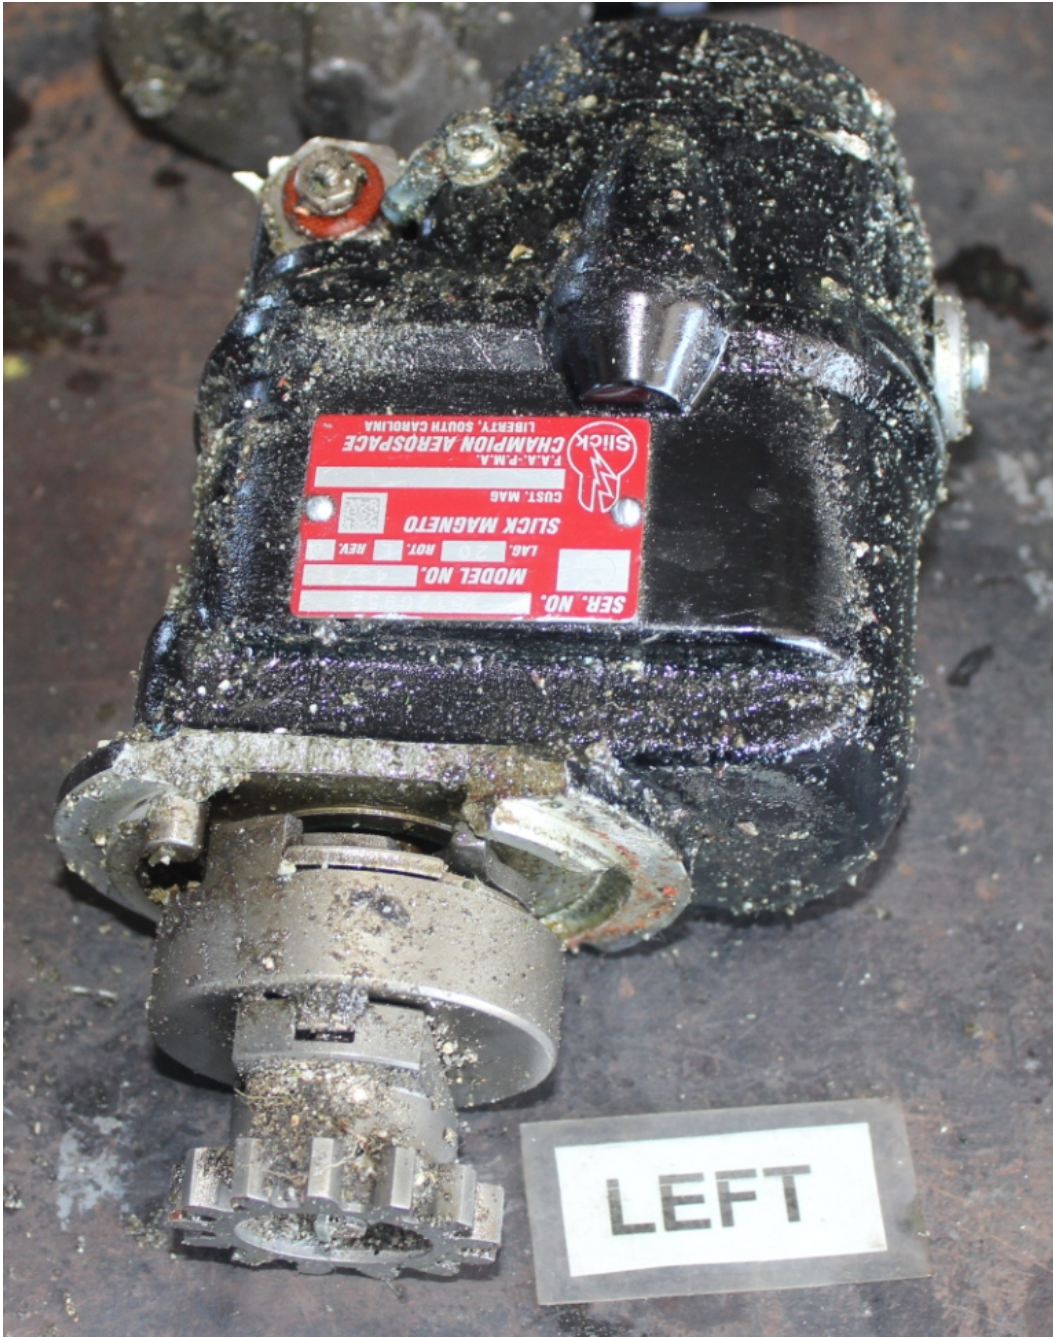
- The left magneto sustained impact damage, and was fracture-separated from its mounting pad.
  - o The fracture surface signatures on the magneto-mounting flange were consistent with overload forces.

- o The sections of magneto flange that remained at the mounting pad were securely clamped
- Magneto to engine timing could not be ascertained.
- The impulse coupler drive was found intact and secure.

- o The drive functioned normally during hand rotation of the drive
- The magneto produced spark at the four leads during hand rotation of the drive.
- The right magneto had sustained impact damage, and was fracture-separated from the mounting pad.

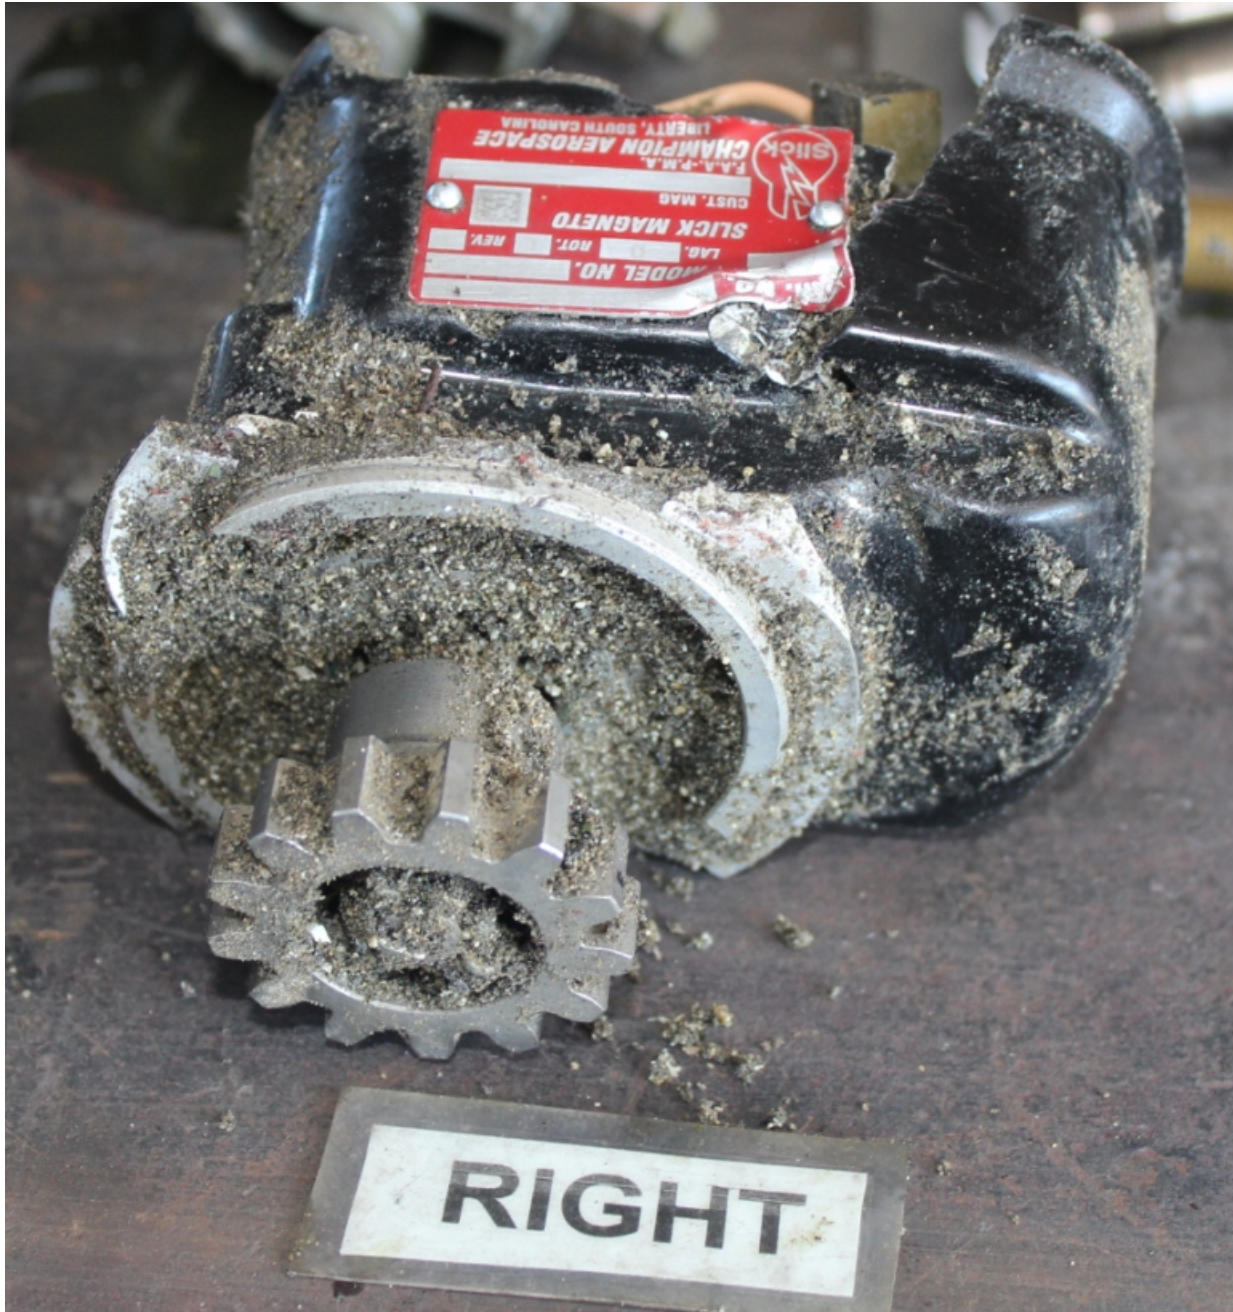
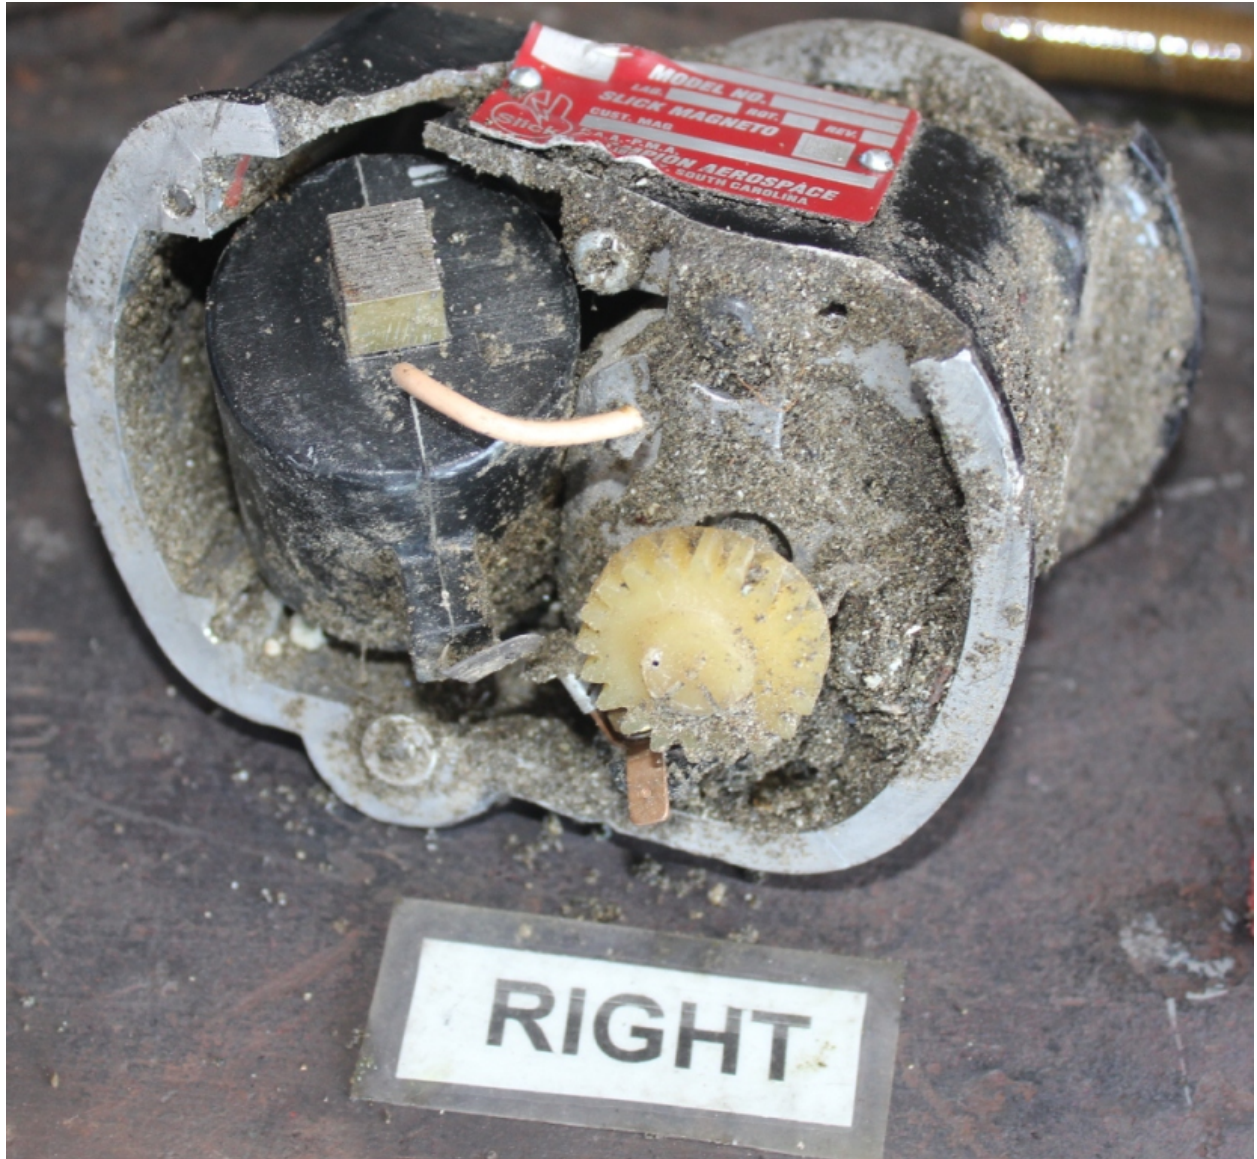
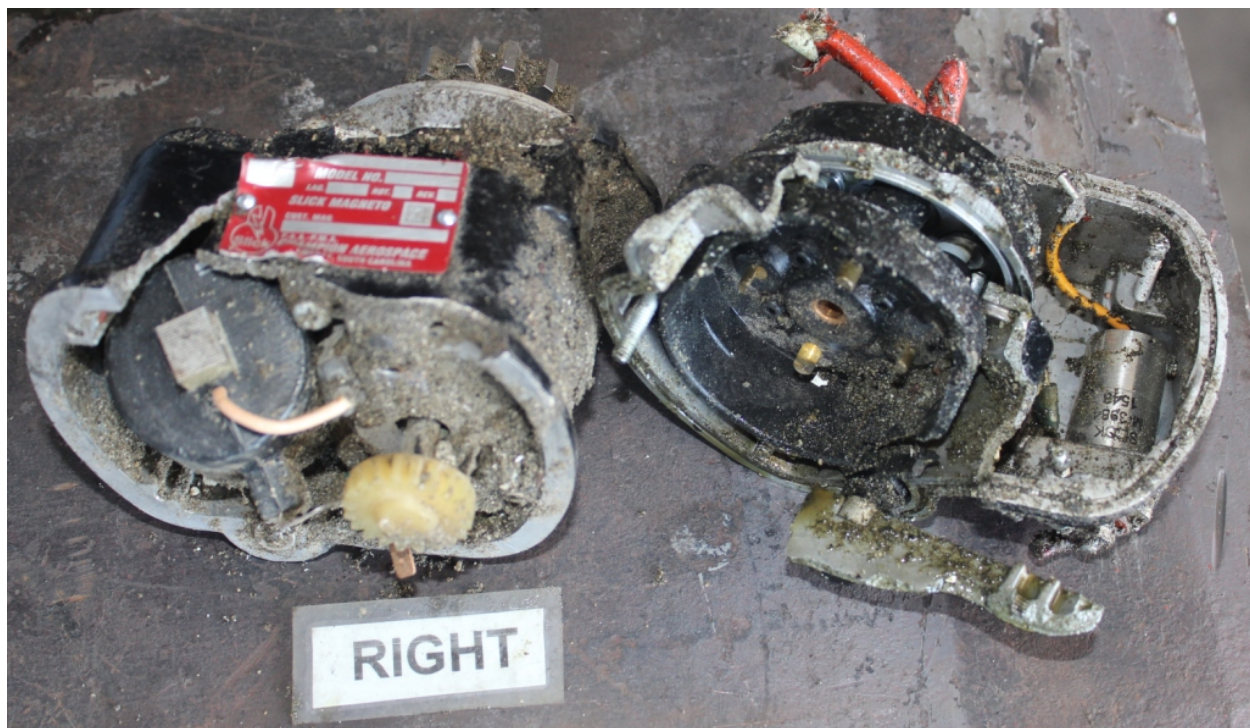
- o The fracture surface signatures at the magneto-mounting flange were consistent with overload forces.
  - o The sections of magneto flange that remained at the mounting pad were securely clamped.

- Magneto to engine timing could not be ascertained.
- The drive was found intact and secure.
- The magneto housing and internal components had sustained impact damage which rendered the magneto unsuitable for testing.

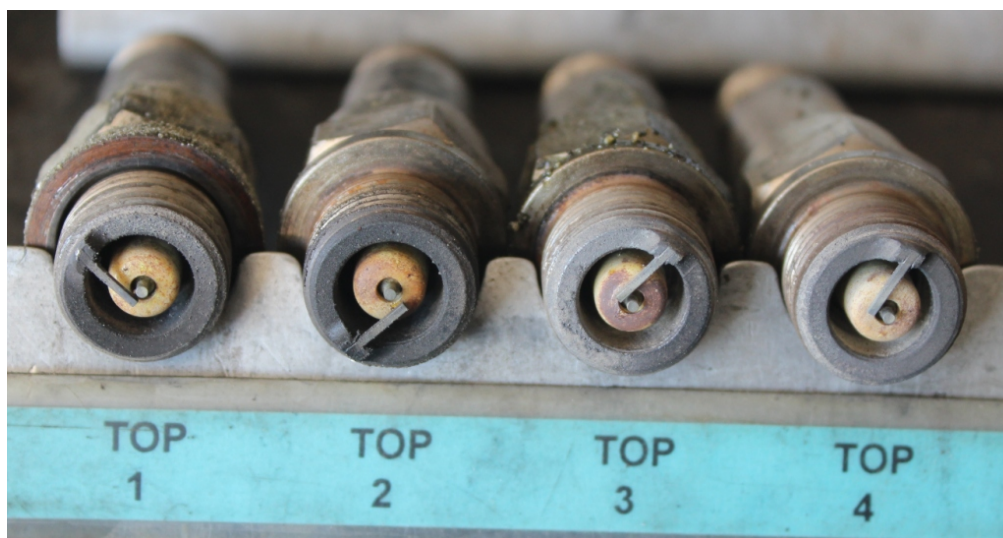
Figure 35 - Top Spark Plug Electrodes

- The spark plugs were secure at each position with their respective ignition leads attached.
- The removed spark plugs were examined and photographed.
  - o The spark plug electrodes were mechanically undamaged

- o According to the Champion Spark Plugs Check-A-Plug chart AV-27, the spark plug electrodes displayed coloration consistent with normal operation.
- The ignition harness was attached at each magneto and respective spark plug

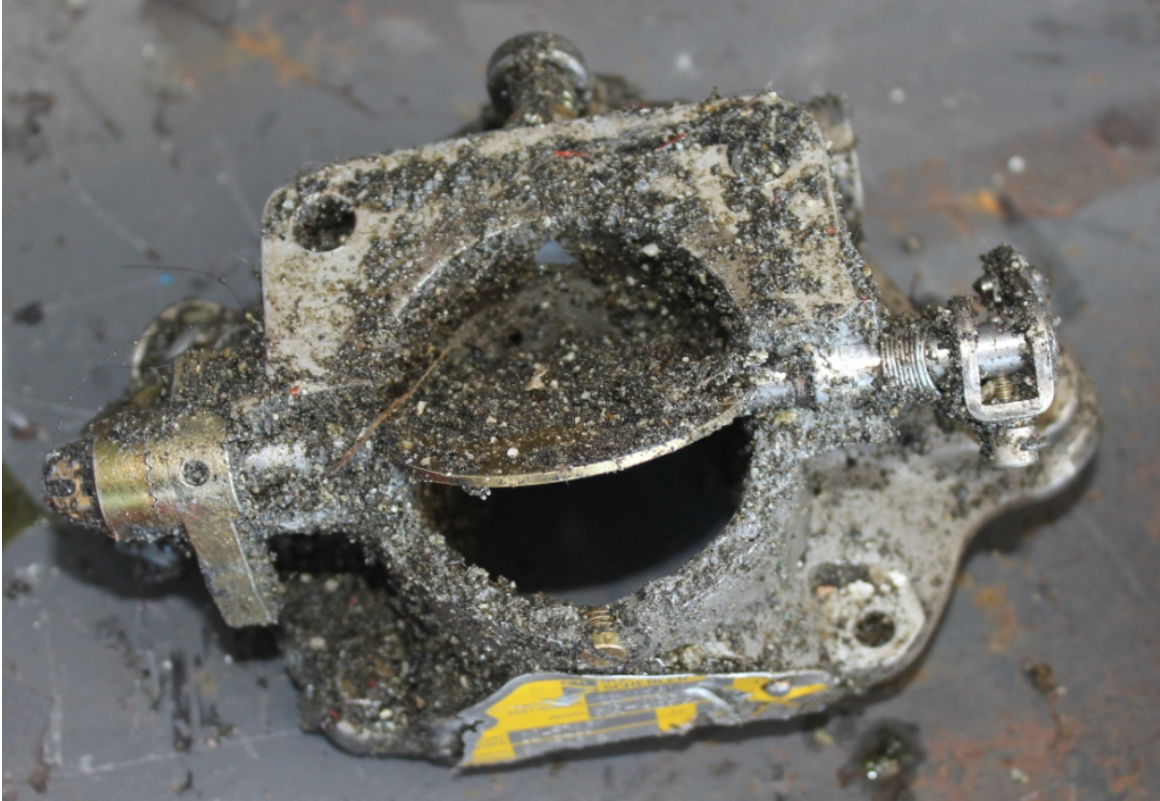
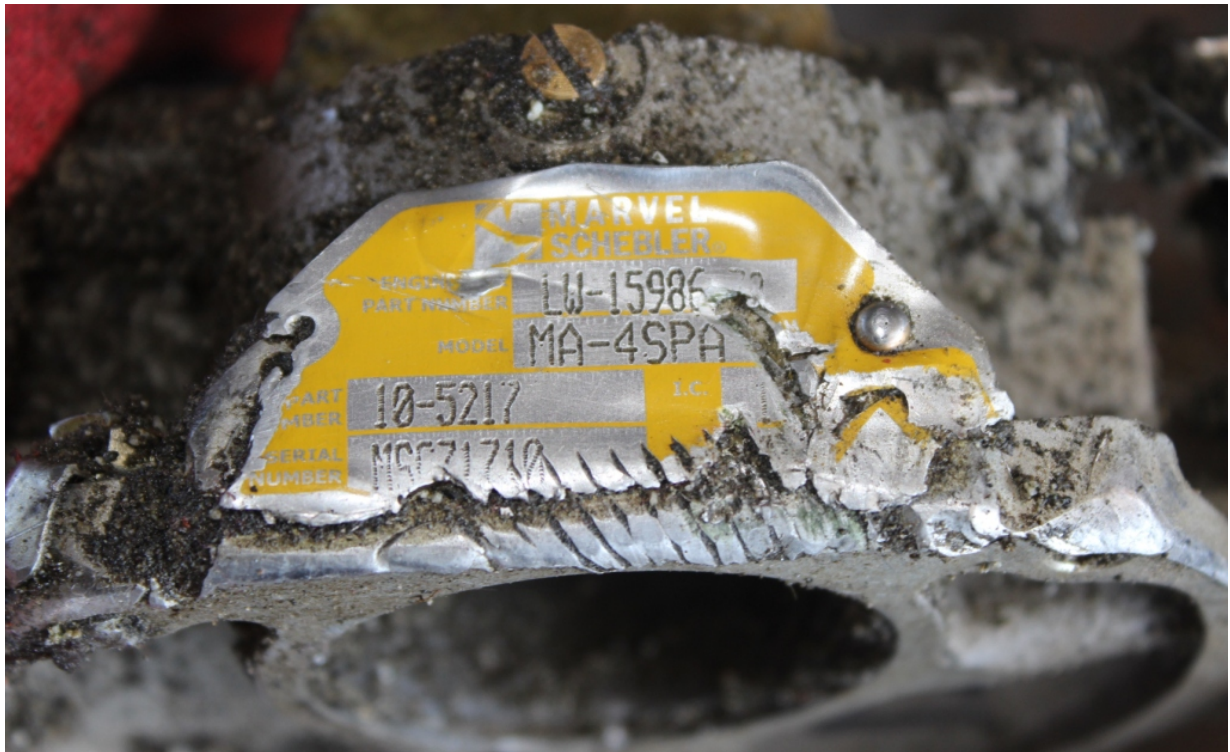
- The fuel system utilizes gravity fed fuel; there is no engine driven fuel pump.
- The carburetor was fracture-separated from the engine
  - o The portion that remained attached at the mounting pad was secure. The fracture surface signatures were consistent with overload.

- The throttle control rod end was found securely attached at the control arm of the carburetor.
  - The castellated nut and cotter pin remained secure and the serrated interface at the throttle arm remained securely mated.
- The mixture arm had been pulled from the carburetor due to overload.
- Both the throttle and mixture controls had been moved beyond the normal operating range during the accident.
  - Reliable setting positions at the time of impact could not be determined due to damage
- The section of the carburetor that housed the throttle valve was fracture separated from the carburetor body due to impact.
  - The float assembly and needle valve were destroyed.
- The foam filter element remained securely attached to the airbox bracket.
  - The filter element remained intact and exhibited no evidence of pre-impact obstruction to airflow.
