## **NATIONAL TRANSPORTATION SAFETY BOARD**

# **AIRFRAME AND ENGINE EXAMINATION**

**WPR19FA080**

Location: Desert Hot Springs, California  
Date: February 5, 2019  
Aircraft: Cessna 172M, N20556, Serial # 1726139  
NTSB IIC: Michael Huhn

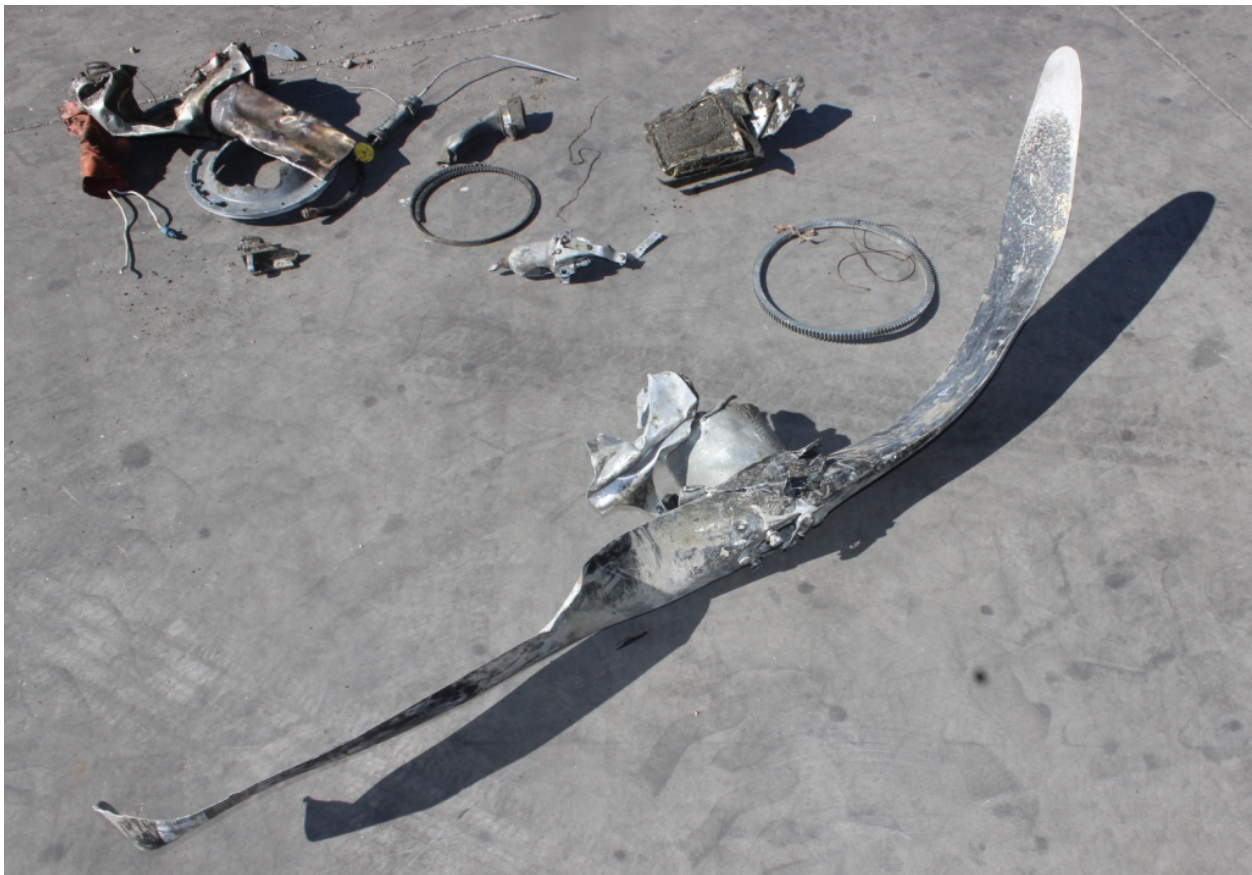
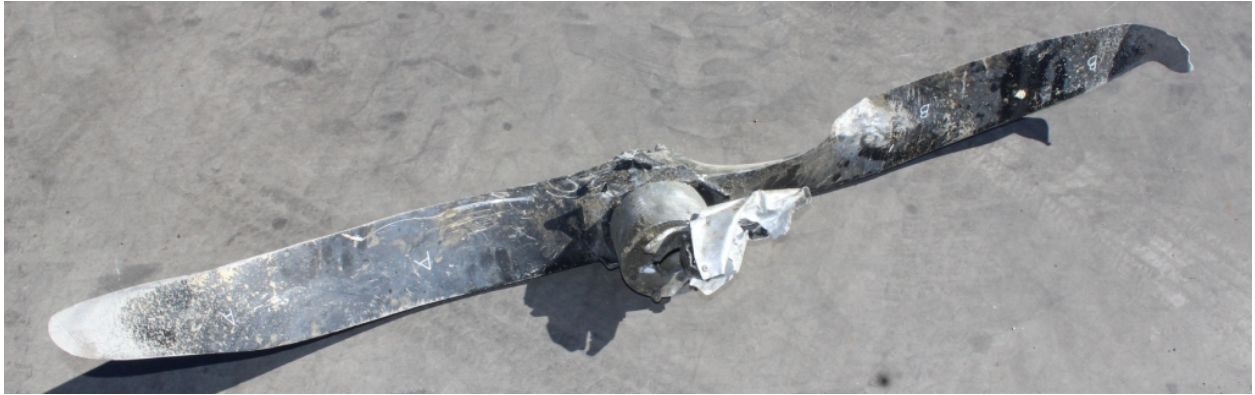
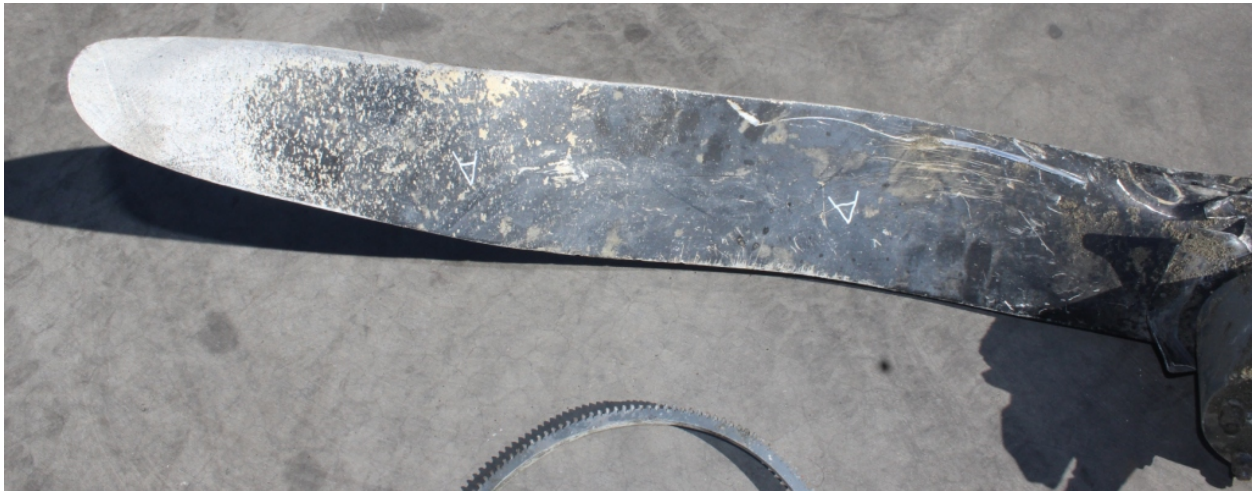
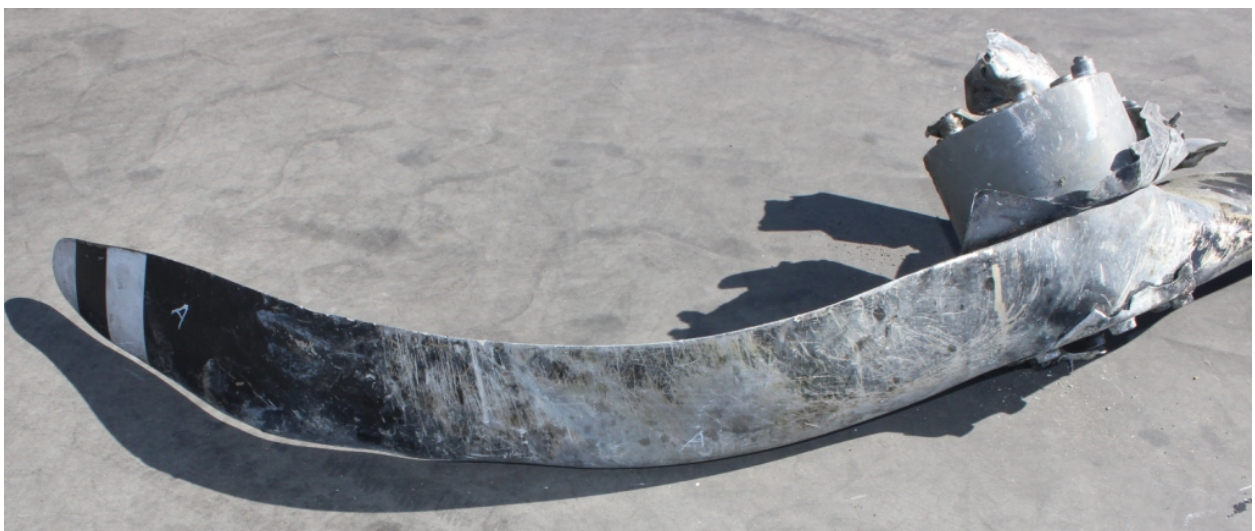
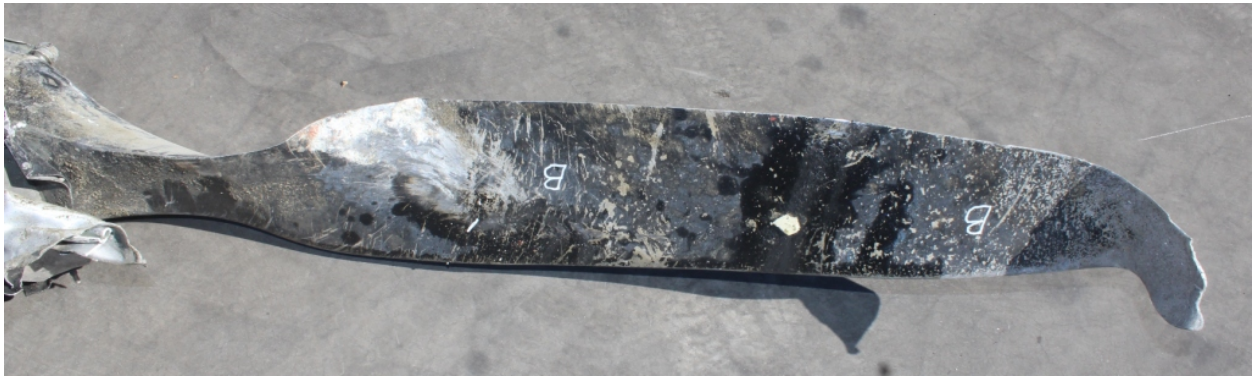
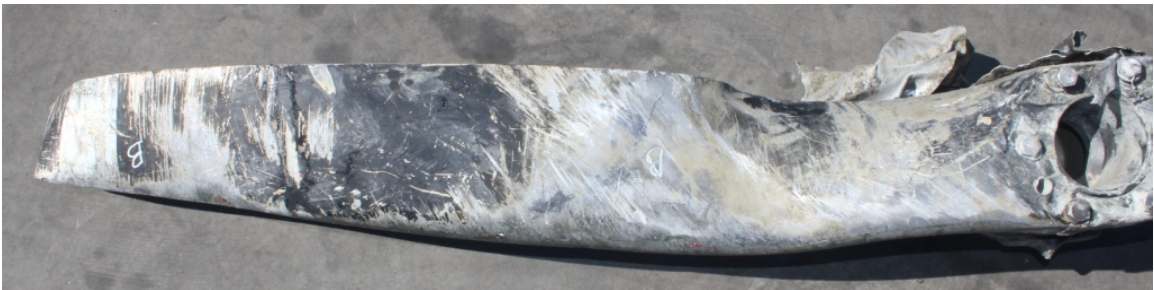
- The metal two bladed fixed pitch propeller was fracture-separated from the crankshaft flange at the mechanical attachments.
- The fracture surfaces exhibited signatures consistent with overload due to the absorption of rotational energy.
- The propeller blades remained attached to the hub.
- The metal spinner was fracture-separated from the propeller/hub.
- The propeller blades displayed varying degrees of leading edge gouging, torsional twisting, chordwise striations across the cambered surface, and trailing edge “S” bending.
- The signatures were consistent with the absorption of rotational forces applied at the crankshaft at the time of impact.
