## **NATIONAL TRANSPORTATION SAFETY BOARD**

### **SITE and ON-SCENE INFORMATION (Rev B)**

**NTSB Accident: WPR19FA080  
Accident Date: February 5, 2019**

Location: Desert Hot Springs, California  
Date: February 5, 2019  
Aircraft: Cessna 172M, N20556, Serial # 1726139  
NTSB IIC: Michael Huhn

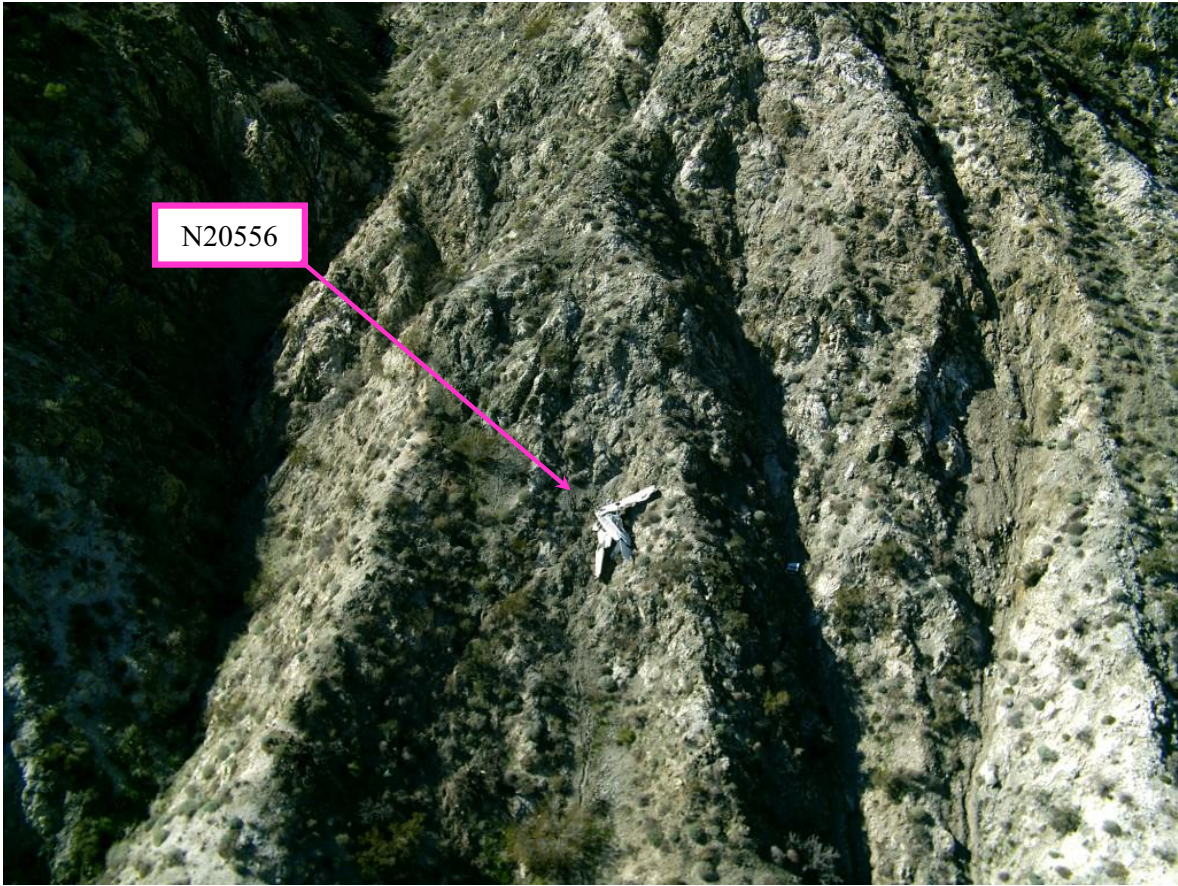
- The lower cowl and the nav light lens fragments were found about 30 ft above the main wreckage; this is considered to be the impact point
  - The terrain at the impact point and between that and the wreckage was steeper than the terrain where the wreckage came to rest

**Figure 5 - Impact Location**

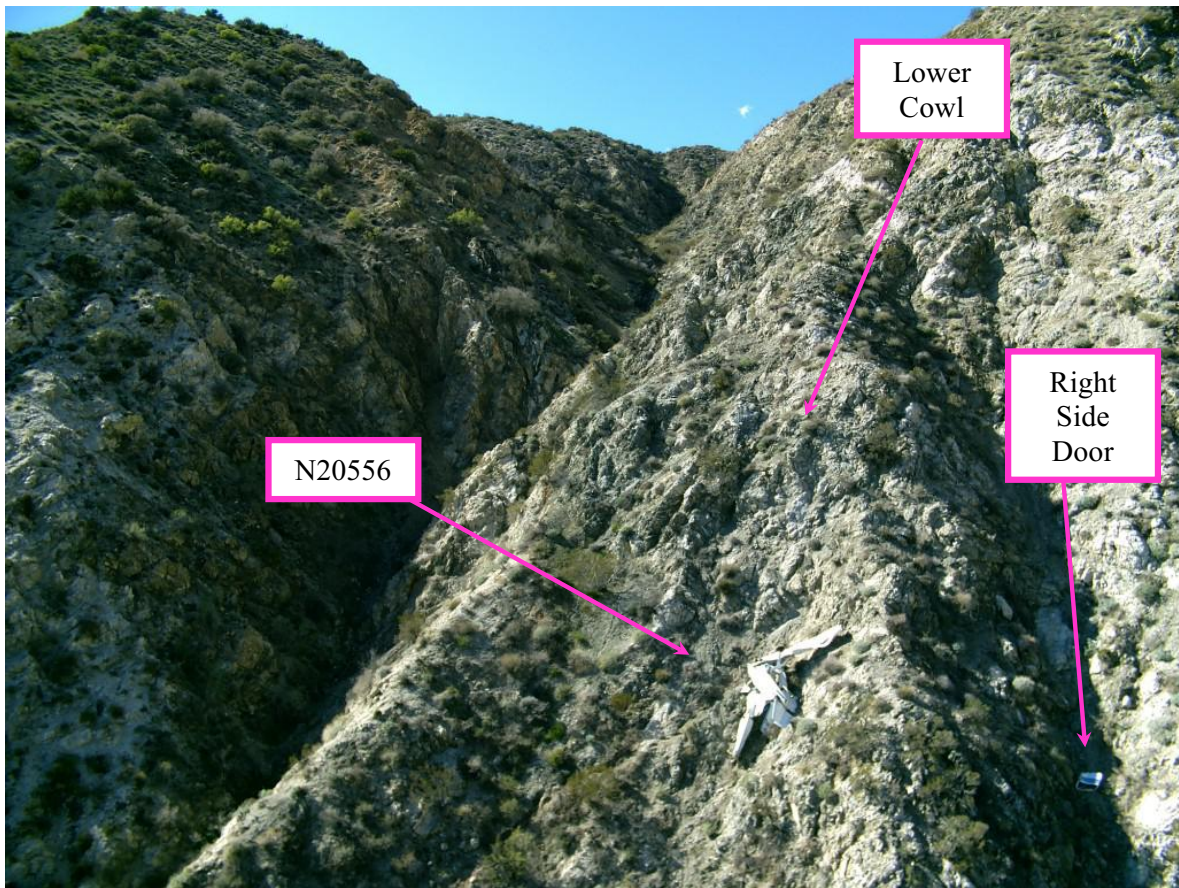
- The wreckage was on steep, unstable terrain about 300 ft above the road
- The wreckage was observed to be precariously situated on the mountain slope, which limited the extent of the examination of the wreckage in situ

**Figure 6 - Wreckage on Steep Terrain**

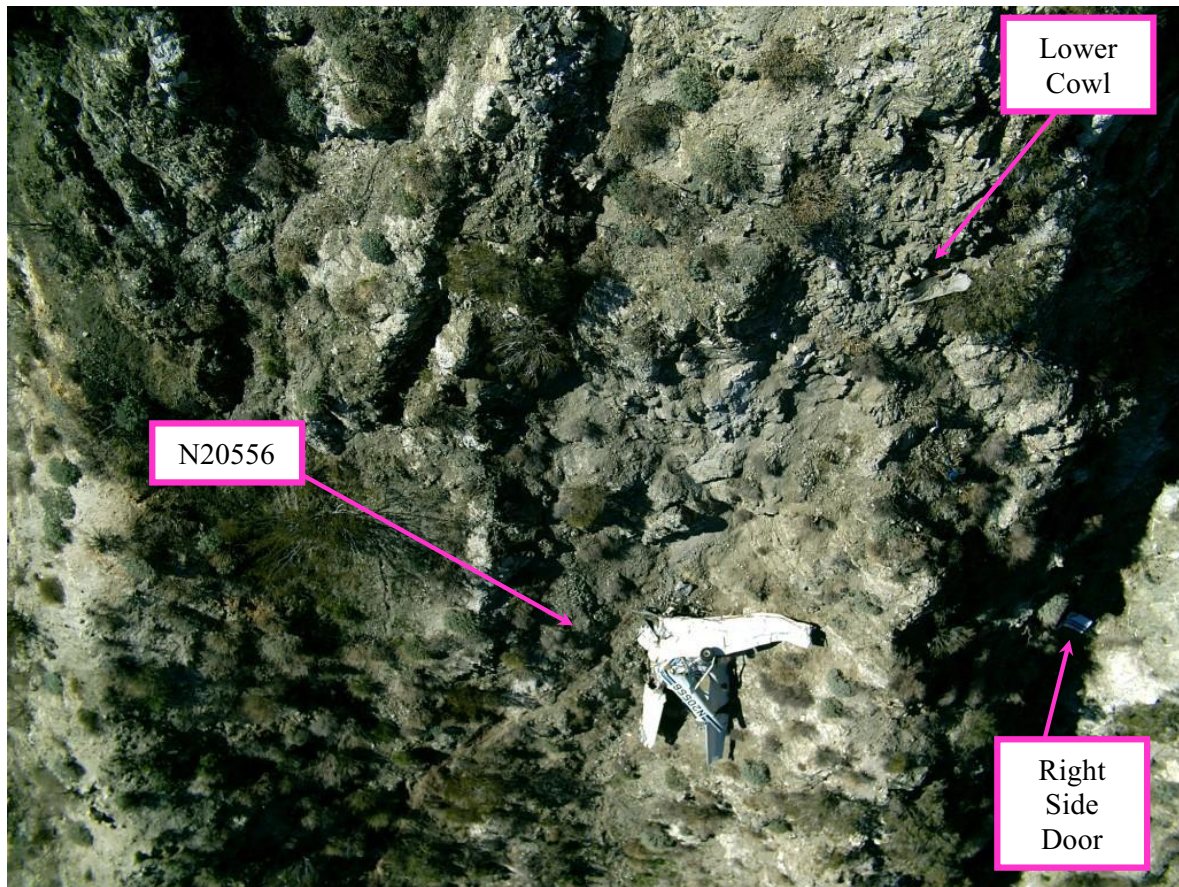
- The forward section of the airplane was upright, and partially covered with soil/rocks that had slid downhill
- The fuselage was severely crushed and torn, and the wings and empennage were severely torn and deformed

Figure 7 - Wreckage Overview

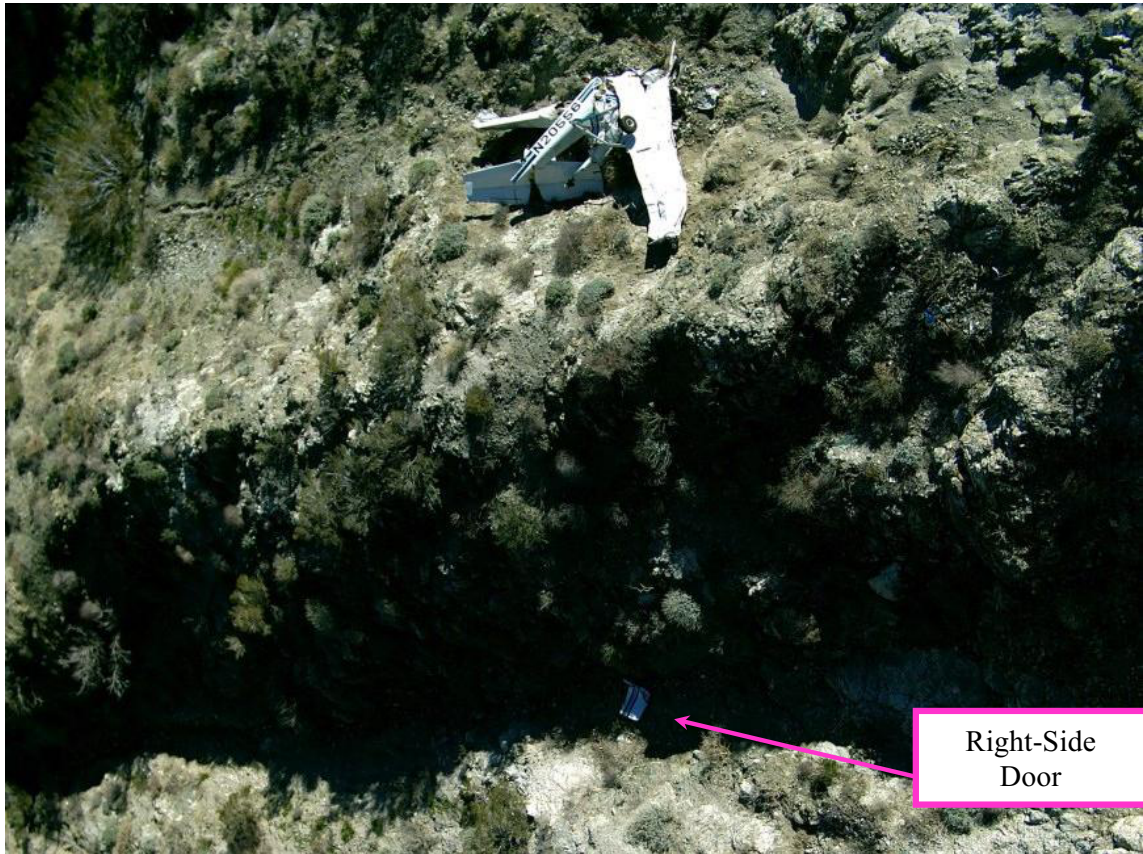
**Figure 8 - Wreckage Overview**

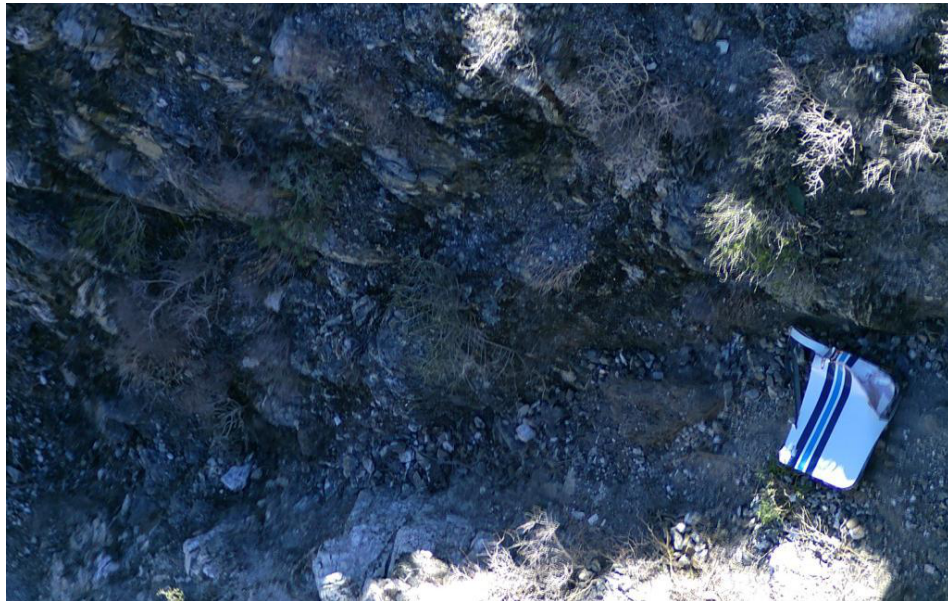
**Figure 9 - Right-Side Door**

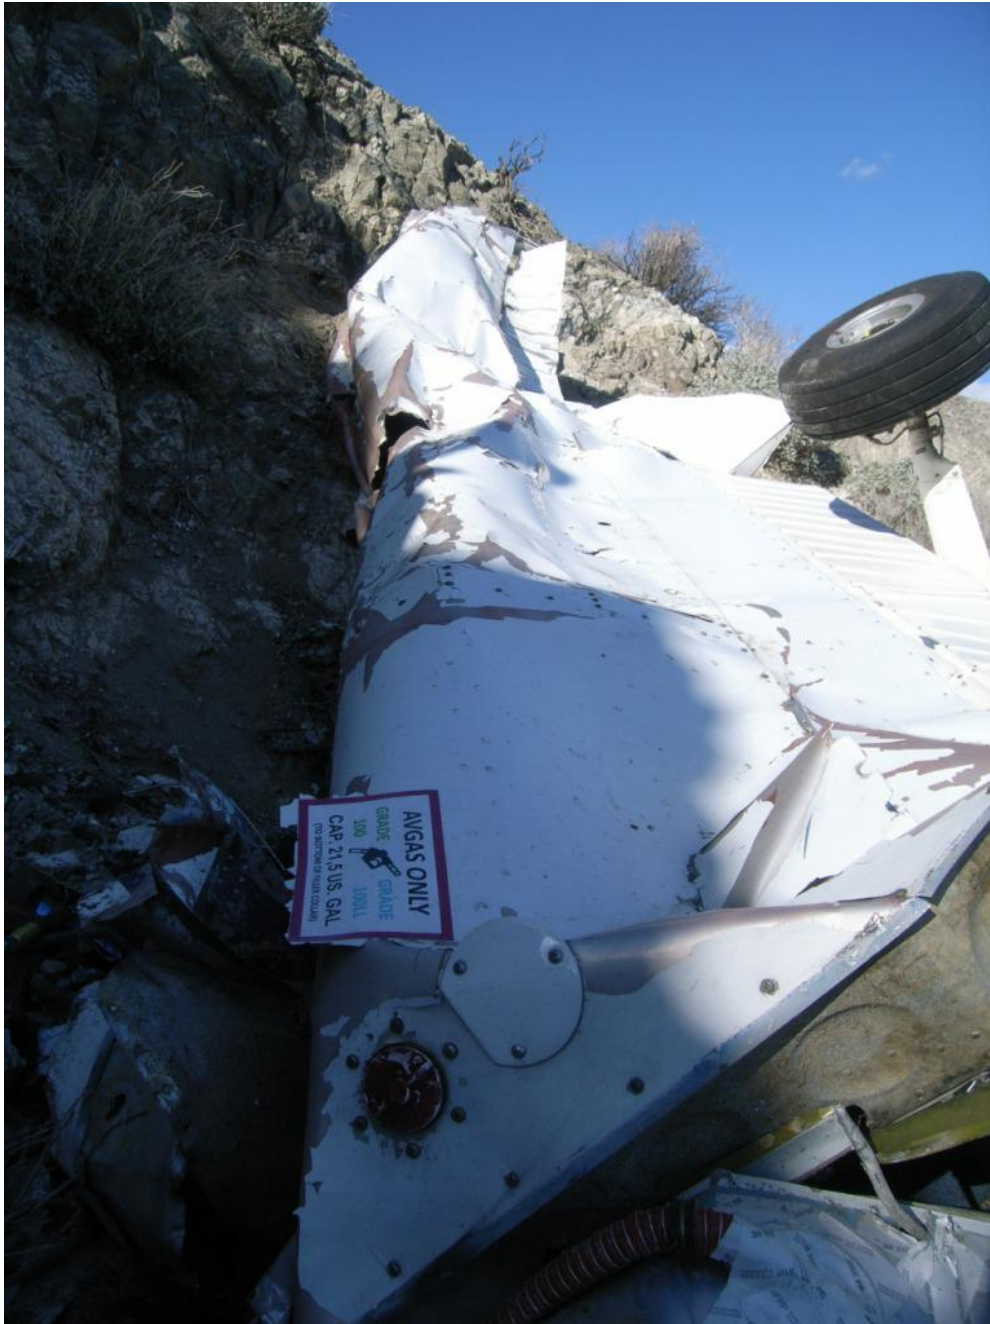
- Both fuel caps were observed installed securely in their respective filler necks
- All flight control surface balance weights appeared to be present
- Multiple control cables were visible, but their routing and continuity could not be determined due to the level of damage

Figure 14 - Right Wing & Fuel Cap

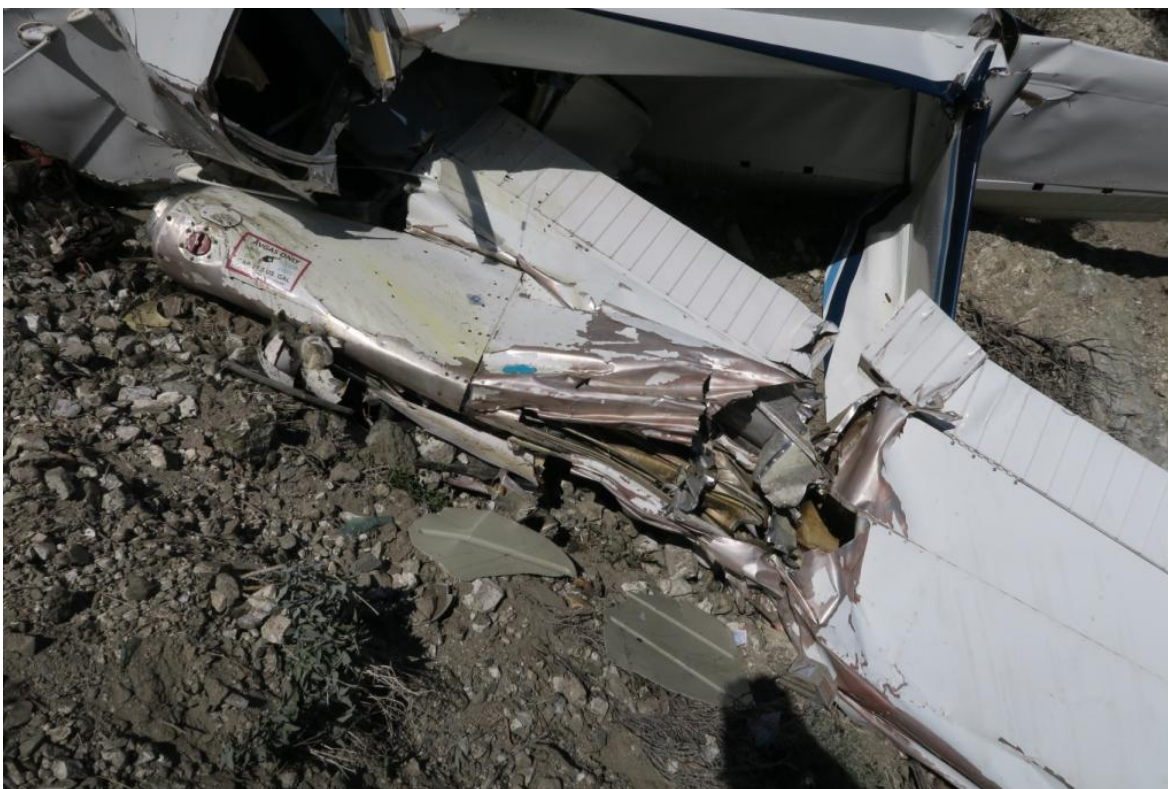
- Both wings had LE aft crushing continuously across their full spans
- Both ailerons remained attached to the wings
- Both flaps remained attached to their wings, and appeared to be fully retracted

**Figure 15 - Left Wing LE Crush Damage**

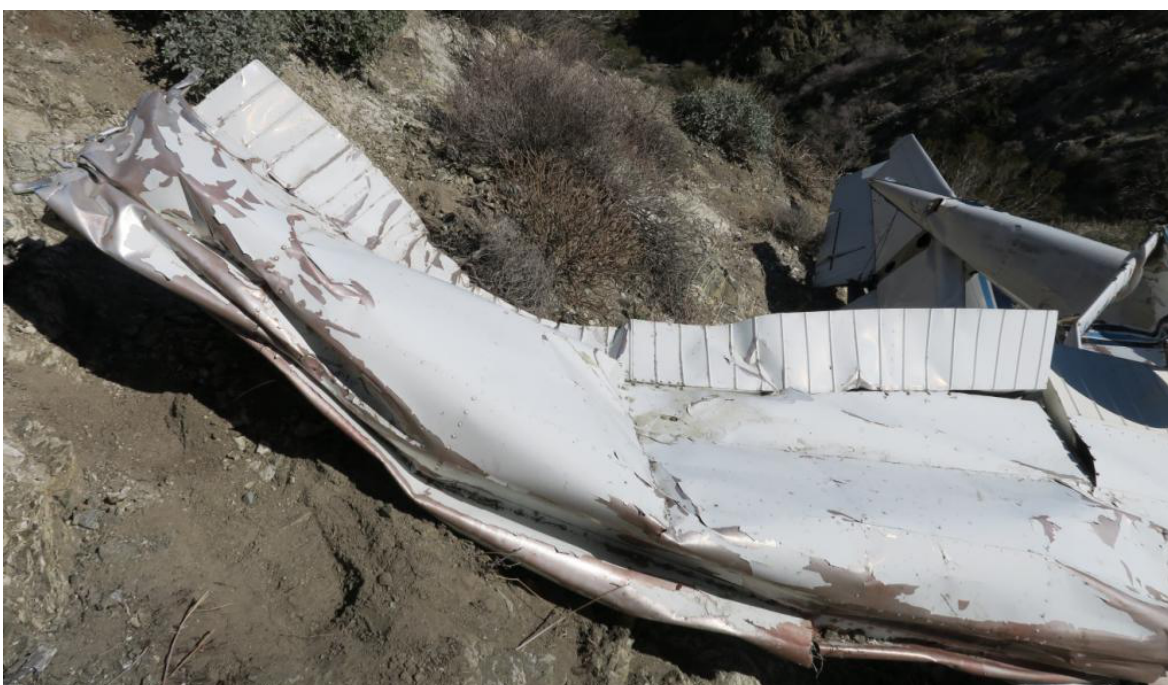
**Figure 16 - Right Wing LE Crush Damage**

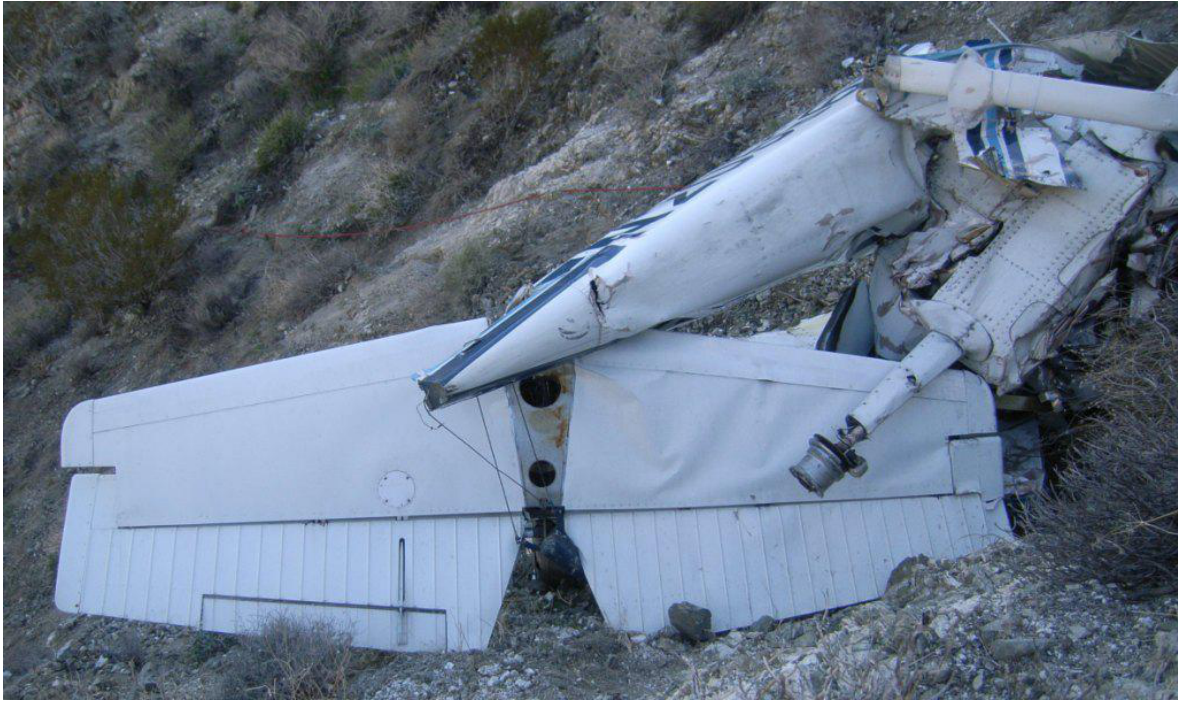
- The horizontal stabilizer was mostly intact, but mostly separated from the aft fuselage
- Both elevators remained attached to the horizontal stabilizer, and the pitch trim tab remained attached to the right elevator

**Figure 19 - Horizontal Stabilizers and Elevators**

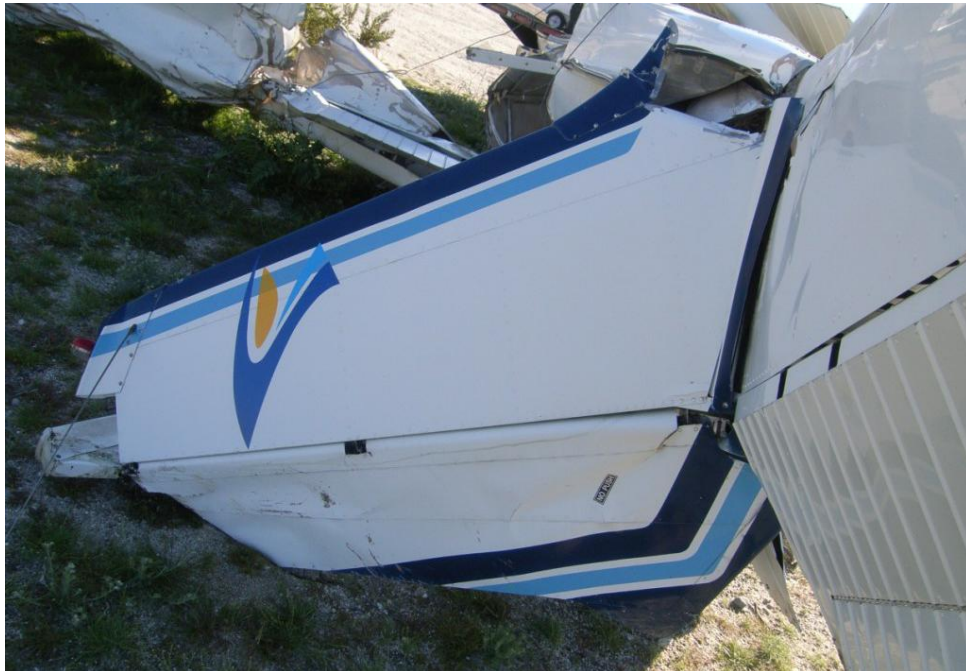
- The fin remained attached to the aft fuselage, and the rudder remained attached to the fin
- Both wings were upright, but crushed, torn, and swept aft about 45°

**Figure 24 - Fin and Rudder**

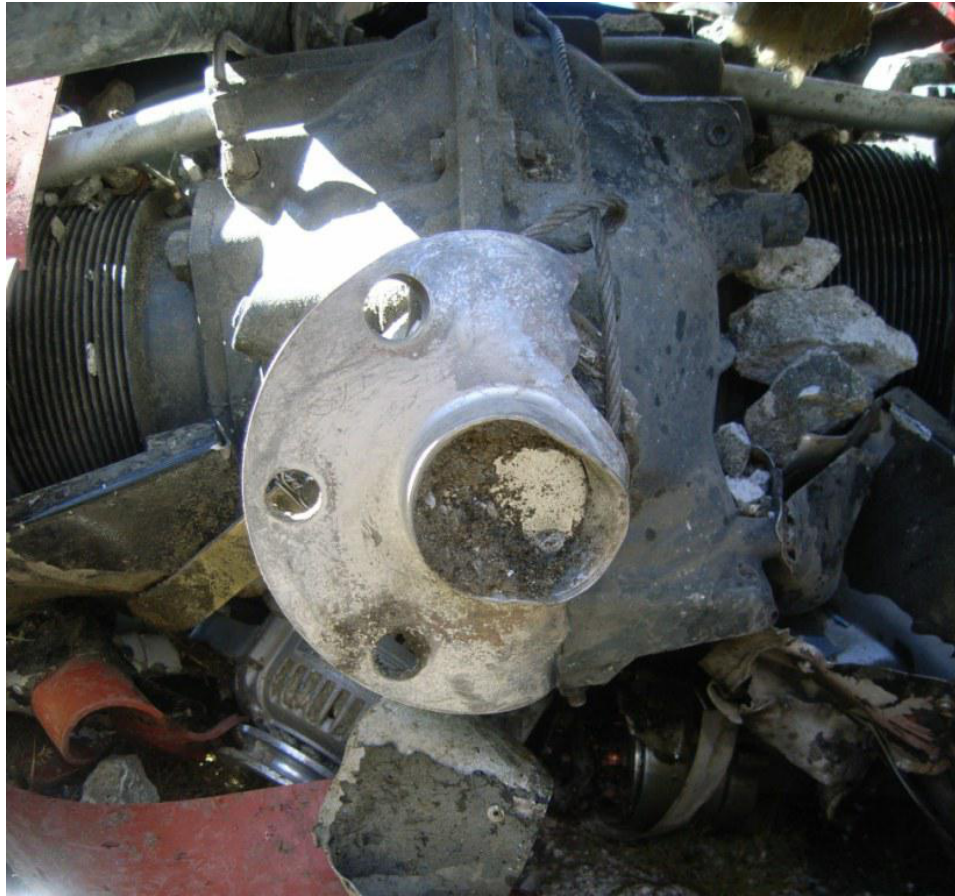
- The condition and location of the wreckage warranted its extraction by helicopter
- The helicopter crew packaged and recovered the wreckage to a clearing about a mile from the accident site
- The two (and only) victims were recovered from the wreckage
- The wreckage was partially examined and photographed and loaded onto a truck for transport to a secure facility where it could be examined in detail
- The all metal fixed pitch two blade propeller was fracture-separated from the engine at its attach flange

**Figure 25 - Propeller Flange & Engine**

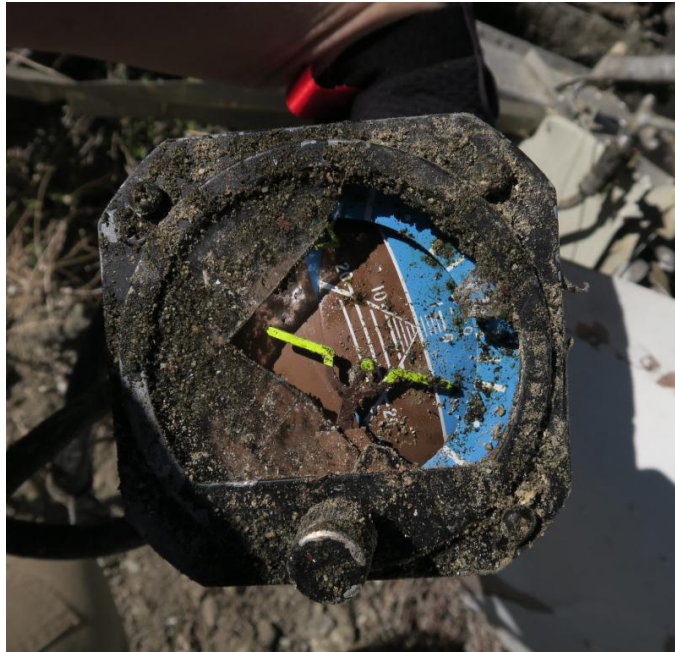
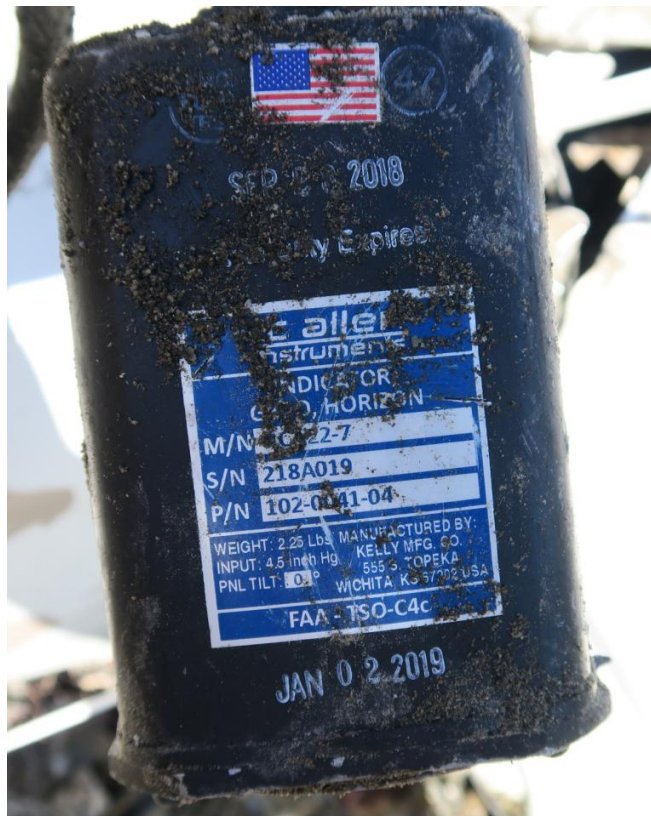
- The onboard clock was stopped at 0115:47 (consistent with being set to UTC time, equivalent to 1815:47 PST)
- The artificial horizon was fracture-separated from the instrument panel
  - It was date stamped January 2, 2019
- No other useful instrument or control indications were able to be made at this time

Figure 27 - Artificial Horizon

Figure 28 - Artificial Horizon

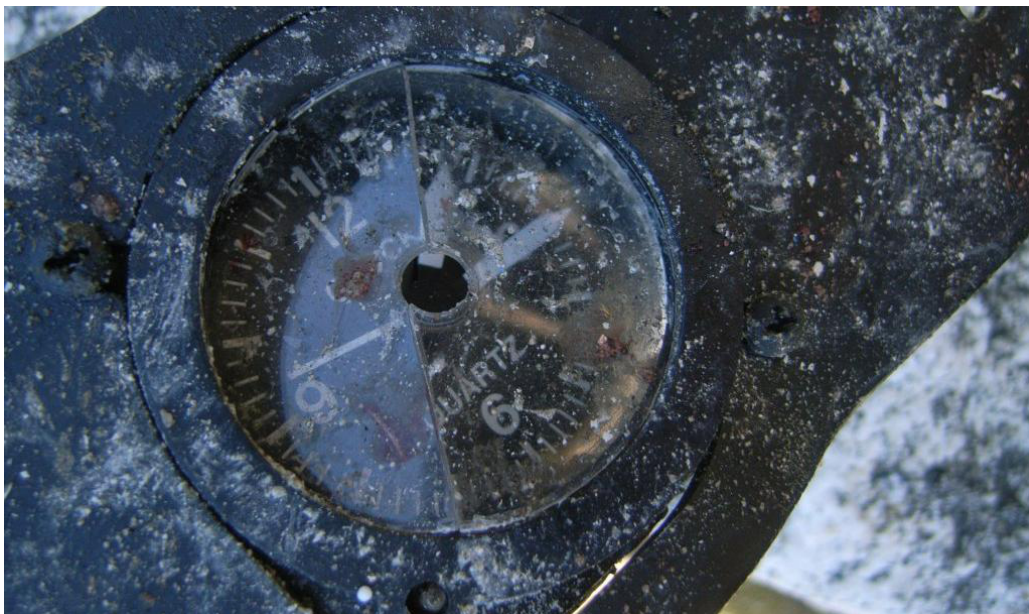
**Figure 30 - Clock Indicating Accident Time**

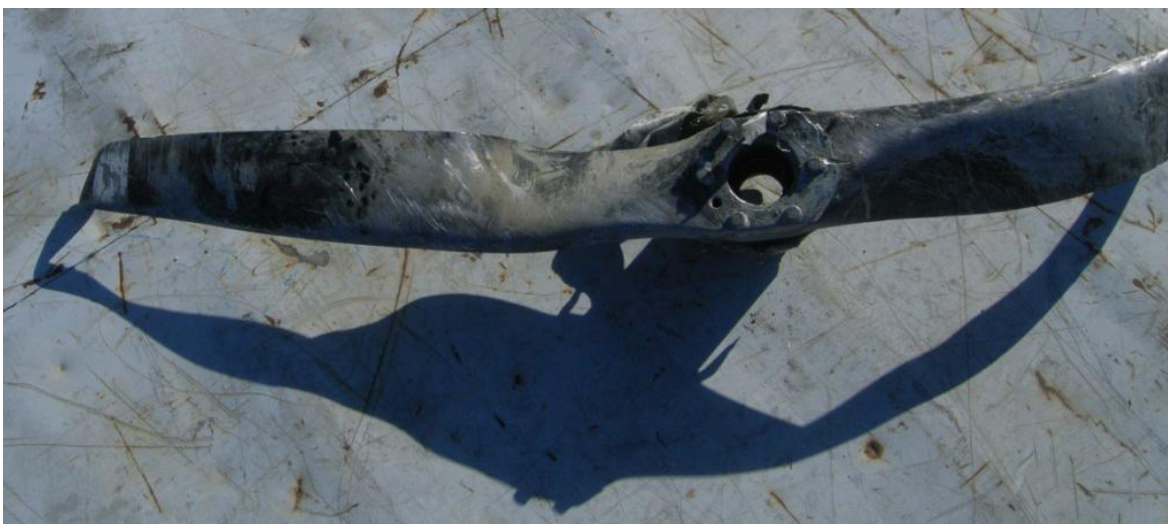
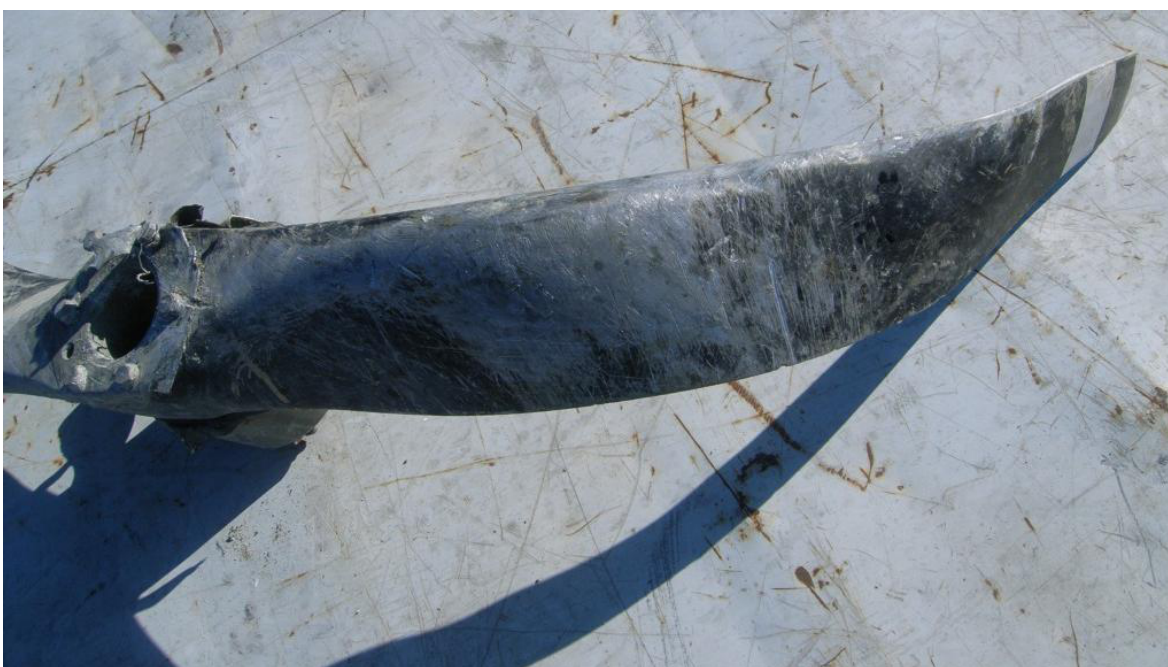
**Figure 32 - Blade Deformation**

**Figure 33 - Blade Deformation**
