## **NATIONAL TRANSPORTATION SAFETY BOARD**

### **ONSITE EXAMINATION NOTES**

**WPR19FA083**

Location: Walnut Creek, CA  
Date: February 8, 2019  
Aircraft: N3270F  
NTSB IIC: Albert Nixon

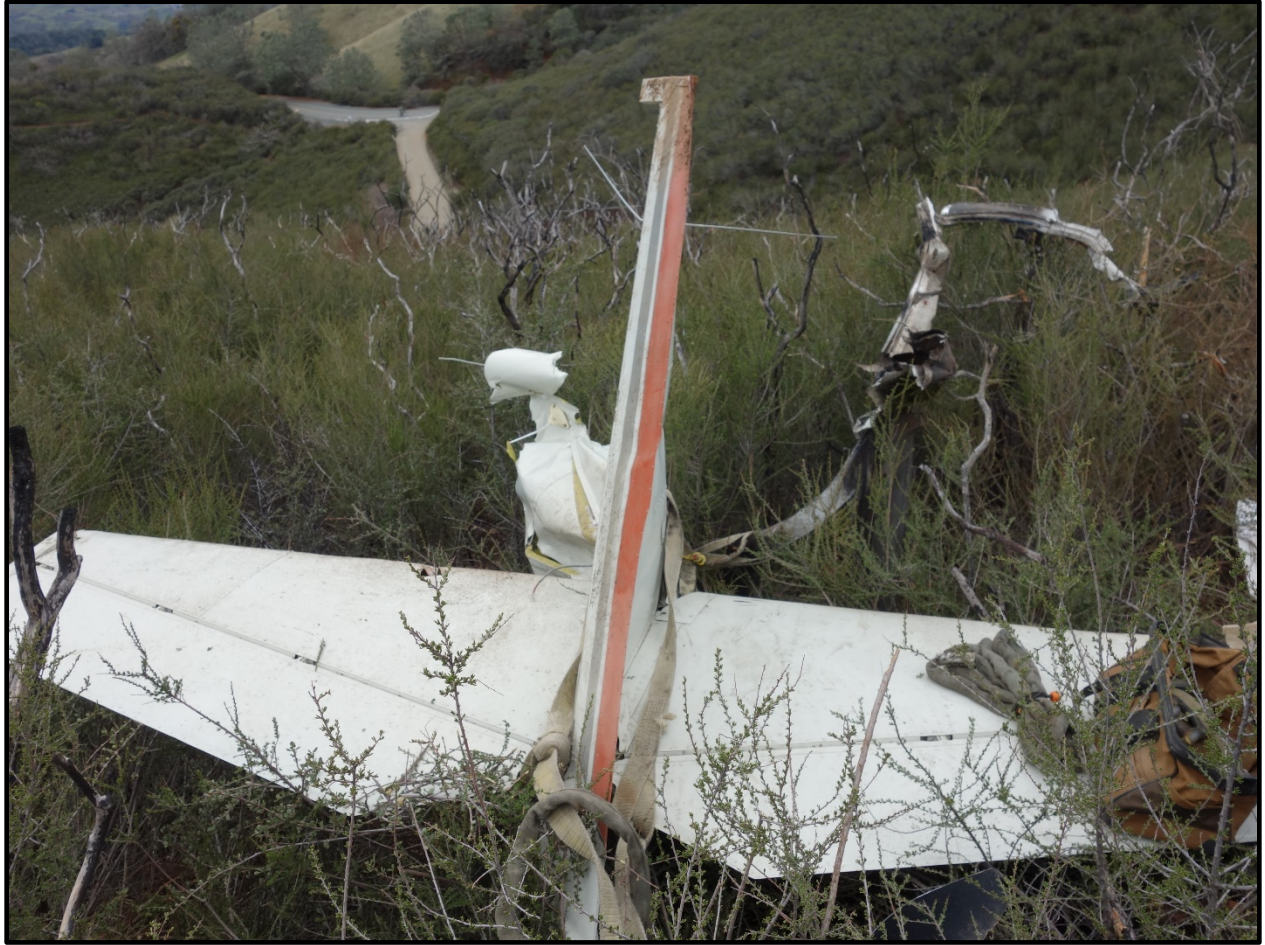
Figure 1: Airplane wreckage viewed from the aft side being prepared for recovery.

The fuselage came to rest on a heading of about 113° magnetic. The left wing remained attached and the right wing was separated. The empennage was separated from the fuselage about 3 ft from the leading edge of the horizontal stabilizer. Flight control continuity was unable to be established due to impact damage and airplane position on the hill.
