## **NATIONAL TRANSPORTATION SAFETY BOARD**

### **AIRFRAME AND ENGINE EXAMINATION**

**WPR19FA083**

Location: Walnut Creek, CA  
Date: February 8, 2019  
Aircraft: N3270F  
NTSB IIC: Albert Nixon

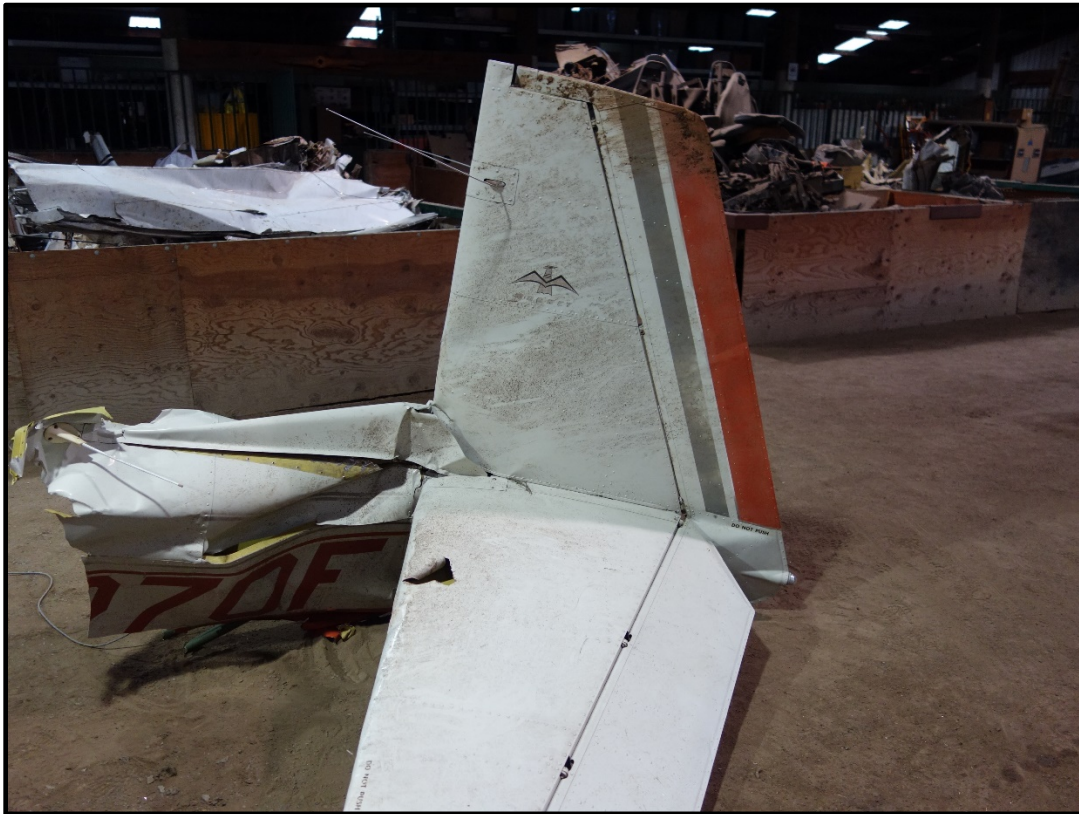
The empennage was relatively intact. The rudder and elevators were attached.

Figure 1: Airplane tail section viewed from the left side during examination.
