## **NATIONAL TRANSPORTATION SAFETY BOARD**

### **SUMMARY OF AIRPLANE EXAMINATION**

**(WPR19FA084)**

| Aircraft: | Cirrus SR22, N917SR |

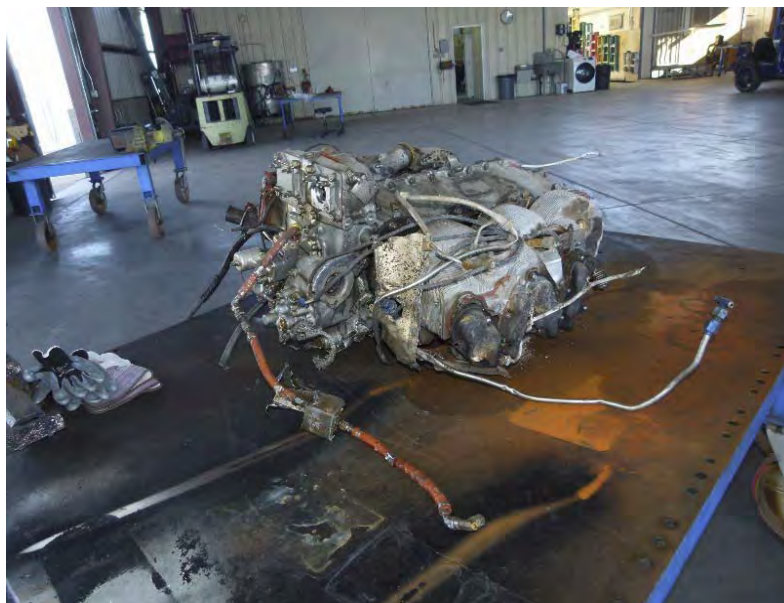
Figure 1 - photo of engine as received

The engine had been recovered from the accident site and placed on a table for the examination. The engine exhibited severe impact damage and most of the accessories were separated from the engine and located with the airframe wreckage. The crankshaft propeller flange was fractured from the crankshaft and was not found in the wreckage. The crankshaft exhibited 45° shear lips and radial cracking.

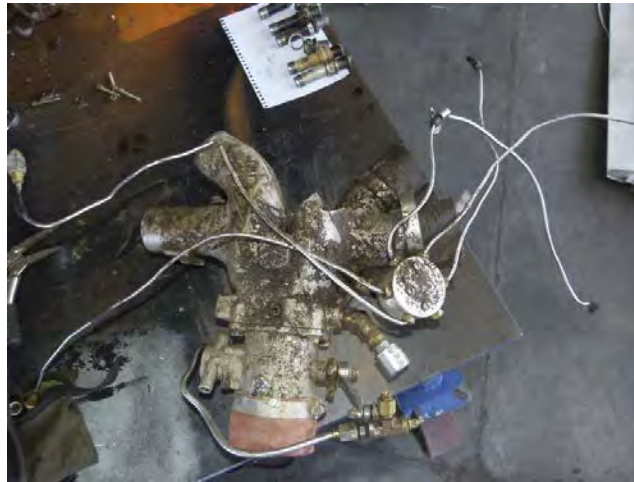
Figure 2 - photo of induction system

- The induction system was impact separated from the engine and various induction system pieces were noted within the aircraft wreckage. The induction manifold exhibited impact damage, but the throttle moved freely by hand.

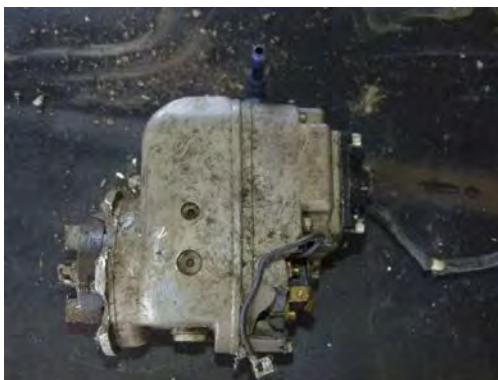
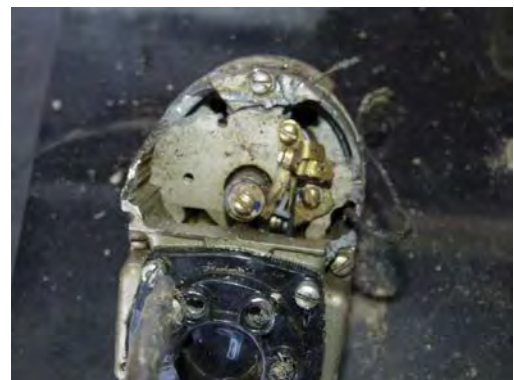
- The left magneto, serial number D08IA313, was impact separated from the engine and located within the aircraft wreckage. The mounting flange was fractured, and the magneto points cover was broken away exposing the points to damage. The magneto drive turned freely by hand with impulse coupling engagement. No spark was produced due to the impact damaged points. The magneto was disassembled and no preimpact anomalies were noted.

Figure 3 - left magneto

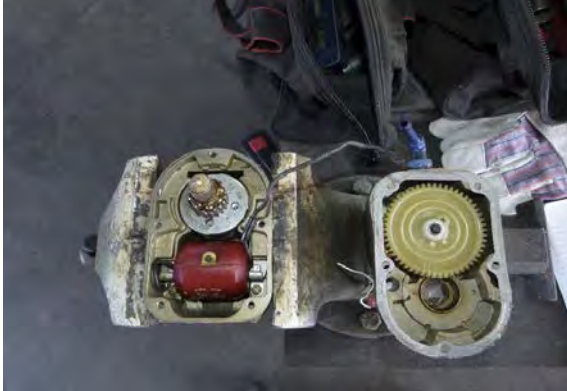
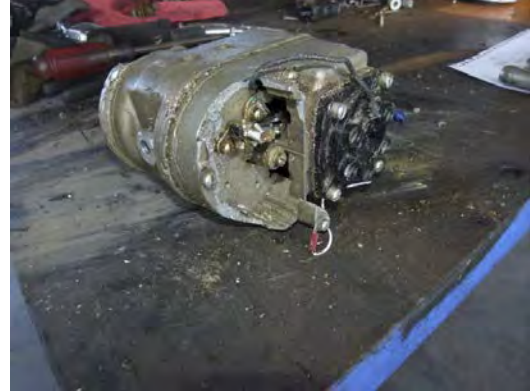
- The right magneto, serial number D08IA307, was impact separated from the engine and located within the aircraft wreckage. The mounting flange was fractured, and magneto

points cover was broken away exposing the points to damage. The magneto drive turned freely by hand with impulse coupling engagement. No spark was produced due to the impact damaged points. The magneto was disassembled and no preimpact anomalies were noted.

Figure 5 - right magneto

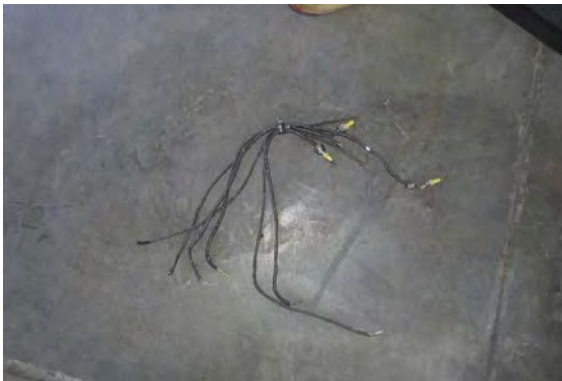
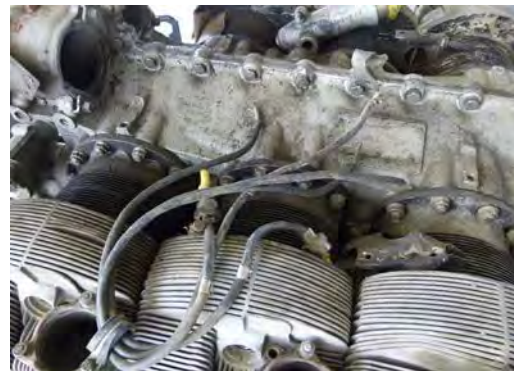
All twelve of the ignition harness leads were damaged and cut in multiple places.  
photo

Figure 7 - ignition harness leads

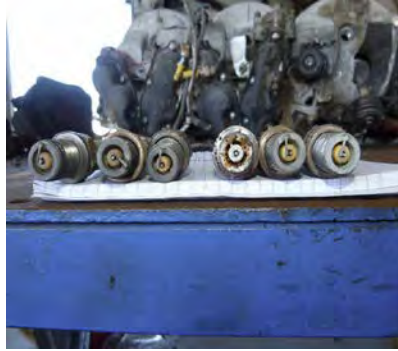
The top spark plugs were removed, and the bottom spark plugs examined with a lighted bore scope. The spark plugs exhibited light colored combustion deposits and normal electrode wear.

Figure 9 – top spark plugs

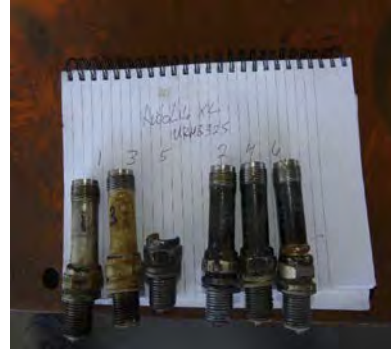
Figure 10 - bottom spark plugs

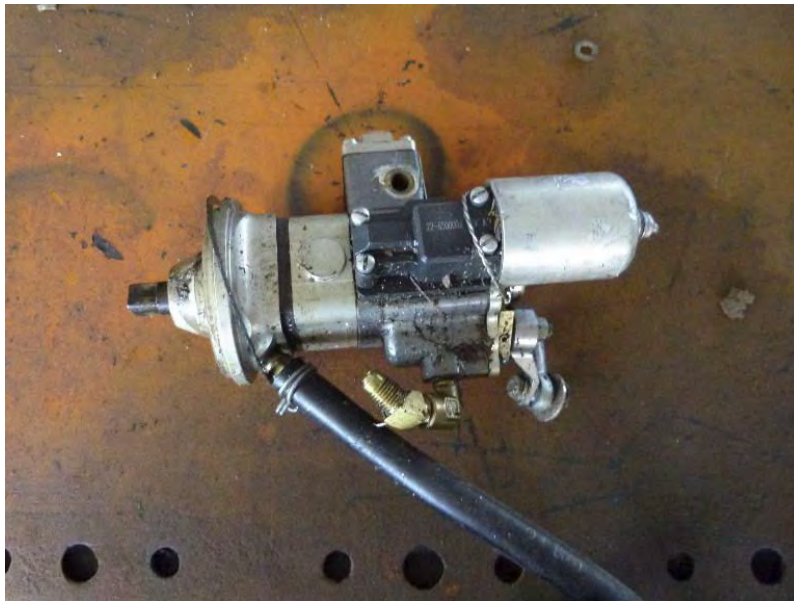
Figure 11 - engine driven fuel pump

- Fuel pump - The engine driven fuel pump remained attached to the engine and exhibited impact damage to the mixture control arm and the aneroid. Several of the fuel line fittings were fractured. The engine driven fuel pump was removed, and the drive coupling was intact. The mixture control moved freely by hand from stop to stop. The engine driven fuel pump was disassembled and no preimpact anomalies were noted

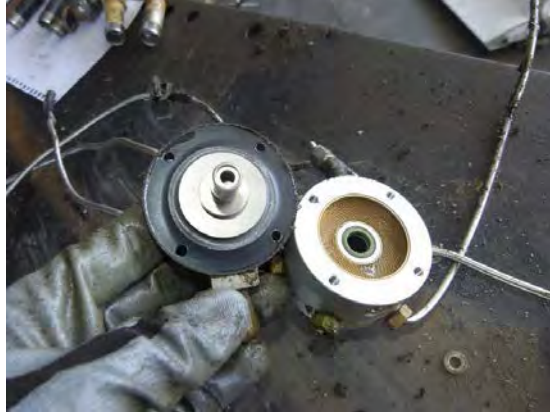
Figure 12 - fuel manifold valve

- The fuel manifold valve was located in the airframe wreckage and was still attached to the induction manifold. The fuel manifold valve was disassembled, and the fuel screen was clean. The diaphragm was intact, and the retaining nut was secure.

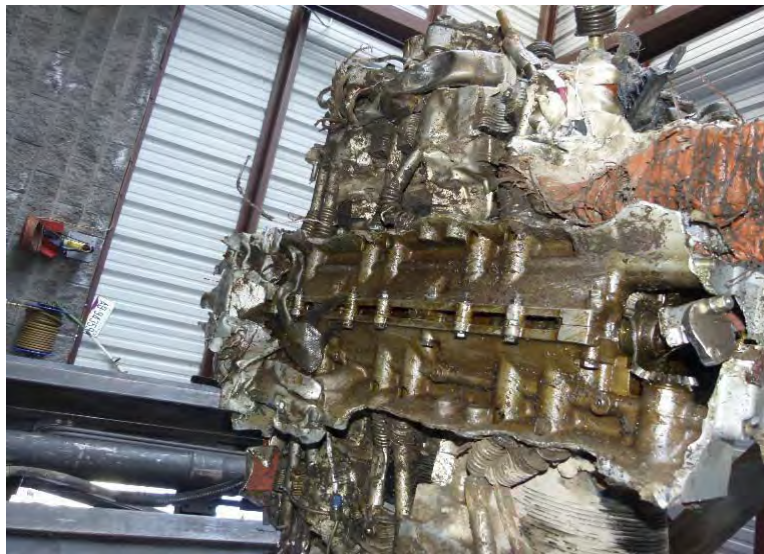
Figure 13 - oil sump

- The oil sump was impact separated from the engine.

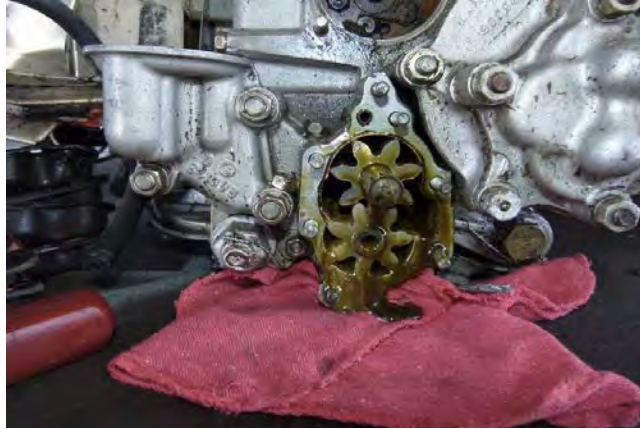
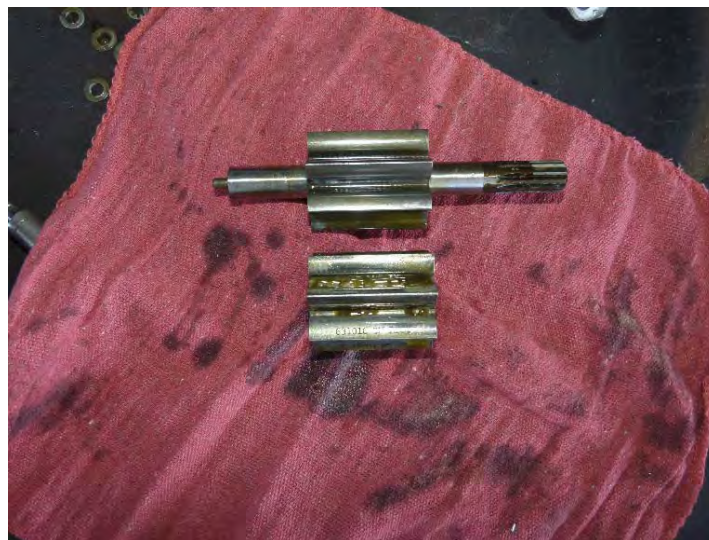
- The oil pump was disassembled, and oil was noted in the pump. The gear teeth and housing showed normal wear and no signs of hard particle passage.

Figure 14 - oil pump

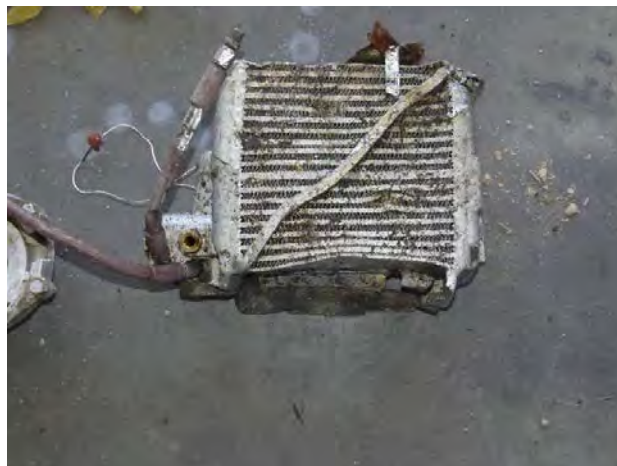
Figure 16 - oil cooler

- The oil cooler was separated from the engine and exhibited impact damage.

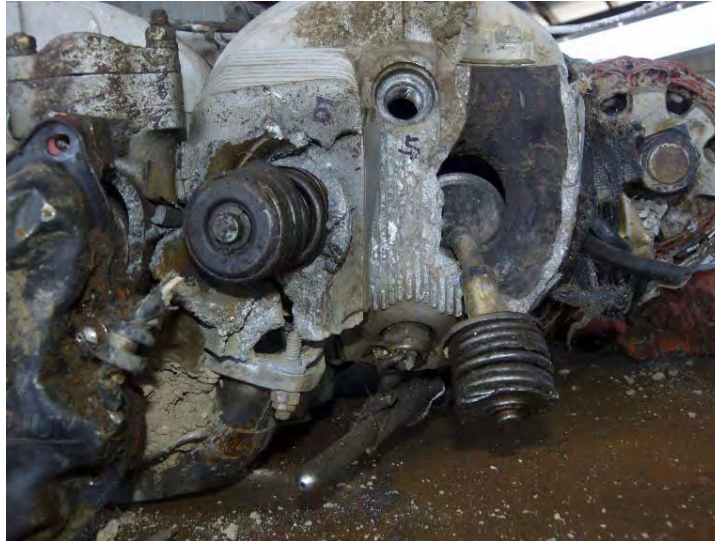
Figure 17 - #5 cylinder

- The cylinders remained attached to the crankcase and all exhibited varying degree of impact damage. The number five cylinder head was partially missing and the intake valve was loose and bent. The cylinder combustion chambers were inspected with a lighted bore scope and no pre-impact anomalies were noted.

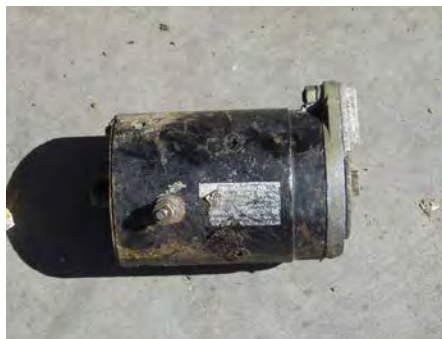
Figure 18 - starter

- The starter was impact separated from the starter adaptor and located within the airframe wreckage.

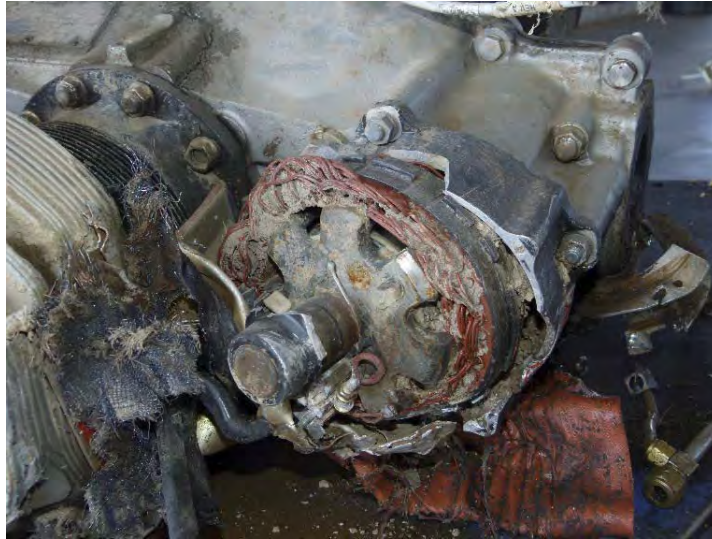
Figure 19 - Alternator

- The alternator was impact damaged.

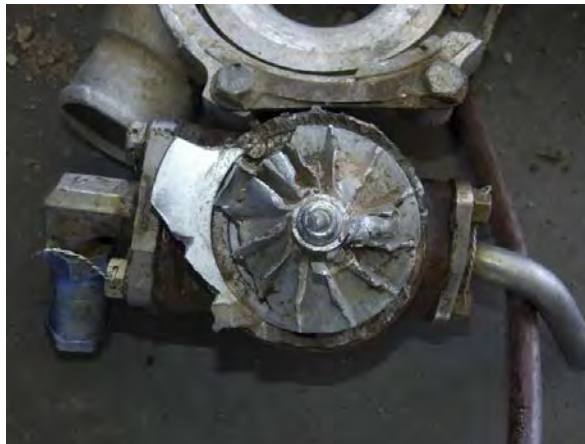
Figure 20 - turbocharger

- The turbo chargers were impact separated from the engine and damaged. One turbo charger was broken in half with the compressor scroll and compressor wheel separated. The turbine and compressor wheels exhibited blade damage opposite of rotation and some outer pieces of the blades were missing.

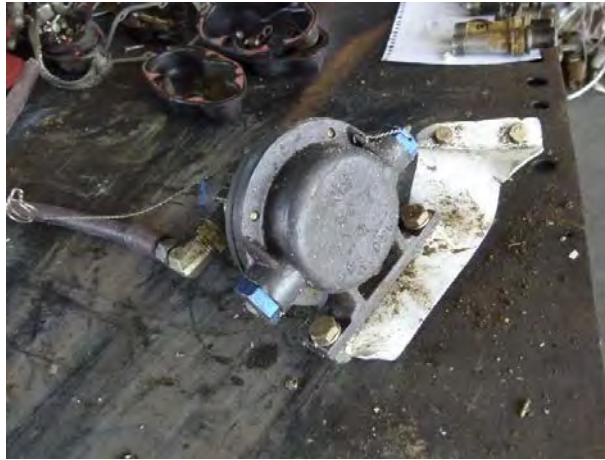
Figure 21 - turbo controller

- The controller was found loose in the airframe wreckage and damaged.

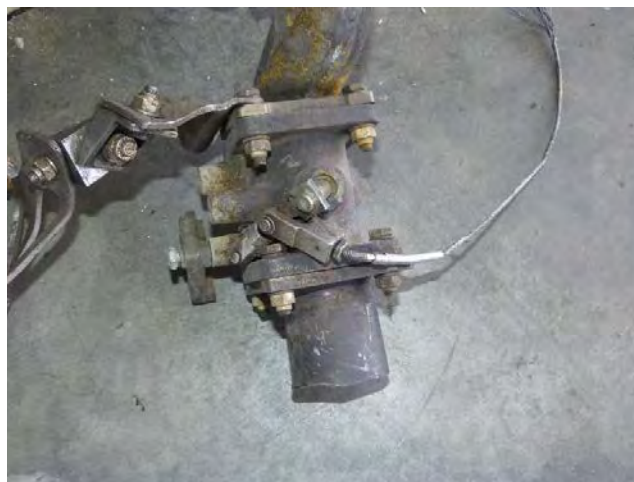
Figure 22 - wastegate

- The wastegate were impact damaged.

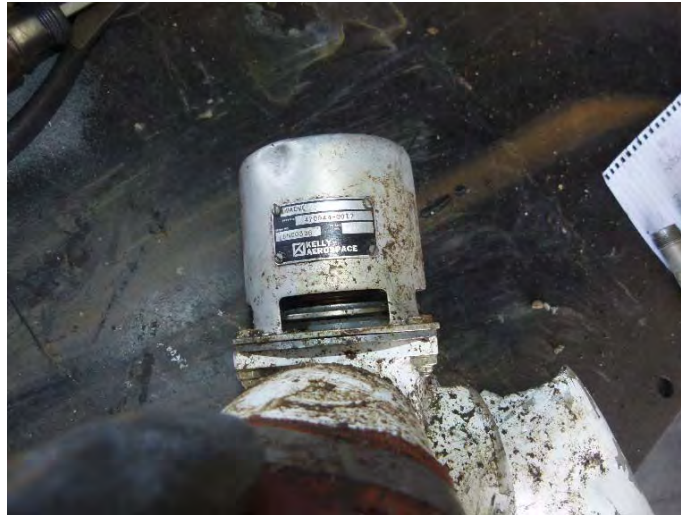
Figure 23 - overboost valve

- The overboost valve was still attached to the induction elbow and exhibited light impact damage.

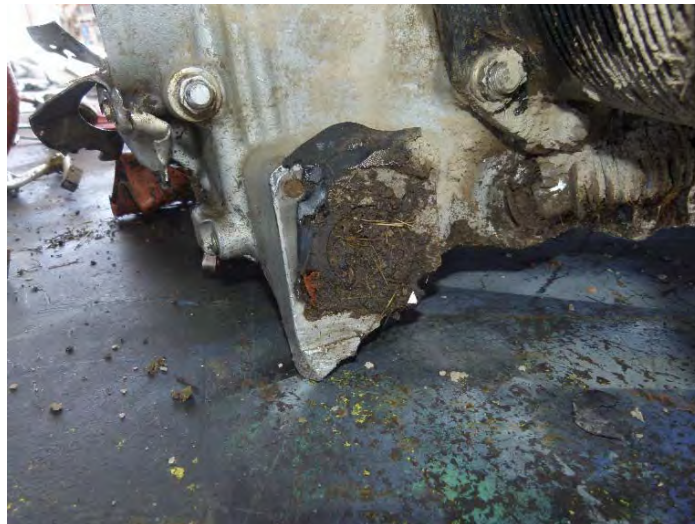
Figure 24 - propeller governor

- The propeller governor was impact separated from the engine and not observed in the wreckage.

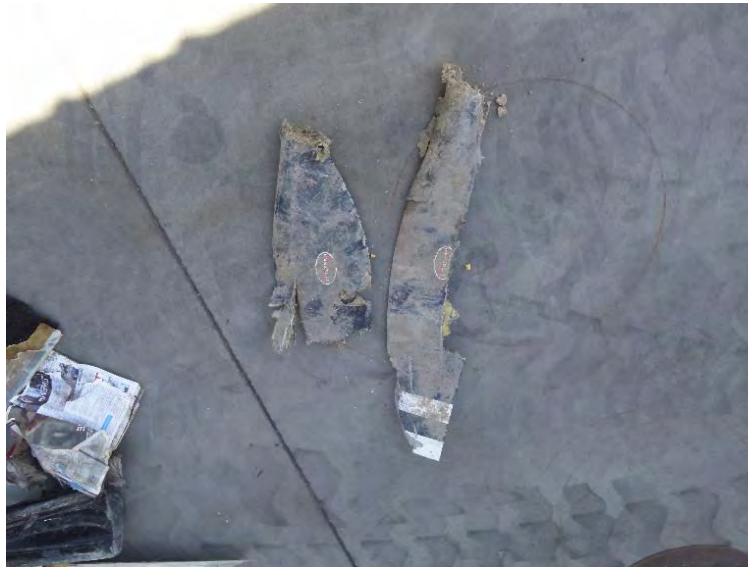
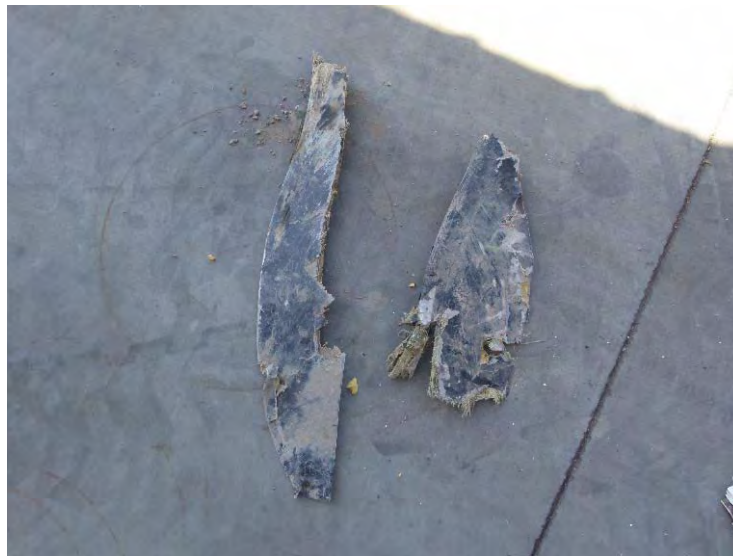
- The propeller hub and crankshaft propeller flange were fractured from the crankshaft and not observed with the wreckage. Two damaged partial composite propeller blades were found in the wreckage.

Figure 25 – two partial Hartzell propeller blades (front view)

Figure 26 – two partial Hartzell propeller blades (rear view)
