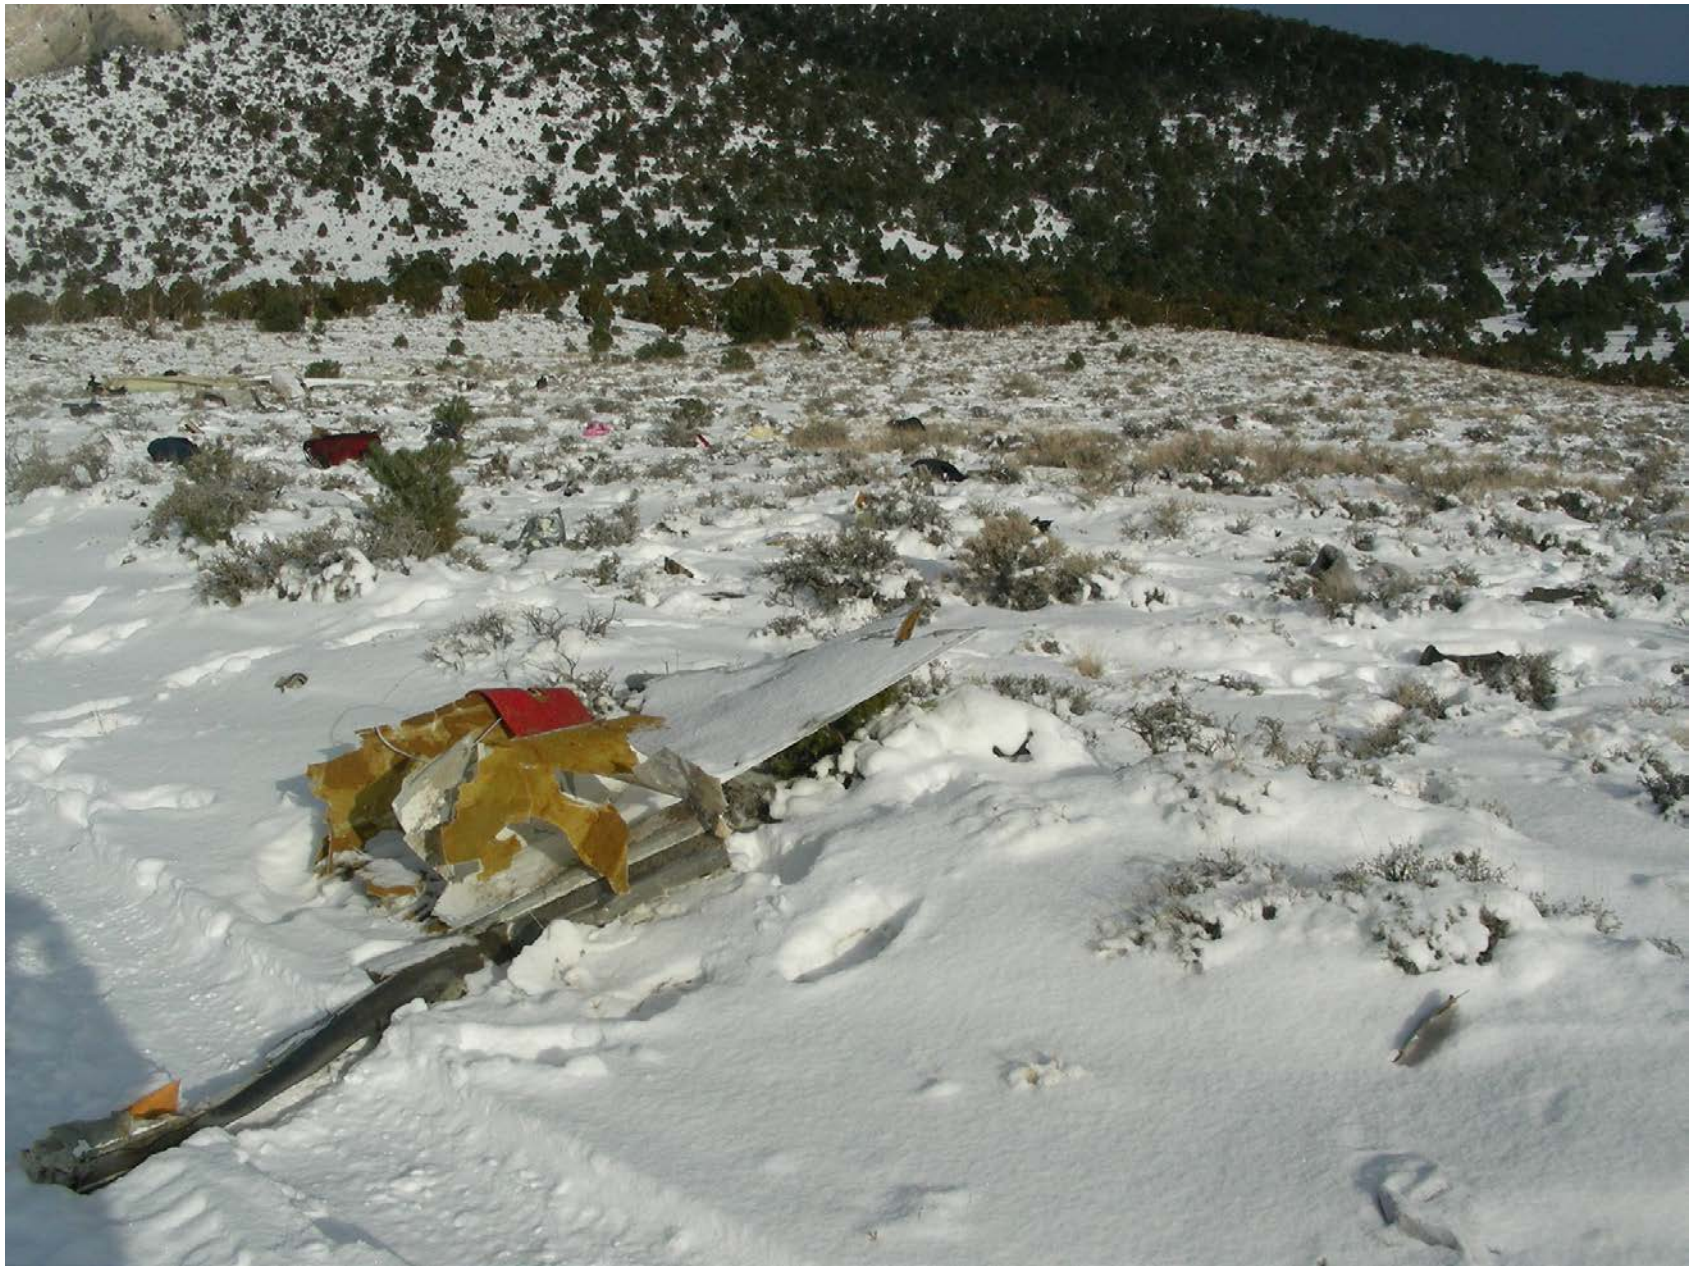
**Photo 1 – view of debris field looking northeast**

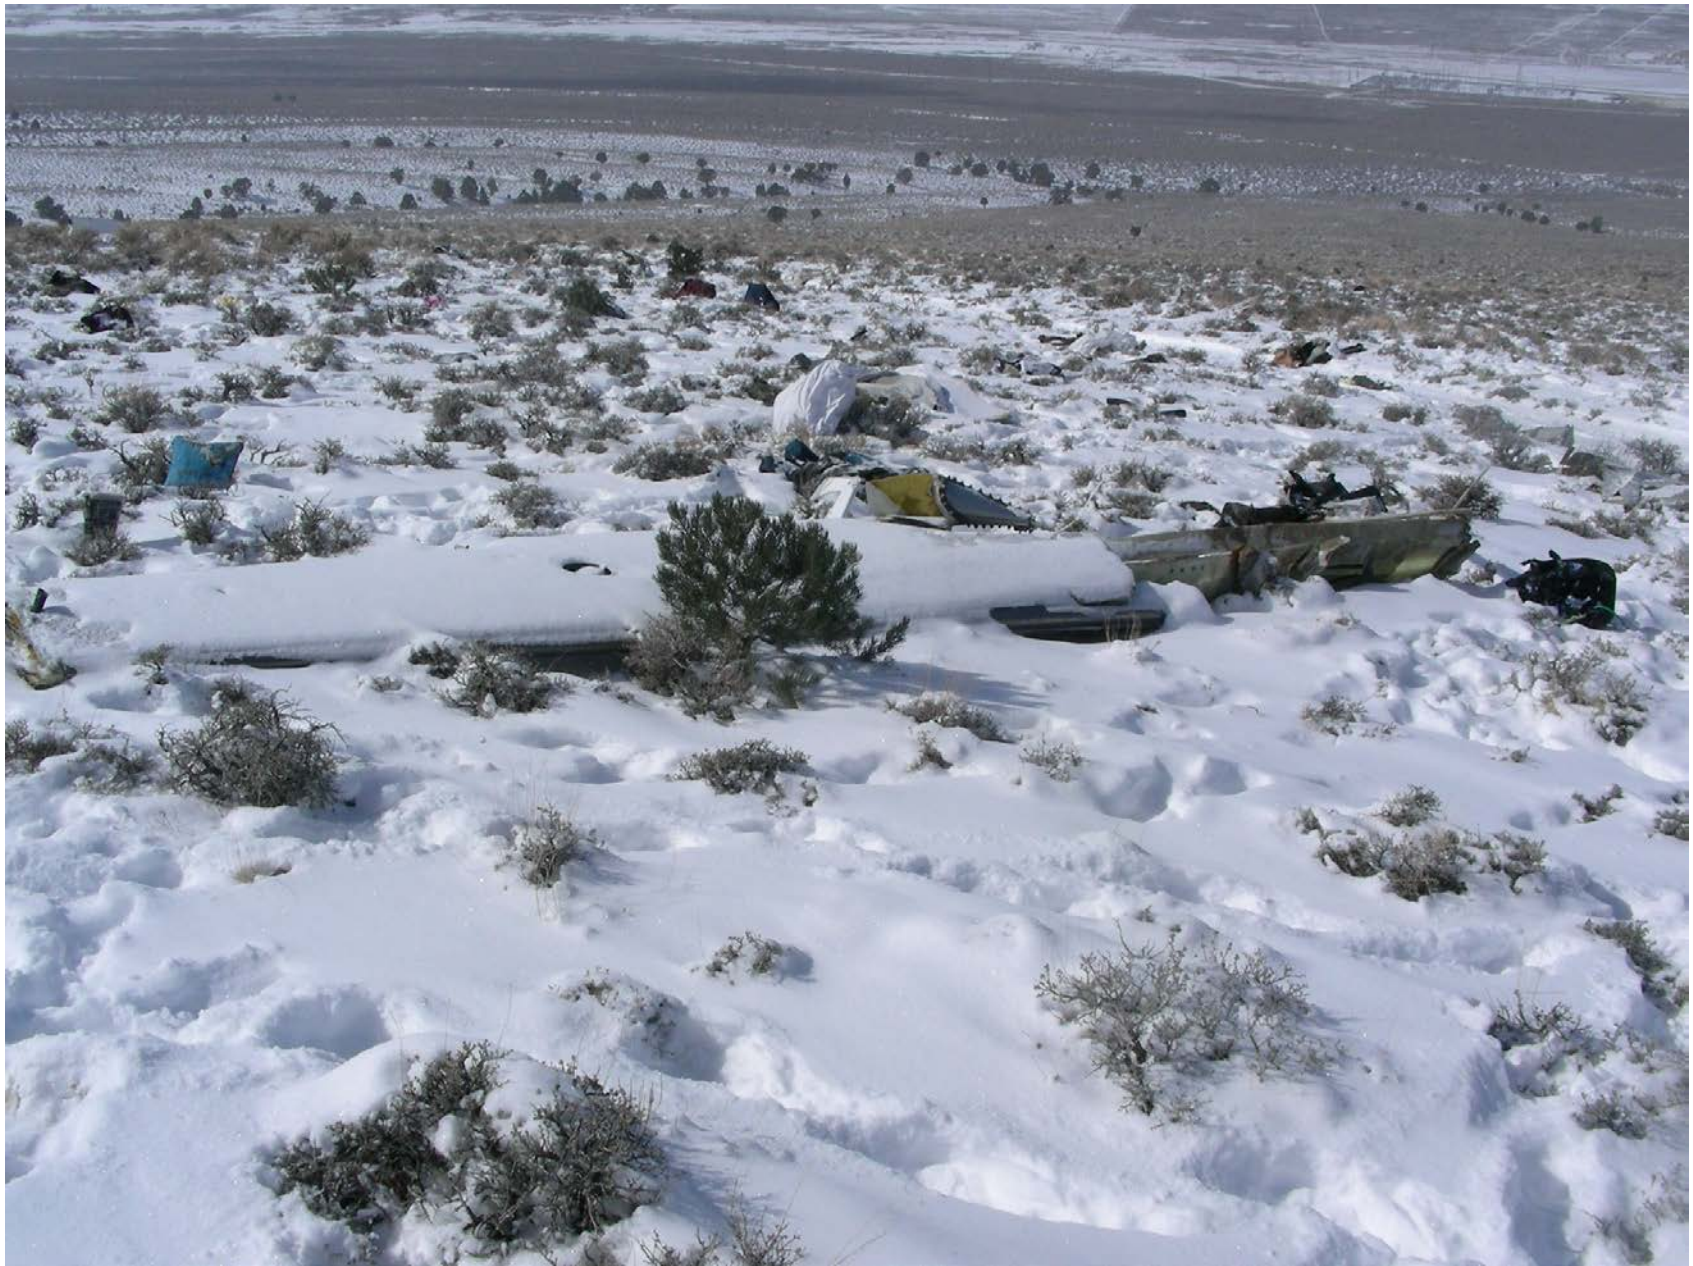
**Photo 2 – view of debris field looking southwest toward ELY**

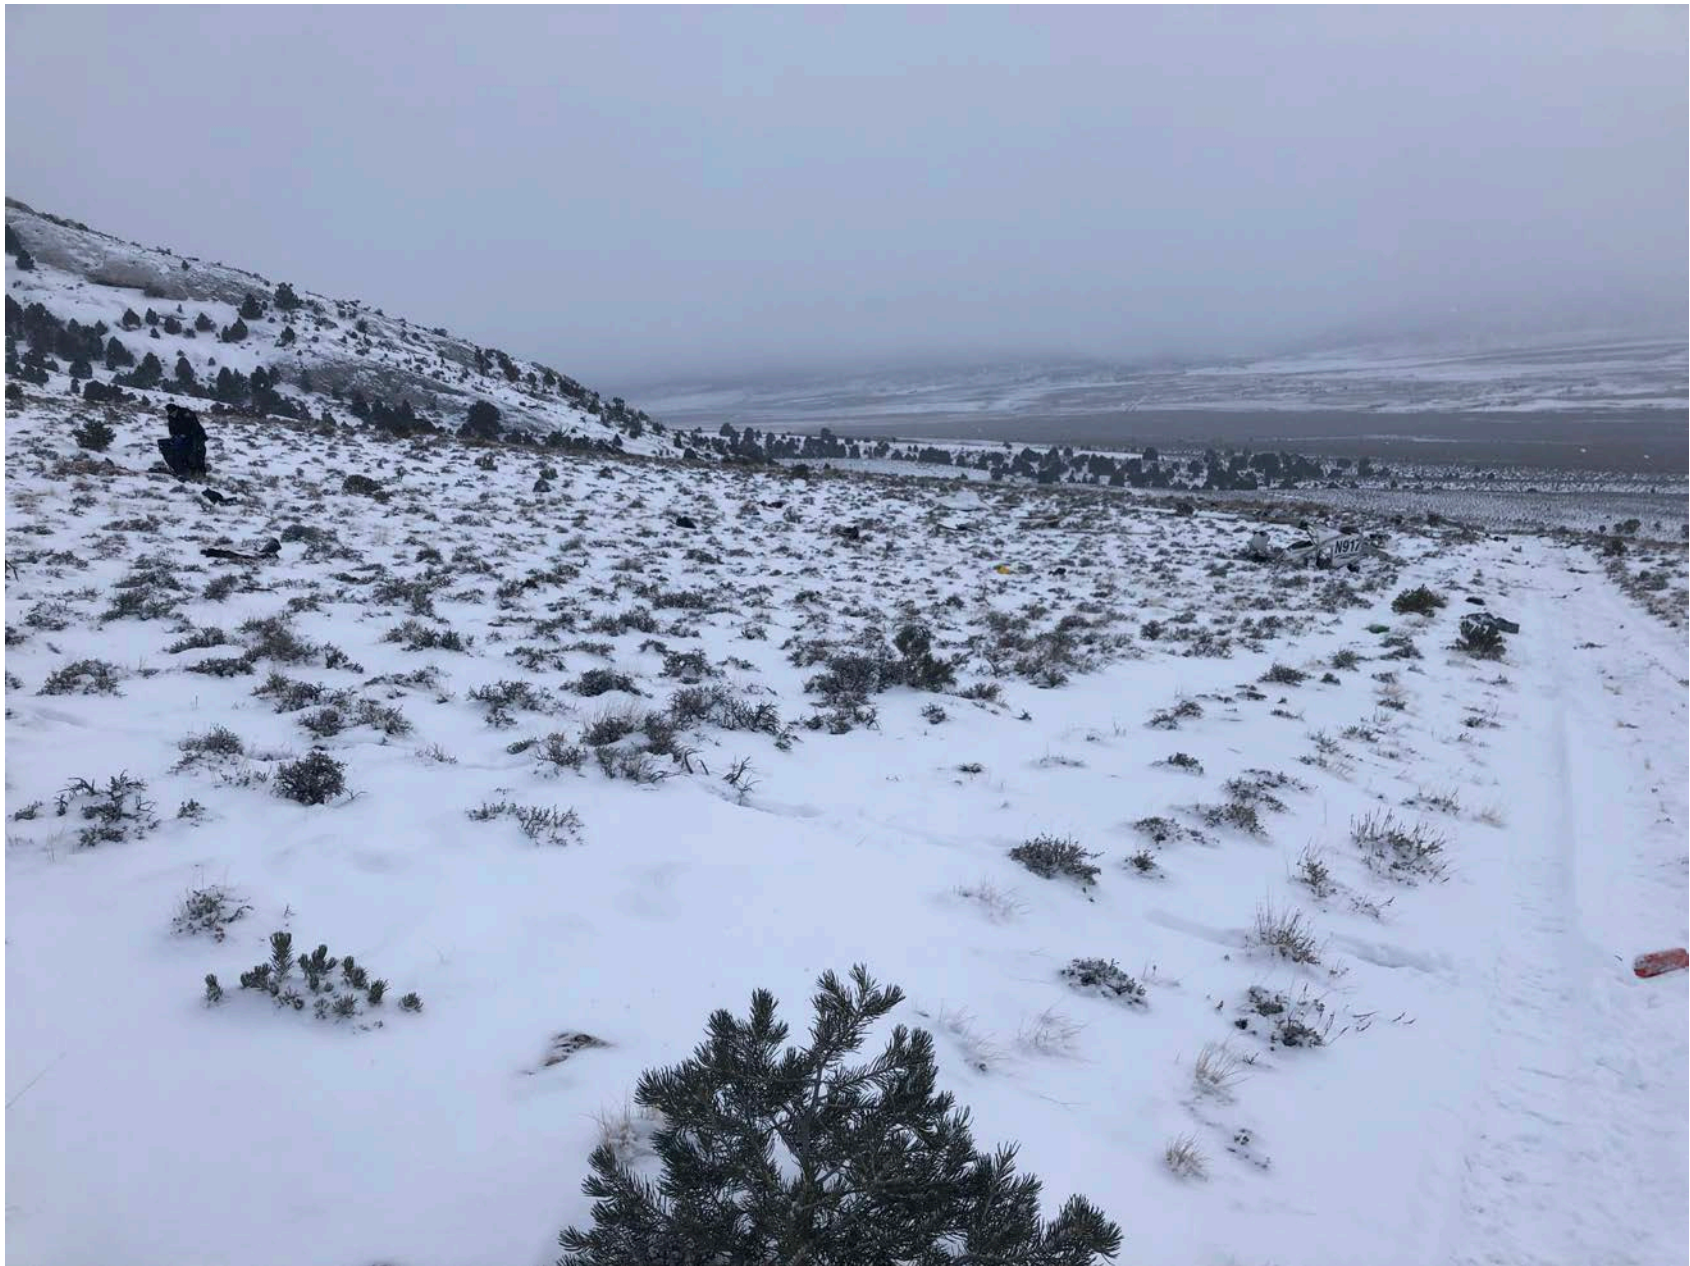
**Photo 3 – view of debris field looking south**

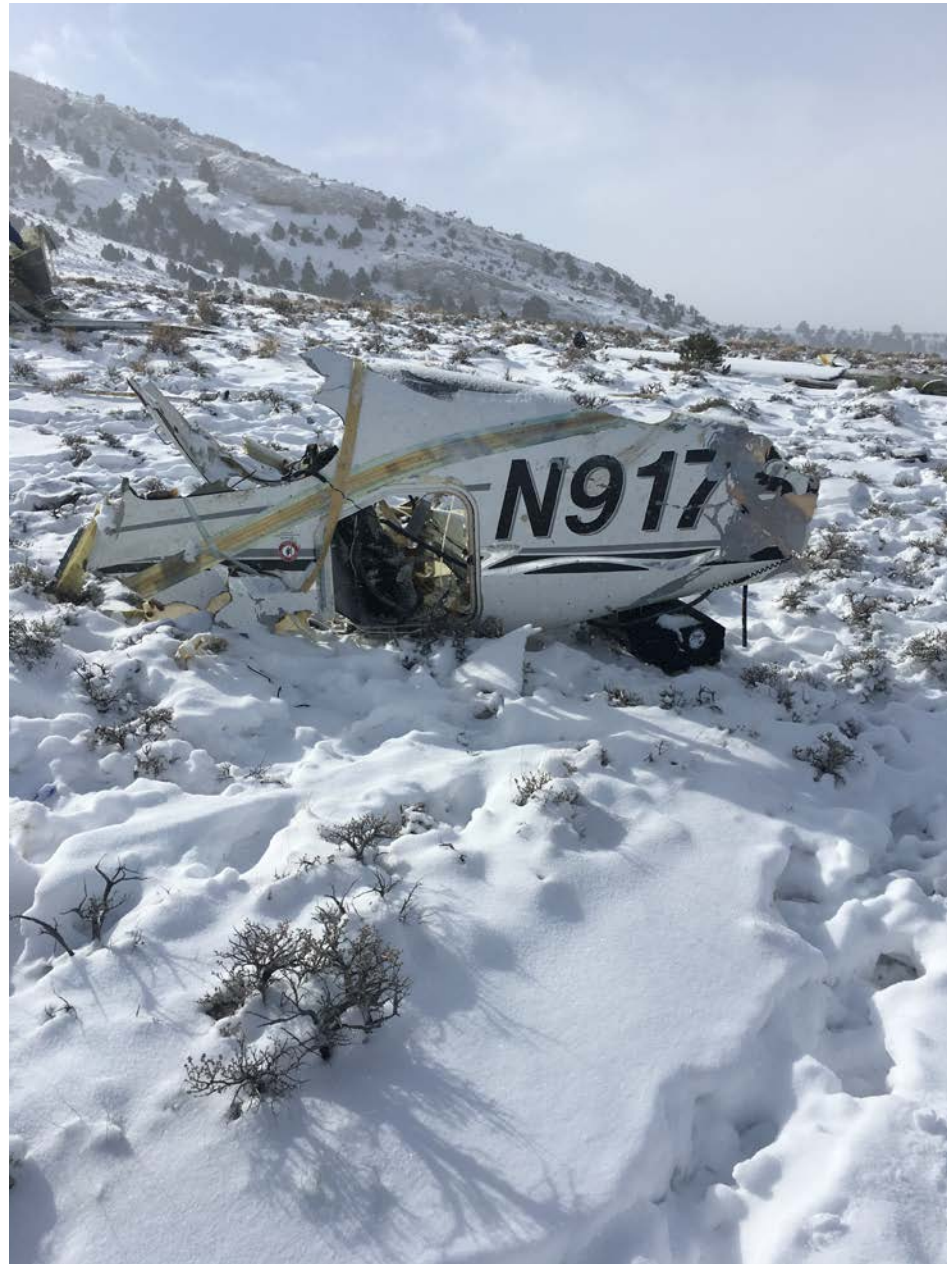
**Photo 4 – view of main body of wreckage looking southeast**

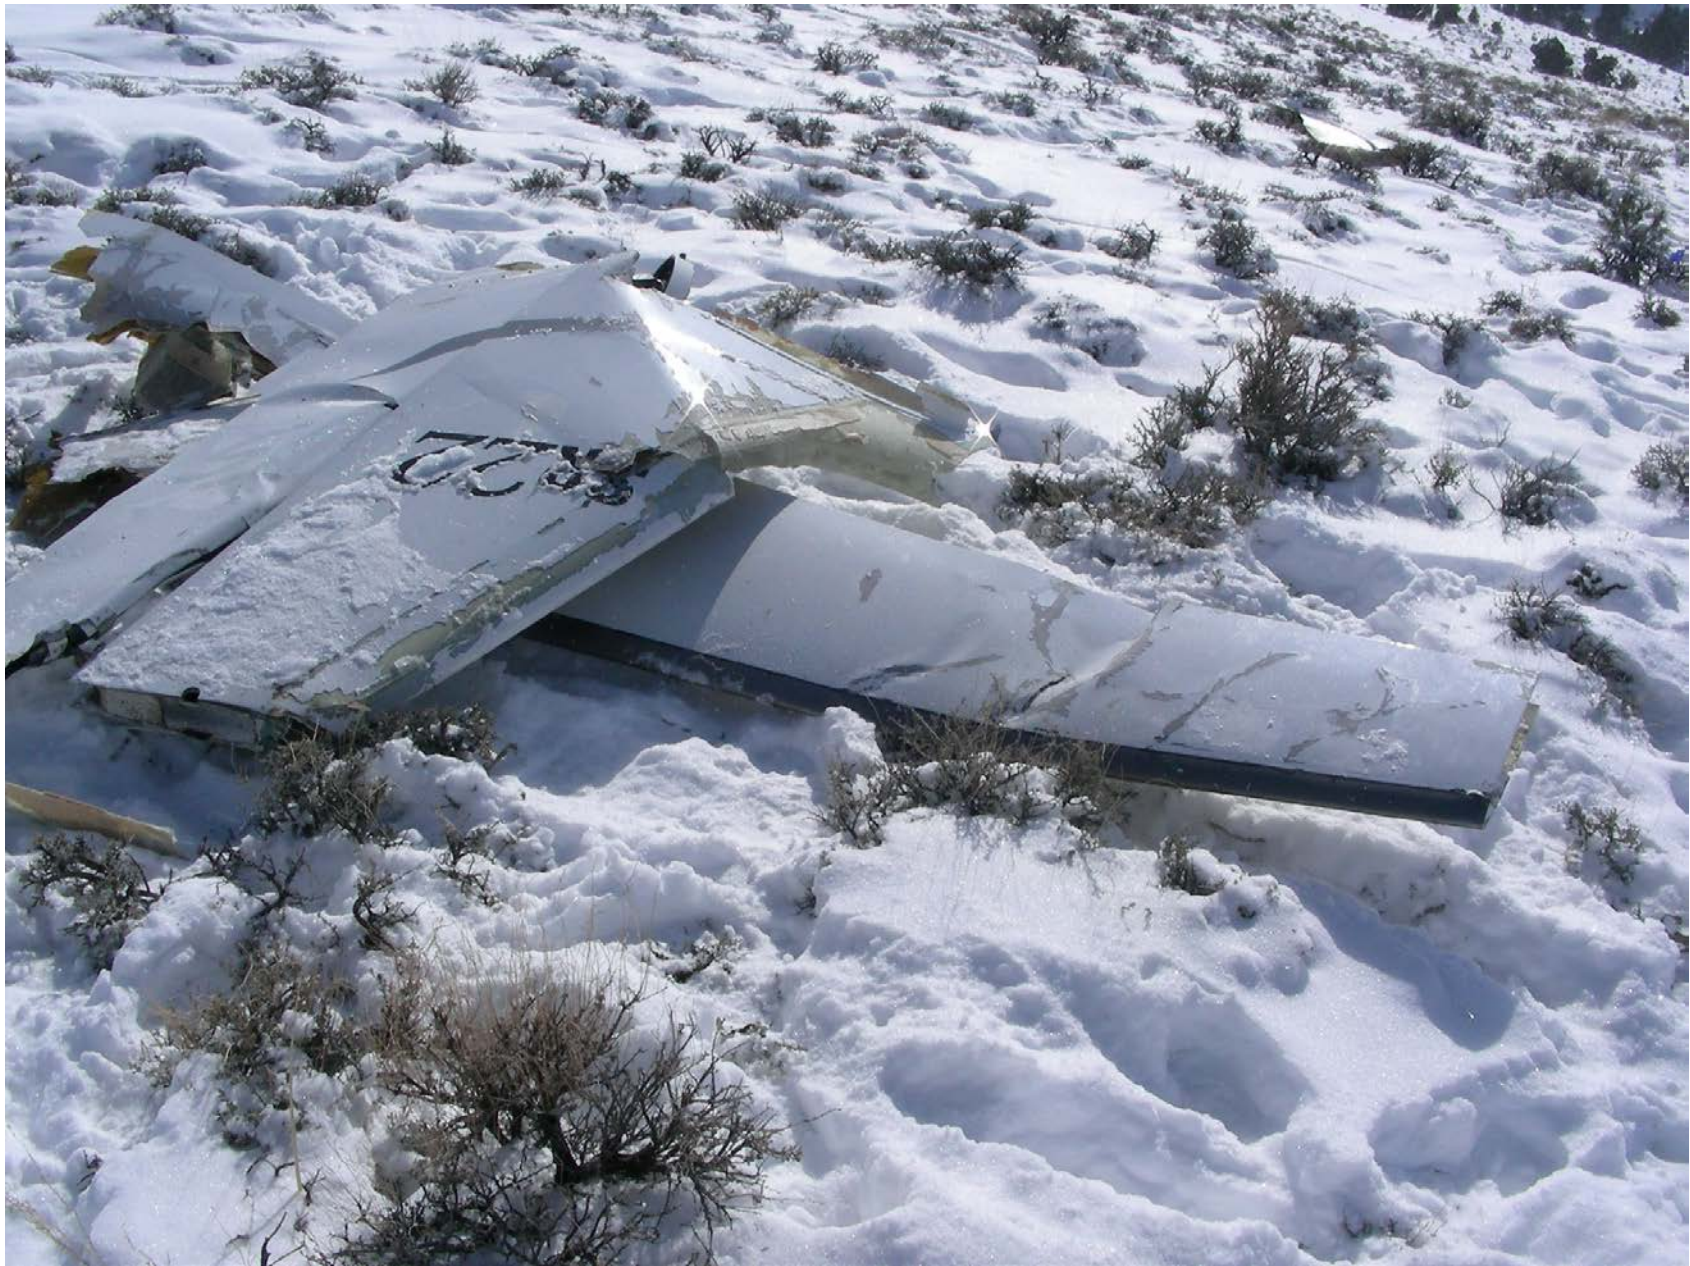
**Photo 5 – view of empennage – horizontal and vertical stabilizers and rudder**

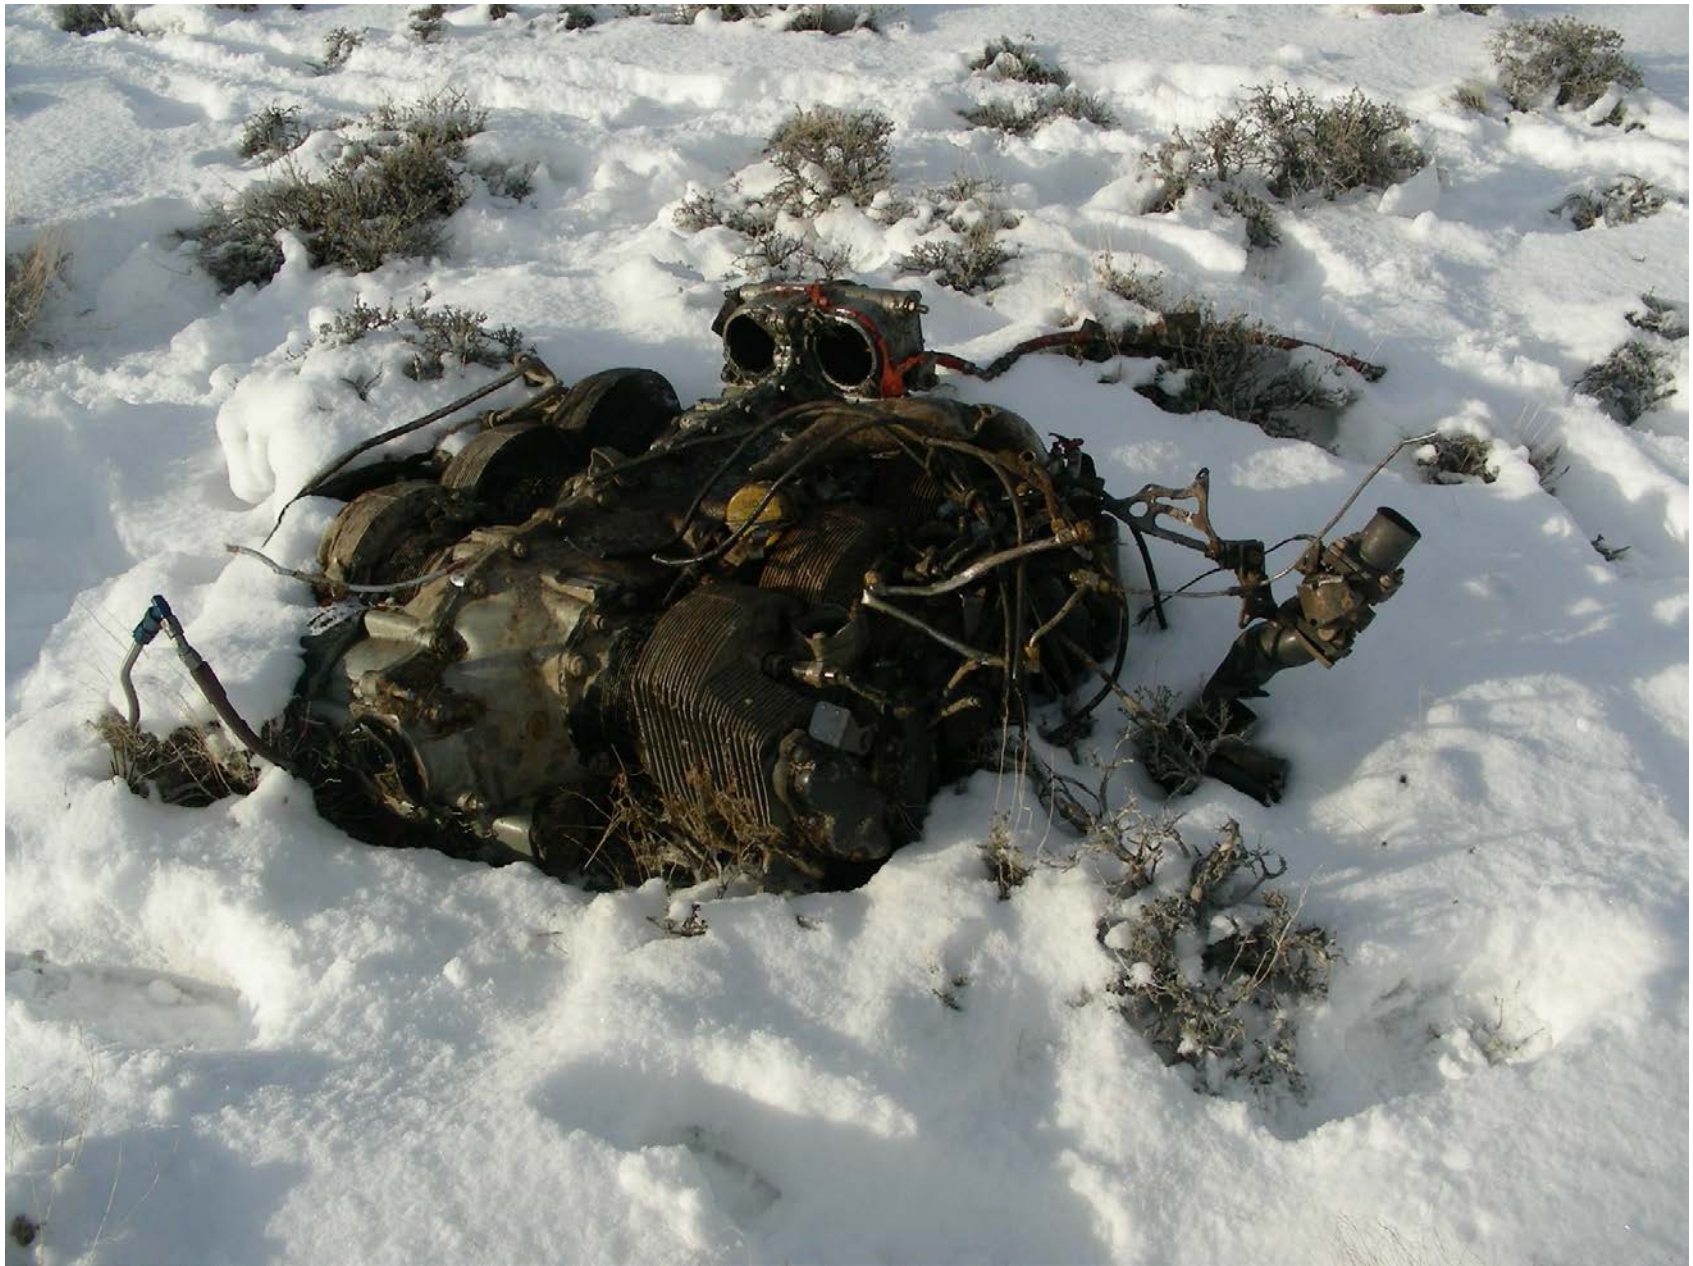
**Photo 6 – view of separated engine**
