## **NATIONAL TRANSPORTATION SAFETY BOARD**

# **AIRFRAME AND ENGINE EXAMINATION**

**WPR19FA091**

Location: Forks, WA.  
Date: March 8, 2019  
Aircraft: Bell Helicopter UH-1B  
NTSB IIC: Fabian Salazar

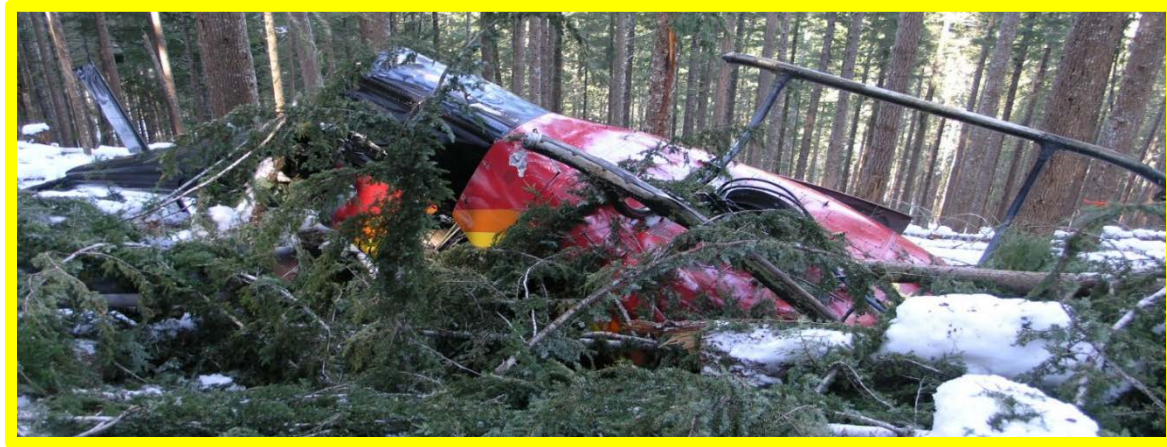
Examination of the accident site revealed the helicopter came to rest inverted on a heading of about 100° in an area of recently felled trees. The fuselage sustained extensive damage. The nose of the aircraft had folded over to the top of the fuselage. The top of the fuselage, just forward of

the engine doghouse, had folded up and aft to the point of striking the main rotor mast. There was no post impact fire and the line remained attached to the cargo hook (See photos 1 and 2).

Photo 1. Showing the helicopter at the accident site.

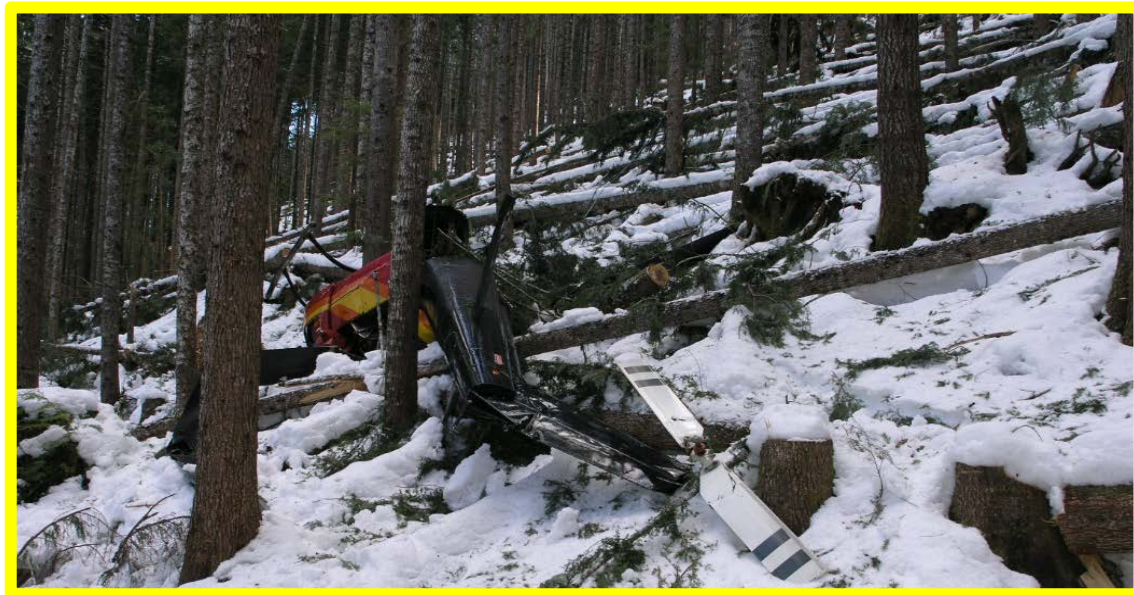
Photo 2. Showing the rear view of the helicopter at the accident site.

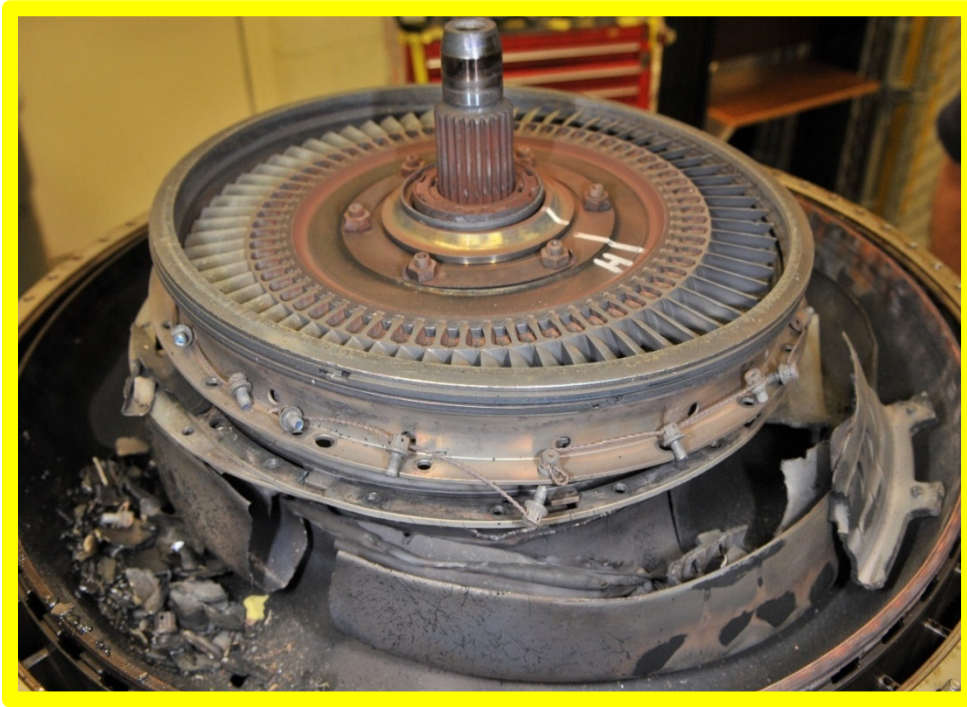
There was a large amount of fragmented internal components (nuts, bolts, safety wire, metal fragments,) found deposited in the combustion area.

Photo 3: T-53-L-13B Engine showing the gas producer turbine rotor assembly and internal engine damage.

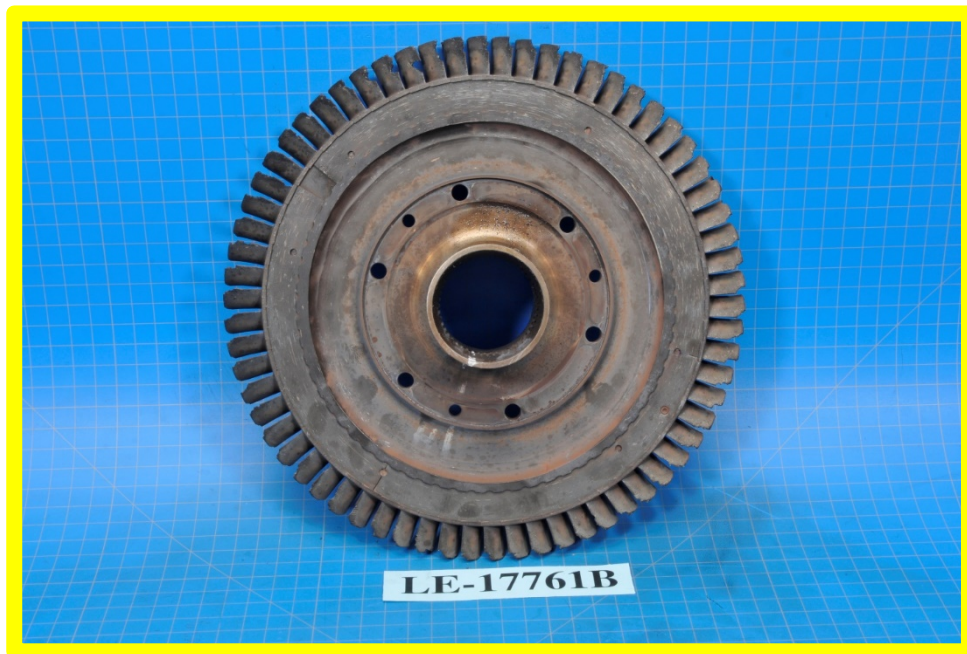
The first stage gas producer (GP) nozzle was damaged and fragmented. The sealing ring (seal disk) separated into multiple pieces. This component was sent to the Honeywell Aerospace metallurgy lab for further examination. The first stage GP turbine rotor displayed damage to all turbine blades at the leading edge and the tips.

Photo 4: First stage gas producer turbine rotor. Photo courtesy of Honeywell Aerospace.

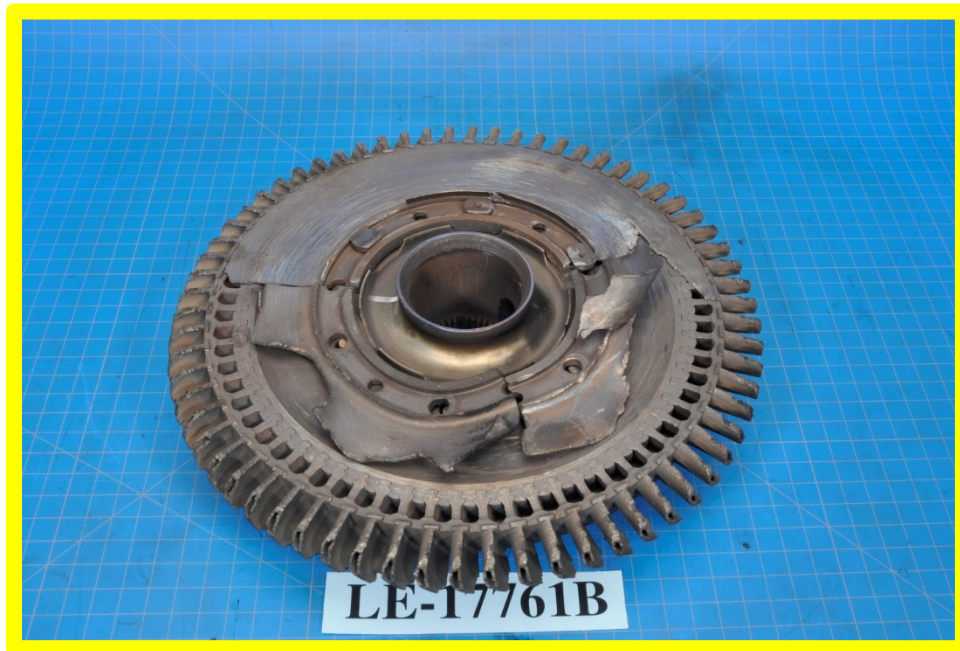
Photo 5: First stage gas producer turbine rotor with sealing disk resting in place. Photo courtesy of Honeywell Aerospace.

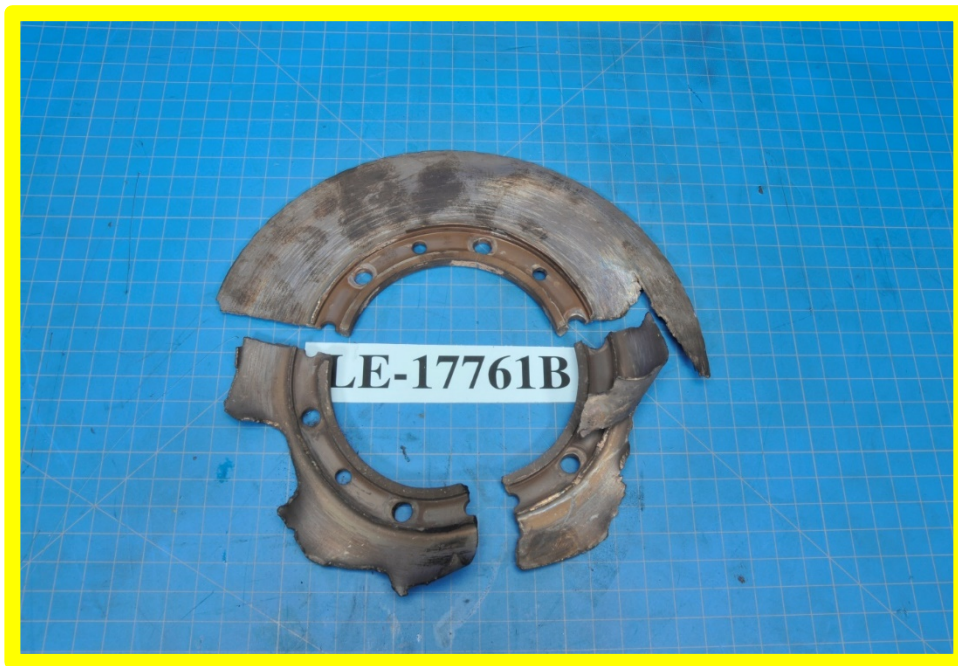
Photo 6: First stage GP sealing disk. Photo courtesy of Honeywell Aerospace.

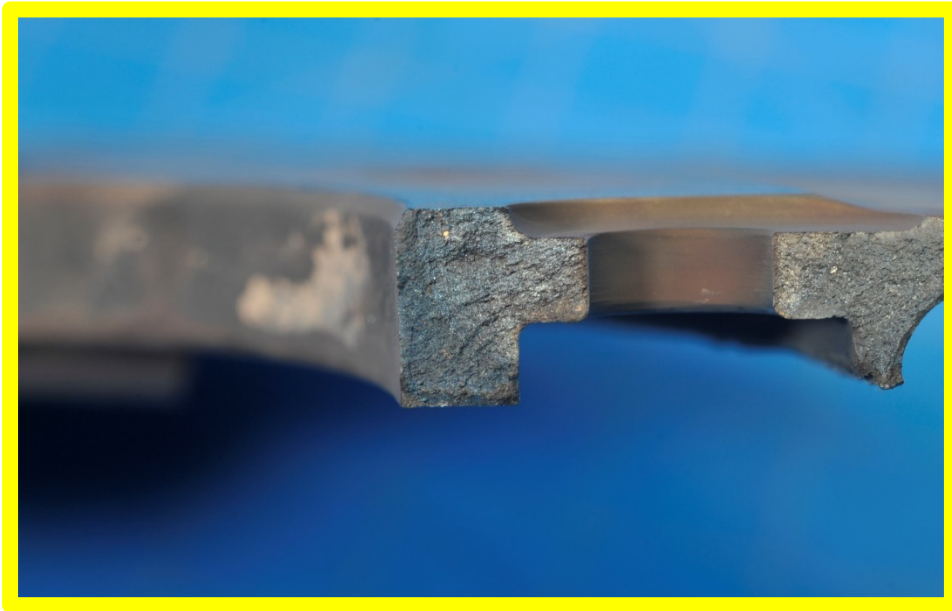
Photo 7: First stage sealing disk, side view. Photo courtesy of Honeywell Aerospace.

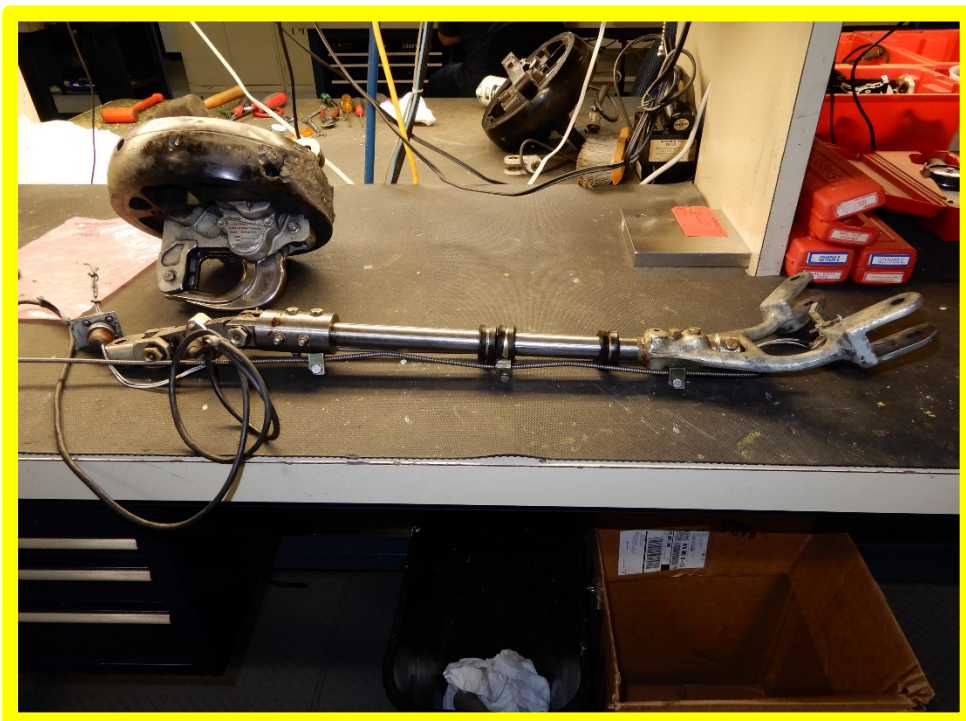
Photo 8. Cargo hook assembly

The cargo hook remained attached to the underside of the helicopter. The cargo hook was examined at the secure facility and operated normally in both electronic release of the hook and manual release of the cargo hook. The cargo hook mount was a military design. It displayed a significant bend towards the left-hand side. The manual release cable was found attached to the cargo hook and continuity was established from the manual cargo release pedal on the right side of the pilot station. The torque tube from the right-side manual cargo release to the left-side cargo release pedal was damaged.

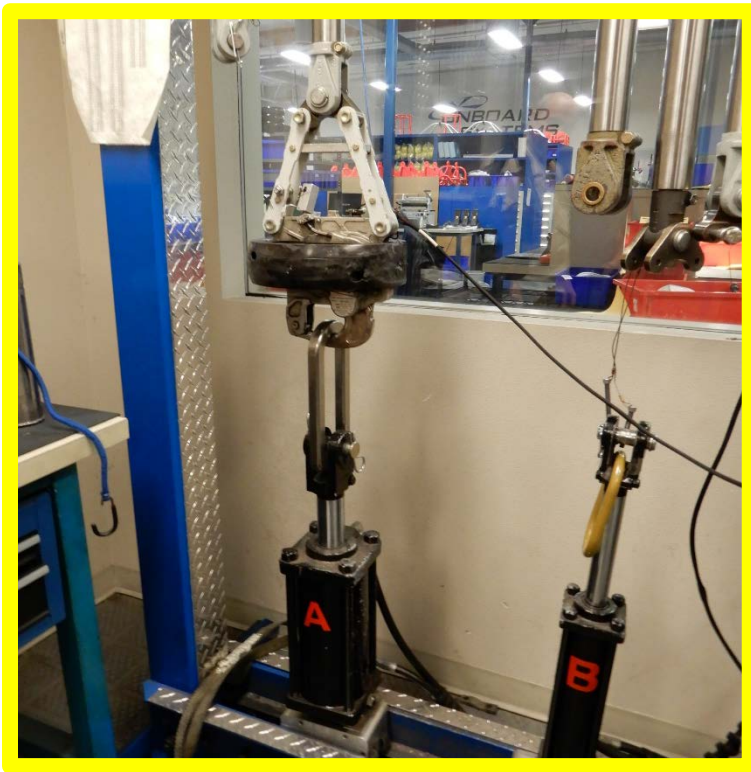
The cargo hook was moved to Onboard Systems International Inc. for examination. The cargo hook underwent an acceptance inspection revealing that no anomalies were found that would have precluded normal operation. The acceptance inspection included operating the cargo hook release in the manual and electronic modes up to loads equaling the maximum allowed cargo load.

Photo 9. Cargo hook examination, showing cargo hook on test stand.

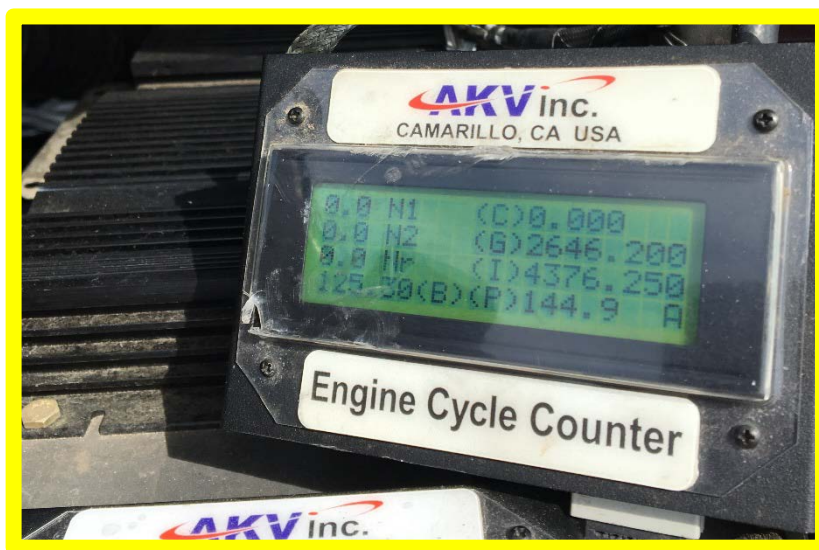
Photo 10. Engine cycle counter, Page A

An N1/N2 Cycle Counter was found mounted to the instrument panel. The Cycle Counter was sent to AKV Engineering, Camarillo, California and found to be operating normally. Information from the Cycle Counter's three pages was recorded.
