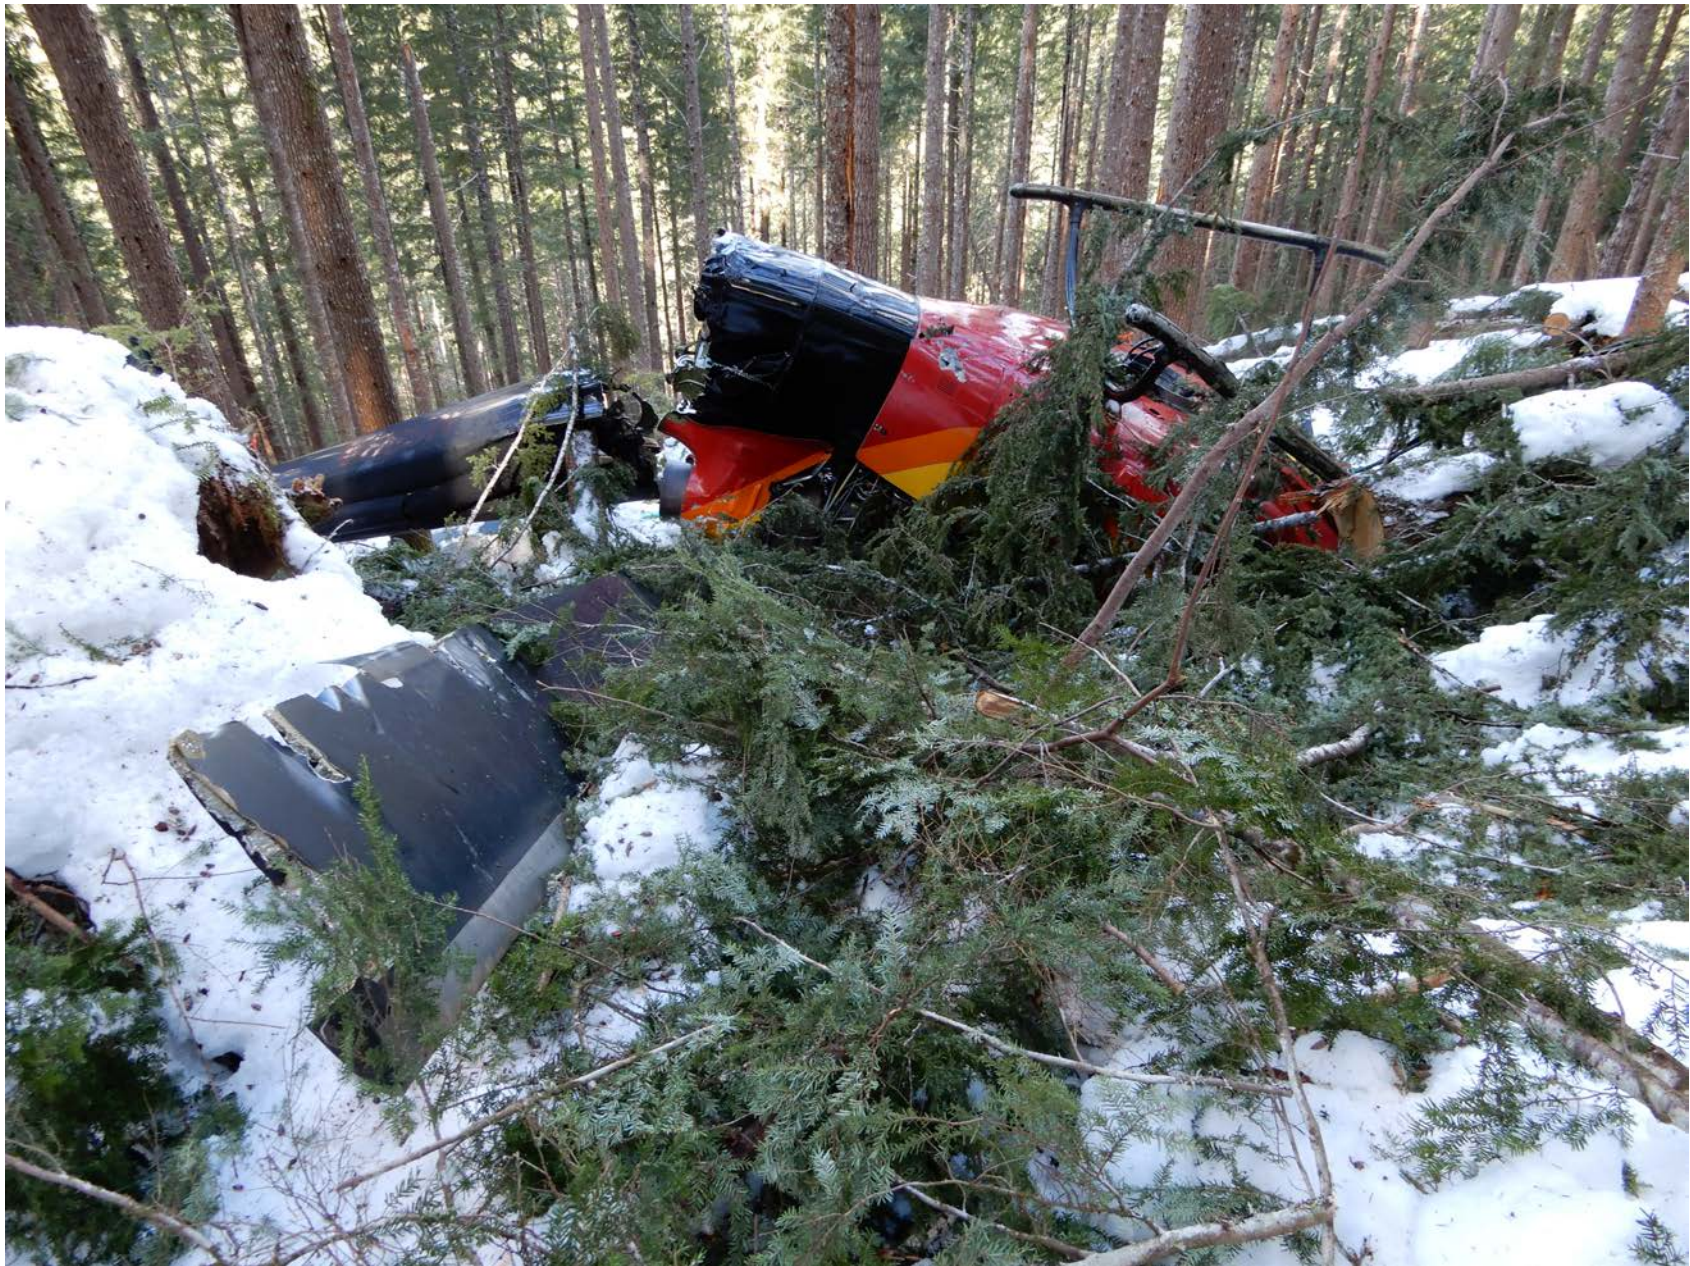
**Photo 1 – N64RA left-side view.**

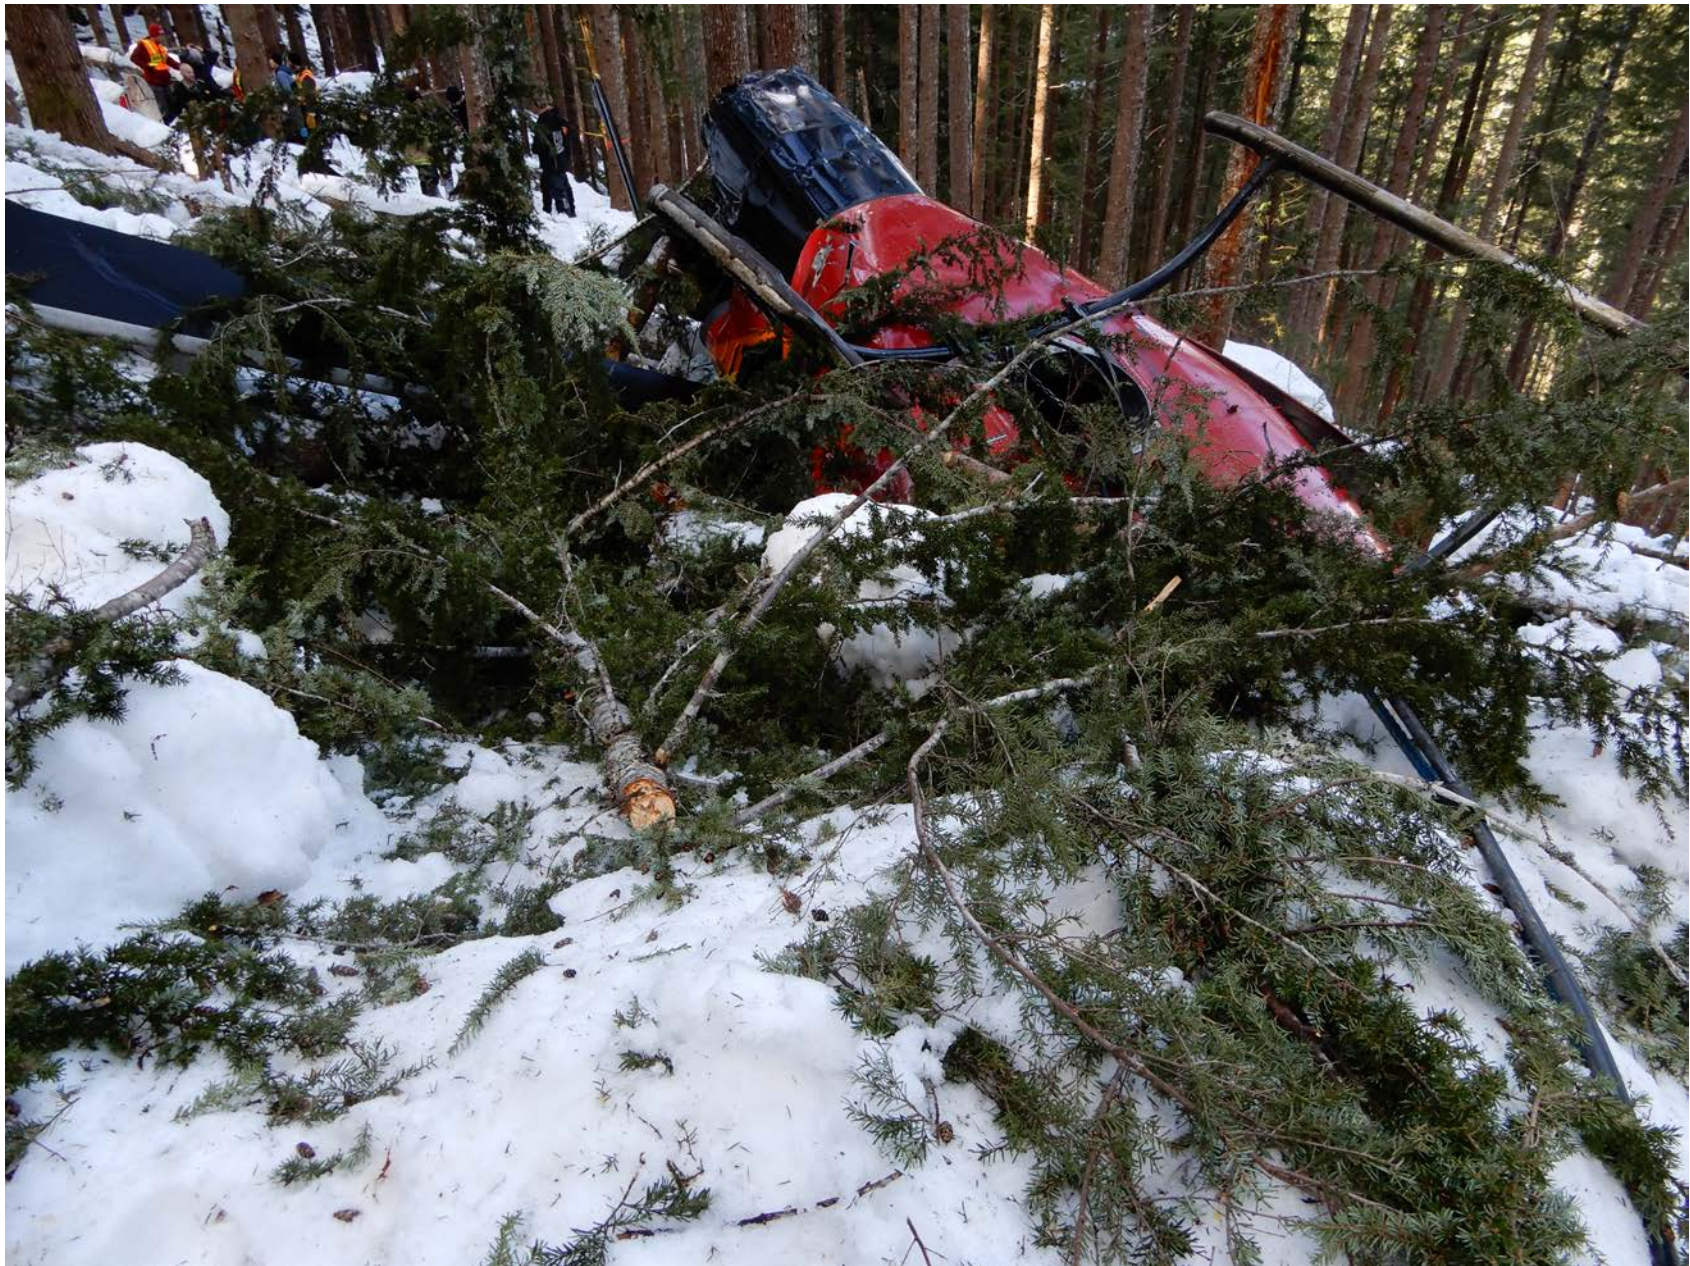
**Photo 2 – N64RA left-front view**

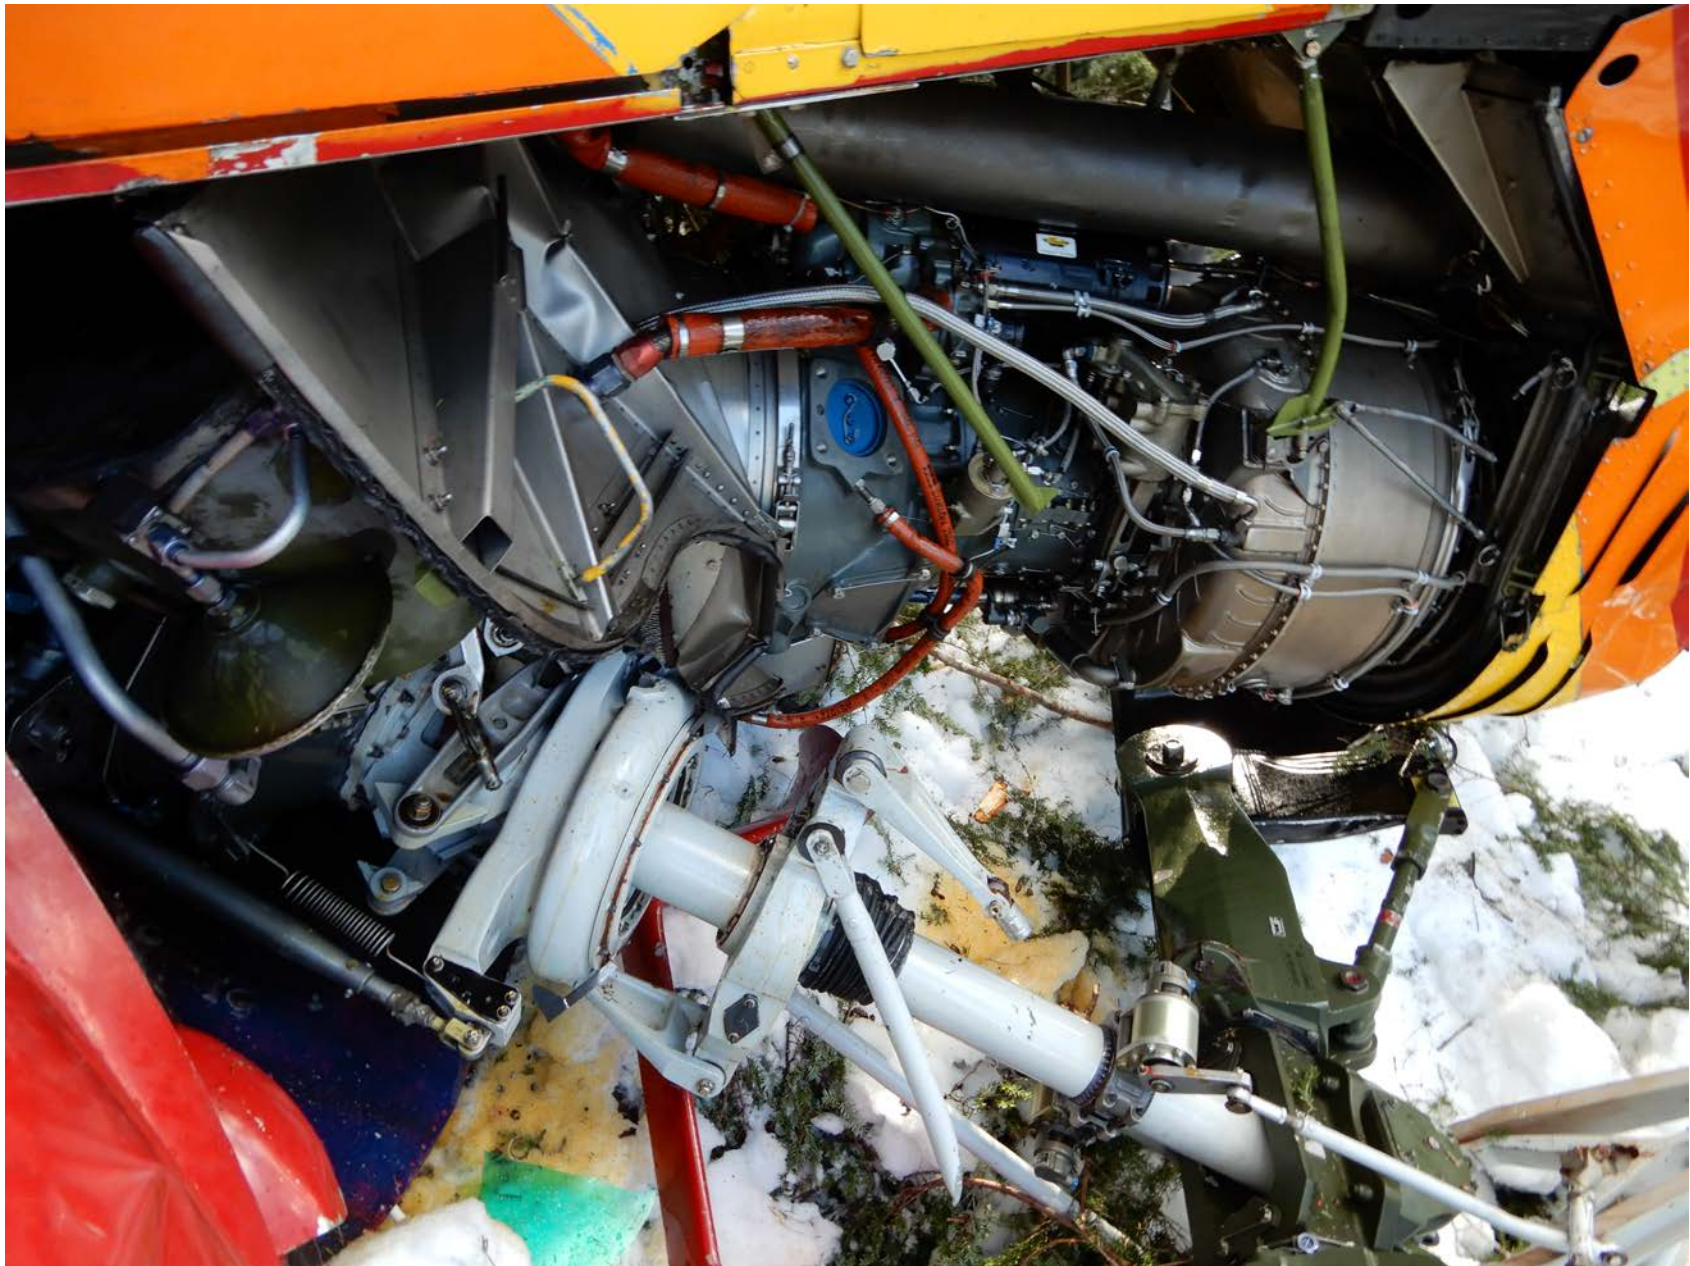
**Photo 3 – N64RA showing right side of engine and main rotor assembly.**

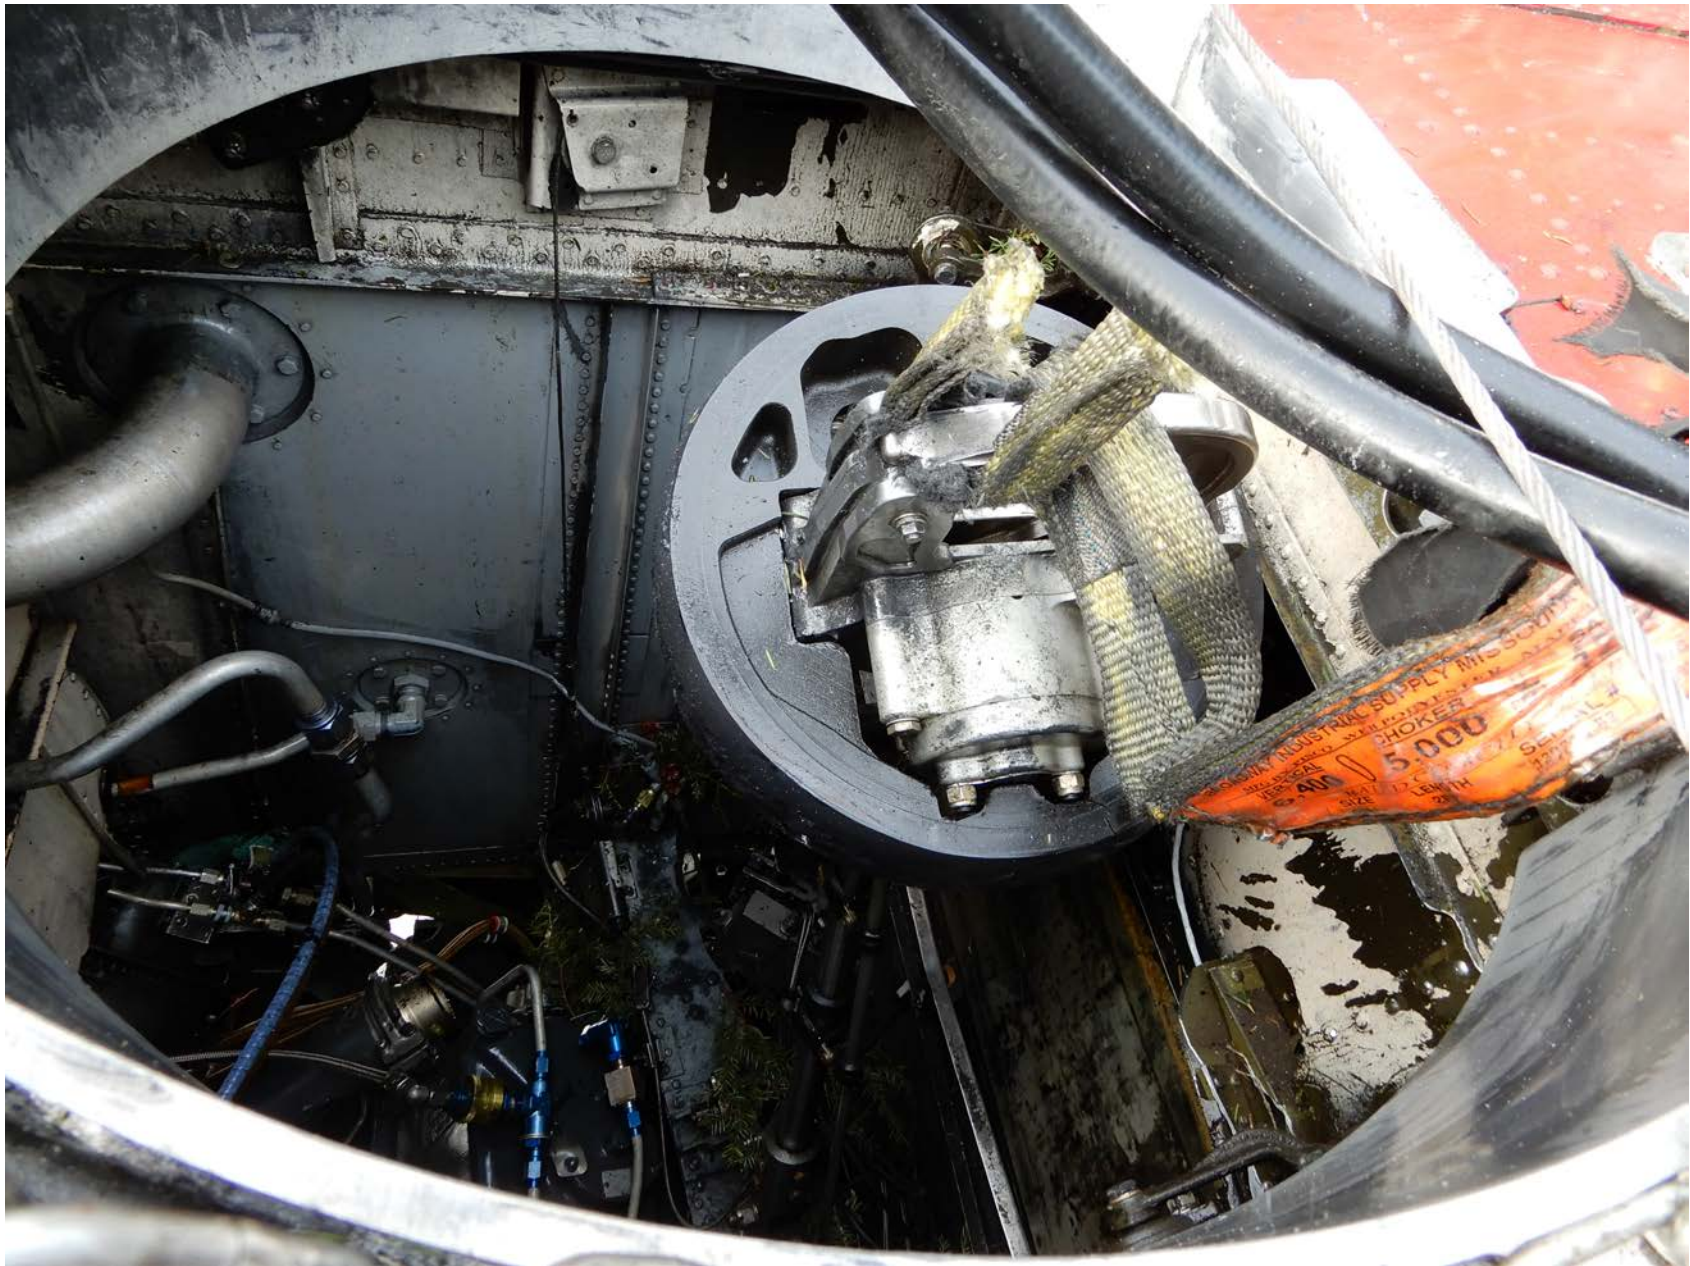
**Photo 4 – N64RA showing cargo hook with strap secured in hook.**

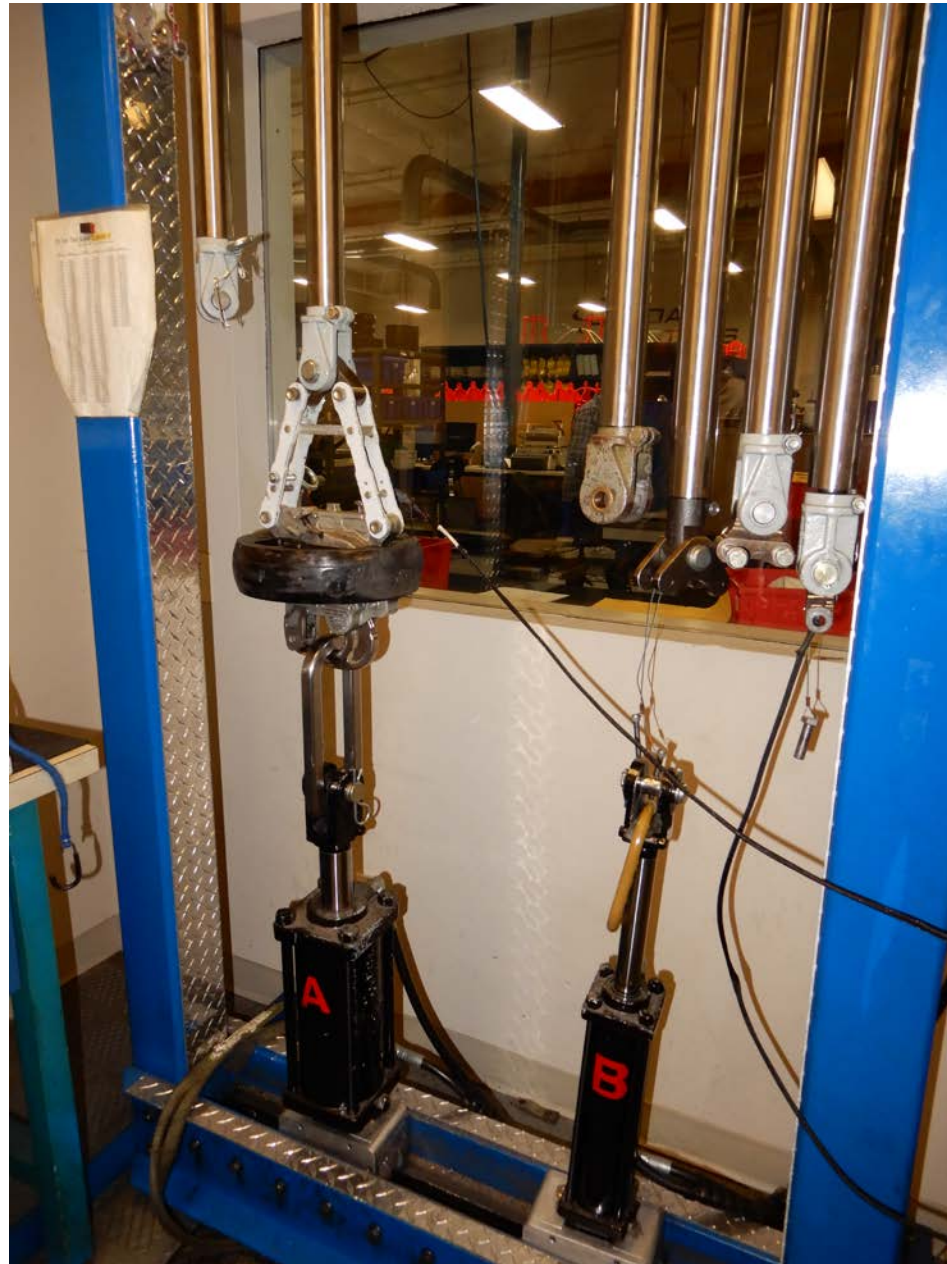
**Photo 5 - N64RA cargo hook on test stand.**

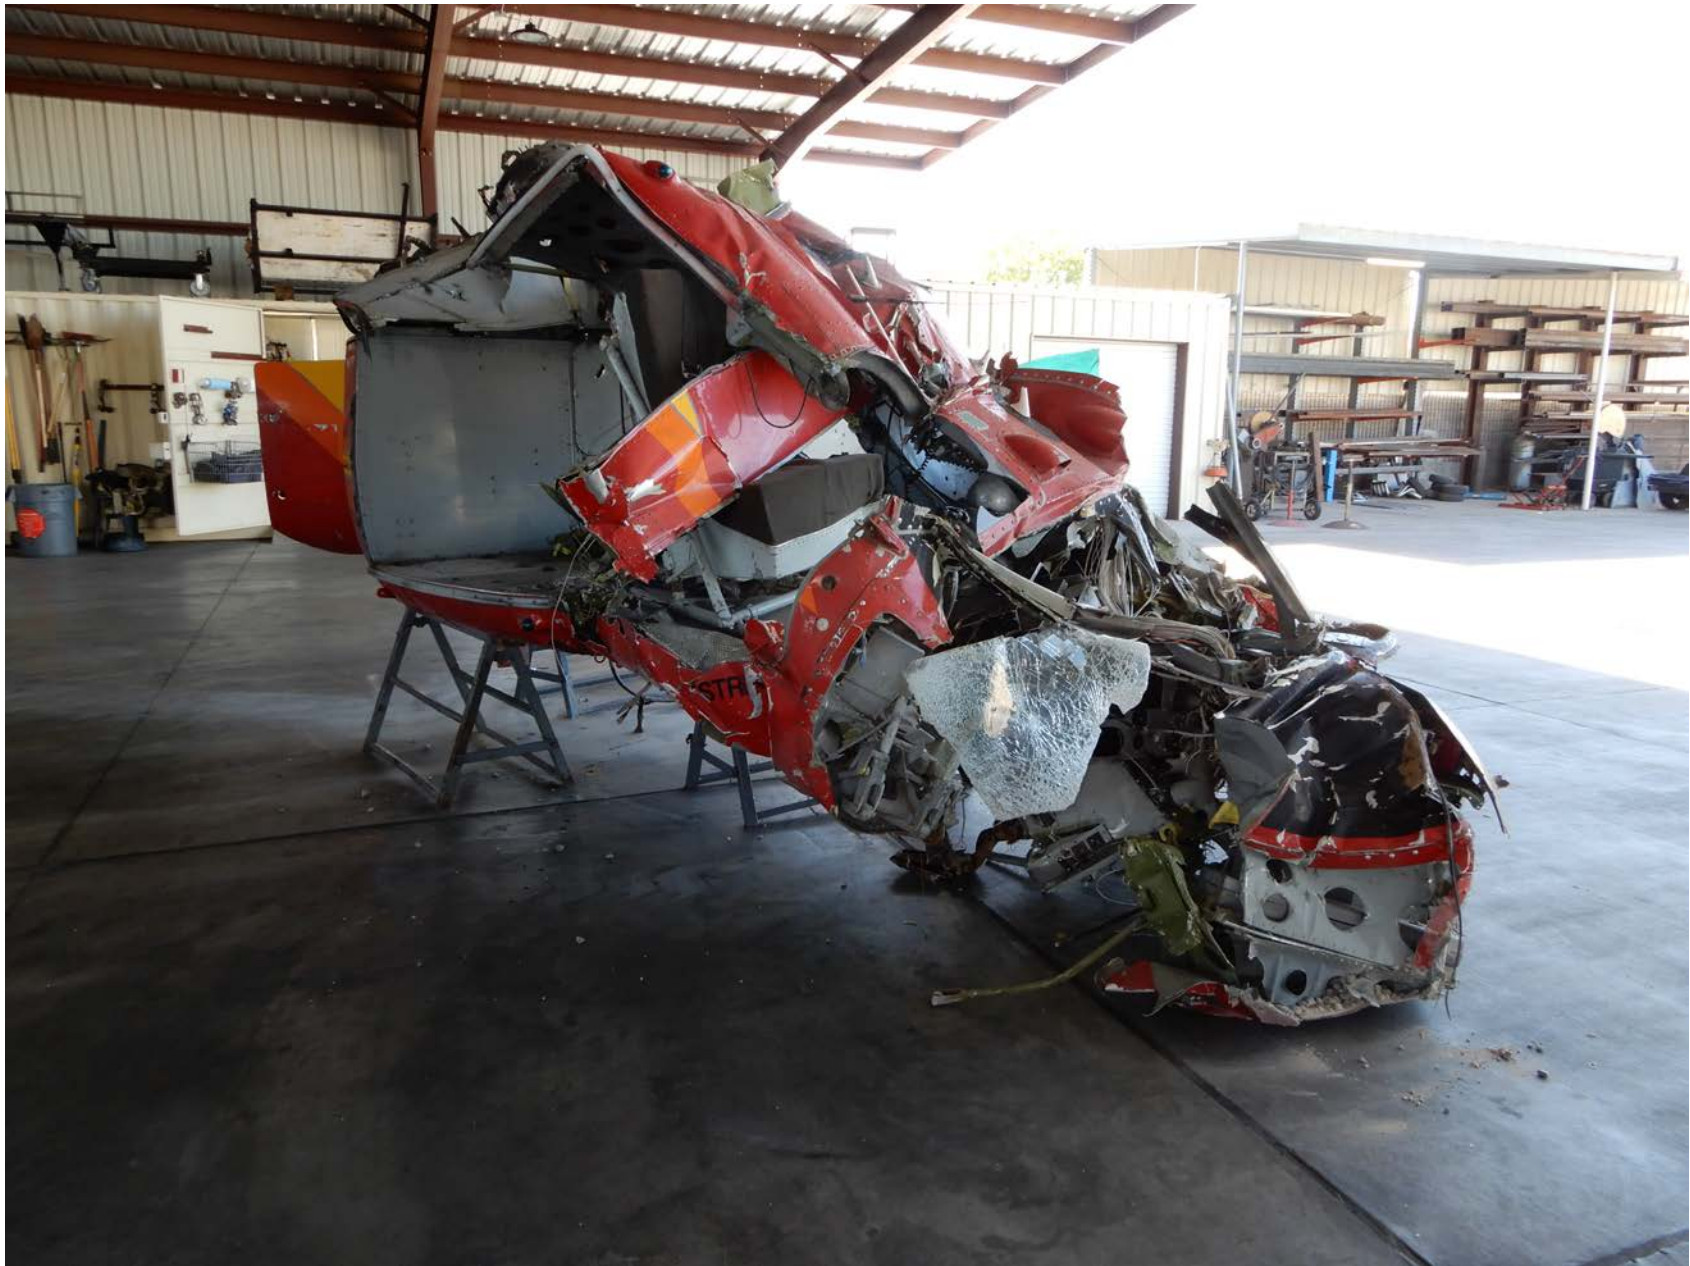
**Photo 6 - N64RA at exam facility, right-front view.**

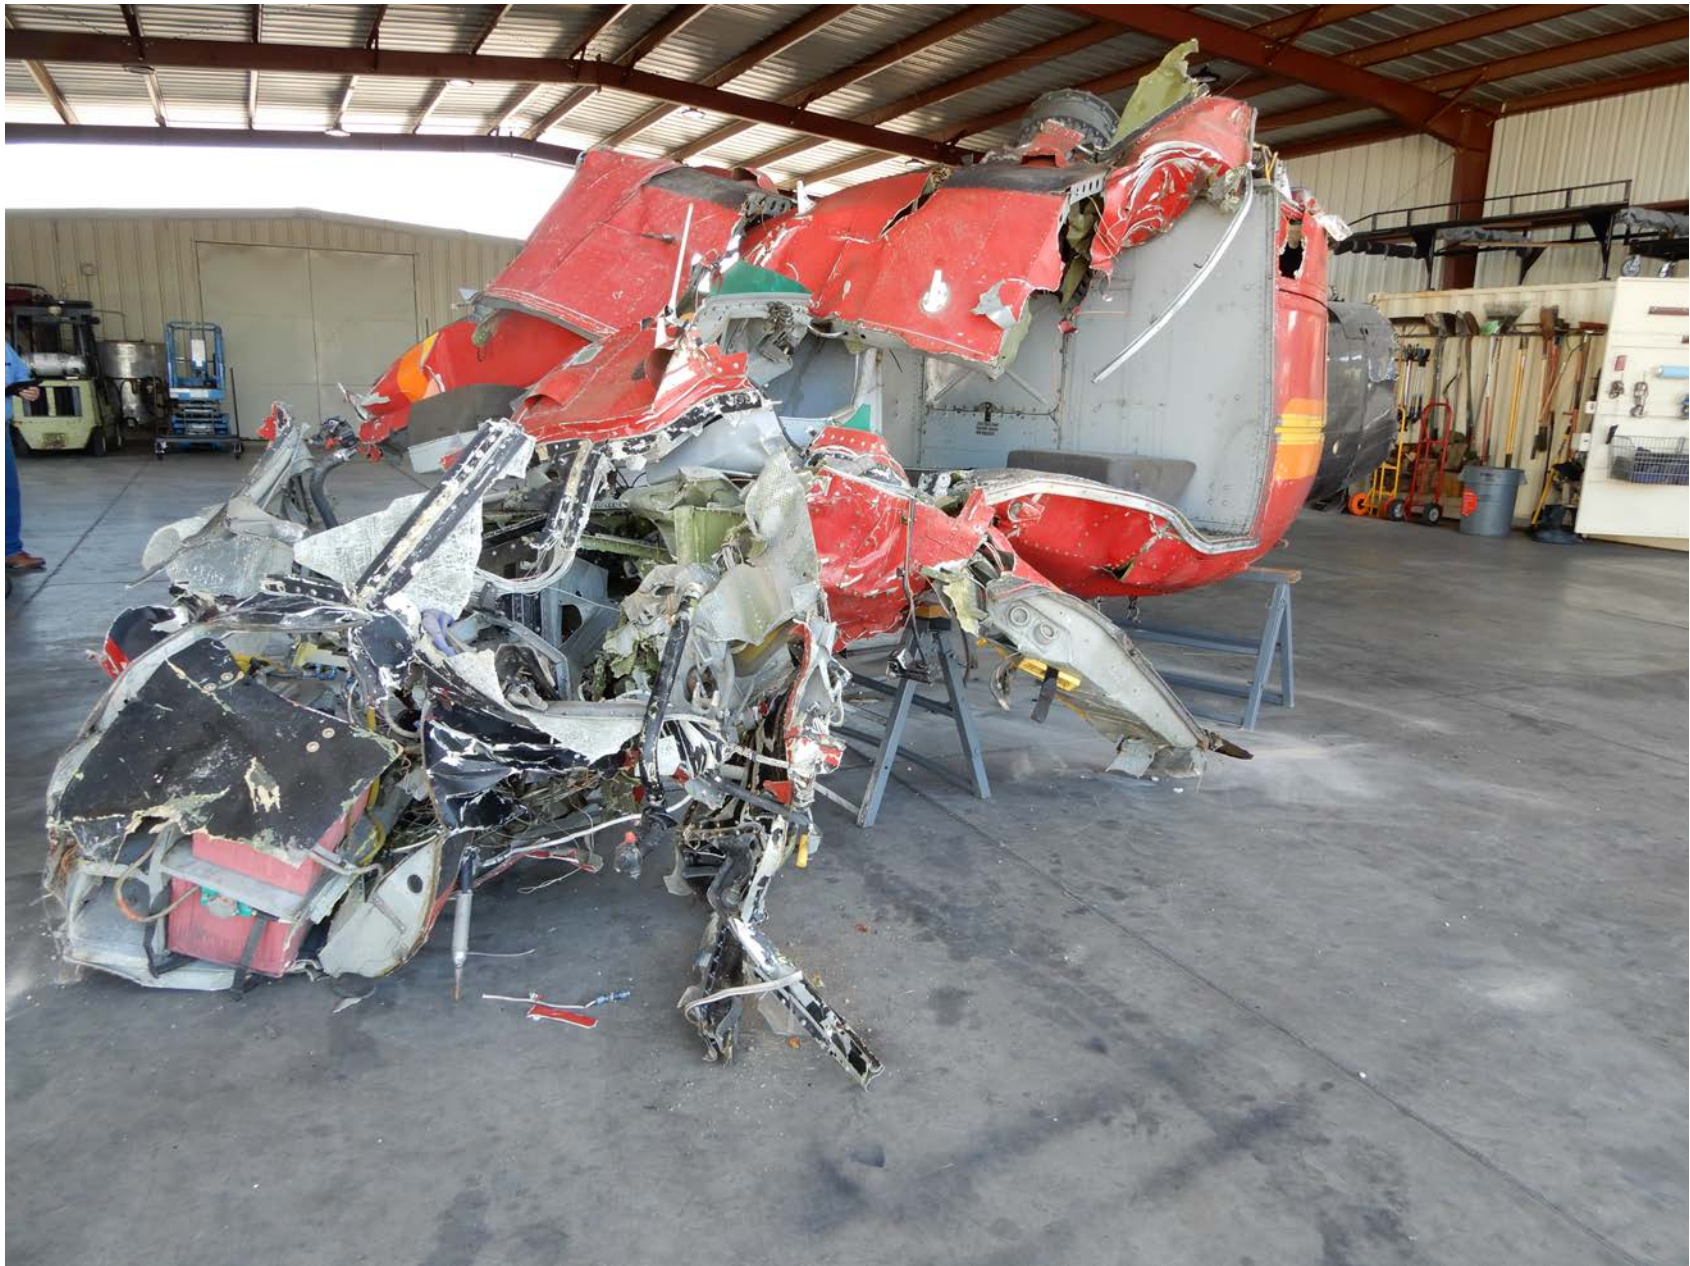
**Photo 7 - N64RA at exam facility left-front view.**

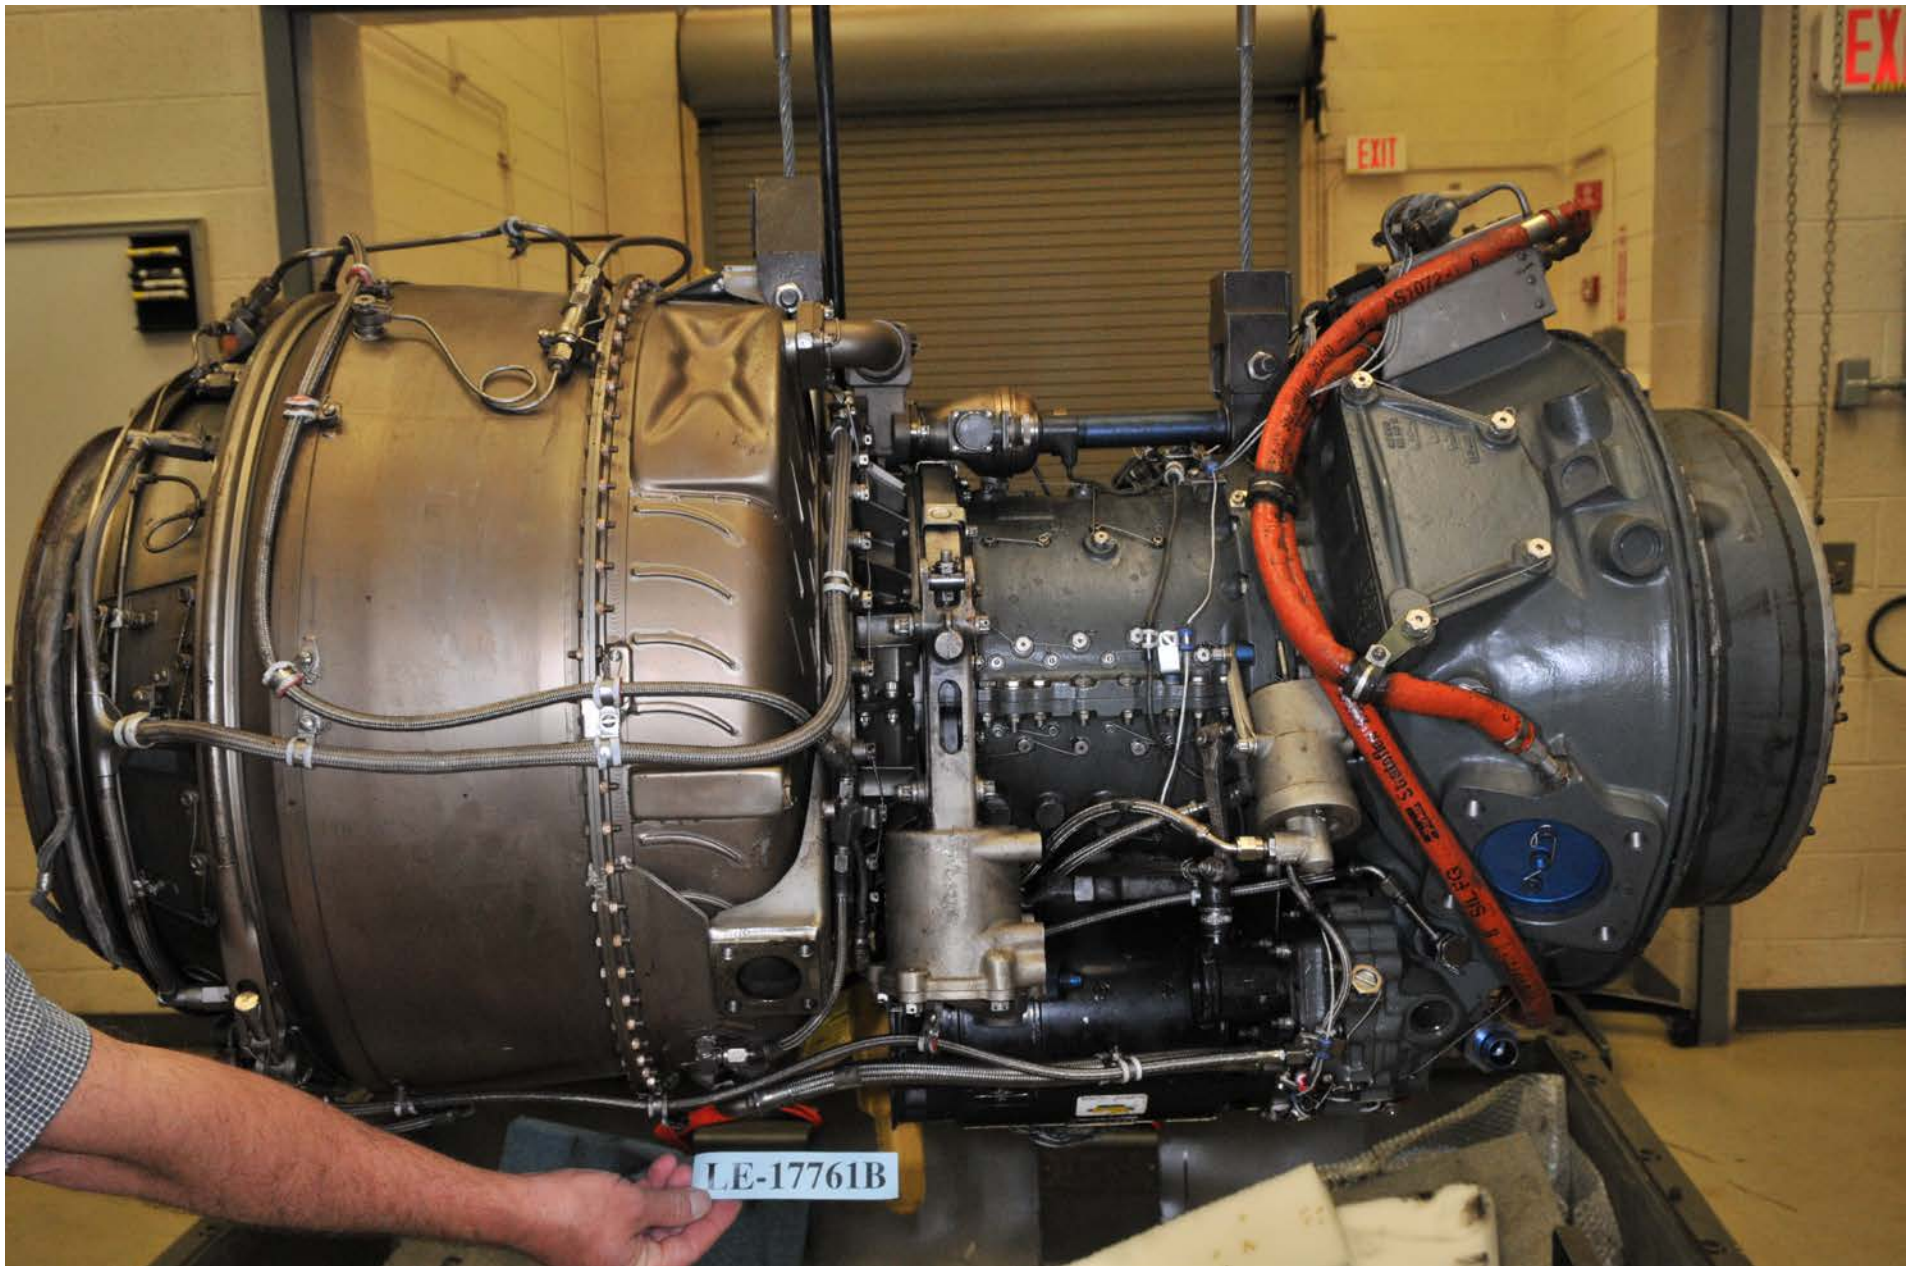
**Photo 8 - T53-L-13B engine at exam facility, right-side view.**

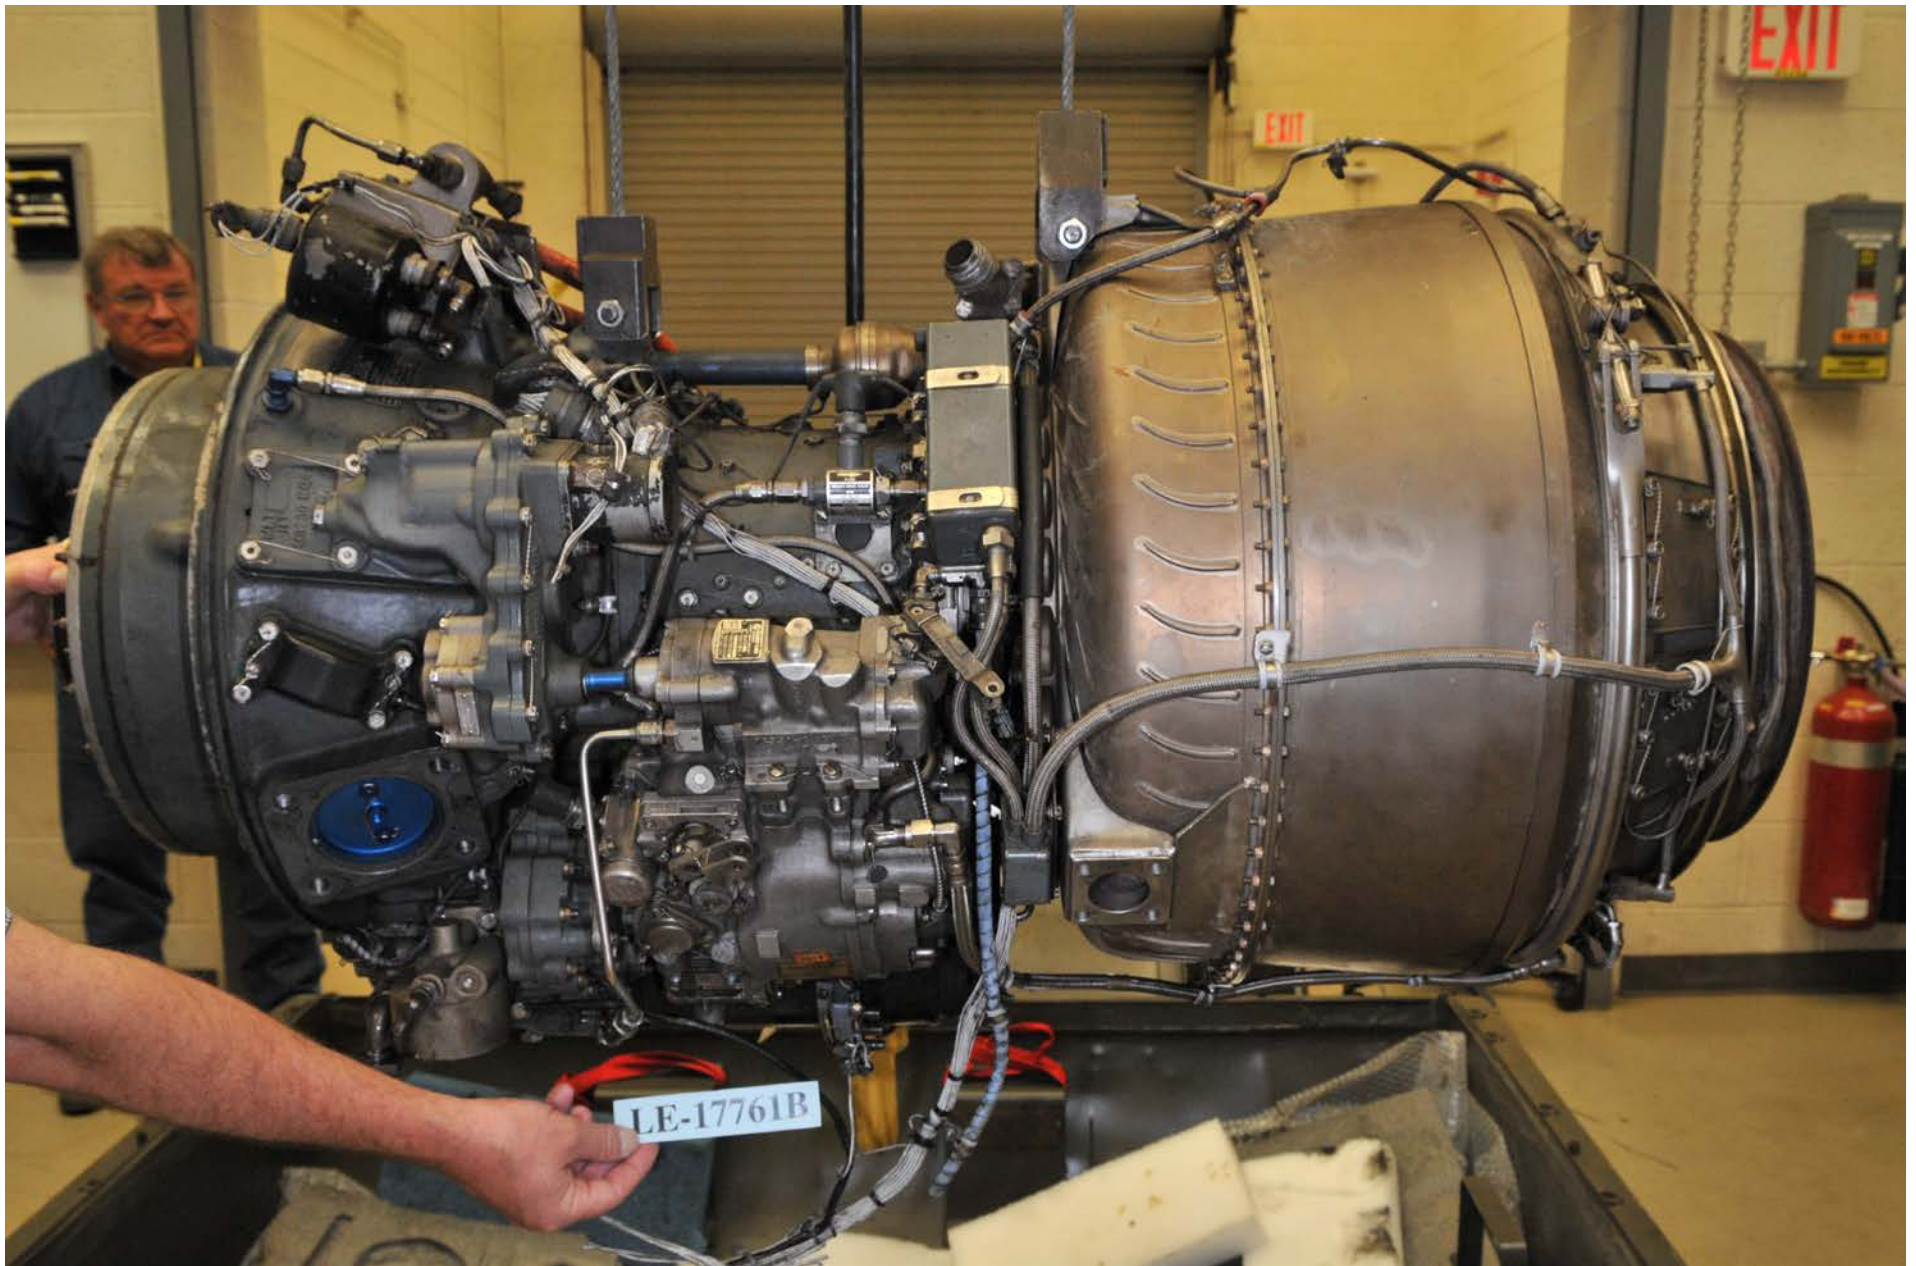
**Photo 9- T53-L-13B engine at exam facility, left-side view.**

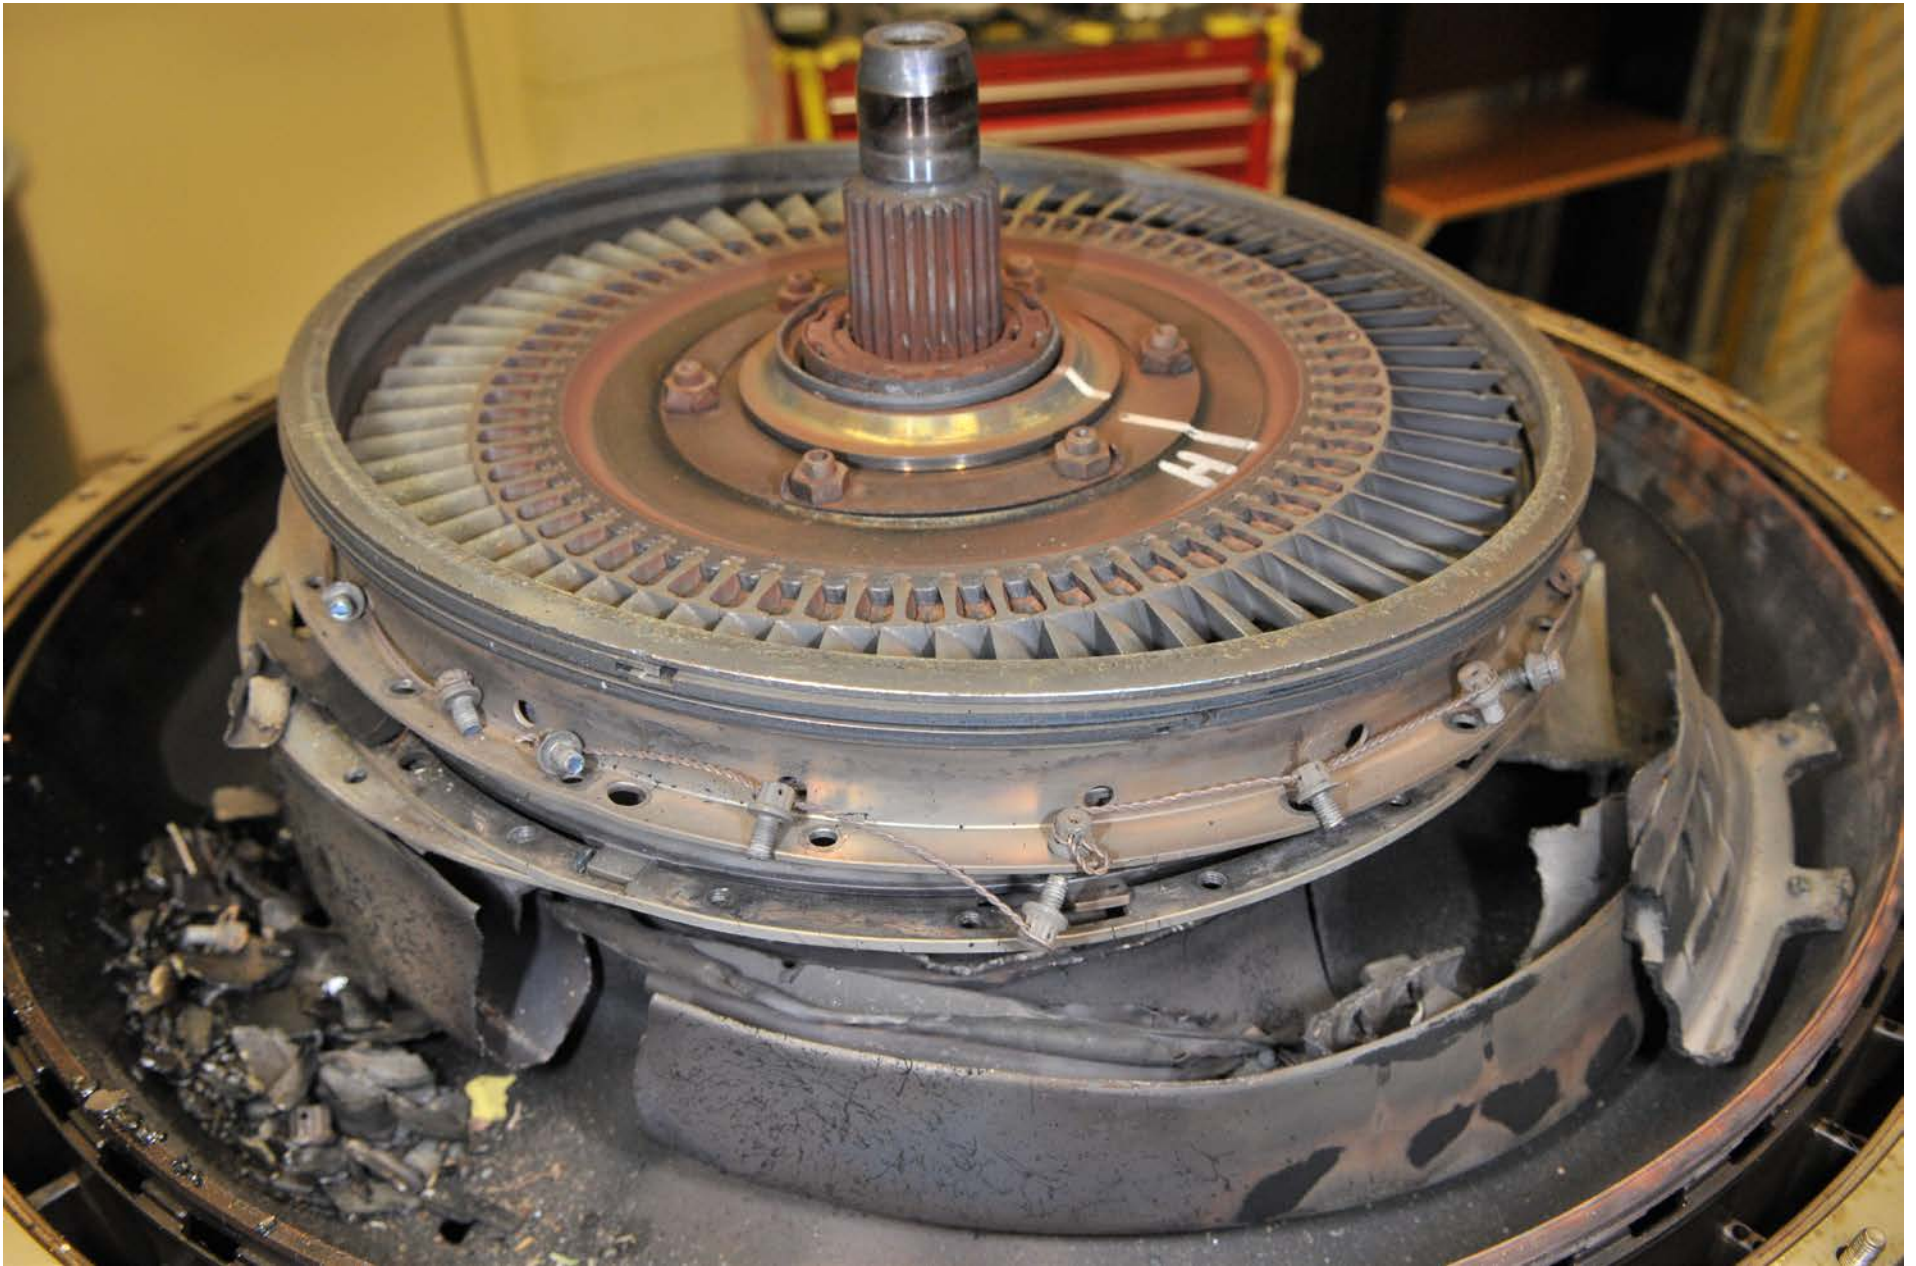
**Photo 10 – T53-L-13B engine with large amount of debris resting in the combustion chamber.**
