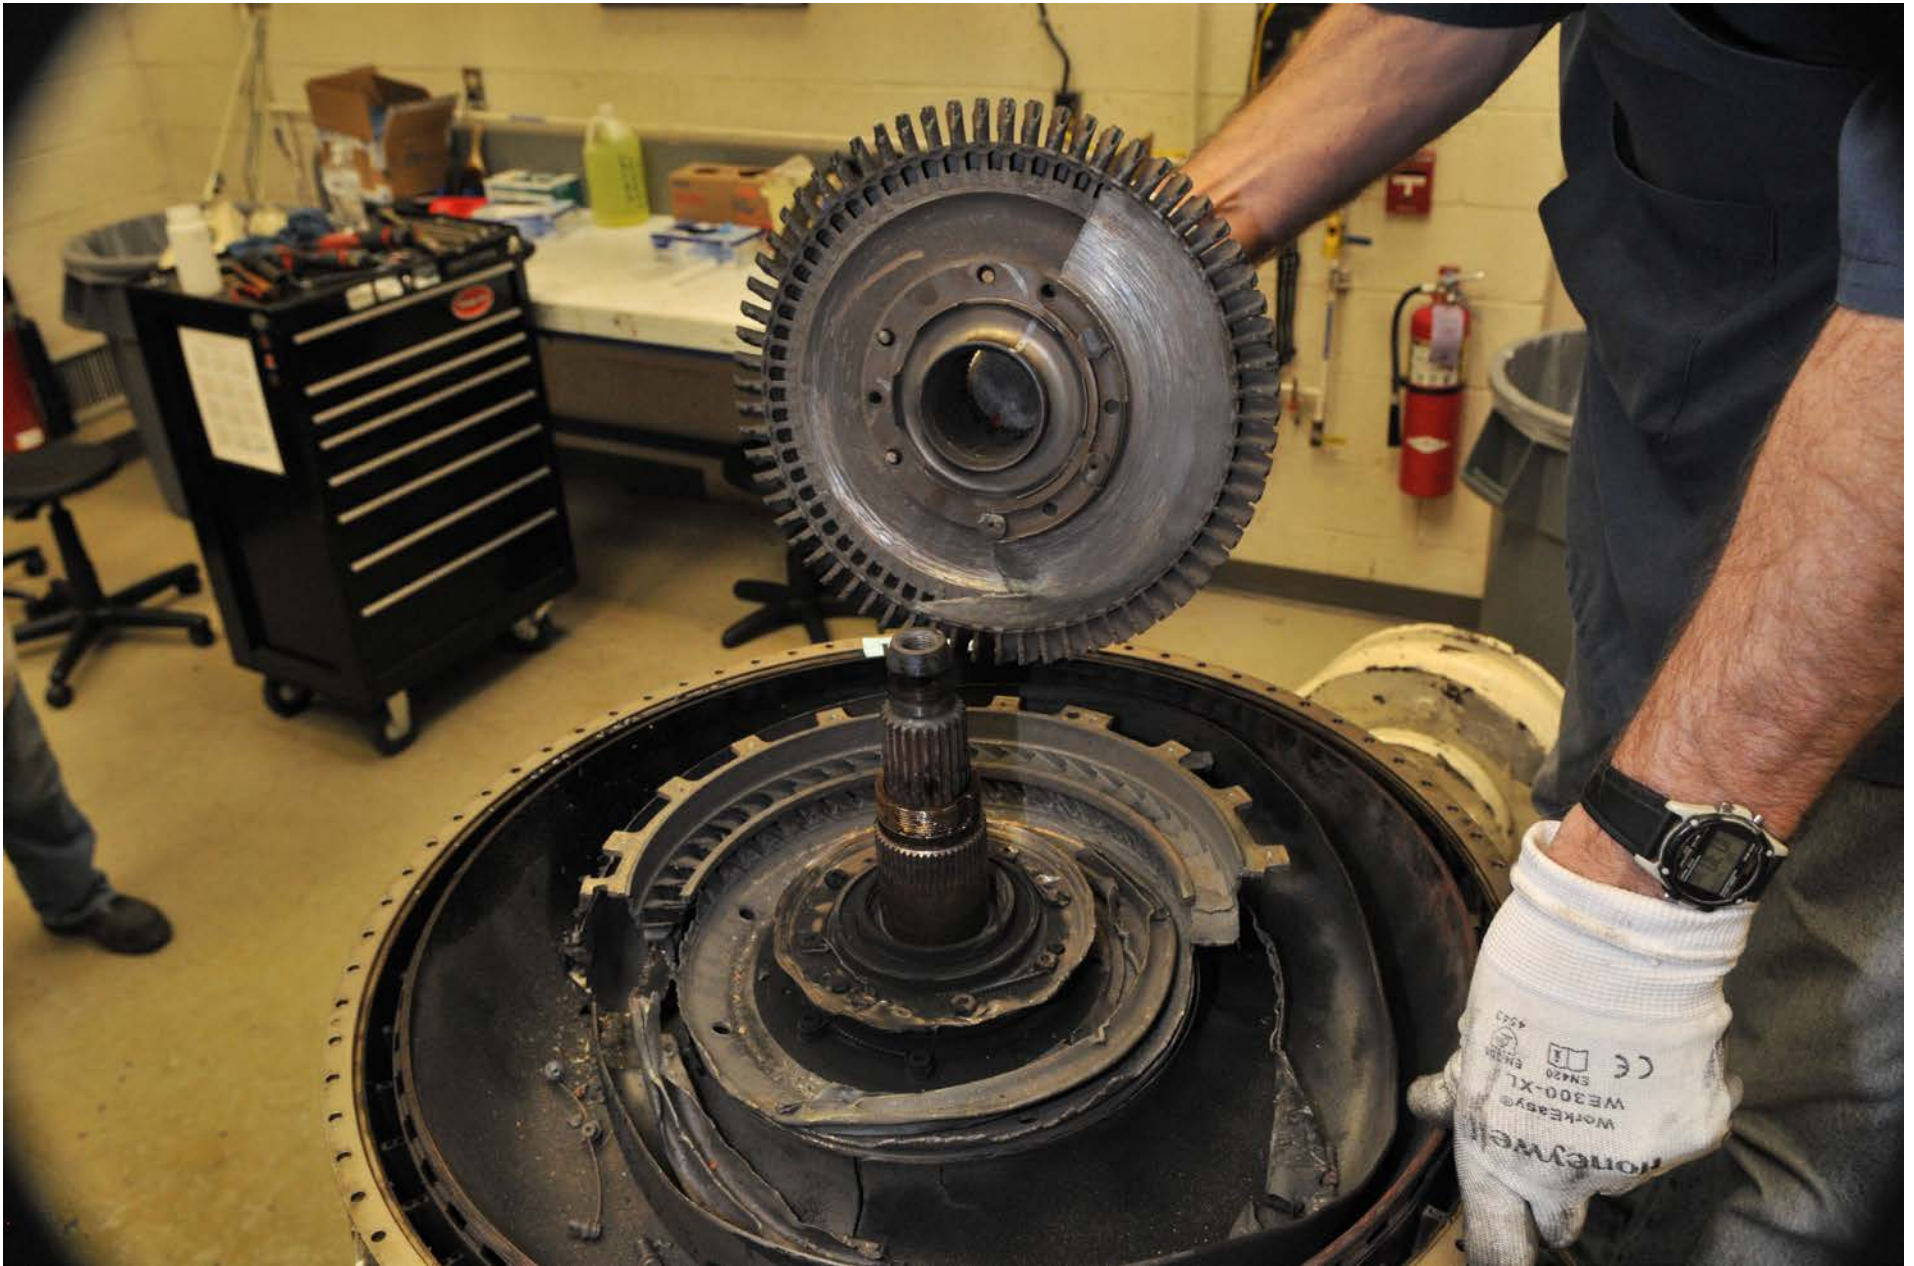
**Photo 11 – First-stage turbine rotor with a portion of the first stage sealing disk remaining attached.**

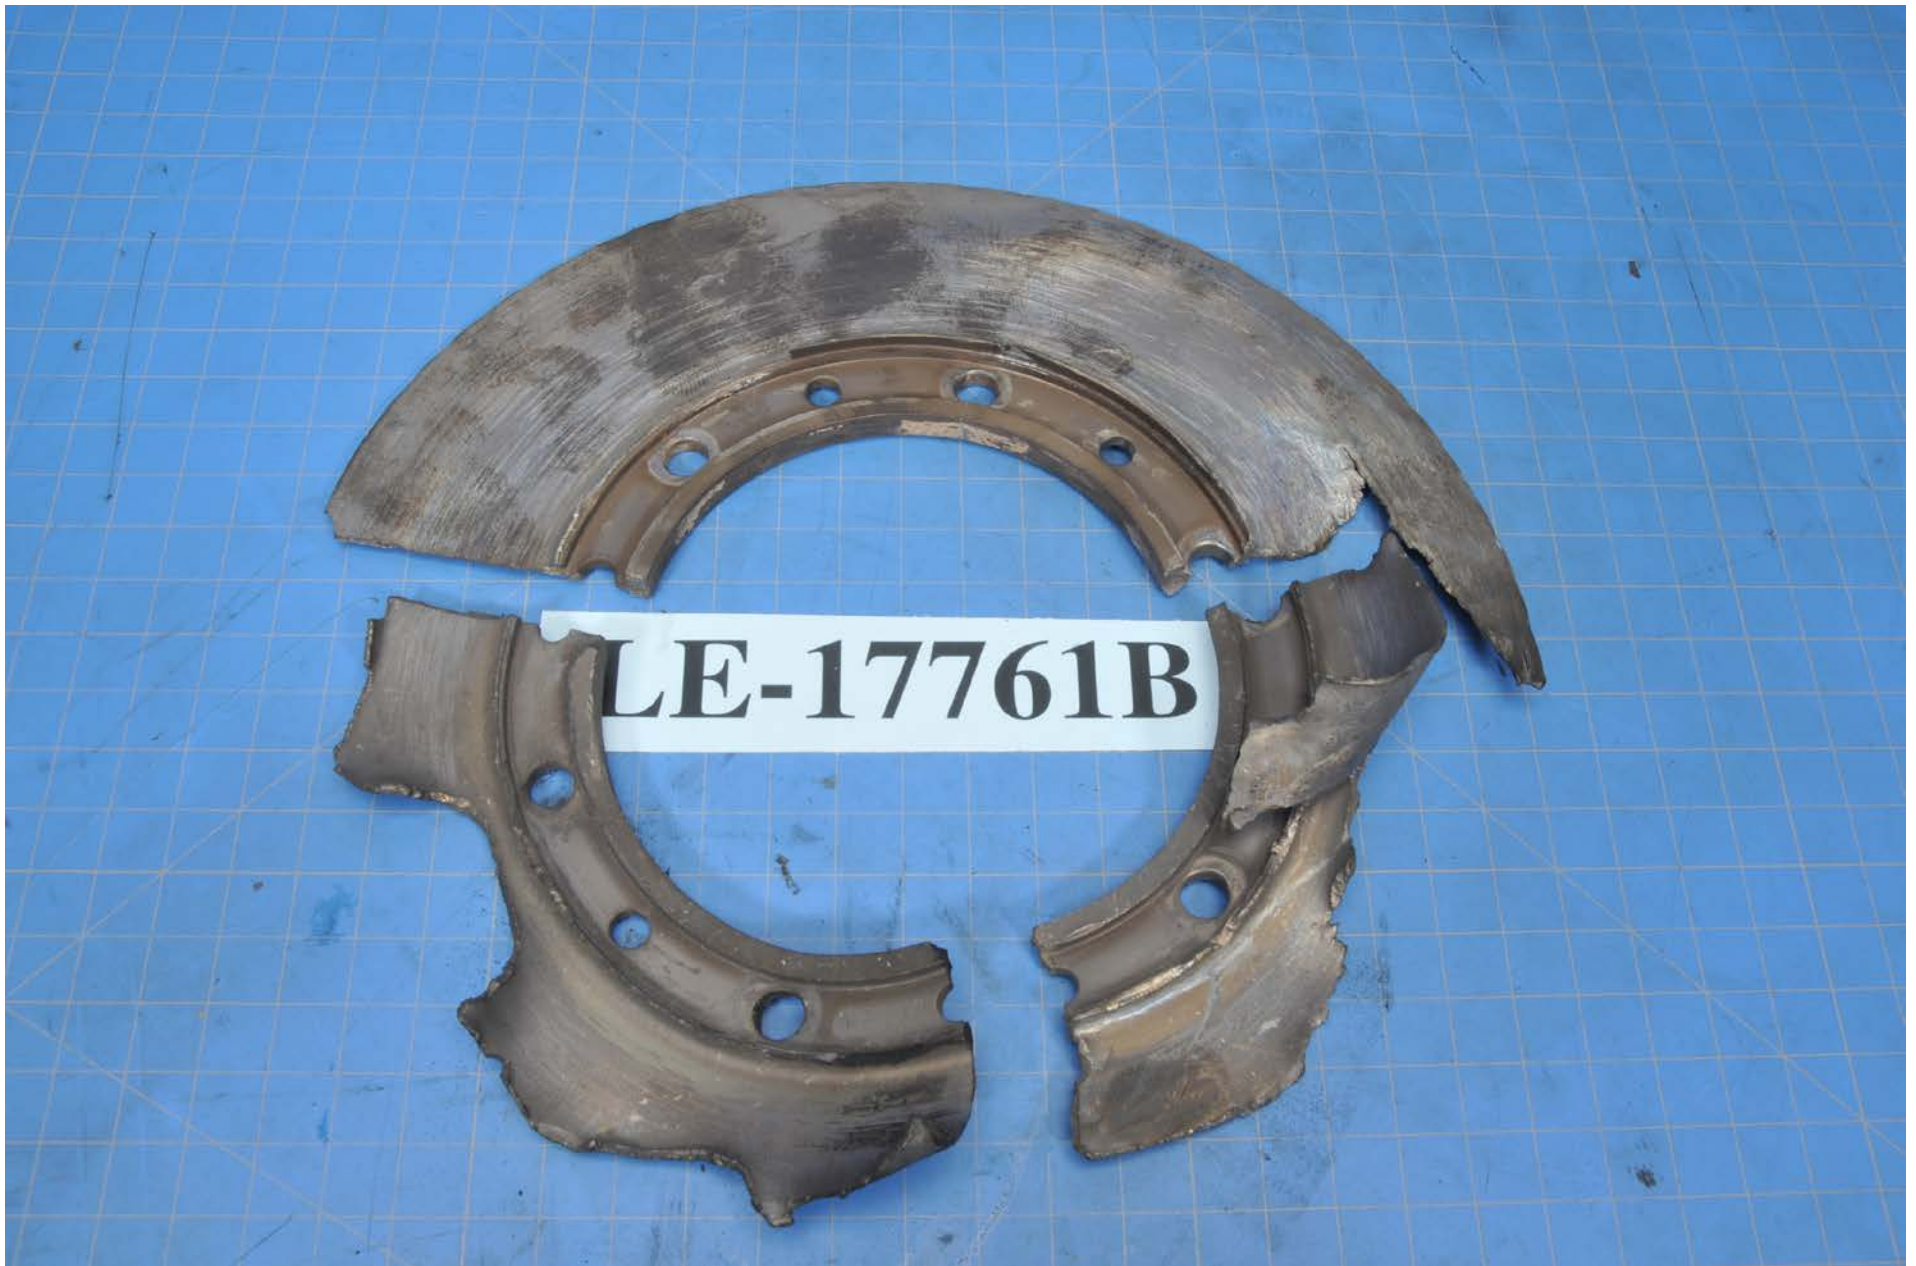
**Photo 12 – First stage sealing disk shown in three fragments. Photo curtesy of Honeywell Aerospace.**

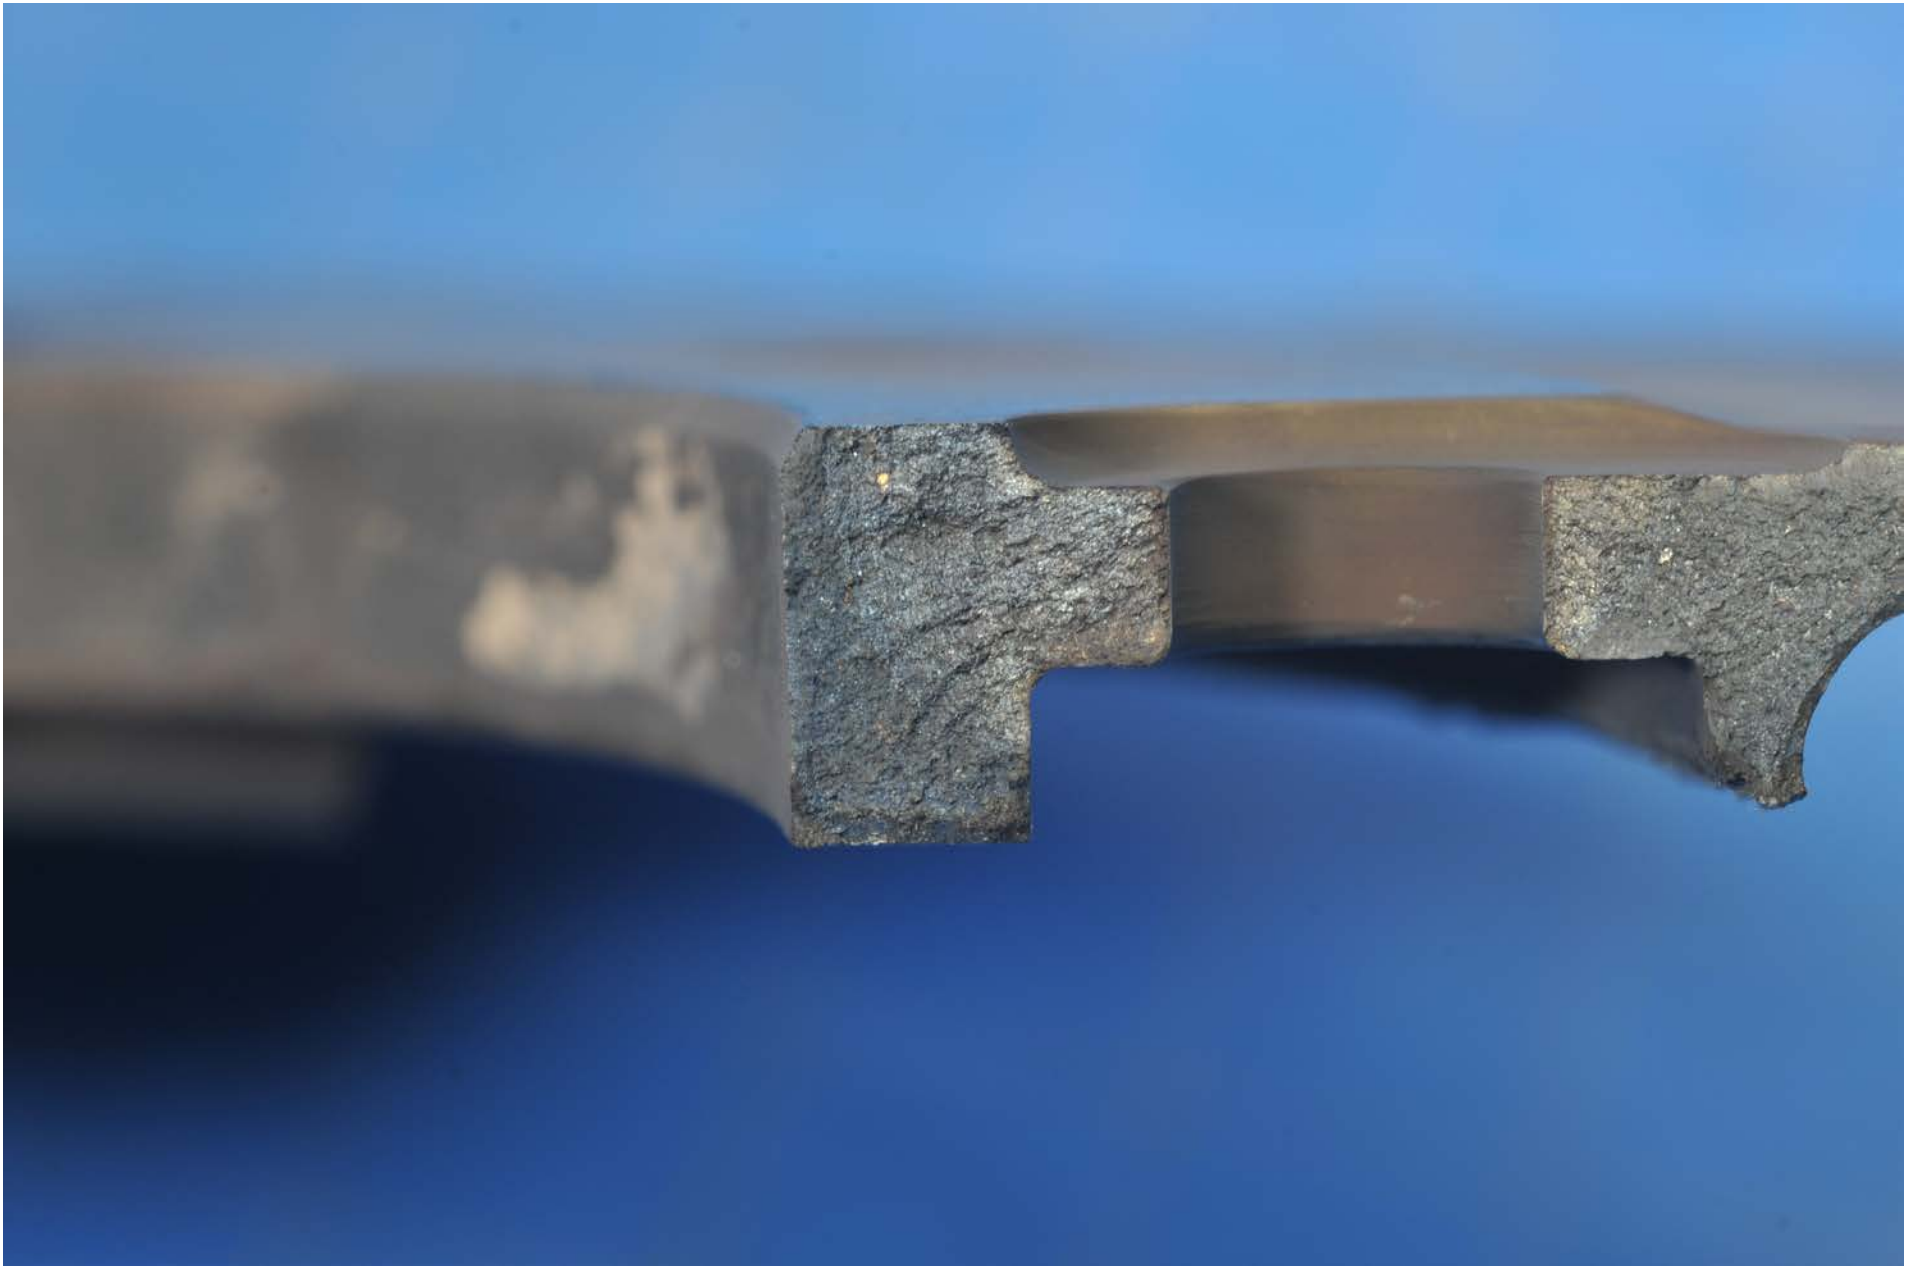
**Photo 13 – Fragment-end view of the first stage sealing disk. Note the arc-shaped striations consistent with low-cycle fatigue. Photo courtesy of Honeywell Aerospace.**
