## **NATIONAL TRANSPORTATION SAFETY BOARD**

### **ON SCENE OBSERVATIONS**

**WPR19FA093**

Location: Pahokee, Florida  
Date: March 8, 2019  
Aircraft: Piper PA 23-250, Registration N5894Y, Serial #27-3048  
NTSB IIC: Samantha Link

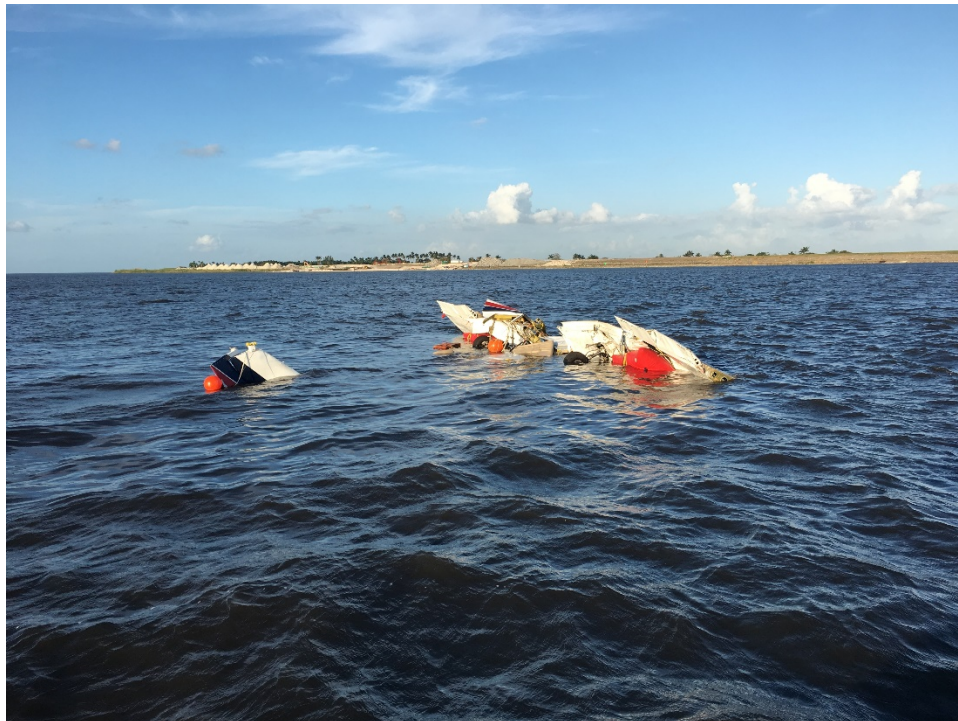
**Figure 1: Airplane in Water (with Air Bladders Under Wings)**

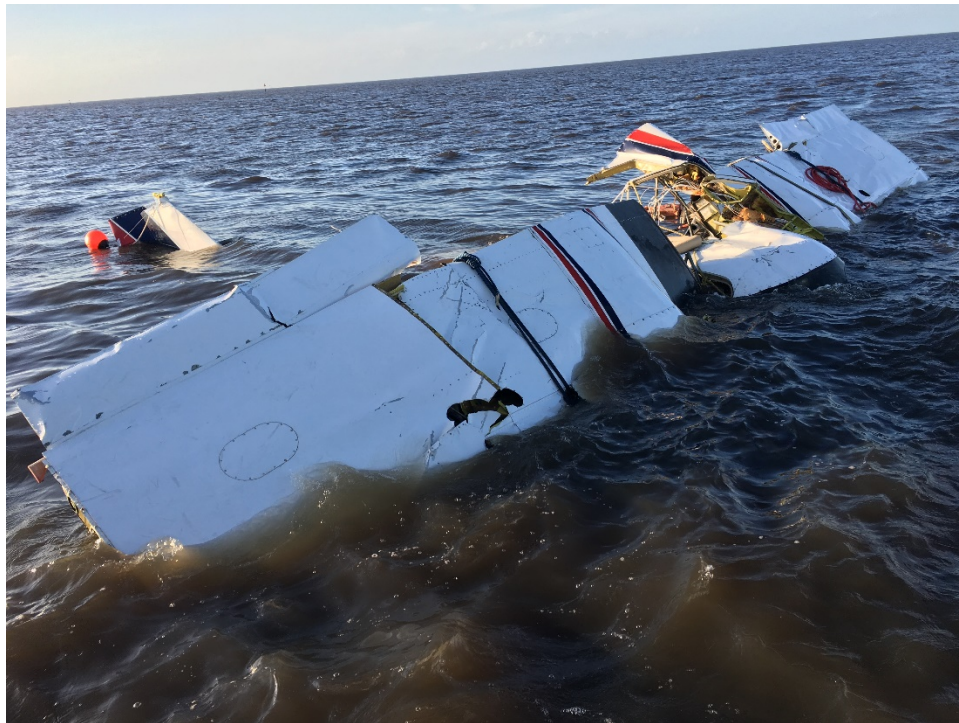
Figure 2: Upper Wing (Air Bladders Under Wings)

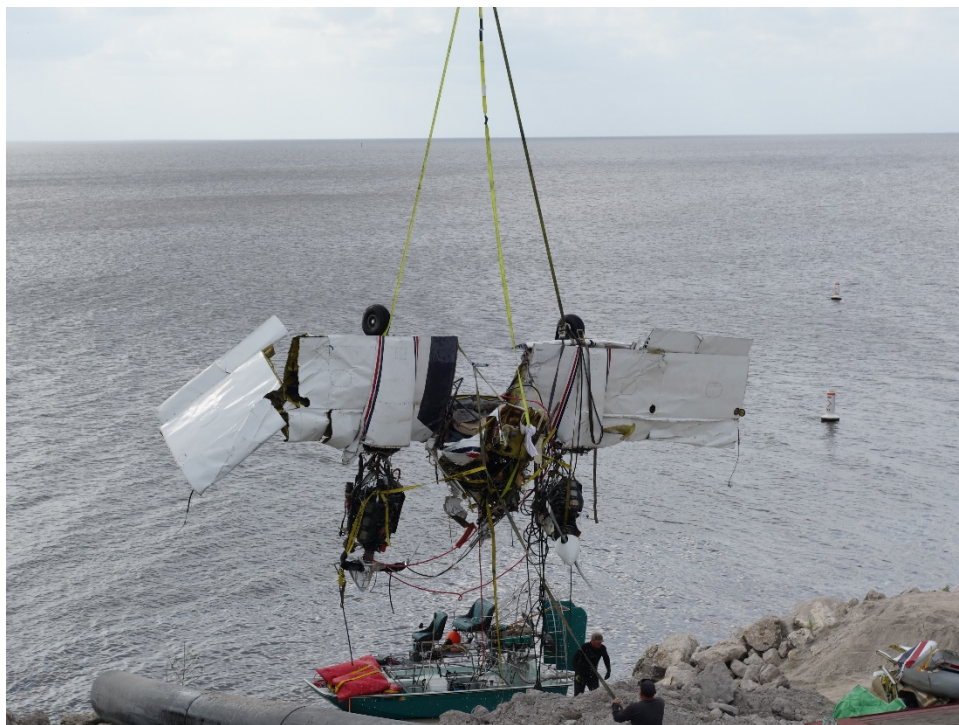
Figure 3: Wings, Engines, and Instrument panel being recovered

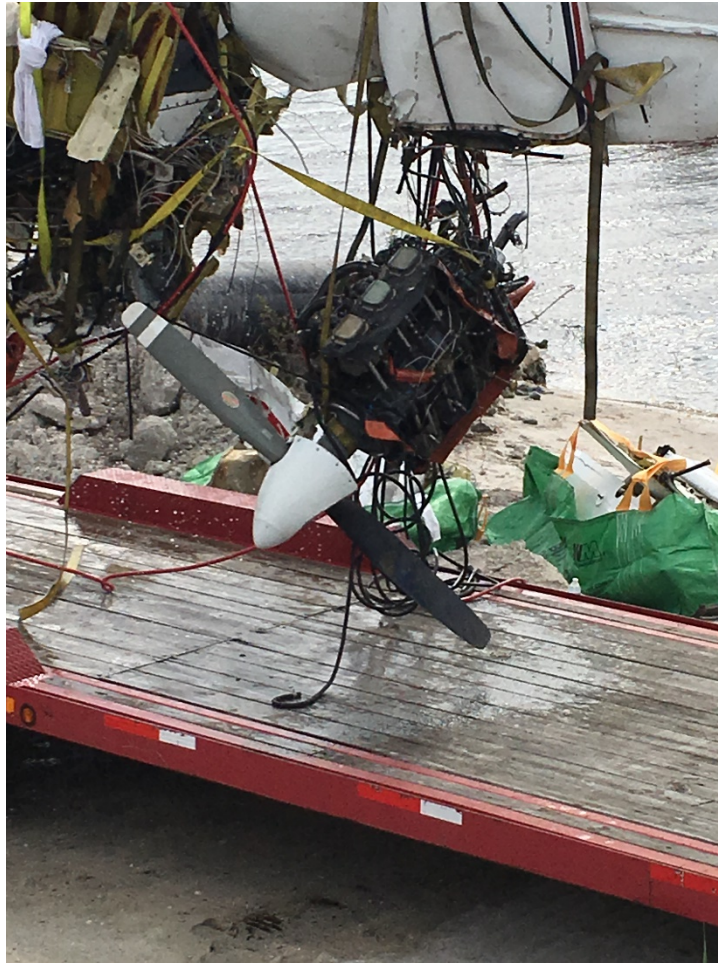
Figure 4: Left Engine

The wings, engines, and instrument panel were recovered from the water. The engines were fracture separated from their engine mounts. The left engine propeller blades were mostly undamaged and in the feathered position; there were no obvious signs of catastrophic failure of the left engine. The right propeller blades were both bent aft; there were also no obvious signs of catastrophic failure of the right engine. The left wingtip was not present nor was it found in the water. The leading edge of the left wing was crushed aft about midspan. In addition, 45-degree wrinkles were observed at various locations in the wing skin. The left aileron was bent midspan and the left flap was still present and moved freely. The left main landing gear remained attached and moved freely. The right wingtip was separated from the airframe, although it was located near the main wreckage. The right wing was separated about midspan, and 45-degree wrinkles were noted in the wing skin. The flap was fracture separated from the airframe and the aileron was bent midspan. The right main landing gear remained attached and moved freely. Since the airplane was immediately placed onto a trailer, the instrument panel was unable to be observed.

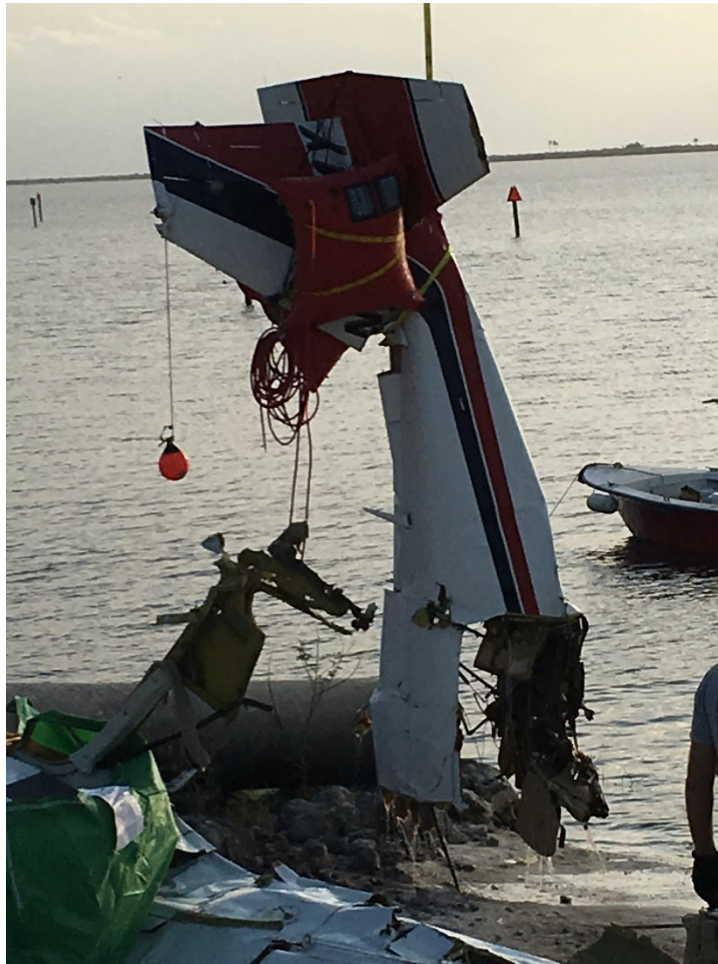
The cabin area and the empennage were recovered. All six seats were present along with the floor and ceiling, however, the side walls were not attached. The baggage compartment was mostly intact, and the door was found open. The empennage was mostly intact and undamaged. The stabilator and rudder remained attached to the airframe.

Figure 6: Cabin, Aft Fuselage, and Empennage
