## **NATIONAL TRANSPORTATION SAFETY BOARD**

# **LEFT ELECTRIC FUEL PUMP EXAMINATION**

**WPR19FA093**

Location: Pahokee, Florida  
Date: March 8, 2019  
Aircraft: Piper PA 23-250, Registration N5894Y, Serial #27-3048  
NTSB IIC: Samantha Link

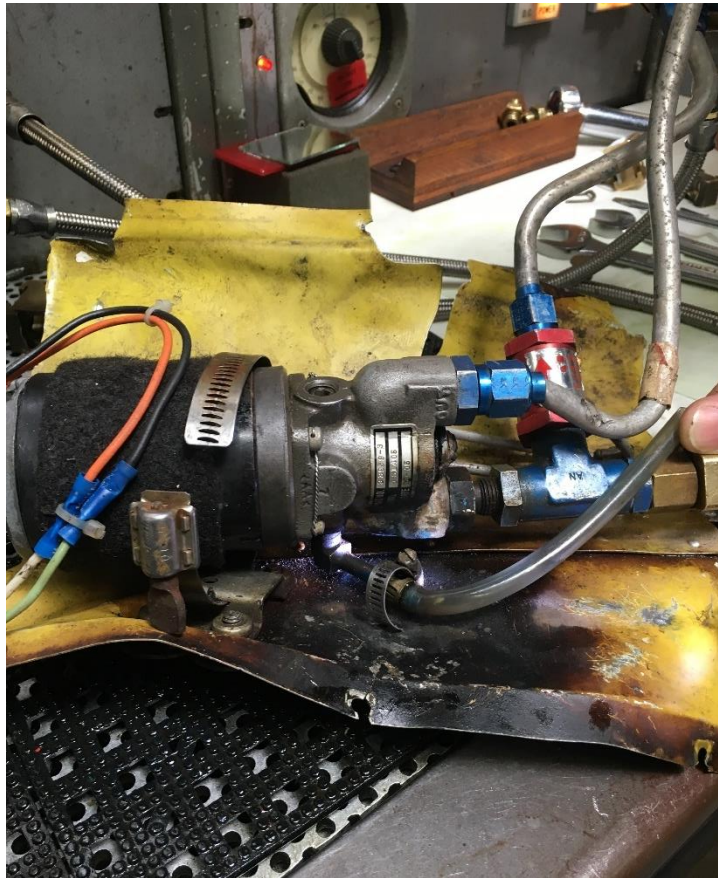
- When the pressure was increased to 14 PSI, fuel was observed exiting the overboard drain.
- The electric fuel pump was installed onto a test bench and operationally tested in comparison to ATP Standards.

Figure 1: Pressure Test at 14 PSI

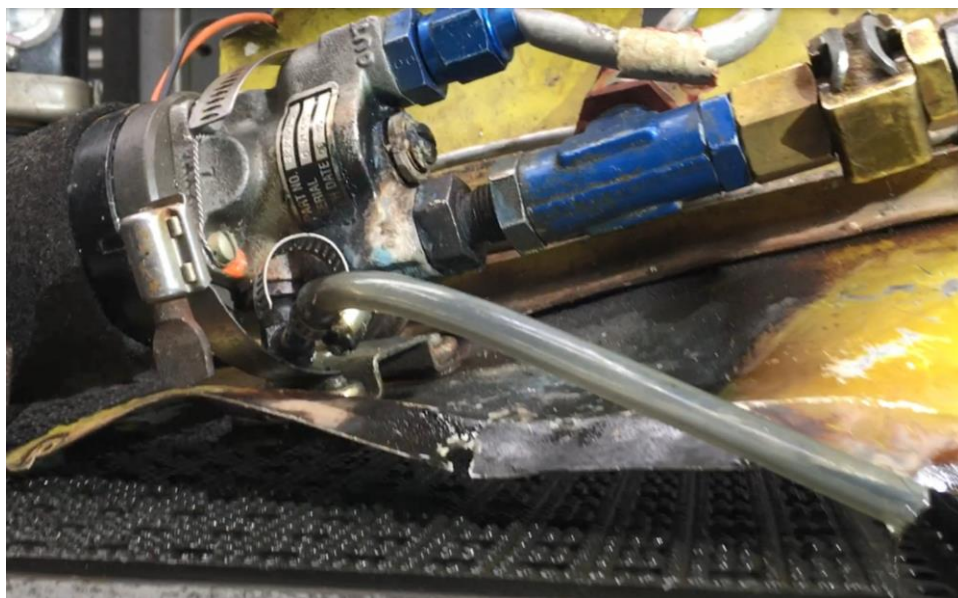
- The electric pump was in the vicinity of the appropriate ATP standards.
  - When 5 PSI inlet pressure was added, fuel exited the overboard drain at about 25 mL per minute.

Figure 2: Operational Test (with 5 PSI Inlet Pressure)

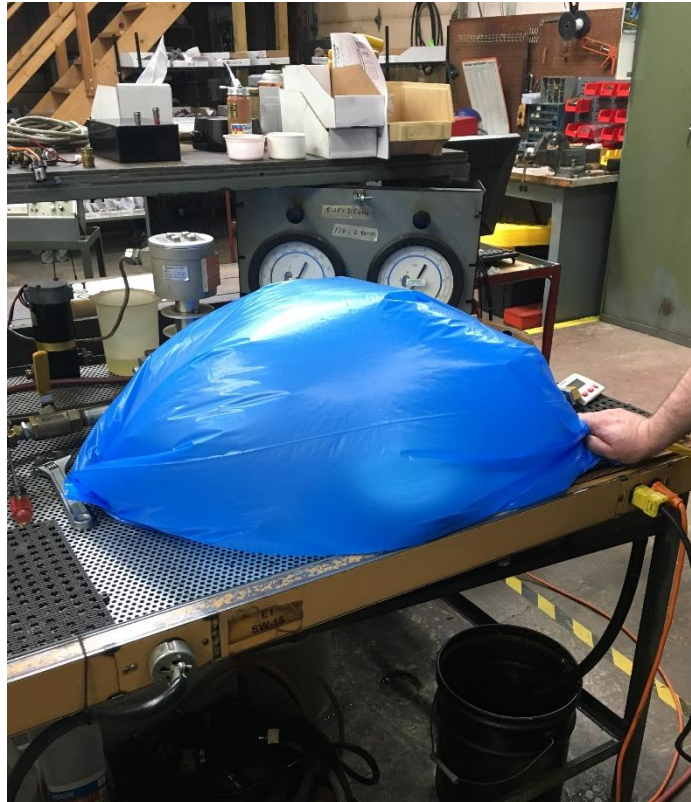
- A vacuum pump was added to the outlet to simulate an engine driven fuel pump pulling fuel through the electric pump while the pump was in the off position.

- The entire assembly was placed in a bag full of air in attempt to determine if a significant amount of air was being pulled in through the pump.
    - The bag did not appear to lose air.

Figure 3: Vacuum pump was attached to the pump outlet and the assembly was placed in a bag.

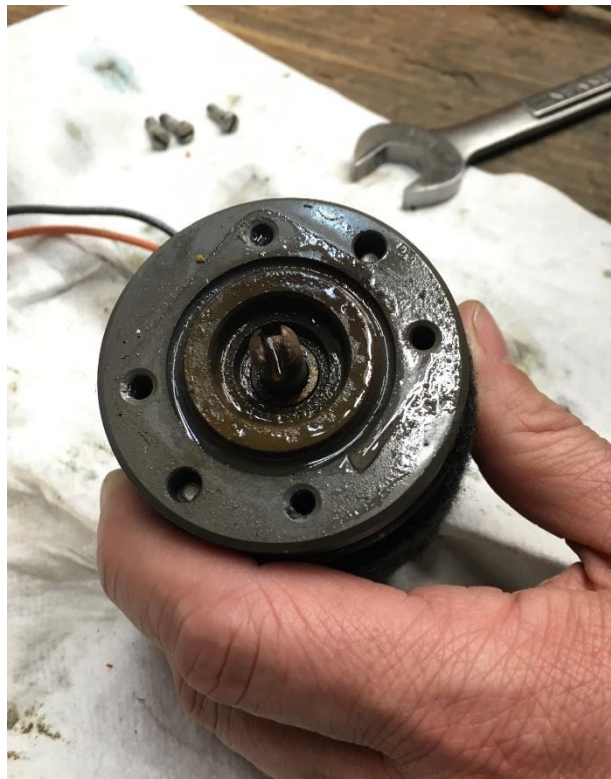
- The fitting was unremarkable.
- The pump motor was removed from the pump
  - Fuel was noted in the drive cavity between the pump and motor.
    - Some rust was noted on the drive

Figure 4: Drive from Motor

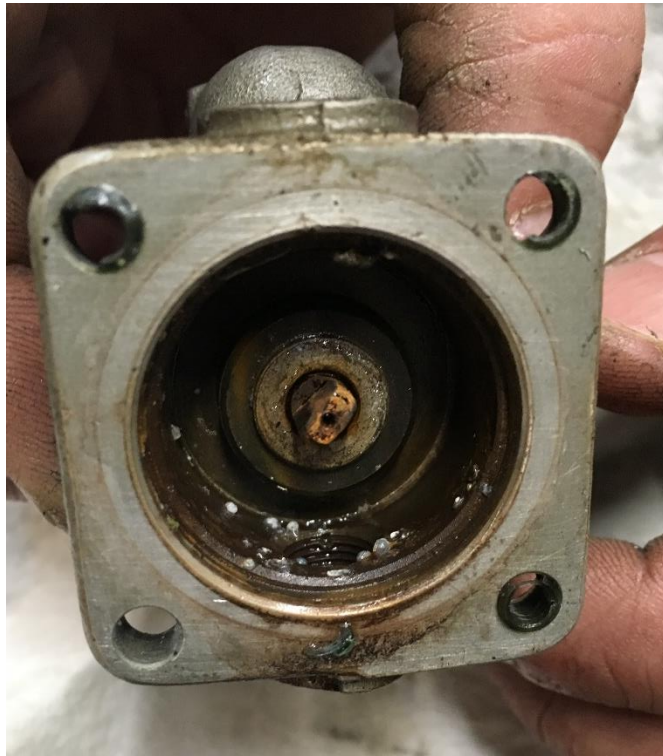
Figure 5: Pump Drive

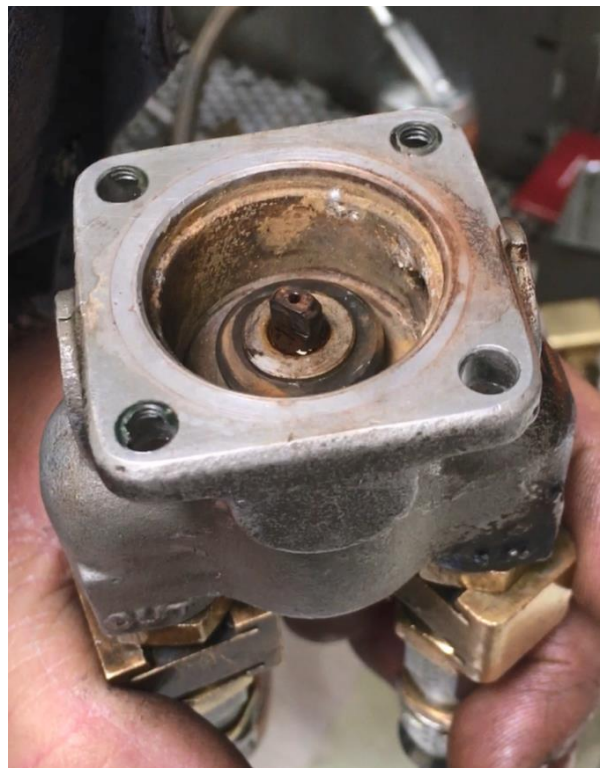
- The pump cavity was wet with fuel and some unknown debris was noted
- The pump itself was installed onto a test bench and was pressure tested.
  - Fuel was observed seeping from around the drive shaft consistent with a shaft seal leak.

Figure 6: The pump Itself was Installed onto a Test Bench
