## **NATIONAL TRANSPORTATION SAFETY BOARD**

# **AIRFRAME AND ENGINES EXAMINATION**

**WPR19FA093**

Location: Pahokee, FL  
Date: March 8, 2019  
Aircraft: Piper PA-23-250, Registration N5894Y, Serial #27-3048  
NTSB IIC: Samantha Link

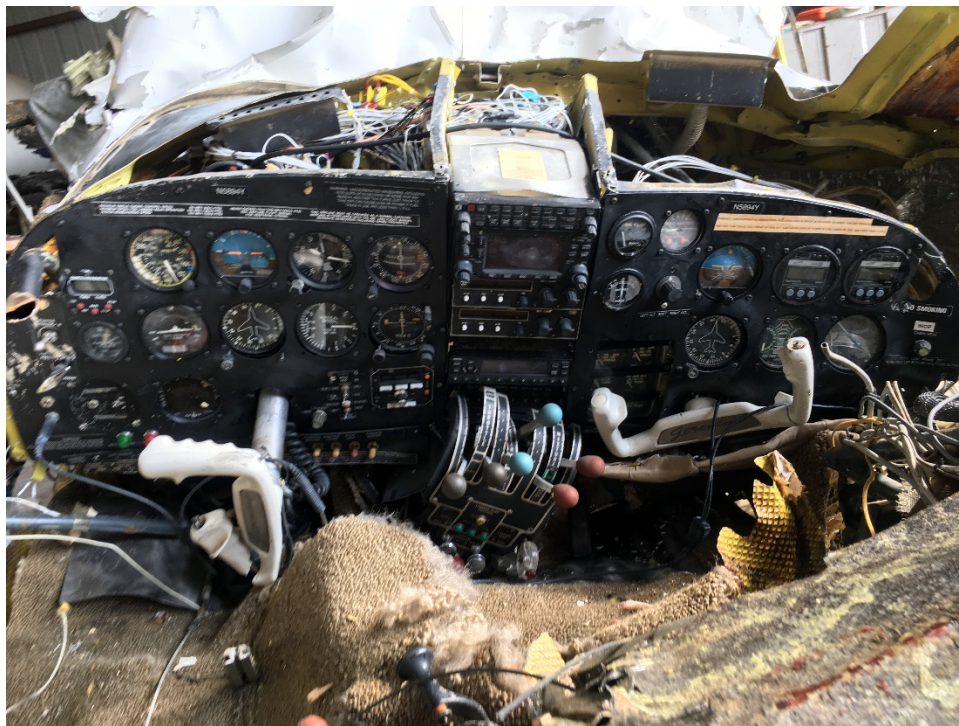
Figure 1: Instrument Panel

- Fuselage
  - o The top of the cabin, aft fuselage, and empennage were separated from the wings.
  - o The main wing spar remained continuous throughout.
  - o The floorboards were separated from the structure.
  - o The sides of the cabin and nose section, including the forward baggage compartment, were separated from the fuselage.
  - o The instrument panel remained attached to the airframe and structure forward of the main wing spar.

- A JPI 760 engine monitoring unit was found installed onto the instrument panel. It was removed and send to the NTSB Recorders Laboratory for further examination.

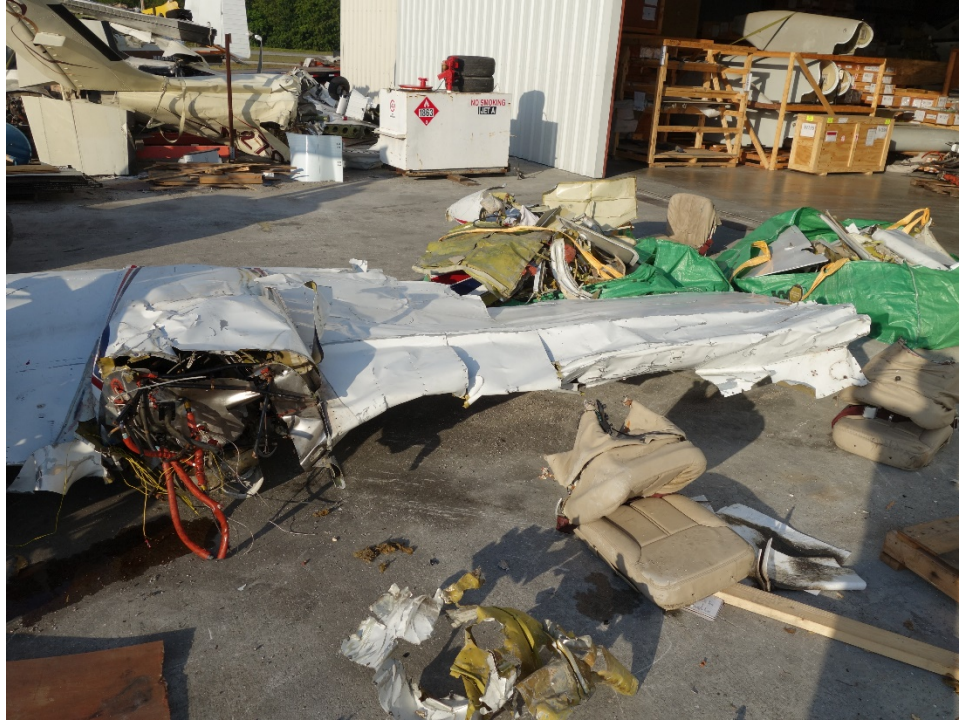
Figure 2: Left Wing

- Left Wing
  - o Exhibited crush damage throughout.
  - o Left engine truss mount was fractured and the engine remained attached by cables, lines, and hoses.

- o The engine cowling was separated from the wing.
- o The left wingtip fuel tank was not present.
- o The inboard fuel bladder was torn from its mounts and breached; no fuel was present.

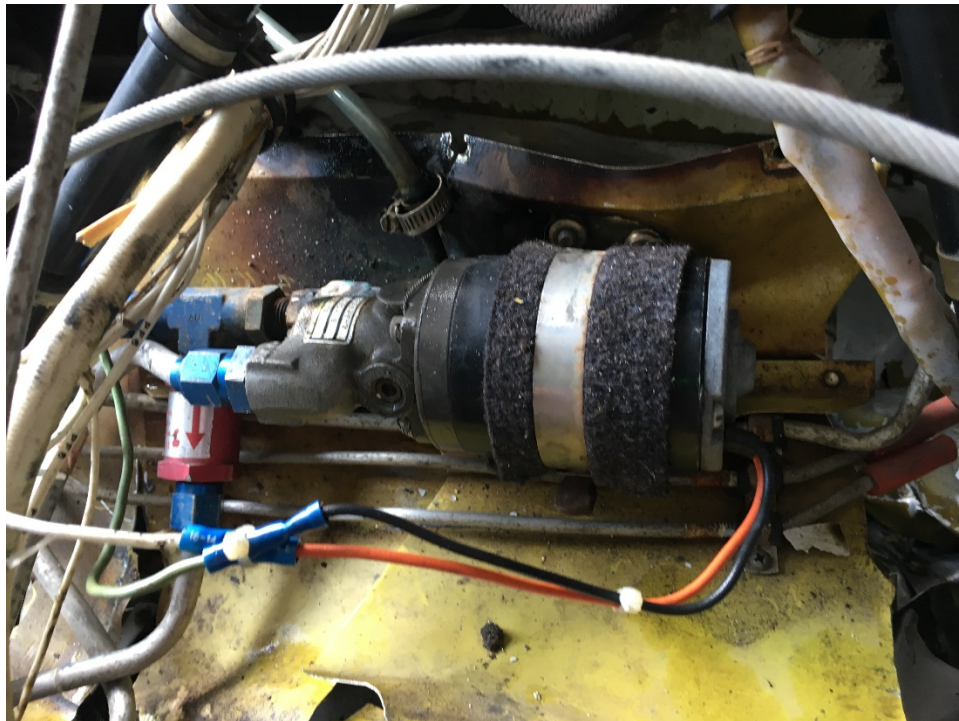
Figure 3: Left Wing Electric Fuel Pump

- The valve was moved through its different positions and air passed through accordingly with no blockages or debris noted.
- o The electric fuel pump in the nacelle was observed to have an area of dark staining around the pump's inlet and adjacent fitting. The color of the stains were blue along the edge and became dark brown towards the center of the discolored area. The discoloration continued onto the nacelle panel below the pump.

- The electric fuel pump wires were electrically connected to a 12V power source and the pump was able to pump water from the bucket.
- Right Wing
  - o The right wing exhibited crush damage throughout.

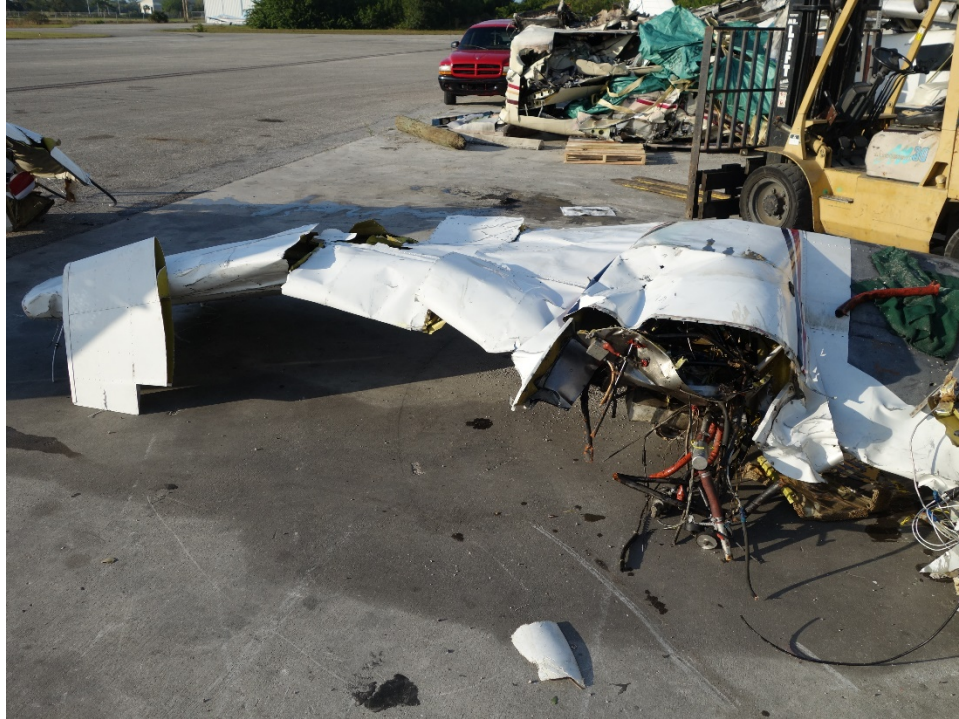
Figure 5: Right Wing

- o The right engine truss mount was fractured, and the engine remained attached by cables, lines, and hoses.
  - o The engine cowling was removed from the wing.

- o The right wingtip fuel tank was found separated from the wing.
  - o The outboard fuel filler cap remained intact.
  - o The inboard fuel bladder was torn from its mounts and breached.

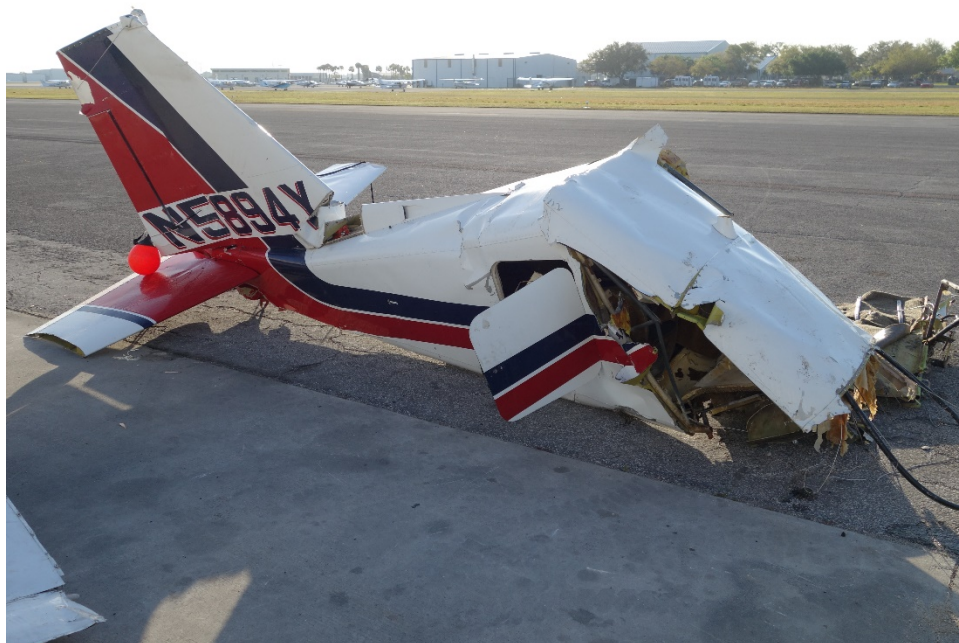
Figure 6: Empennage, Aft Fuselage, and Cabin Area

- o The electric fuel pump in the nacelle was connected to a 12V power source and the pump was able to pump water from a bucket.
- Empennage
  - o The empennage was mostly intact and undamaged

- o The stabilator remained attached to its hinges and the stops were unremarkable.
- o The stabilator trim tab remained attached to the stabilator
- o The stabilator trim actuator was partially separated from its mount
  - The jackscrew was extended about 0.5 inch which corresponds to a full tab up (nose down) setting.
- o The rudder remained attached to its hinges.
  - The rudder stops were intact and unremarkable.
- o The rudder trim tab remained attached to the rudder
- o The rudder trim actuator jackscrew was not extended which corresponds to a full tab right (nose left) trim setting.

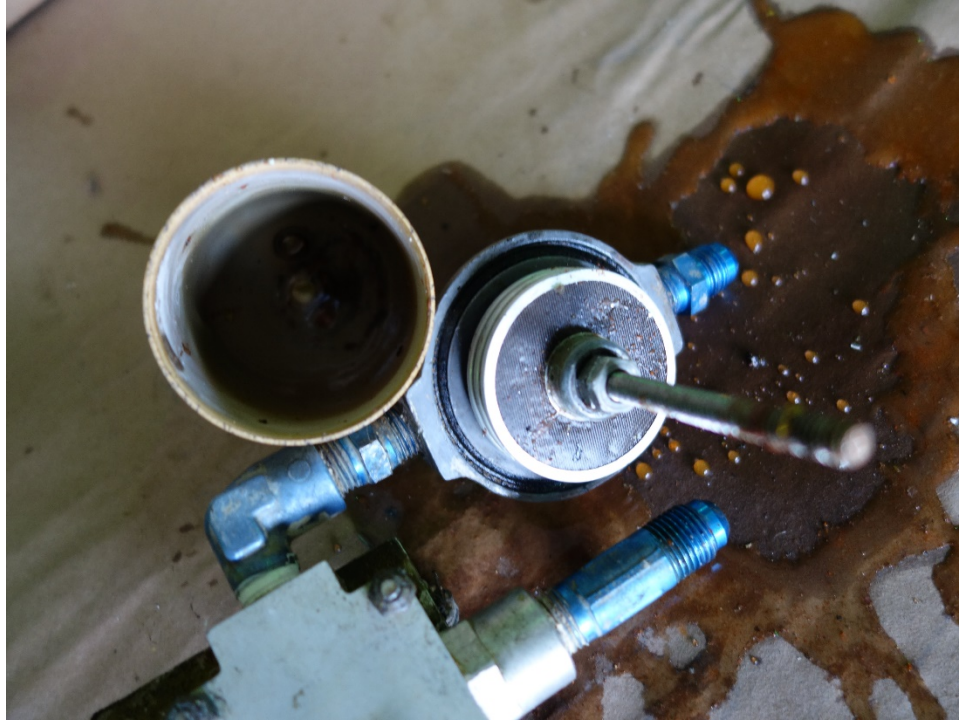
Figure 7: Left Wing Fuel Strainer

- The filler opening remained attached to the fuel bladder and the cap was intact.
- o The fuel strainer was removed from the airframe.
  - The screens were dark colored

- Particles were present on the surface of the screens consistent with having been submerged in dirty water.
- o The fuel selector valve was observed in an intermediate position and would not allow the passage of low air pressure.

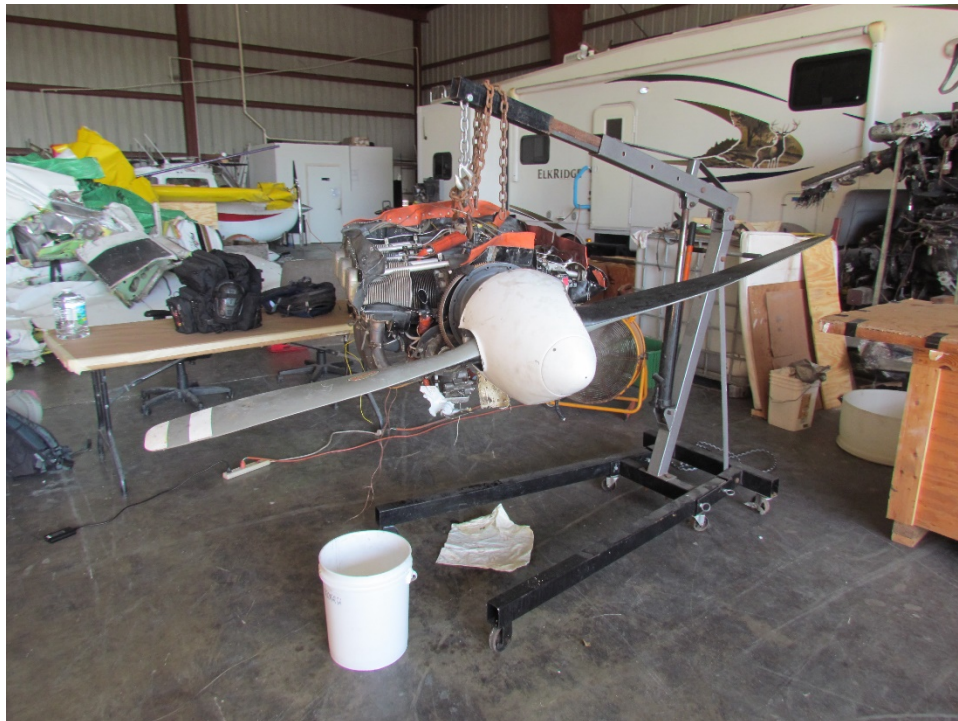
Figure 8: Left Engine Propeller Blades

- The Hartzell propeller blades were feathered.
  - One blade had a slight aft bend.
- Both magnetos were remained attached to the engine. They were removed and cleaned/dried.

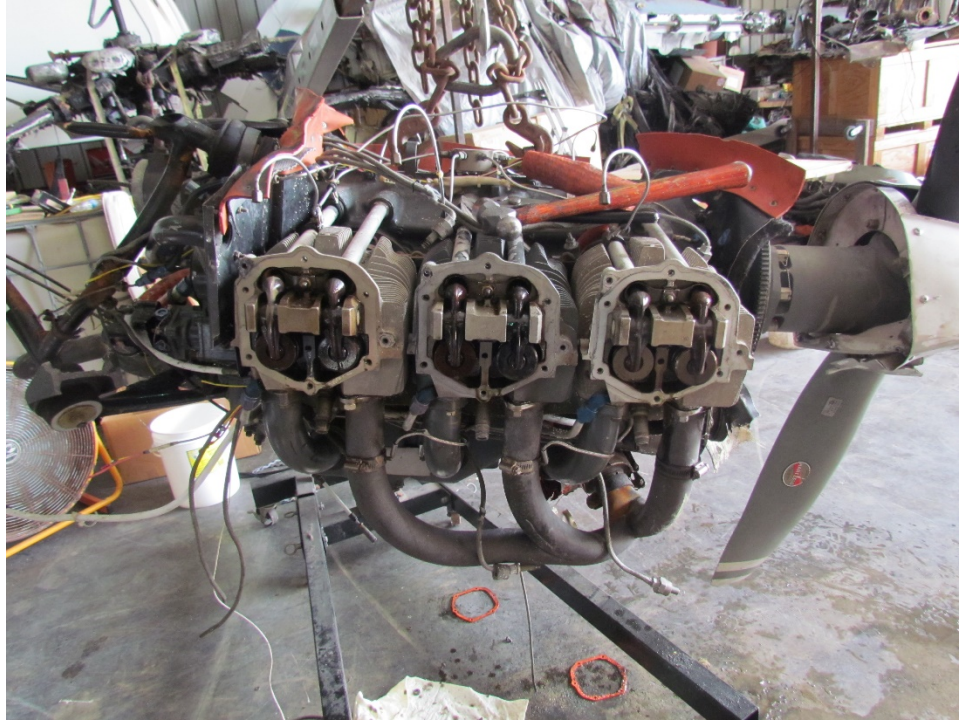
Figure 9: Even Cylinder Side of Engine

- The spark plugs were removed and exhibited normal operating wear signatures.
  - It was noted that the even side cylinders were oily.
- The fuel nozzles were removed from the engine and were clear of debris.

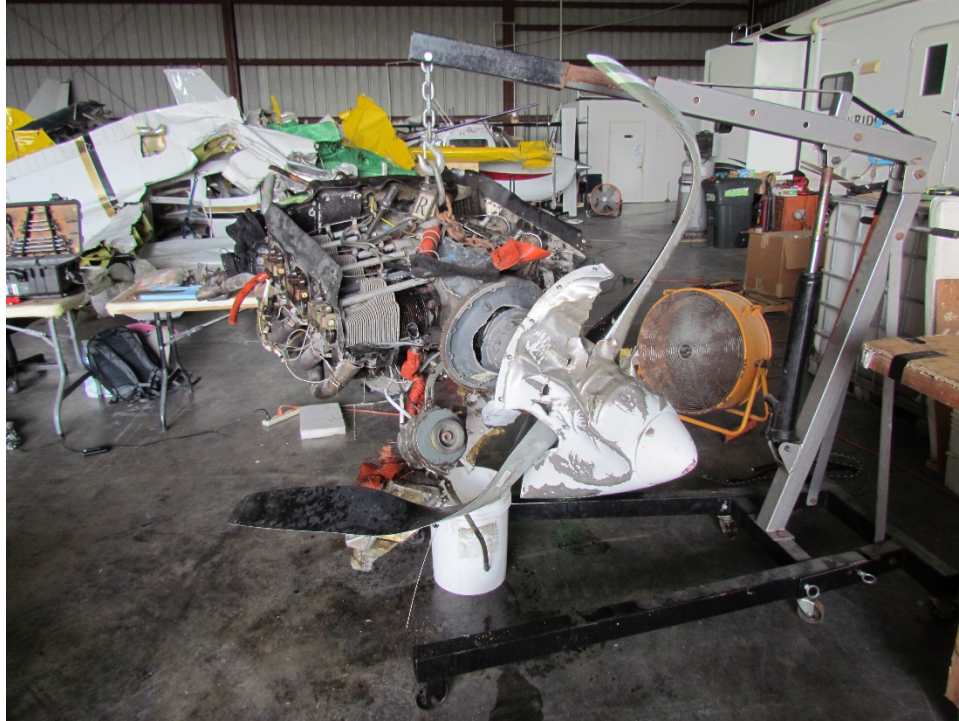
Figure 14: Front of Right Engine

- Visual inspection did not reveal any obvious anomalies that would have precluded normal operations.
- The starter ring gear was pushed aft and fractured around the crankshaft.

- The belt was not present.
- The spinner was crushed inward and exhibited spiral fracture damage.
- Both propeller blades were bent aft about midspan.

- One blade had a second bend in it about 1/3 from the blade tip.
- The spark plugs were removed from the engine and exhibited normal operating signatures.

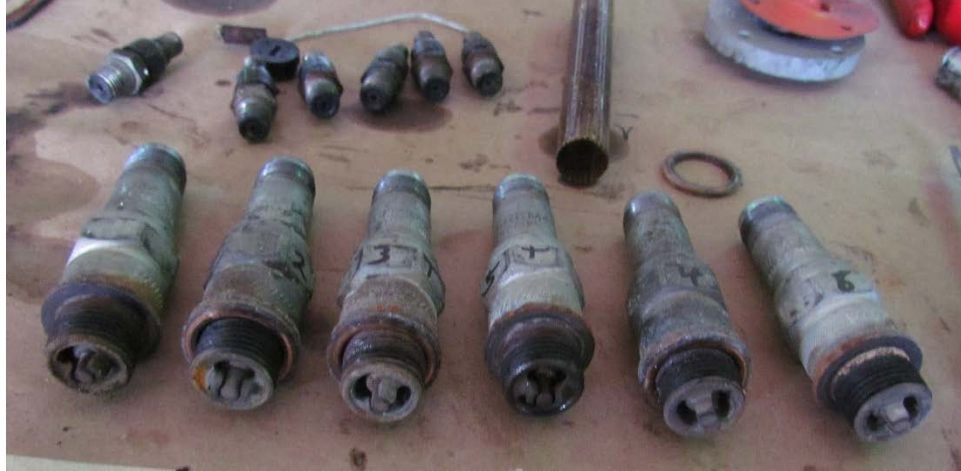
Figure 18: Spark Plugs and Fuel Nozzles

- Some rust was observed on the electrodes consistent with the airplane being submerged.
- The fuel nozzles were removed from the engine and were clear of debris.

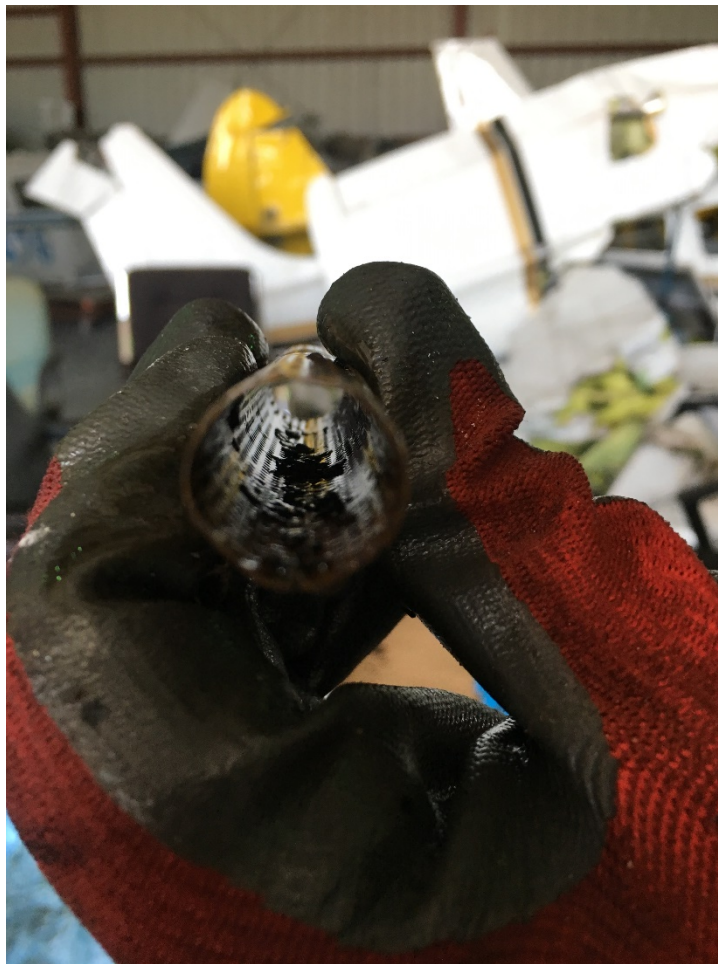
Figure 19: Oil Pickup Screen

- The valves, piston, and cylinder walls exhibited normal operating signatures.
- The oil pickup screen was removed, and some carbon despoths were observed within it.
