**NATIONAL TRANSPORTATION SAFETY BOARD  
Western Pacific Regional Office  
Federal Way, Washington**

**Airframe and Engine Report  
April 9-10, 2019  
Phoenix, Arizona**

NTSB Accident Number: **WPR19FA096**  
IIC: **T. Cornejo**  
Aircraft: **N800DC - Beech BE-50**

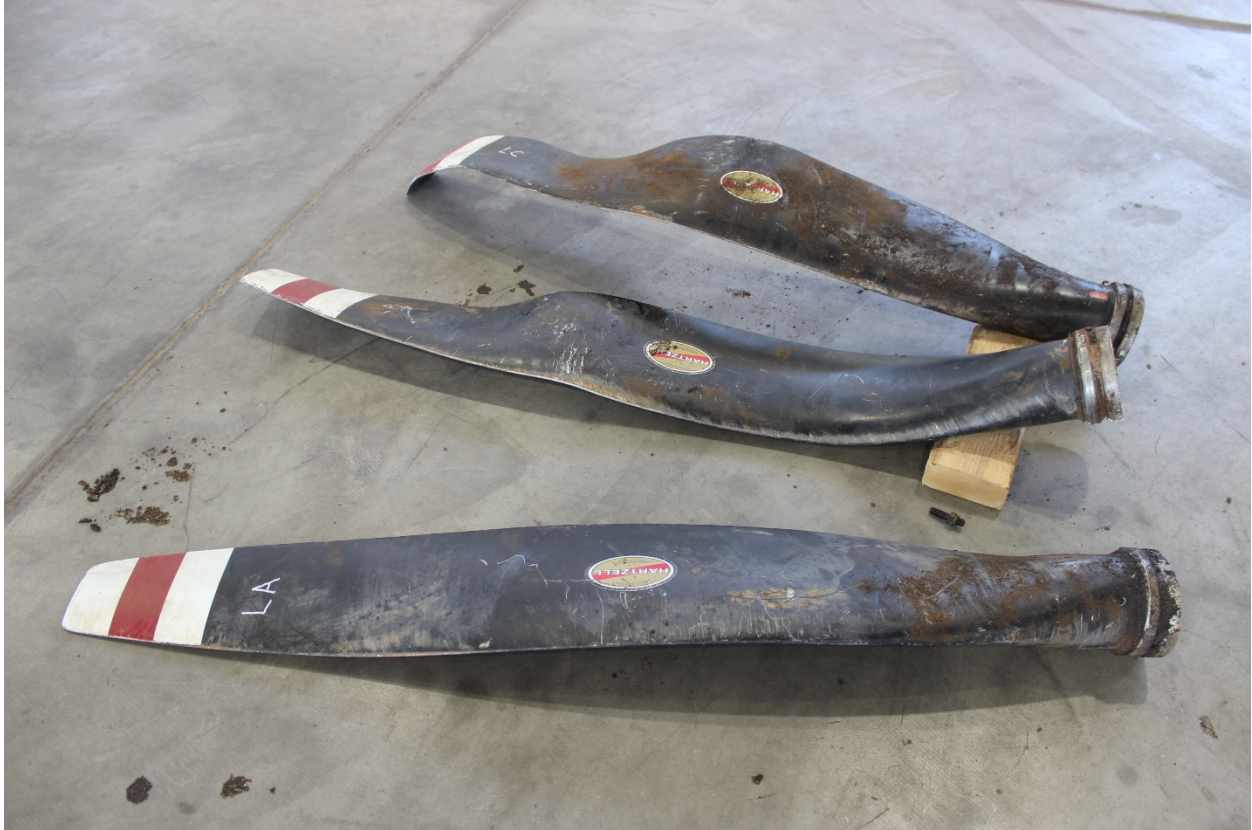
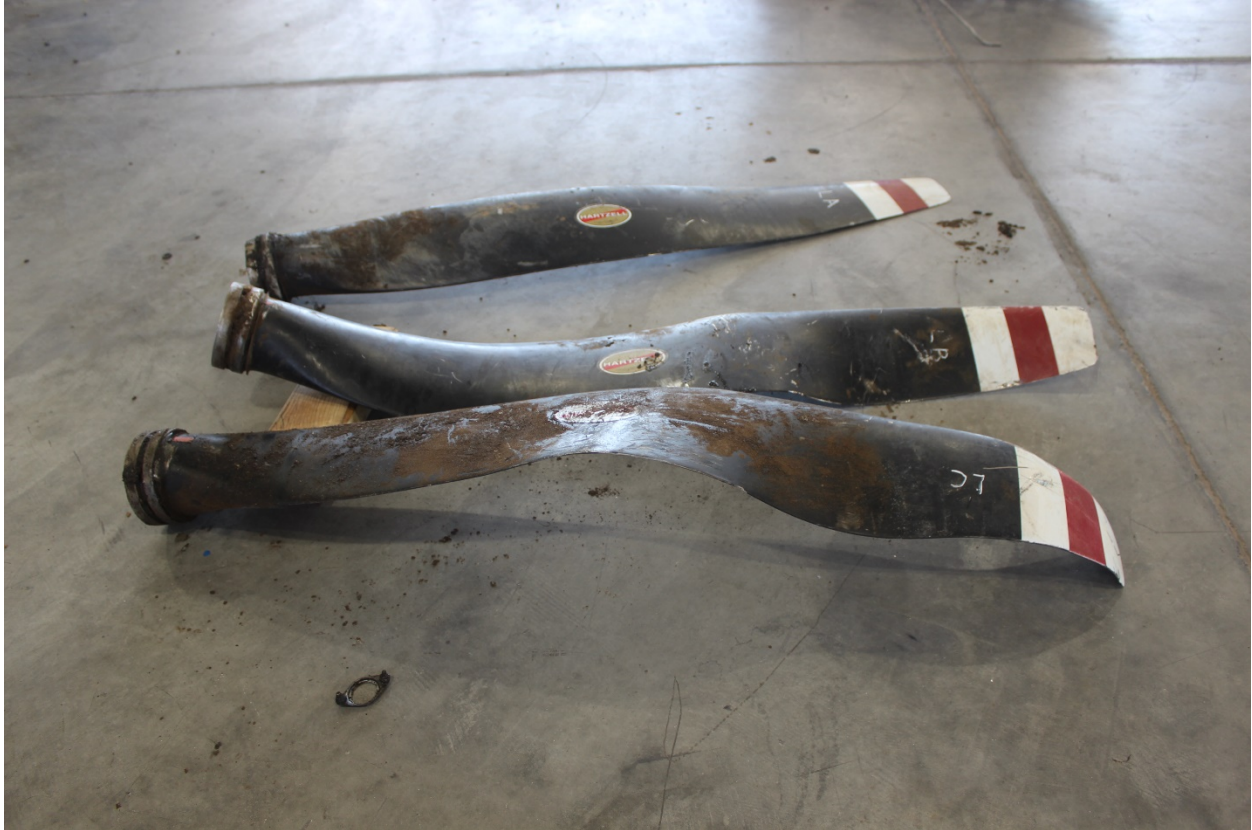
The left engine was partially separated from the airframe and the left propeller was partially separated from the engine.

Photo 03 - Left Engine Propeller Blades (Photo Courtesy of Lycoming)

Photo 04 - Left engine Propeller Blades (Photo Courtesy of Lycoming)

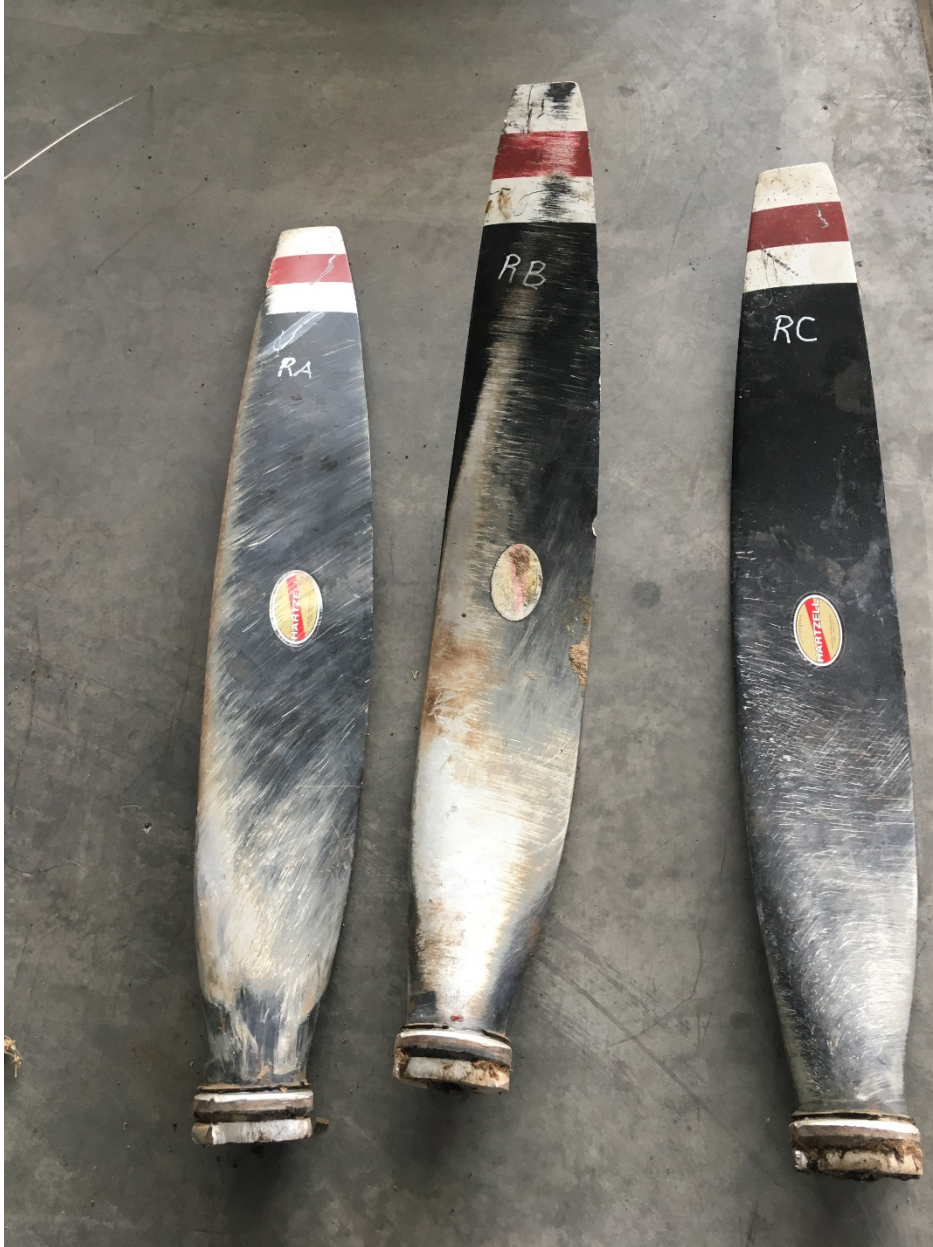
The right engine was partially separated from the airframe. The propeller assembly remained attached to the engine.

Photo 05 - Right Engine Propeller Blades (NTSB)
