NATIONAL TRANSPORTATION SAFETY BOARD  
Office of Aviation Safety  
Western Pacific Region

## **FIELD EXAMINATION**

WPR19FA096

Location: Riverside, California  
Date: March 16, 2019  
Aircraft: Airplane Beech BE-50, N800DC  
NTSB IIC: Tealeye Cornejo

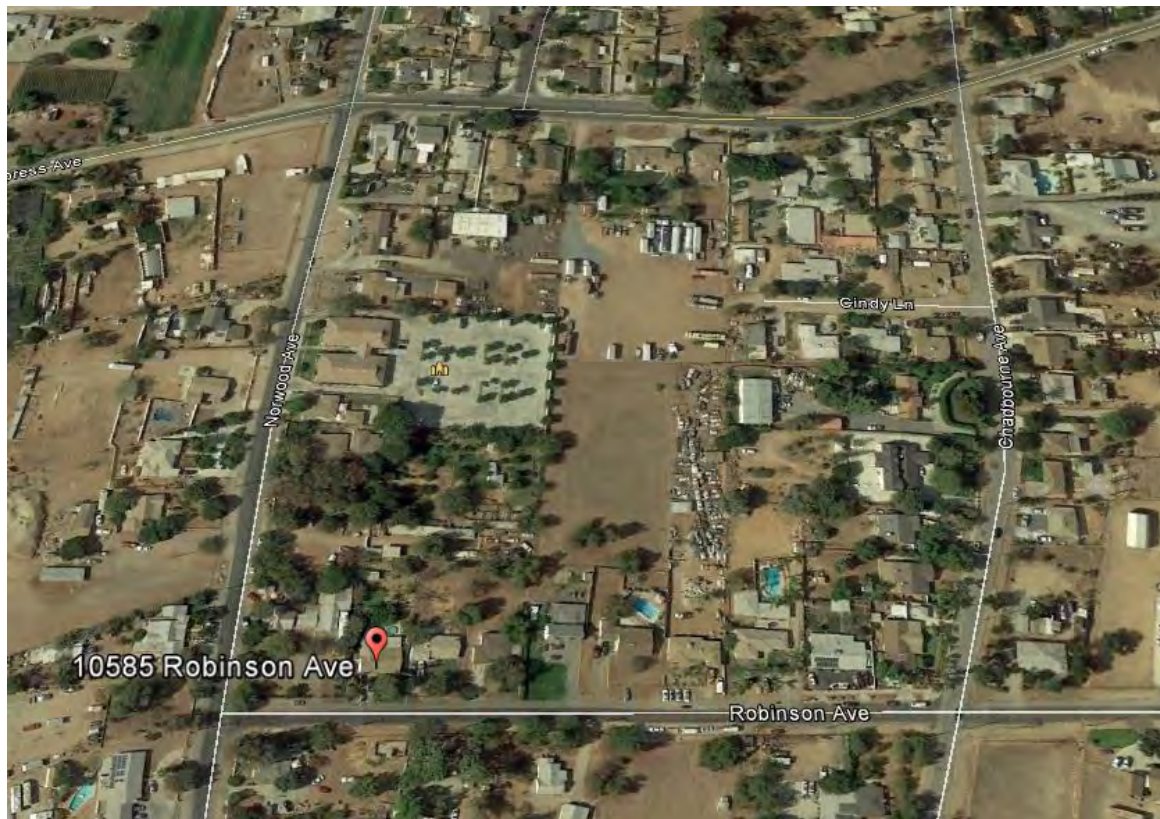
Photo 01 - Overview of Accident Area (GoogleEarth)

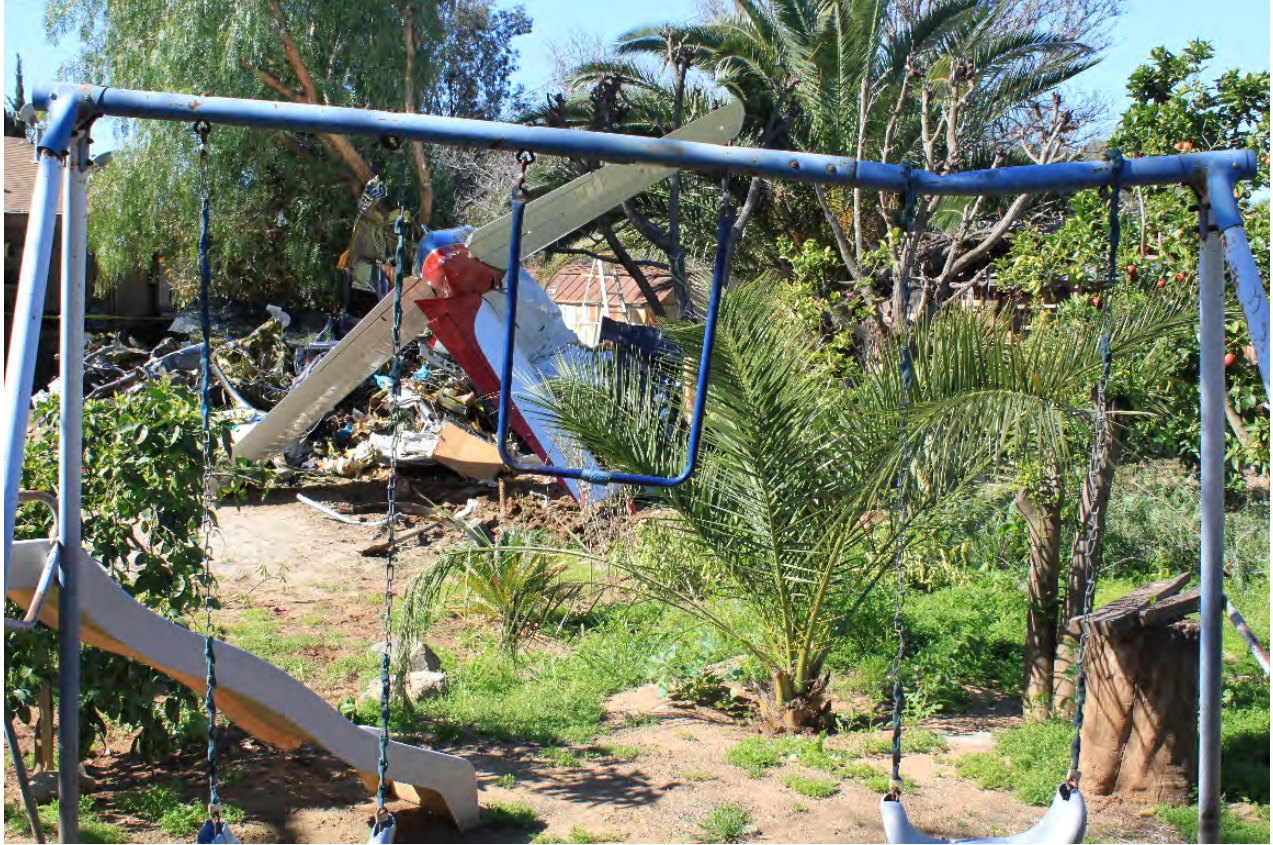
Investigators from the NTSB and the FAA accessed the wreckage on March 16. On March 17 the NTSB, the FAA, and party representatives from Textron Aviation and Textron Lycoming Engines accessed the accident site. All major structural components of the airplane were in the backyard of a residence. The airplane came to rest inverted between two trees; the terrain was flat, and the area contained several fruit trees. The GPS coordinates were 33°56.311 N/ 117°29.184 W at an elevation of 784 ft above ground level (agl). The debris path was along a 050° magnetic heading.

Photo 02 - Accident Site (NTSB)

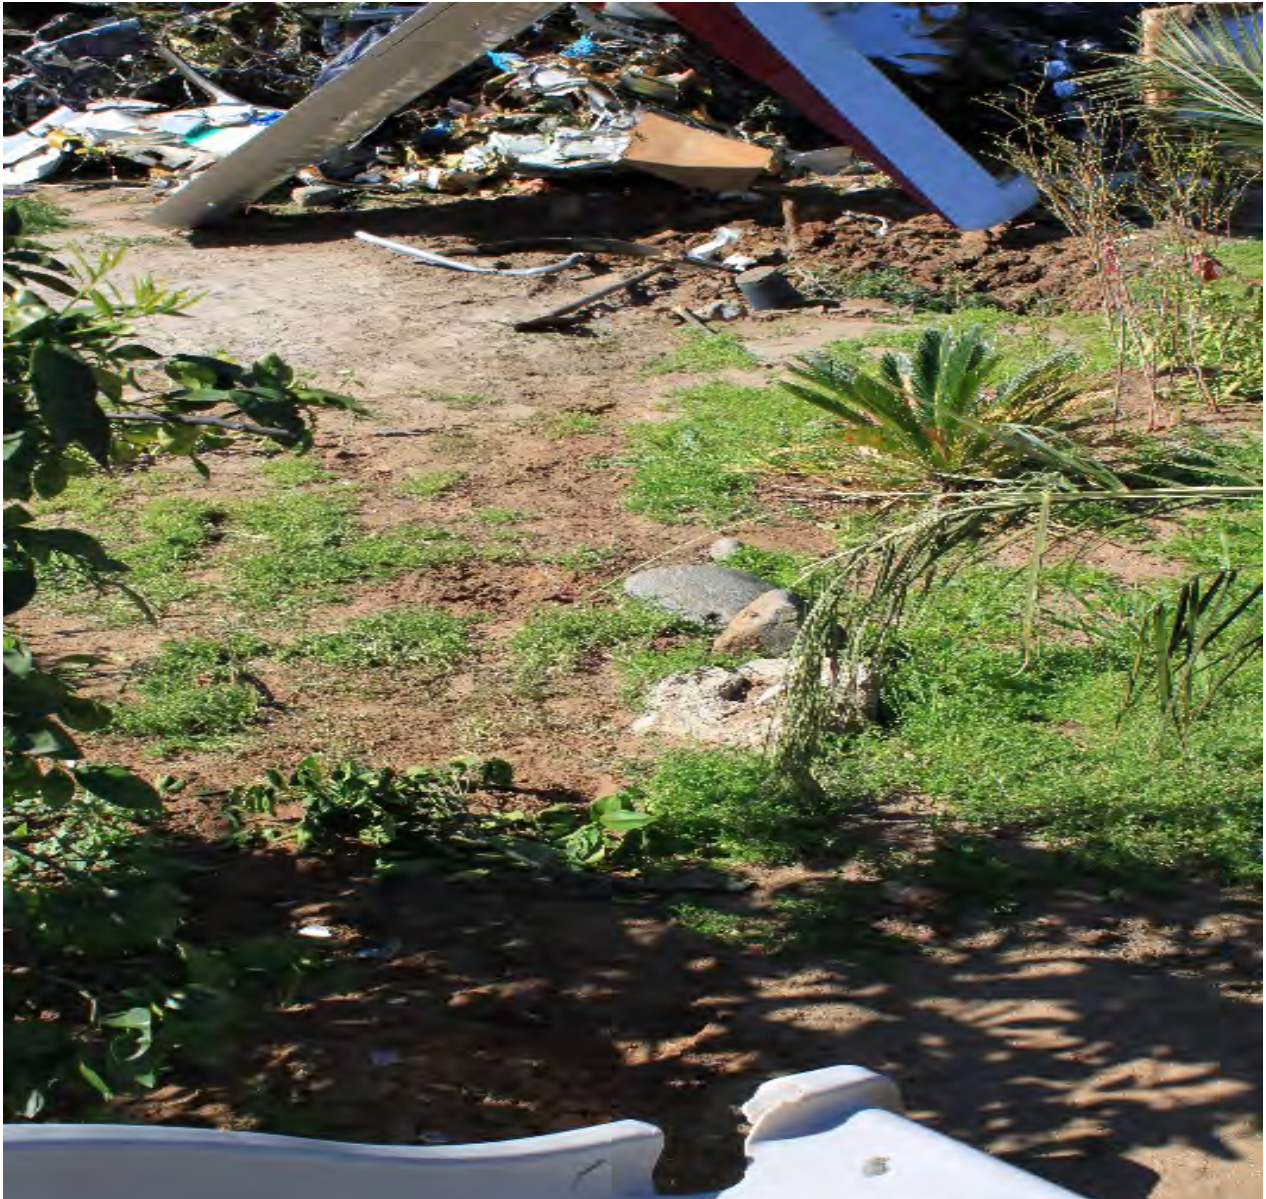
The first identified point of contact (FIPC) was a swing set in the northeast corner of backyard. The top metal bar had a depression in it, as well as paint similar to the airplane embedded in the top of the brace, and the bottom of the plastic slide was broken. The debris path was short and compact with a total length of about 25 feet. There was wing impression near the slide that extended out toward the main wreckage. Green colored lens was identified in the impression.

Photo 03 - Debris Path (NTSB)

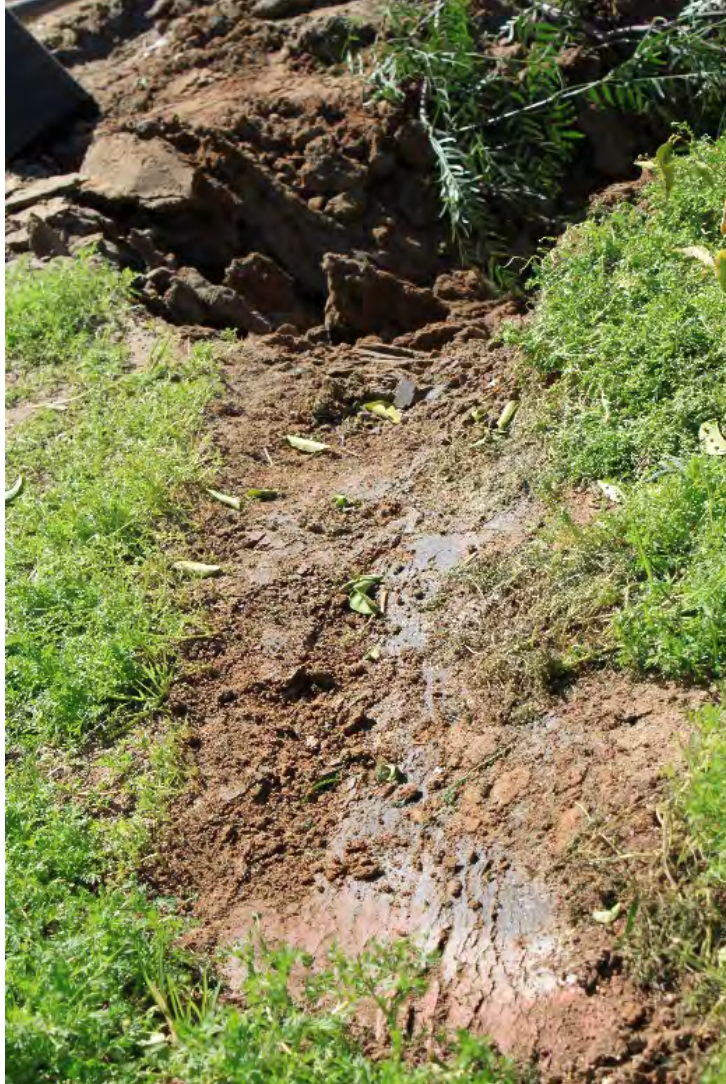
Photo 04 - Propeller Blade Strike (NTSB)

Each engine was equipped with a 3-bladed Hartzell propeller. All 3 blades separated from the right engine. Two of the 3 propeller blades separated from the left engine. Several tree branches appeared to have been cut by the propeller blades. Near the impact crater for the right engine was an impact mark consistent with a propeller blade.

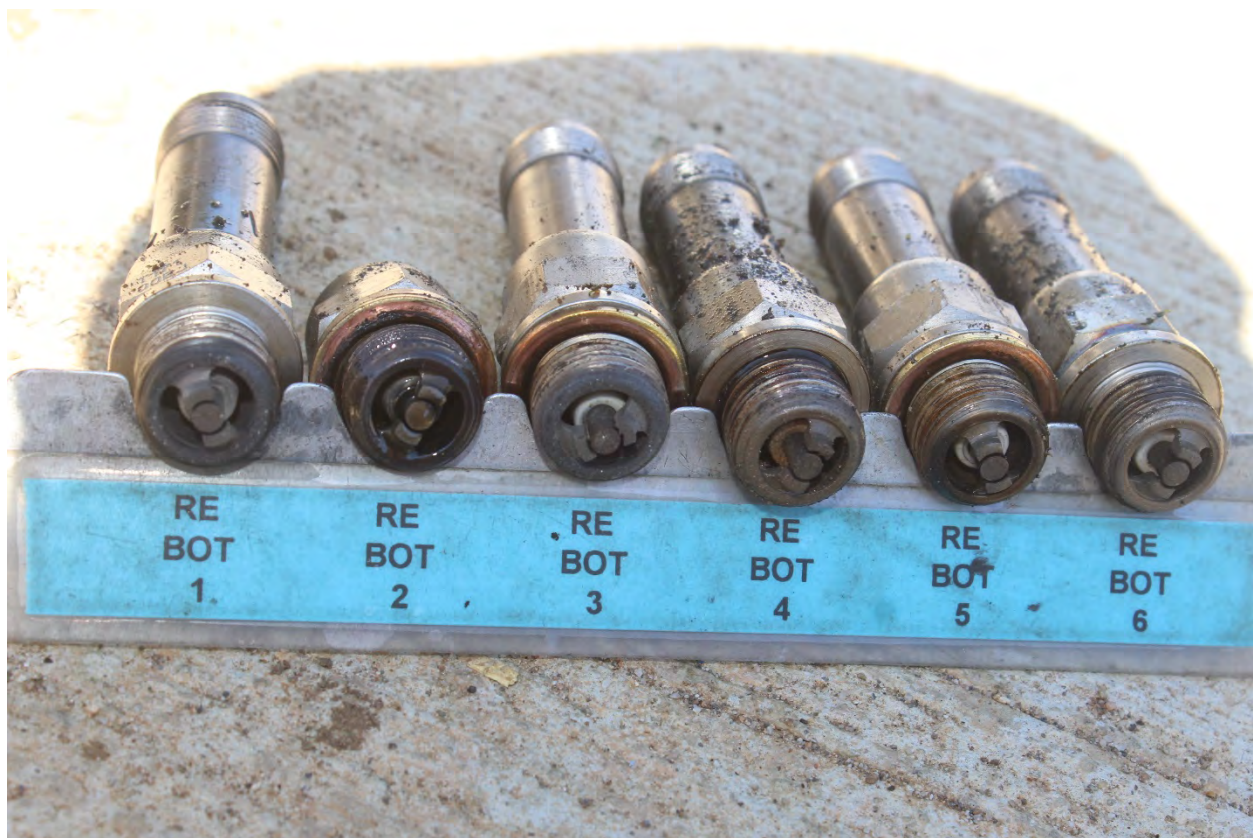
The bottom spark plugs for the right engine were removed, according to the Aviation Champion Spark Plug check-a-plug chart AV-27, the spark plugs electrodes displayed coloration consistent with normal operation.

Photo 5 - Bottom Spark Plugs Right Engine (Photo Courtesy of Lycoming)

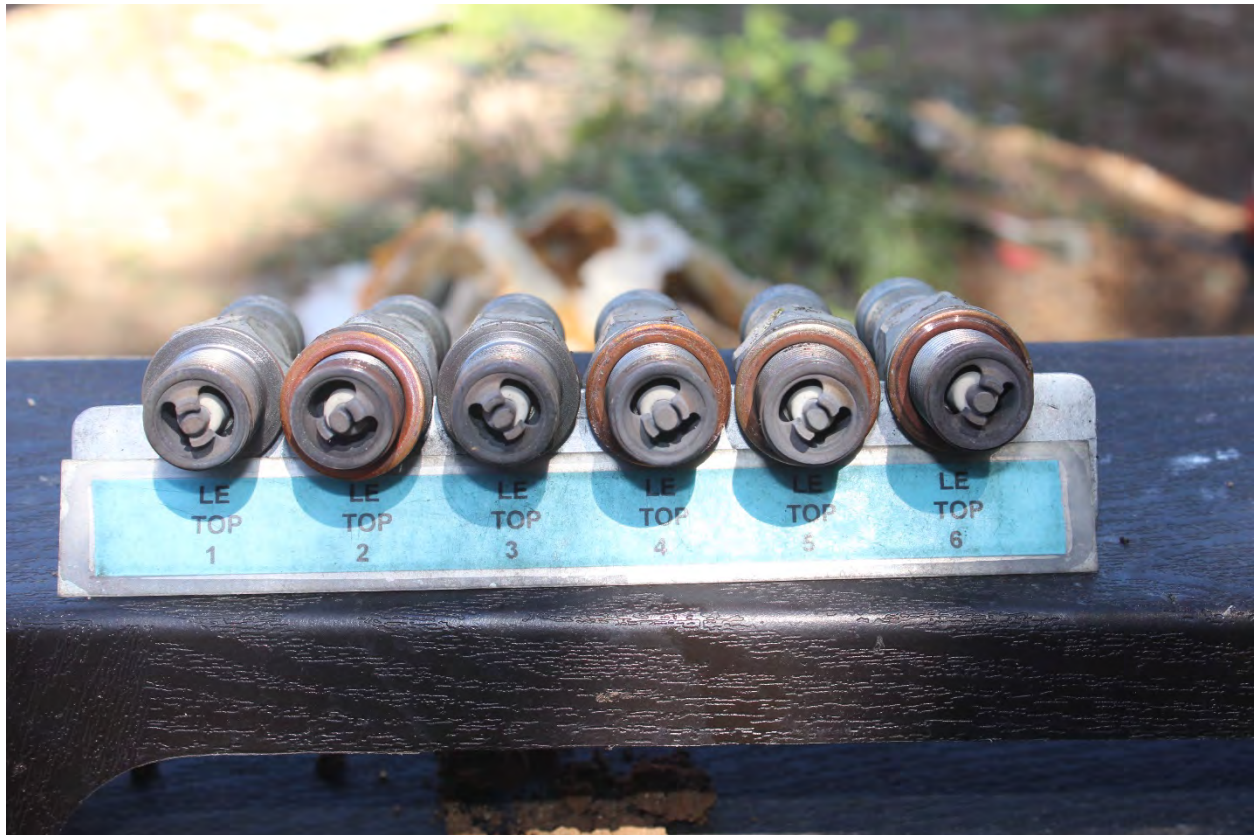
The top spark plugs for the left engine were removed, according to the Aviation Champion Spark Plug check-a-plug chart AV-27, the spark plugs electrodes displayed coloration consistent with normal operation.

Photo 06 - Top Spark Plugs Left Engine (Photo Courtesy of Lycoming)
