## **NATIONAL TRANSPORTATION SAFETY BOARD**

# **AIRFRAME AND ENGINE EXAMINATION**

**WPR19FA103**

Location: Farmington, New Mexico  
Date: March 31, 2019  
Aircraft: Cirrus SR-22, N173CT, SN: 2961  
NTSB IIC: Elliott Simpson

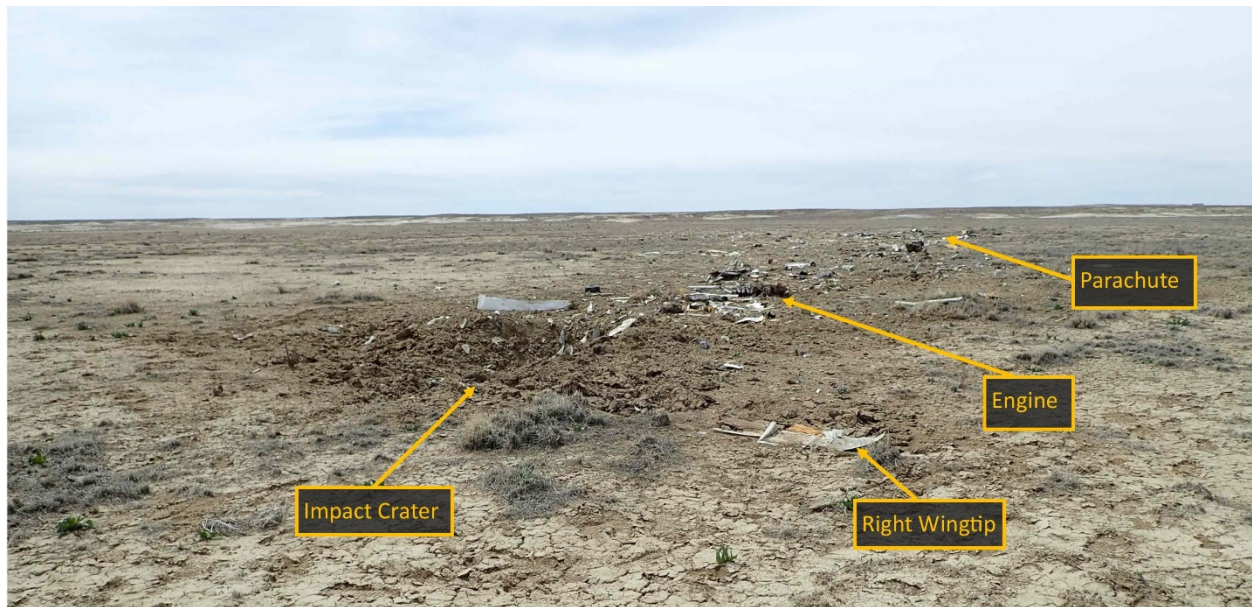
Photo 1 – Accident site debris field

The first identified point of impact was a 4-ft-deep by 10-ft-wide crater which contained the nose landing gear assembly, two propeller blades, and fragmented engine and airframe components. Two matching linear impact marks, the total length of which corresponded to the airplane's wingspan, emanated from the crater on a north-south heading. The right wingtip and green navigation lens fragments were found at the tip of the northern mark, and red navigation lens fragments were located at the tip of the southern mark. (Photo 1).

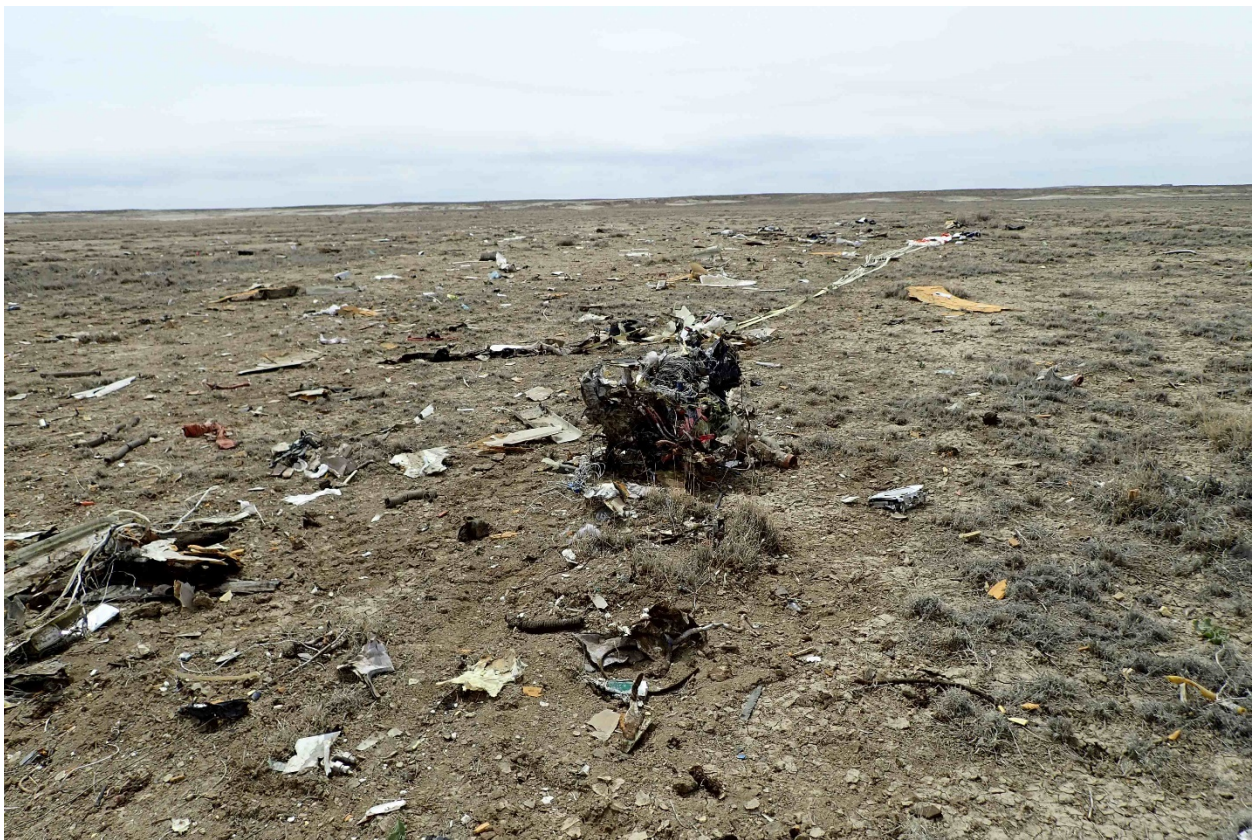
Photo 2 – Engine and parachute

The debris field was 450 ft long, on a heading of about 210°. The engine came to rest about 30 ft beyond the crater (photo 2), and the remainder of the debris was composed of fragmented pieces of composite main cabin and wing structure, fanned out to a width of about 100 ft. The aluminum ailerons, elevators, and flaps were crushed and distributed throughout the debris field, and the farthest components were the left forward seat and a wing fuel cap.

The rocket-powered airframe parachute was located in the center of the debris field. The harness cables remained attached to their respective airframe fittings, and the top of the parachute canopy remained folded evenly along its pleats and had not unfurled (photo 2). Although the canopy lines had extended to their full length, the solid-fuel rocket motor remained attached to the parachute assembly and had not been expended (photo 3). These findings were consistent with the parachute system having not been activated in flight.

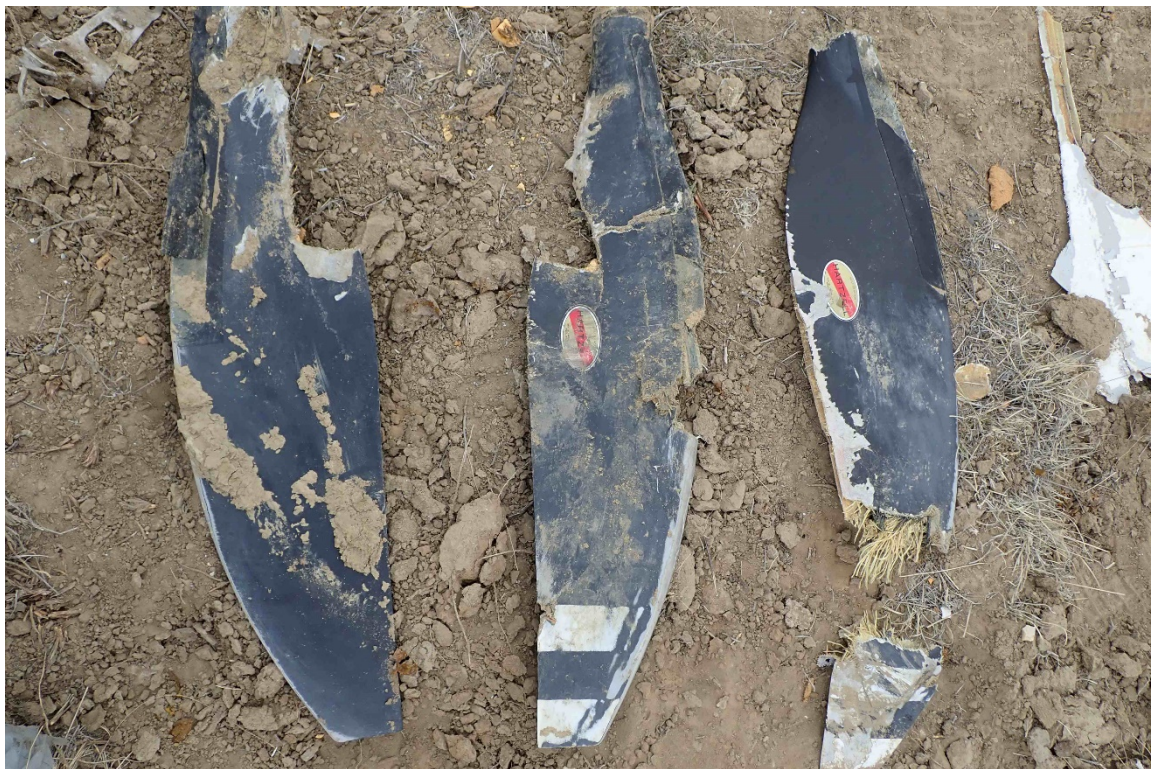
Photo 4 – Propeller blades

All three propeller blades were separated from the hub and had fragmented. Two propeller blades were located in the impact crater. The third propeller blade was located in the debris field

approximately 200 feet from the initial point-of-impact. The spinner was crushed around the impact damaged propeller hub and all three composite blades separated (photo 4).

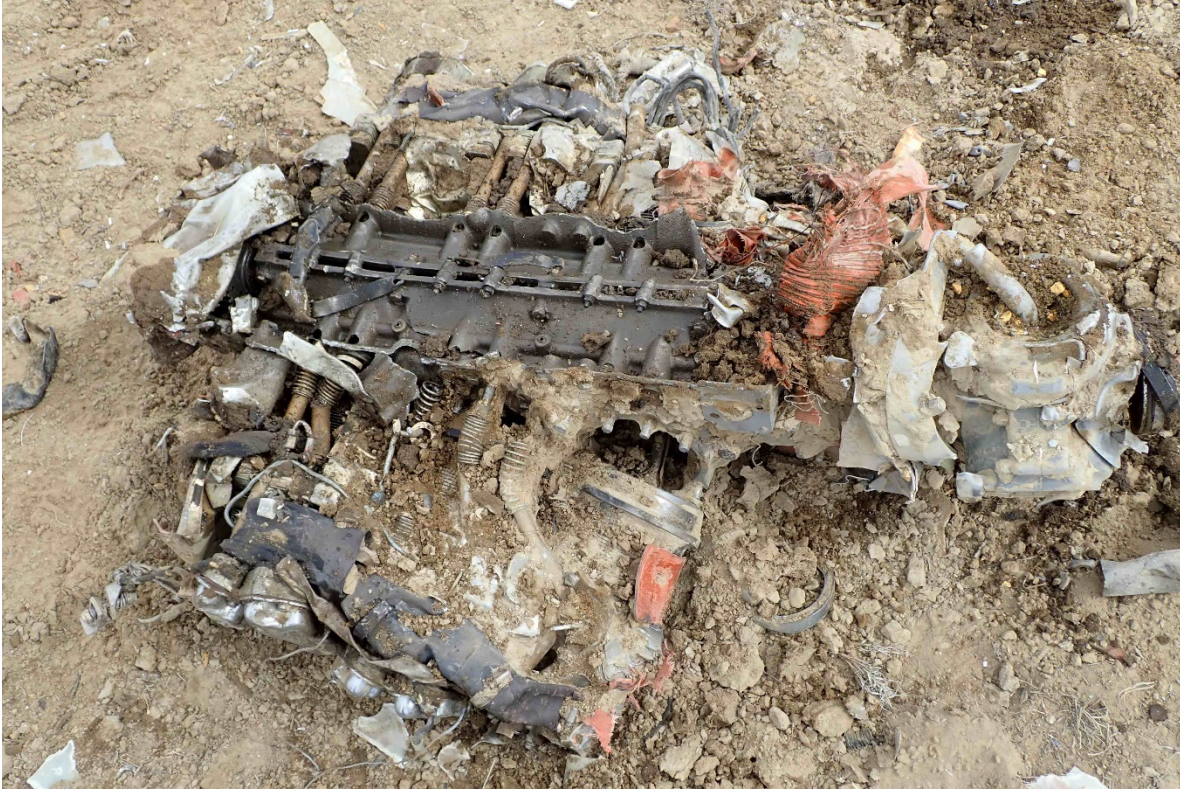
Photo 5 – Engine at accident site

The engine sustained significant impact damage, liberating the oil sump, most of the accessories, and bending the forward cylinders aft (photo 5). Internal examination did not reveal any evidence of catastrophic failure, and examination of the spark plugs revealed that their electrodes exhibited wear signatures and coloration consistent with normal service life and erosion, when compared to the Champion “Check-A-Plug” chart (photo 6).

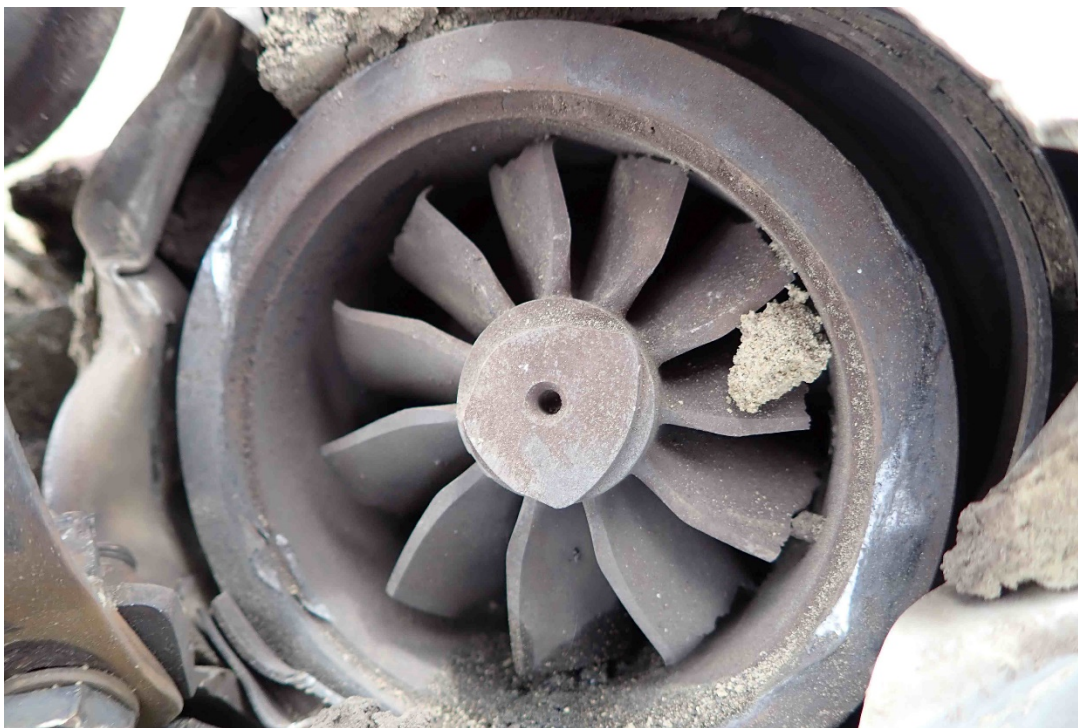
The engine driven fuel pump sustained bending and crushing damage and had broken away from the engine. The drive spline remained within the input drive, and disassembly revealed that the drive vane and impeller blades were damaged (photo 7, 8).

Photo 7 – First turbocharger turbine wheel

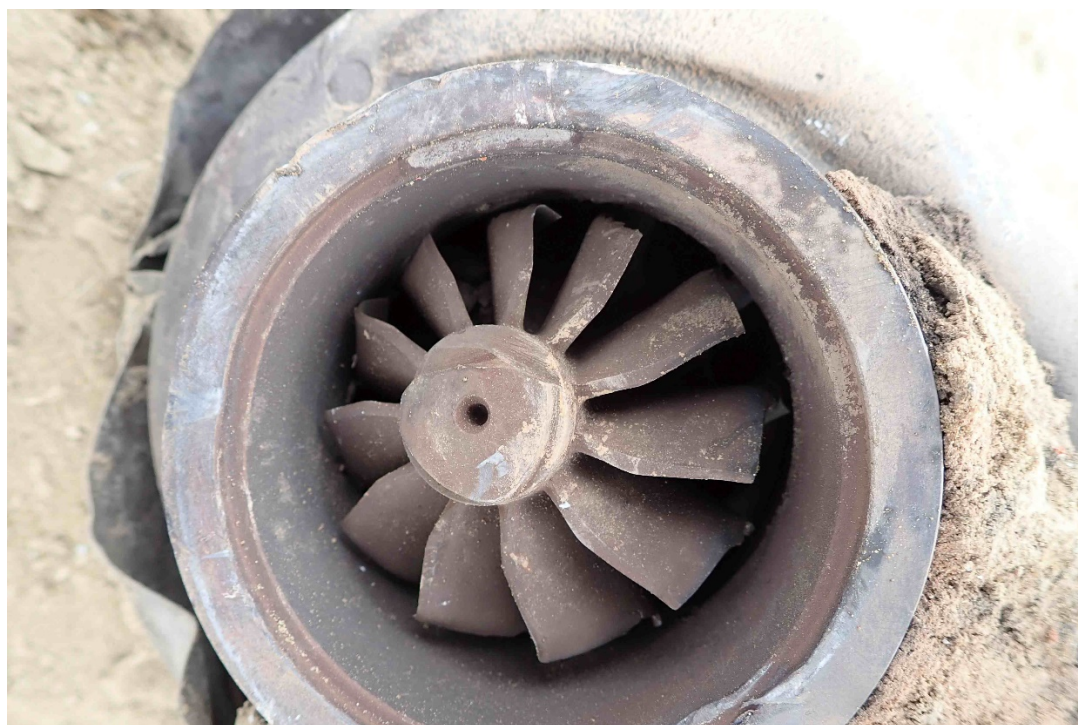
Photo 8 – Second turbocharger turbine wheel
