## **NATIONAL TRANSPORTATION SAFETY BOARD**

# **ENGINE EXAMINATION**

**WPR19FA106**

Location: Santa Fe, NM  
Date: April 8, 2019  
Aircraft: Costruzioni Aeronautiche Tecnam P2002 Sierra,  
Registration Number: N118LS  
NTSB IIC: Albert Nixon

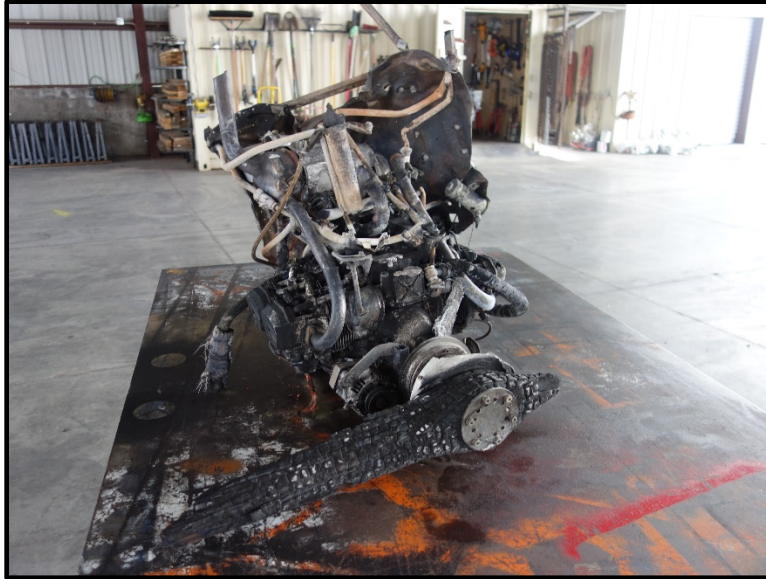
Examination of the Rotax 912 ULS2 engine revealed that it was thermally damaged particularly on the bottom portion. The crankcase was intact. The rocker covers were removed. Rocker cover No. 1 exhibited a ¼ inch hole on the front bottom portion consistent with impact damage. The crankshaft was able to be rotated by hand rotation using the flywheel retainer bolt and rotational continuity was established throughout the engine and valve train in all cylinders. The pick-up coils for the ignition were thermally damaged. The flywheel from the ignition housing was removed and examined and no anomalies were noted. All the spark plugs were removed, and their electrodes exhibited "normal wear" signatures when compared to the Champion Check-A-Plug comparison chart and all anomalies were consistent with thermal damage and the position of the engine.

**Figure 1: Engine being prepared for examination as viewed from the front.**
