## **NATIONAL TRANSPORTATION SAFETY BOARD**

### **ONSITE EXAMINATION NOTES**

**WPR19FA106**

Location: Santa Fe, NM  
Date: Apr 8, 2019  
Aircraft: N118LS  
NTSB IIC: Albert Nixon

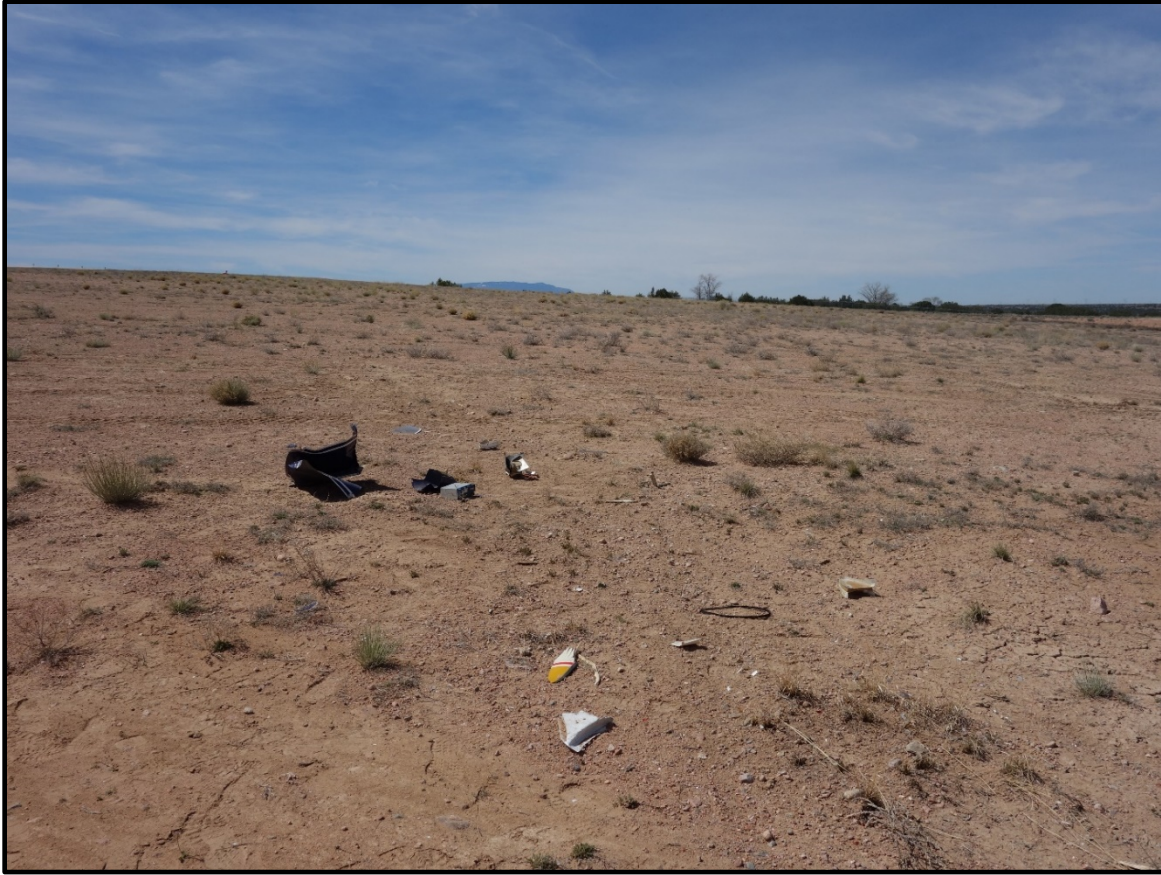
Examination of the accident site revealed that the airplane impacted terrain about 527 ft northeast from the departure end of runway 33, at the Santa Fe Regional Airport, Santa Fe, New Mexico. The elevation was about 6303 ft. The terrain was flat, desert, and with very light vegetation. All major components of the airplane were contained within the main wreckage site. Wreckage debris was scattered about 100 ft from the main wreckage. The first identified point of contact was a large area of disturbed dirt, about 2 ft long by 2 ft wide in size and 2 inches deep, where several pieces of the lens from the green position light were located. The disturbance was about 91 ft from the main wreckage. About 18 ft further, another ground disturbance about 2 1/2 ft long, 2 ft wide, and an inch deep, where propeller splinters and the top third of a blade were located. Ground scars emanated from this area of disturbed dirt to the area where the main fuselage came to rest. The debris trail was about on a 005° magnetic heading. The airplane's fuselage came to rest upright on a heading of about 175° magnetic. There was a postimpact fire that consumed the left wing and the cabin area.

Figure 1: Airplane wreckage debris trail as viewed looking towards the departure end of runway 33.

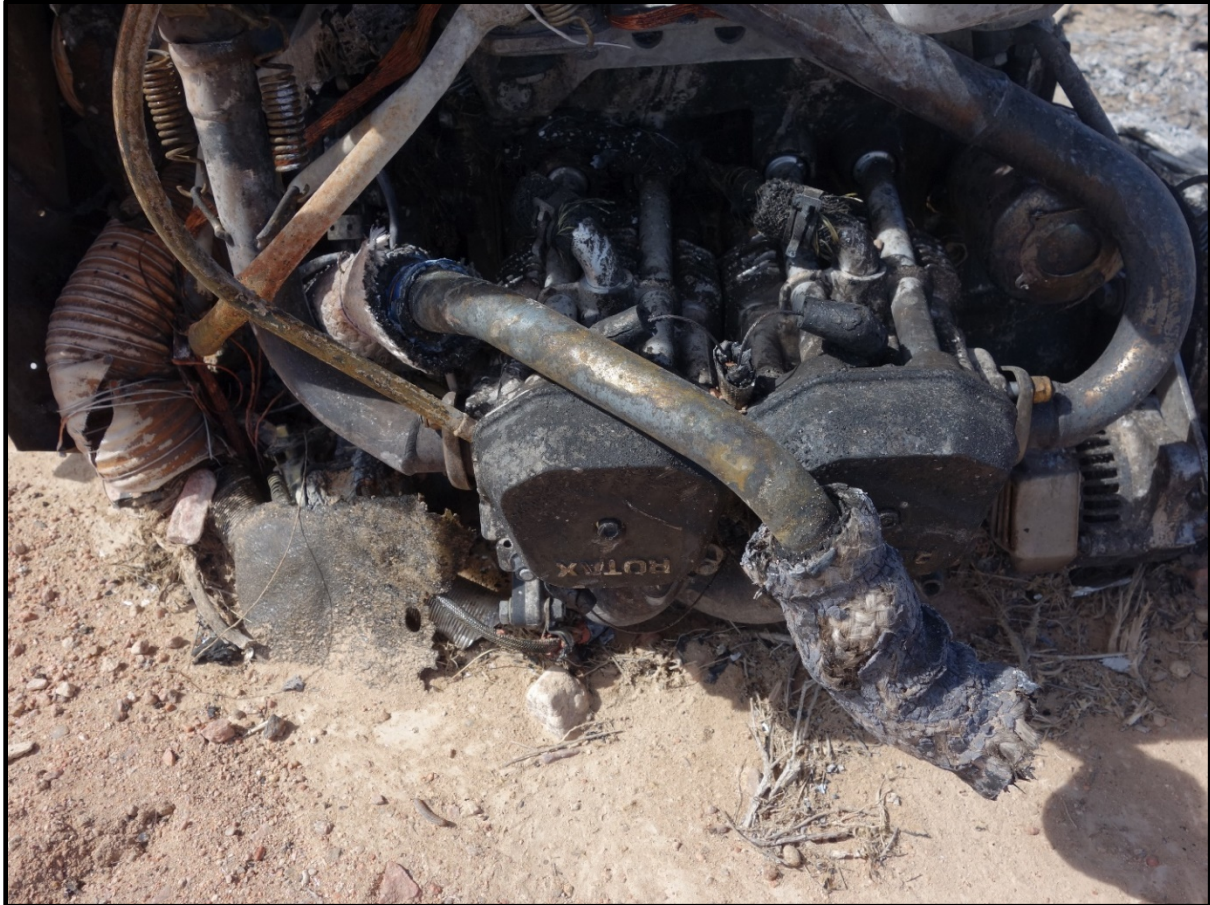
Figure 2: The engine as view from the left side (engine inverted).

The Rotax engine came to rest inverted about 90° to the left of the fuselage heading. The engine was separated from all of the engine mounts. The two-bladed wood propeller remained attached to the crankshaft and sustained thermal damage. One of the blades was separated near the hub and about a 1/3 section of it and several splinters were located near the initial impact area. Some of the blade splinters exhibited chordwise scratches. The propeller spinner was separated and exhibited impact markings.
