## **Engine Investigation Report**

**Rolls-Royce Corporation  
Model M250-C20B  
Engine CAE-830577**

**Nick Shepler  
Air Safety Investigations**

**Accident Date: 16 April 2019  
Investigation Date: 17-18 April 2019  
Report Date: 5 June 2019**

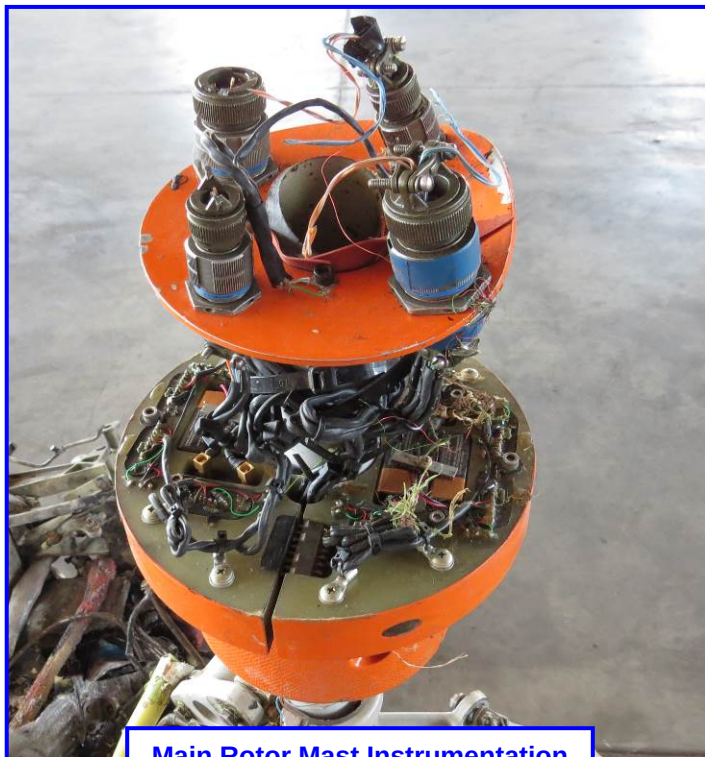
The aircraft exhibited damage consistent with impacting in nearly vertical forces on its right hand side. A significant portion of the cabin structure and passenger compartment was consumed from a post-crash fire. The main rotor mast was heavily instrumented and was fractured just below the connection to the main rotor head. The tail boom was fractured aft of the horizontal stabilizer. Evidence of a main rotor blade strike was noted on the underneath side of the left hand horizontal stabilizer. The main rotor blades exhibited various levels of damage and broom-strawing of the carbon fibre layers.

Main Rotor Mast Instrumentation

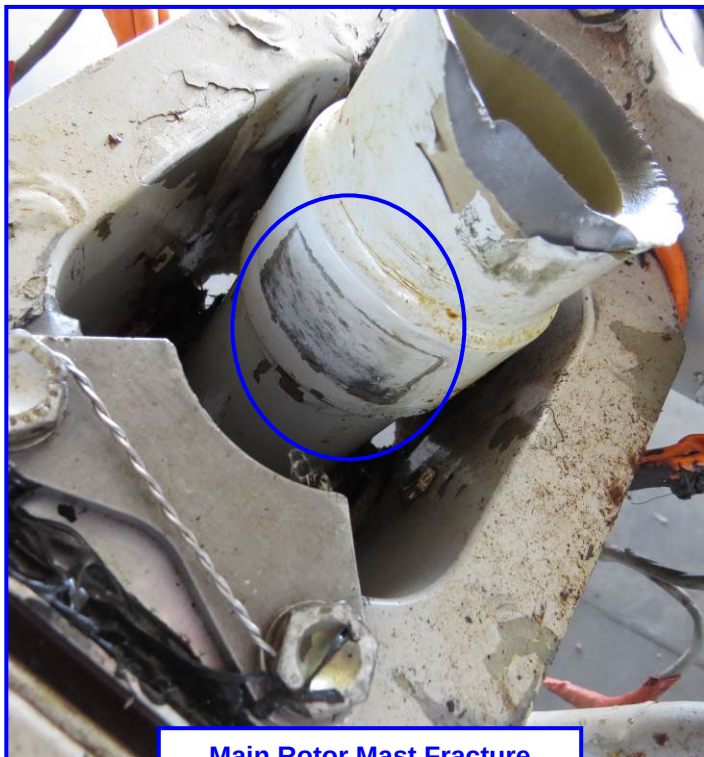
Main Rotor Mast Fracture

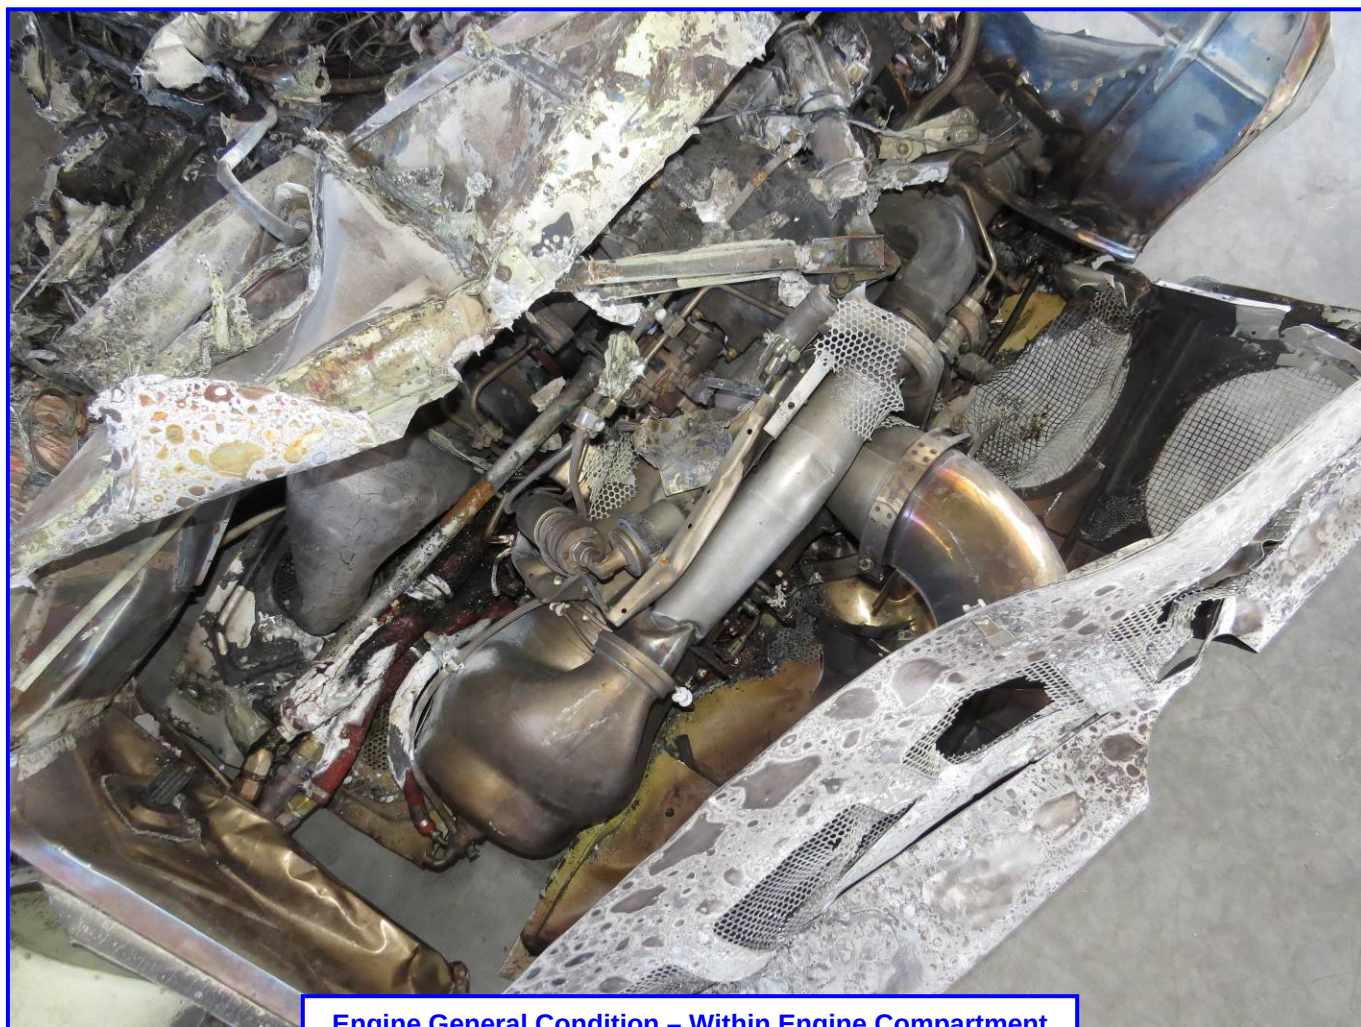
Engine General Condition - Within Engine Compartment

The engine remained mostly intact within its mounts and the engine compartment with only the left hand side aft mount leg detached from the fuselage. The right hand exhaust duct was crushed over and nearly covering the outlet of the exhaust collector support. Both exhaust ducts were subsequently removed in order to extract the engine from the wreckage and to provide better visual access to the exhaust collector support and power turbine rotor. Visual and tactile inspection of the fuel, oil, and electrical connections that were not separated from their respective attachment points appeared secure including various B-nut connections when checked using hand pressure. The engine displayed no visible sign of pre-impact damage, fire, or mechanical malfunction.

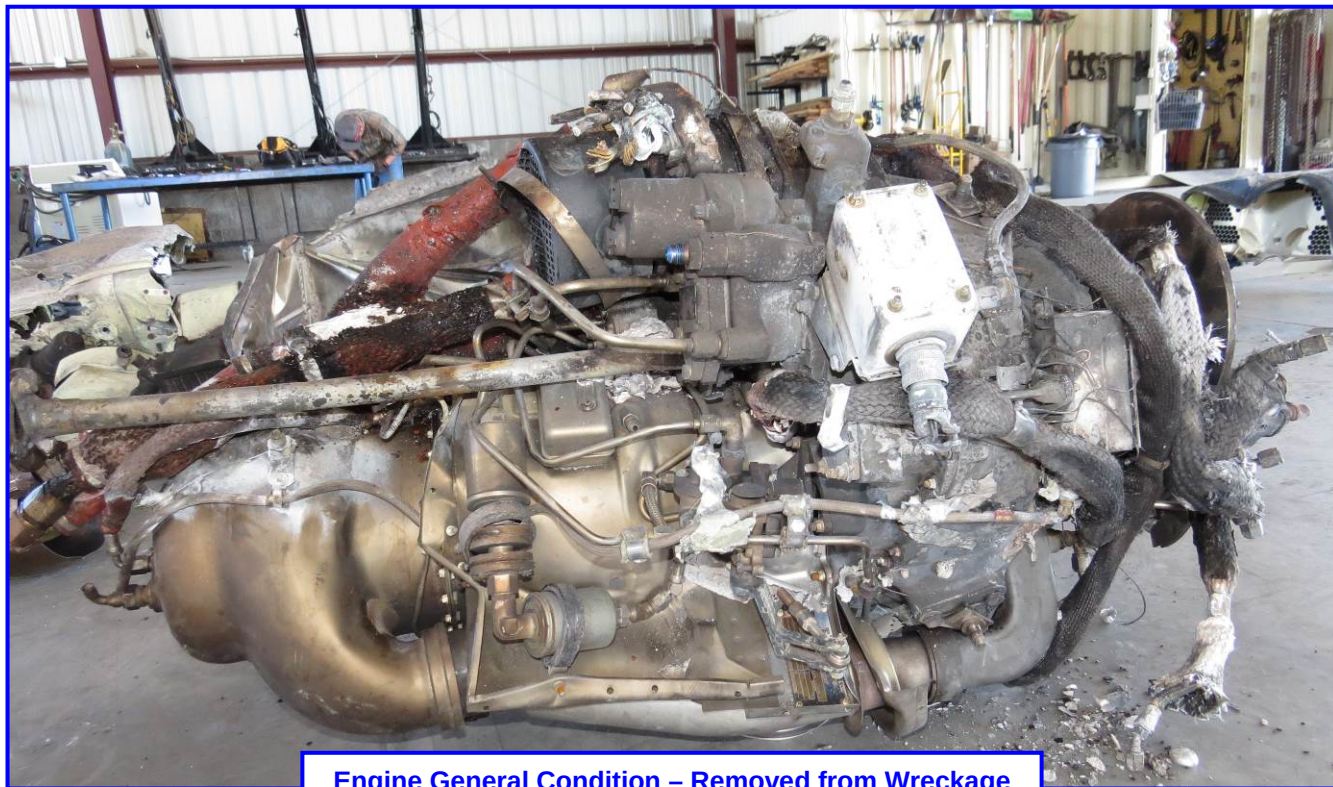
Engine General Condition – Removed from Wreckage

The engine to transmission drive shafting was fractured at the KAflex® coupling fingers forward of the freewheeling unit and rotor brake assembly as well as at the input connection to the main rotor transmission.

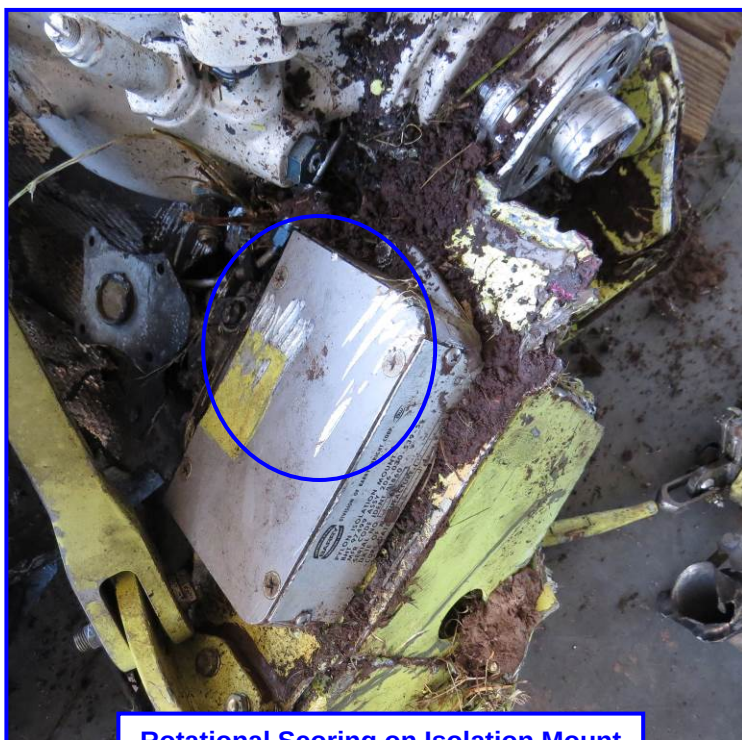
Heavy rotational scoring was noted on the top surface of the isolation mount and at the input shaft to the main rotor transmission.

Rotational Scoring on Isolation Mount

- Rotational scoring on the main rotor transmission isolation mount from contact with fractured KAFlex® forward output drive shaft.
  - Fracture damage to the KAFlex® forward shaft flexure links.

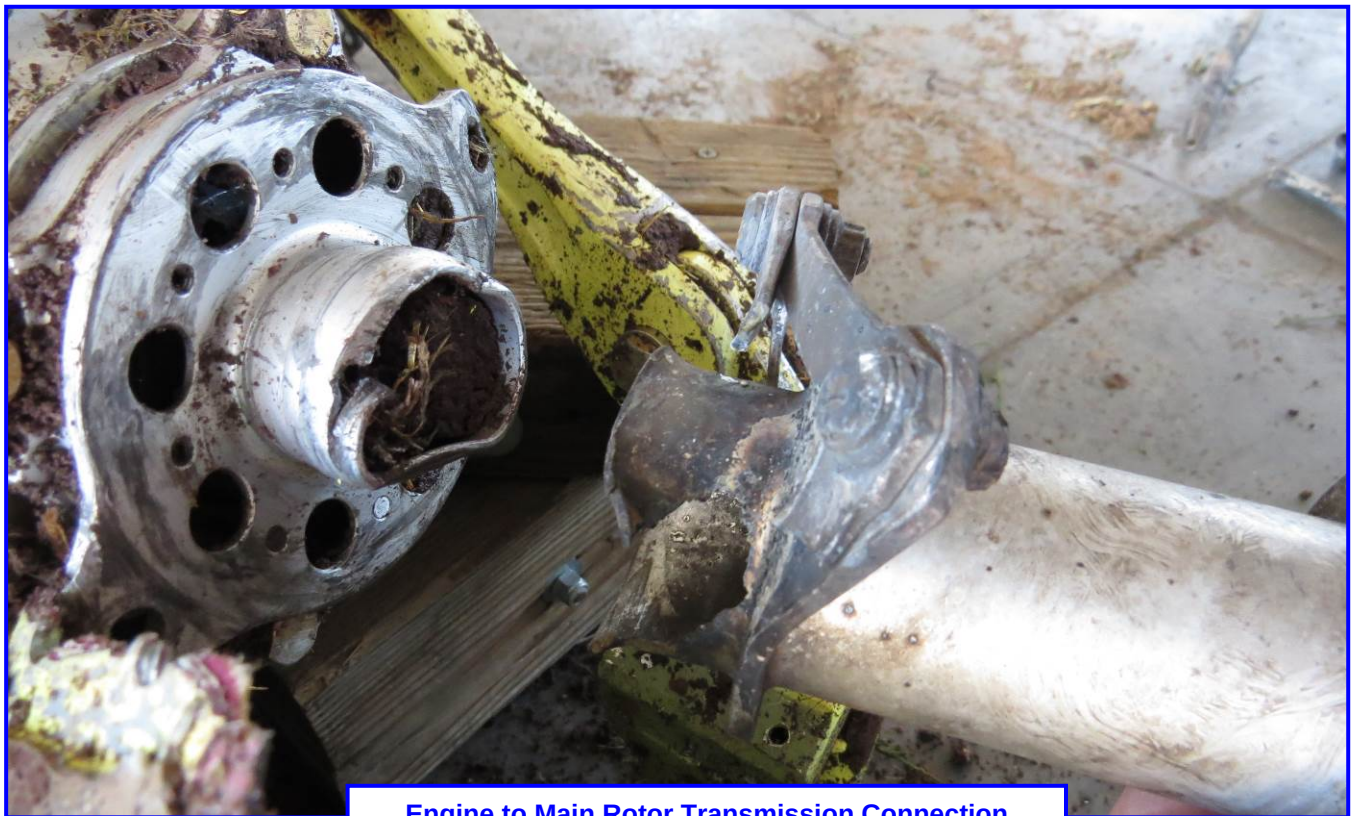
Engine to Main Rotor Transmission Connection

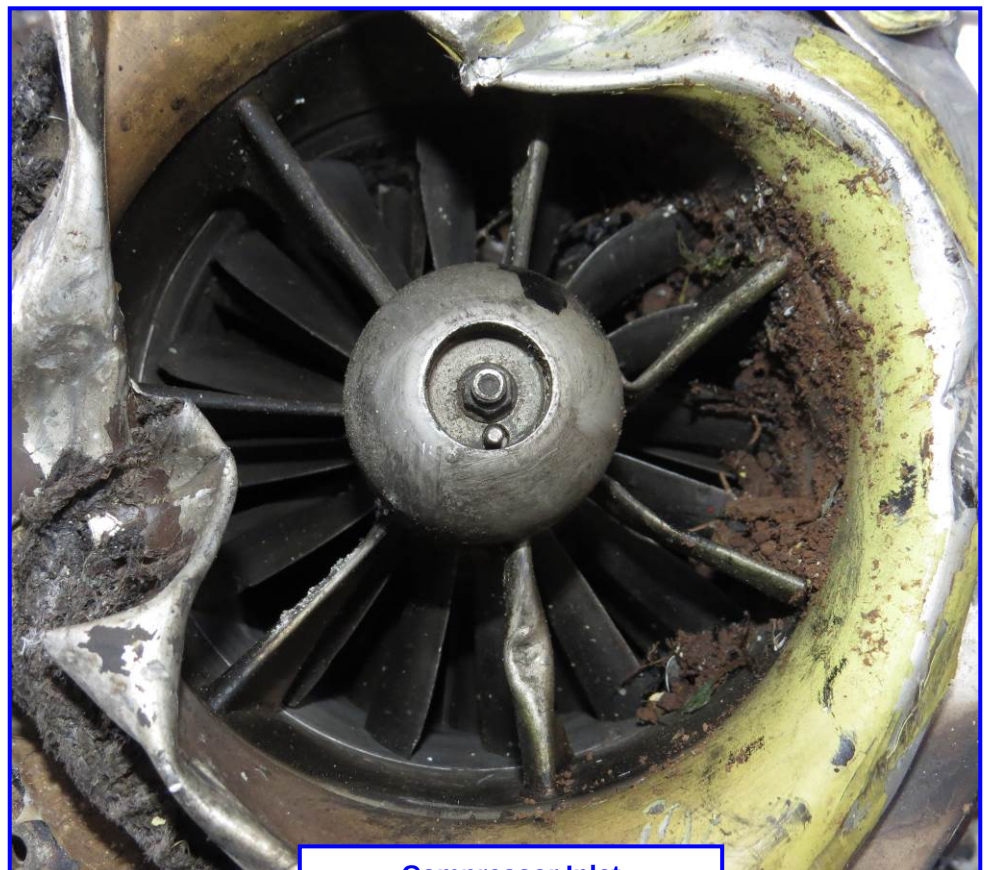
Three of the compressor inlet struts were either heavily dented or buckled from impact forces. A portion of the compressor inlet contained dirt and vegetation back to the 1<sup>st</sup>-stage vane row.

Several of the 1<sup>st</sup>-stage blades exhibited dents, abrasion, and curling at the leading edge tips. Heavy blade bending opposite rotor rotation was observed beyond the 1<sup>st</sup>-stage.

The lower compressor case half was crushed radially inward over the length of the rotor. A large circumferential tear approximately 4" in length was visible on the lower case half.

Compressor Inlet

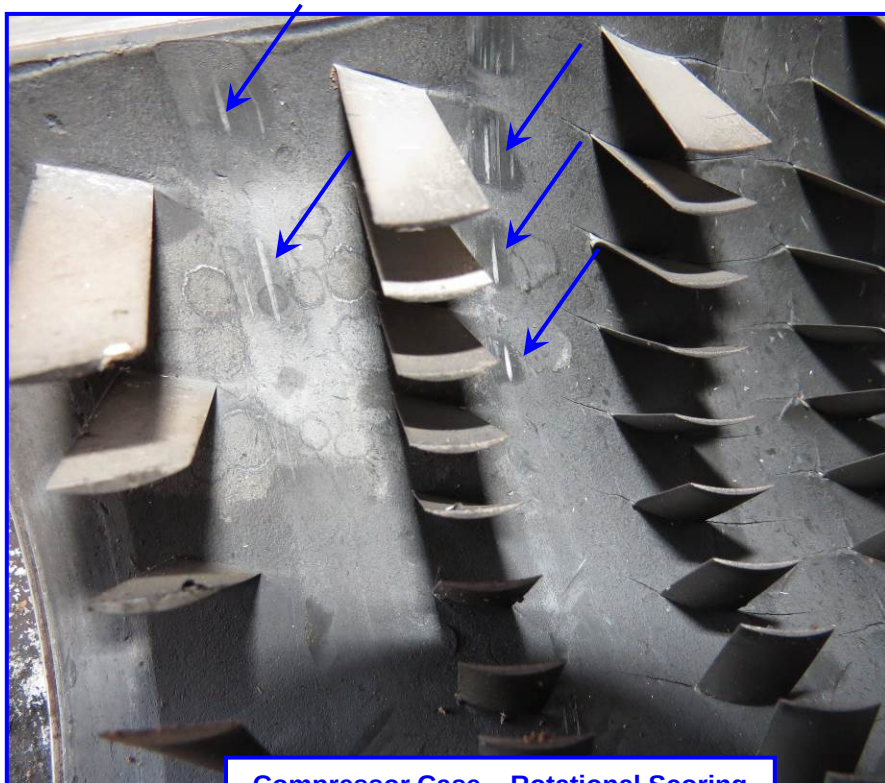
The compressor case halves were later removed to assess the full extent of damage and to attempt rotational continuity of the N1 rotor system. Rotational scoring was noted on a portion of the upper case half in line with stages 2 & 3.

The lower case half showed extensive bending damage to the vanes in stages 1 thru 4. The black plastic inner case coating was also severely damaged and delaminated in large sections.

The compressor rotor blades in the area of inward crush damage on the lower case half were heavily rolled over and bent opposite the direction of rotation.

Compressor Case – Rotational Scoring

- Rotational scoring on compressor stage 2 & 3 blade tracks.

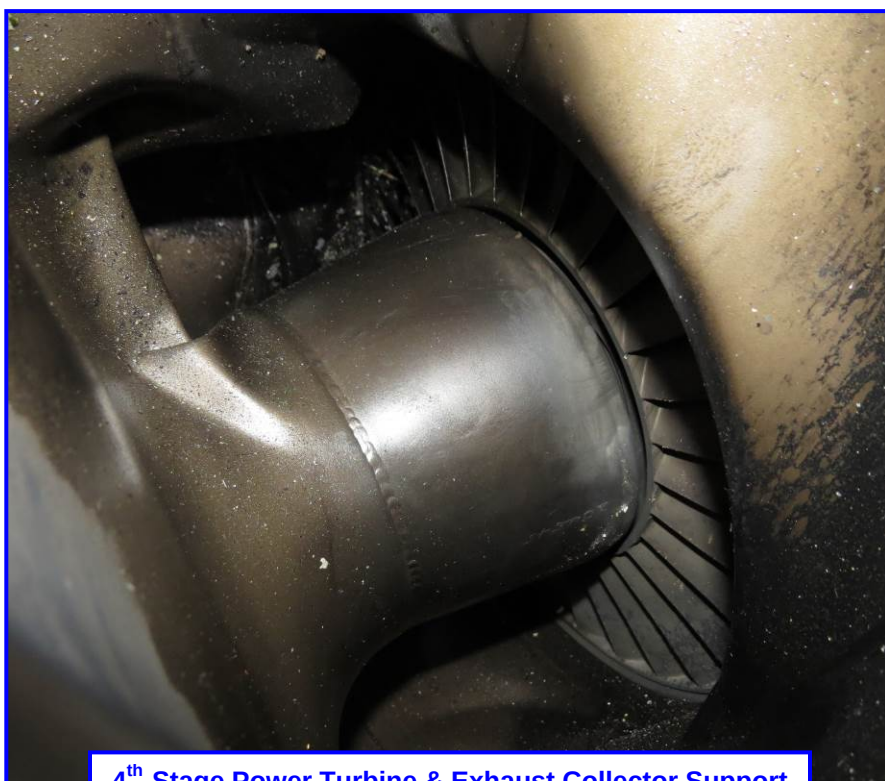
The 4th-stage power turbine blades did not display signs of impact or thermal related damage when viewed thru the exhaust duct outlets. Random pieces of dirt, debris, and similar vegetation were lying inside the exhaust collector support. The support sustained inward crush damage on its right hand side as well as at the tunnel area. Oil wetting was noted at the 3:00 quadrant of the 4<sup>th</sup>-stage power turbine wheel corresponding to the orientation of the engine and wreckage at the crash site.

4<sup>th</sup>-Stage Power Turbine & Exhaust Collector Support

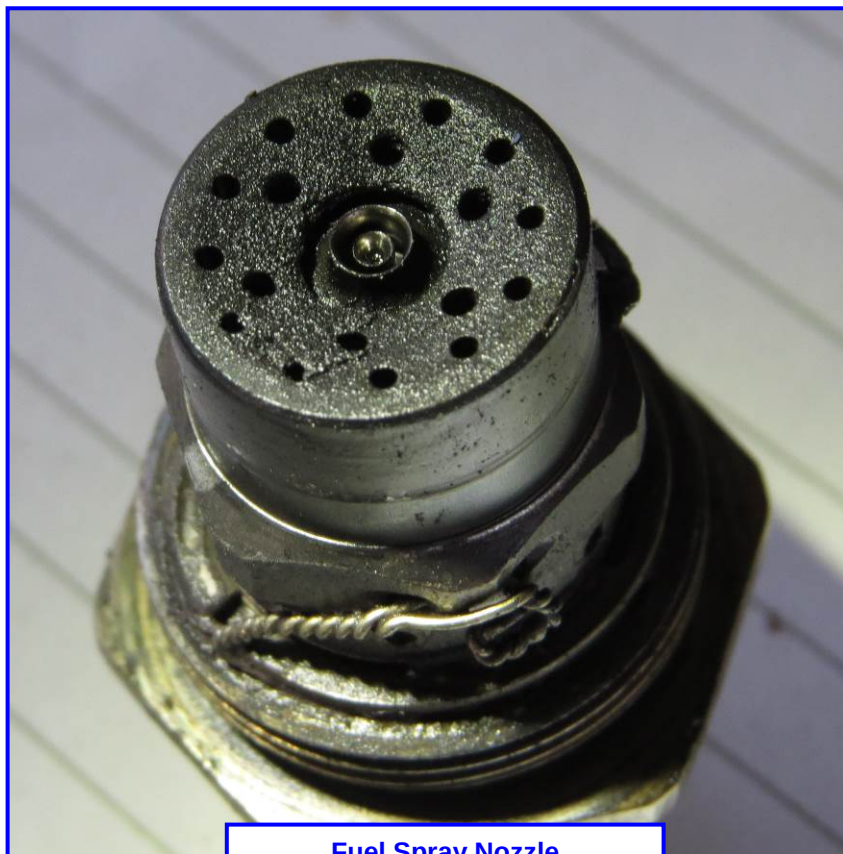
The flex hose between the horizontal turbine fire shield check valve and the fuel spray nozzle was removed prior to removing the nozzle. There was no evidence of fuel in the hose. The fuel spray nozzle was removed and inspected. There was no evidence of obstruction in the fuel spray nozzle inlet. The nozzle tip appeared clean with no discernible evidence of coking or soot. The nozzle was not further disassembled.

Fuel Spray Nozzle

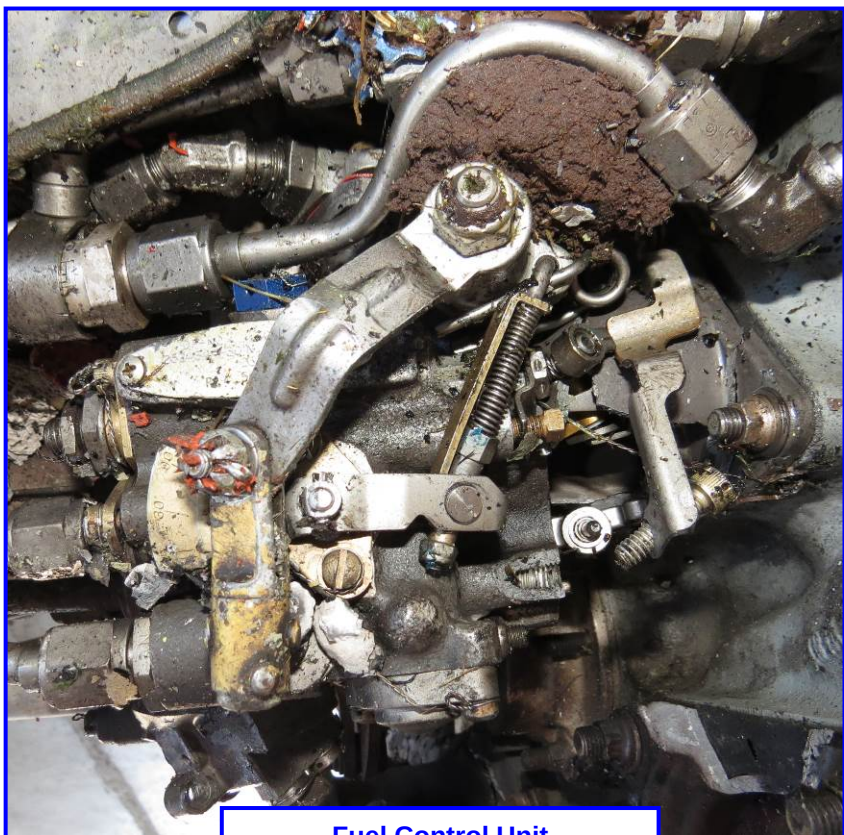
The Fuel Control Unit (FCU) was heavily damaged particularly at its connection with the gearbox. The FCU housing had fractured in multiple locations at the mounting flange. Several of the internal components including the rotating flyweight assembly were exposed.

The airframe linkage up to the FCU input arm was fractured. The actuation arm on the FCU could not be rotated using hand pressure and the FCU pointer was positioned at the "0" mark.

Fuel Control Unit

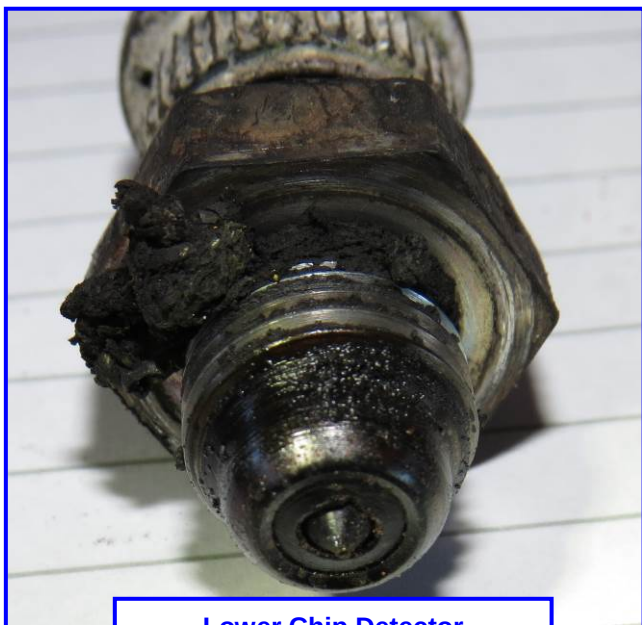
The magnetic chip detectors were removed and inspected. Both chip detectors were void of ferrous metal debris. The upper chip detector did contain a dusty layer of rust colored, crusty debris over the tip and body surfaces. The engine pressure oil filter was removed and inspected. The filter and housing were oil wetted and the filter appeared clean and clear of contamination inside the pleats. The oil filter housing on the gearbox was approximately 2/3 full, the oil appeared normal in color and clarity with no indication of suspended debris. The airframe auxiliary engine oil filter bypass indicator was not extended. The filter assembly was not disassembled and inspected further.

Lower Chip Detector

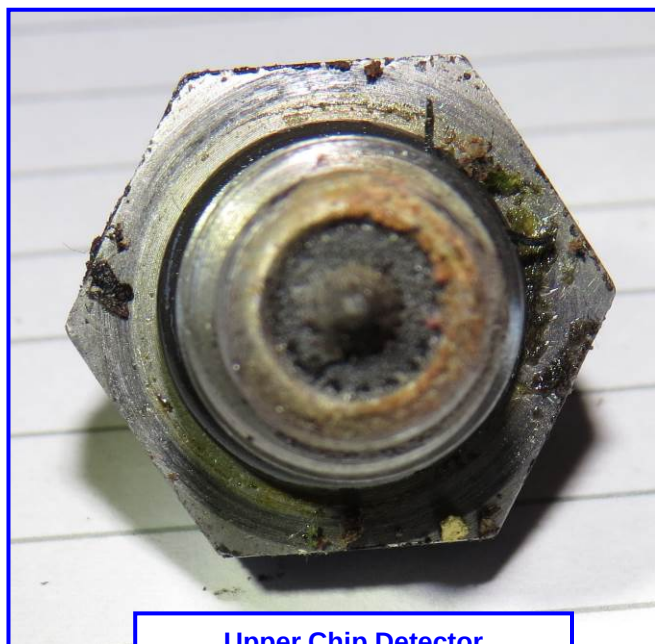
Upper Chip Detector

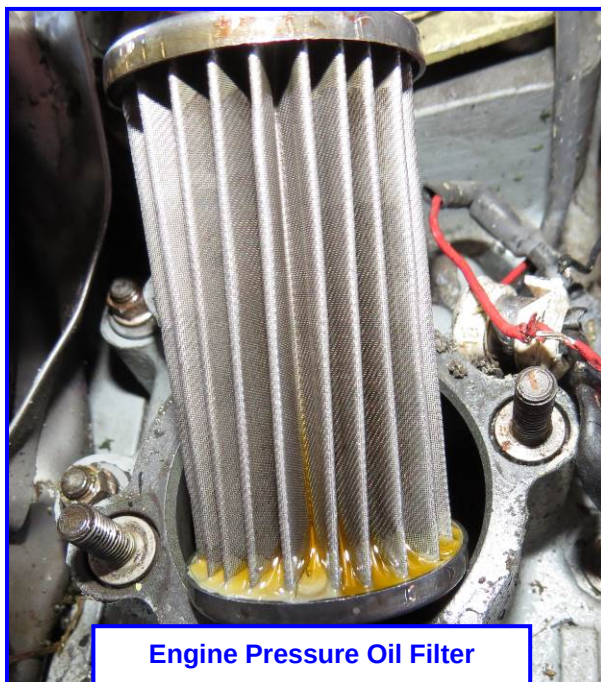
Engine Pressure Oil Filter

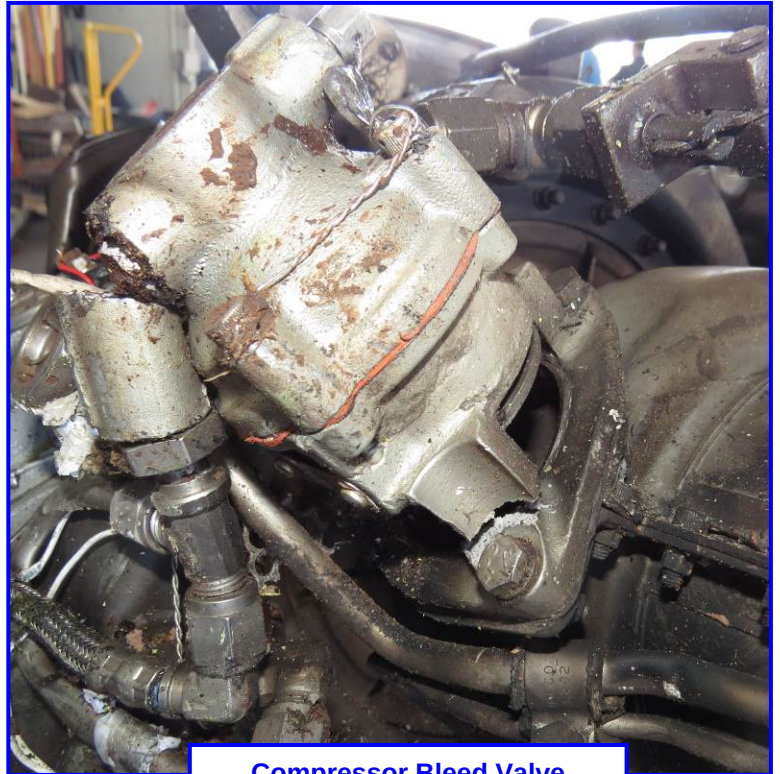
The bleed valve was heavily compromised from impact damage. The valve body had fractured adjacent to the bolt flange and the bleed air off-take connection was broken at the top of the valve housing. The poppet valve could be moved using hand pressure.

Compressor Bleed Valve
