**NATIONAL TRANSPORTATION SAFETY BOARD**  
**Office of Aviation Safety**  
**Washington, D.C. 20594**

**HELICOPTER SPECIALIST'S FACTUAL REPORT**

**NTSB No: WPR19FA109**

Aircraft: N61PH

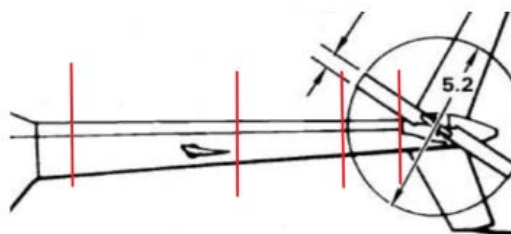
Tail boom remained semi attached to the aft end of the fuselage, with 3 locations that had ripped and separated along its length. First area of damage was immediately after the tail boom attach point aft of station 205.34 that exhibited clockwise torsional deformation, followed by a section that was severed just behind the horizontal stabilizer, followed by a separation between hanger bearings at tail boom stations 109.9 and 136.9, and then severed at the tail rotor gear box fixture forward of station 334.

Figure 2: Tail boom separation location marked by red lines.

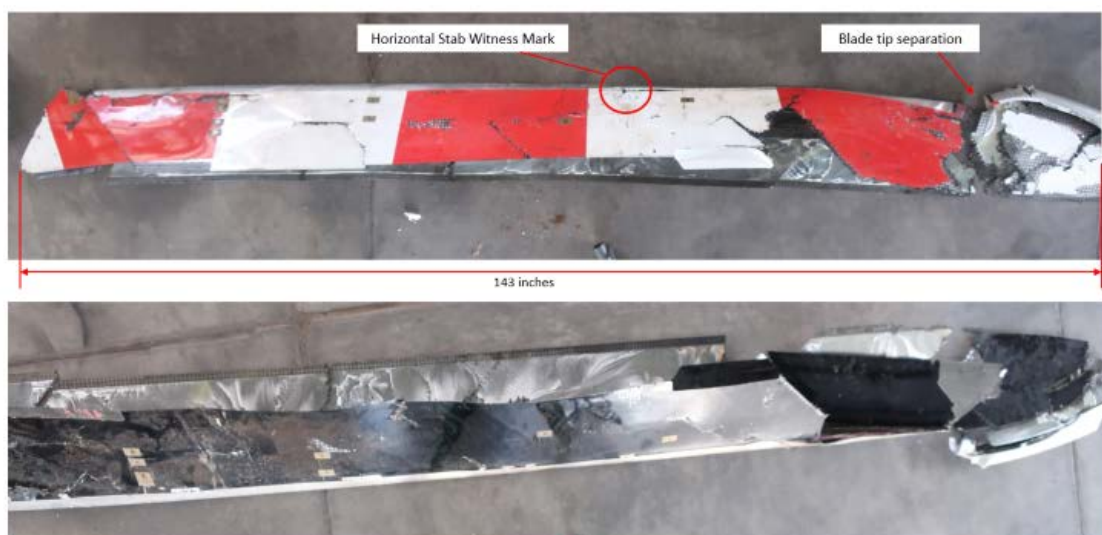
The rotor blade was colored alternating orange and white on the top surface and gloss black on the bottom surface. The leading edge was protected by stainless steel and nickel alloy erosion strips. The length of the upper and lower surface of the blade was instrumented with strain gauges. The rotor blade had separated from the hub. The remaining blade length was 134 inches. A 23-inch section of blade tip had separated from the blade body. The entire length of the blade was split along the trailing edge, white foam after body filler had been liberated. The entire trailing edge carbon fiber strip had separated cleanly from the blade skins. Blade weights were located along the entire interior length of the leading edge. A mid span witness mark matched the curve of the deformed left horizontal stabilizer spar.

Photo 1: Upper and lower surfaces annotating the horizontal stabilizer spar witness mark and blade tip separation

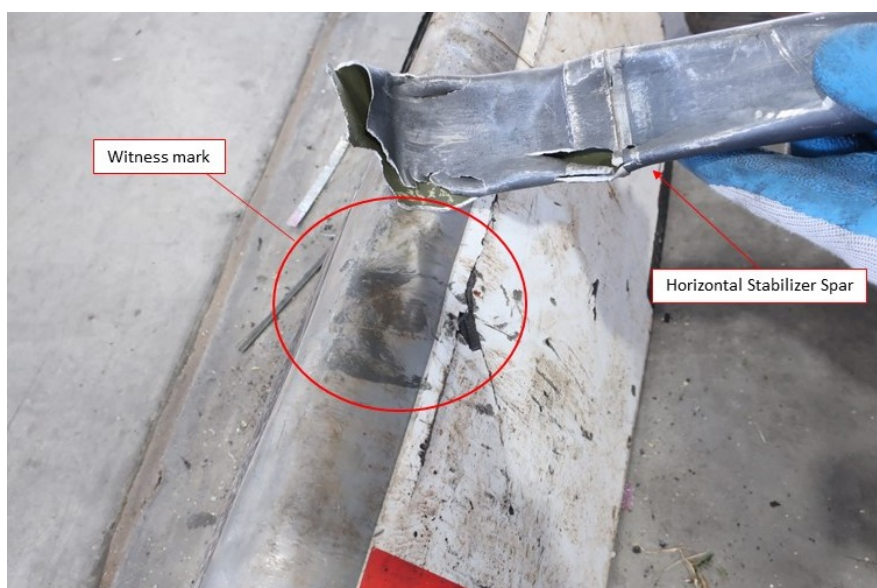
Photo 2: Close up of horizontal stabilizer spar witness mark.

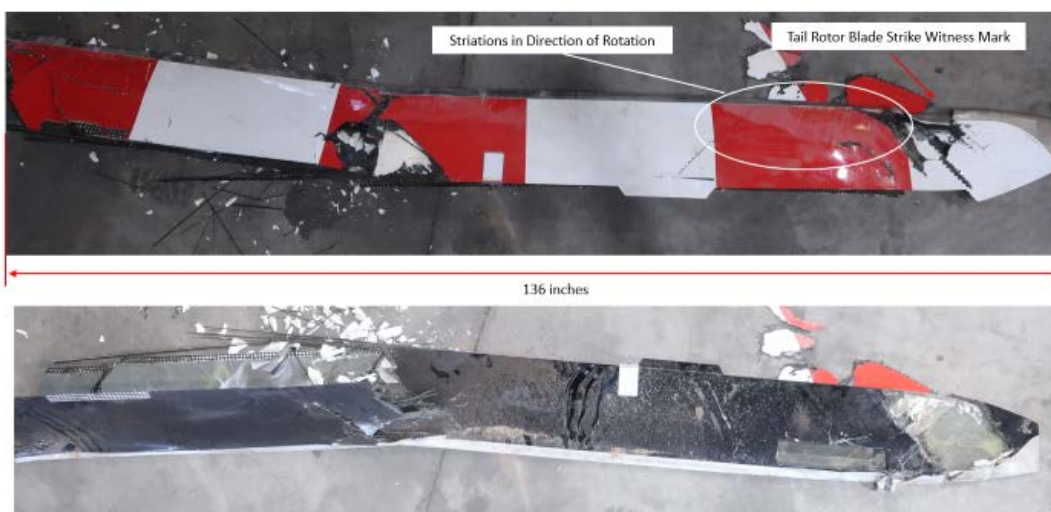
The rotor blade was colored alternating orange and white on the top surface and gloss black on the bottom surface. The leading edge was protected by stainless steel and nickel alloy erosion strips. This blade was not instrumented. The rotor blade had separated from 49 inches from the hub. The remaining blade length was 134 inches. A 22-inch section of rotor tip had separated from the blade. The rotor tip leading edge erosion strip had a lengthwise witness mark consistent with tail rotor leading edge contact.

Photo 3: Upper and lower surfaces of unmarked rotor blade.

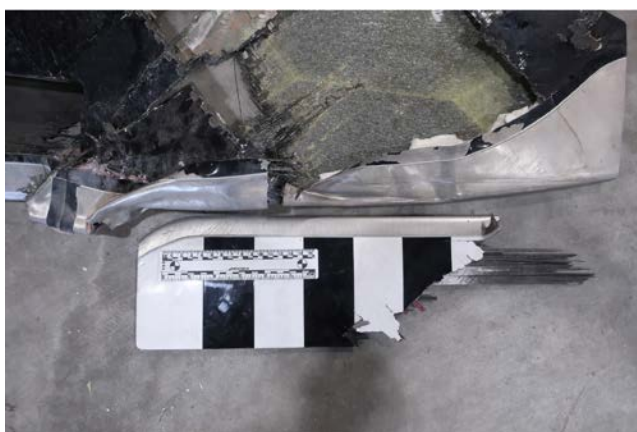
Photo 4: Tail rotor blade leading edge aligned next to main rotor blade tip.
