# NATIONAL TRANSPORTATION SAFETY BOARD

## MATERIALS LABORATORY FACTUAL REPORT

Report No. 19-071

Place : Ft. McDowell, Arizona  
Date : April 16, 2019  
Vehicle : Bell 206B, N61PH  
NTSB No. : WPR19FA109  
Investigator : Andrew Swick, AS-WPR

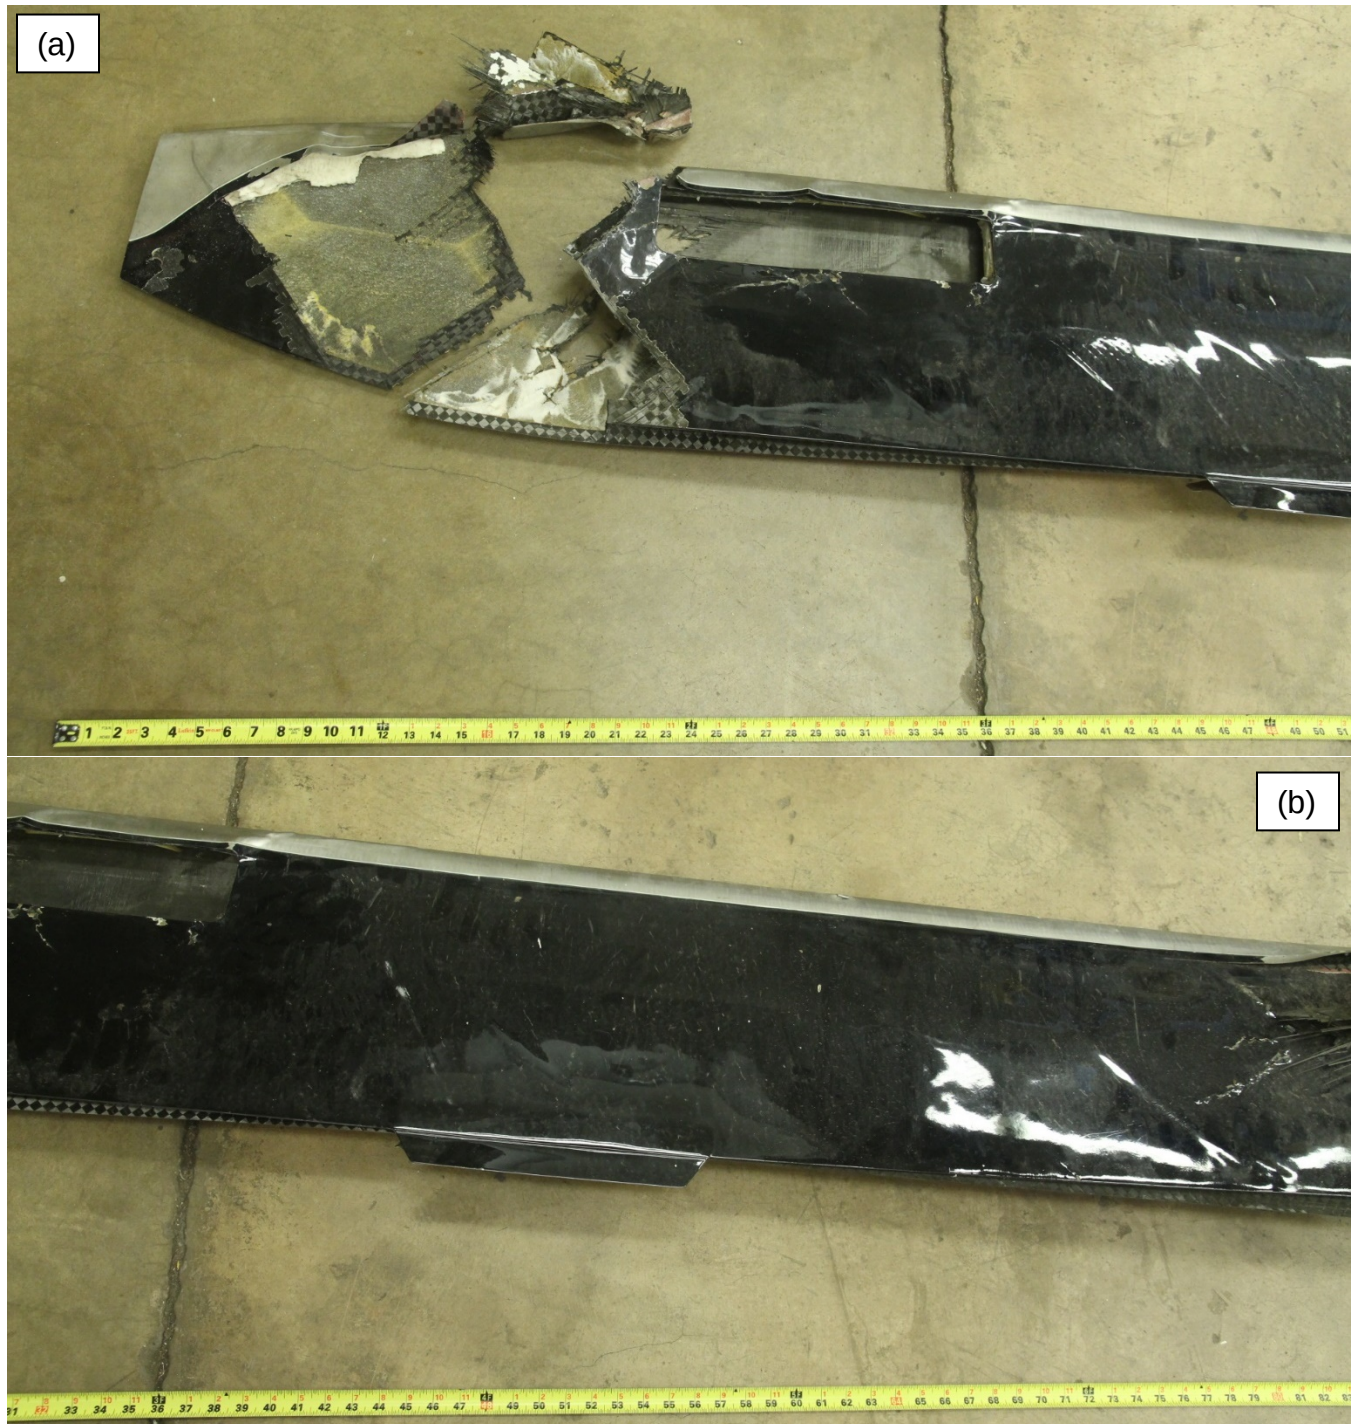
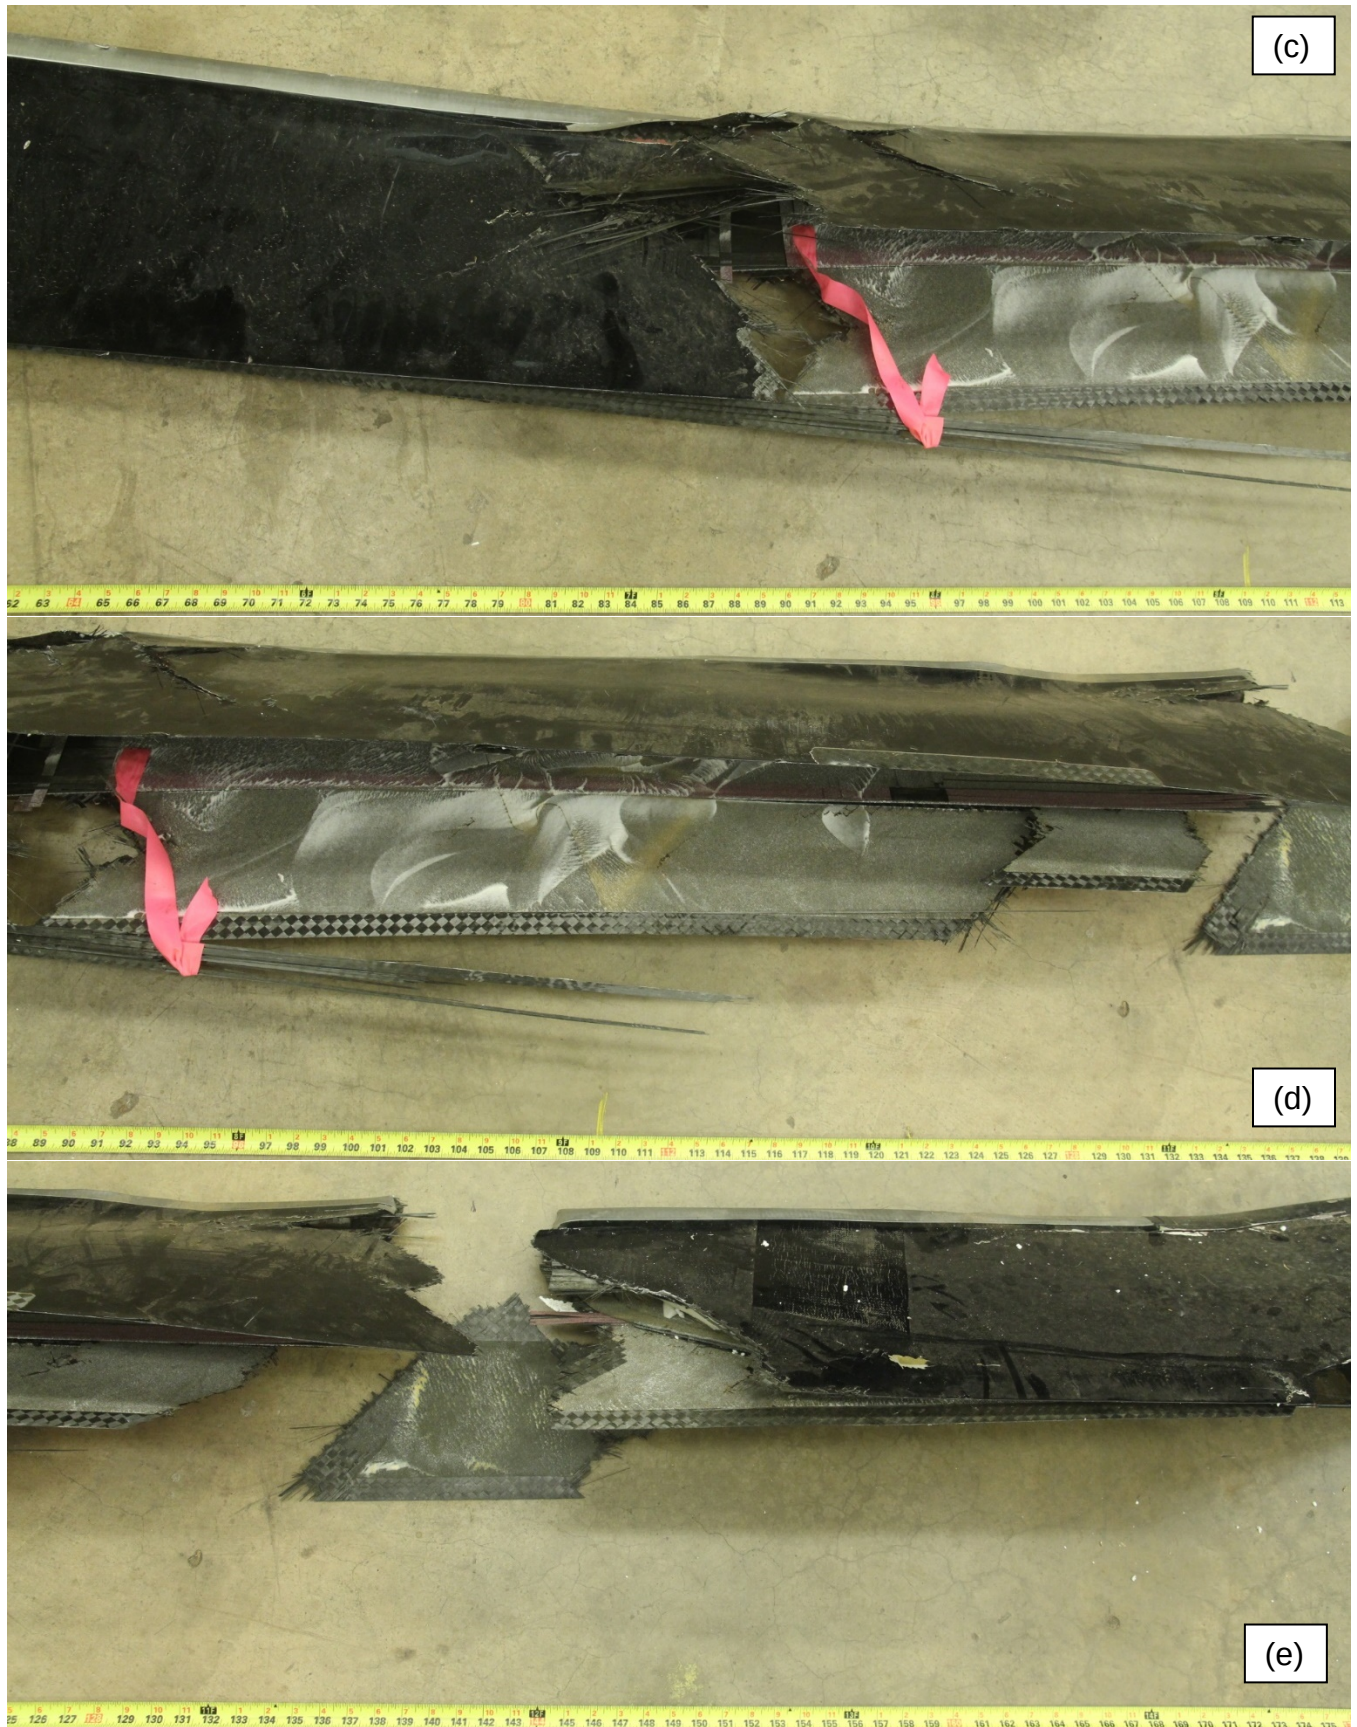
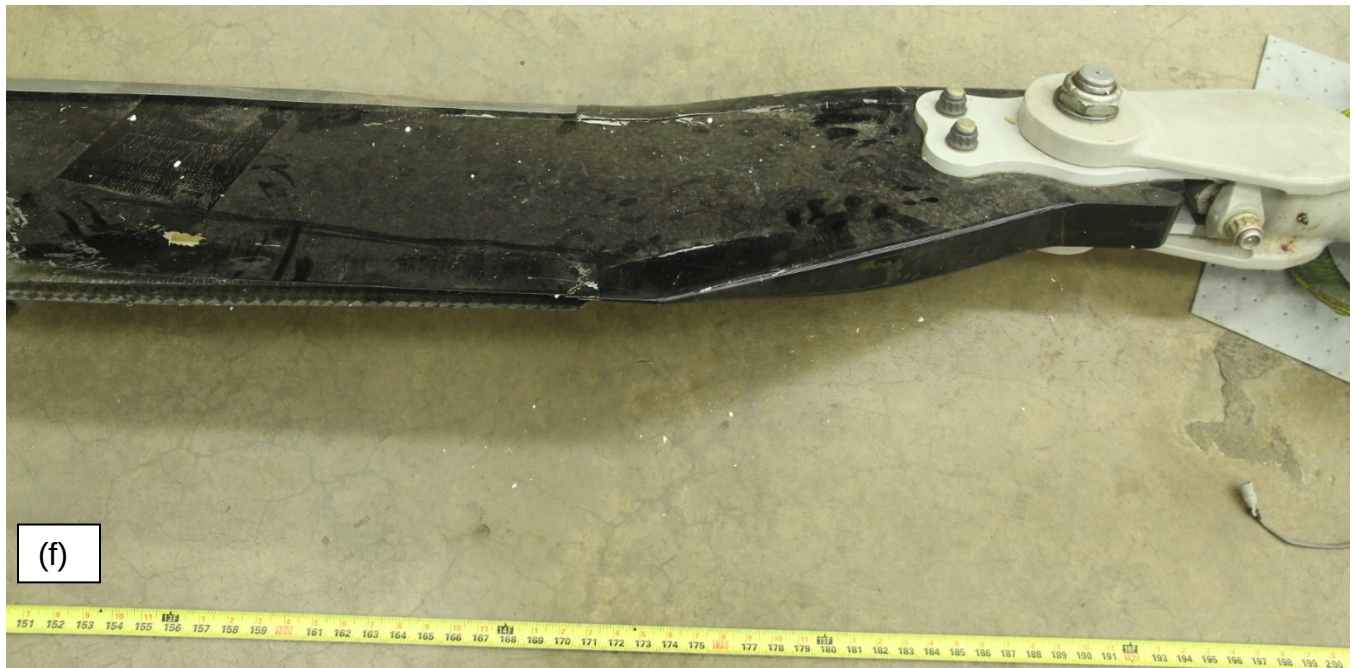
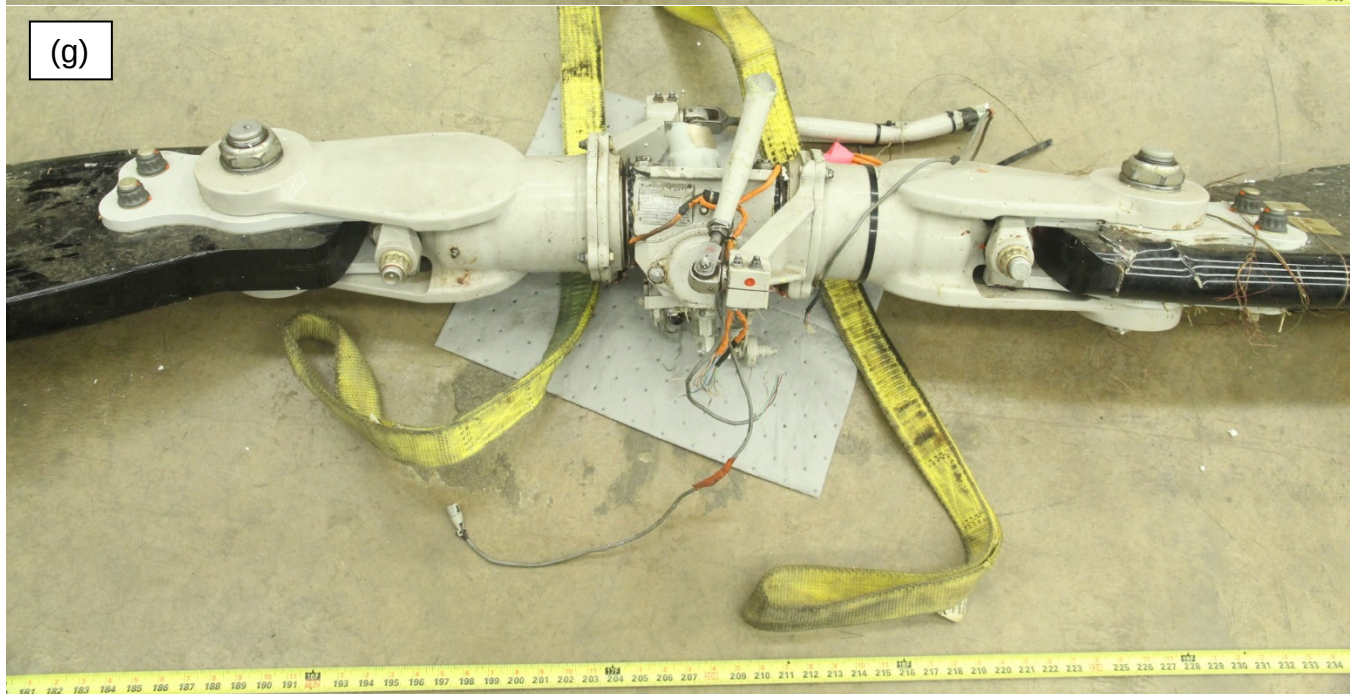
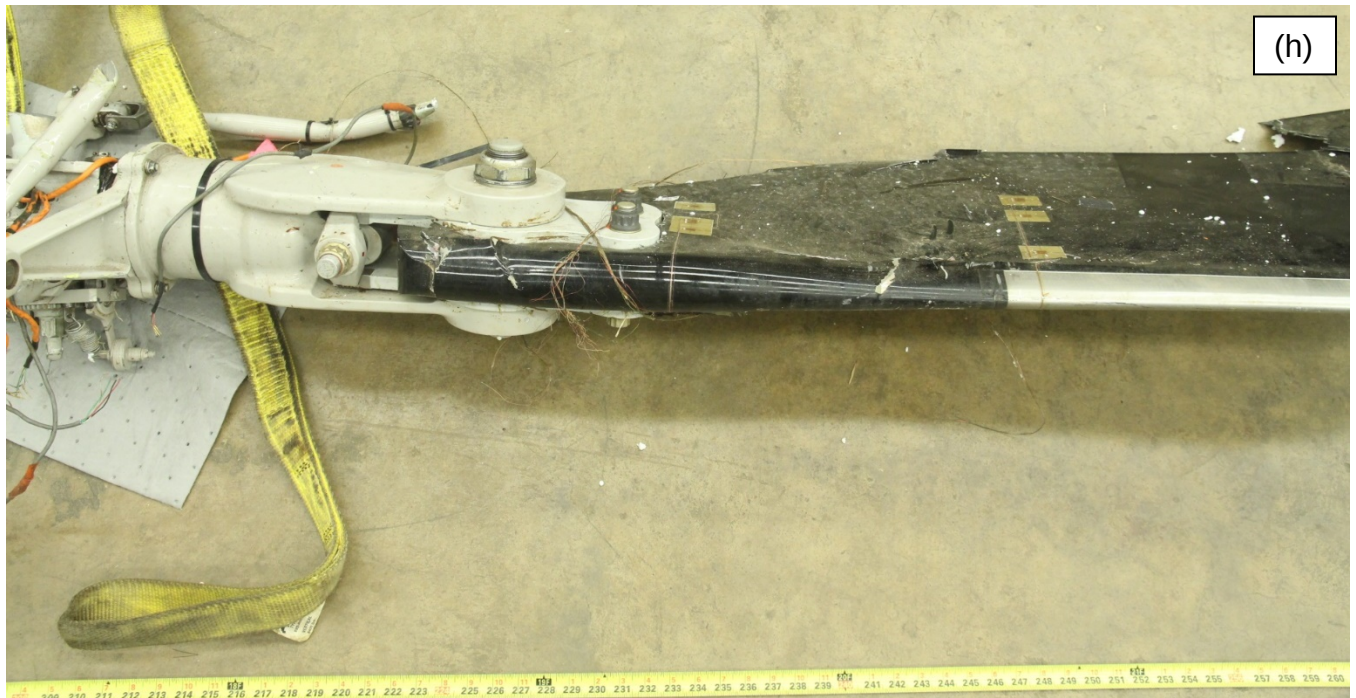
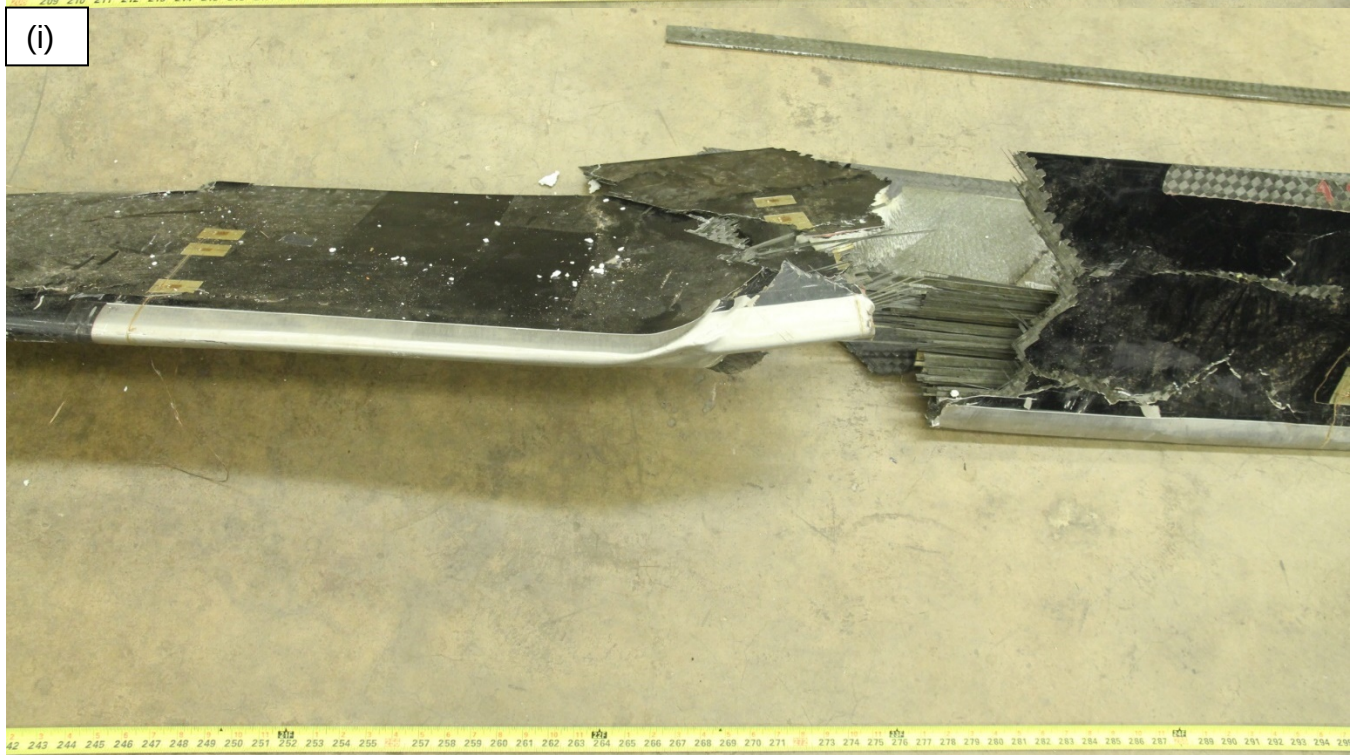
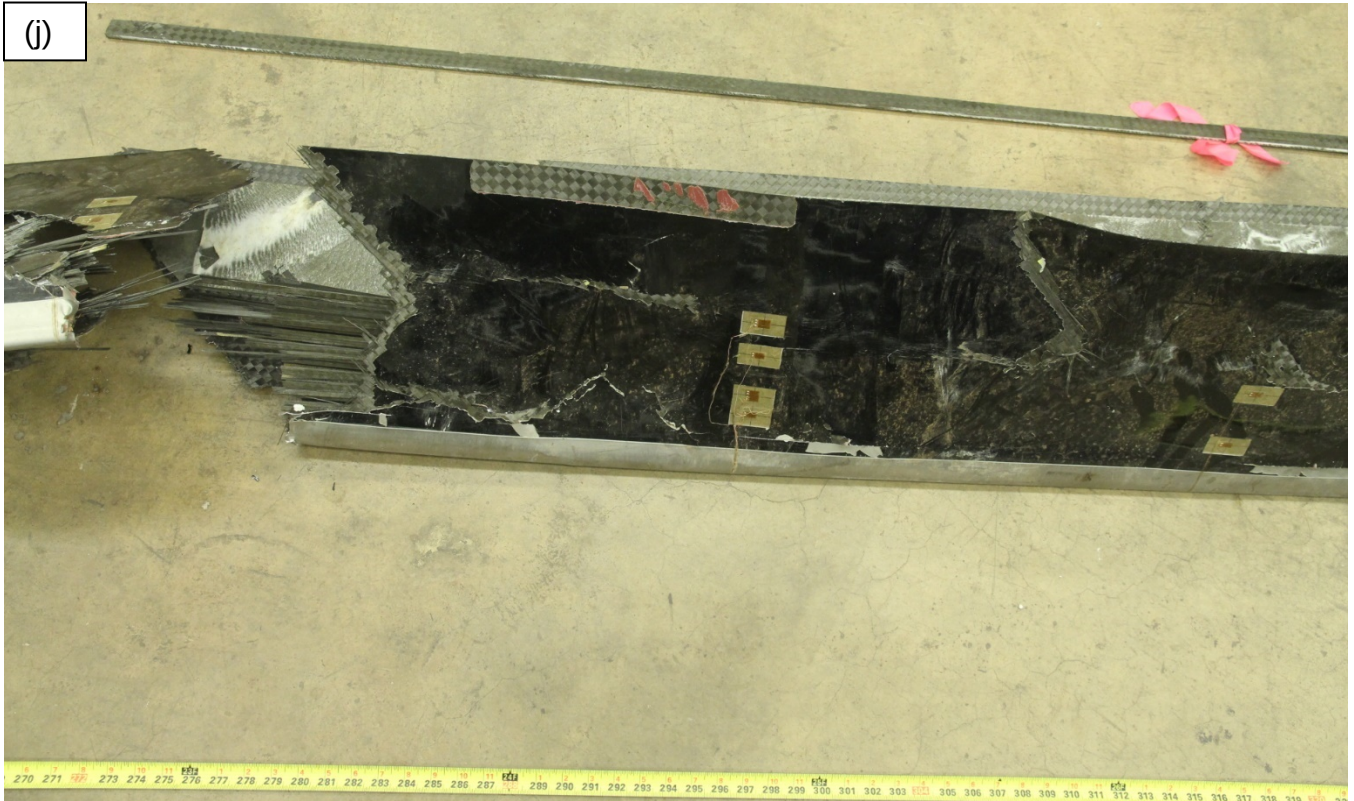
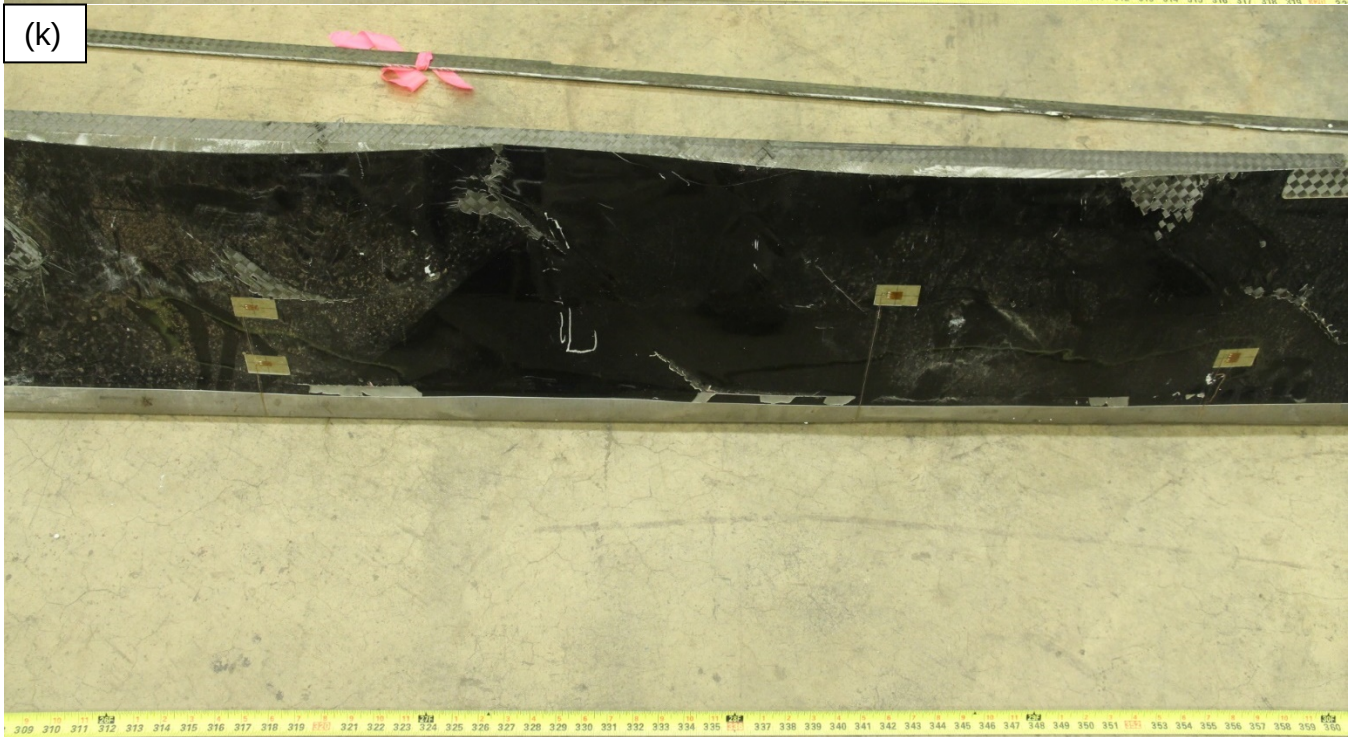
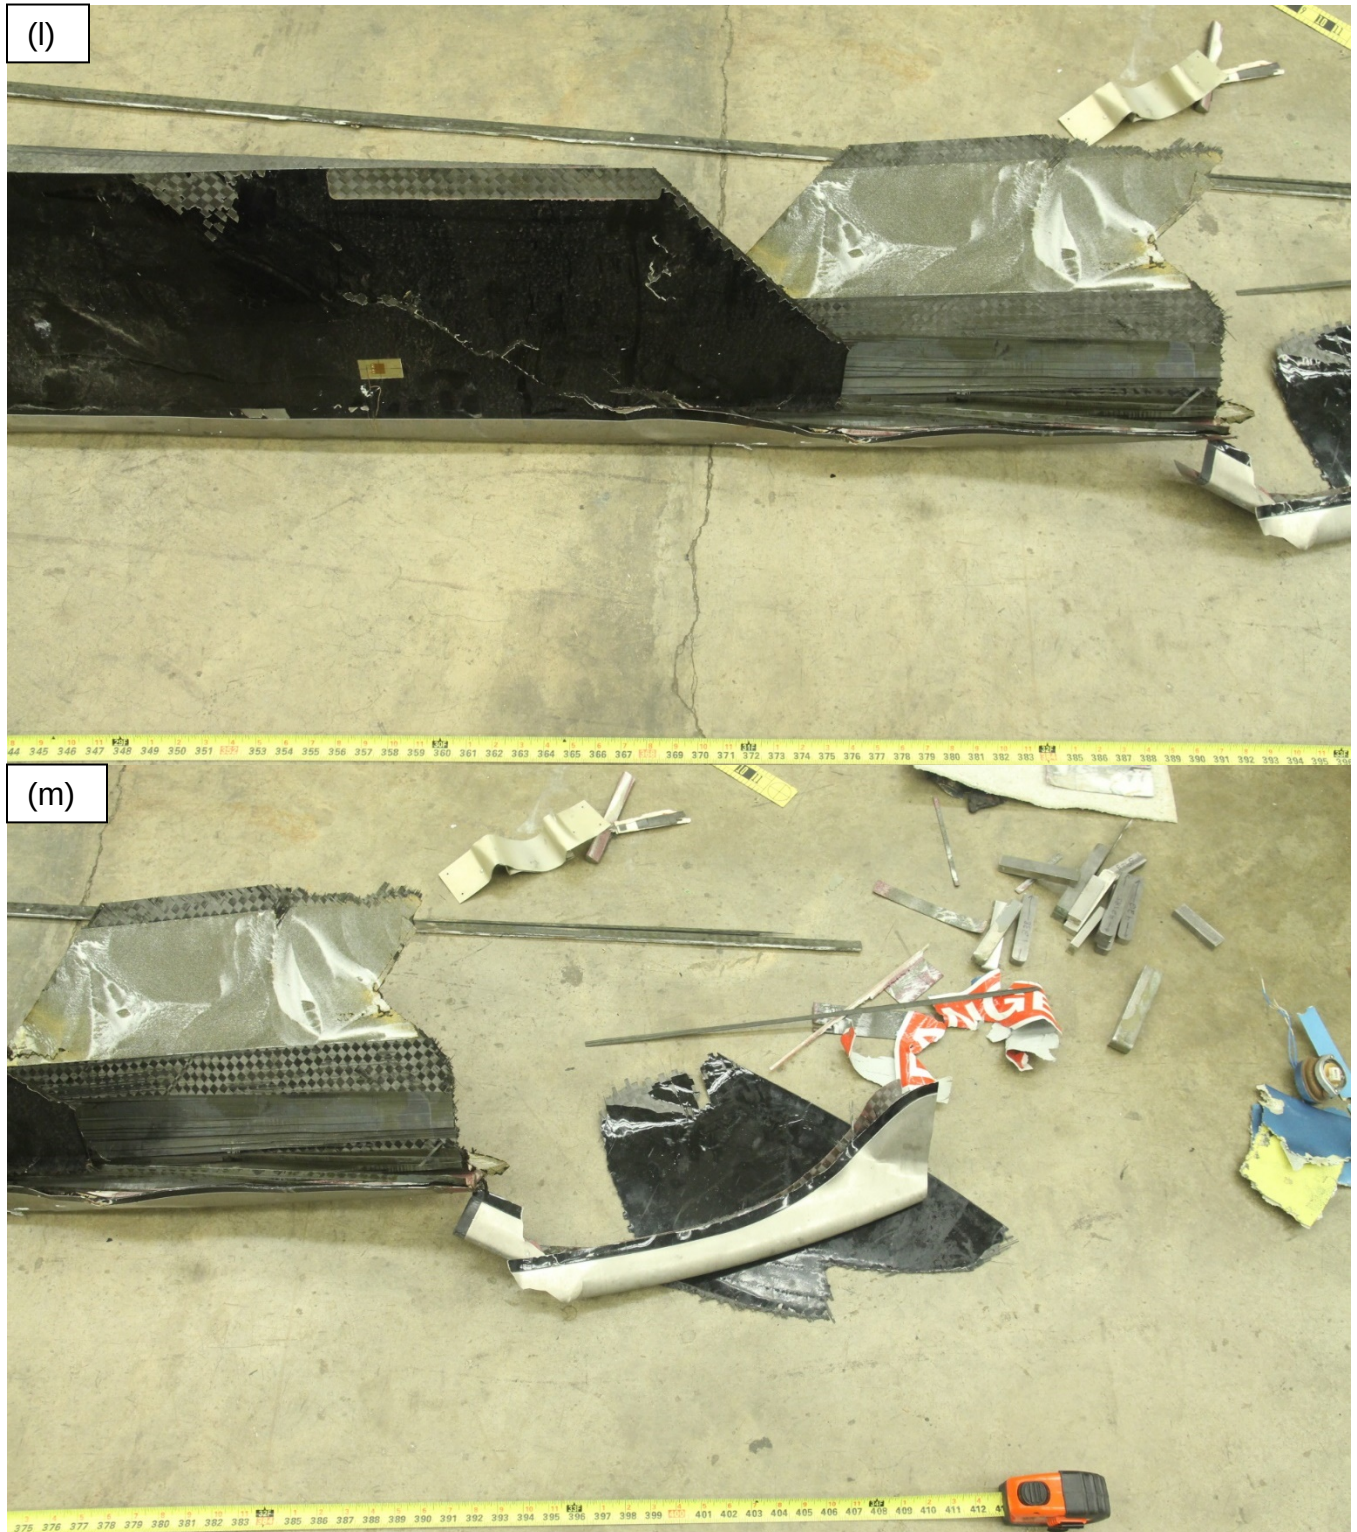
Figure 3 – The major fragments of the main rotor blades and the rotor hub, laid out from one side to the other in order from Blade B tip (a-g) to Blade A tip (h-m).

Figure 1 shows the crate with the parts from the accident, as received. The blades and other components were carefully removed and laid out in the NTSB basement laboratory on the floor in order to accommodate all of the fragments (Figure 2). Figure 3 shows all the major pieces laid out from end to end, in sequential figures. The first blade remnants, shown in Figure 3a – Figure 3g, were labeled “Blade B”, and the pieces in Figure 3h – Figure 3m were labeled “Blade A” for the purposes of this report. Prior to the accident, Blade A had been instrumented with strain gages to record measurements for the developmental tests—many of these pieces of equipment were still attached. Blade B did not exhibit any instrumentation or measurement devices.

through fractures with pieces of skin having completely liberated from the structures. The liberated remnants of skin exhibited triangular shapes consistent with the  $\pm 45^\circ$  plain-weave fabric orientation, with the narrow tip facing the leading edges and the wide side facing the trailing edges. Both blade tips had also fractured, exhibiting crushing and separation of the tip abrasion strip from Blade A (Figure 3m and Figure 6).

As seen in the upper portions of Figure 3j – Figure 3l, the trailing edge strip had separated from the Blade A assembly. A closer view of the separated strip next to the interior surface of the Blade A trailing edge is shown in Figure 8. According to the Planform from the 20635000-501 drawing, the trailing edge strip was a unidirectional carbon fiber piece. The interior of the blade skin was a  $45^\circ$  plain-weave. The blade skin and strip were co-cured together during manufacturing.

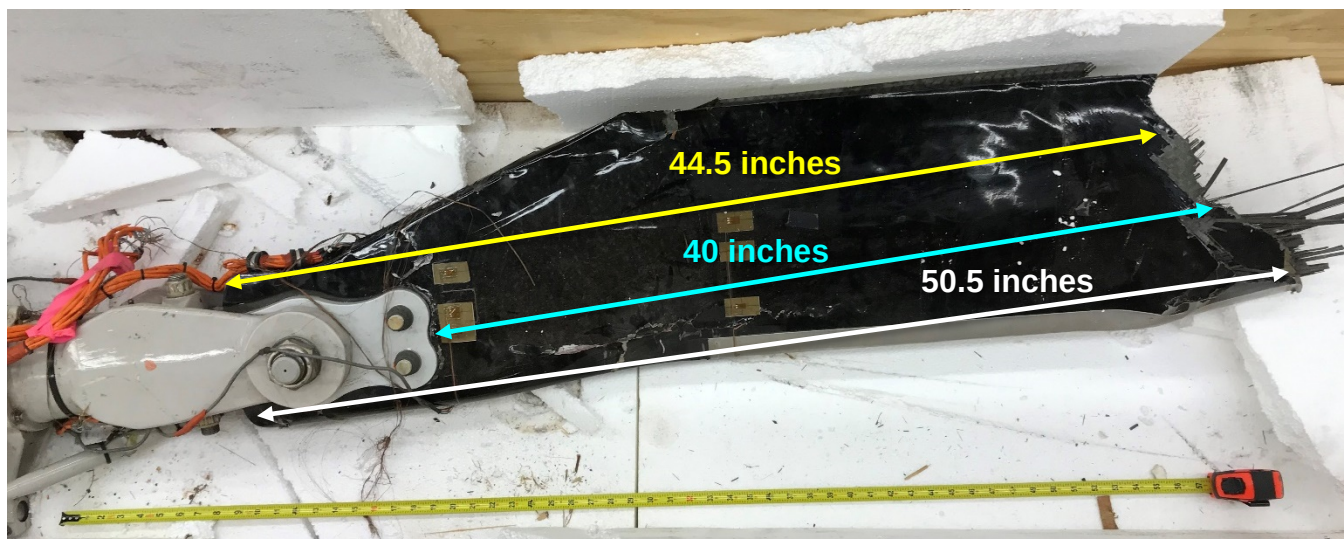
The rotor blades had fractured in multiple locations. The two most prominent fractures were located several feet from the blade roots where the blade remnants were still attached to their respective grip plates. Figure 4 shows the measurements underneath the Blade A, and Figure 5 shows the measurements under Blade B. These fractures were

Figure 4 – Underside of Blade A at the blade root. Measurements of the fracture distance to root features are annotated.

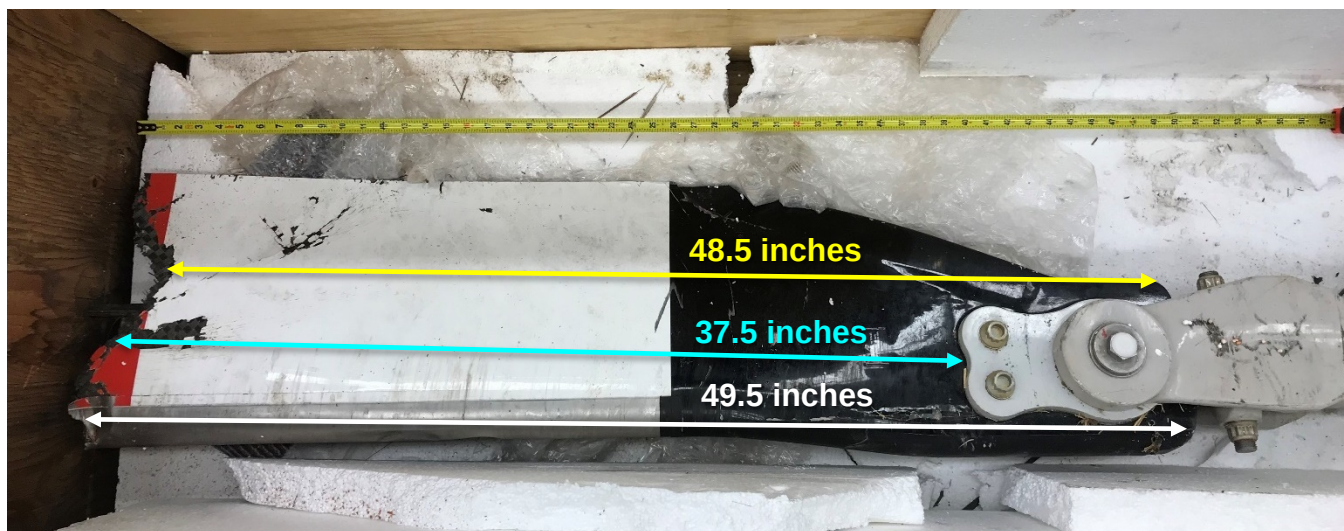
Figure 5 – Underside of Blade B at the blade root. Measurements of the fracture distance to root features are annotated.

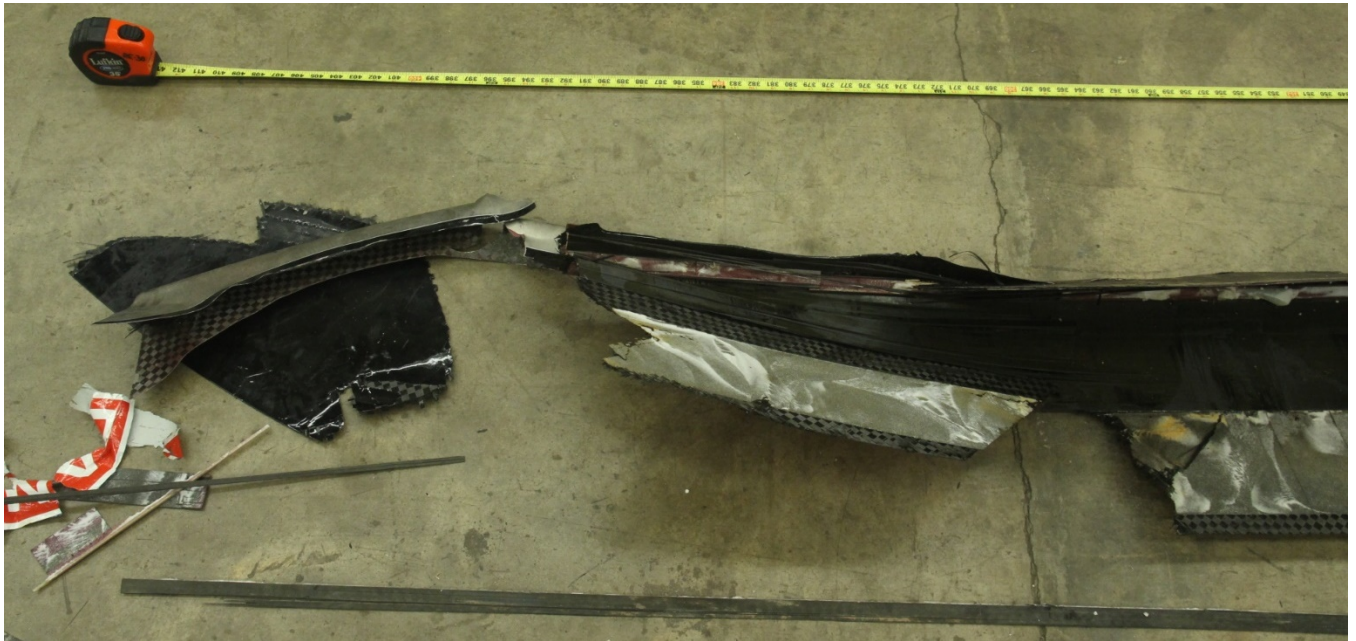
Figure 6 – View of the Blade A tip, viewed from the trailing edge side.

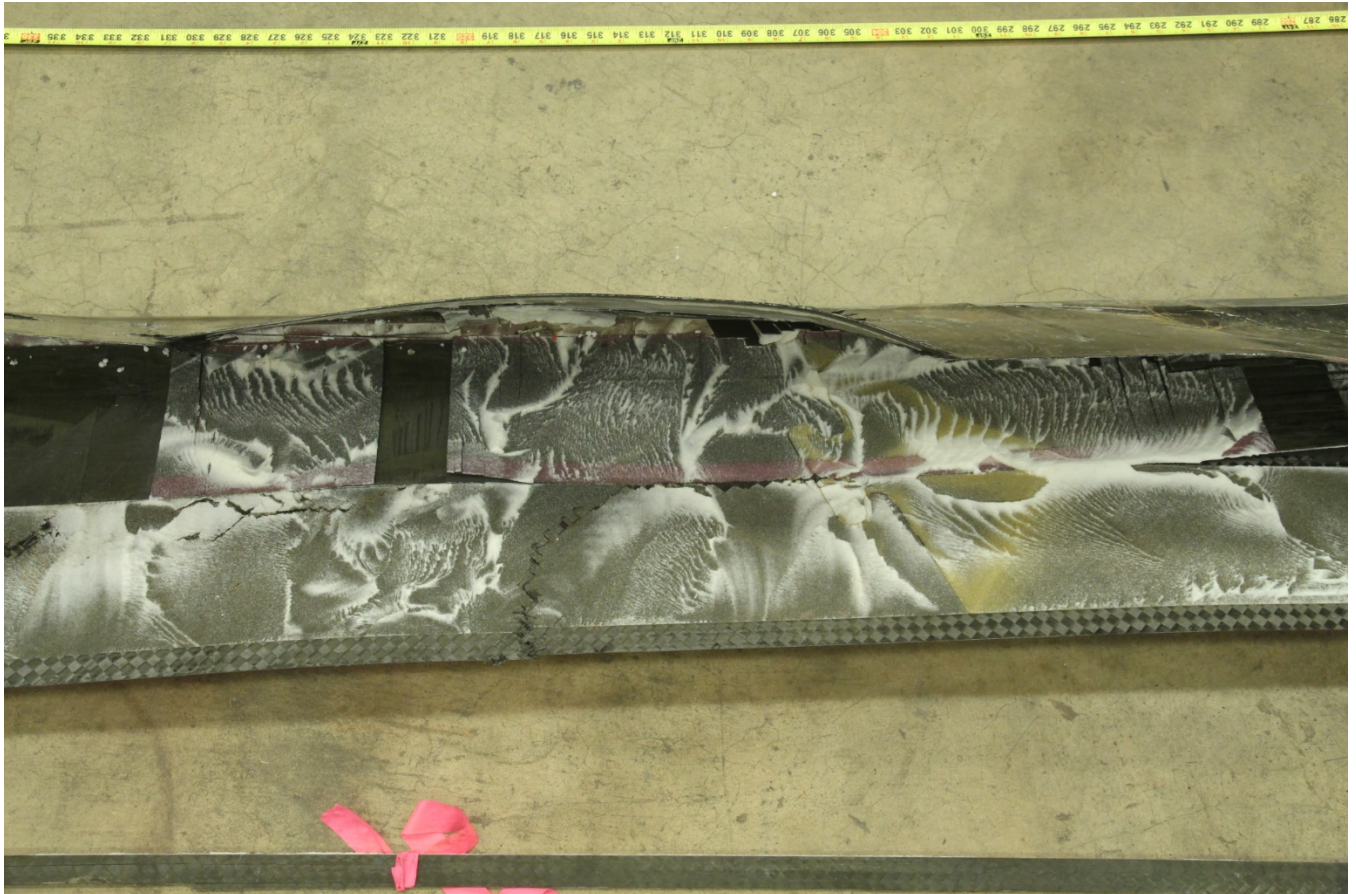
Most of the interior of the blades were absent internal material. The majority of the interior foam was not present inside the blade cores upon receipt. Much of the recovered foam remnants were in a separate bag found inside the crate. Thin, rough layers of foam remnants were still adhered to most of the interior surfaces of the blade skins. The features of these remnants were consistent with cohesive failure of the foam core, and the foam fracture features were inconsistent with adhesive failure or disbonding of the foam with the blade skins (see Figure 7).

Figure 7 – View of the interior of Blade A by from the trailing edge, showing foam remnants on the interior surfaces.

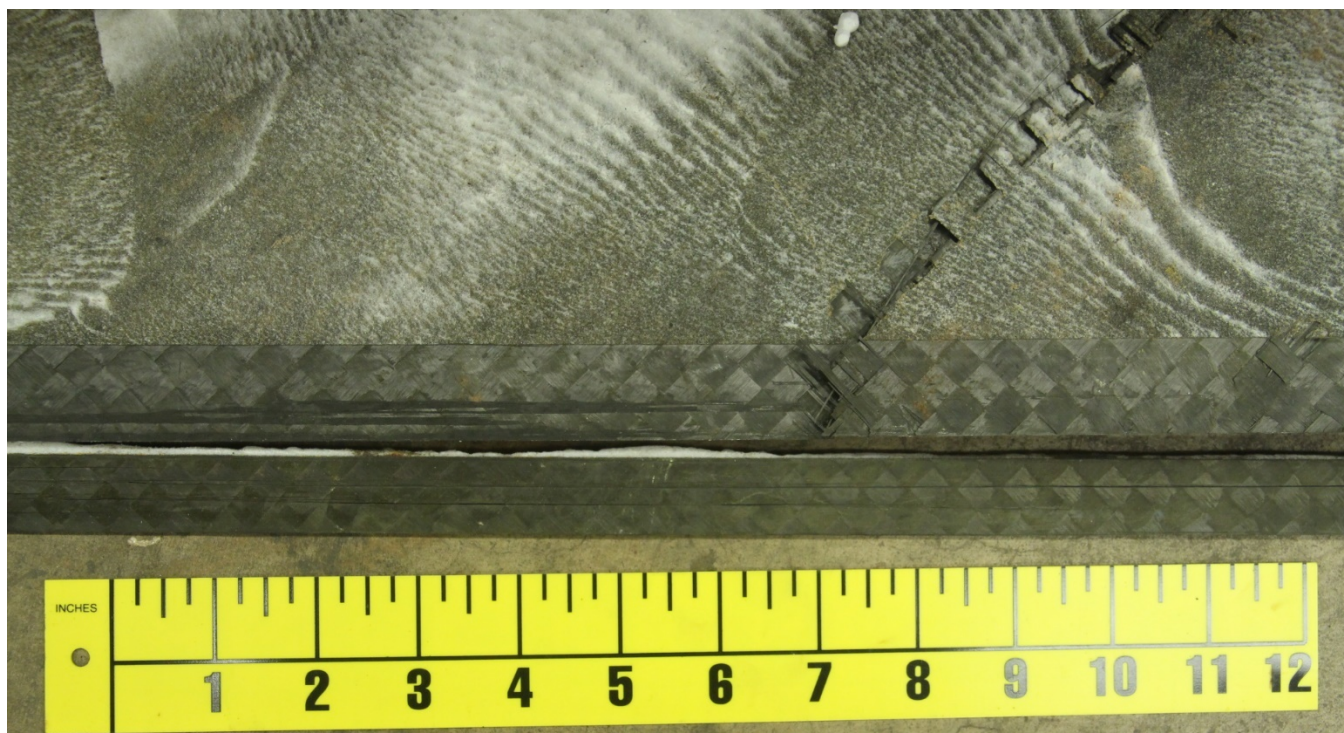
The features observed on the surface of the separated strip were consistent with fracture of the blade skin and were inconsistent with adhesive separation of the strip from the blade skin or fracture/delamination of the strip. Figure 8 and Figure 11 show adhered foam on the inboard surface of the trailing edge strip, consistent with cohesive fracture of the foam core at the trailing edge.

Figure 8 – View of the separated trailing edge strip beneath the trailing edge of the rotor skin interior of Blade A. Both faces show the 45° plain-weave pattern of the skin layup.

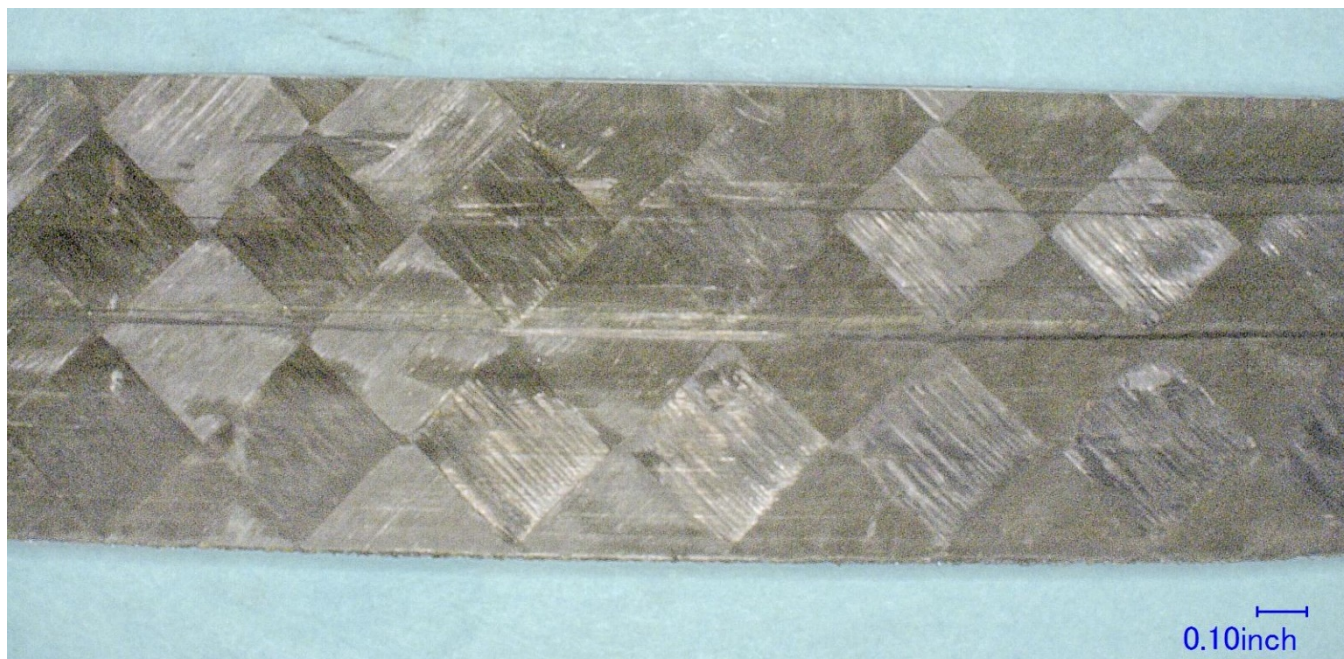
Figure 9 and Figure 10 show a typical surface of the strip fragment. This surface exhibited the  $45^\circ$  plain-weave pattern visible on the mating blade skin. When intentionally split open in the laboratory examination, the strip interior exhibited a unidirectional orientation of the fibers (see Figure 11). Sections of the strip were taken for later microscopic and materialographic examination.

Figure 9 – Closer view of the Blade A trailing edge strip surface, showing the 45° plain-weave pattern on the exposed surface (~10X).

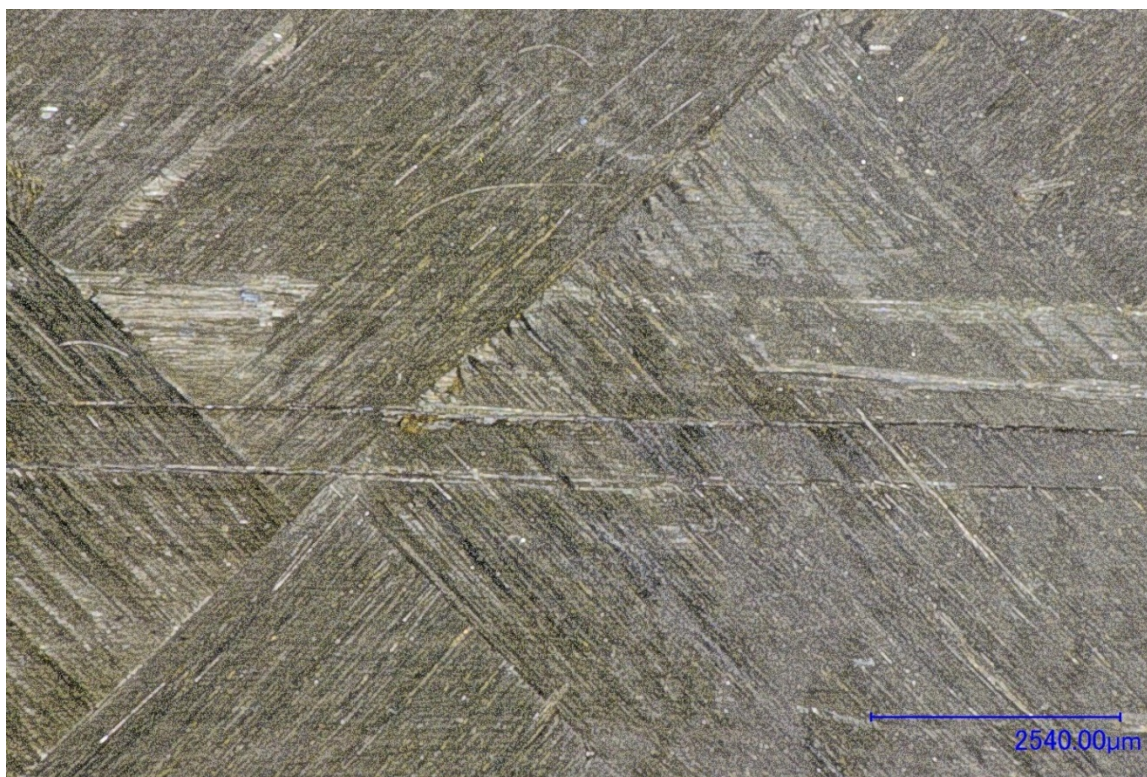
Figure 10 – Closer view of the outer surface of the trailing edge strip, showing the 45° plain-weave pattern (~30X).

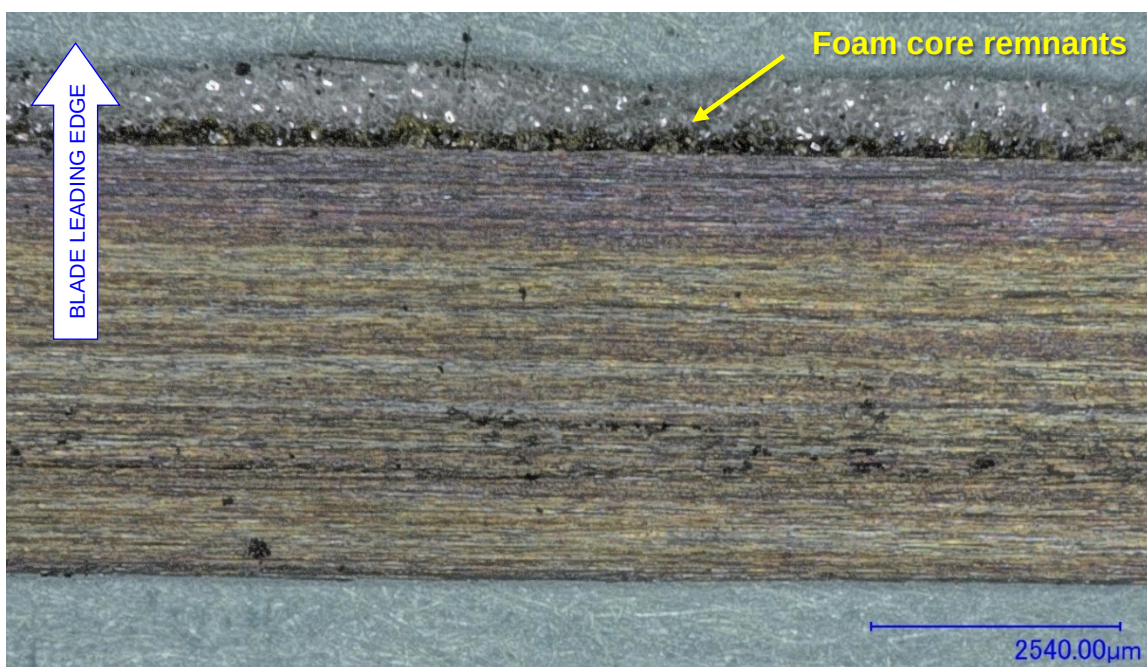
Figure 11 – Closer view of the inner surface of the trailing edge strip, showing the unidirectional fiber pattern of the interior strip composite and residual foam core still adhered (~30X).

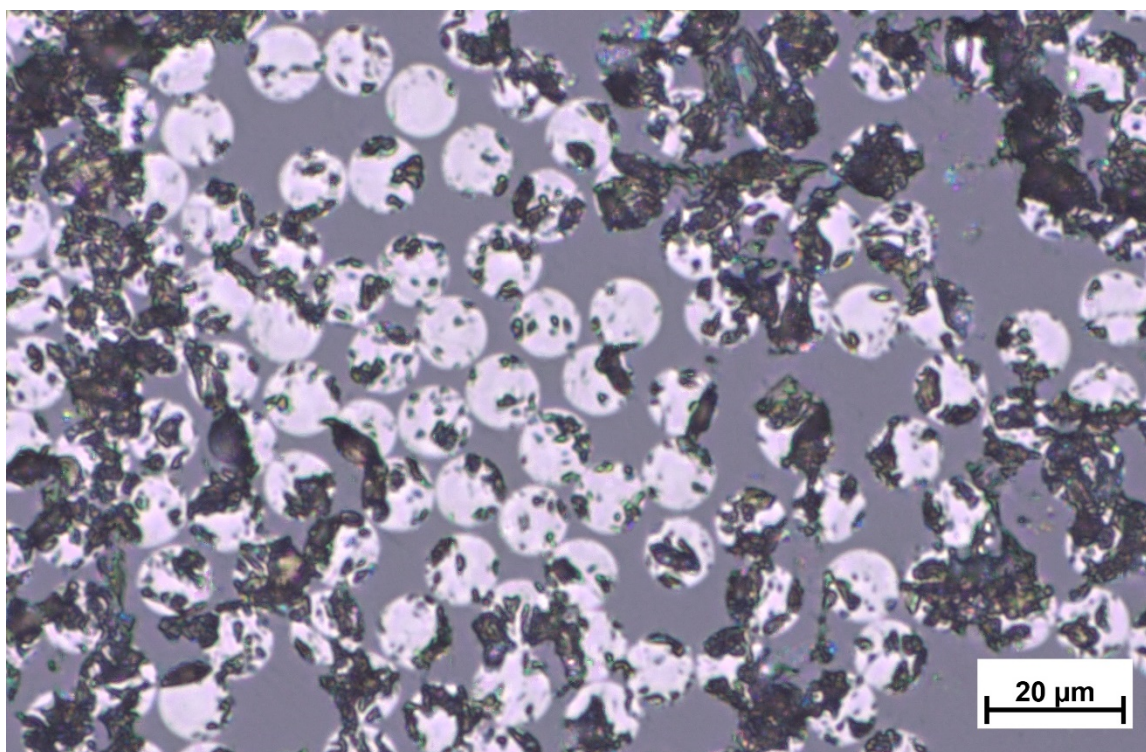
Figure 12 shows a portion of the cross-sectioned and mounted trailing edge strip. Figure 13 shows a closer view, showing the  $90^\circ$  cross section of the carbon fibers in an epoxy matrix. In both views, the carbon fibers were oriented  $90^\circ$  to the cross section. None of the strip interior showed fibers with a  $45^\circ$ ,  $0^\circ$ , or other angle orientation.

Figure 13 – Bright field (BF) view of the trailing edge strip in cross section, showing carbon fibers (white) in an epoxy matrix (gray). The dark material was an artifact of the polishing process (~as polished, ~1000X).

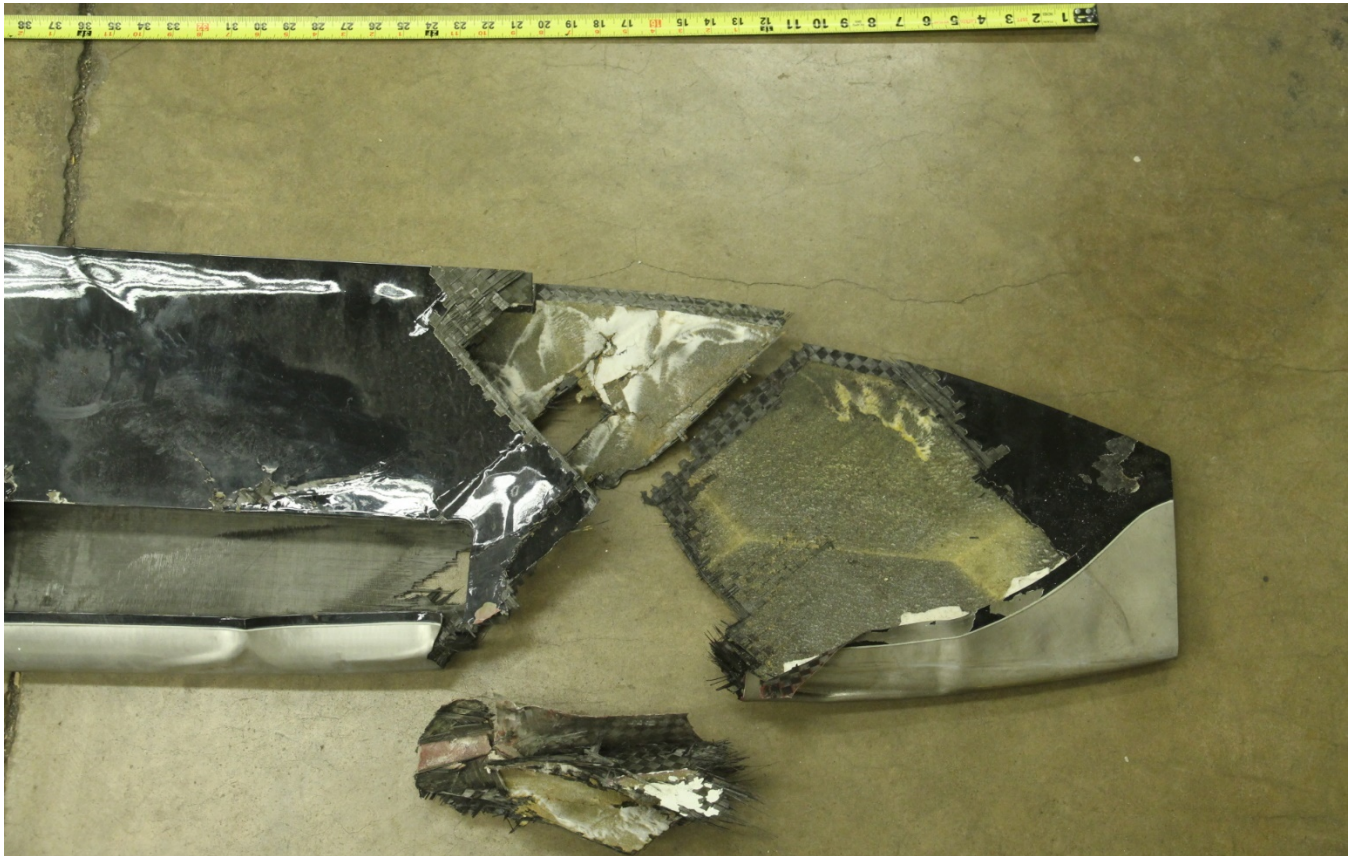
Figure 14 shows the Blade B tip remnant. The tip abrasion strip exhibited paint transfer marks consistent with impact with another object. The pattern of fracture, buckling near the fracture, and tearing in the lower blade surface was consistent with composite skin fracturing upward and aft, toward the trailing edge of the blade.

Figure 14 – View of the Blade B tip from the underside (leading edge faces downward).
