# NATIONAL TRANSPORTATION SAFETY BOARD

## MATERIALS LABORATORY FACTUAL REPORT

Report No. 19-071

Place : Ft. McDowell, Arizona  
Date : April 16, 2019  
Vehicle : Bell 206B, N61PH  
NTSB No. : WPR19FA109  
Investigator : Andrew Swick, AS-WPR

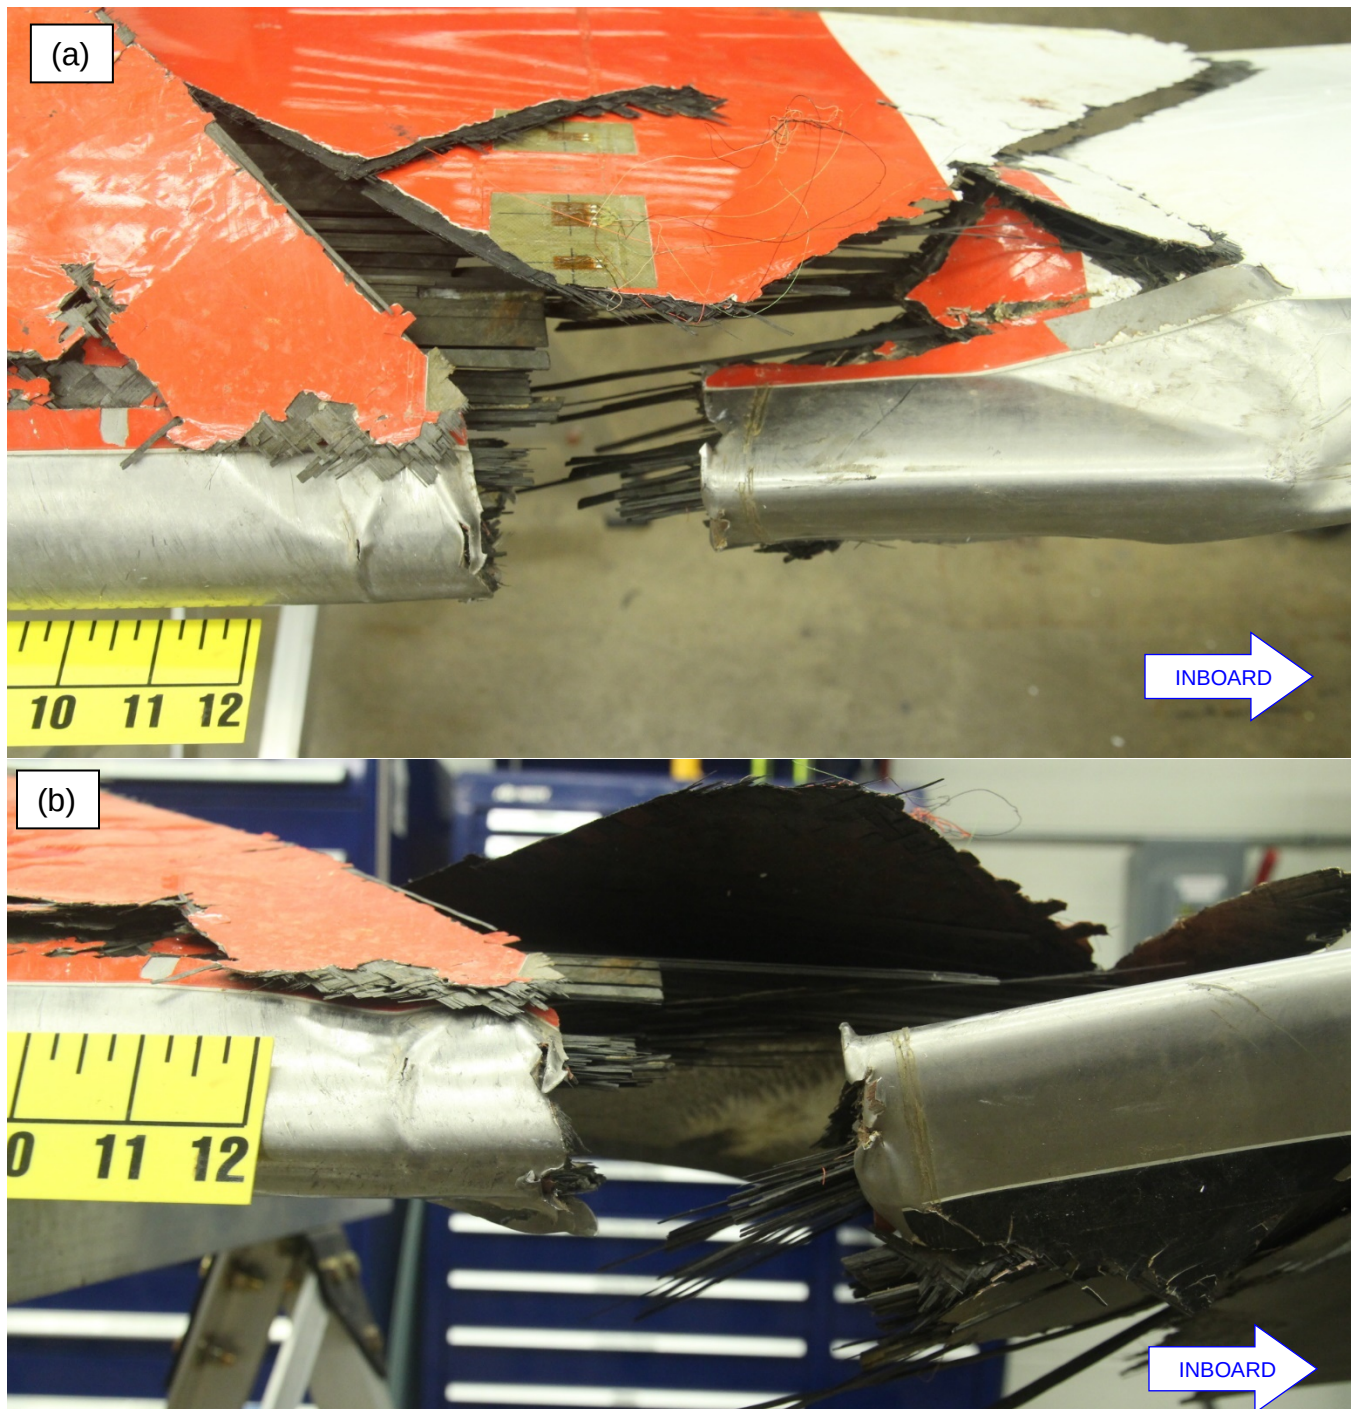
Figures 15 through Figure 17 show the leading edge, top, and bottom views of the inboard fracture of the Blade A. The location of this fracture, approximately 40 inches from the grip plate or 44–51 inches from the blade root. This fracture location corresponded

with the location where an internal doubler stack terminated. Figure 15 shows fracture of the metallic leading edge abrasion strip. The strip exhibited indications of bending downward on the lower side, buckling inward on the inboard side and tensile tearing in the middle. These fracture features were consistent with fracture under multiple loading directions.

Figure 15 – The upper side of the inboard fracture on Blade A from (a) a top angled view and (b) a view of the leading edge.

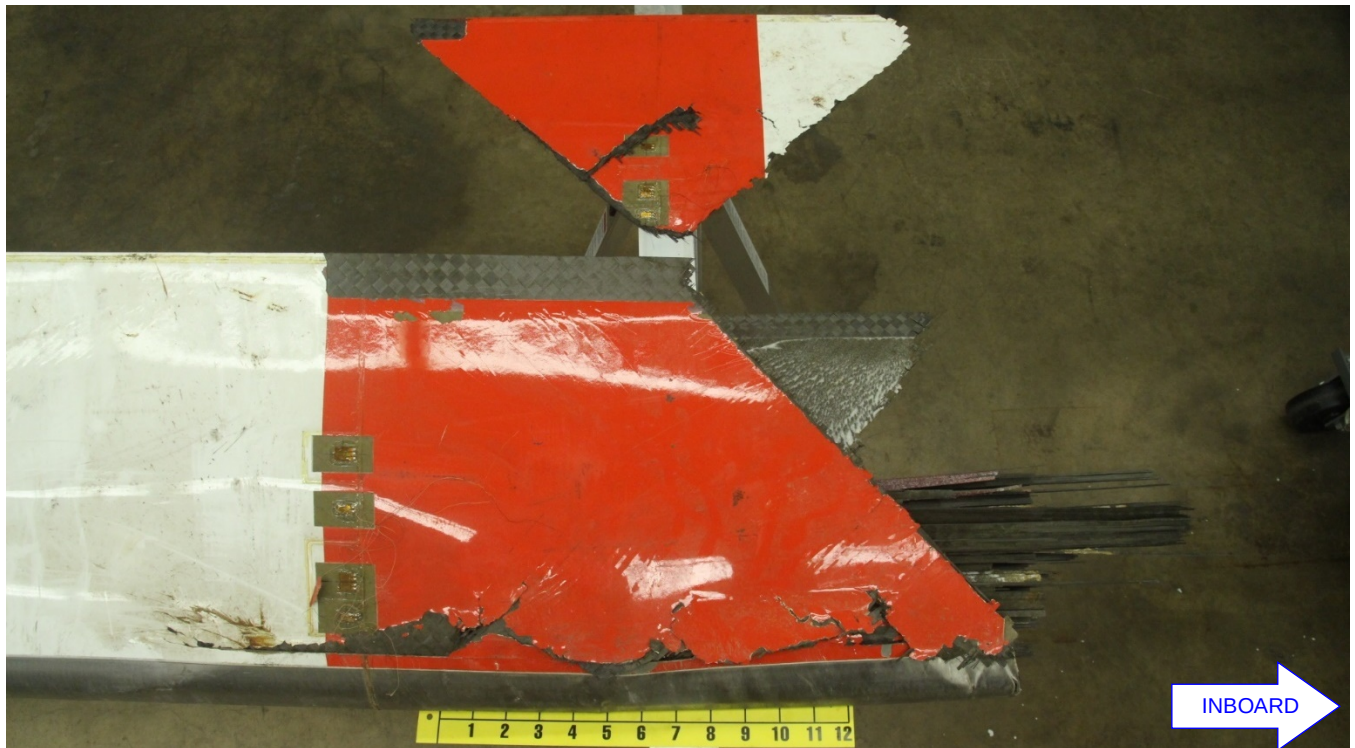
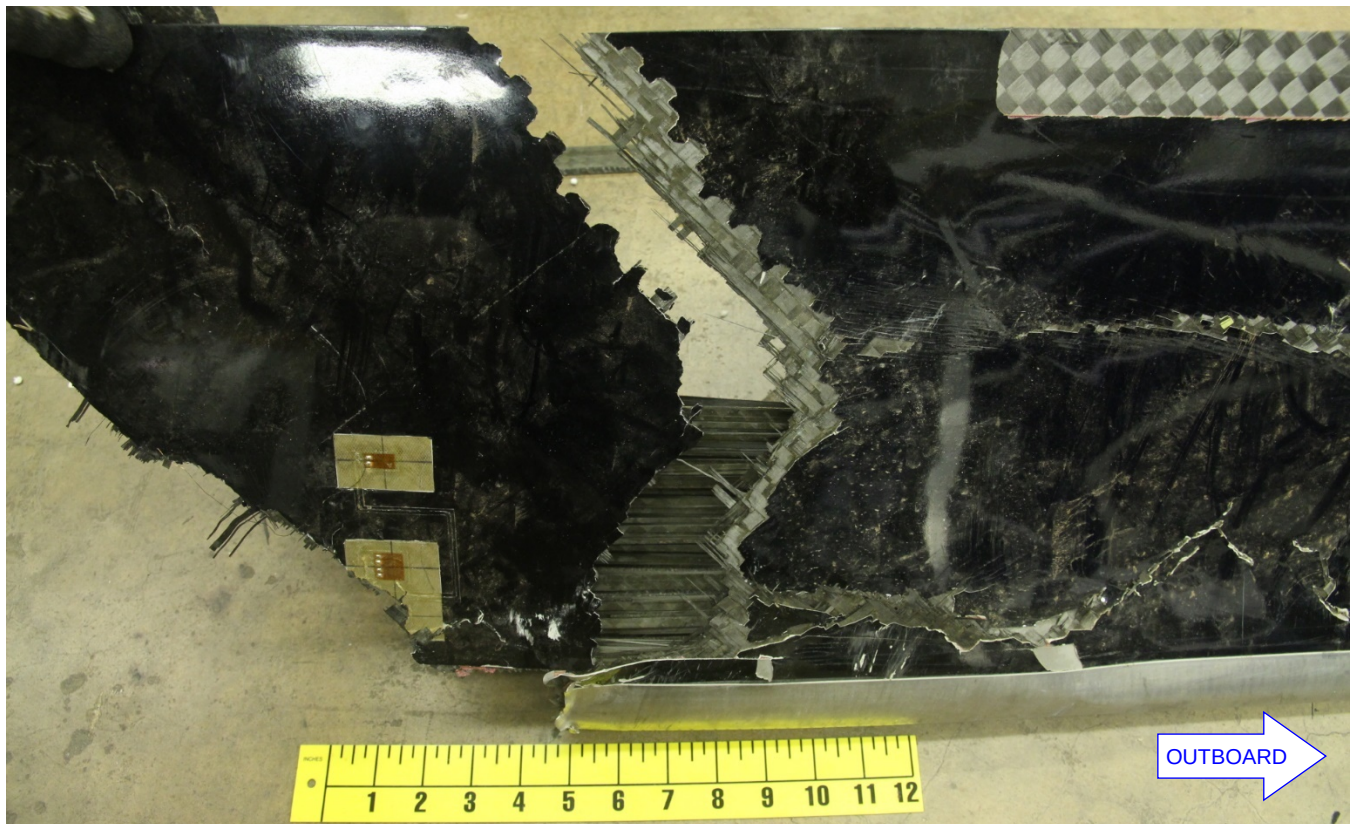
The upper blade skin surface exhibited a triangular shaped fragment, consistent with the  $\pm 45^\circ$  plain-weave fabric orientation. The fracture surfaces of this fragment were relatively straight, with the outer paint remaining present adjacent to the fracture surface. In contrast, the lower skin fractures exhibited a more jagged orientation, mirroring the jagged orientation and underlying skin's  $45^\circ$  plain-weave pattern. The lower black paint was absent approximately 1 inch away from the fracture surface on this side. These features were consistent with tensile fracture on the upper blade surface and compressive fracture on the lower surface. This fracture pattern was consistent with Blade A having been bent downward at fracture.

Figure 16 – Top view of the inboard fracture of Blade A, showing mating skin fragments.

Figure 17 – Bottom view of the inboard fracture of Blade A, showing mating skin fragments.

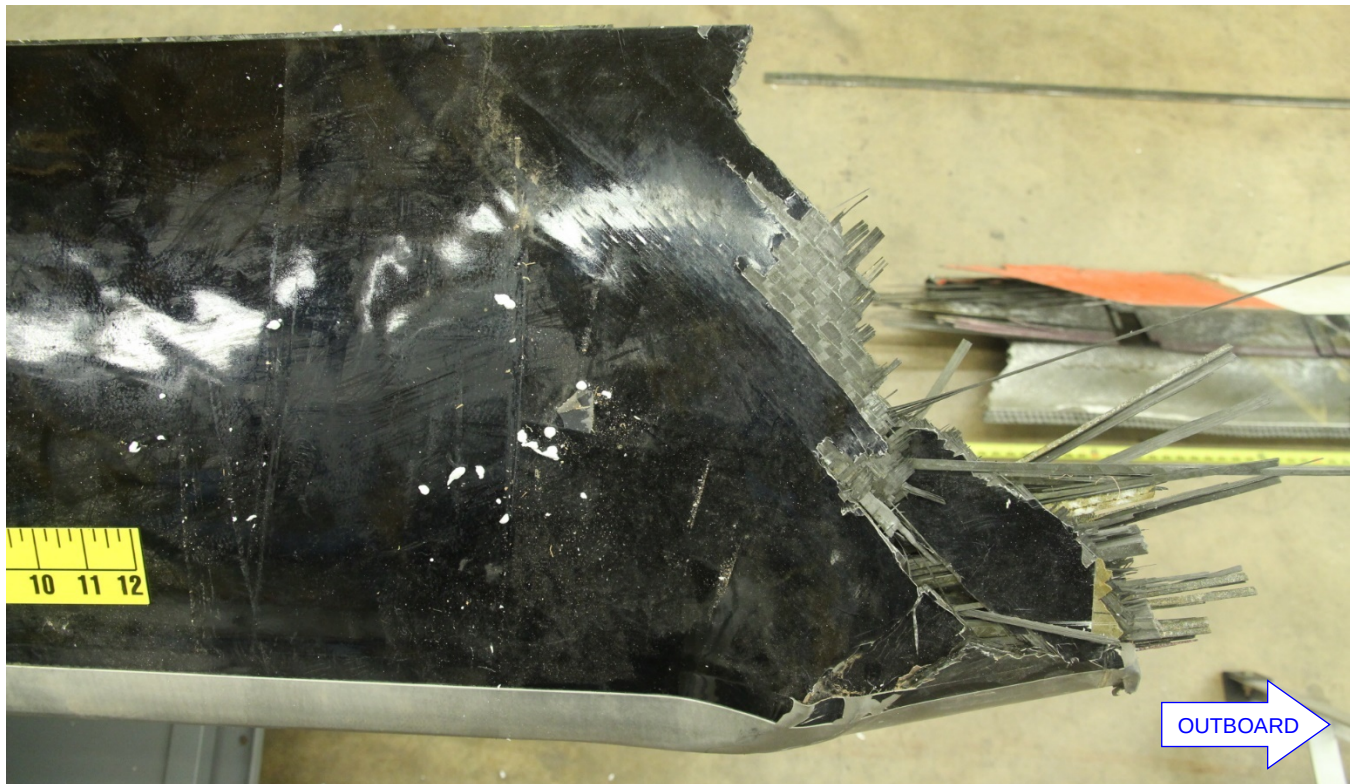
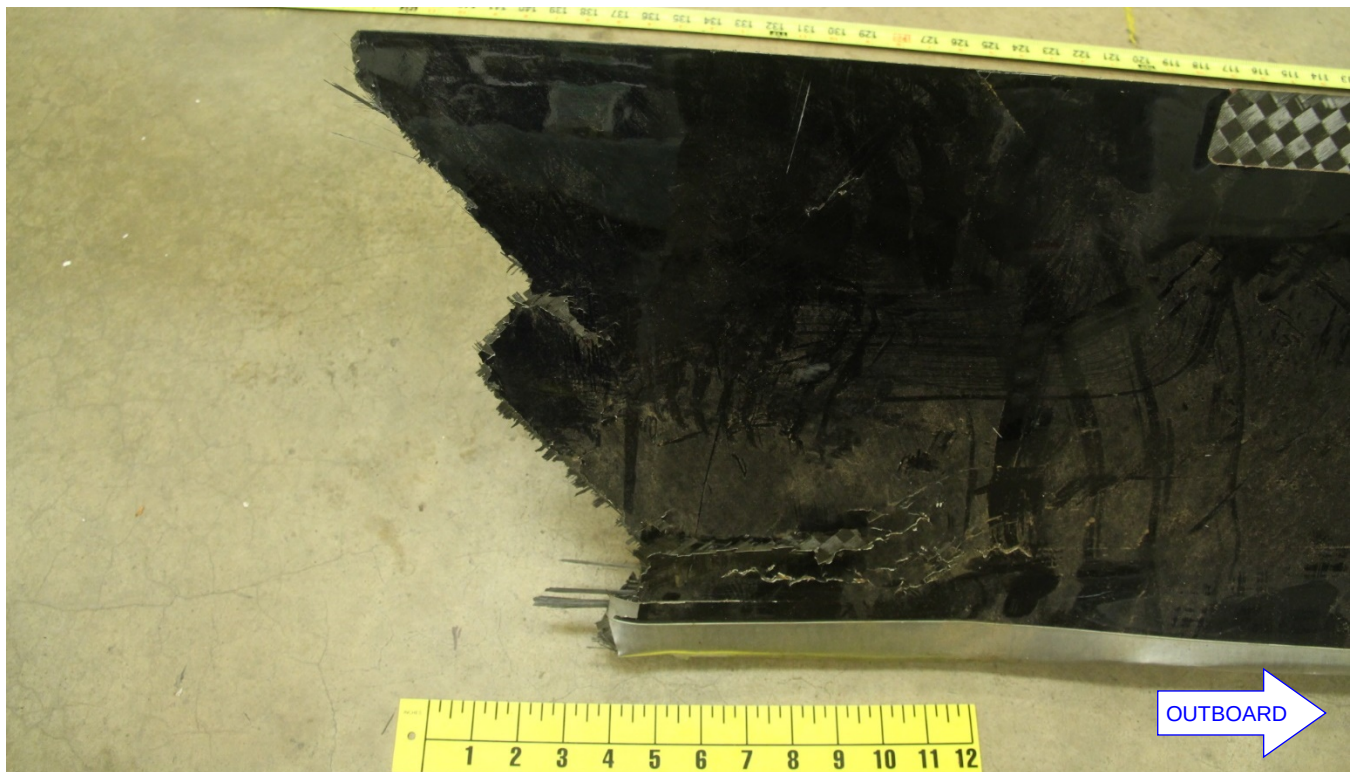
Figure 18 through Figure 20 show the fracture surfaces of the inboard fracture of Blade B (the blade that had not been instrumented). These surfaces were separate from the combined reconstruction, viewed from the trailing edge and bottom side, shown in Figure 3e. On these figures, the leading-edge metallic abrasion strip was buckled inward with a slight downward bend. The woven composite fibers on the bottom blade skin showed some crushing and buckling on the leading edge, but they exhibited pullout along the leading portion of the fracture surface. While the middle section of the blade skin surface showed some paint peeling in the middle, much of the paint pattern was still present adjacent to the fracture surface on the leading and trailing edge sides (see Figure 19).

Figure 18 – Bottom view of the outboard fracture of Blade B.

Figure 19 – Mating fracture surface of Blade B from Figure 18.

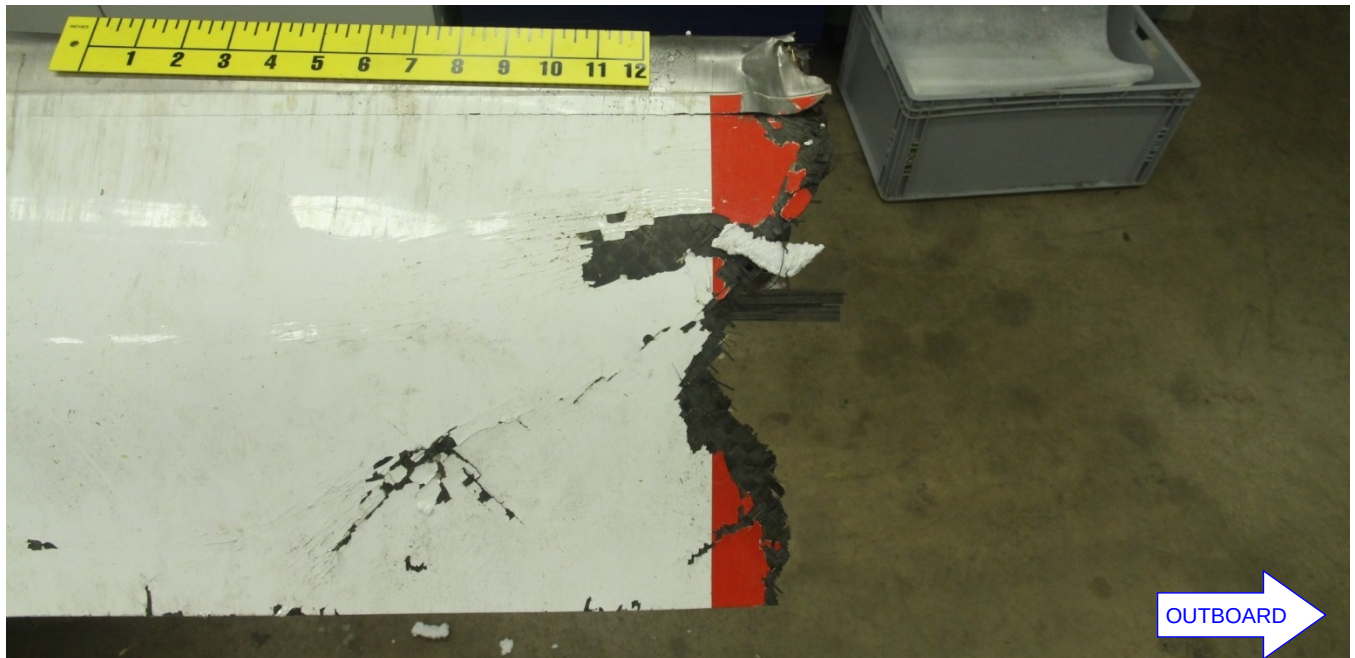
On the top side of Blade B, the fracture pattern on the skin was generally wavy, with paint absent 1 to 2 inches from the skin fracture (see Figure 20). The metallic leading-edge abrasion strip exhibited S-shaped compressive buckling on the upper face. In addition, the paint on the outboard section of the trailing edge had cracked. All of these features were consistent with compression on the upper surface and tension on the lower surface, with some evidence of twisting or torsion. This pattern was consistent with upward bending of Blade B at this fracture location. This fracture location was also consistent with the location of the doubler termination, approximately 37.5 inches from the grip plate, or 48-50 inches from the blade root.

Figure 20 – Top view of the inboard fracture of Blade B.

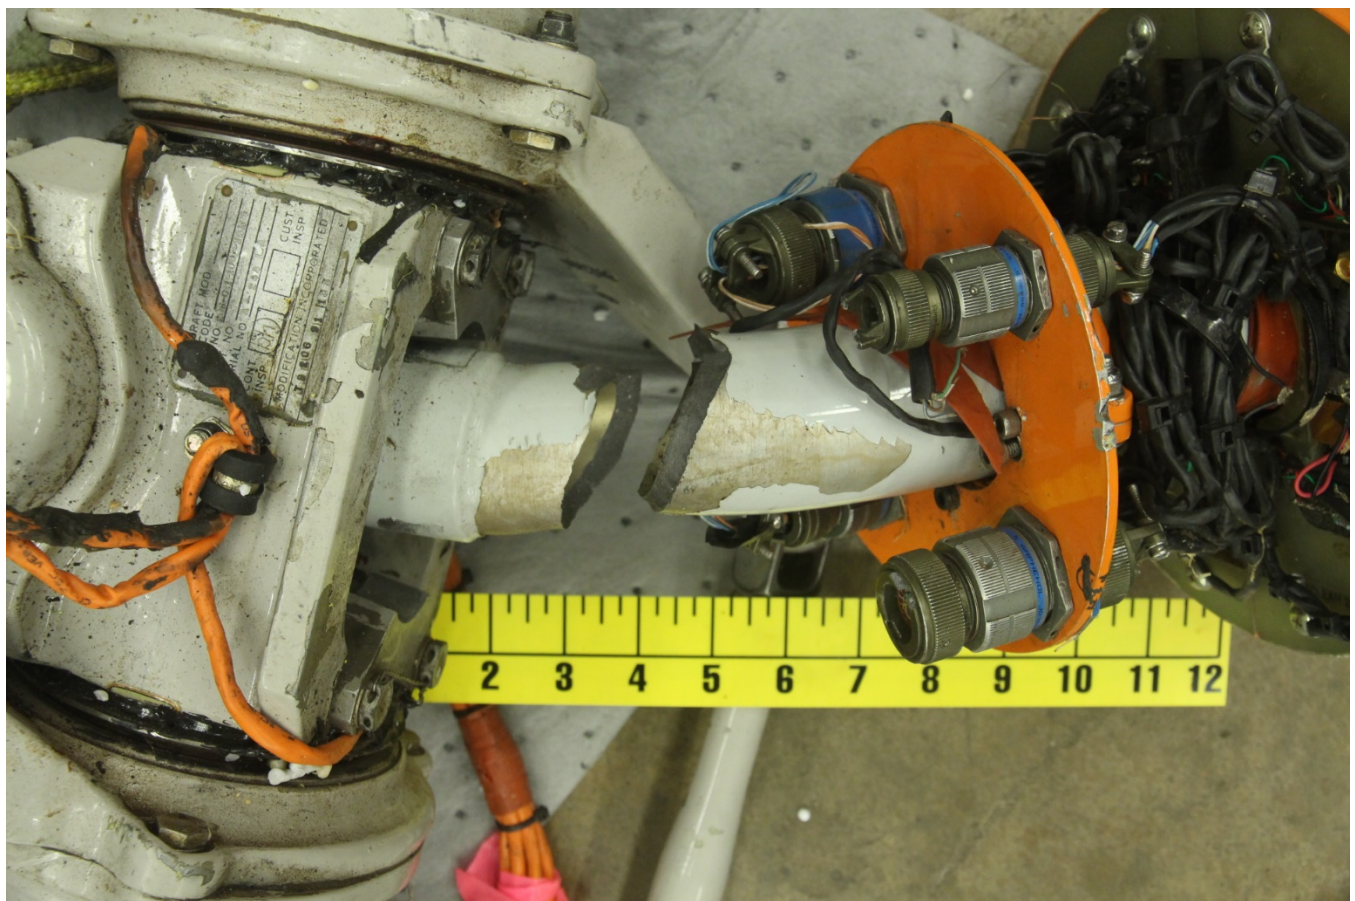
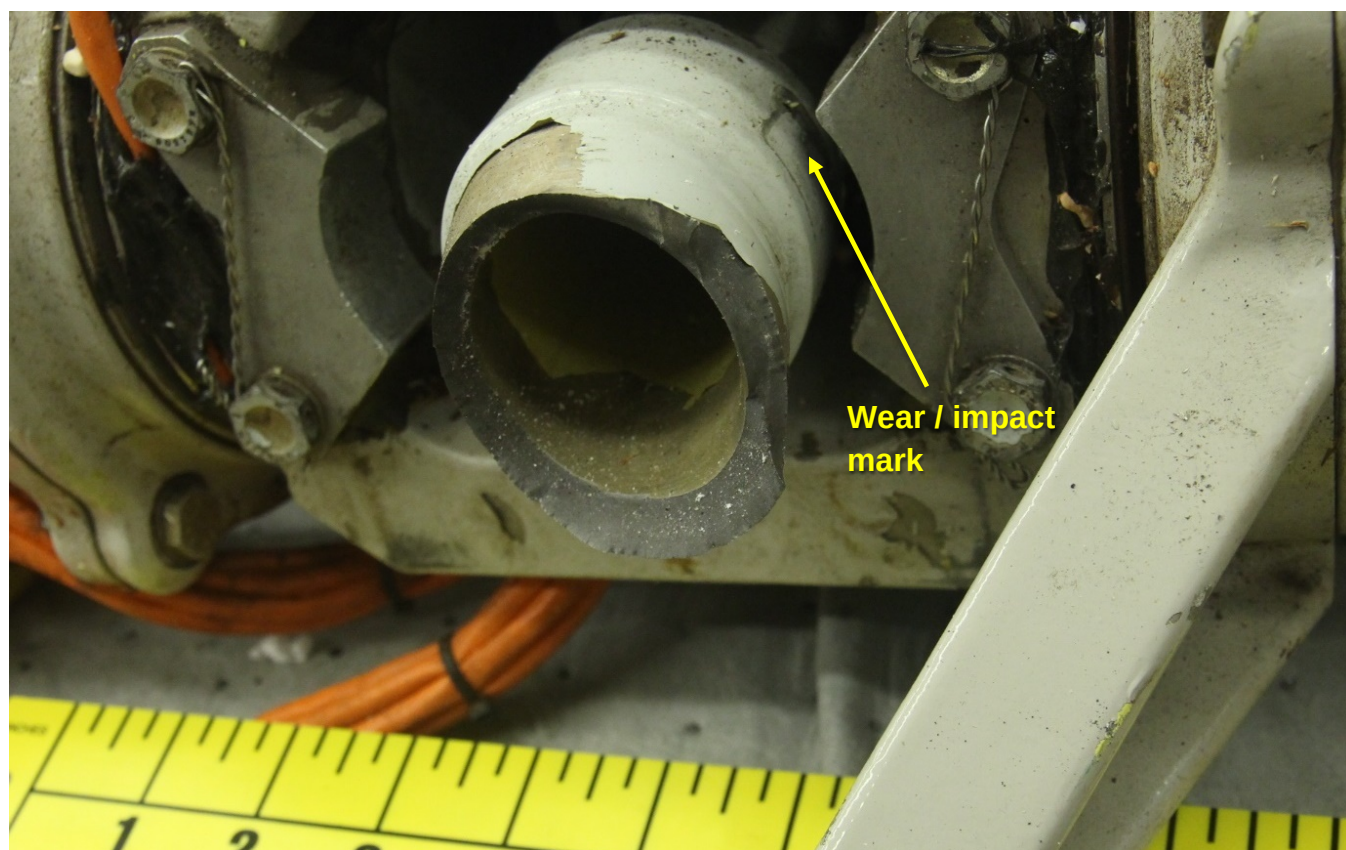
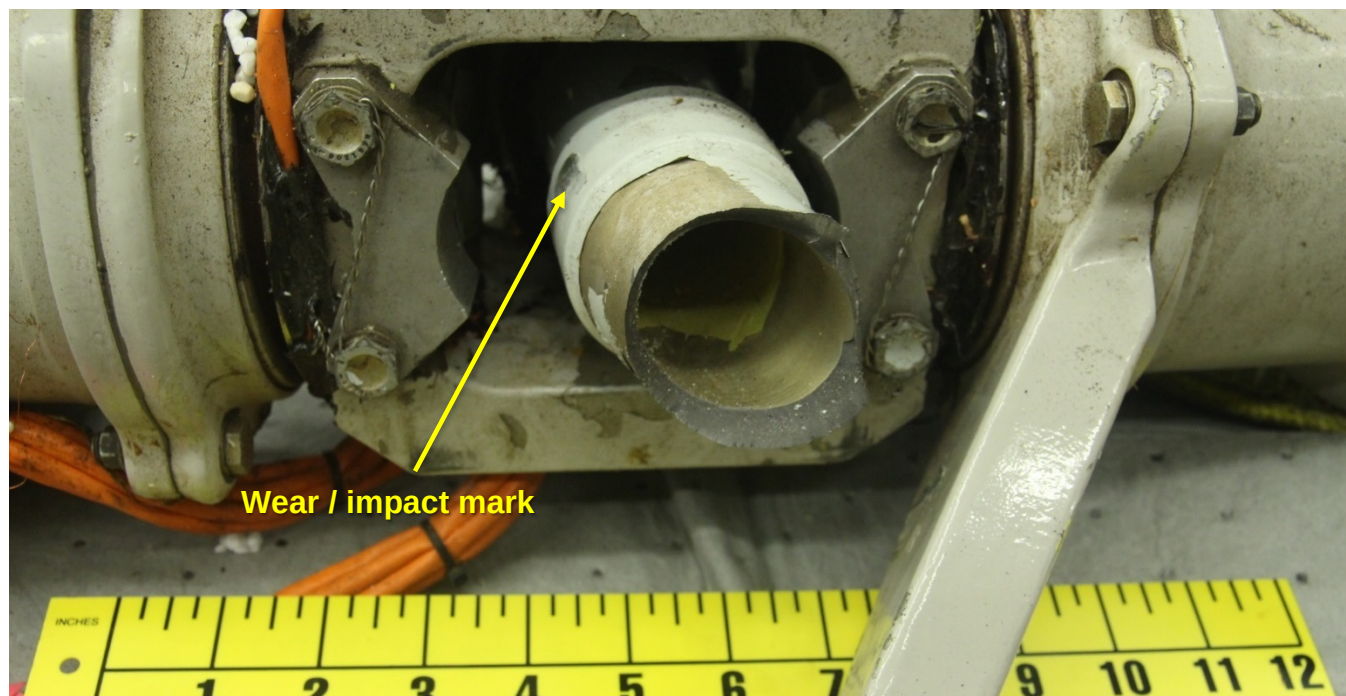
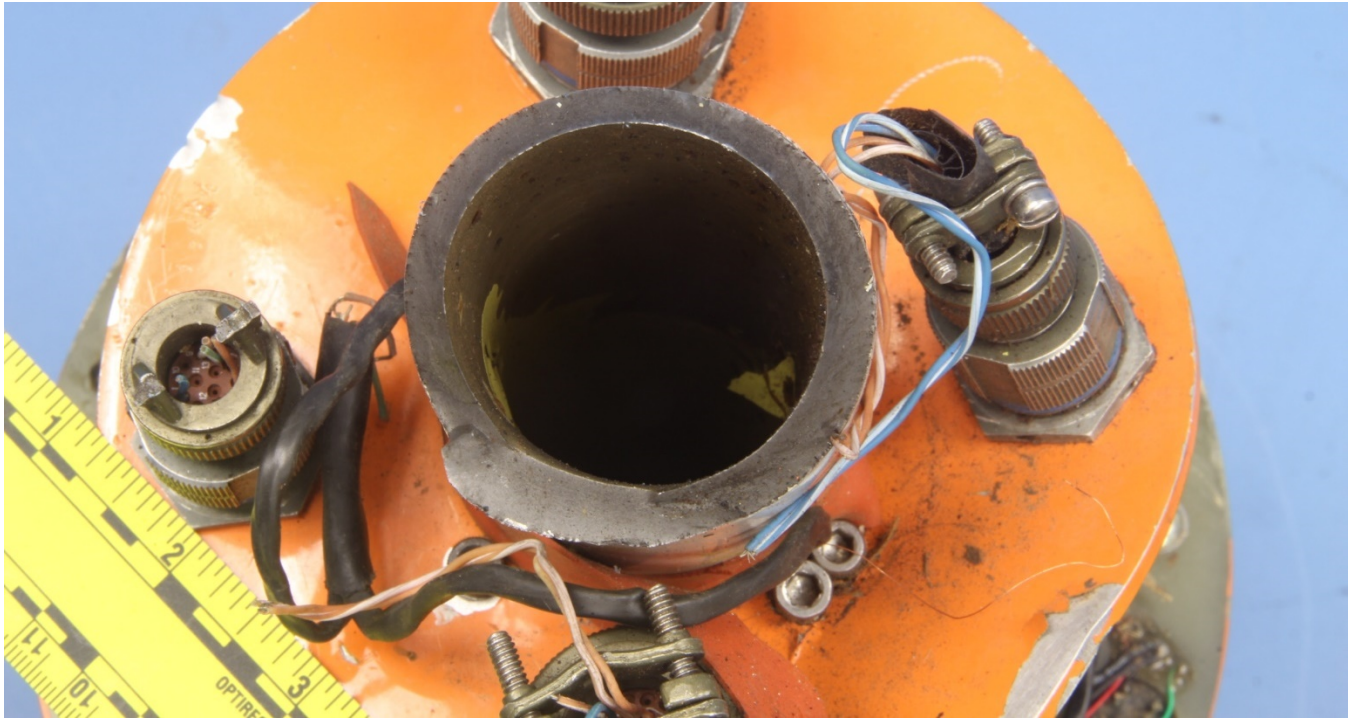
The main rotor mast had fractured approximately 2.75 inches from the bottom of the housing, shown in Figure 21. The mast exhibited a general bend along the location of the fracture. Some paint was absent on the mast surface, shown facing the reader in Figure 21. As shown in Figure 21 through Figure 27, the mast exhibited thinning or necking near the fracture surface. This fracture surface was oriented at an inward-facing  $45^\circ$  angle relative to the mast direction. The fracture surface exhibited a lull, flat luster. The portion of the fracture surface on the concave side of the bend exhibited a change in orientation, although still angled. This feature suggested that this area was under compression at the

fracture. These features were consistent with a bending load at the fracture location of the mast, in the direction of the compressive fracture section.

Figure 21 – View of the mating sides of the fractured main rotor mast.

Figure 22 – Side view of the upper mast fragment, showing impact marks in the paint on the side wall.

Figure 23 – Side view of the upper mast fragment opposite Figure 22, showing impact marks in the paint on the side wall.

Figure 24 – The lower mast fracture surface viewed facing the reader.

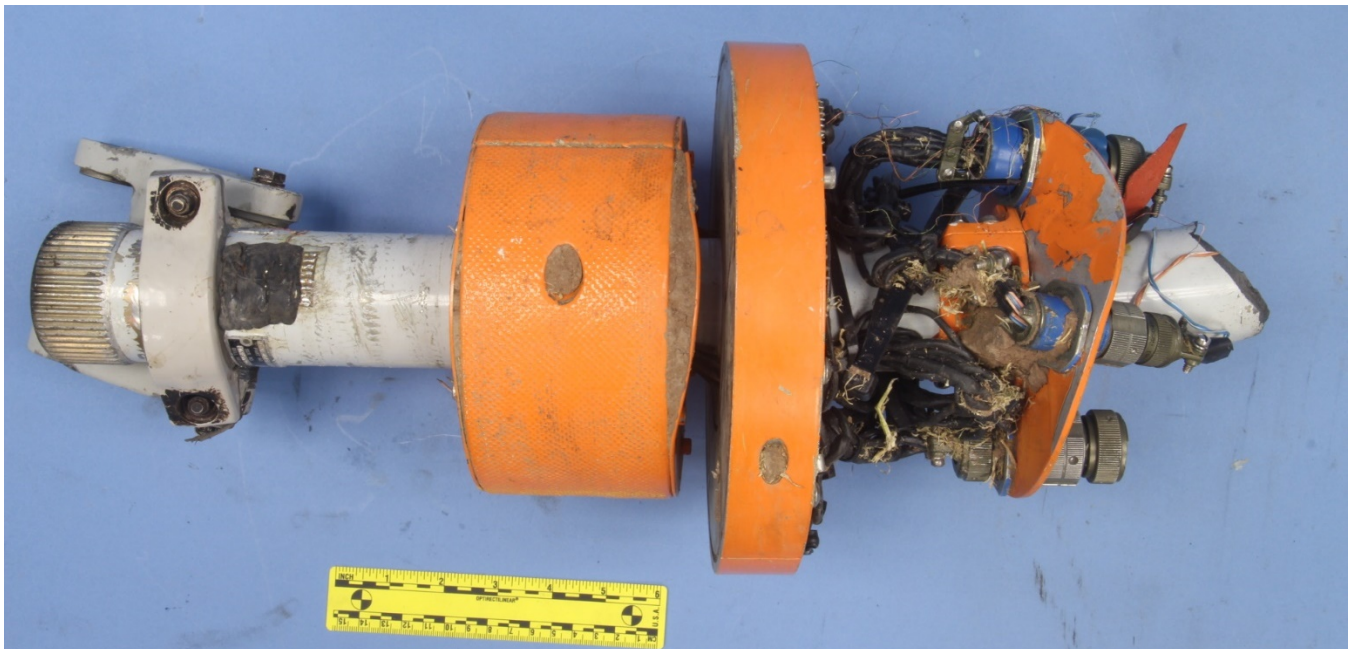
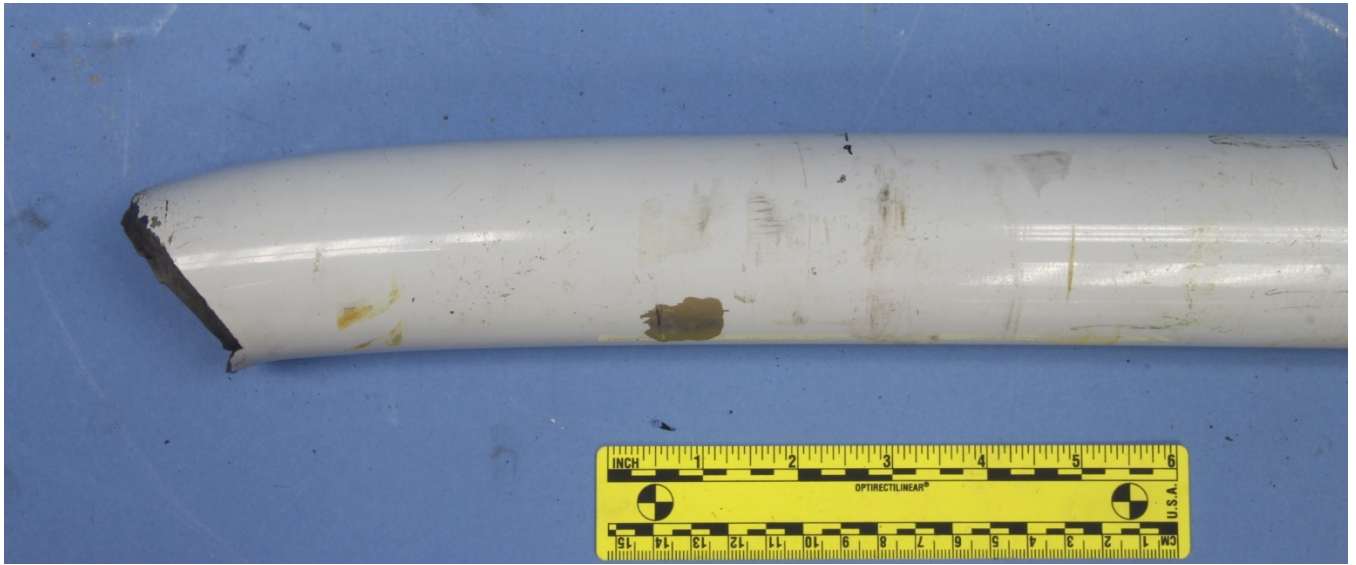
Figure 25 and Figure 26 show the lower mast fragment. This fragment had been sectioned in the splined area, located on the left of Figure 25. Orange-painted instrumentation had been affixed to this section of the mast. Figure 26 shows the lower mast fragment after removal of the instrumentation. Using digital measurement techniques, the bend was calculated as being 15.5° downward in Figure 26.

Figure 25 – View of the lower fragment of the main rotor mast (with orange instrumentation affixed). The fracture surface is to the right.

Figure 26 – Side view of the lower mast fracture, after removal of the orange instrumentation.

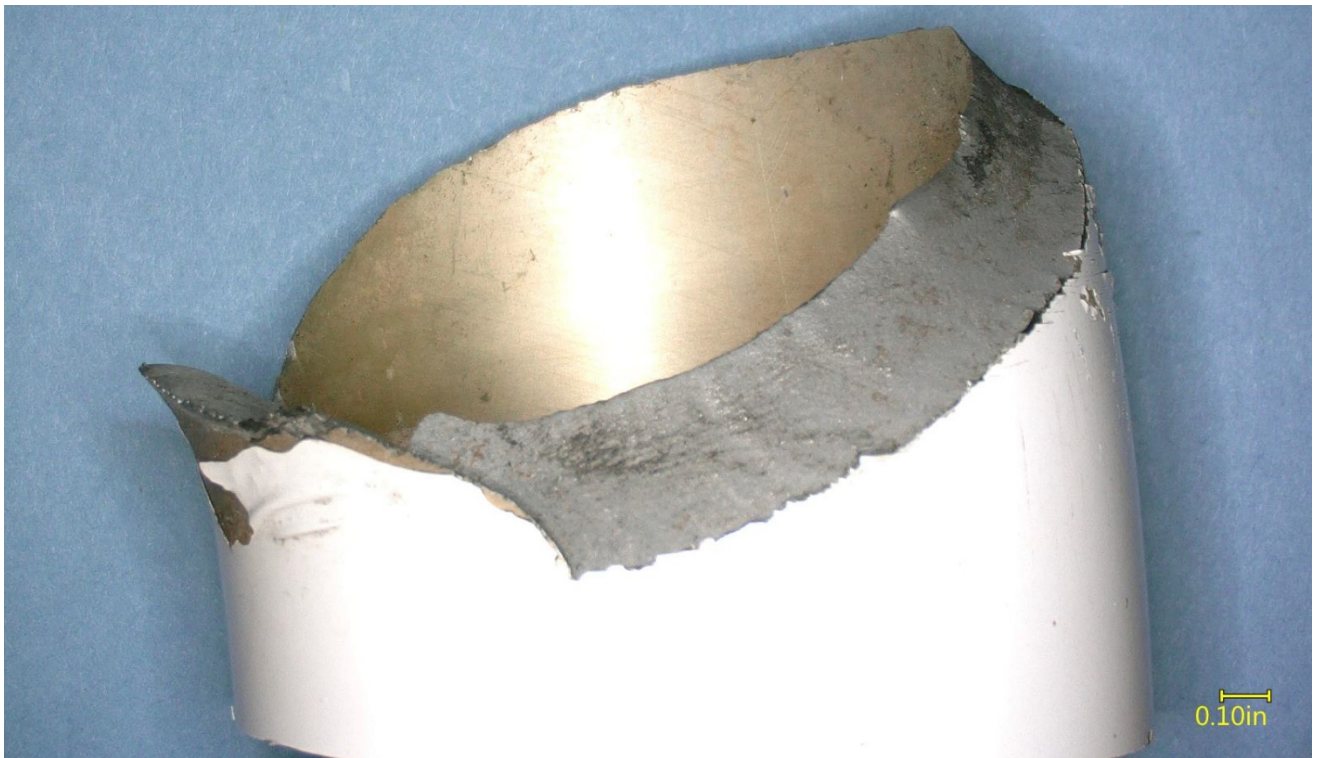
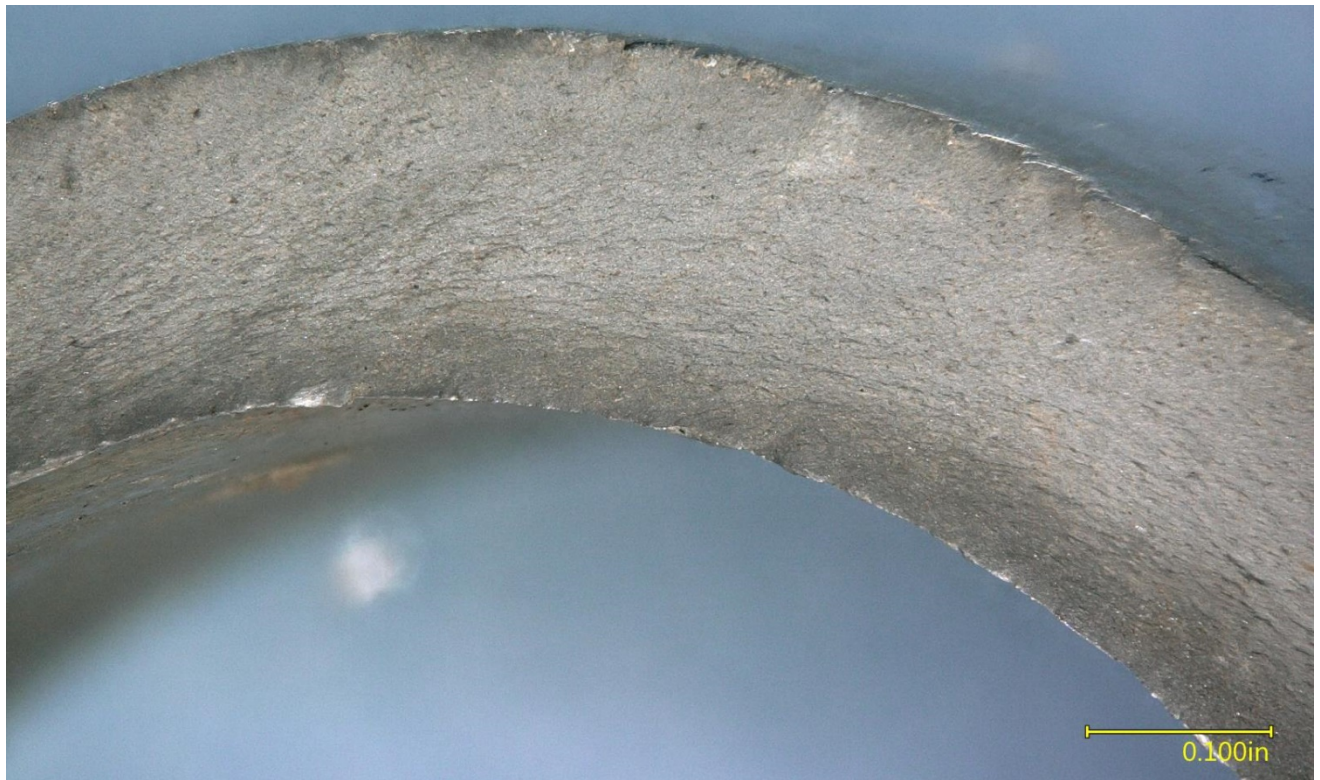
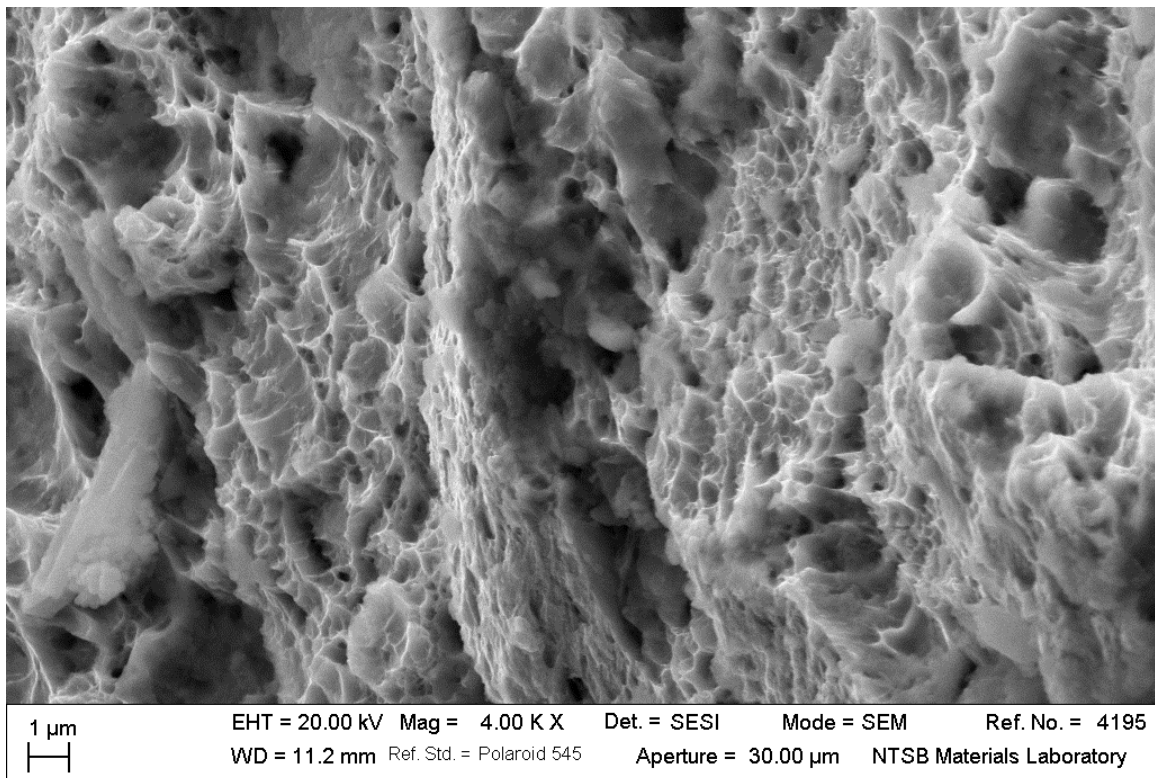
The fracture surface of the rotor mast, depicted in Figure 26, was sectioned for microscopic analysis. Figure 27 shows this sectioned fracture surface, which exhibited a general 4° slant angle orientation in relation to the mast direction. Figure 28 shows an area of the mast fracture surface from a flat view. This section of the fracture surface exhibited chevron marks, consistent with overstress fracture of a thin-walled tube (plane stress conditions). The mast fracture surface was examined using a scanning electron microscope (SEM). As illustrated in Figure 29, the fracture surface exhibited dimple rupture, consistent with overstress fracture.

Figure 27 – View of the mast fracture surface, after sectioning.

Figure 28 – Top view of the sectioned mast fracture surface, showing chevron marks.

Figure 29 – Secondary electron (SE) micrograph of the mast fracture surface, showing dimple rupture.

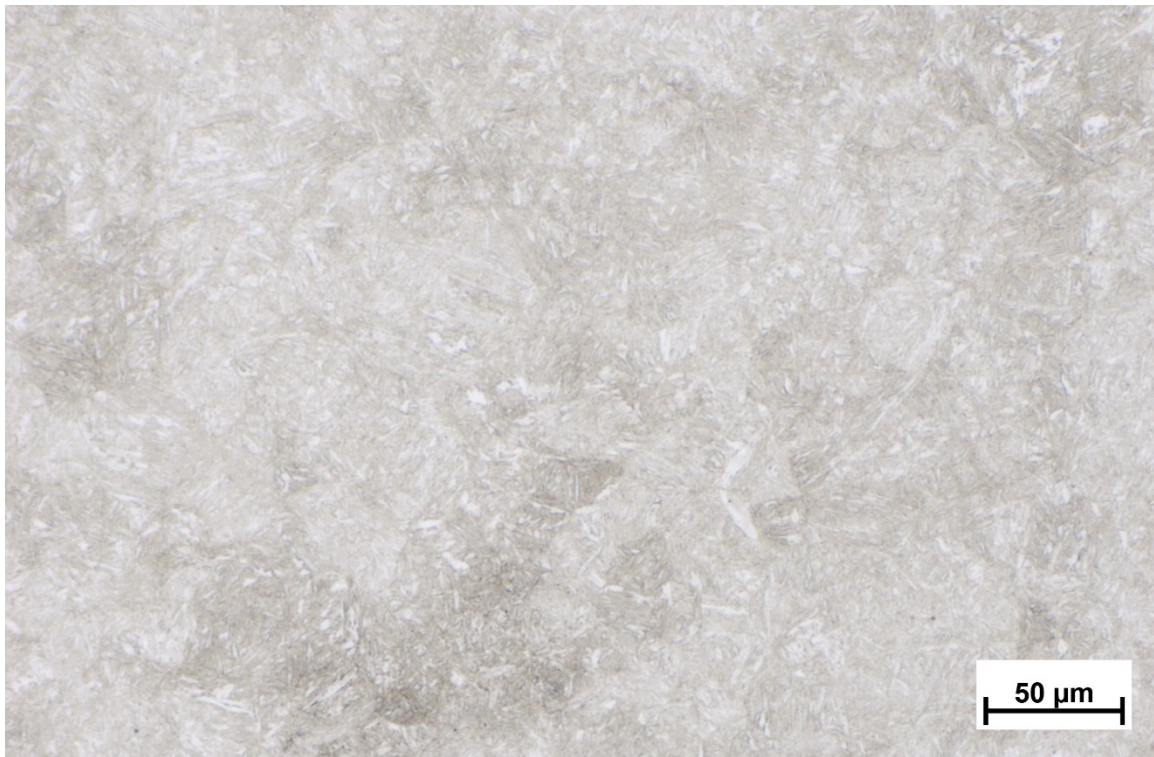
A portion of the mast wall was sectioned, mounted, and polished. The chemical composition of the mast section was examined using energy dispersive x-ray spectroscopy (EDS) and x-ray fluorescence (XRF). The chemical composition was consistent with a 4340 alloy steel. Figure 30 shows a typical area of the mast microstructure. The microstructure exhibited tempered martensite. The hardness was measured per ASTM E18.<sup>1</sup> The hardness averaged 41 HRC, which was consistent with the observed microstructure and composition of the alloy for the mast.

Figure 30 – Bright-field (BF) optical micrograph of the mast microstructure (~500X, etched 2% Nital).

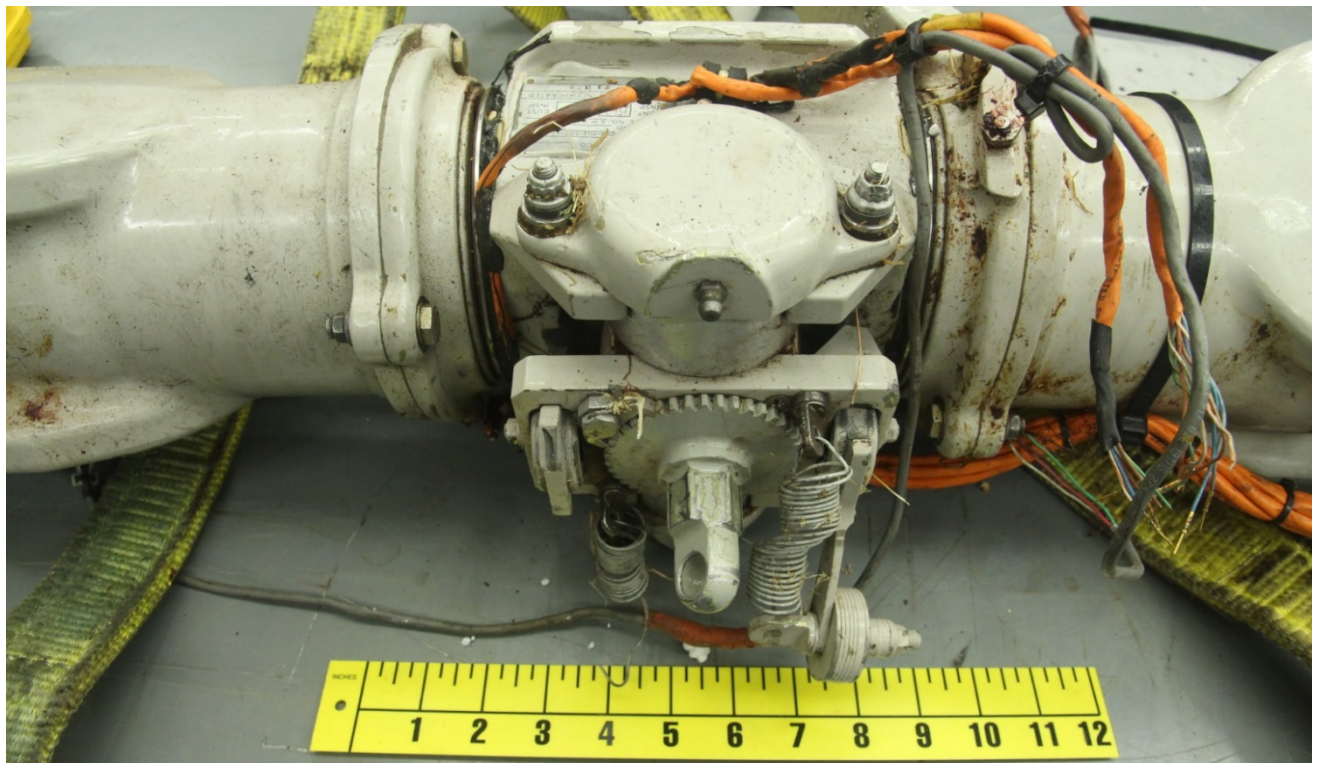
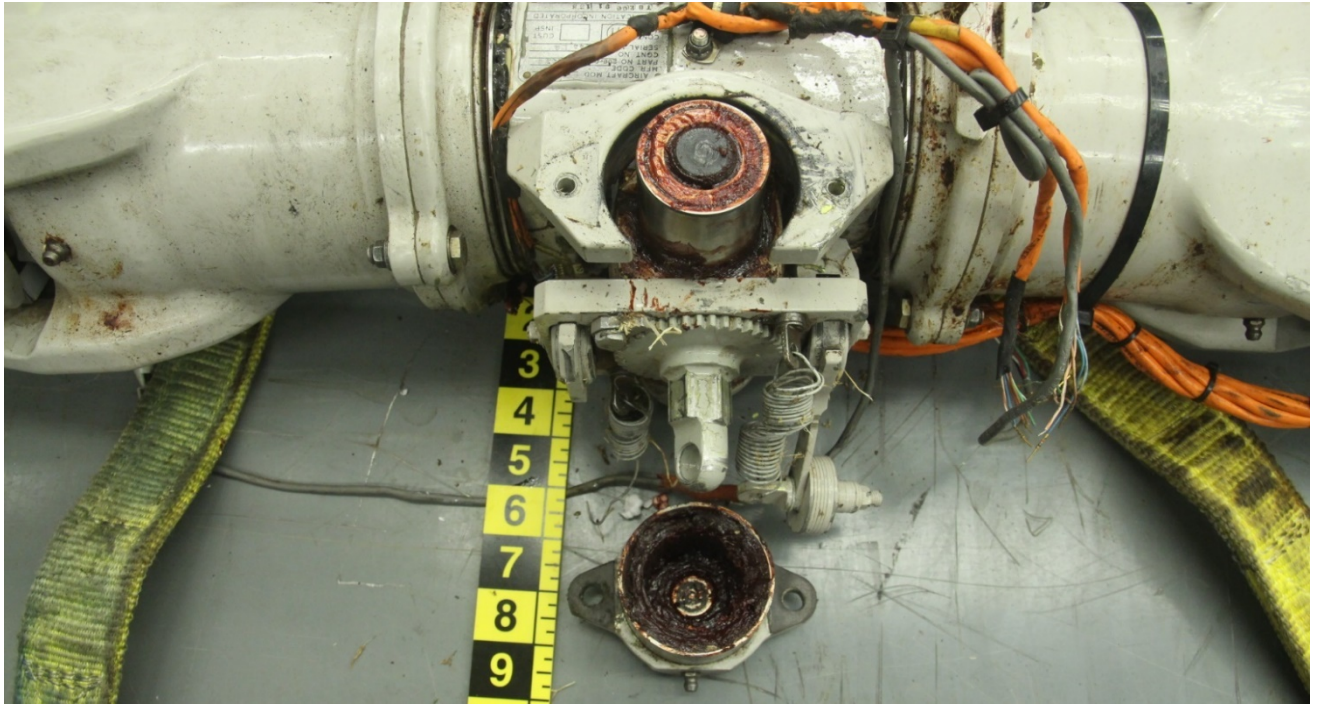
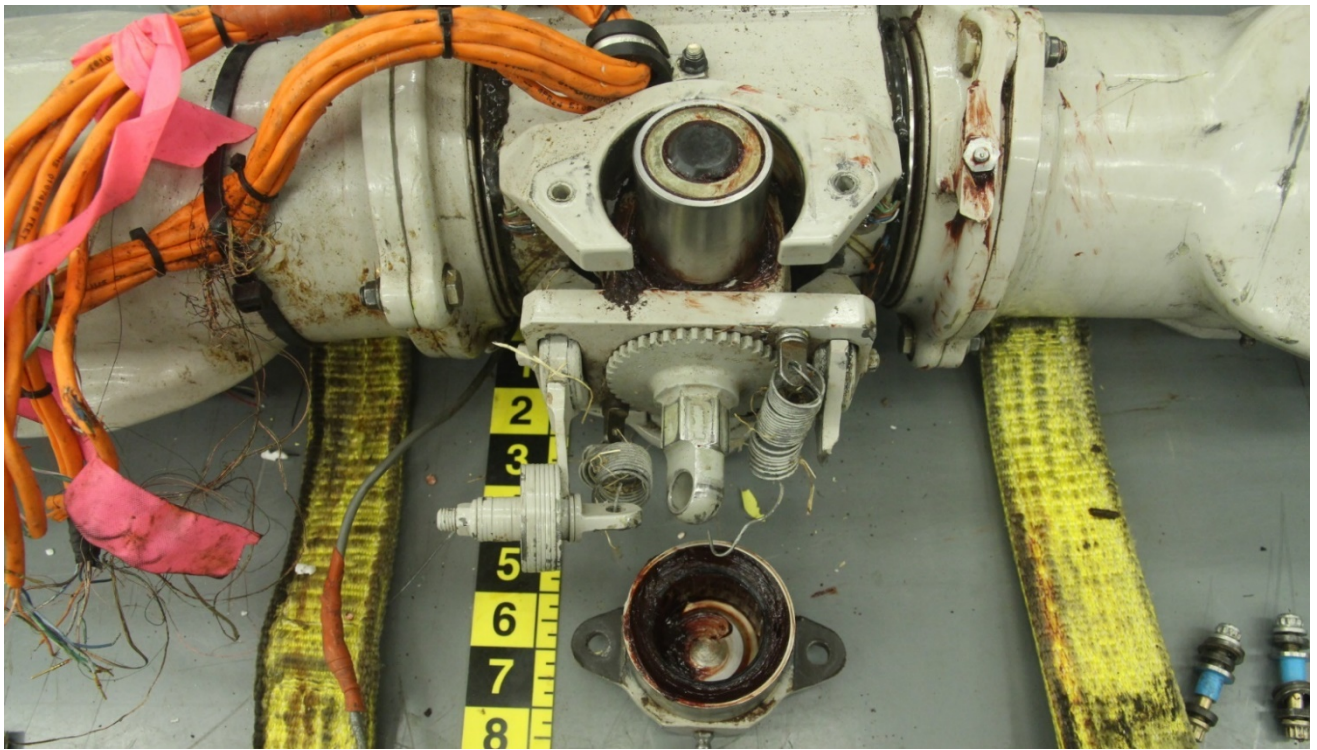
Figure 31 through Figure 33 show the upper rotor hub assembly, specifically the bearings located at 90° to the blade roots. The covers of the bearings were removed, as demonstrated in Figure 32 and Figure 33. These roller bearings had been well greased, and the cage and the rollers still maintained suction on the inner race from installation. The bearings rotated readily, and there were no indications of scratches, gouging, loose debris, or wear on the surface on the inner race (see Figure 33).

Figure 31 – An angled view of the upper main rotor hub as received, showing the bearing cover on this side.

Figure 32 – View of Figure 31, after the bearing cover on this side was removed.

Figure 33 – The opposite bearing from that in Figure 31 and Figure 32, with the cover removed.

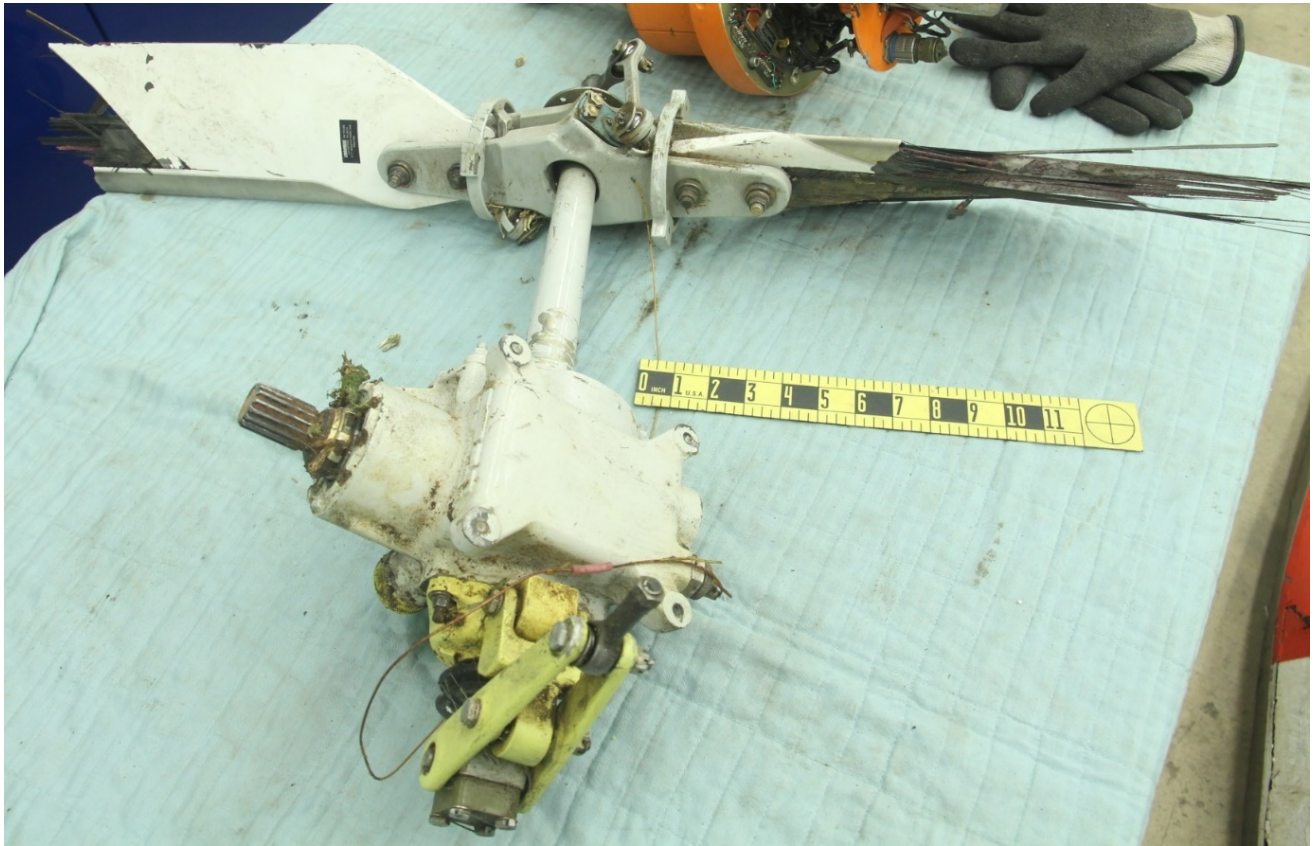
Figure 34 shows the tail rotor assembly, as received. The tail rotors had fractured outboard of the blade roots, with heavy splintering and separation of the blades. One outer fragment of one of the tail rotor blades was received with the shipment.

Figure 34 – The tail rotor assembly, as received.
