# NATIONAL TRANSPORTATION SAFETY BOARD

## MATERIALS LABORATORY FACTUAL REPORT

Report No. 19-071

Place : Ft. McDowell, Arizona  
Date : April 16, 2019  
Vehicle : Bell 206B, N61PH  
NTSB No. : WPR19FA109  
Investigator : Andrew Swick, AS-WPR

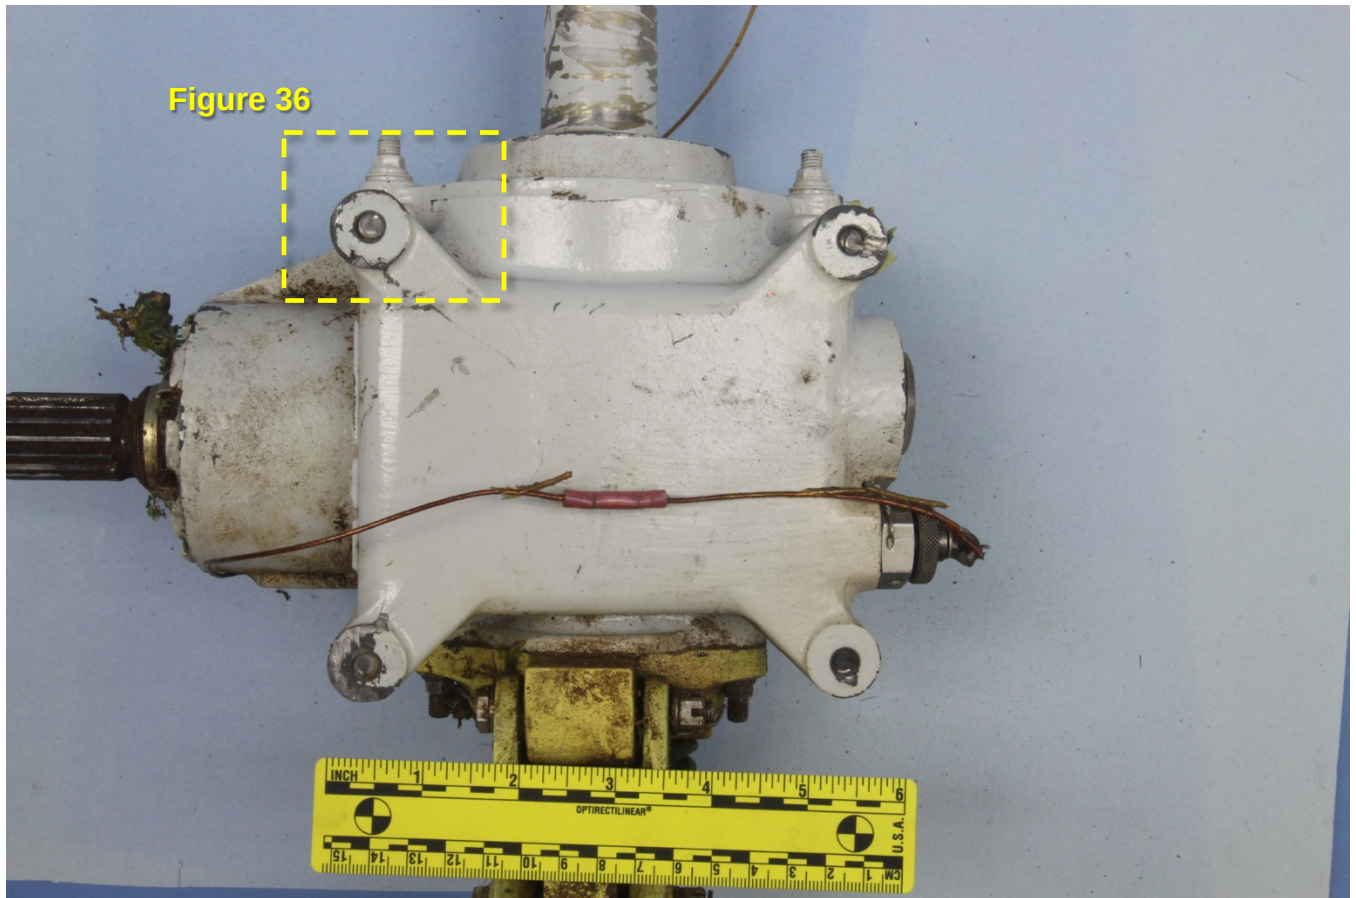
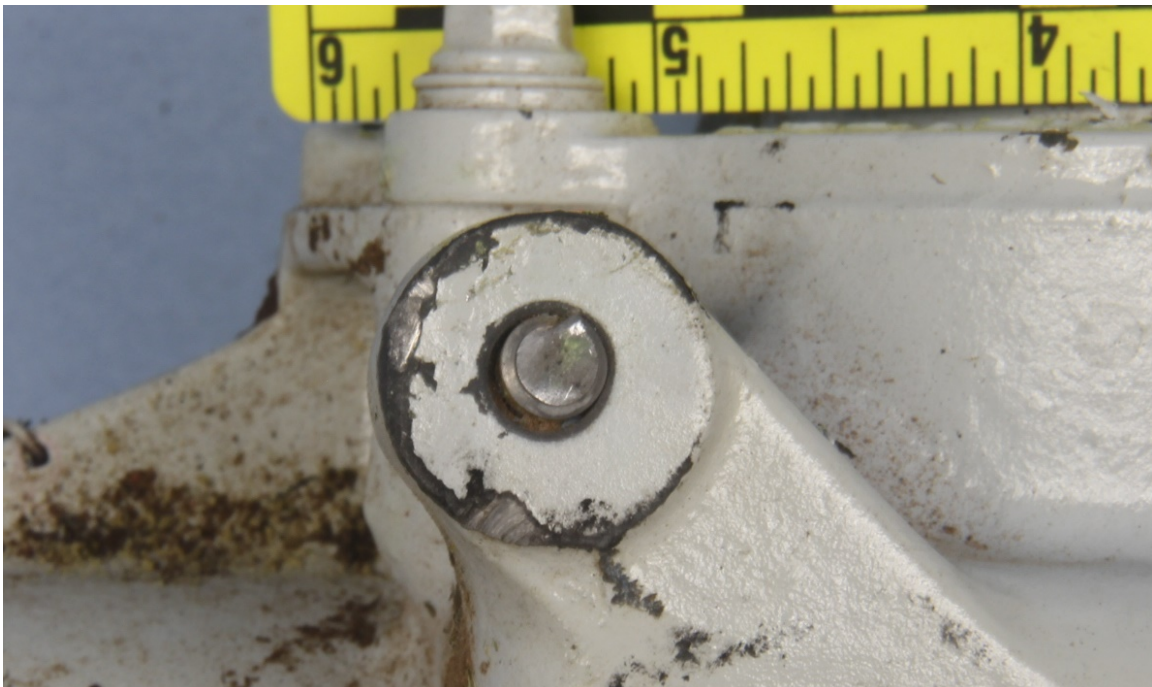
Several of the attachment bolts for the tail rotor gear box housing had fractured. Four of the threaded bolt remnants are shown in Figure 35. As exemplified in Figure 36, the bolts exhibited indications of outward pullout and bending. The fracture surfaces

exhibited rotational features, with shear lips on one side. The fracture surfaces were dull in luster, with a rough surface texture. The fracture surfaces were all located at thread roots of the bolts. These features were all consistent with overstress fracture of the bolts.

Figure 35 – Fractured bolts of the tail rotor gear assembly.

Figure 36 – Closer view of one of the fractured bolts in Figure 35.

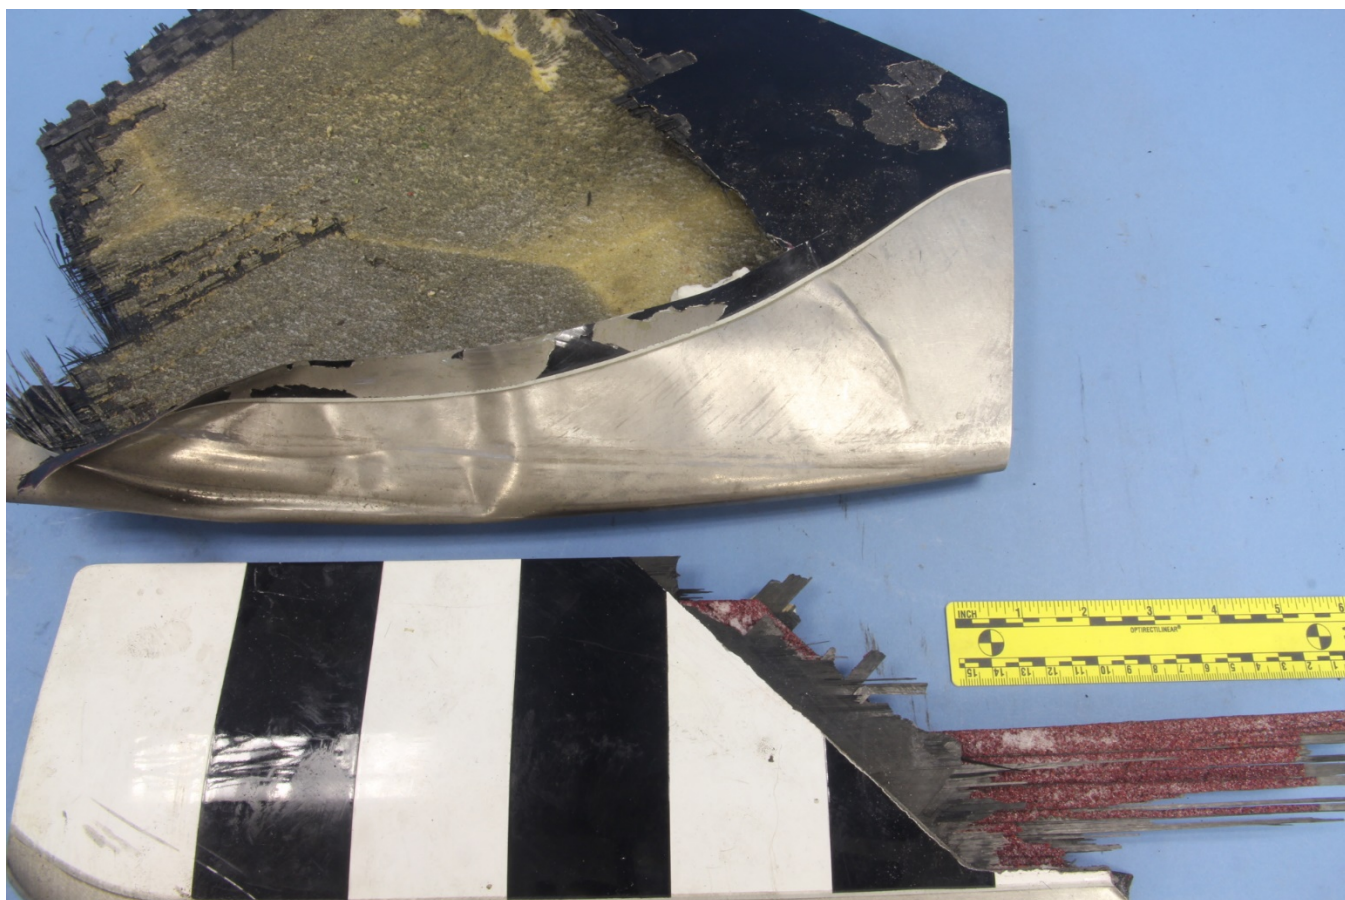
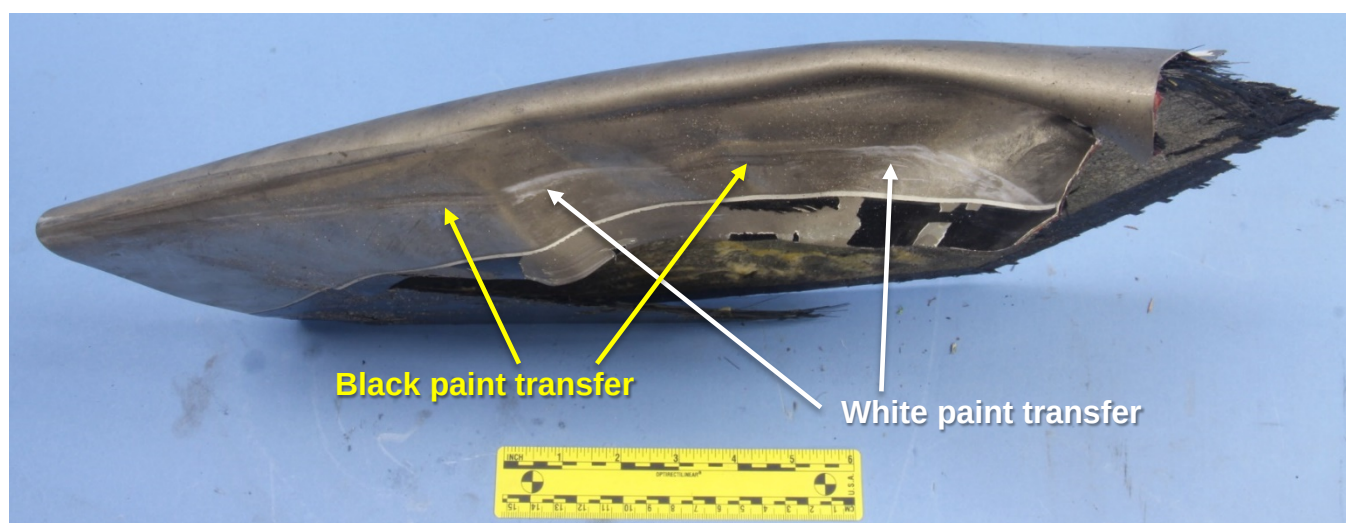
The leading edge blade tip abrasion strips were examined further, as displayed in Figure 37 through Figure 40. Figure 37 shows the lower side of the tip from Blade B, and Figure 38 shows an edge-on view. In both figures, the underside of the metallic tip had been indented in an upward manner. The indented area exhibited a linear paint transfer mark. This paint transfer mark exhibited a pattern of alternating white and black colors. Angled scrape marks were present, consistent with having moved away from the banded paint transfer area. The width of these colors corresponded to the alternating white and black paint stripes on the tail rotor blade remnant. The matrix and the received tail rotor blade fragment were positioned together for comparison in Figure 37.

Figure 37 – View of the Blade B tip abrasion strip, showing corresponding black and white paint transfer consistent with the widths of the paint pattern of the below tail rotor blade fragment.

Figure 38 – View of the leading edge of the Blade B tip abrasion strip, showing impact on the lower side and alternating white and black paint transfer, as demonstrated in Figure 37.

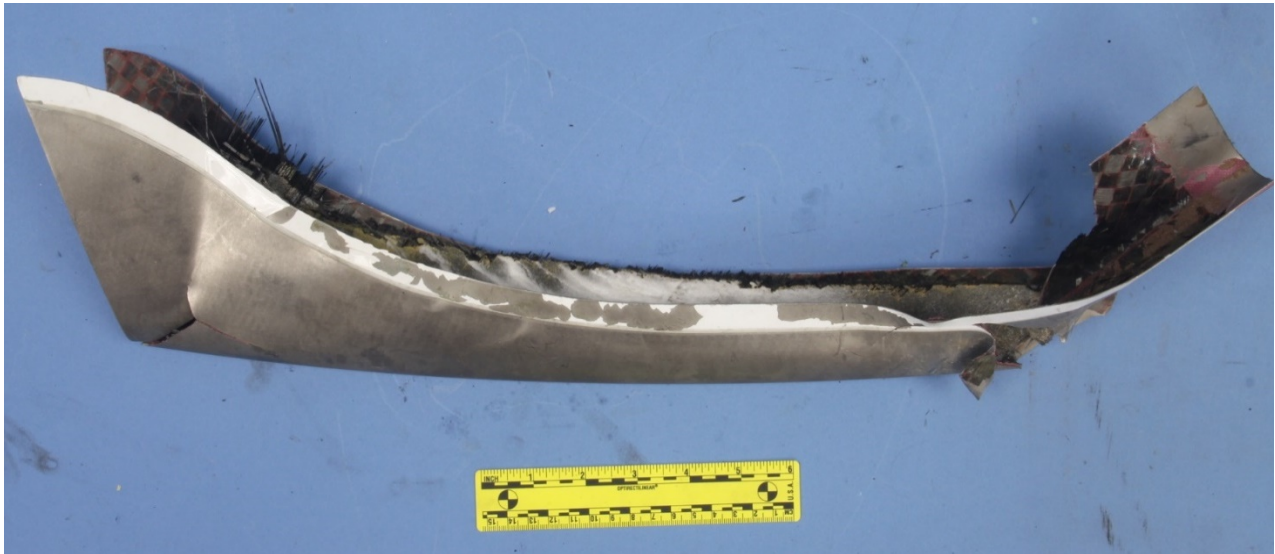
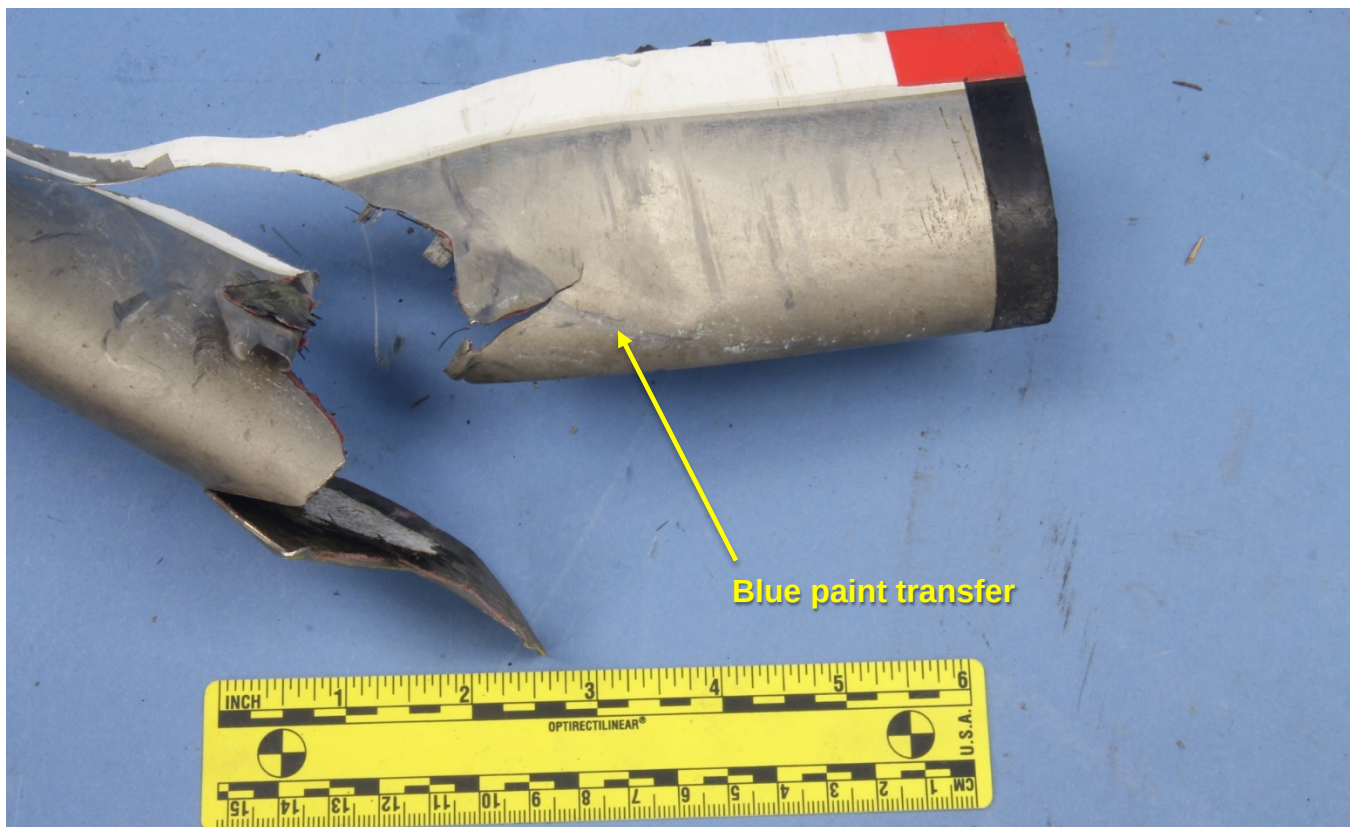
The blade tip abrasion strip of Blade A is shown in Figure 39 and Figure 40. This tip exhibited features consistent with an impact with another object. The tip had been torn and ripped at the location of the fracture. The outboard portion, while still attached to the rest of the tip, was bent aft and slightly upward. The inboard fracture surface was crumpled in an inboard direction, with the bottom section bent downward. At the outboard portion, a rounded dent was present. Blue paint transfer was present along the leading edge of the tip. Paint transfer and scrape marks emanated aft along the top of the tip.

Figure 39 – Top view of the blade A tip abrasion strip remnant.

Figure 40 – View of the fracture/tear on the Blade A tip abrasion strip, showing blue paint transfer at the fractured indent.

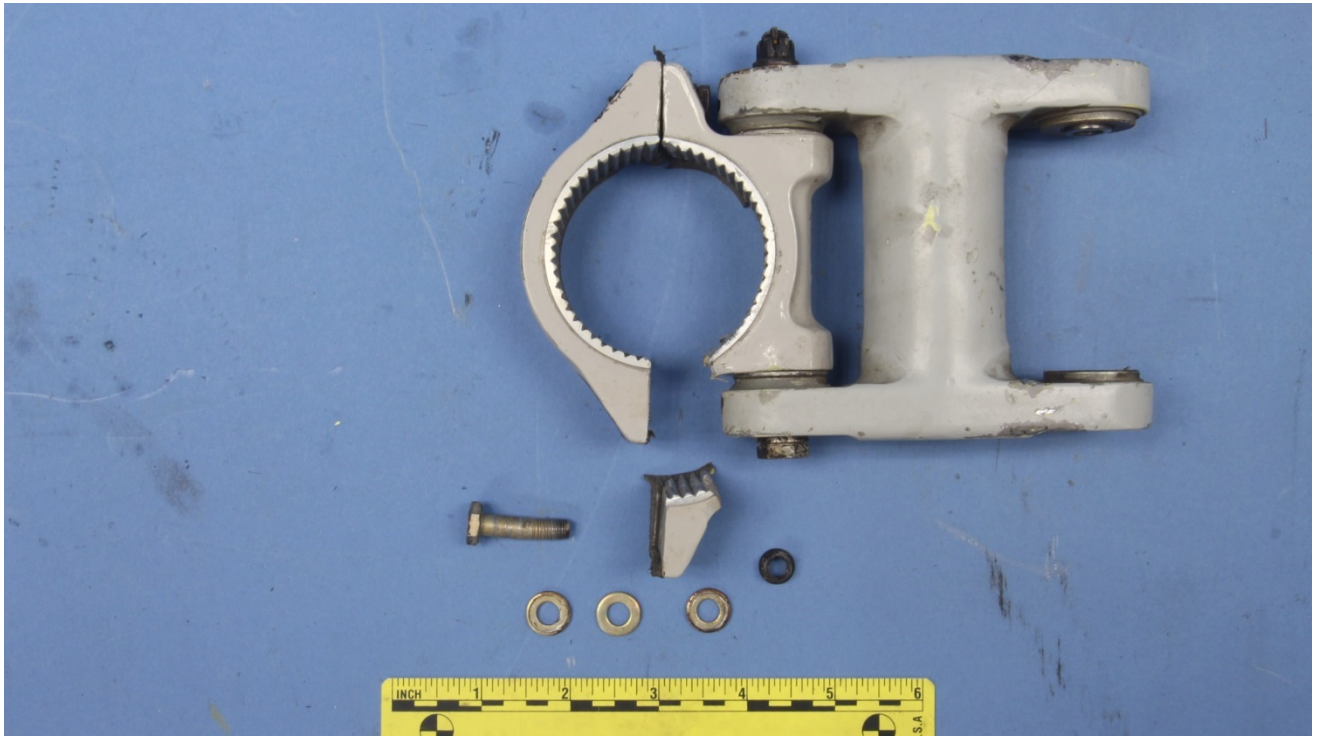
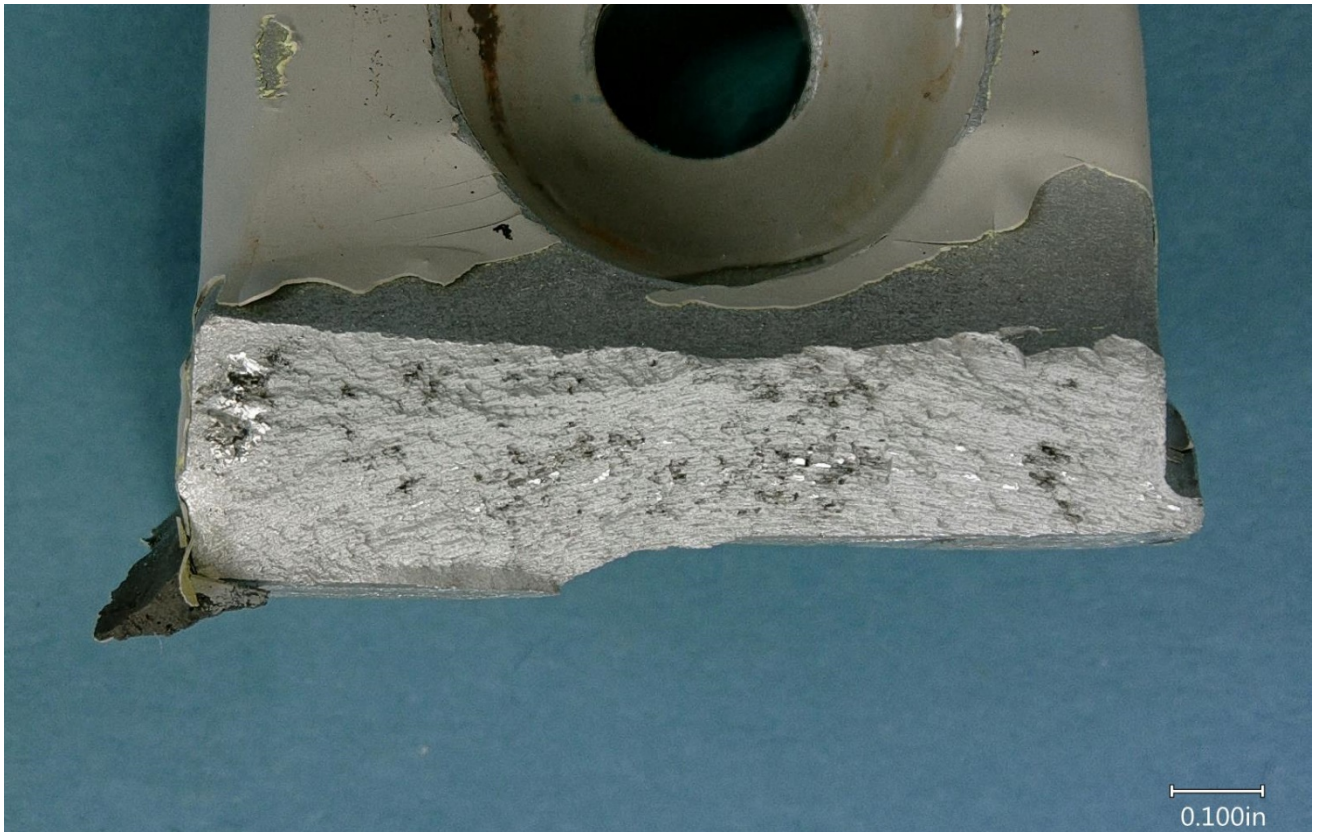
Figure 41 show components from the collar set and lever assembly, after disassembly and removal from the mast. Of note was the collar had fractured. Figure 42 shows a closer view of the collar fracture surface. This surface exhibited river patterns and was generally rough with a dull luster. Later examination of the fracture surface using a SEM found dimple rupture on the fracture surface. These features were consistent with overstress fracture in an outward bending direction. The chemical composition of the collar was inspected using XRF. The collar composition was consistent with an AA 7075 aluminum alloy.

Figure 41 – Components from the collar set assembly and lever assembly, after removing from the rotor.

Figure 42 – Closer view of the collar fracture surface, showing river patterns and paint spall.
