## **NATIONAL TRANSPORTATION SAFETY BOARD**

### **SUMMARY OF AIRPLANE EXAMINATION**

**WPR19FA116**

| Aircraft: | Vans RV-8A |

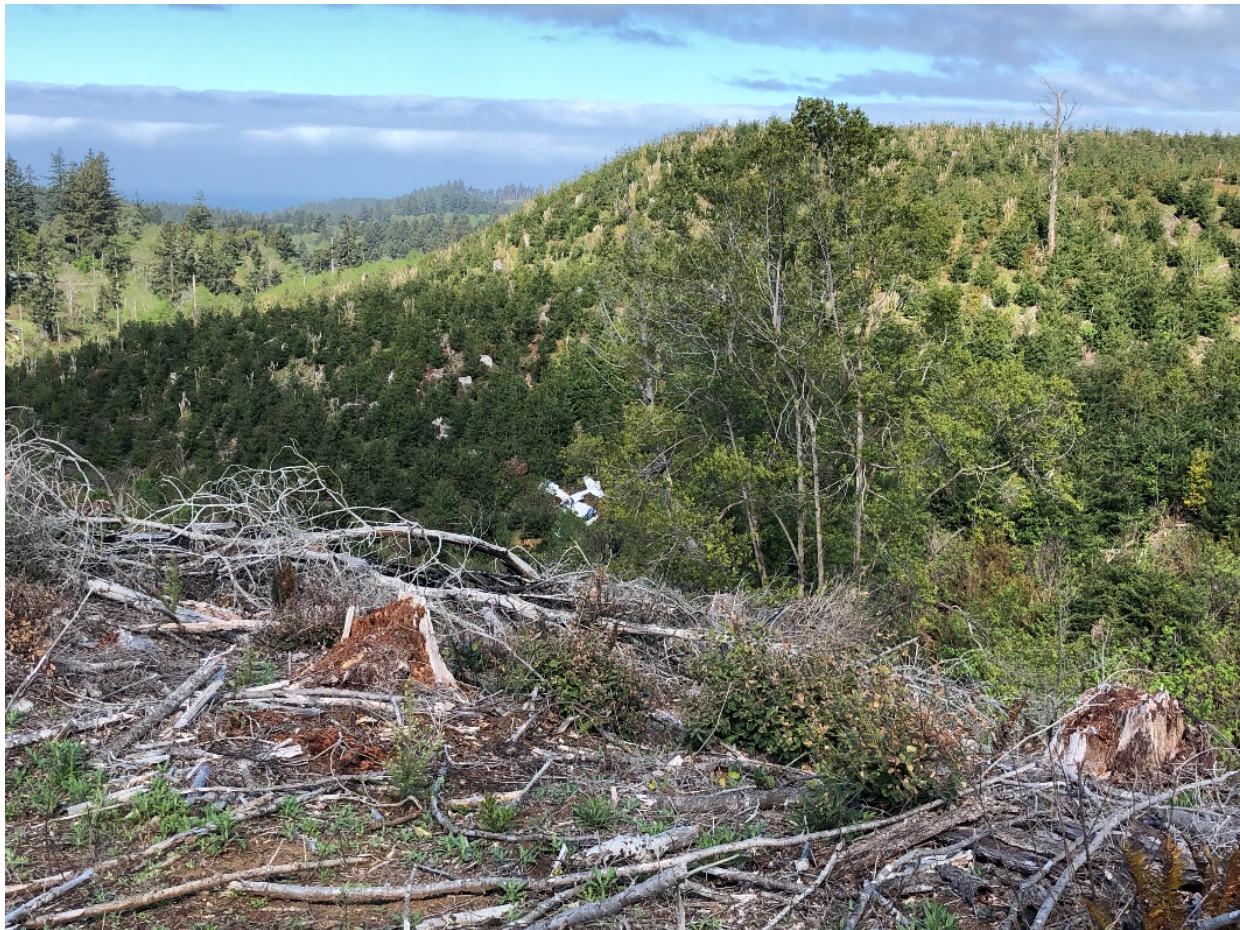
Figure 1 - photo of accident site

An onsite examination of the airplane was performed by representatives from the NTSB and the FAA on April 20, 2019. The assessment of the wreckage revealed that the airplane came to rest in a thick, brush covered ravine on a slope of about 20°, in an upright orientation on a magnetic heading of about 170°. This location was about 3,400 ft northwest of the departure end of the runway 30 from which the pilot had just performed touch-and-go landing. The airplane came to rest intact after having impacted terrain in a steep nose-down attitude, with substantial damage observed throughout the airplane. There was no postcrash fire. The airplane was recovered from the accident site on April 20, 2019.
