# NATIONAL TRANSPORTATION SAFETY BOARD

MATERIALS LABORATORY FACTUAL REPORT

Report No. 19-073

Place : Brookings, OR  
Date : April 18, 2019  
Vehicle : Vans RV8A, N791PF  
NTSB No. : WPR19FA116  
Investigator : Tom Little

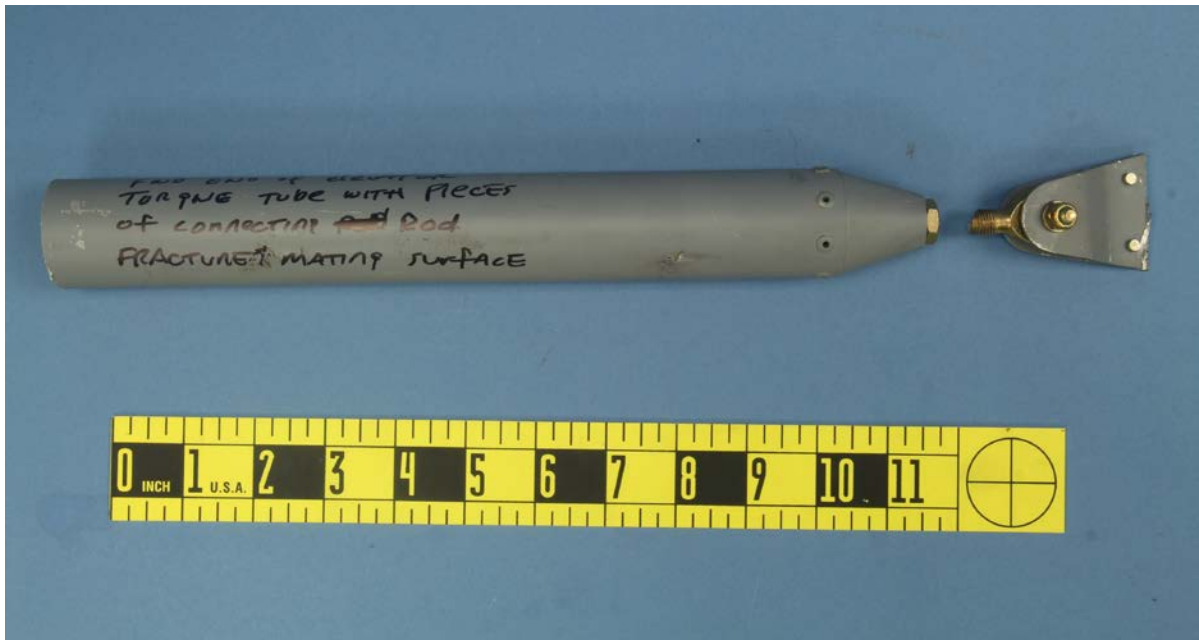
Forward section of elevator torque tube and fractured connecting rod (Figure 1).

Figure 1: Forward section of elevator torque tube and fractured connecting rod as received.

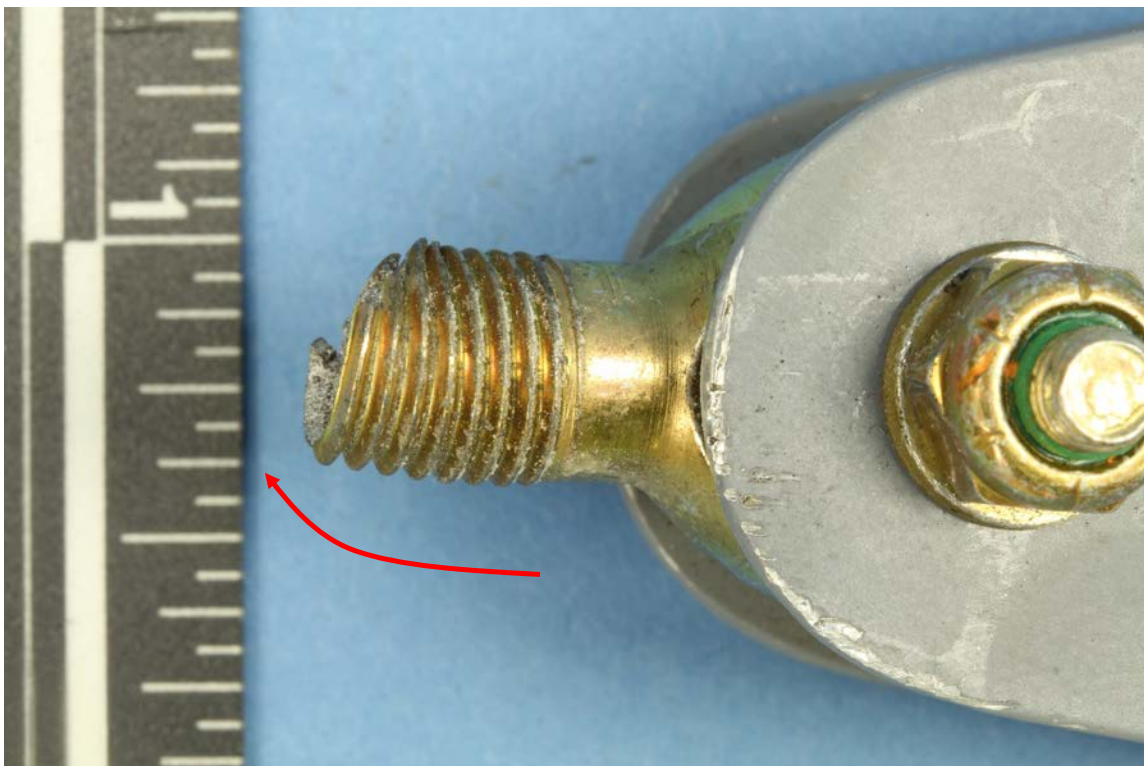
The connecting rod fractured at the nut where it was threaded into the forward portion of the elevator torque tube. The fracture surfaces of the connecting rod were examined using a stereo microscope. The threaded shank portion of the connecting rod exhibited plastic deformation (Figure 2). The plastic deformation consisted of bending of the threaded shank and resulted in elongation of the thread pitch on one side of the threaded shank and compression of the thread pitch on the other. Some thread was torn out at the final fracture point (Figure 3). This fracture is consistent with bending overstress.

Figure 2: Connecting rod shank exhibiting plastic deformation.

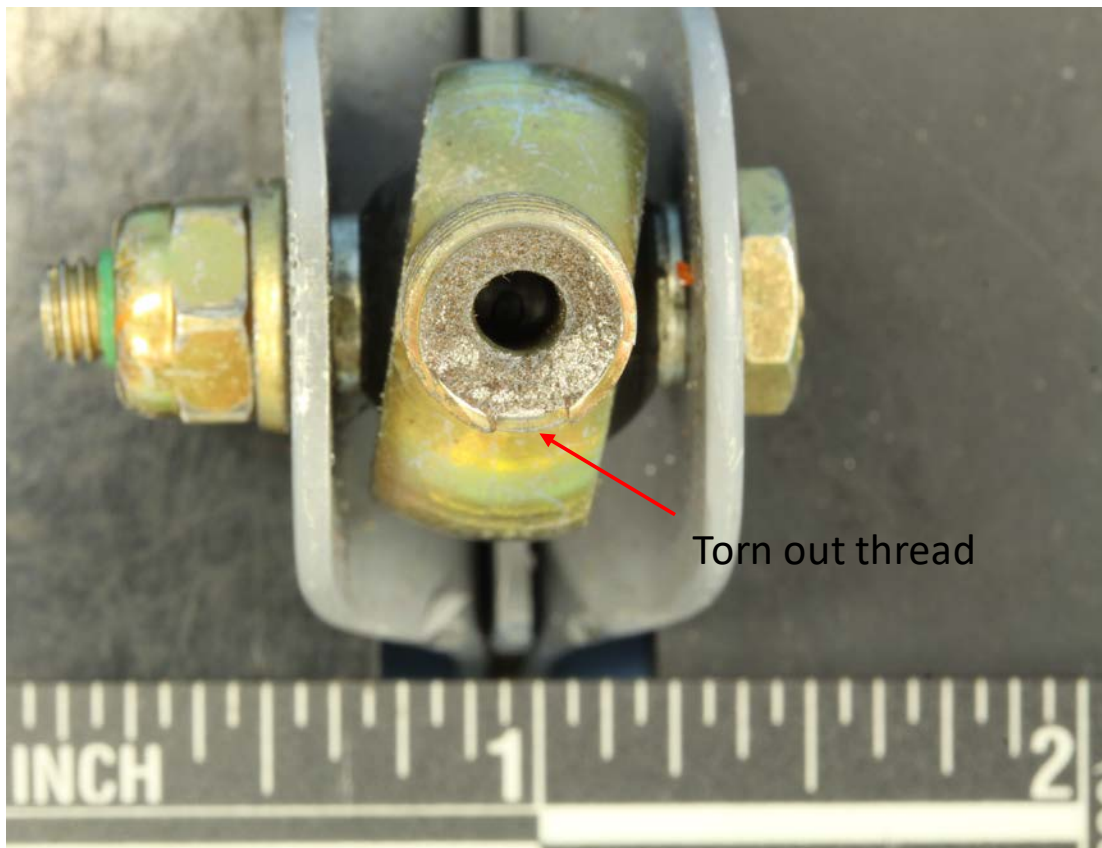
Figure 3: Torn thread at final fracture point.
