## ACCIDENT WPR19FA126

On May 01, 2019, about 1100 Pacific daylight time, a Cessna T182P airplane, N7302S, experienced a loss of engine power and collided with a power line while making an emergency landing to a grassy marsh in Mill Creek, California. The flight instructor and front-seated passenger sustained serious injuries; the rear-seated pilot-rated passenger was fatally injured. The airplane sustained substantial damage. The airplane was registered to and operated by Air Carriage, Inc. under the provisions of Title 14 Code of Federal Regulations Part 91 as a personal flight. Visual meteorological conditions prevailed and no flight plan had been filed. The flight originated from Chino Airport, Chino, California, about 1010.

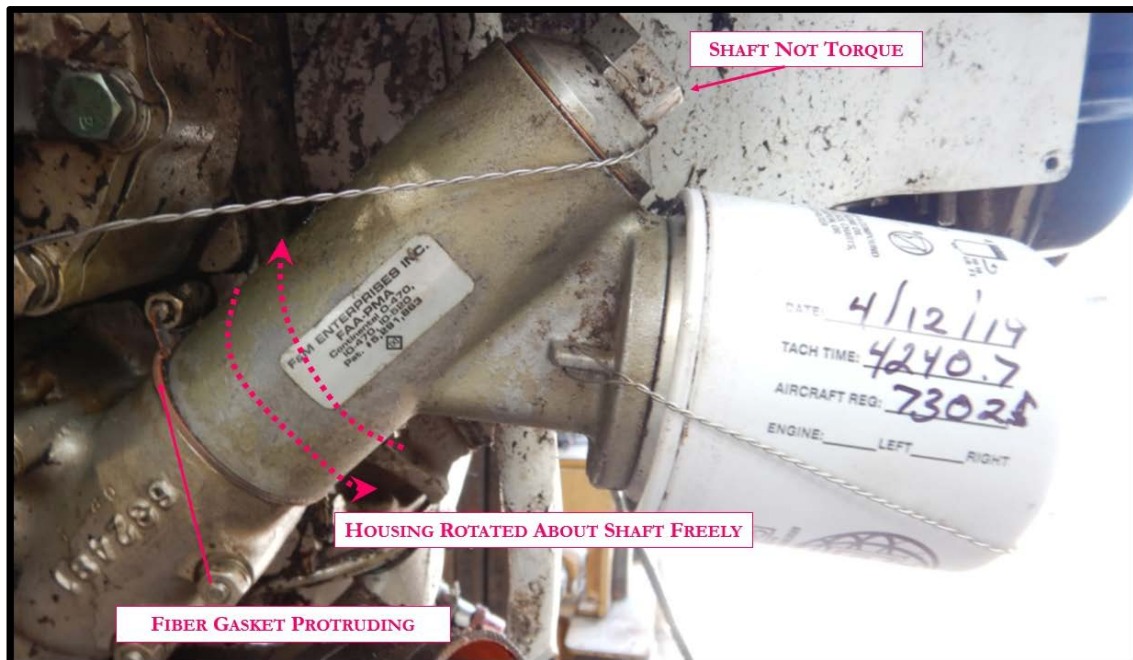
An examination of the engine revealed signatures consistent with the engine experiencing a loss of power due to oil starvation. A further examination of the engine oil filter adapter, revealed that it was loose where the adapter housing could be rotated about the shaft. Investigators removed the safety wire and attempted to assess the breakaway torque of the adapter which was required to be 65 foot-pounds (ft/lbs). The torque was less than 20 ft/lbs, which was the force set on the torque wrench.

Picture 01: Oil Filter Adapter

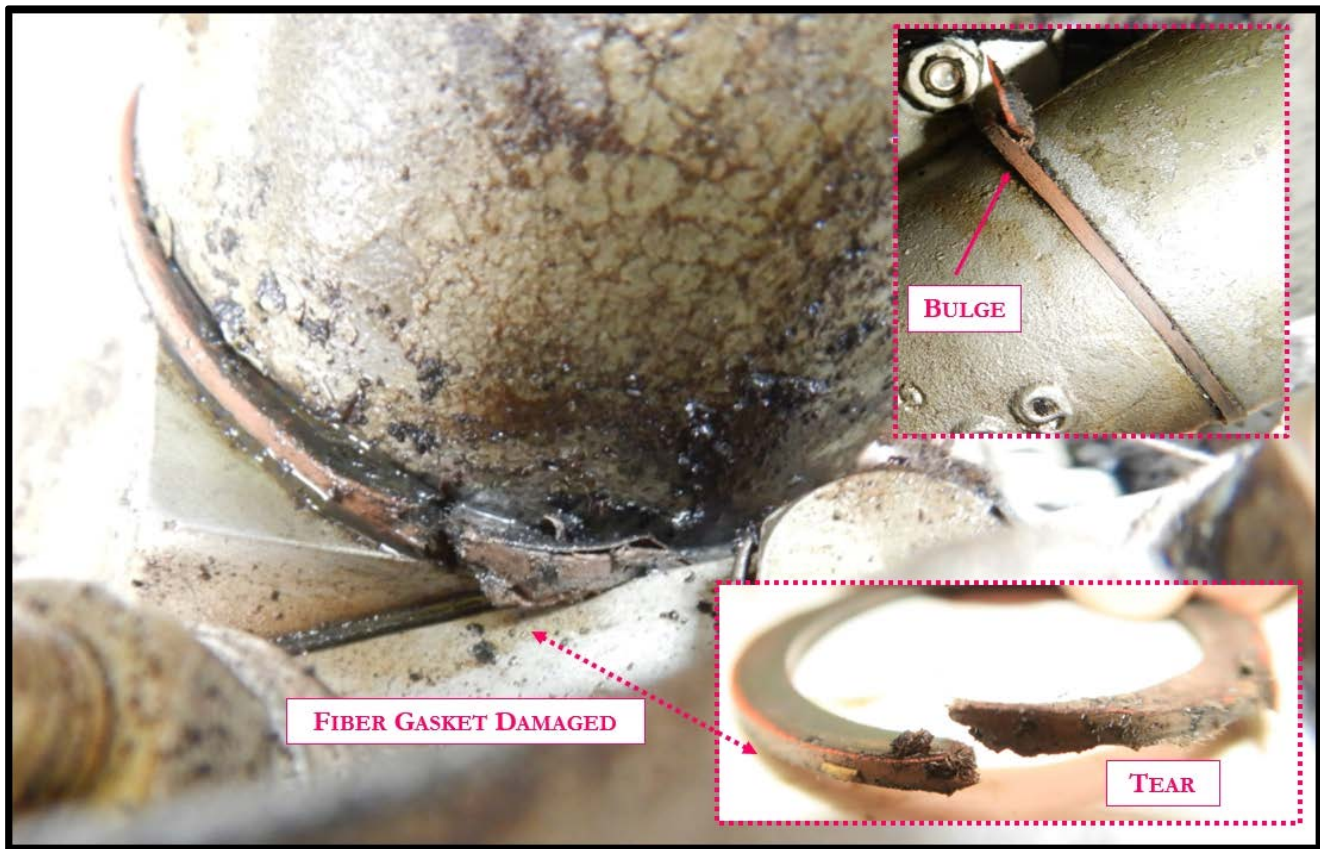
A closer examination of the filter adapter revealed that the fiber gasket, located between the oil pump casting and the adapter housing was protruding with the outside edge extending beyond the castings. Removal of the adapter revealed that the fiber gasket was completely split.

Picture 02: Oil Filter Adapter Fiber Gasket

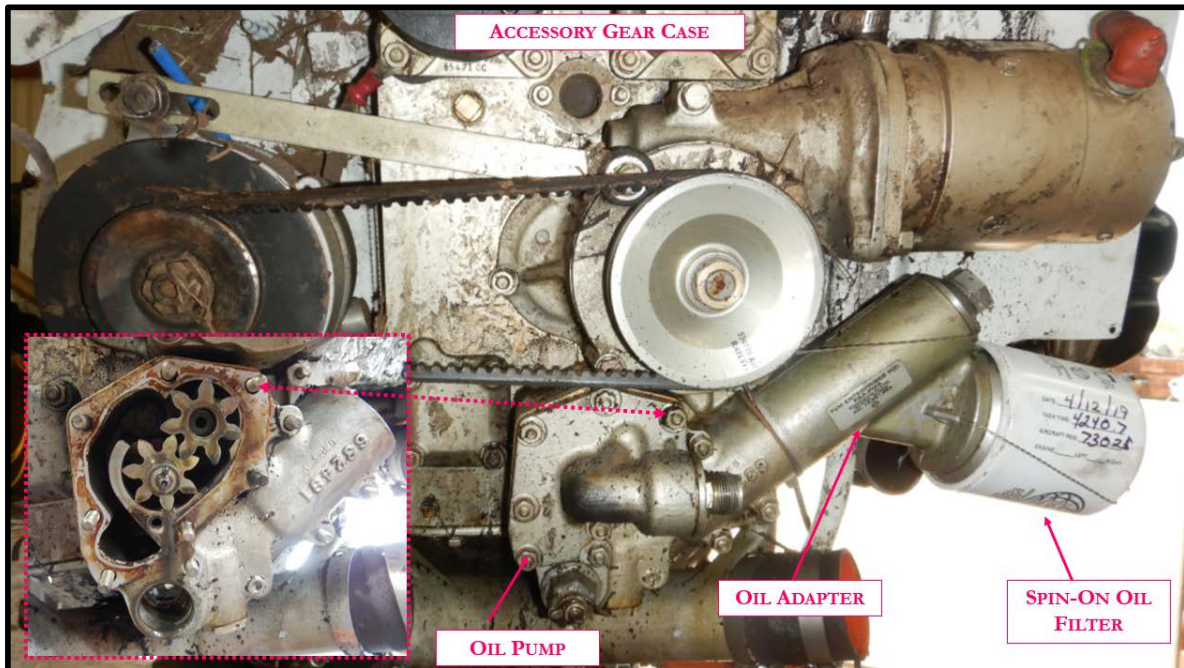
Picture 03: Oil Filter Adapter as Installed

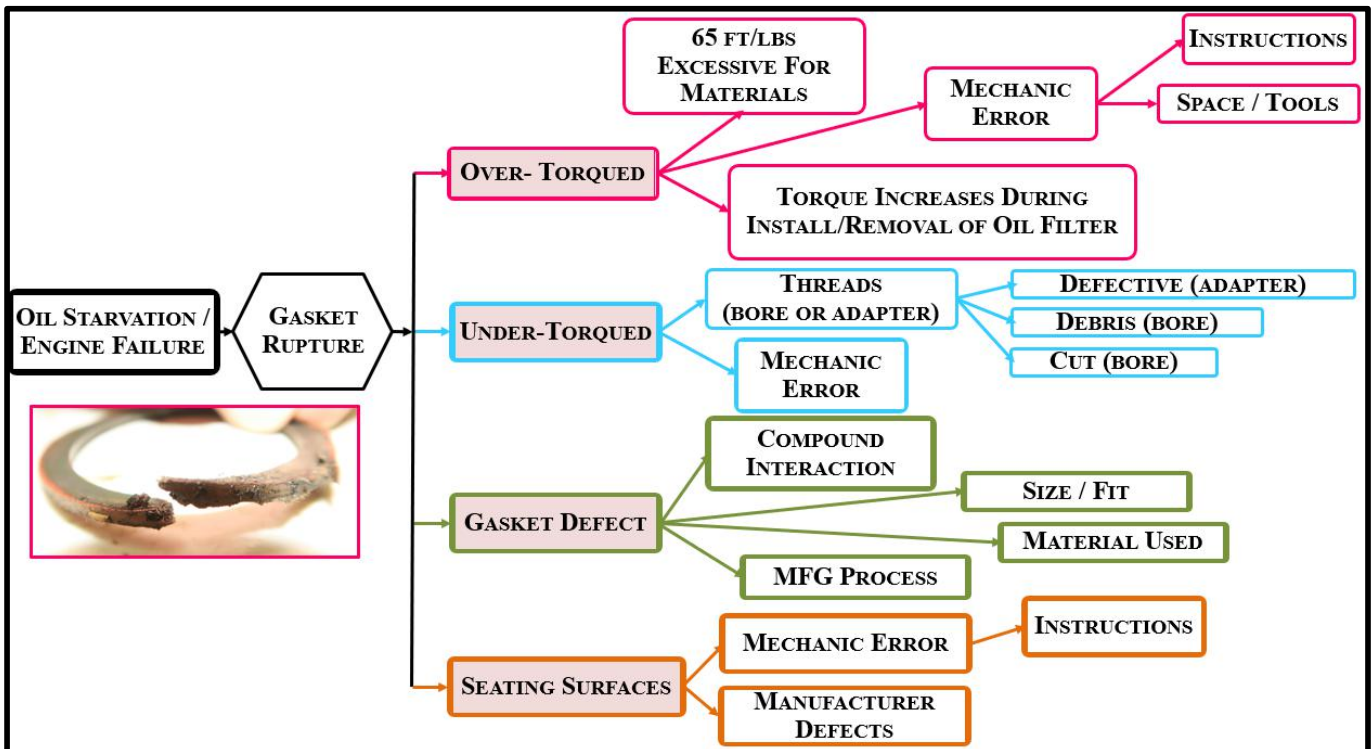
The tear in the fiber gasket was located on the flange closest to the forward by the cylinder. In a discussion with the FAA, Cessna, Continental, and NTSB the parties discussed the methods in which the gasket could have ruptured:

Picture 06: Fault Tree of Possible Failure Origins

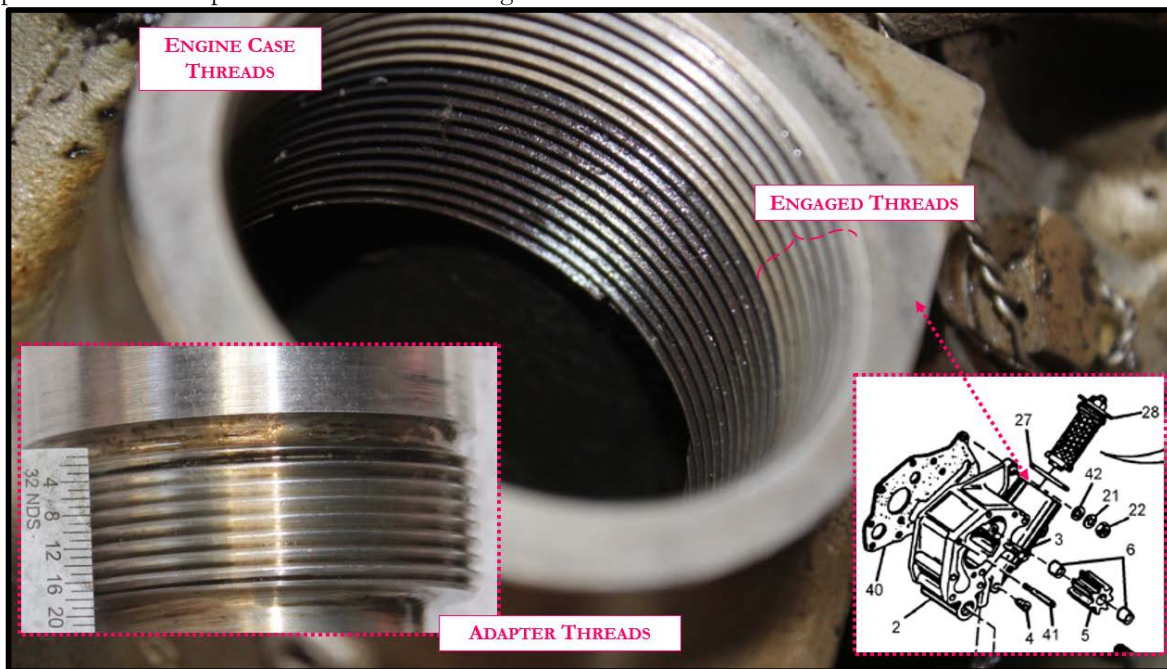
The adapter threads are deeper in the bore than the original screen threads.

Picture 10: Oil Filter Adapter Threads

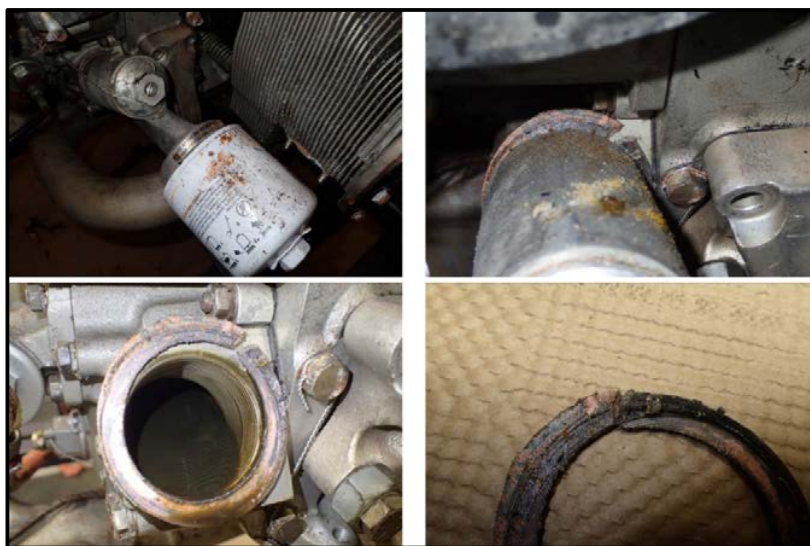
ERA16LA217 (Beech P35) – Nearly the same accident-

A total loss of engine power due to inadequate maintenance of the oil filter adapter, which resulted in an oil leak and subsequent oil starvation to the engine.

*Picture 13: Prior Accident*

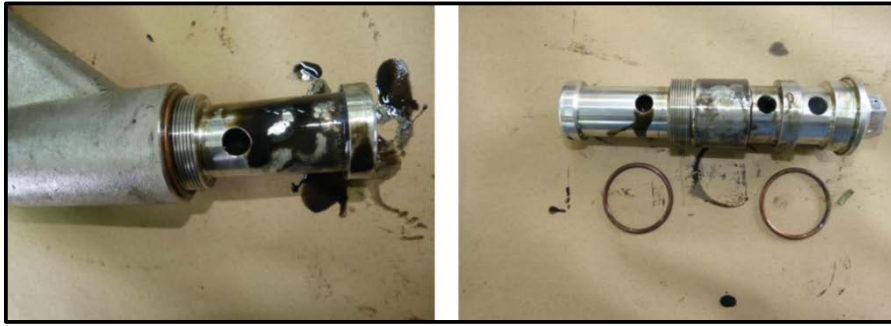
ERA14LA436 (Bellanca) -used 2 copper gaskets

The improper installation of the oil filter adapter at an unknown time, which resulted in an oil leak and subsequent oil starvation to the engine.

Picture 14: Prior Accident

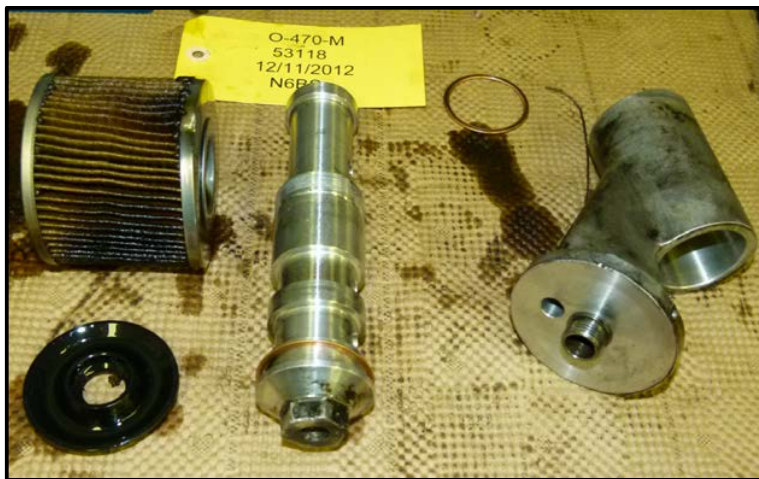
CEN13FA044 (Cessna 310) -used 2 copper gaskets

The pilot's failure to maintain airplane control after he shut down the right engine in flight due a loss of oil pressure... the mechanic's improper assembly and installation of the right engine's oil filter adapter, which resulted in a loss of oil to that engine.

Picture 15: Prior Accident

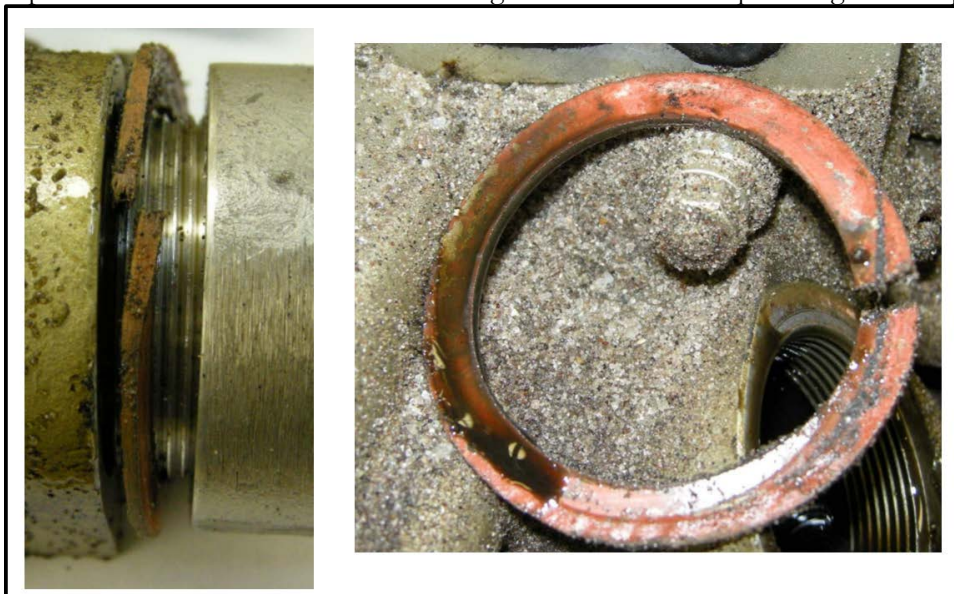
ERA10LA335 (Cessna 210)

The loss of engine power due to the failure of the oil filter gasket and the subsequent engine oil depletion.

Picture 16: Prior Accident

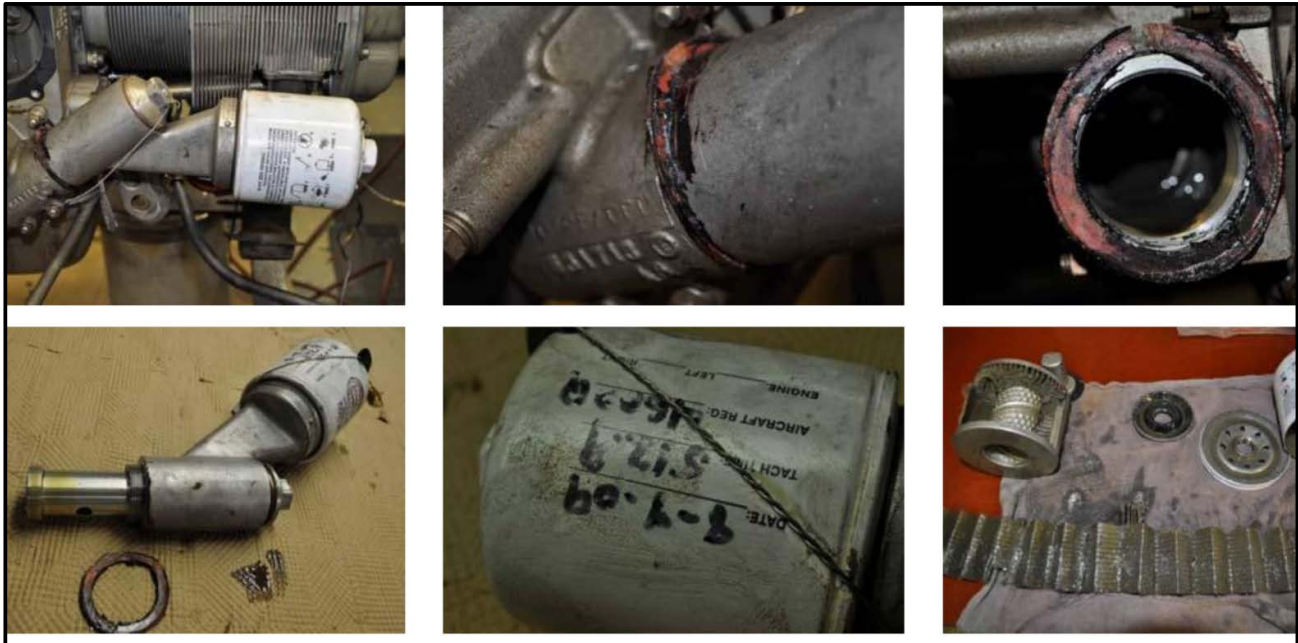
WPR09LA422 (Cessna 210)- Nearly the same accident

A total loss of engine power due to the displaced oil filter adapter gasket, which resulted in an oil leak and oil exhaustion. Contributing to the accident was the unsuitable terrain for a forced landing.

Picture 17: Prior Accident

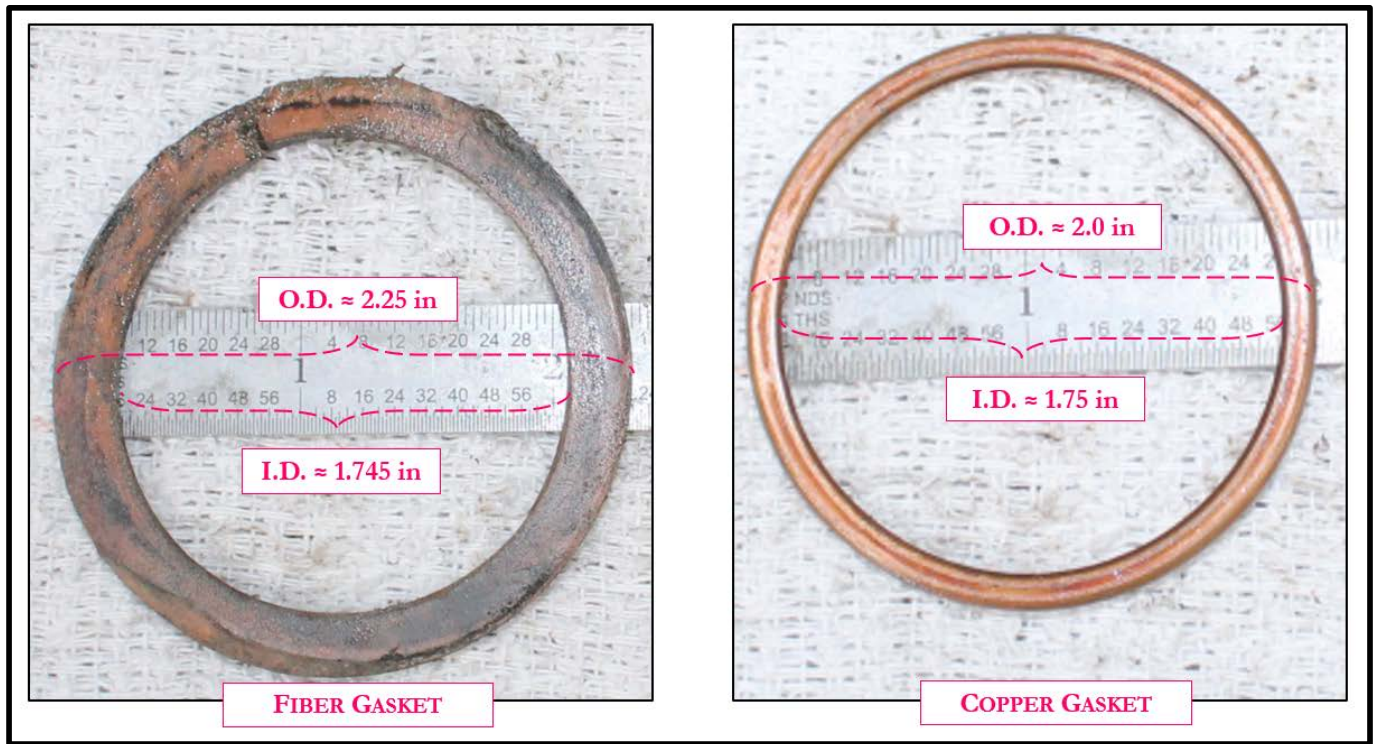
Based on the patent, forum discussions, and changes in F&M instructions, it is likely that the oil filter adapter was originally designed and sold with two AN900 copper crush gaskets. The original Continental oil screen required copper gasket MS35769-48 (OD 2.0 in, ID 1.75 in, ring width 0.688 in, thickness 0.094 in), which is likely the same gasket that was used for the adapter. GPI stated that fiber gaskets supplied to F&M were OD 2.25 in ID 1.745 in, ring width 0.505 in, thickness 0.063 in. The annular groove was 0.125 in wide and the depth is unknown.

Picture 20: Measurements of Fiber vs. Copper Gasket

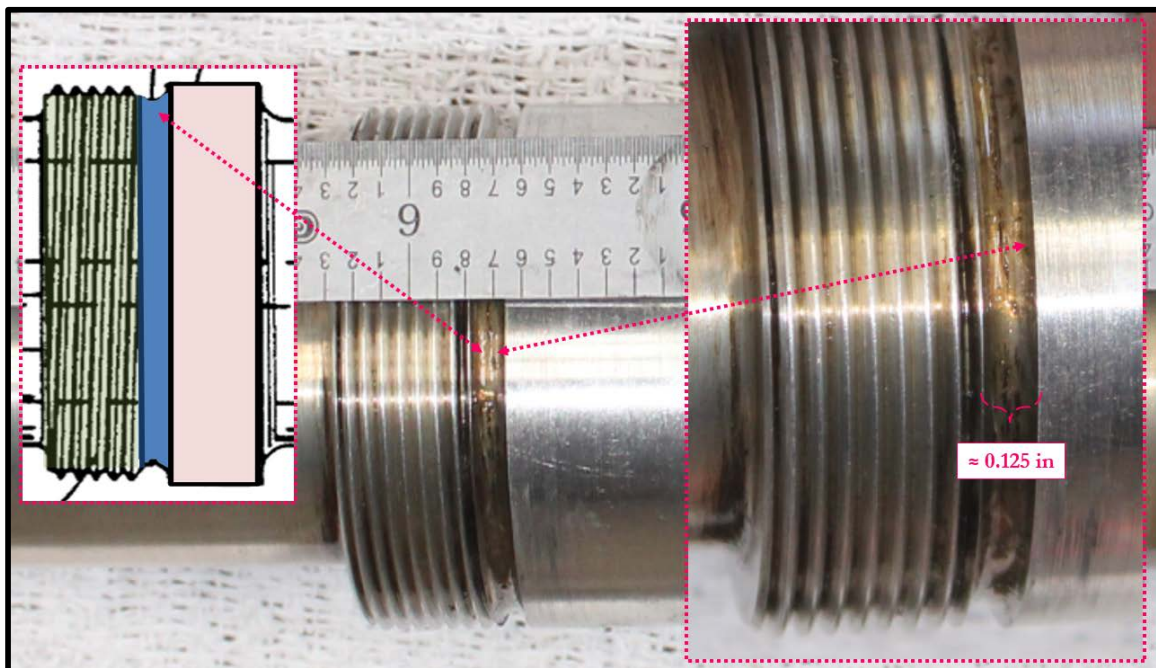
Picture 21: Measurements of Annular Groove

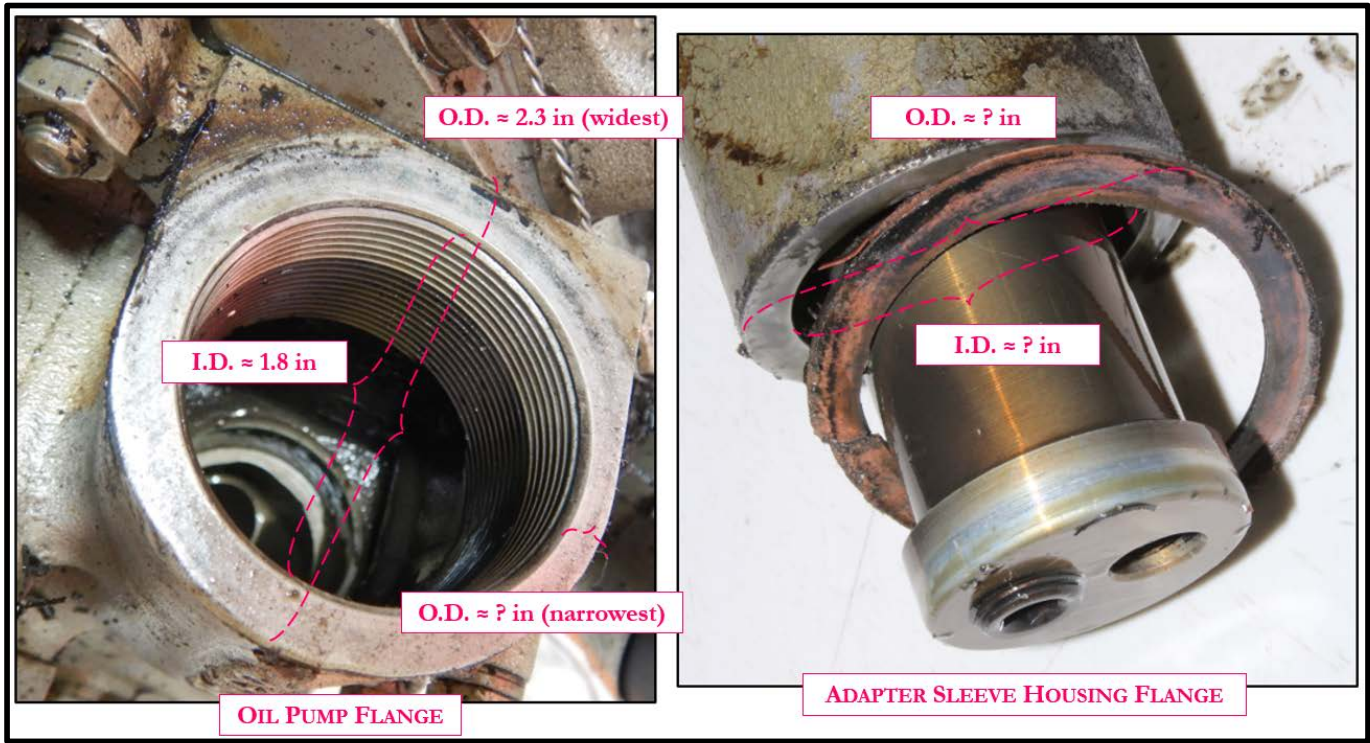
The oil pump housing flange measured about 2.3 in at the widest portion and the flange width thickness varied; the narrowest portion, where the bottom lip was the thinnest, gave an unknown OD and ID, but the OD is presumably less than 2.3 in. The width of the flange then is an estimated 0.5 in. The oil adapter sleeve housing flange OD and ID are unknown.

Picture 22: Measurements of Flange on Oil Pump and Adapter Sleeve Housing

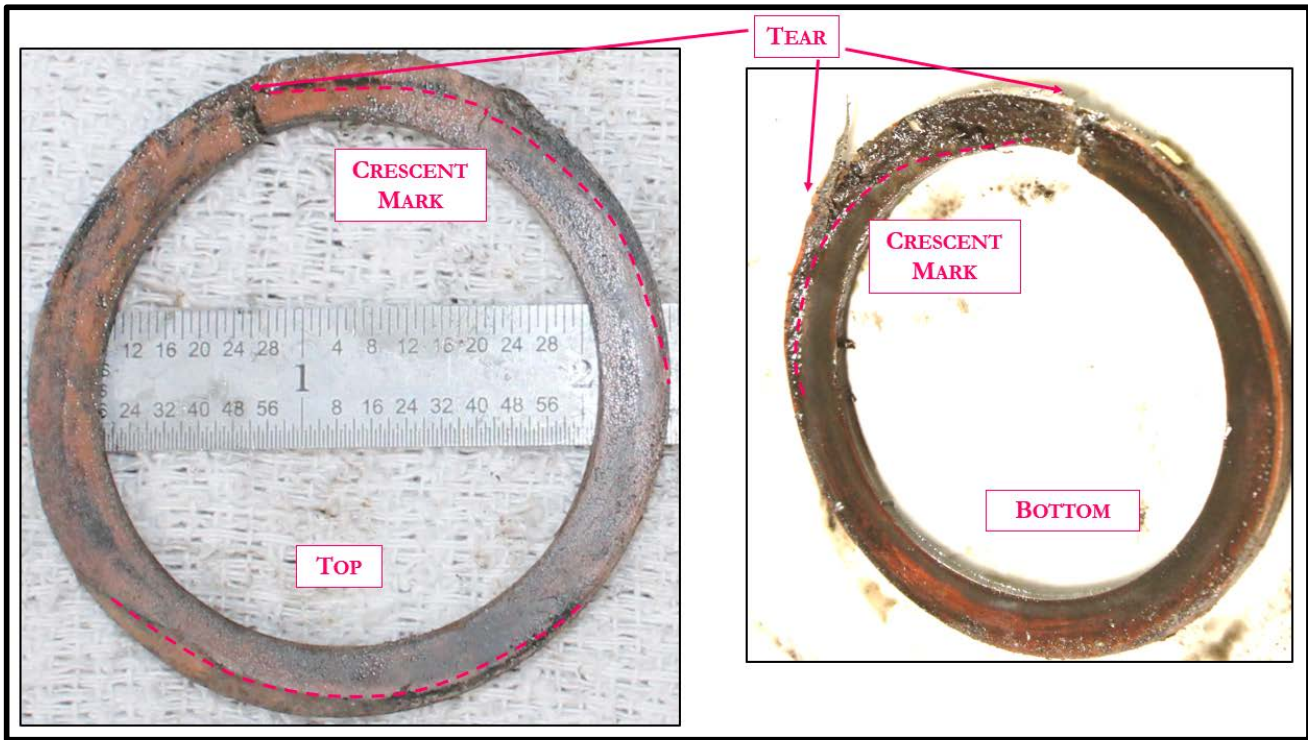
The gasket had numerous impressions and markings consistent with the crescent shape of the flanges.

Picture 23: Gasket Showing Impressions/Marks

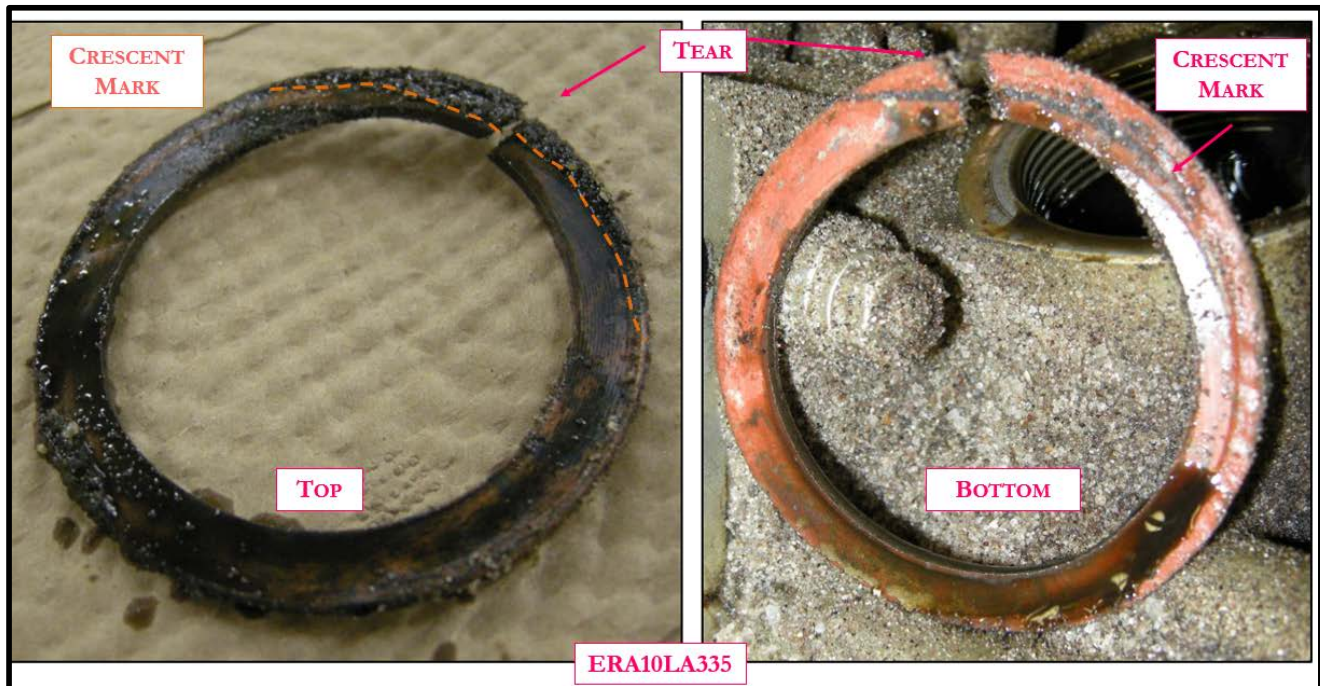
A review of pictures of prior accidents revealed that there were crescent marks similar to the accident mark. Better quality photographs are currently be searched for.

Picture 24: Prior Accident Gasket Showing Impressions/Marks

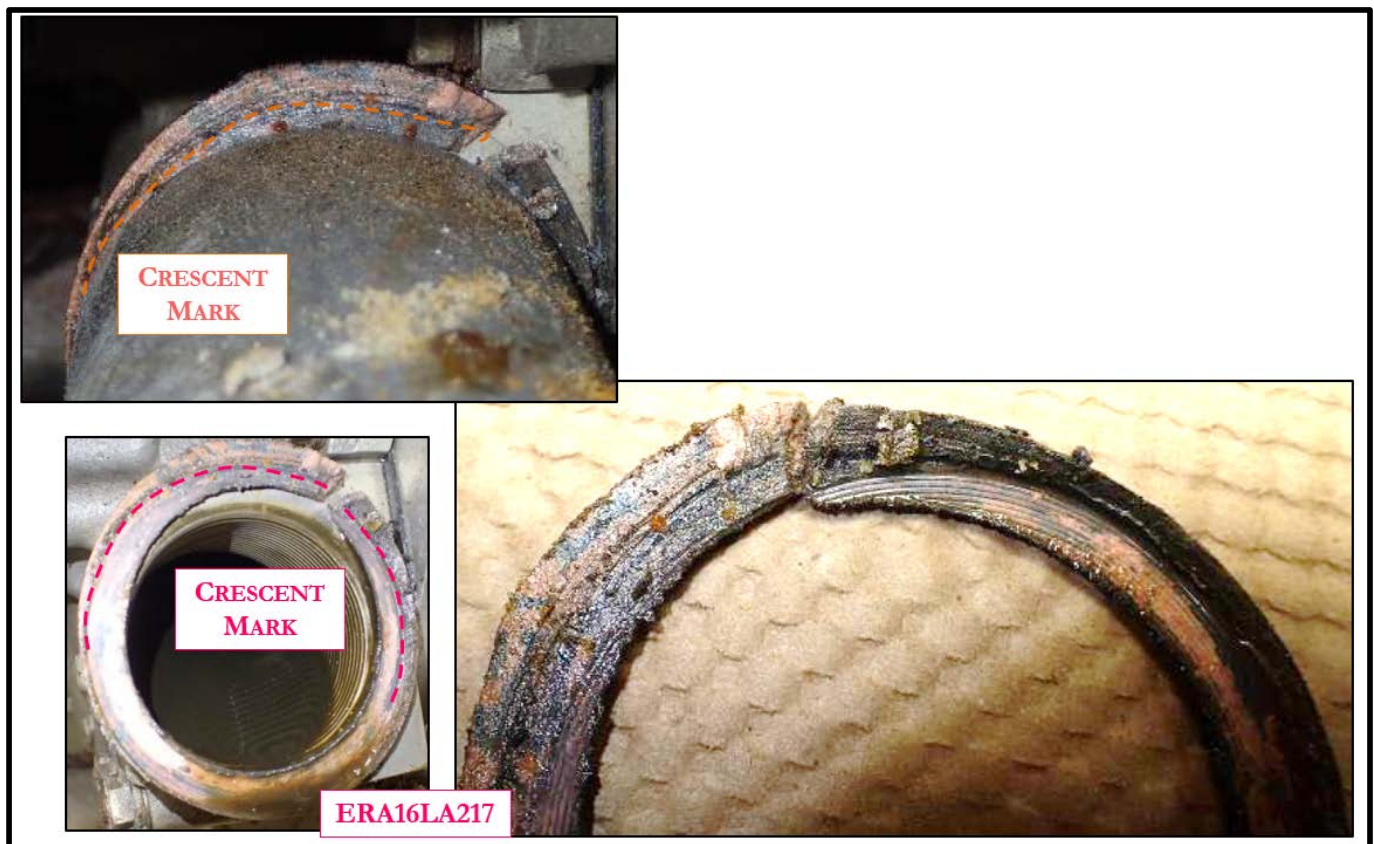
Picture 25: Prior Accident Gasket Showing Impressions/Marks

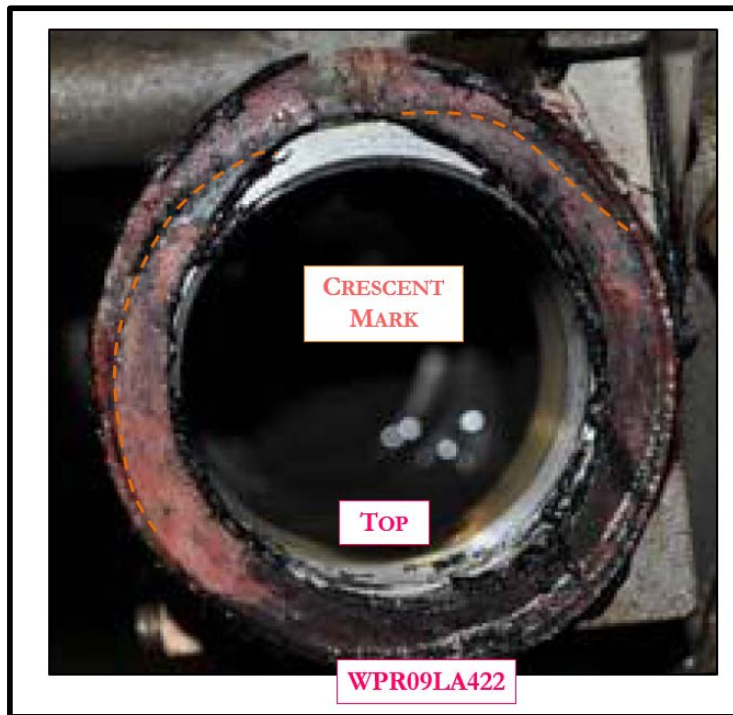
Picture 26: Prior Accident Gasket Showing Impressions/Marks

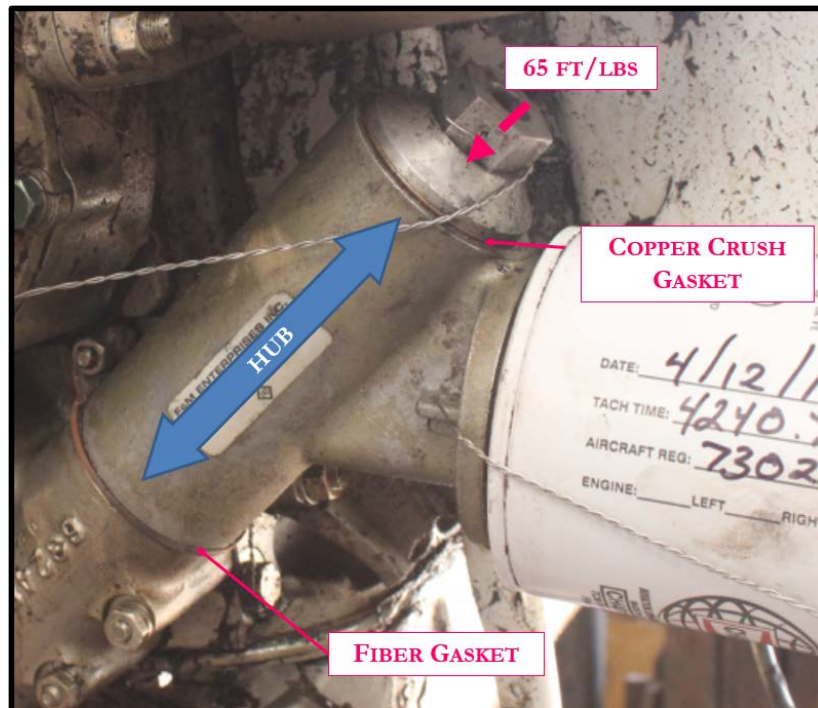
The 65 ft/lbs of torque applied to the adapter head is very different than 65 ft/lbs because of the copper crush gasket.

Picture 27: Torque Applied to Adapter Hub

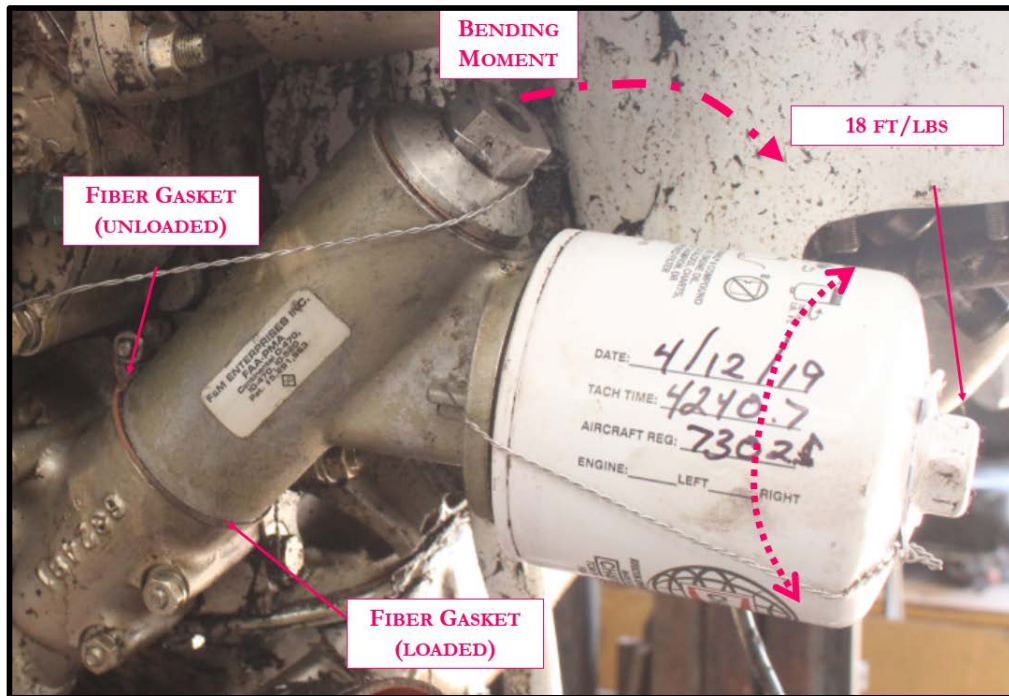
The loads applied to the gasket from the removal/installation of the oil filter and the long arm of where the oil filter is located (with constant vibration) result in uneven compression of the gasket which lead to blowout.

Picture 28: Loads on Gasket
