## EXAMINATION NOTES

### HISTORY OF FLIGHT

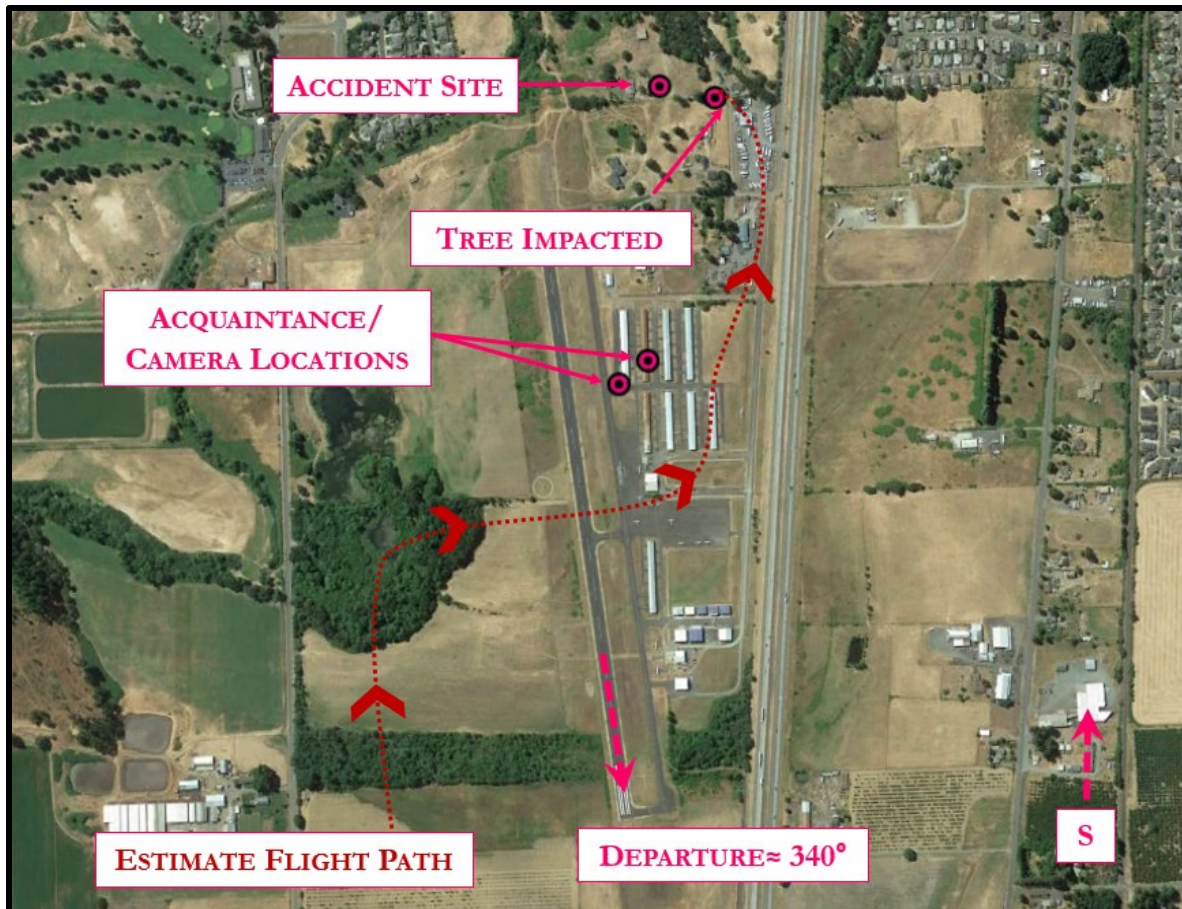
Figure 1: Accident Site in Reference to the Estimated Flight Path

An acquaintance of the pilot was at the airport, adjacent to the taxiway) recording the flight on his cellular phone. A review of the video disclosed that the pilot departed on runway 34 at 2028:20. After departure, the trike made a right turn and briefly continued south until making another right turn. The trike crossed west over the runway about midfield and then made a left turn to fly south over the hangars (refer to Figure 1). The trike began to descend and the acquaintance lost visual contact as it disappeared below the hangar roof line. The acquaintance ran to reposition further west on the airport by the pilot's hangar. The video again showed the trike at 2030:36. The trike began a left turn which became steeper where the entirety of the upper wing surface could be seen. The trike briefly disappeared behind a tree and then at 2030:41 an orange shape can be seen low in the trees, consistent with the color of the lower wing.

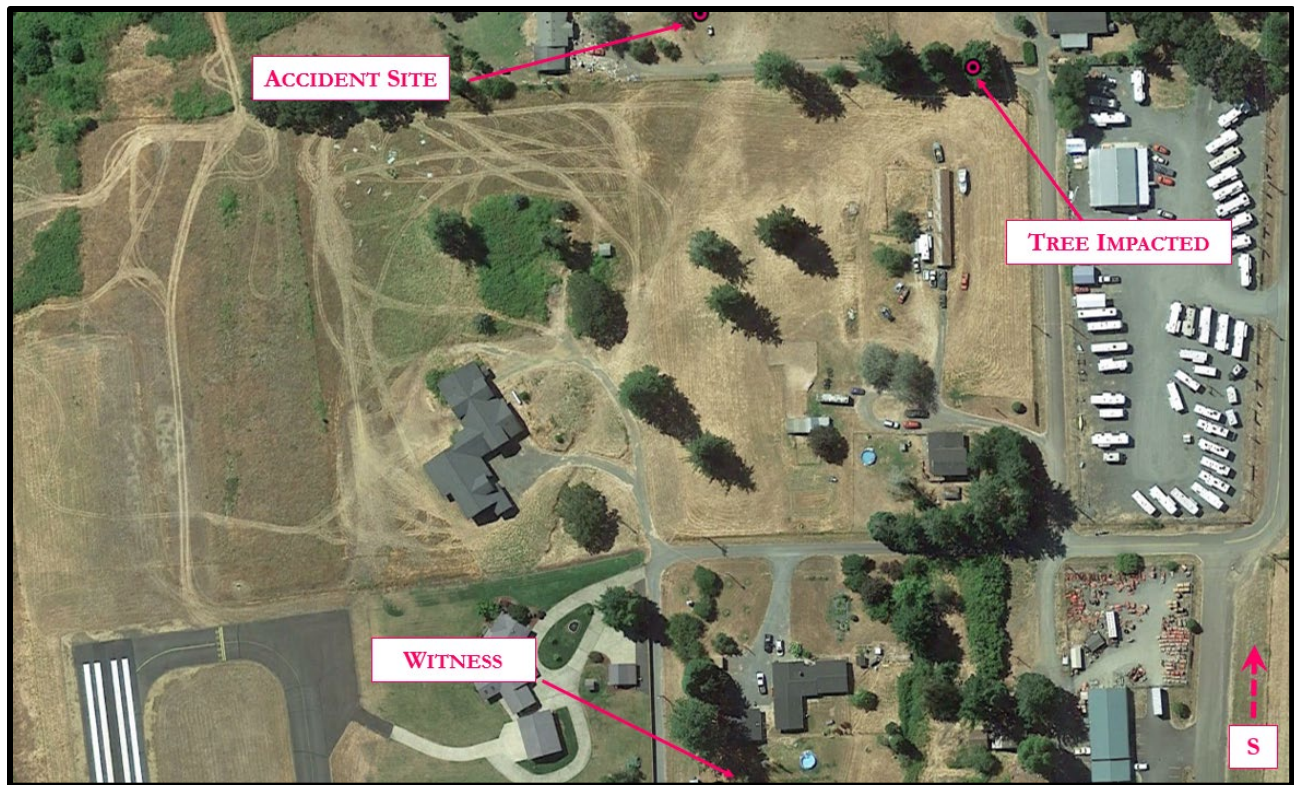
Figure 02: Accident Site in Reference to the Witness

A witness, located at a residence 825 ft south of the accident site (refer to Figure 02), stated that he observed the trike maneuvering very low to the west of his location. He recalled that the trike continued south and then made a left turn. The trike impacted a tree and the wing folded over upon itself. He did not hear any unusual noises but did reference that the trike seemed lower than they normally fly.

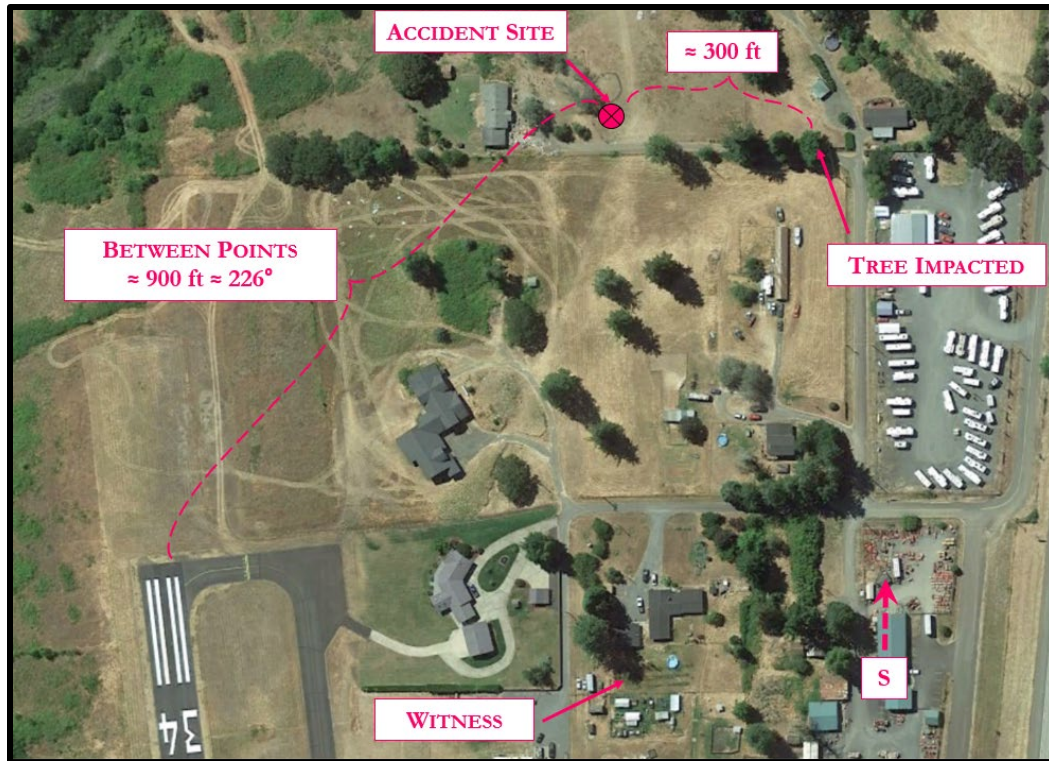
Figure 04: Accident Site in Reference to the Airport Showing Debris Field

The accident site was located on the property of a residence about 900 feet south of the runway. In character, the terrain was composed of dirt and soft grass. The wreckage was found distributed over a 100-foot distance on a median magnetic bearing of about 226°. The impact marks on the more westerly tree in a cluster were consistent

with the trike impacting the branches at about 80 feet above ground level (agl). The 300 feet between the tree and accident site contained debris consisting primarily of right-wing rib pieces and portions of tree debris.

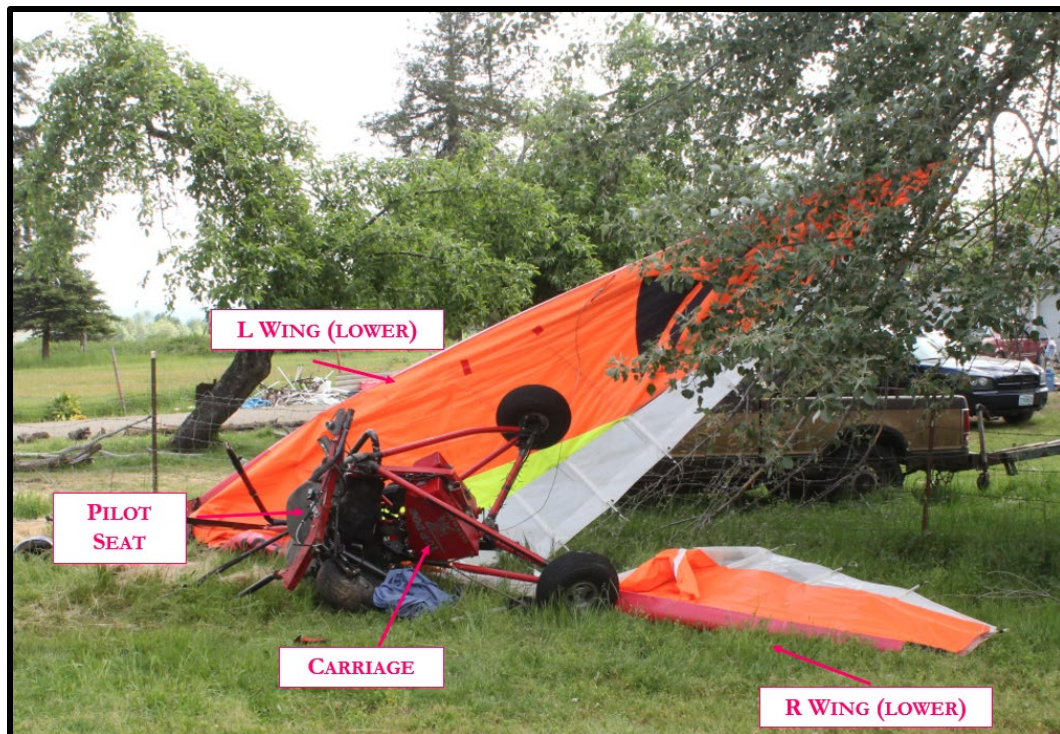
Figure 06: Wreckage

A resident that lived in the house adjacent to the accident site reported that she was the first person to arrive on scene. She stated that at that time, the trike you come to rest with both leading edge services on the ground and the cockpit area nosed in to the terrain. At the time investigators arrived at the accident site, the wreckage had been

moved to facilitate trying to provide medical assistance to the pilot. The left wing was folded upward in the right wing was on the ground.

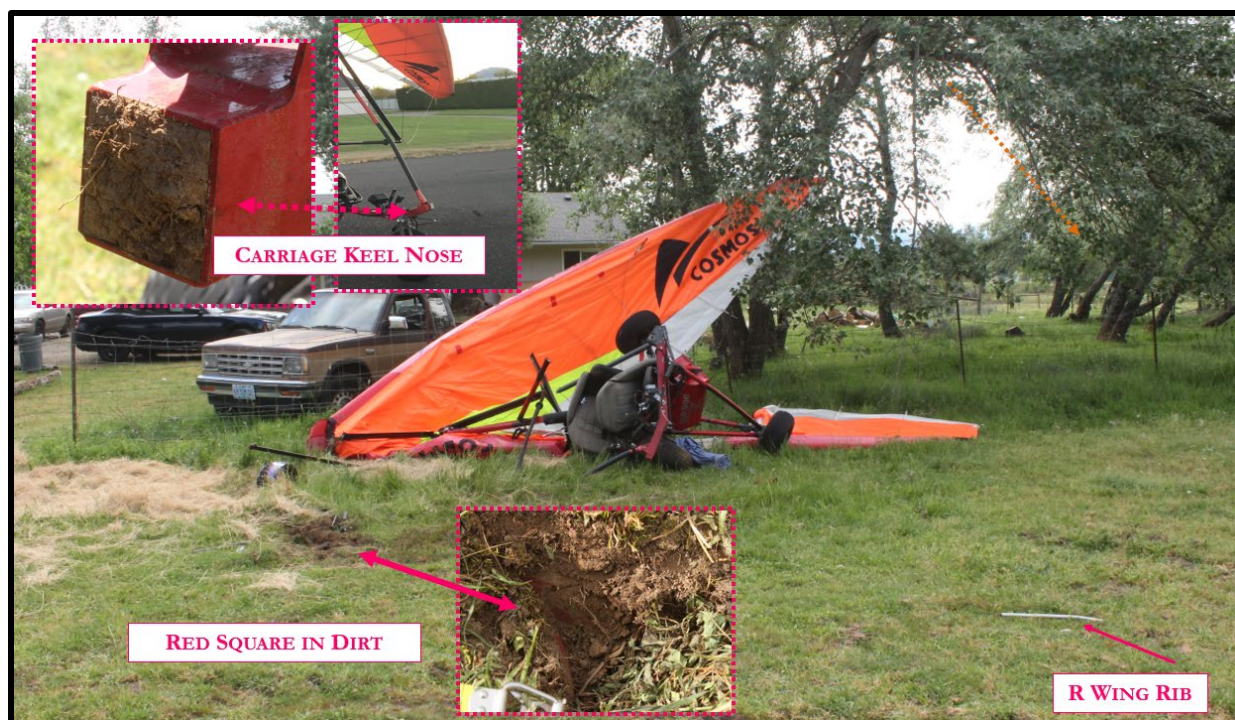
Figure 07: Accident Site Impact Marks

The carriage was fractured and numerous areas. The left shock strut was slightly bowed in the carriage keel was bent and numerous places. The keel under the saddle-style fuel tank had broken. There was an impression in the dirt that was square and orientation and red in color consistent with the most forward area of the carriage keel. The keel nose contained impacted dirt imbedded at least 8 inches into the tubing. The ground scar impressions and areas of fracture were consistent with the trike impacting a near vertical attitude, banked slightly left.

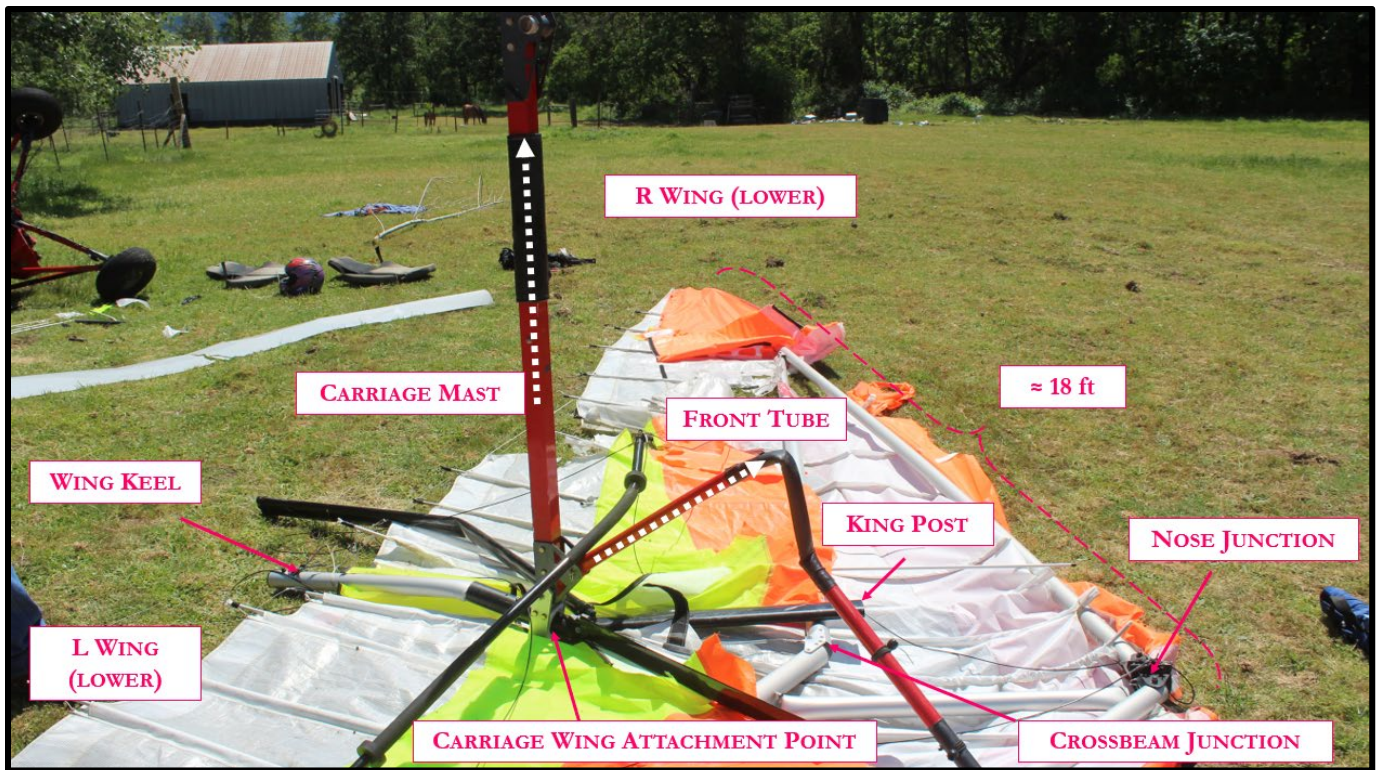
Figure 10: Lower Wings Showing Controls

The right wing had numerous punctures most outboard on the leading edge (around rib 8) with a diagonal tear oriented aft and inboard (around rib 6). The damage started about 10 feet outboard, although there was no damage to the leading edge tubing. The carriage mast was connected at the carriage wing attach point (hang point) and disconnected at the trike body. The front nose tube was attached at the hang point and bent in several locations.

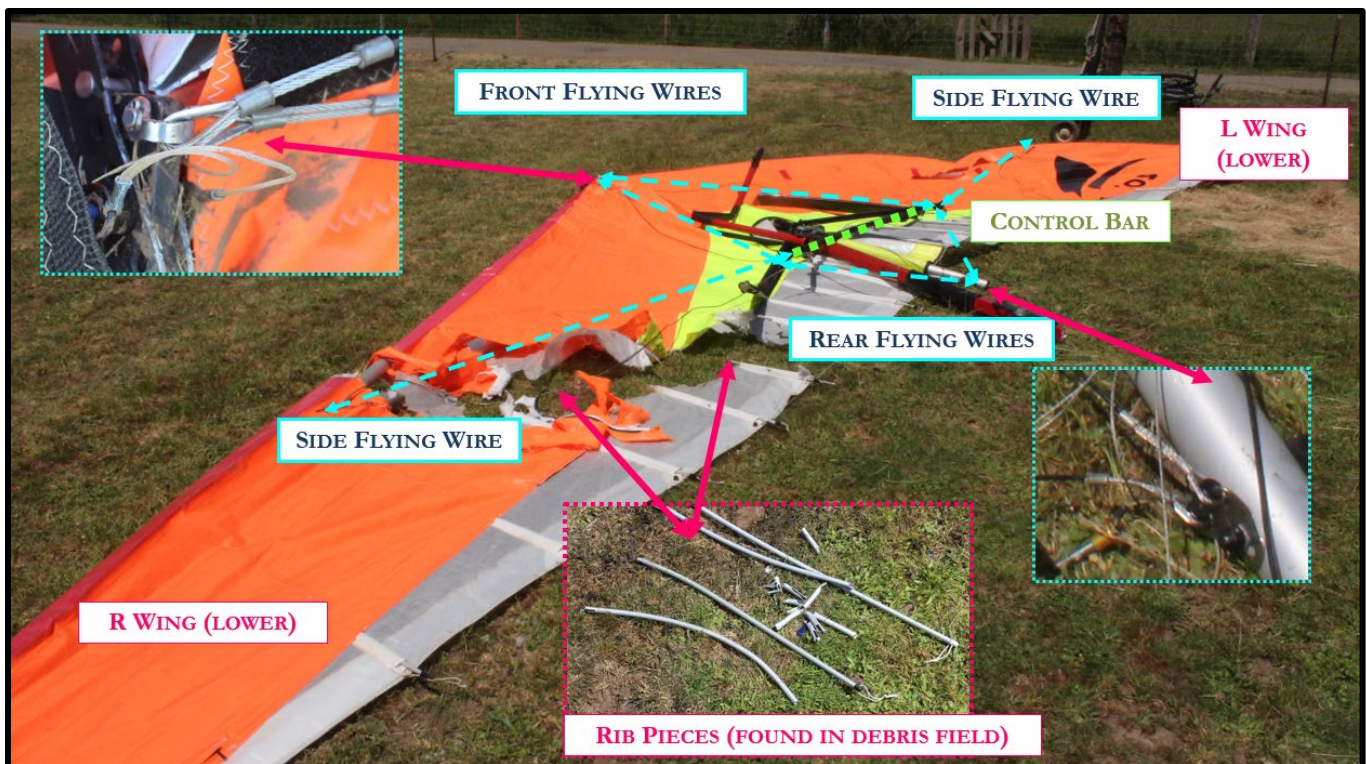
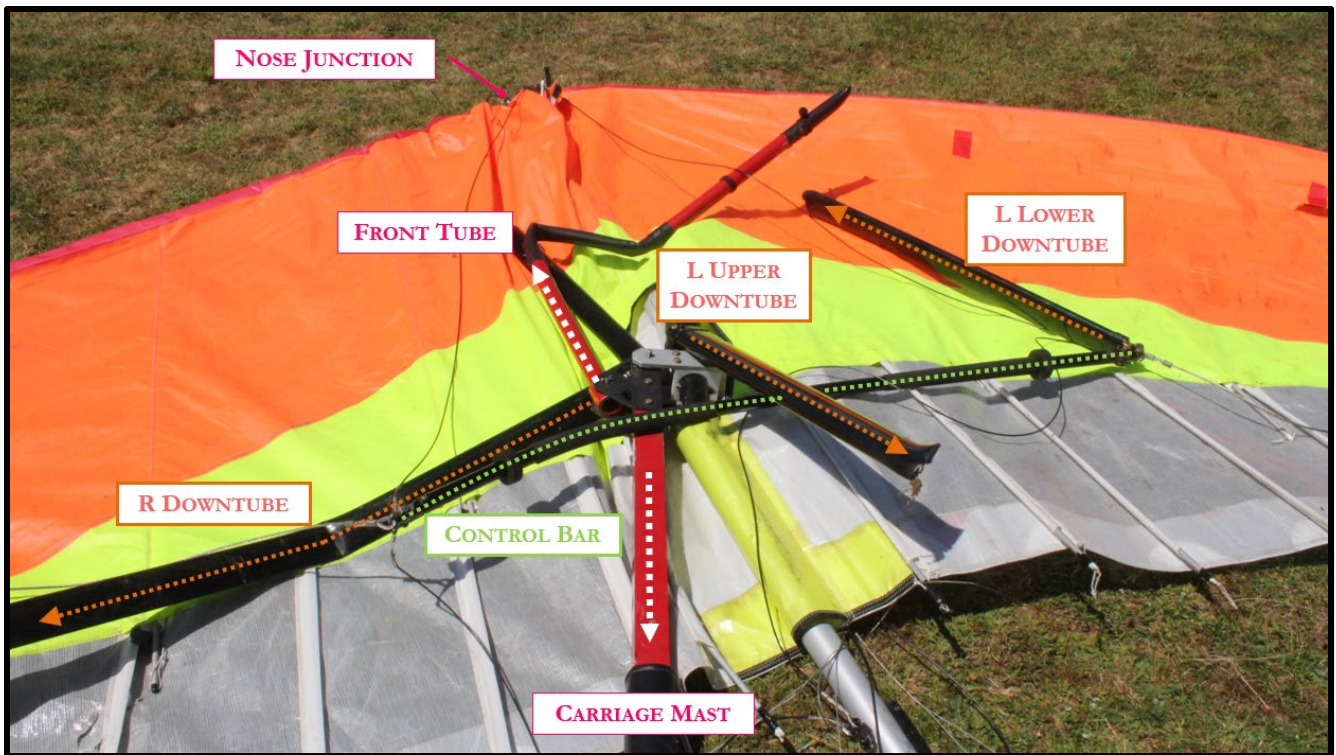
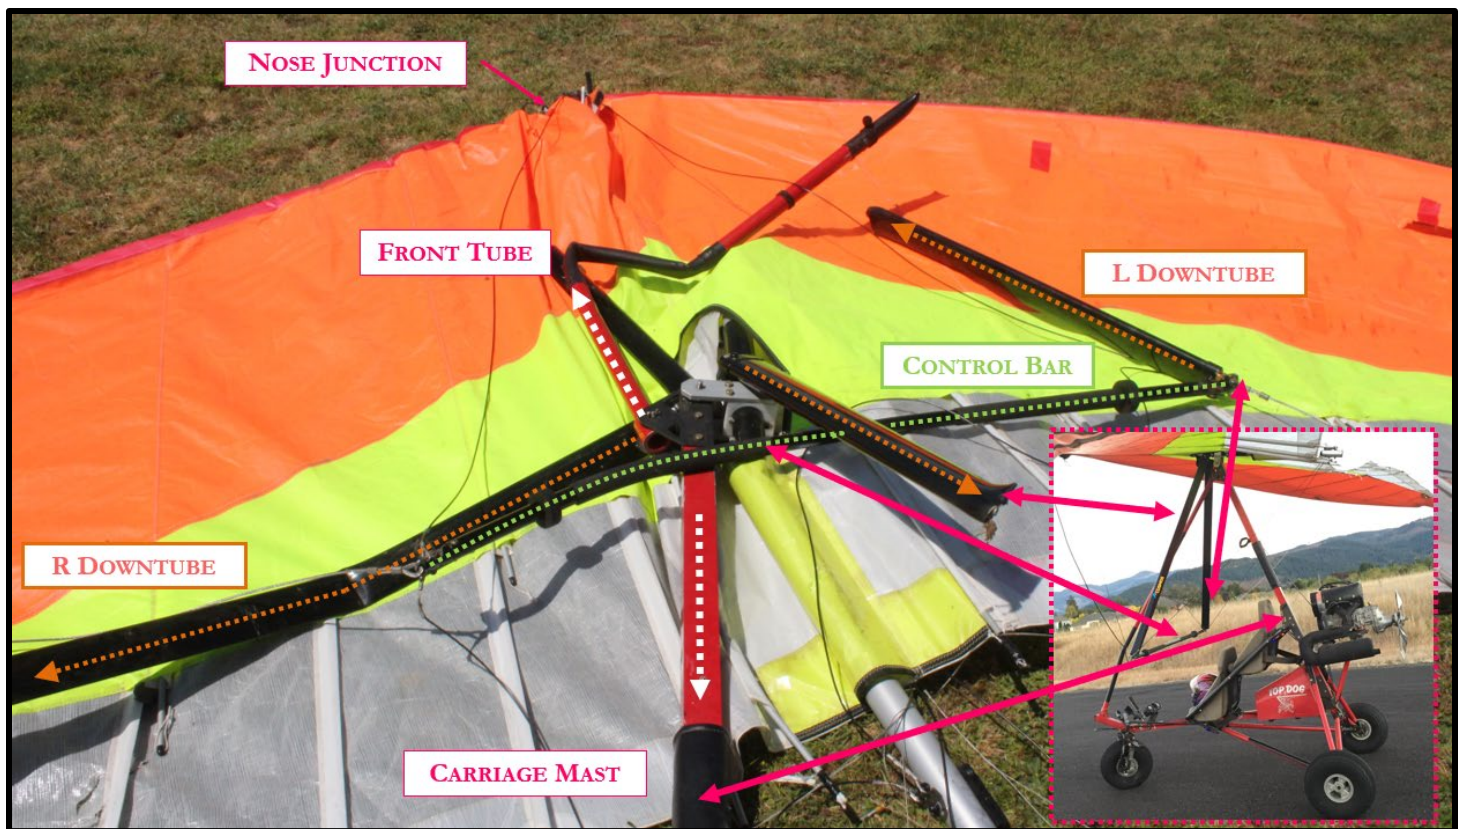
The control frame corner brackets (located on each of the control bar) had the side, rear and front flying wires attached. The other ends of the wires were connected at their respective attach fittings. The right downtube was bent about midspan and remained attached at the hang point and was disconnected at the control bar, with fracture surfaces consistent to overload. The left downtube had fractured about midspan; the upper portion remained attached to the hang point in the lower portion was attached to the control bar.

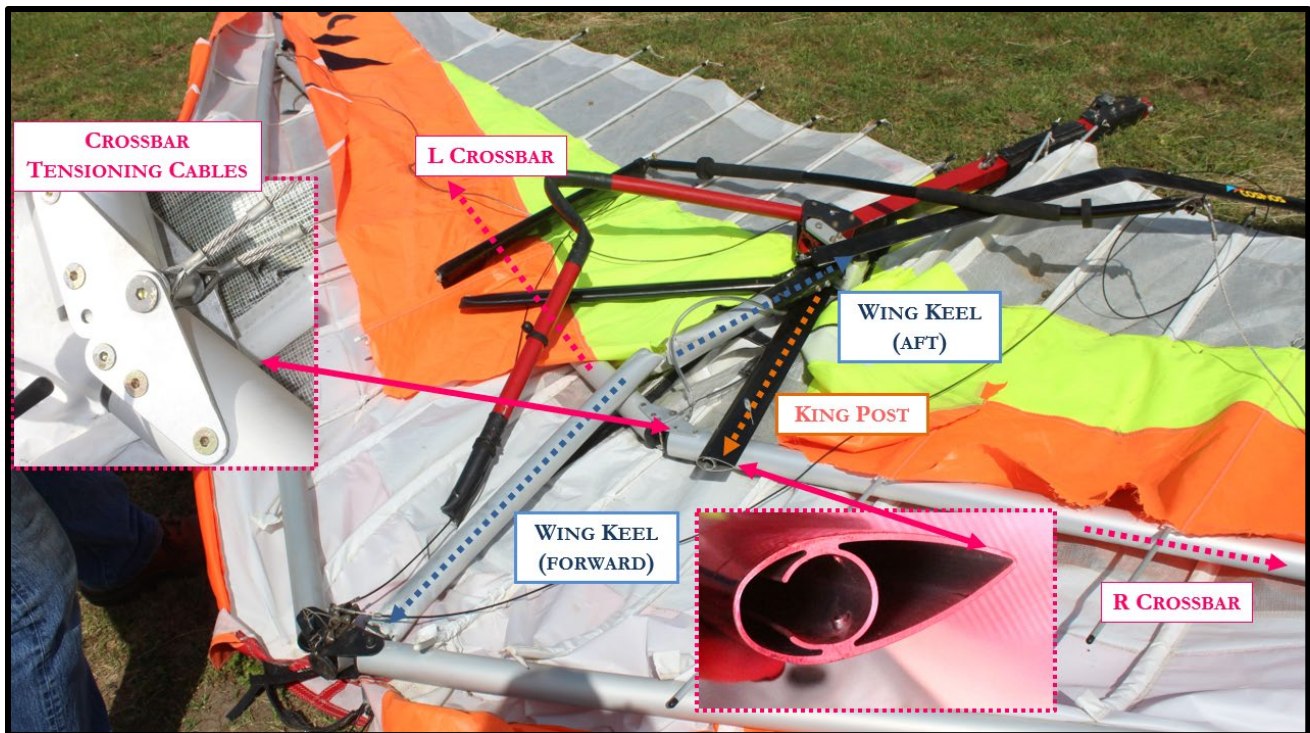
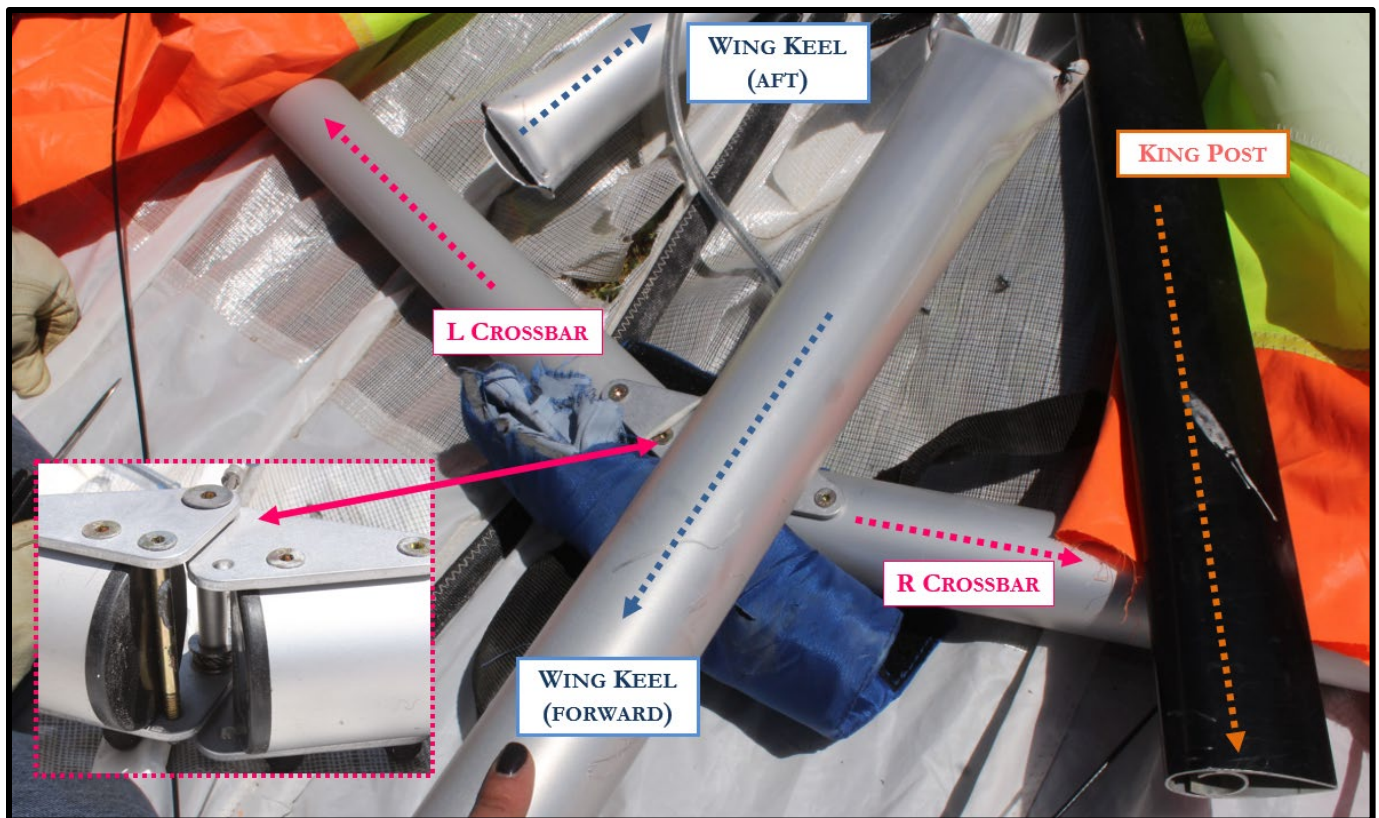
The wing keel had separated midspan with the forward portion remaining attached at the nose junction; the fracture was consistent with the down bending force. The right and left crossbars were attached at their plates and the cross bar tensioning cables were attached. The king post remained attached at the hang point.

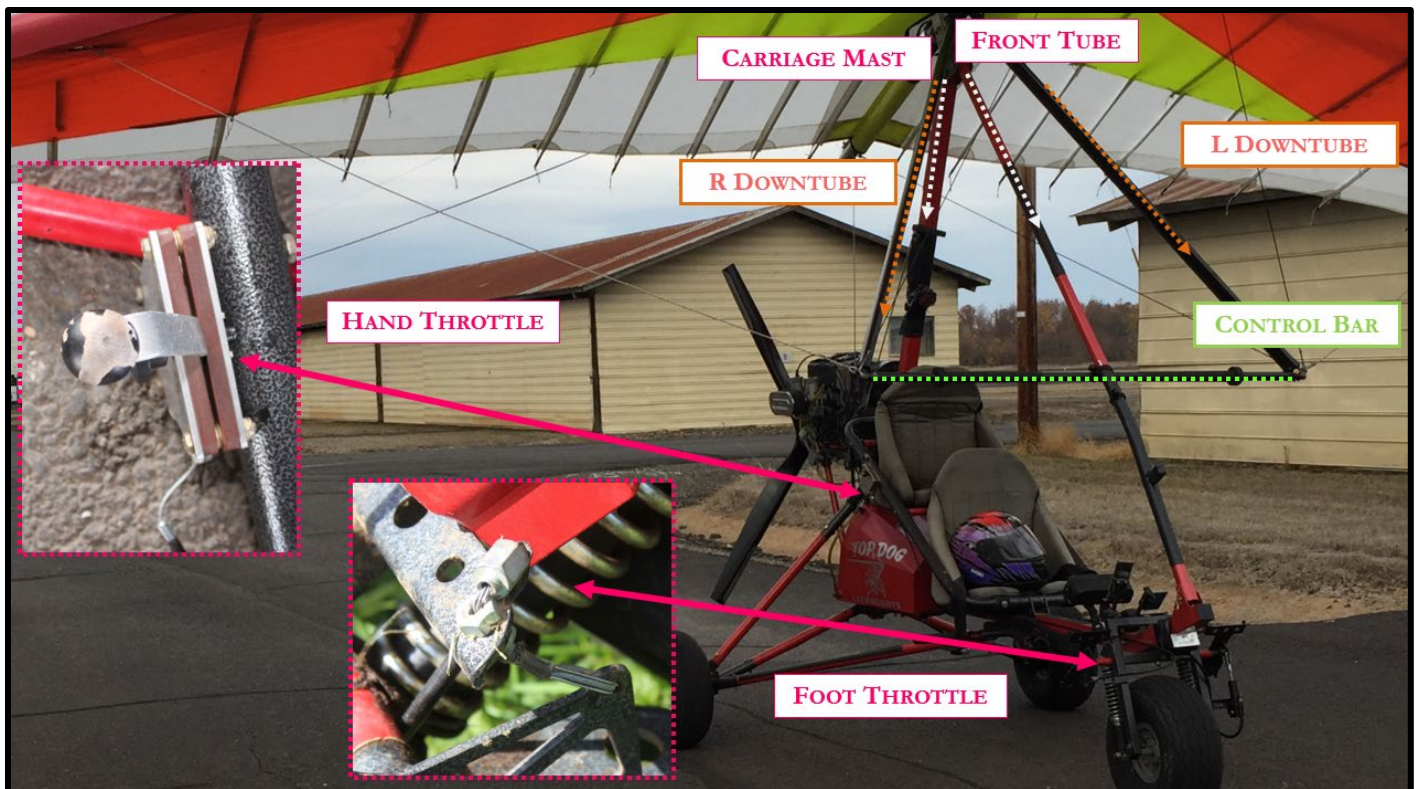
Figure 16: Throttles

There was fuel found within the fuel filters and throughout the fuel lines. The foot throttle was still connected at the panel and continuous back to a carburetor. The hand throttle cable had fractured and both ends were broom-strawed consistent with an overload event. From the fracture area, the cable was continuous to another carburetor.

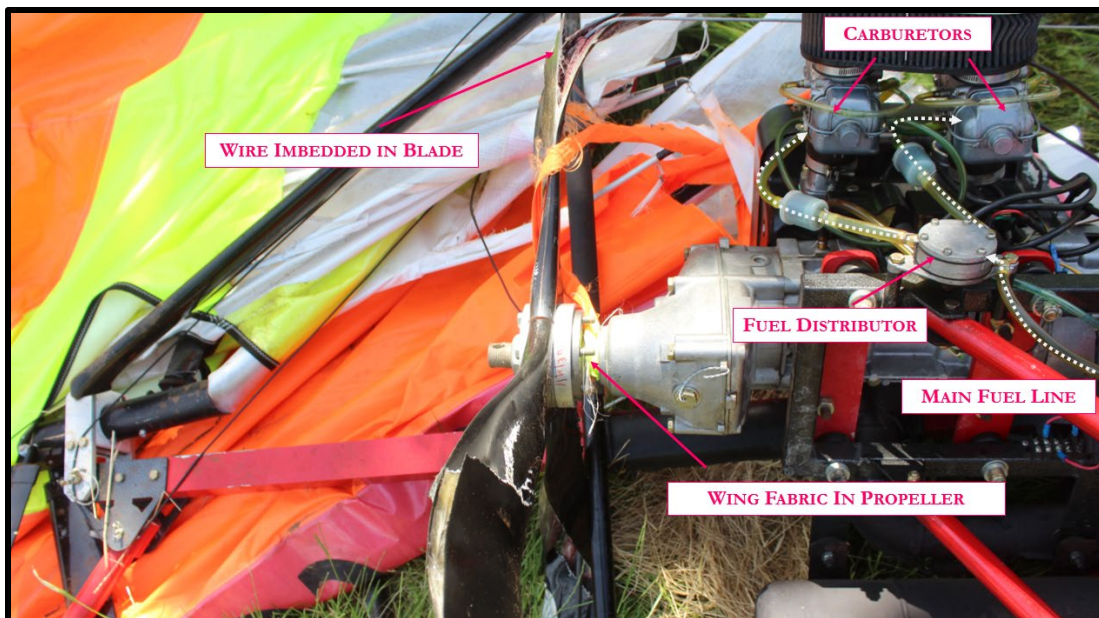
Figure 17: Engine and Fuel Lines

Portions of the wing fabric was wrapped tightly around the propeller. An end portion of the seatback rod had protruded into the fan and pieces of blade had been fractured. A portion of wire was embedded within a propeller blade consistent with the wire contacting the propeller when the wings had flexed.
