## **NATIONAL TRANSPORTATION SAFETY BOARD**

### **ACCIDENT SITE / AIRFRAME / ENGINE EXAMINATION SUMMARY**

**WPR19FA146**

Location: Santa Ynez, California  
Date: May 15, 2019  
Aircraft: Aviat Aircraft Inc., A1-B, N236AM  
NTSB Investigator-in-Charge: Joshua Cawthra

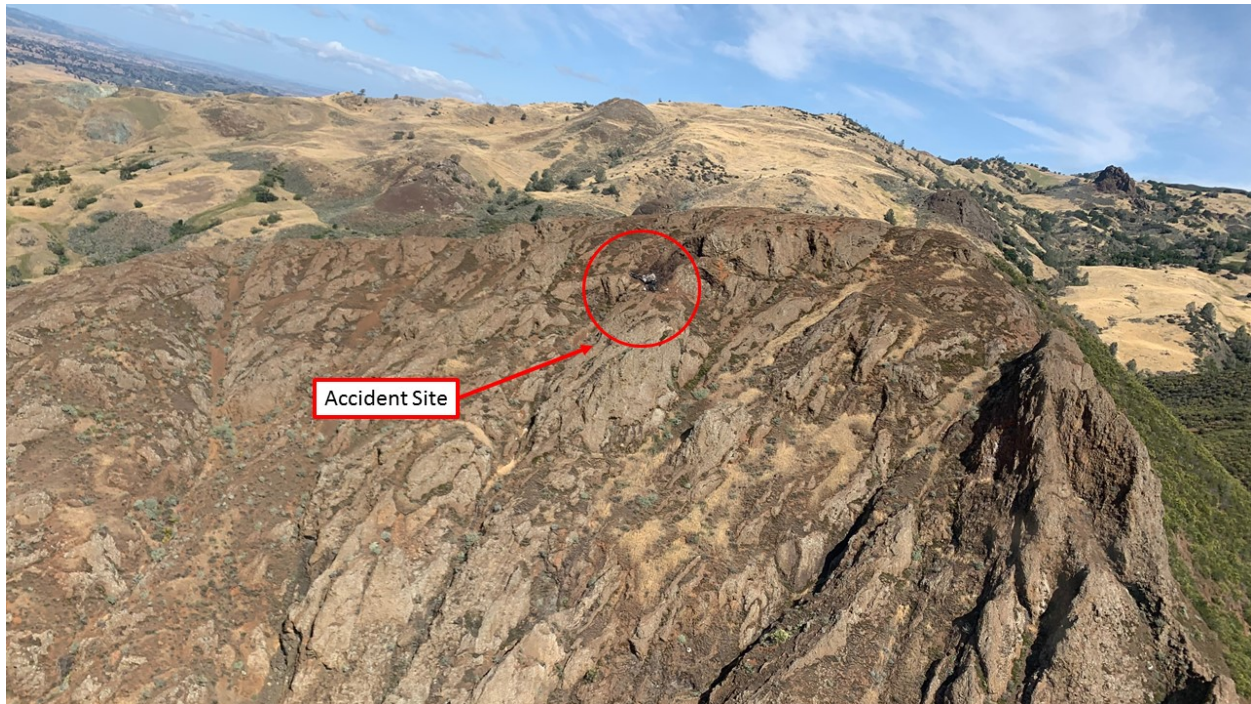
Examination of the accident site revealed that the airplane impacted steep rising mountainous terrain at an elevation of about 2,700 ft msl, and an approximate heading of 284° magnetic. The main wreckage came to rest upright about 30 ft below the initial impact point and was mostly consumed by fire. All major structural components of the airplane were observed at the accident site. The wreckage was recovered to a secure facility for further examination.

Figure 1: Aerial view of the accident site.

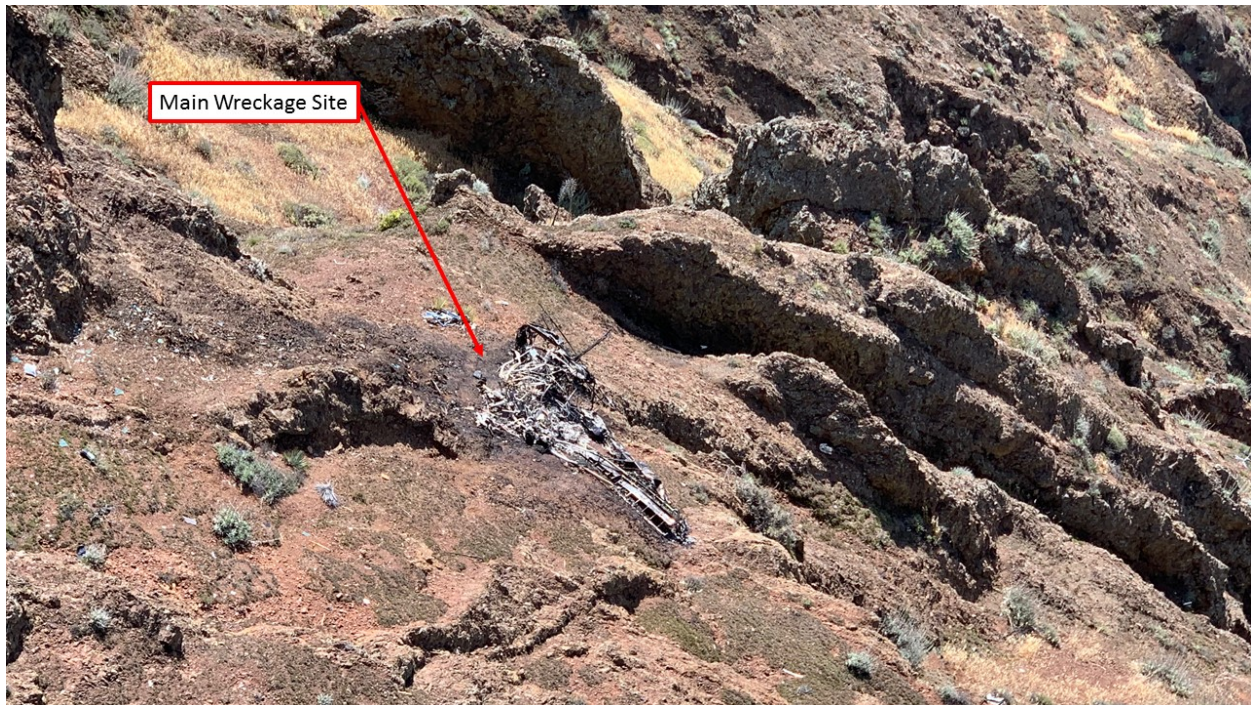
**Figure 2:** Aerial view of the accident site.

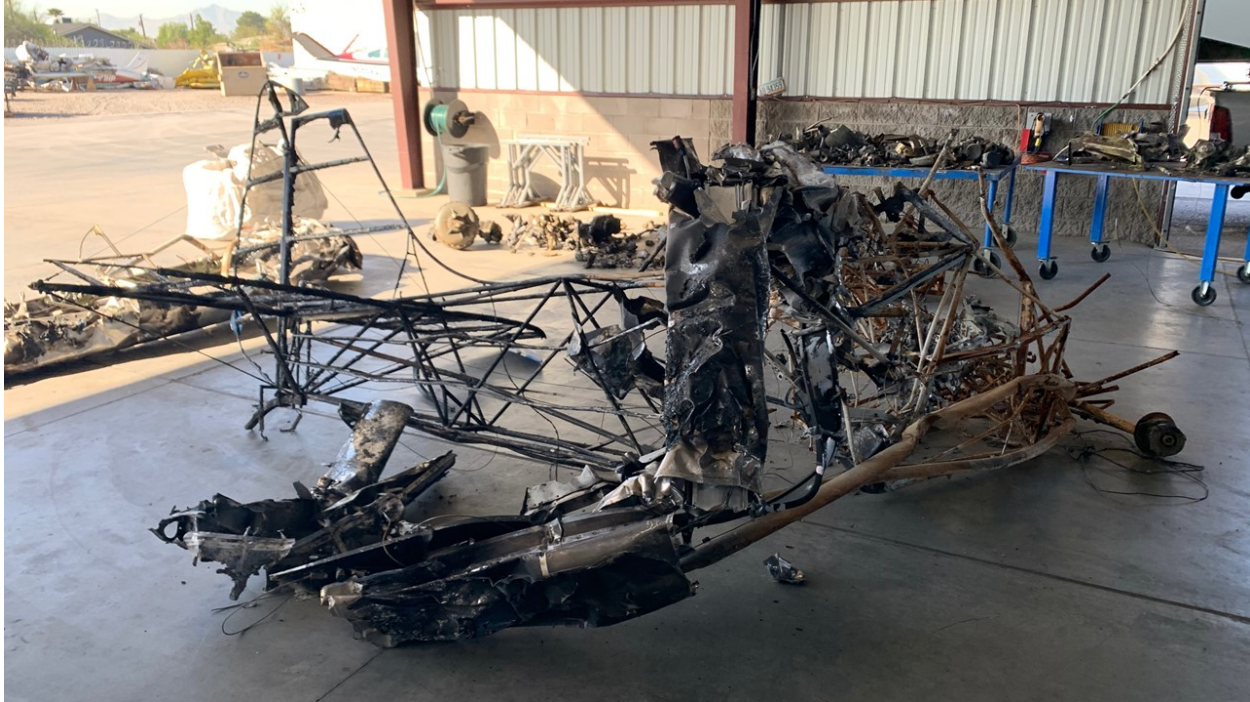
The recovered wreckage exhibited severe thermal fire damage. With the exception of the outboard left horizontal stabilizer, all of the fabric covering was burned and/or melted away from the wing and fuselage structure. The right wing remained attached to the airframe, and was bent upward and aft. The left wing was separated from the airframe.

**Figure 3: Recovered airframe.**

The fuselage was bent about 60 to 70 degrees, just aft of the rear seat.

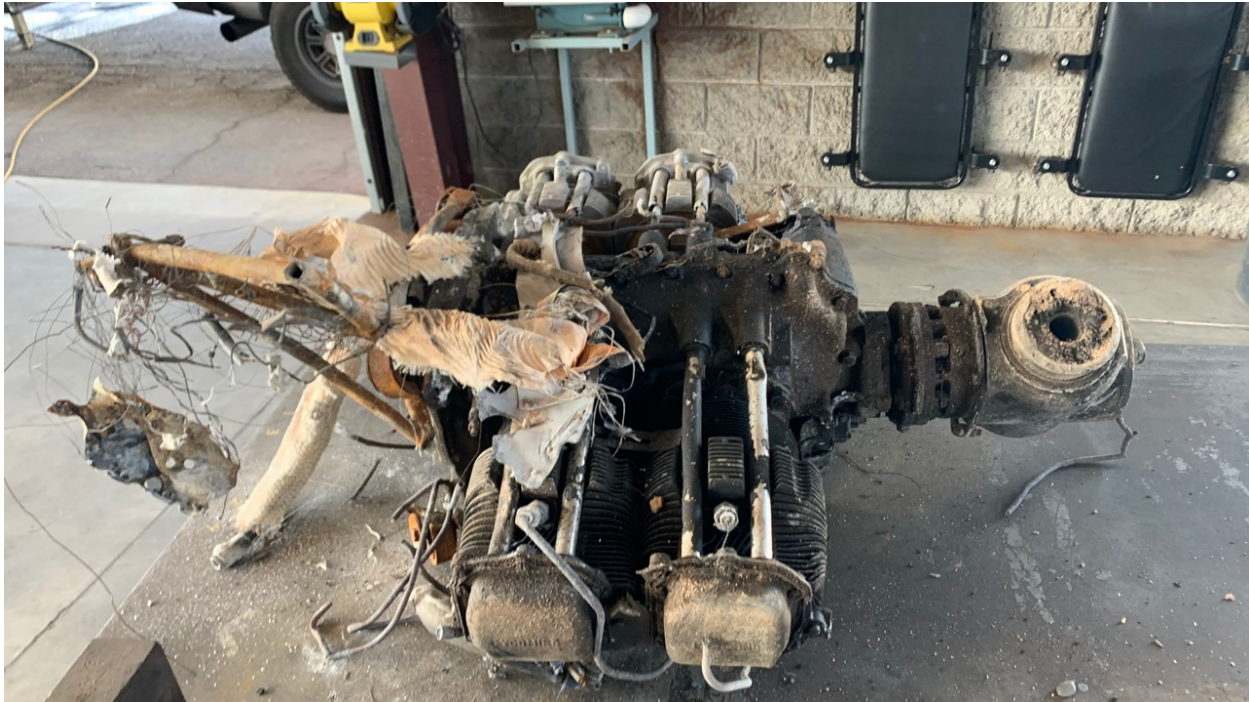
The engine was separated from the airframe, however remained attached to the engine mount structure and exhibited thermal/fire damage. The right magneto was separated and remains of the left magneto remained attached to the accessory housing. The rear accessory housing was mostly burnt away, exposing internal components. The dowel pin was intact. The alternator was separated. The starter remained attached. The propeller governor remained attached. The propeller hub remained attached to the crankshaft. Both wooden propeller blades were separated at the blade root and not located.

Figure 4: Recovered Engine

The crankshaft would not rotate when using a hand tool attached to the crankshaft. Holes were drilled into the upper portion of the crankcase. Using a borescope, the internal areas of the crankcase and cylinders were examined. Evidence of heavy corrosion (rust) was observed throughout the internal areas of the engine and cylinders. All connecting rods, pistons, and valves were intact. No evidence of any catastrophic failure was observed. The intake and exhaust valves exhibited normal operational signatures.
