# NATIONAL TRANSPORTATION SAFETY BOARD

## MATERIALS LABORATORY FACTUAL REPORT

Report No. 20-015

Place : Melba, Idaho  
Date : May 19, 2019  
Vehicle : Beech C35, N1888D  
NTSB No. : WPR19FA150  
Investigator : Thomas Little, ASI-WPR

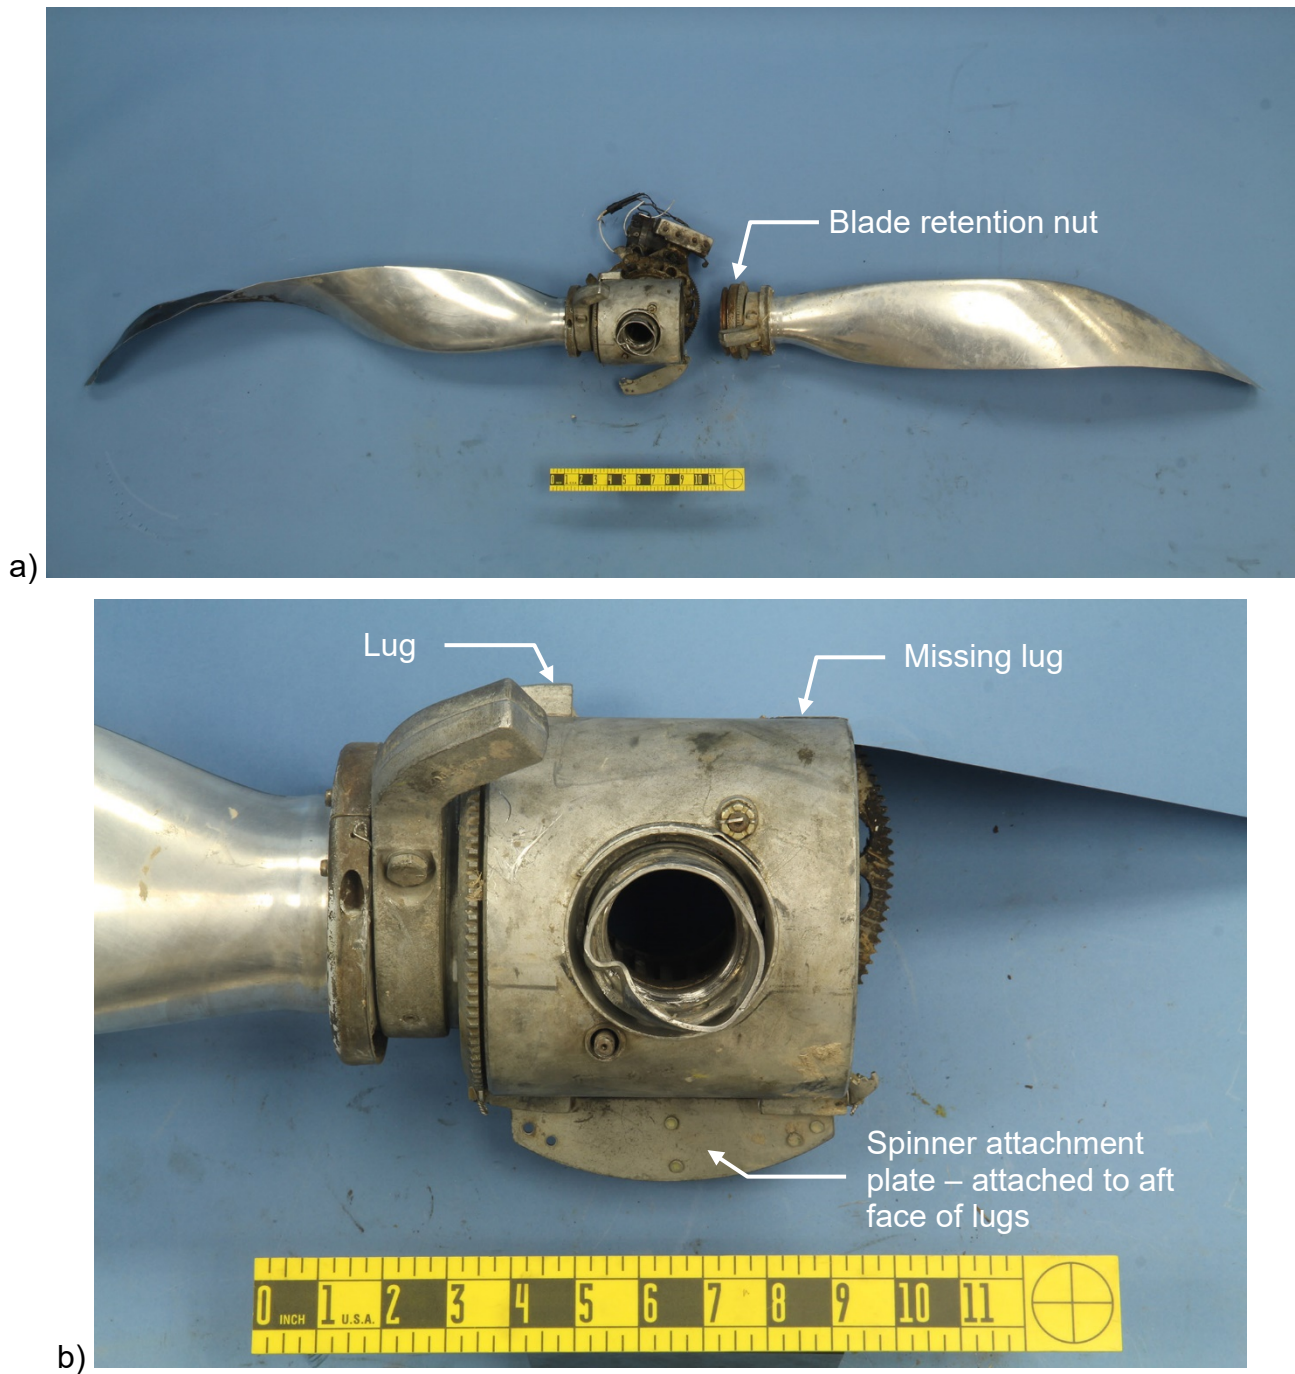
The propeller blades were both deformed, as shown in figure 1a. The separated blade exhibited an aft bend and clockwise twist of the blade tip so that the leading edge at the blade tip was rotated toward the aft direction, as shown in figure 1c. The retained blade also exhibited a clockwise twist mid span, but the tip was bent forward, as seen in figure 1a.

The as-received hub was missing one of the lugs as indicated in figure 1b, 2a, and 3b. The spinner attachment plate on the same side of the hub was also missing. The blade retention clips, in the as-manufactured condition, are attached to the end faces of the lugs with a bolt and lockwire and have teeth along one of their edges that interlock with mating teeth around the outer circumference of the blade retention nuts, as shown in figures 3c and 3d. With the clips installed in this manner, the blade retention nut would

**Figure 1:** a) Overview image of the propeller hub assembly with one attached propeller blade, to the left of the hub in the image, and one separated propeller blade, set on the right side of the hub in the image and b) closer view of the hub with a missing lug in the upper right side of the image.

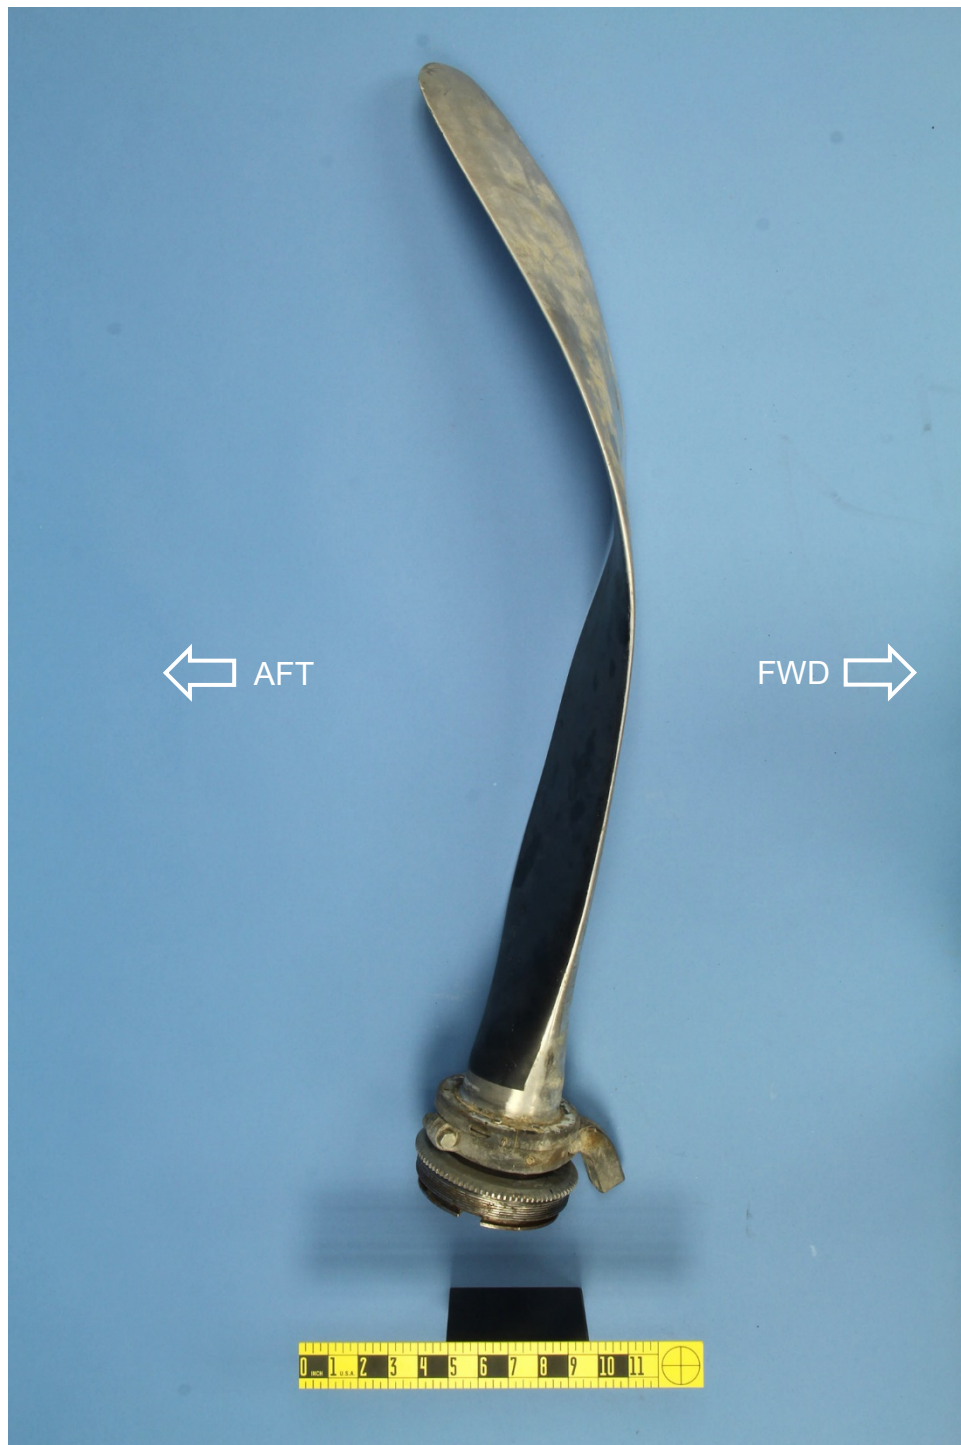
c)  
**Figure 1 (cont.):** c) the separated blade viewed from the leading edge-side showing an aft bend and twist of the blade tip.

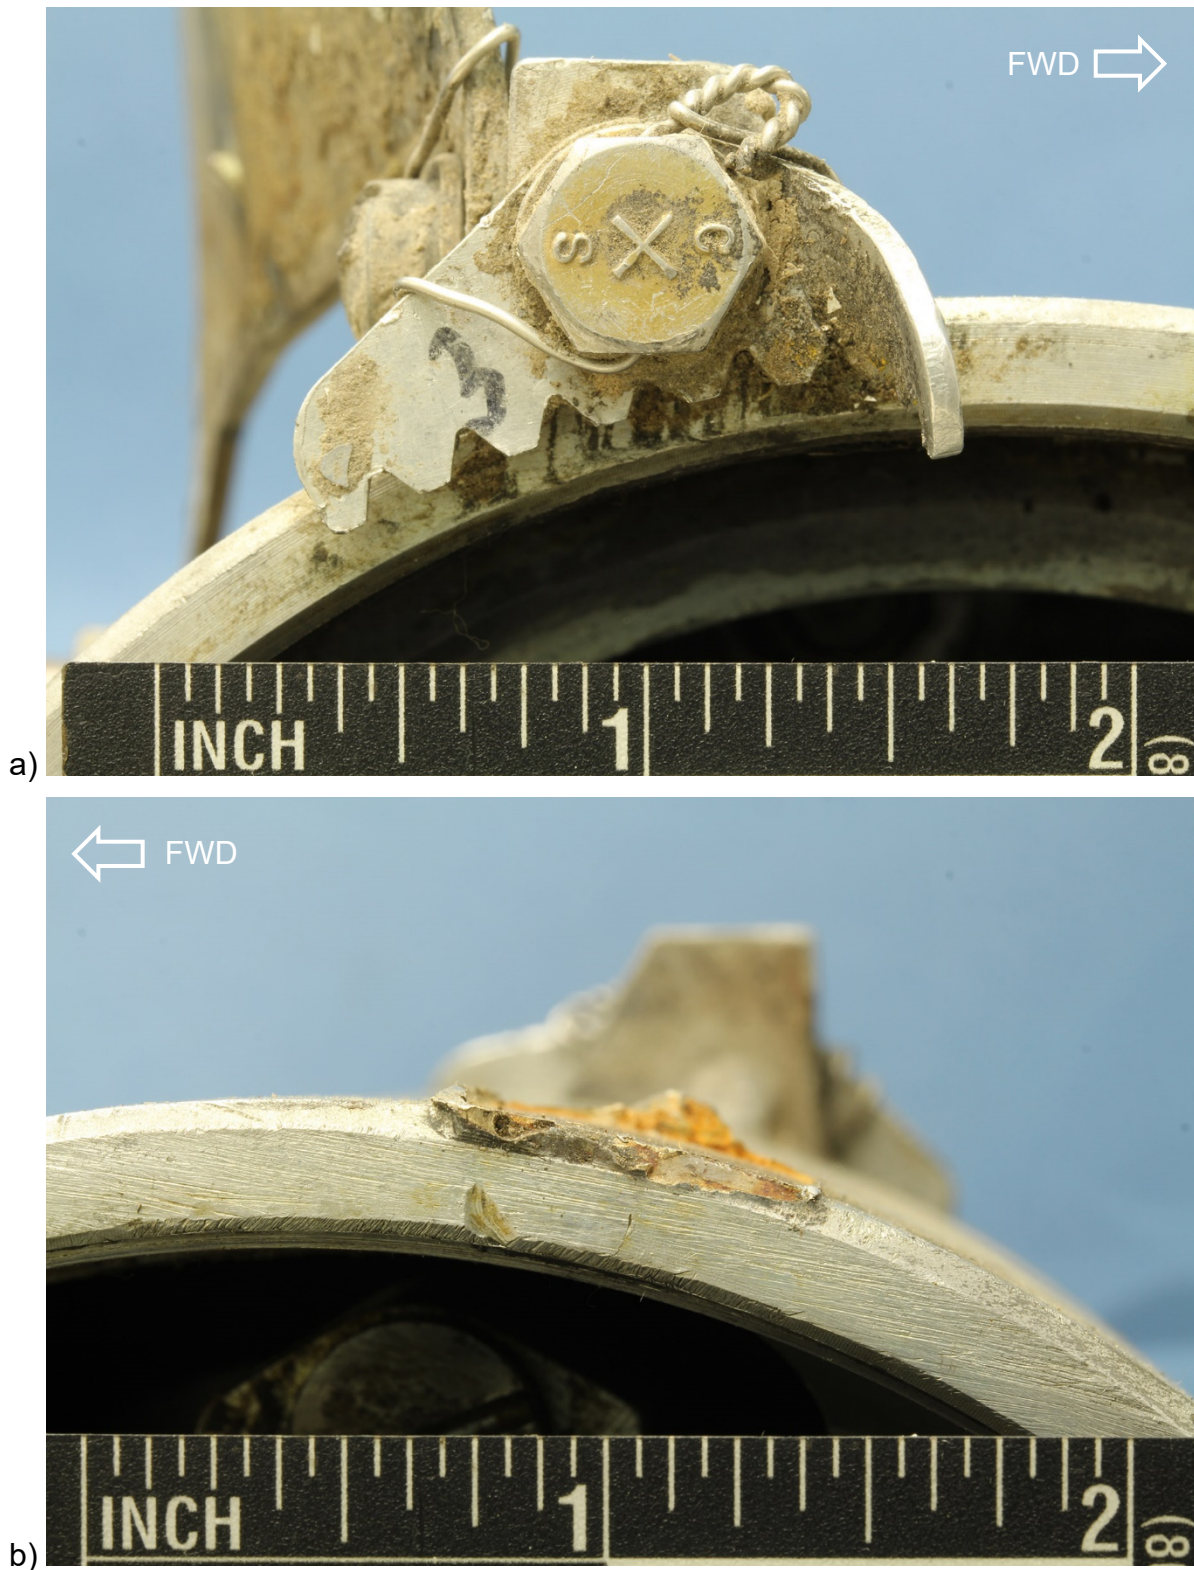
be locked in place and would not rotate out of the hub. The retention clips were present on the three remaining lugs, however one of the clips, on the side of the hub with the separated blade, was bent (figure 3a), with the forward portion of the clip bent outward and aft.

**Figure 3:** a) and b) Longitudinal views of the two lugs on the side with the separated propeller blade. The retention clip was bent on one lug and the other lug was missing.

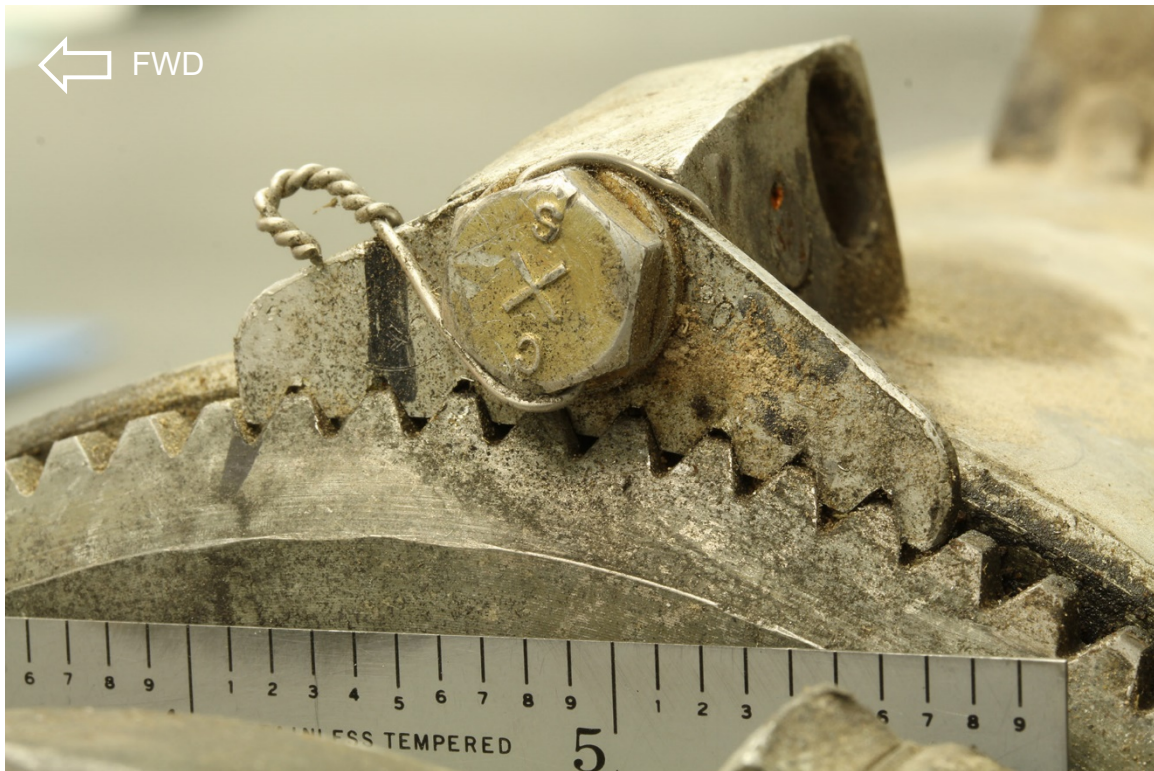
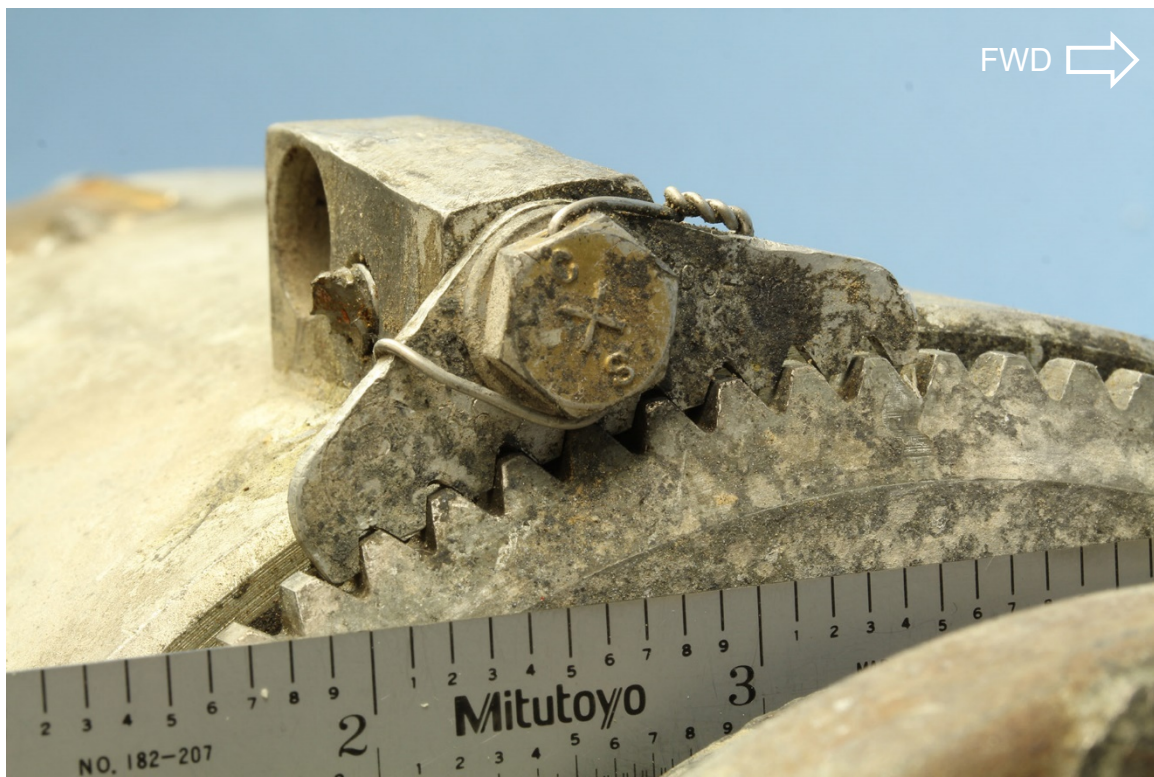
**Figure 3 (cont.):** c) and d) Images of the two lugs and blade retention nut clips on the intact side of the hub.

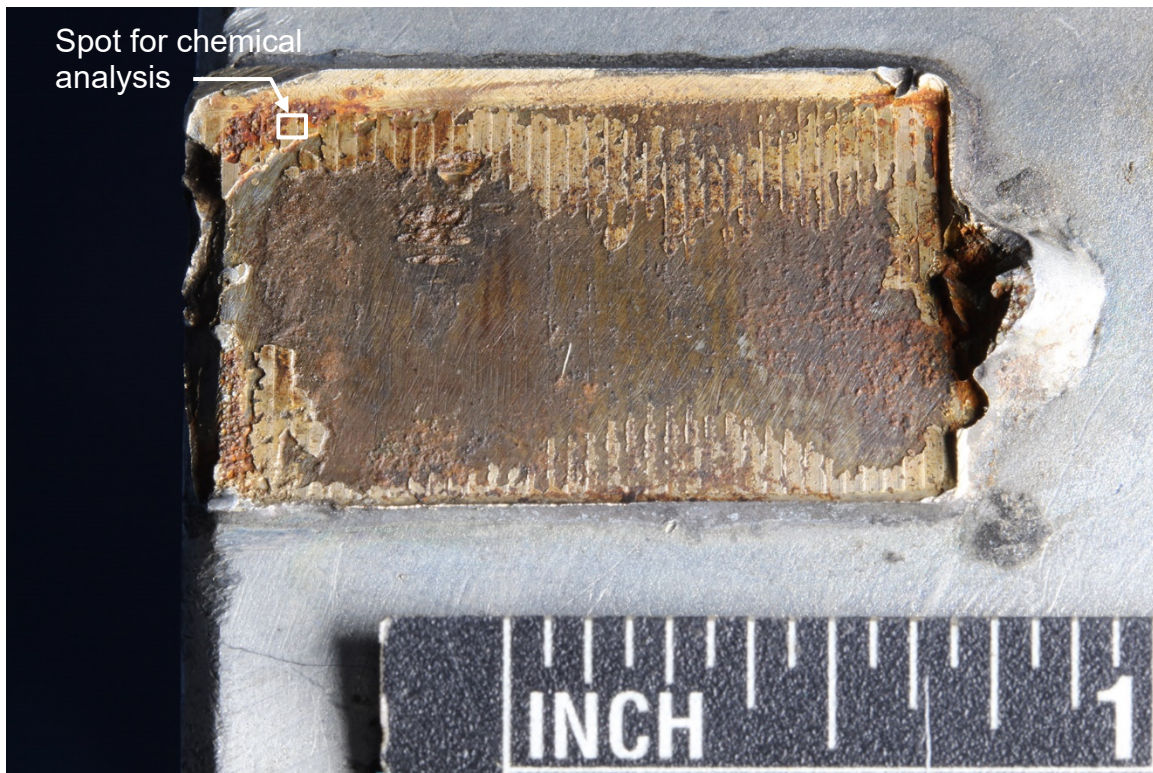
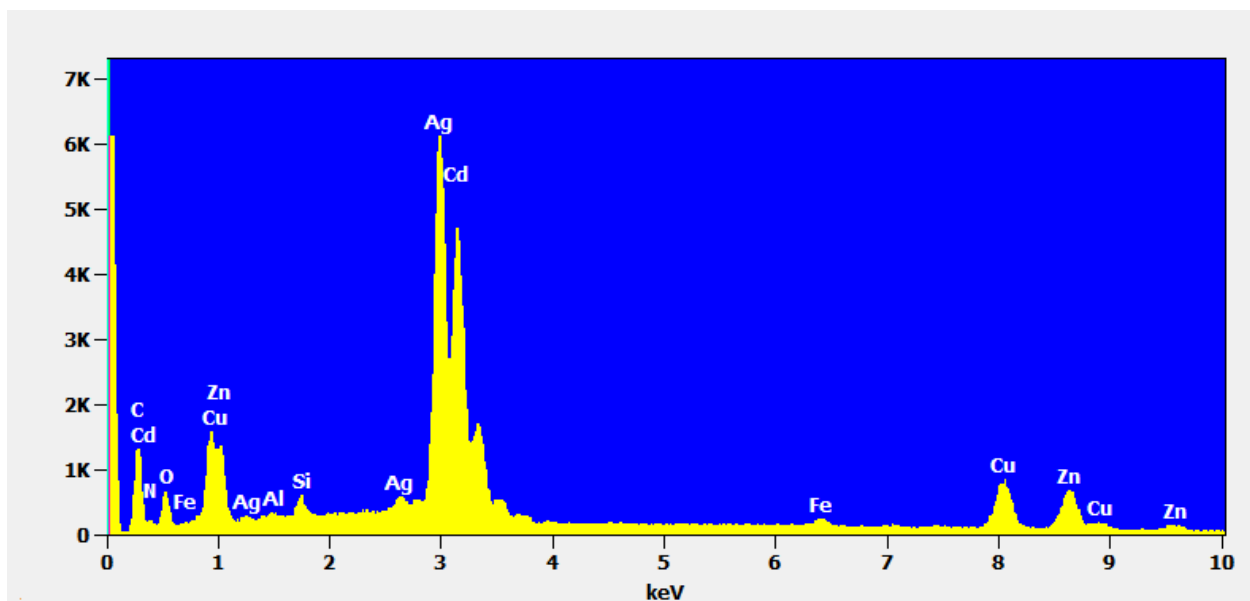
The attachment pad for the missing lug is shown in figure 4a. There was a bronze-colored brazing material around the perimeter of the pad of unknown composition, while the interior was a dark brown/black color, typical of an iron oxide. The composition of the brazing material was examined using a scanning electron microscope (SEM) equipped with an energy dispersive x-ray spectrometer (EDS). In order to fit the pad in the SEM, the hub was first disassembled and an abrasive cutting saw was then used to cut a piece of material from the hub that contained the attachment pad as well as one of the intact lugs from the side of the hub that retained its propeller blade (figure 5a and 5b). The strip was then sectioned into smaller pieces using the same method and the intact lug was further cut so that its brazed joint could be viewed in cross section (figure 5c). The EDS spectrum from the brazing pad with the missing lug is shown in figure 4b. The spectrum exhibited primarily silver (Ag), cadmium (Cd), copper (Cu), and zinc (Zn), consistent with cadmium-containing silver brazing alloy. The EDS spectrum from the intact lug's brazed joint is shown in figure 5d. The spectrum exhibited primarily copper (Cu), which was consistent with the material and process used by the original manufacturer to braze the lugs to the hub.

**Figure 4:** a) Image of the brazing pad for the disbonded lug and b) energy dispersive spectroscopy of the brazing compound indicating the presence of primarily silver (Ag), cadmium (Cd), copper (Cu), and zinc (Zn).

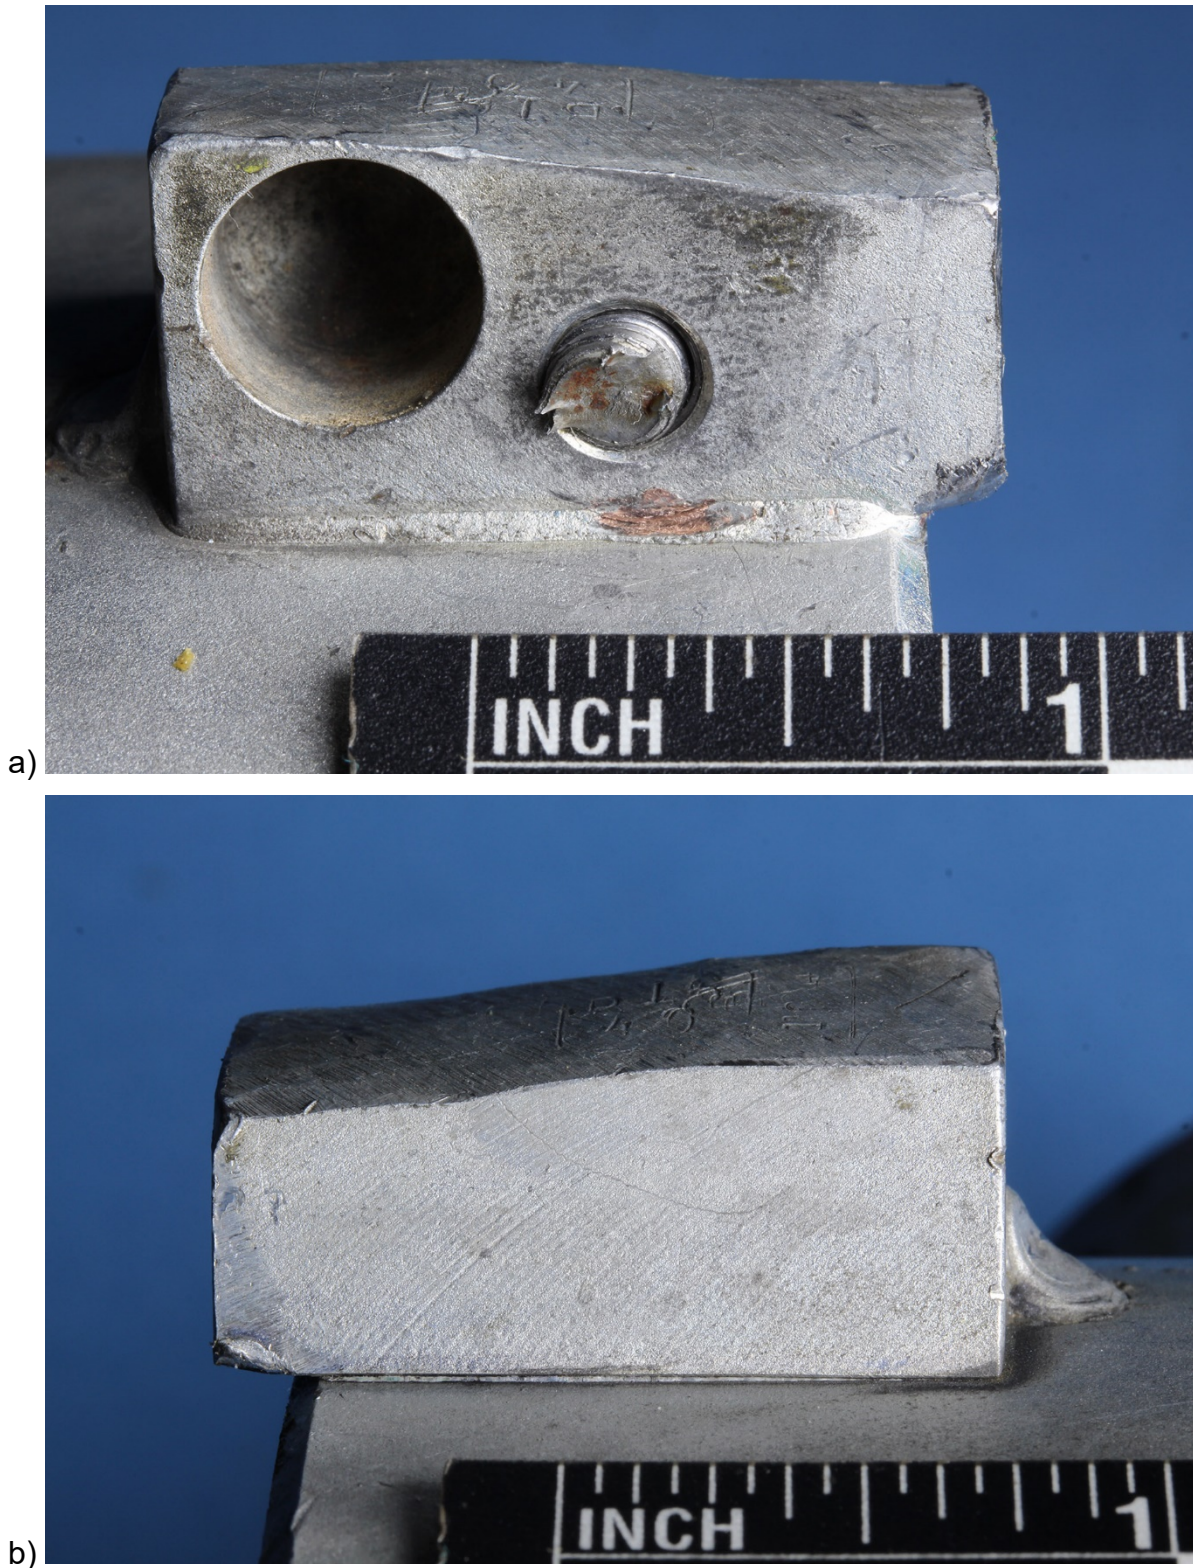
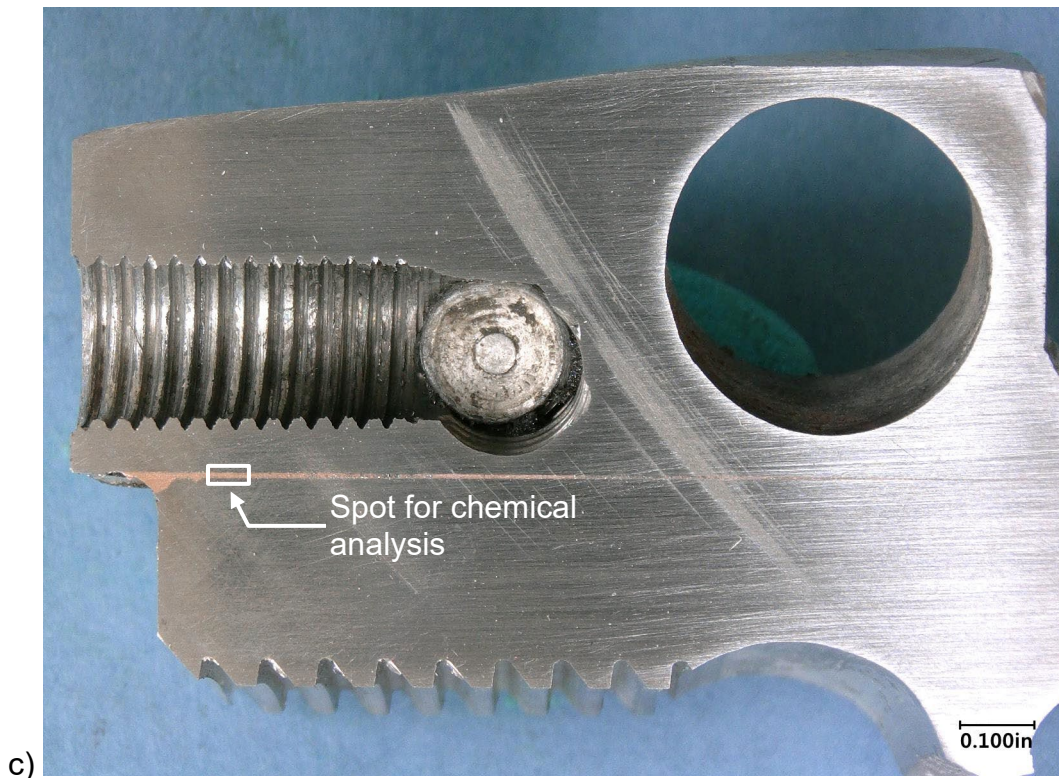
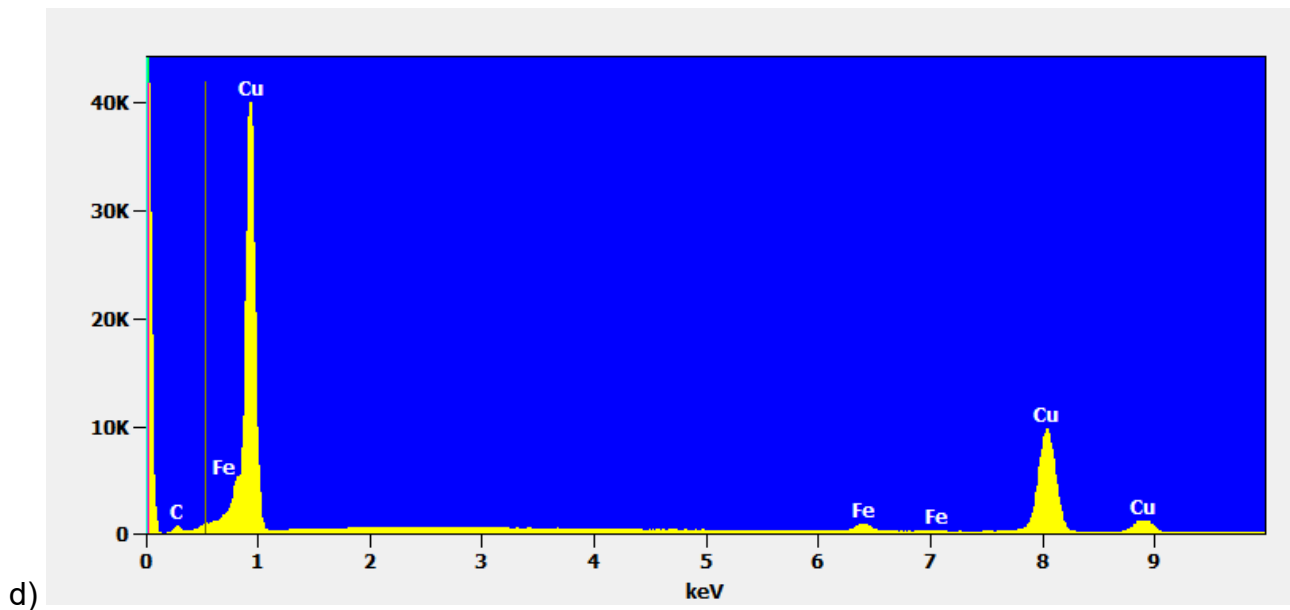
**Figure 5:** Images of an intact lug on the side of the hub with the retained propeller blade (see also figure 3d): a) aft face of the lug looking forward and b) forward face of the hub looking aft;

**Figure 5 (cont.):** c) Image of a sectioned piece of the lug and hub joined by a brazing material. The view is of the aft piece looking in the aft direction; and d) energy dispersive spectroscopy of the brazing compound indicating the presence of copper (Cu).

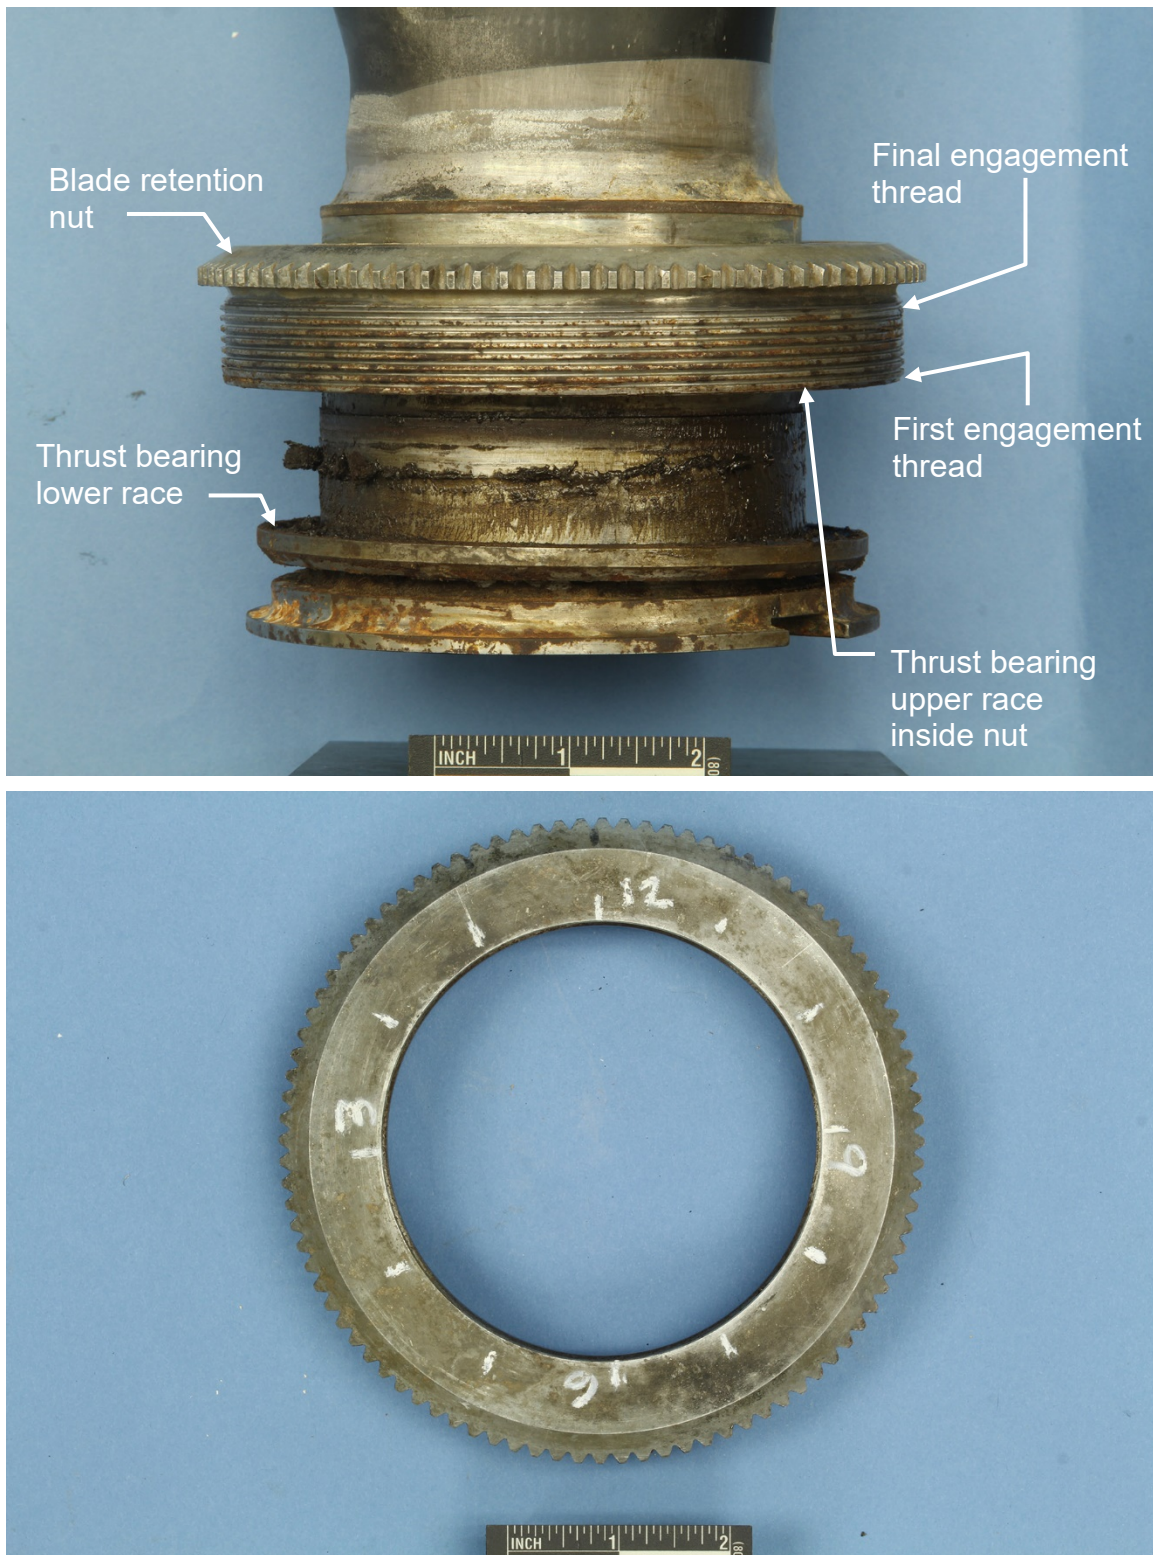
The thrust bearing at the root of the propeller blade was examined for any notable features. The blade/bearing assembly is shown in figure 6a. The shank end of the blade has a support flange which backs the lower race. The blade retention nut serves as a support for the upper race. Thirty-one ball bearings are captured between the lower and upper races. During the original manufacture of the blade, the shank and blade are separate pieces. The races and blade retention nut are assembled over the shank and the blade is then joined to the shank. To examine the races and the blade retention nut, the blade was therefore cut from the shank using a band saw. The nut could then be examined separately as shown in figure 6b. For convenience, the circumference of the nut was labelled with clock positions with 12 o'clock starting at an existing black marking on the nut and the clock positions assigned as if viewing from the root of the blade toward the tip.

**Figure 6:** a) Image of the separated propeller blade showing the shank-end with the blade retention nut and bearing races still attached and b) image of the blade retention nut after the blade was cut and the nut removed. The perimeter of the nut was labelled with clock positions starting with 12 o'clock at a preexisting black mark on the nut.

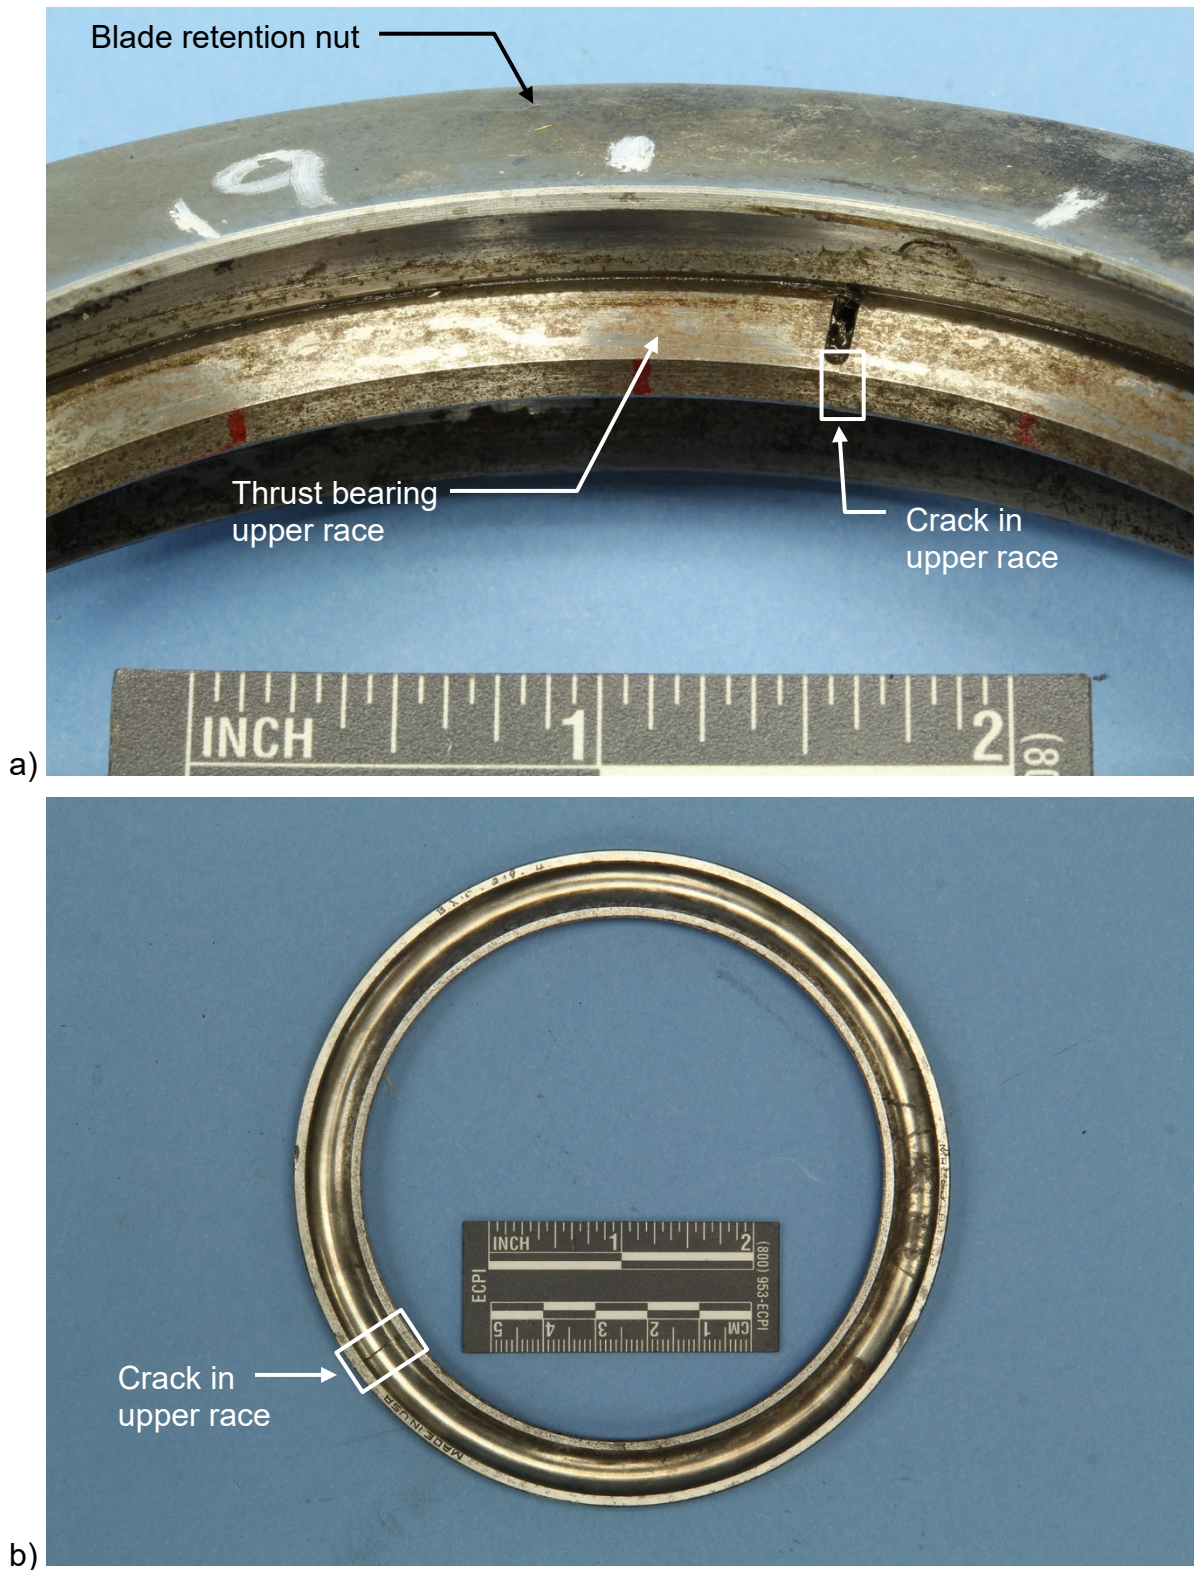
An examination of the lower race did not reveal any notable features. However, visual examination of the upper race revealed a crack located at a notch incorporated into the backside of the race located between the 7 o'clock and 8 o'clock positions, as indicated in figures 7a and 7b. The notches are intended to facilitate removal and replacement of the races if necessary. To examine the fracture surfaces, the race was sectioned using an abrasive cutting saw. One of the fracture faces is shown in figure 8a. The fracture surface exhibited a rough appearance with some apparent rubbing damage. A curvilinear crack progression mark was consistent with the crack starting at the center of the notch. The fracture surface was examined using a SEM (not shown) and the fracture surface exhibited dimple features that were consistent with an overstress fracture.

**Figure 7:** a) and b) Images of the the thrust bearing upper race showing the location of a crack at a manufactured notch on the backside of the race.

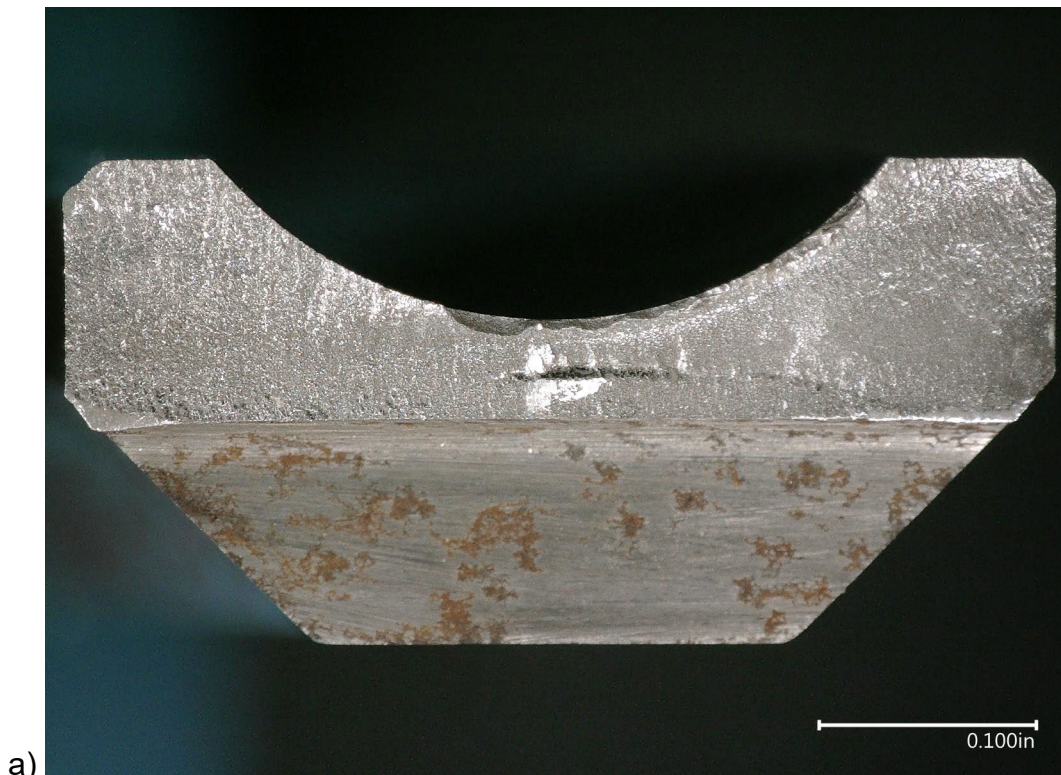
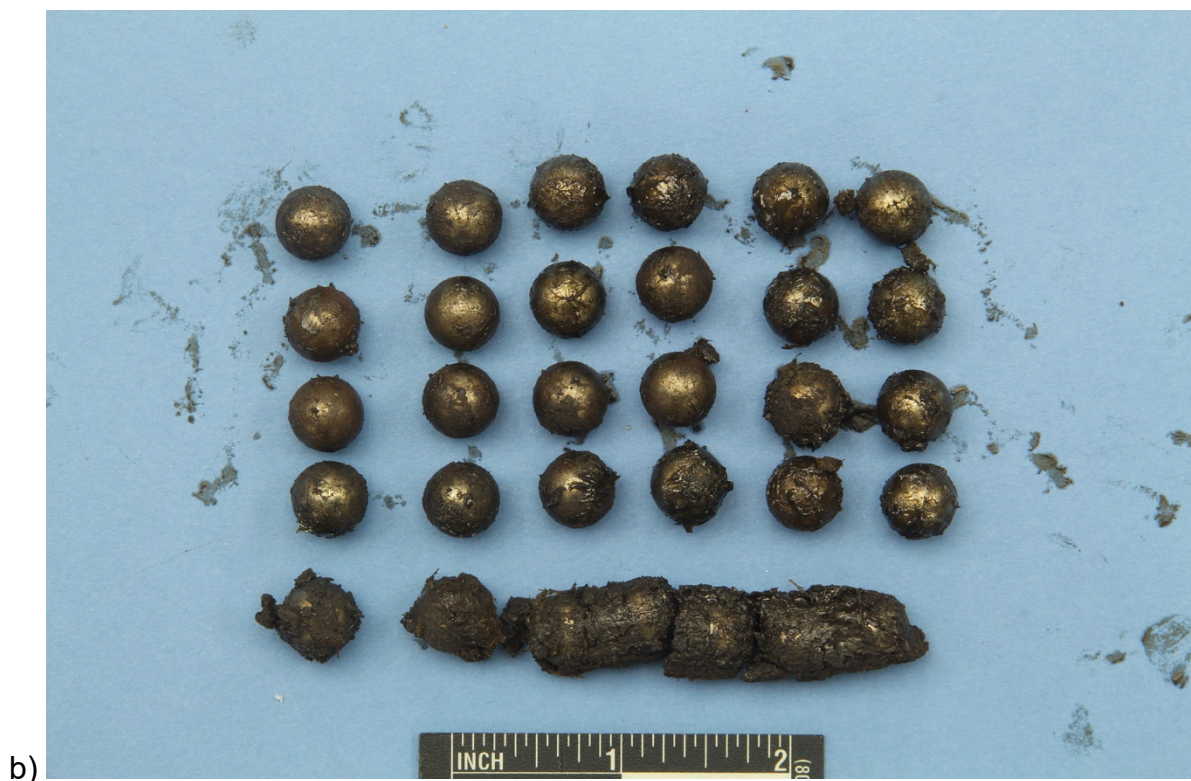
The ball bearings, shown in figure 8b, were covered in a black paste, consistent with a combination grease and dirt. The bearings and raceways were cleaned using solvents in a sonicating bath and examined visually. The surfaces exhibited superficial pitting, discoloration, and/or material transfer but no notable flats, gouges, brinelling marks, etc. were present.

**Figure 8:** a) Image of one of the thrust bearing upper race fracture surfaces and b) image of the thrust bearings (31 total) in their as-received condition.

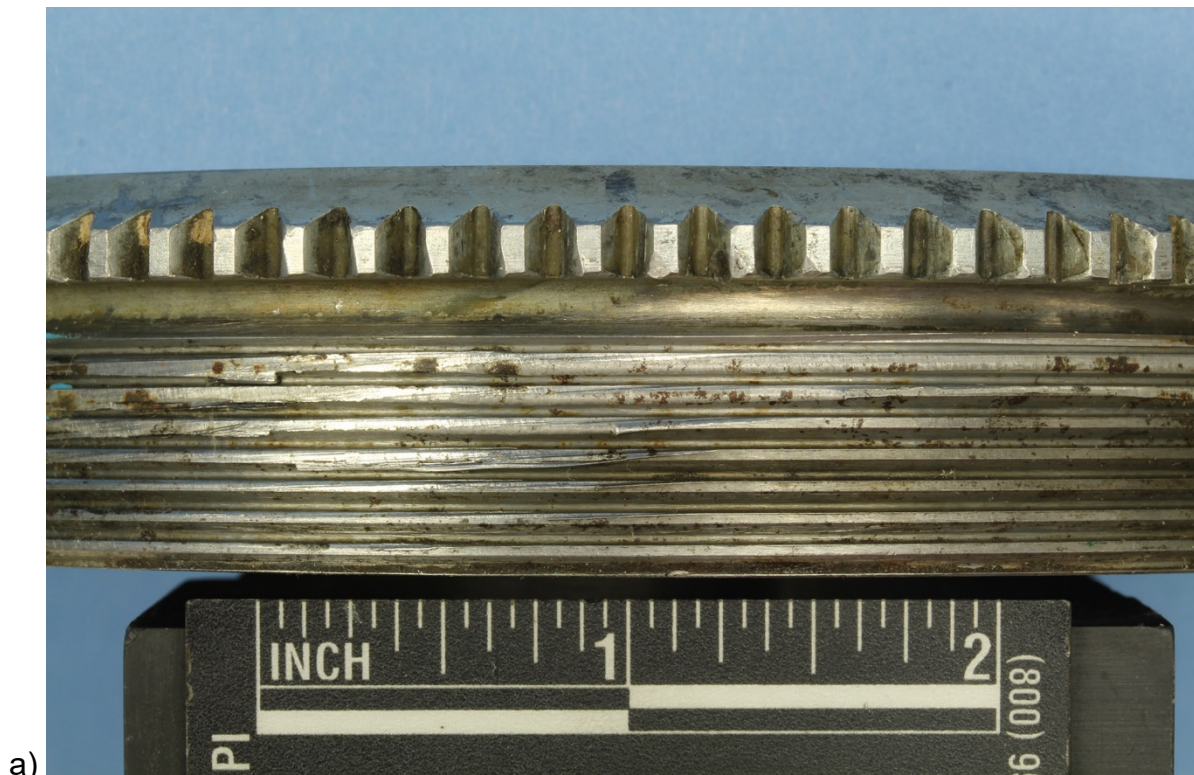
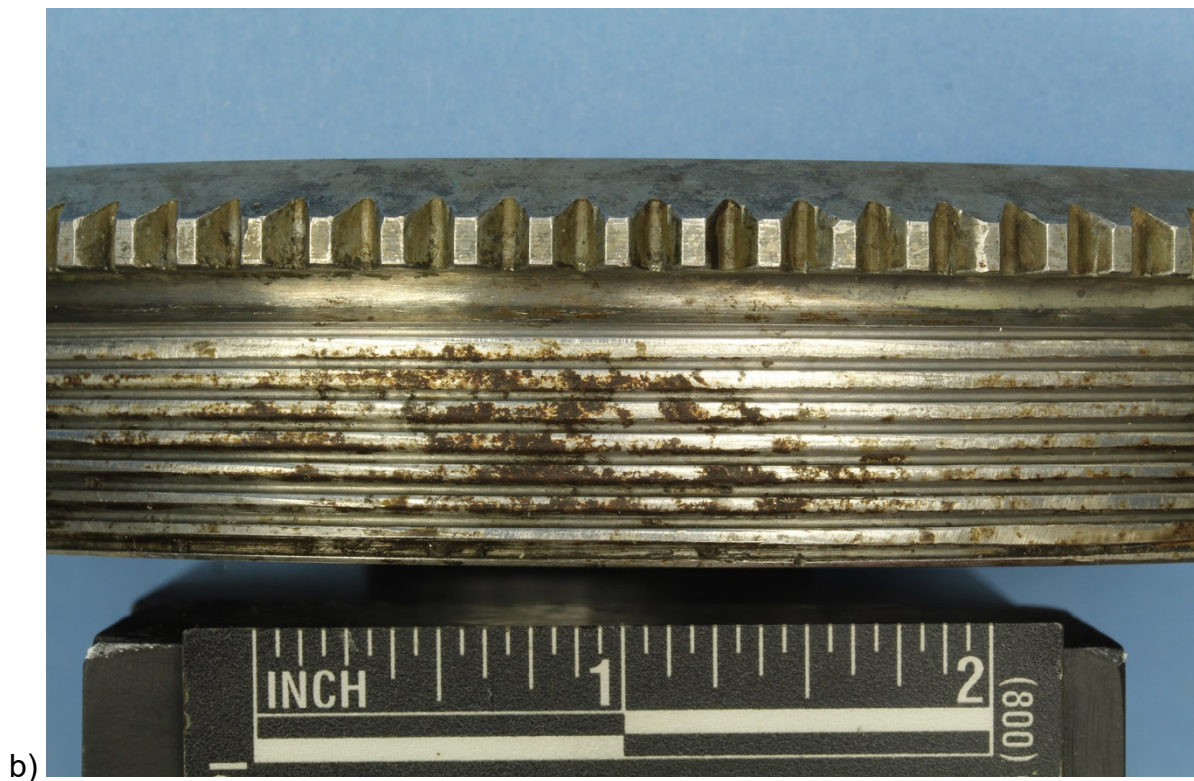
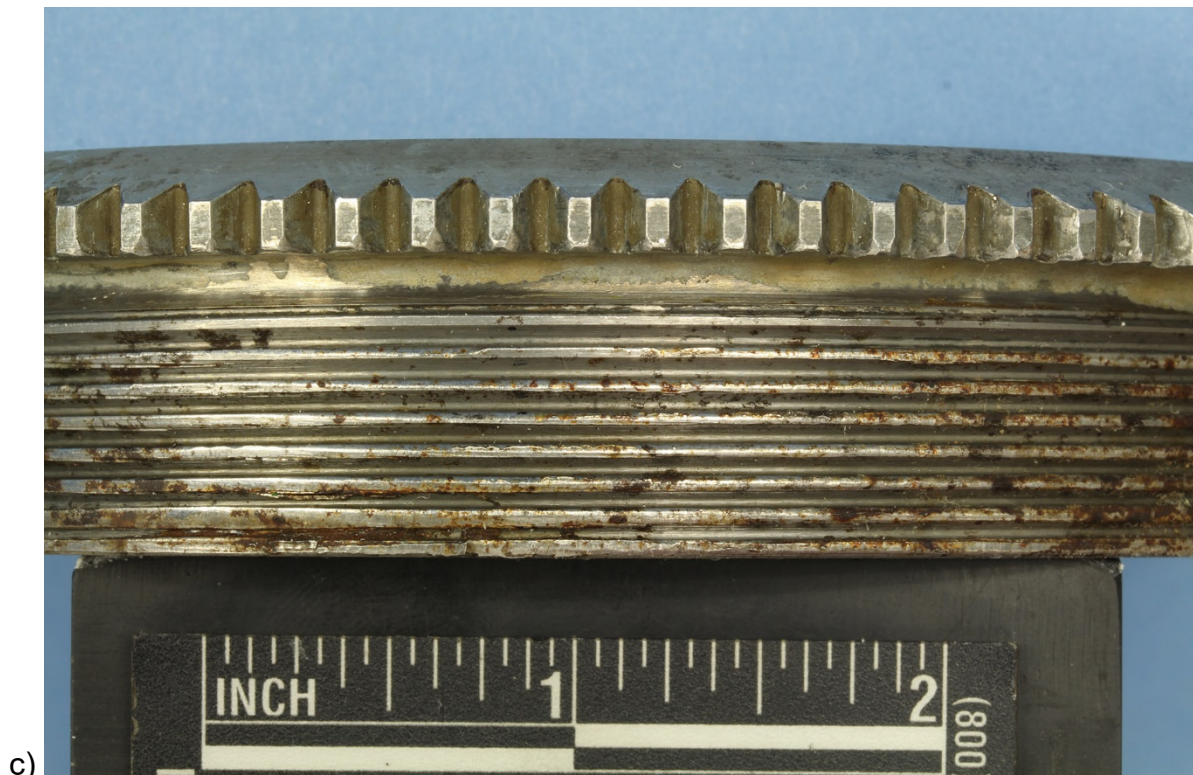
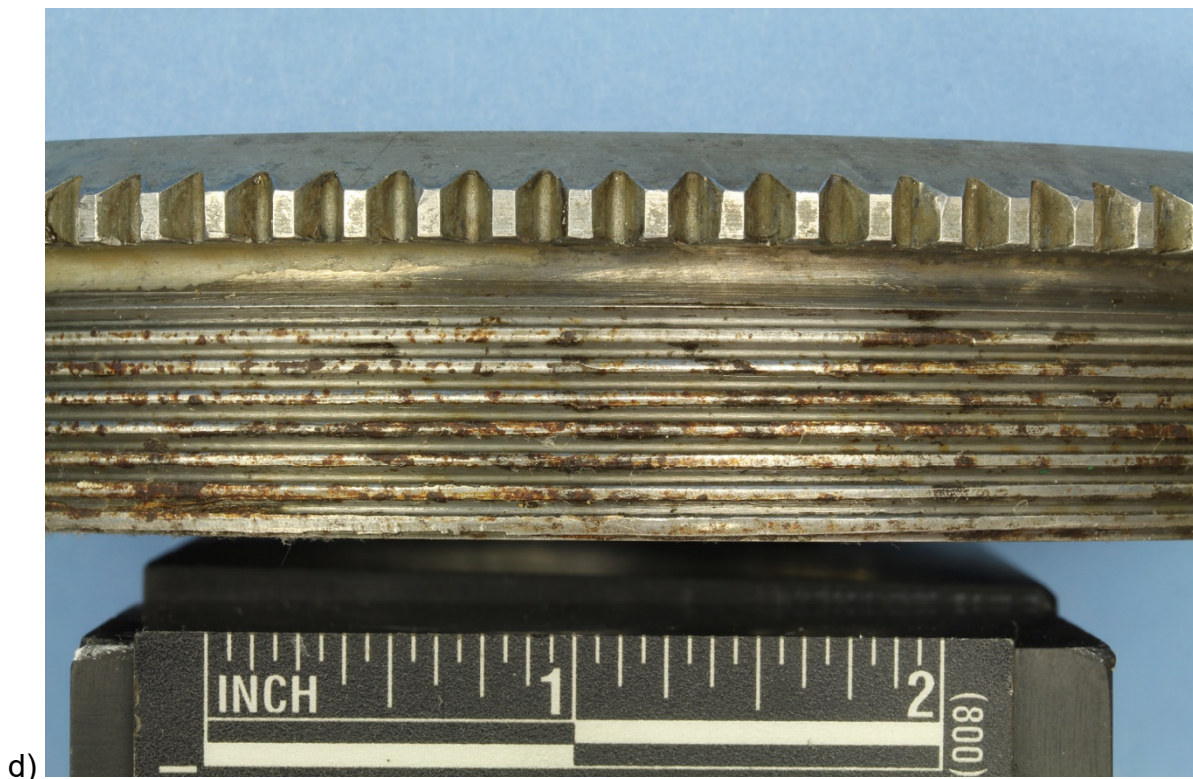
Finally, the male threads on the blade retention nuts and the female threads on the hub were examined for any notable features. The nut from the separated blade exhibited non-uniform wear of the threads around the circumference of the nut, as shown in figures 9a – d, while the female threads on the hub exhibited little to no wear (not shown).

**Figure 9:** Images showing the appearance of the blade retention nut threads at the following positions: a) 12 o'clock; b) 3 o'clock;

**Figure 9 (cont):** c) 6 o'clock; and d) 9 o'clock.
