# NATIONAL TRANSPORTATION SAFETY BOARD

## MATERIALS LABORATORY FACTUAL REPORT

Report No. 20-015

Place : Melba, Idaho  
Date : May 19, 2019  
Vehicle : Beech C35, N1888D  
NTSB No. : WPR19FA150  
Investigator : Thomas Little, ASI-WPR

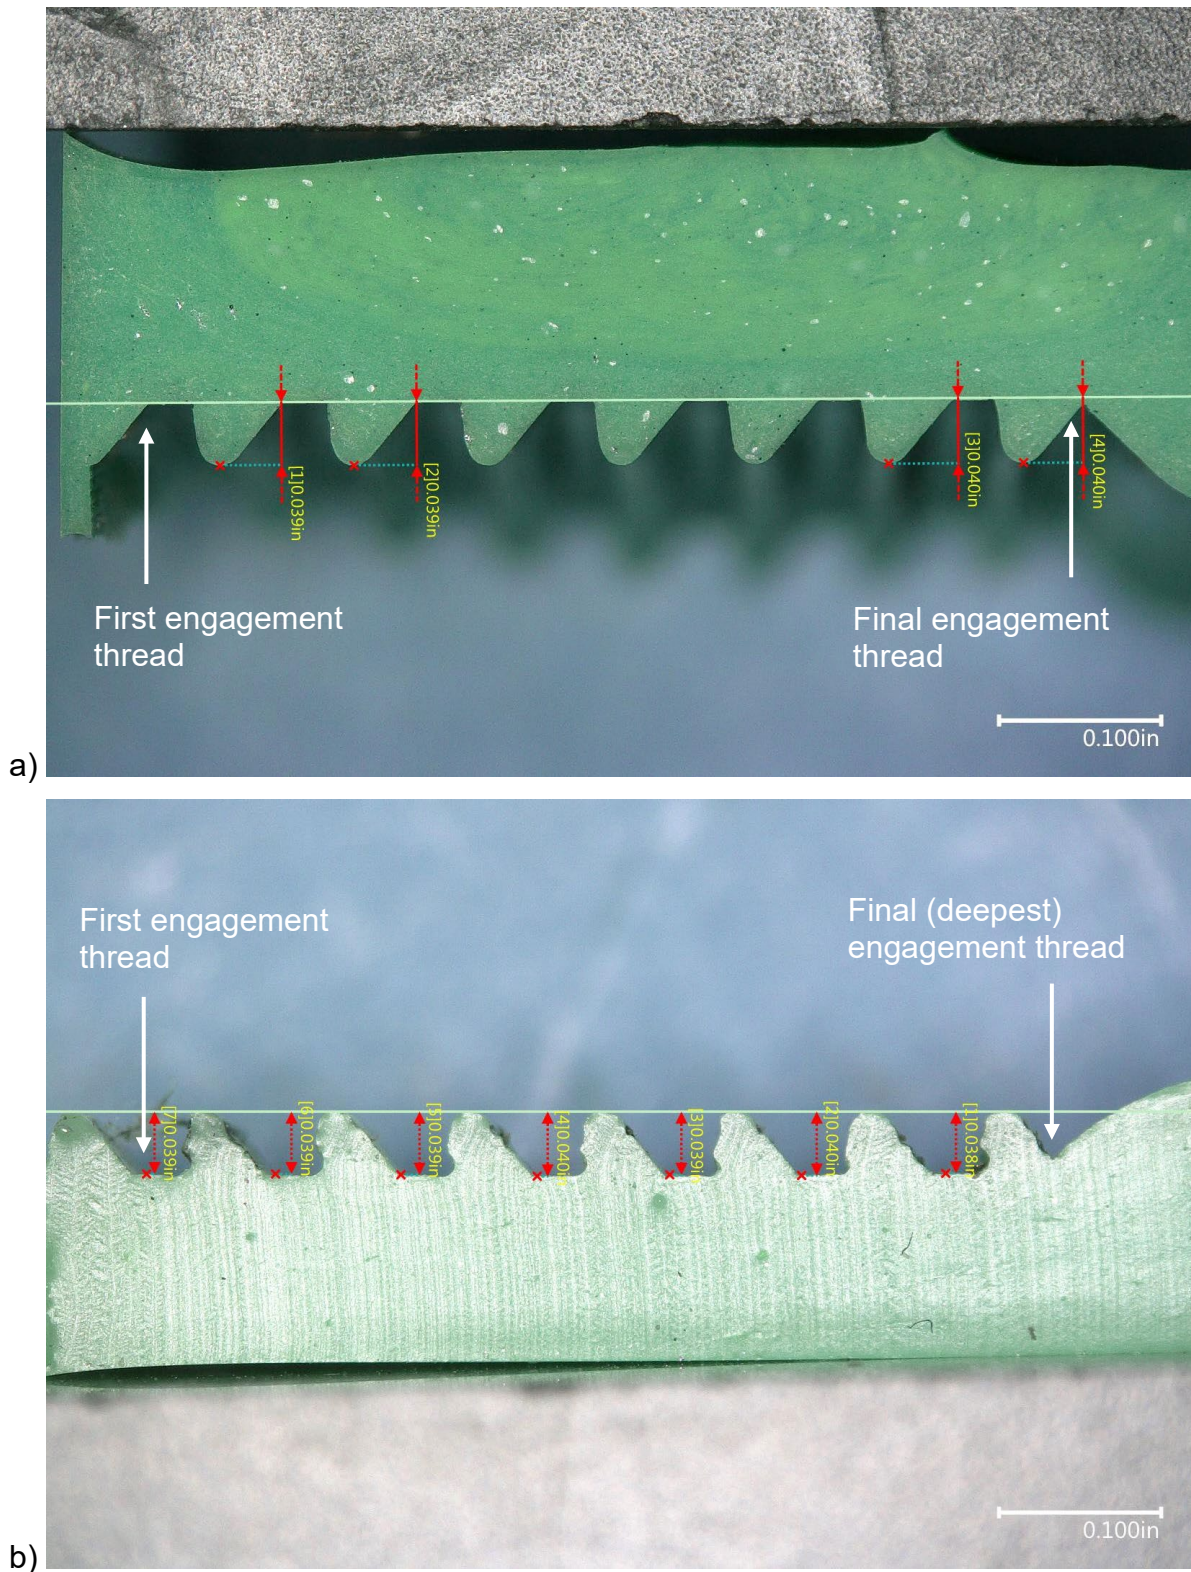
For comparison, sample molds from the side of the hub with the retained blade were also taken and are shown in figures 10a and 10b. For the side with the retained blade, the thread depth on the blade retention nut measured 0.039 inch to 0.040 inch. Similarly, the thread depth on the hub female threads measured 0.038 inch to 0.040 inch.

**Figure 10:** Comparison rubber molds of the threads from the side of the hub with the retained blade: a) external thread profile of the retained blade retention nut and b) the internal thread profile on the hub.

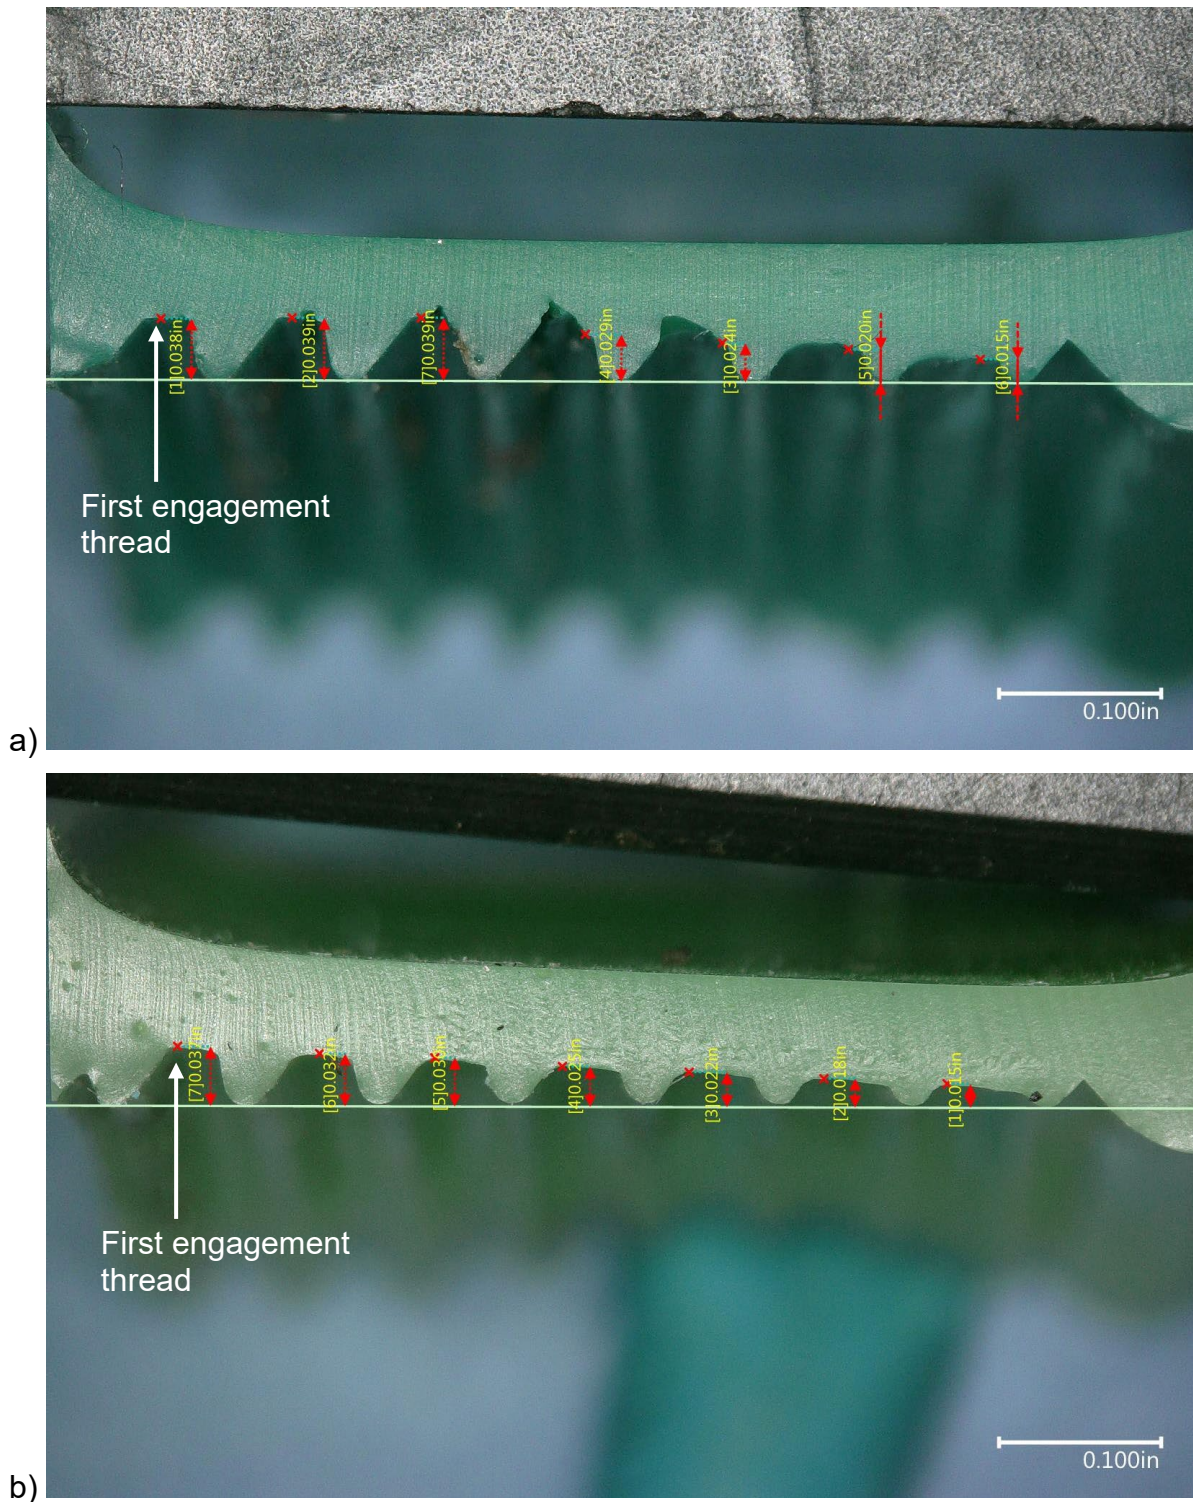
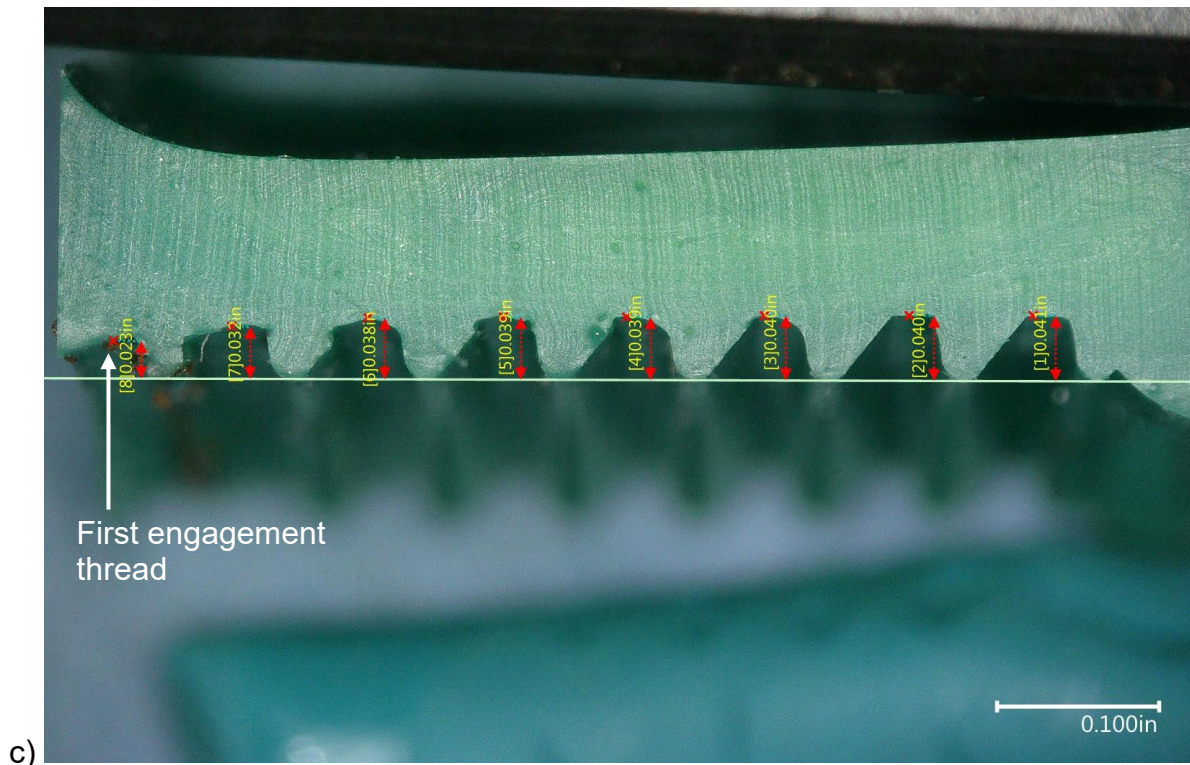
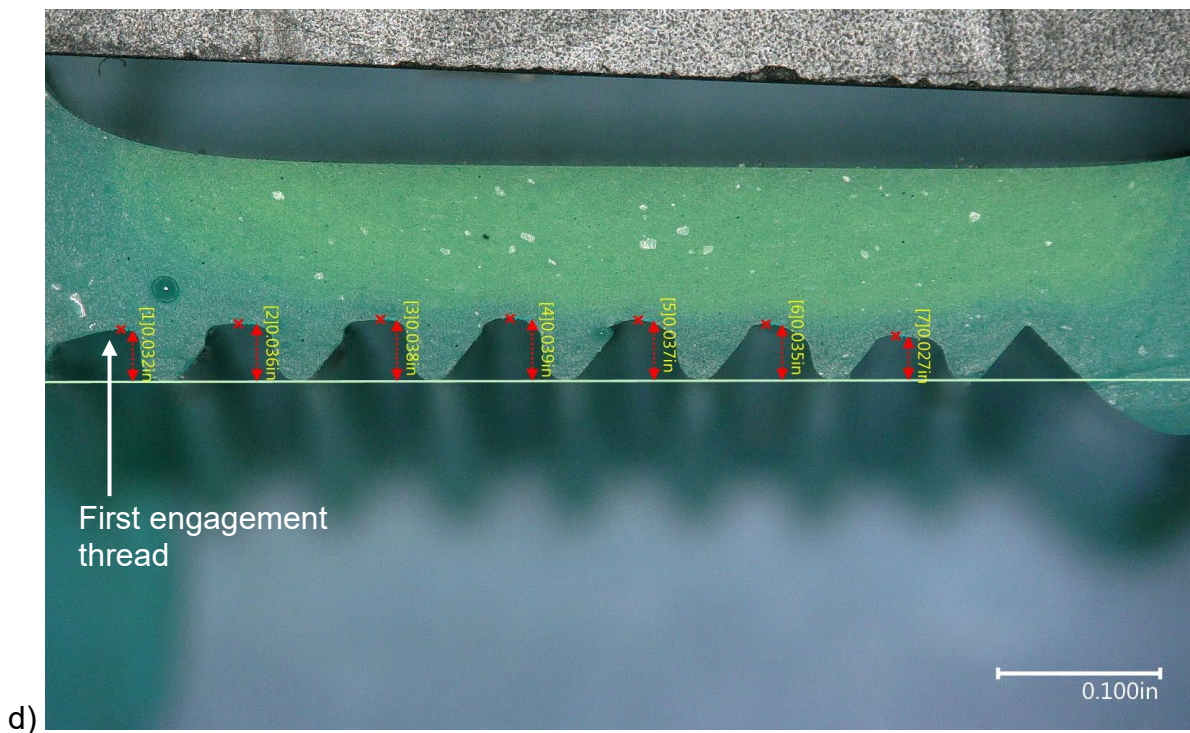
The molds from the separated blade's blade retention nut are shown in figures 11a – d for the 12, 3, 6, and 9 o'clock positions, respectively. The first engagement thread (the first thread to gain purchase as the male and female threads engage) is labeled in each image. For the 12 and 3 o'clock positions, the thread cross-sections exhibited little to no wear at the first engagement thread and greater thread wear at greater depths. For the 12 o'clock position the thread depth started at 0.038 inch and decreased to 0.015 inch. Similarly, for the 3 o'clock position, the thread depth started at 0.037 inch and decreased to 0.015 inch. In contrast, the 6 o'clock position exhibited the greatest thread wear at the first engagement thread. The thread depth started at 0.023 inch at the first engagement thread and increased to 0.041 inch at the greatest depth. The 9 o'clock position exhibited wear at both ends of the cross-section. At the first engagement thread, the depth measured 0.032 inch. It increased to 0.039 inch before decreasing again to 0.027 inch.

**Figure 11:** Images of the cross-section thread profiles from the blade retention nut on the separated blade: a) 12 o'clock; b) 3 o'clock;

c) 6 o'clock; and d) 9 o'clock.

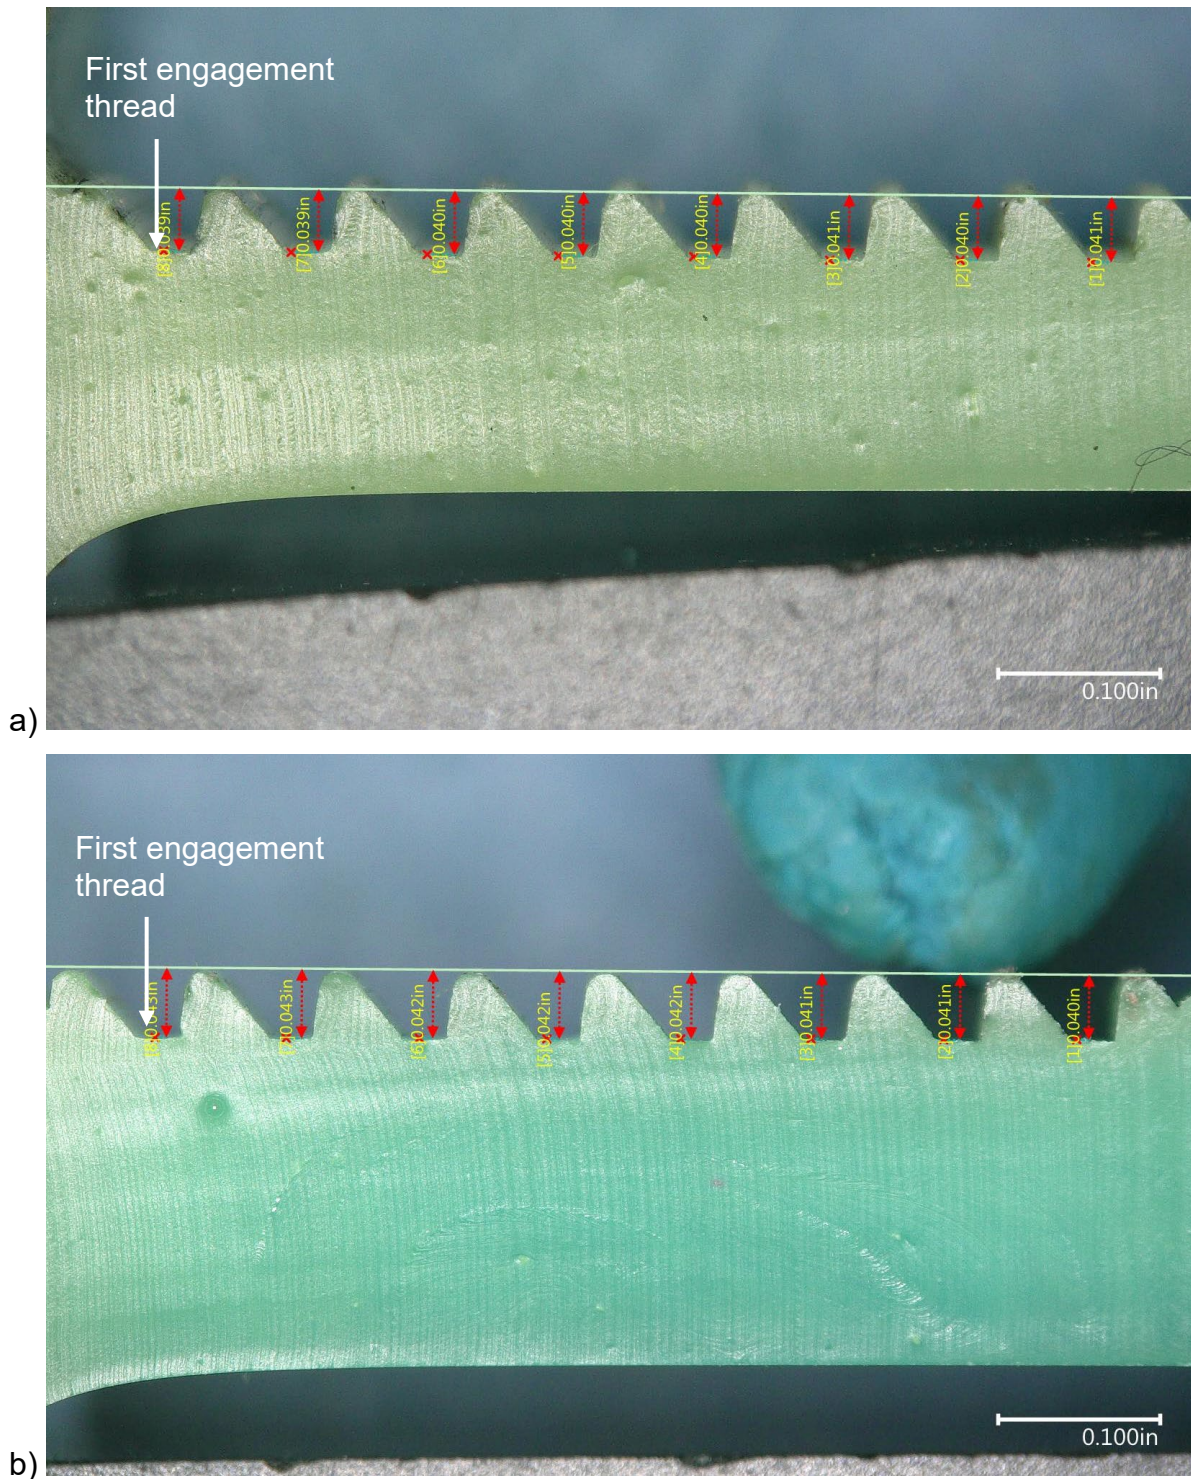
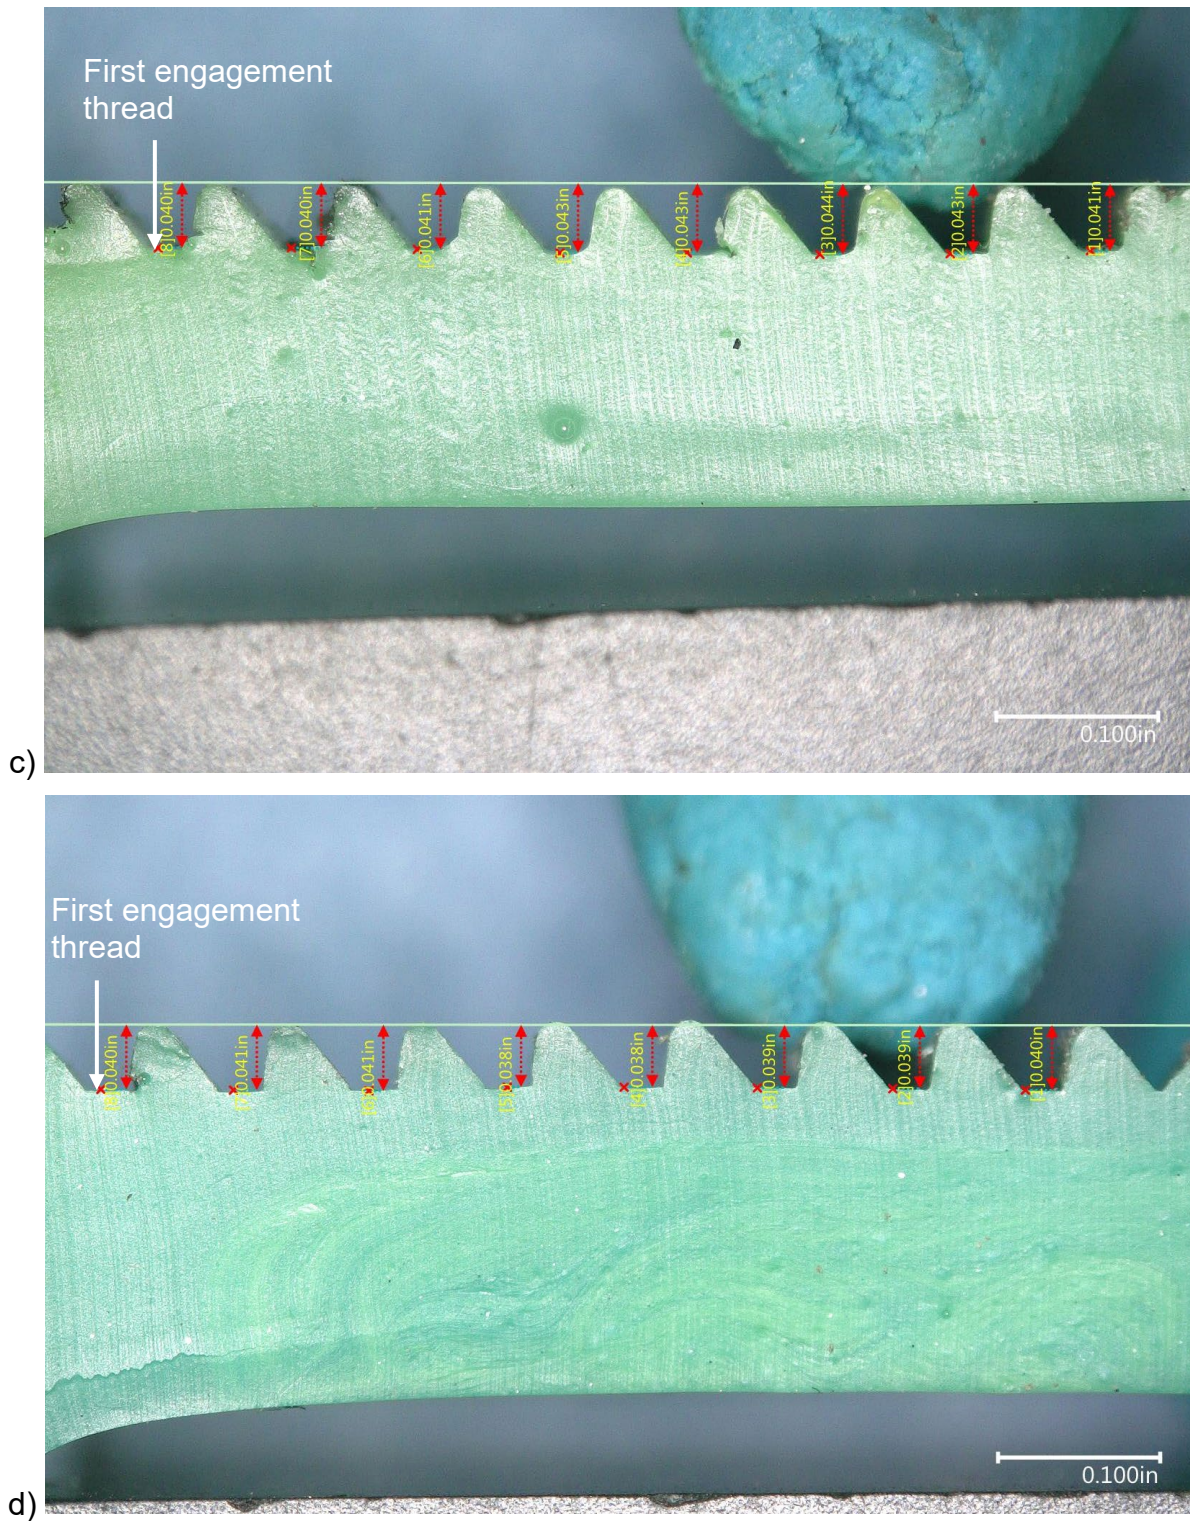
The sample molds from the hub are shown in figures 12a – d for the disbonded lug position, the aft position, the intact lug position, and the forward position, respectively. Cross section depth measurement ranged from 0.038 inch to 0.044 inch across all four locations, compared to the 0.039-inch to 0.040-inch thread depth range measured on the opposite side of the hub as reported above.

**Figure 12:** Images of the cross-section thread profiles from the hub internal threads on the side with the separated blade: a) near the disbonded lug; b) at the aft side of hub;

**Figure 12 (cont.):** c) near the intact lug; and d) at the forward side of the hub.
