## **NATIONAL TRANSPORTATION SAFETY BOARD**

### **SUMMARY OF AIRPLANE EXAMINATION**

**(WPR19FA150)**

| Aircraft: | Beech C35 |

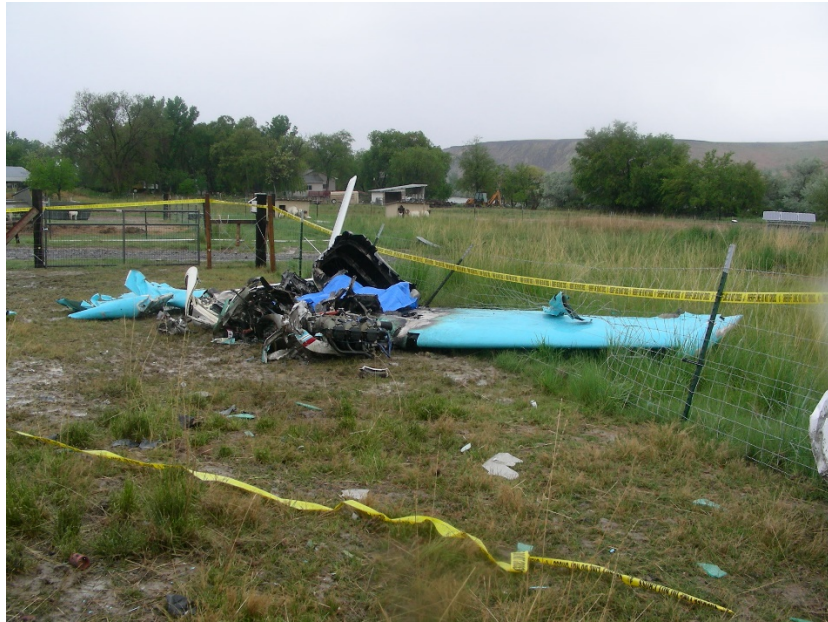
The airplane impacted a goat pasture area on a measured magnetic heading of about 315°. It subsequently came to rest upright in the same pasture on a measured magnetic heading of about 130°. The cabin and cockpit areas of the airplane were consumed by a postcrash fire.

Figure 1 - view of airplane looking northwest

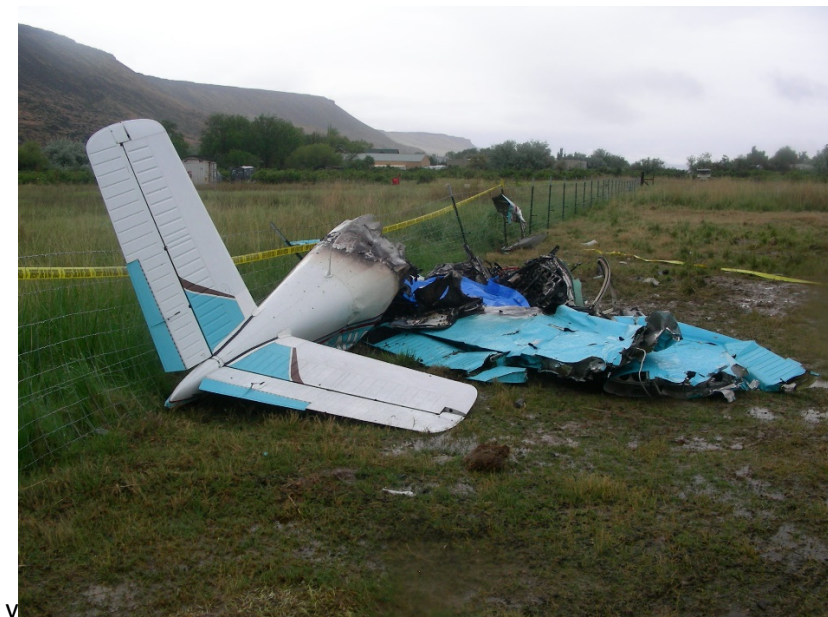
Figure 2 - view of airplane looking southeast

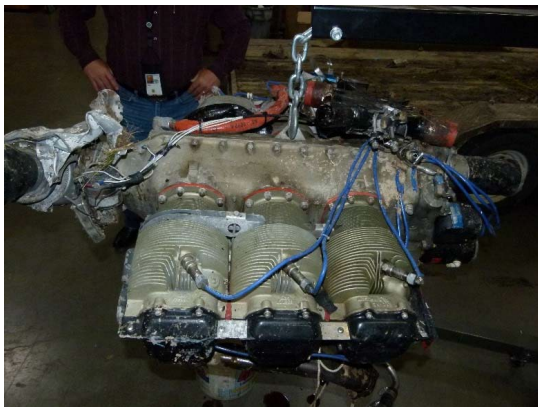
The engine had separated from the airframe and had been placed on an engine hoist by recovery personnel. The induction and exhaust systems were impact damaged. All four engine mount legs were fractured. The right-side crankcase had a crack forward and above the number 5 cylinder. The remote oil sump was still attached to the firewall and was crushed.

Figure 3 - photo 1 of engine

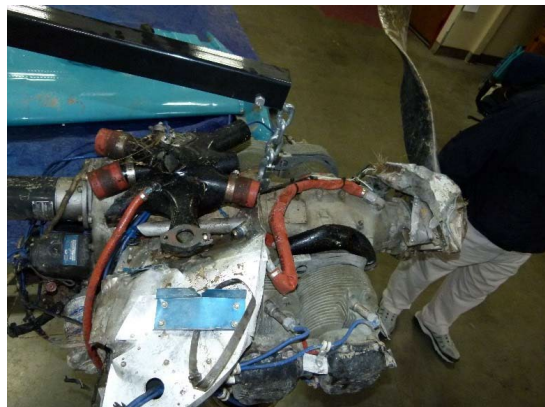
Figure 4 - photo 2 of engine

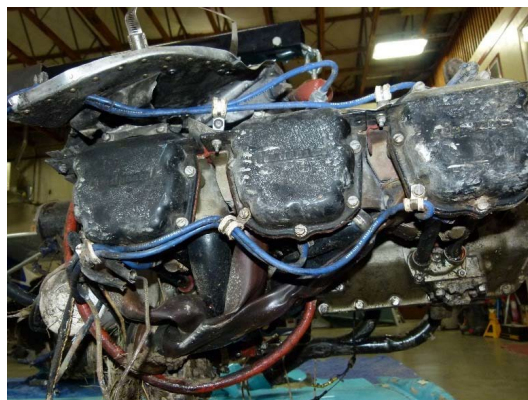
Figure 5 - photo 3 of engine

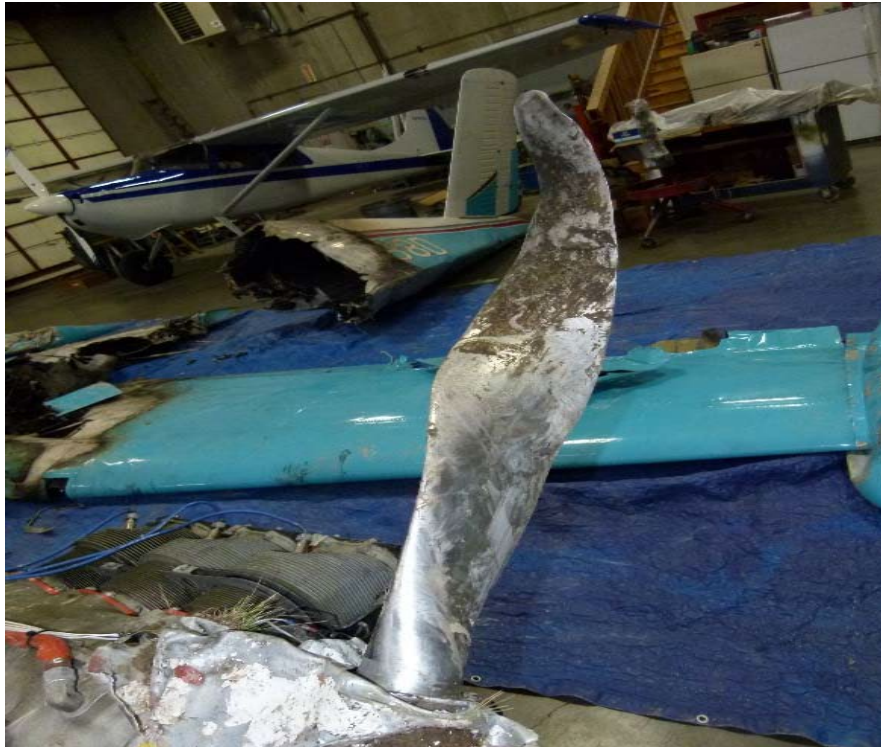
The two-blade, Beechcraft electric propeller remained attached to the splined crankshaft. One propeller blade was loose in the hub and exhibited leading edge polishing, "S" bending and twisting. The second propeller blade was located three months after the accident about 220 ft east-northeast of the main wreckage. The blade was deformed with the blade twisted and the blade tip bent in the aft direction.

Figure 6 - photo of damaged attached propeller blade

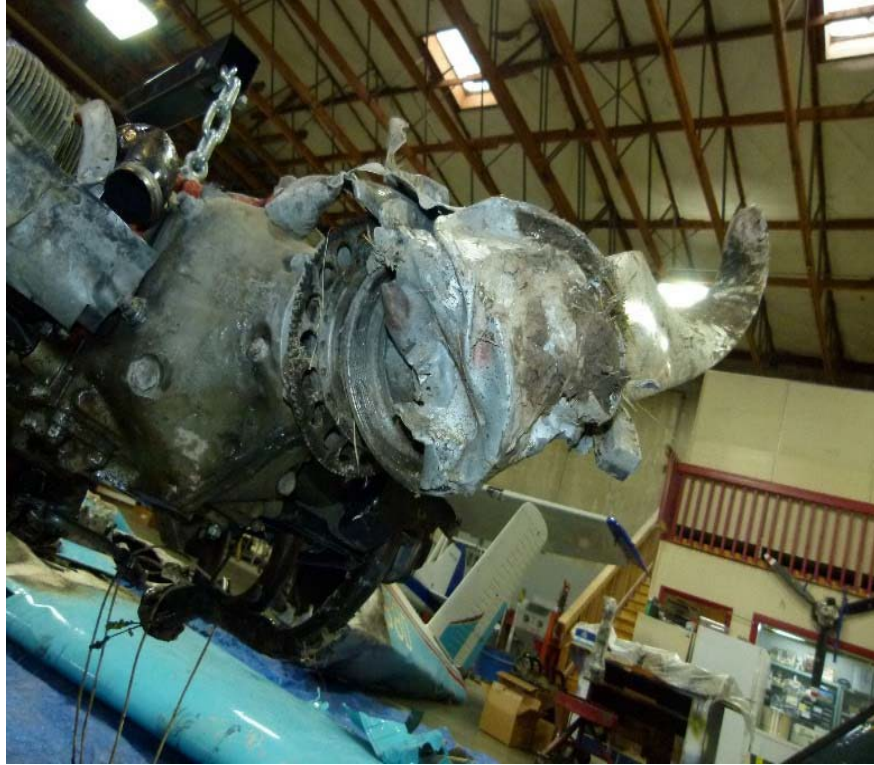
The spinner had been crushed and bent over the hub, partially covering the area of the hub that the missing propeller blade would have normally been. It was noted that one of the two blade retaining locks on the hub was missing and rust was observed where the missing blade

retaining lock would have been. (Refer to the NTSB Materials Laboratory factual report, which is appended to this report, for a detailed examination of the propeller and its blades.)

Figure 7 - photo of damaged propeller hub and attached propeller blade

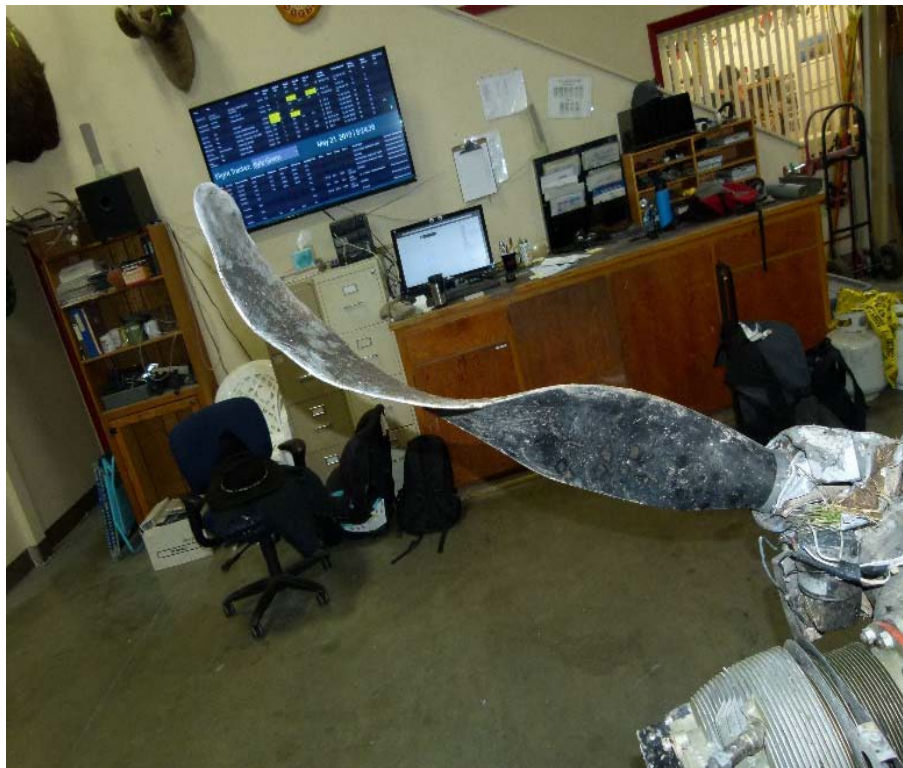
Figure 8 - photo of damaged attached propeller blade

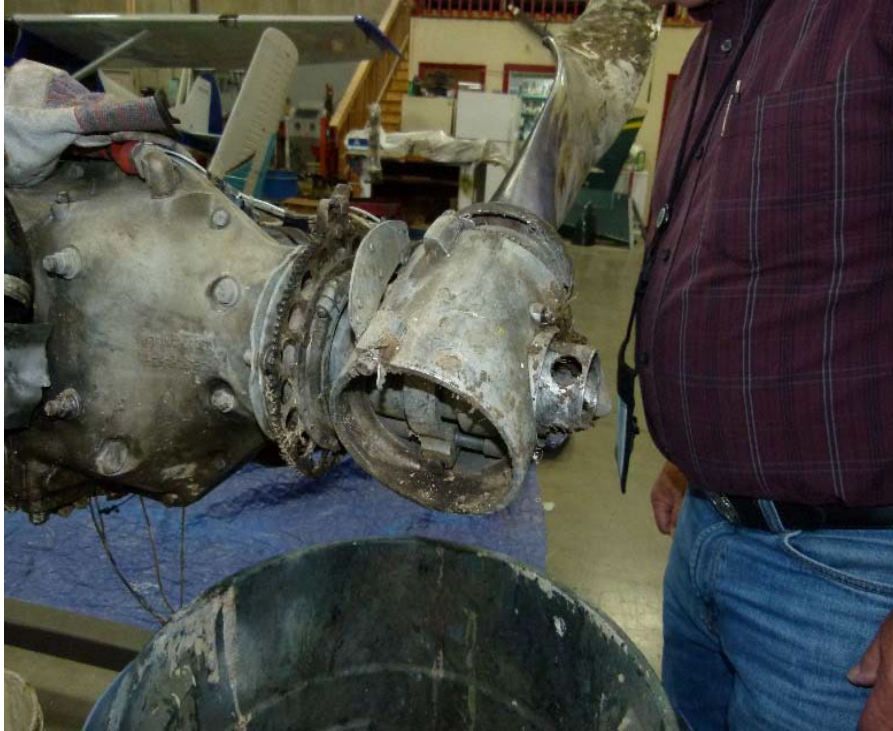
Figure 9 - photo of damaged propeller hub and attached blade

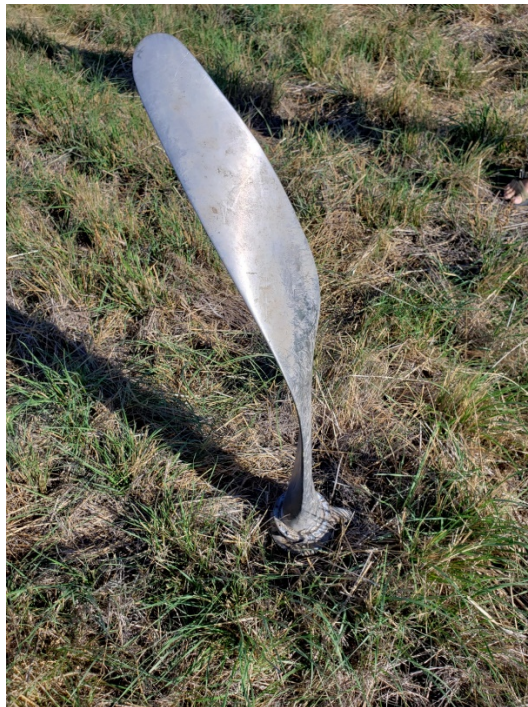
Figure 10 - photo of separated propeller blade

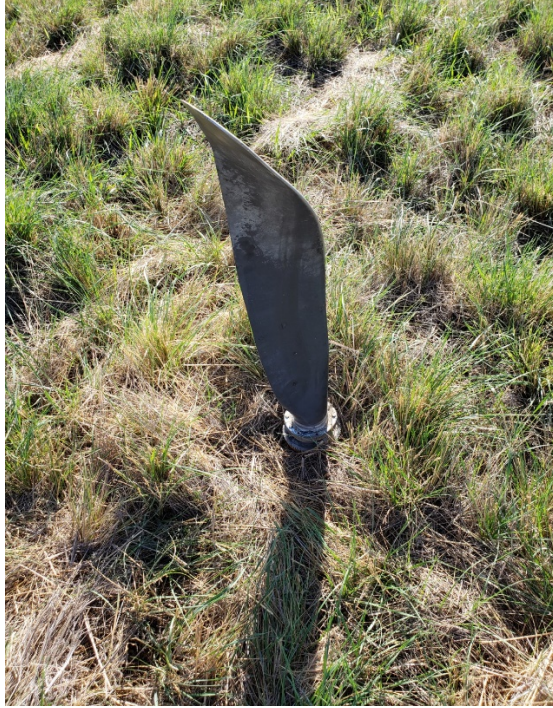
Figure 11 - photo of separated propeller blade
