## **NATIONAL TRANSPORTATION SAFETY BOARD**

### **Exam Notes**

**WPR19FA159**

Aircraft: Experimental Titan II, Registration Number: N4362V

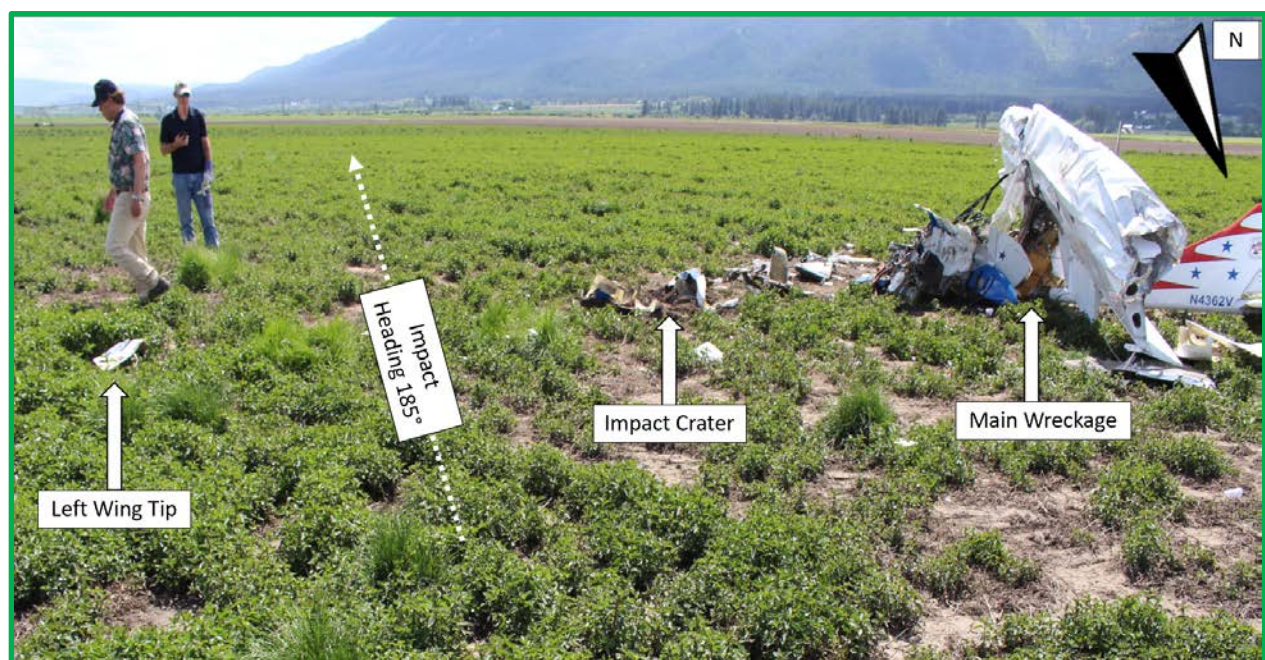
The wreckage was located in a mint field about 1,700 northwest of Summerville, OR. All major structural components were located with the main wreckage. The airplane impacted the ground about 185° magnetic heading. The cockpit was orientated about 133° magnetic heading. The first identified point of impact was identified by a small impact crater and pieces of the left wing tip were found within the crater. Flight control continuity was established for the elevator, ailerons, and rudder.

Figure 1-Main wreckage
