**NATIONAL TRANSPORTATION SAFETY BOARD**

**AIRPLANE & ENGINE EXAMINATION**

**WPR19FA161**

**Lockwood Aviation, Aircam – N123GN**

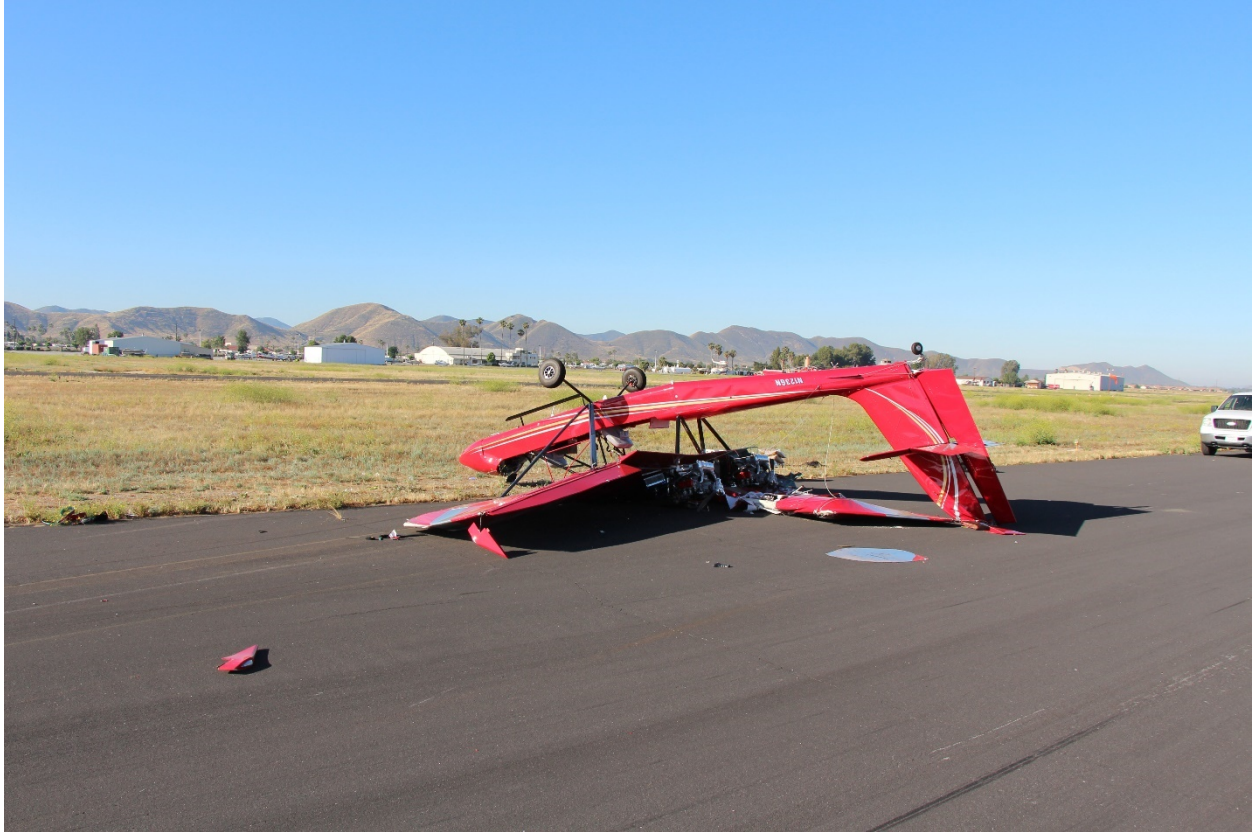
The airplane came to rest on the left runway edge of runway 23, approximately 580 ft from the beginning of the runway (photograph 1). All major sections of the airframe were accounted for at the accident site.

Photograph 1: Accident Airplane at Rest

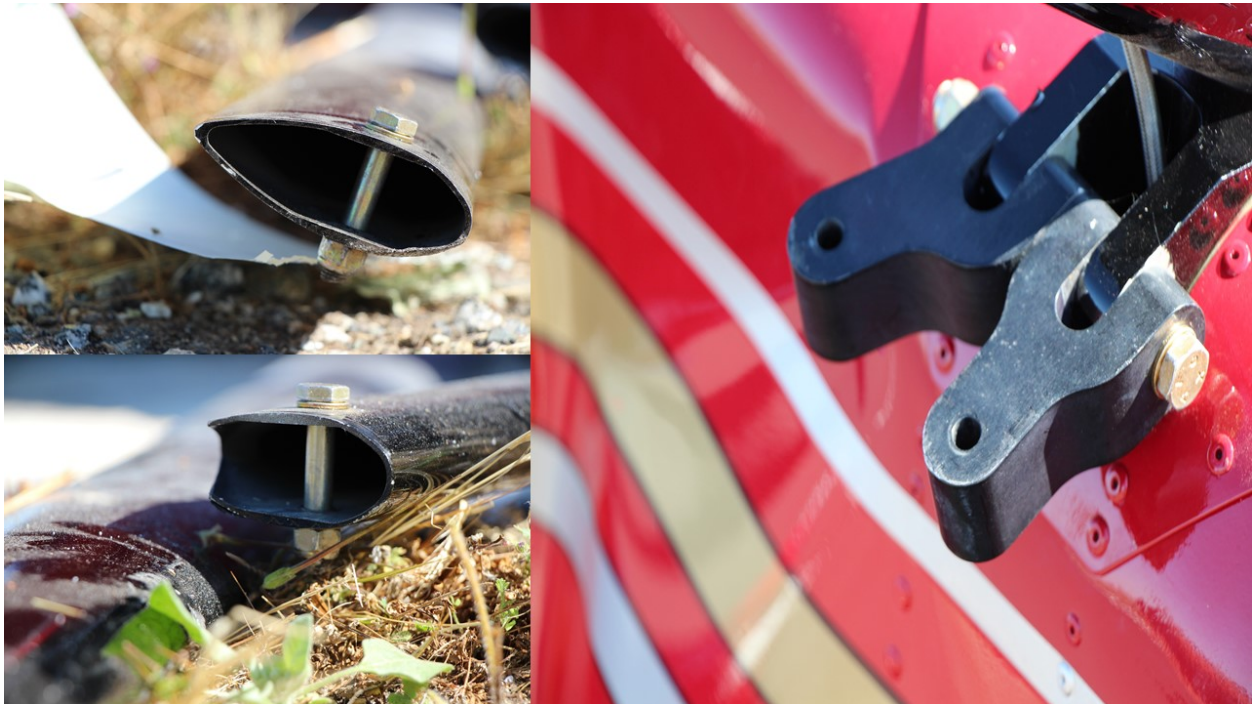
The forward and aft left wing struts were attached at the leading and trailing edge midspan wing brackets. The kit manufacturer noted that they had been correctly assembled at the wing using AN-4 bolts that had been properly torqued. The forward and aft wing strut inside diameter thicknesses were measured at the wing strut attachment fitting ends without making any adjustments. The aft wing strut measured 31/32" in thickness and the forward wing strut measured 15/16", which were both interference fits with the wing strut attachment fittings (photographs 3 & 4). It was noted that the thickness of the wing strut attachment fittings were precisely 1" thick, consistent with manufacturer specifications.

Photograph 2: Left Wing Strut Attachment Fittings

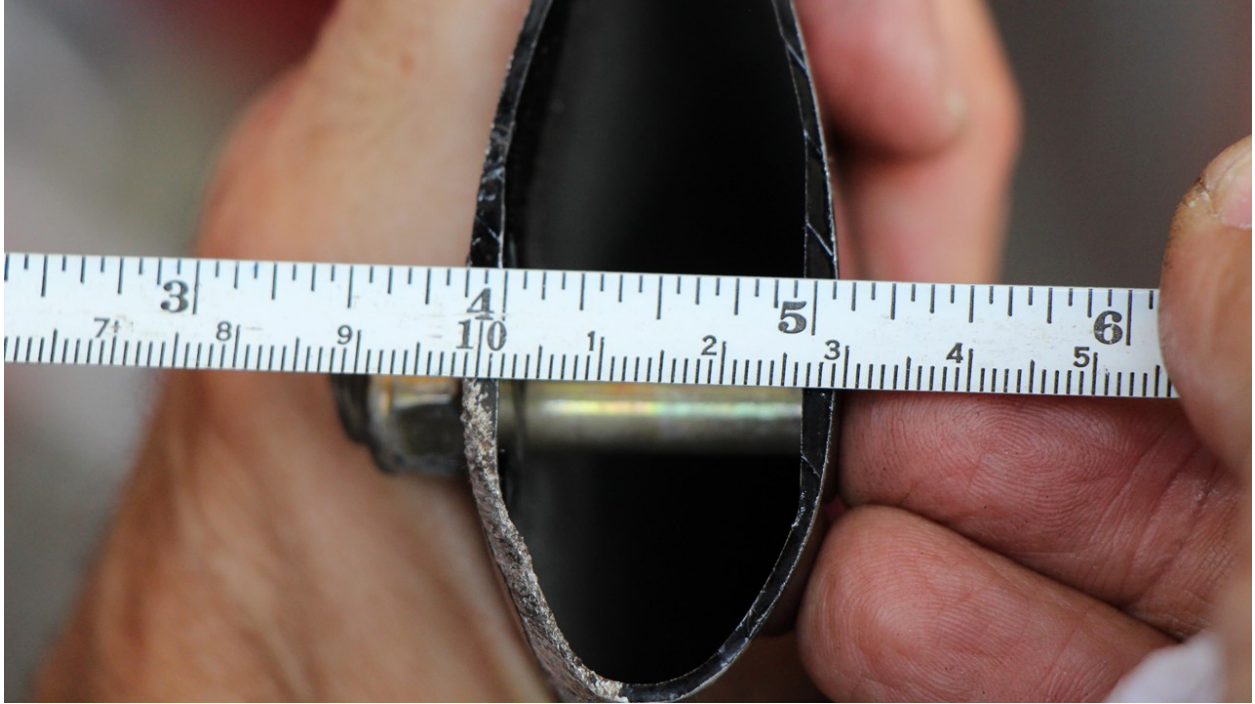
Photograph 3: Left Wing Strut (Forward)

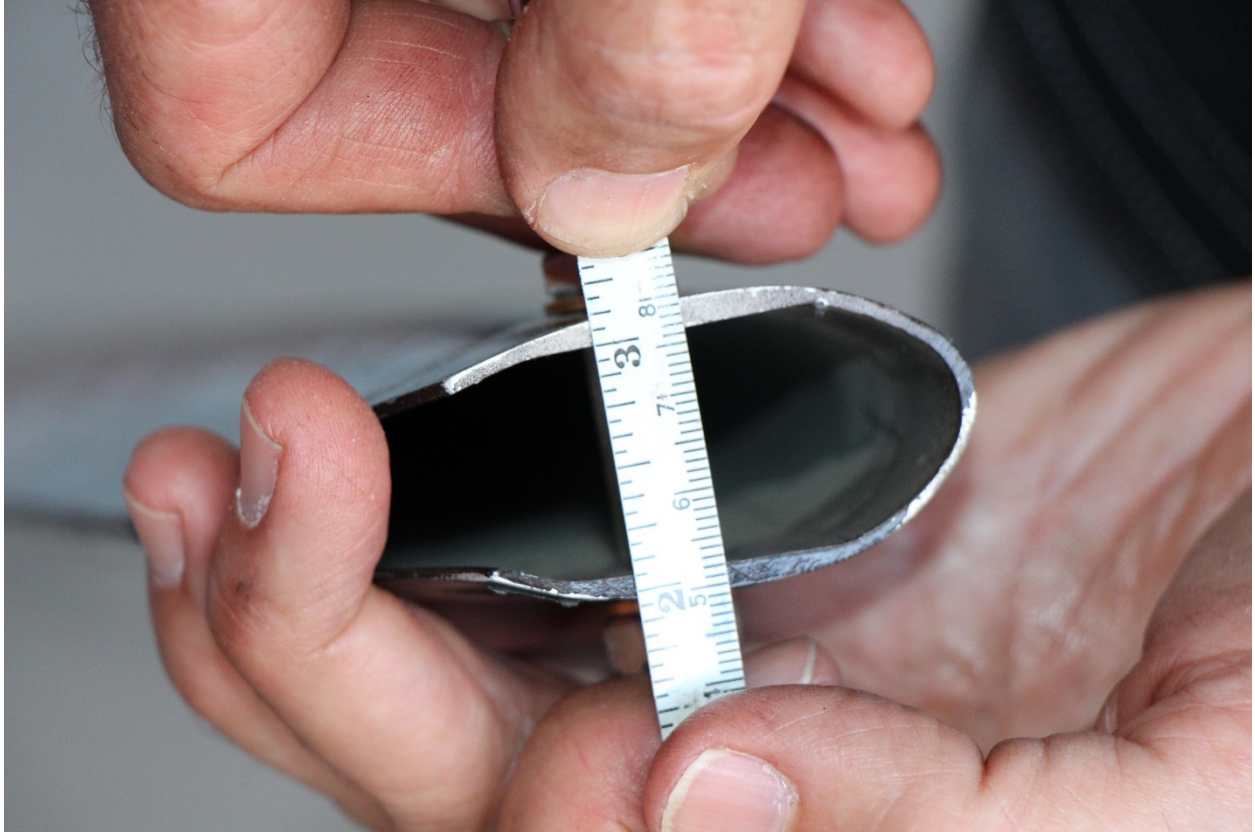
Photograph 4: Left Wing Strut (Aft)

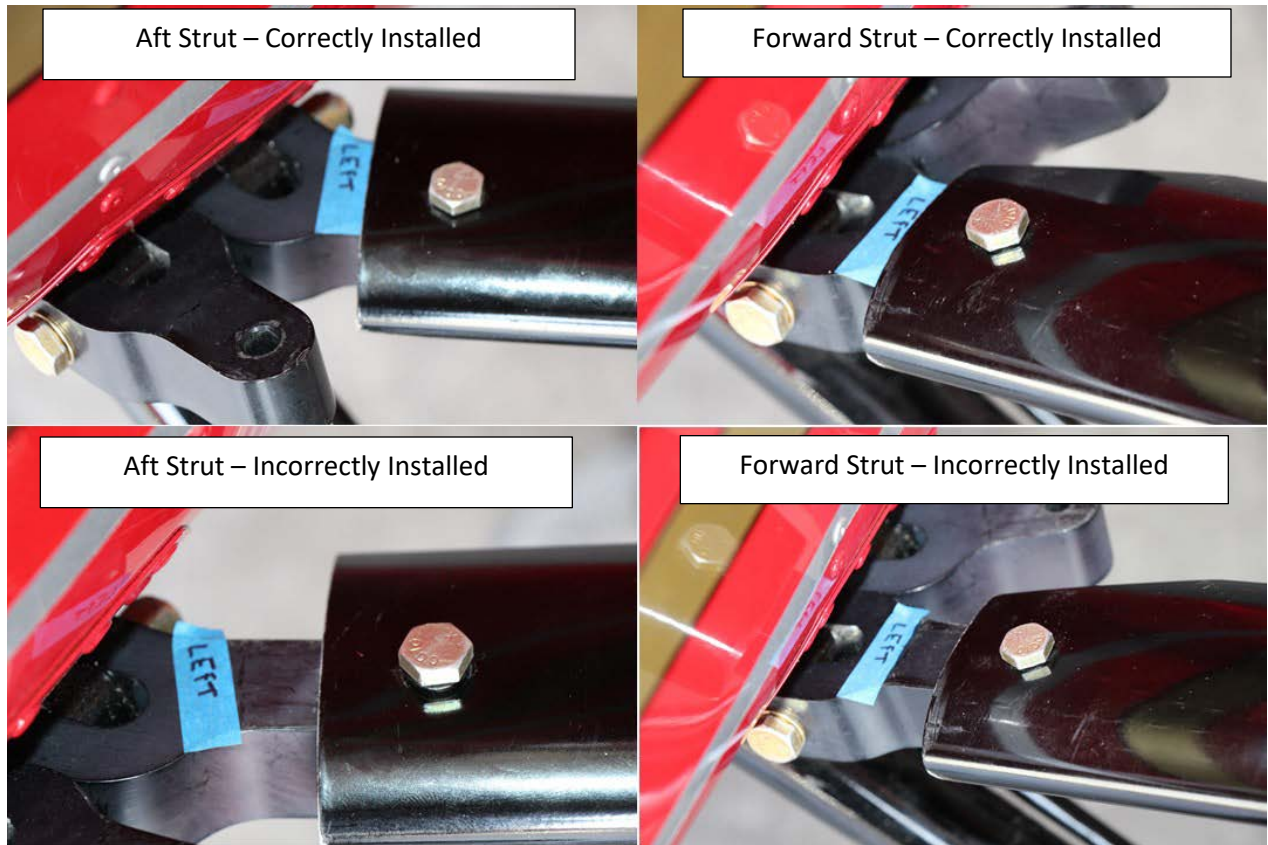
The wing strut bolts were removed and the struts were placed on the wing strut attachment fittings. Both strut bolts were inserted into the struts outside of the attachment point bolt holes and ratcheted down. Two investigators, pulling simultaneously, were unable to pull the struts from the wing strut attachment fittings. The struts were then re-installed in accordance with the manufacturer's rigging manual and compared to their original installation (photograph 5). Photographs 6 & 7 show the amount of exposed strut.

Photograph 5: Left Wing Struts – Correctly and Incorrectly Installed

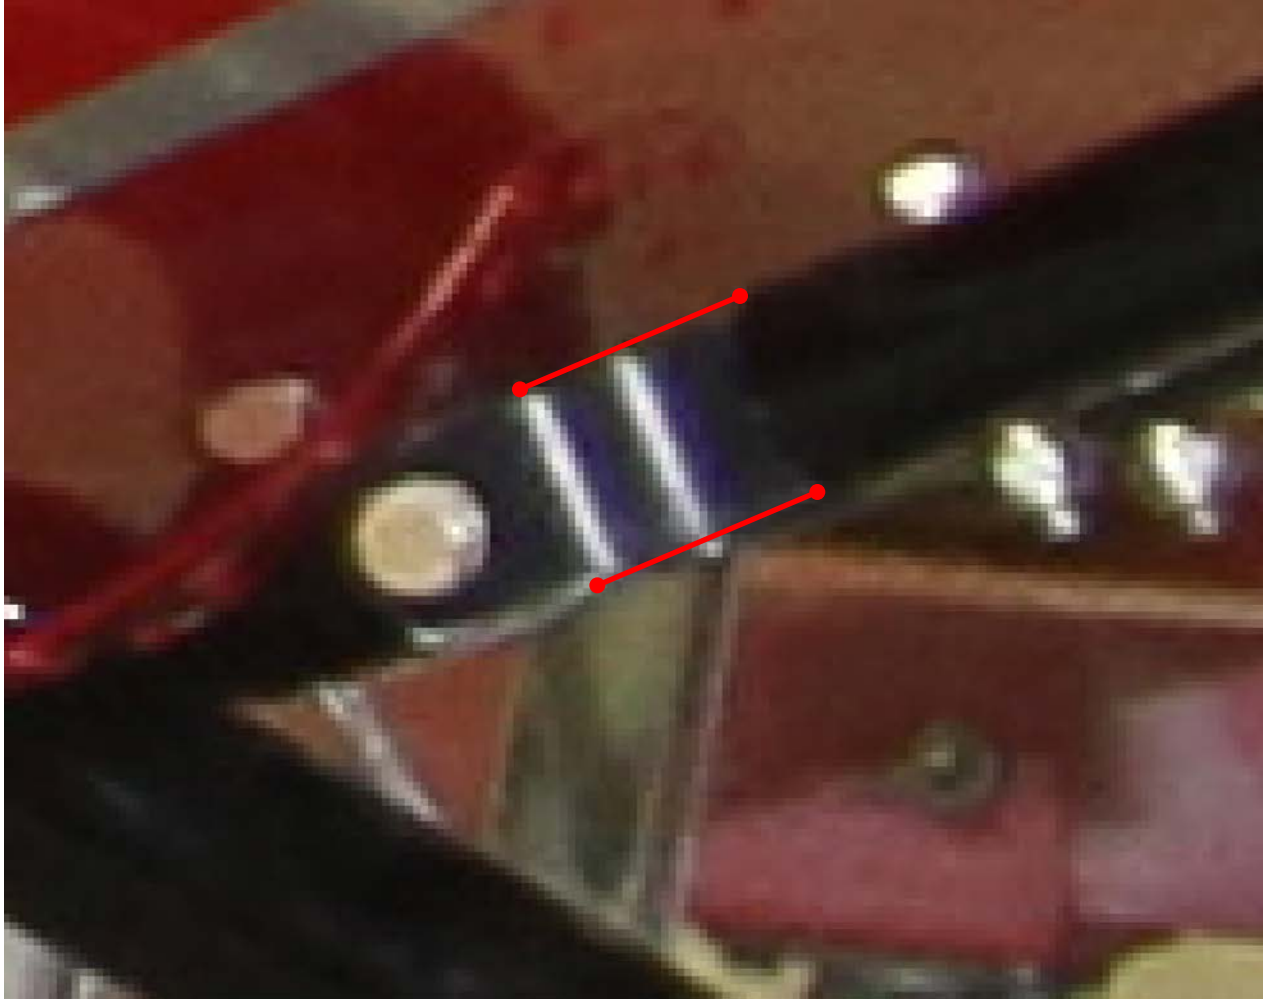
Photograph 6: Photograph of Left Wing Strut taken By Accident Pilot dated January 16, 2019

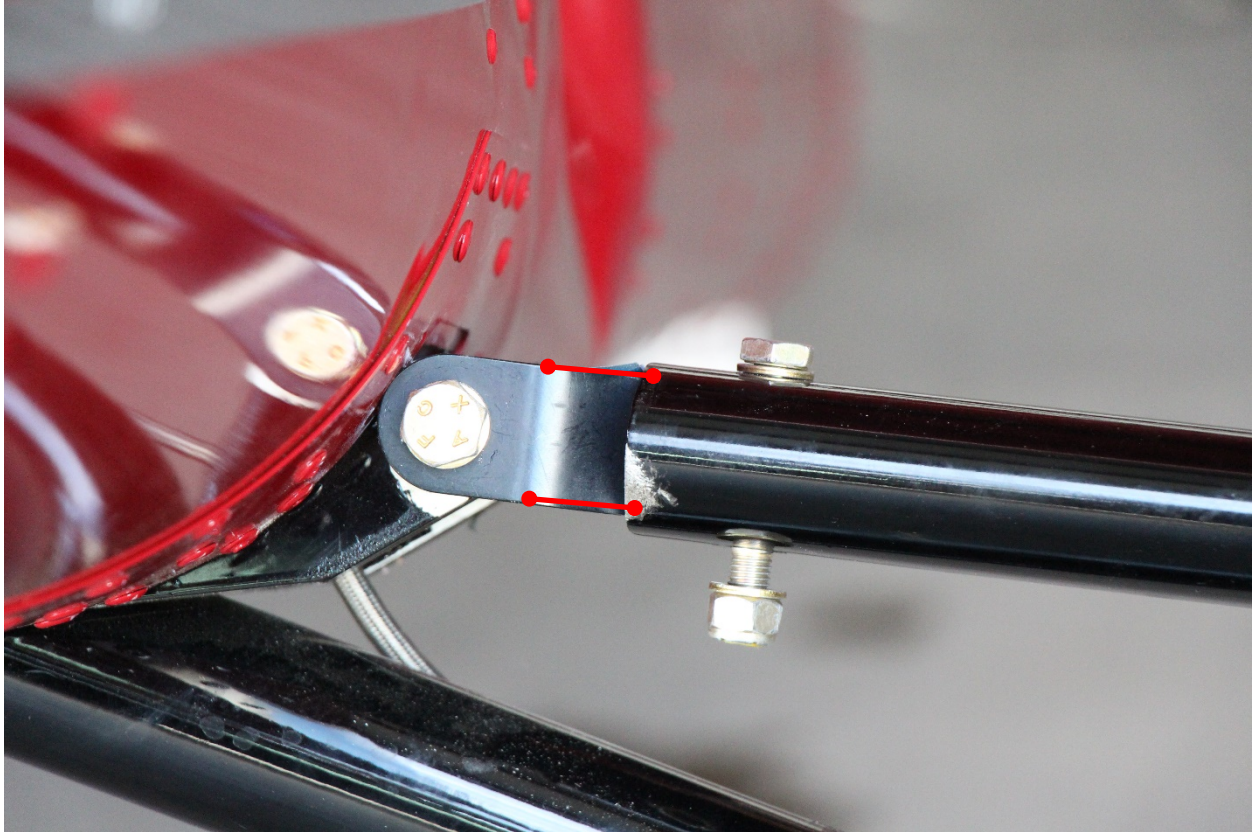
Photograph 7: Left Wing Strut Correctly Installed
