## **NATIONAL TRANSPORTATION SAFETY BOARD**

# **AIRFRAME AND ENGINE EXAMINATION**

**WPR19FA163**

Location: Antioch, CA.  
Date: June 9, 2019  
Aircraft: Piper Aircraft PA 28-151  
NTSB IIC: Fabian Salazar

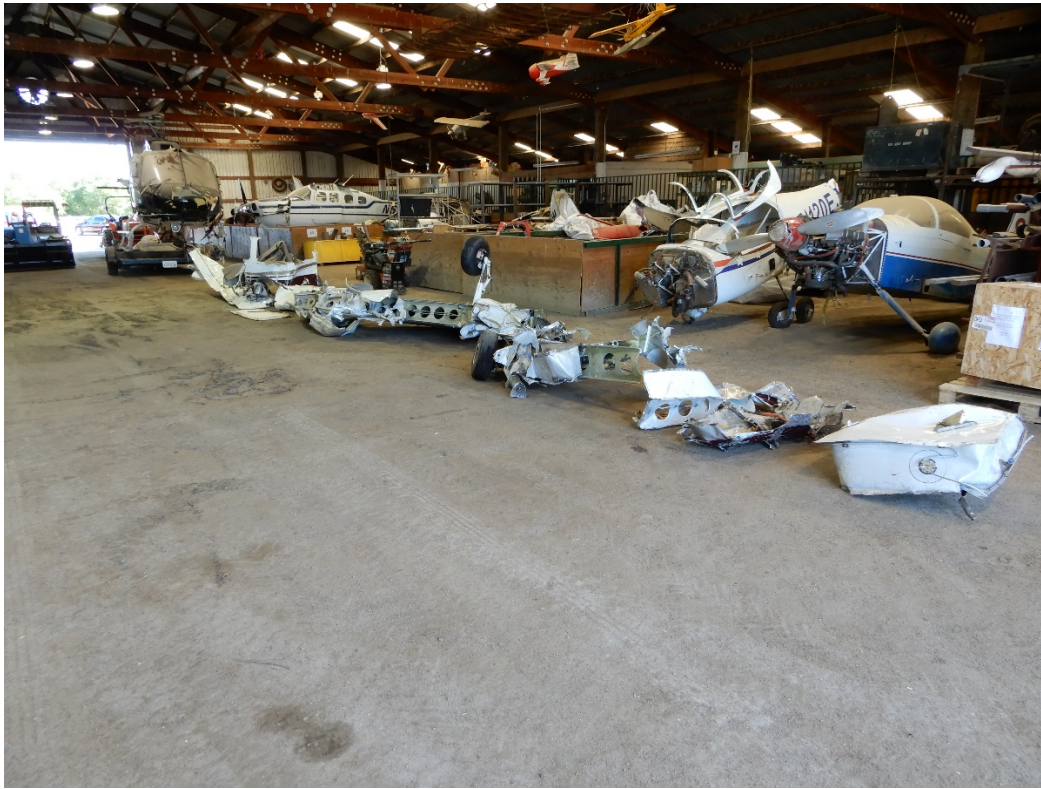
On June 9, 2019, the airplane came to rest in the Broad Slough portion of the San Joaquin River near Antioch, CA. Portions of the airplane were recovered on June 13, 2019, and transported to a secure facility in Pleasant Grove, CA. The fuselage was fragmented, and some of the airframe and several components were not recovered. The recovered components consisted of the empennage and a portion of the tail cone, the left wing assembly, the left-wing fuel tank, some of the cabin structure including interior door panels, some of the seatbelts and lap belts, the rear seat, and the left and right main landing gear. Items missing included but were not limited to the cockpit area of the airplane, the front seats. The cabin area of the fuselage, most of the instrument panel, most of the right wing including the aileron and flap assembly, and the propeller. Some personal items, belonging to the pilot were recovered, including a backpack,

Photo 1. N7943C. Recovered Portions of the Airplane.

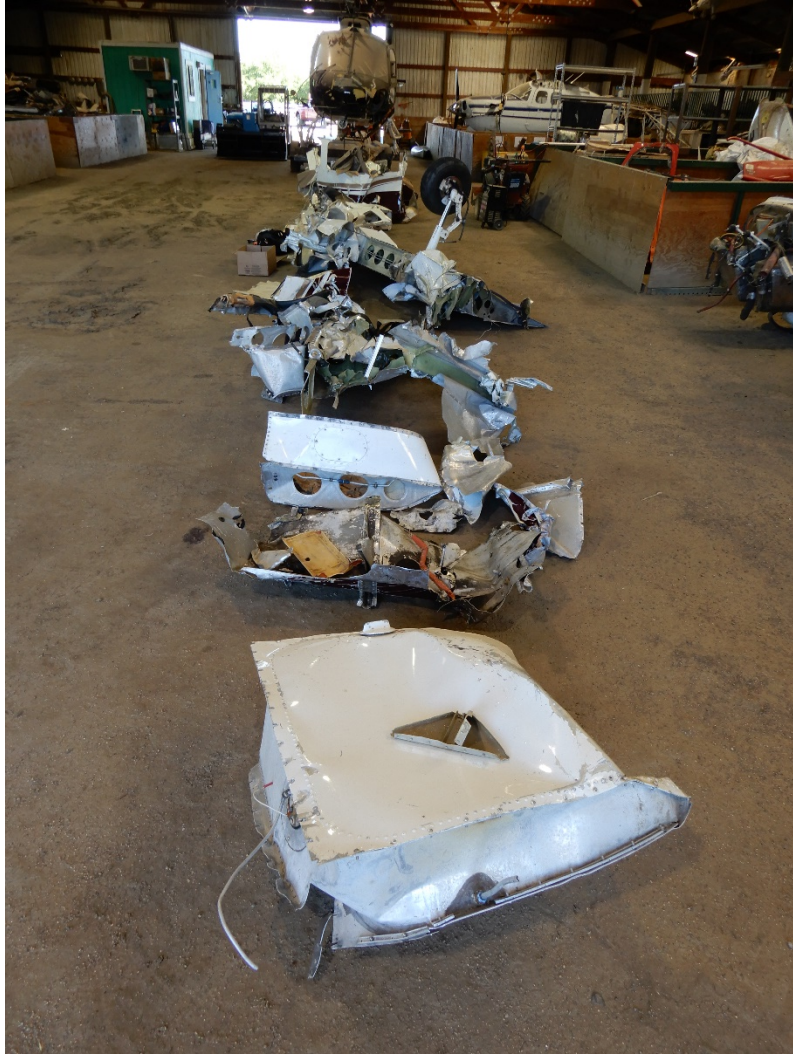
Photo 2. N7943C. Recovered Portions of the Airplane.

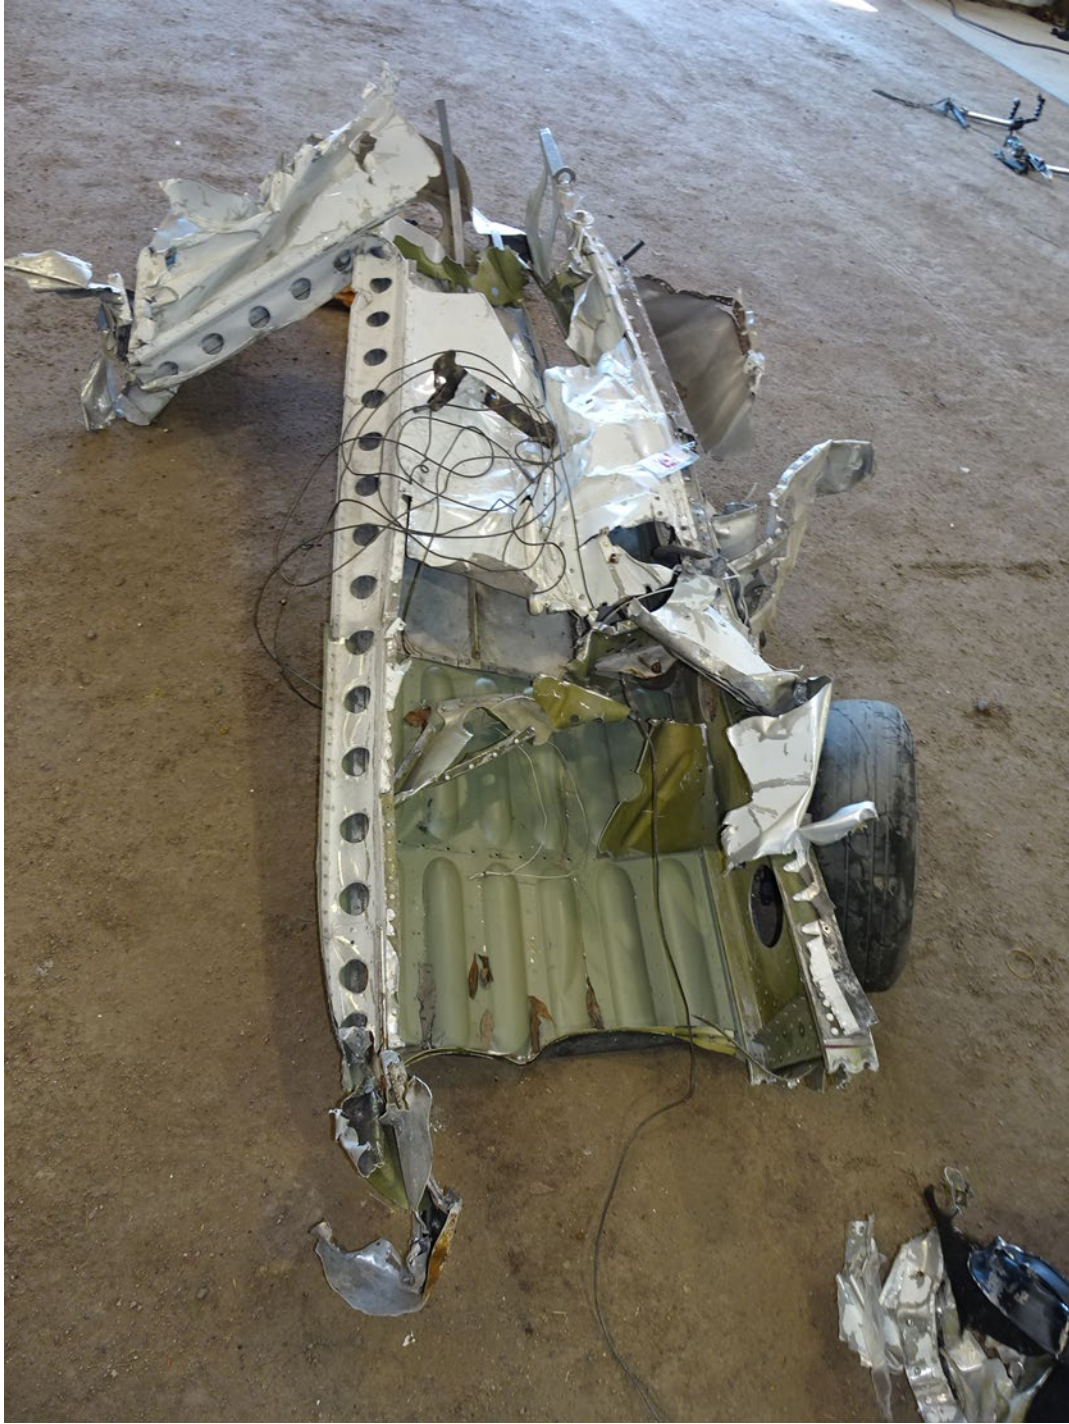
Photo 3. Right Wing

A small portion of the right wing was recovered. This section was a portion of the center of the wing and consisted mainly of the upper wing skin nearest the root, and a portion of the spar. The aileron, flap assembly, the leading edge, portions of the spar, and the right-wing fuel tank were not recovered. The wingtip and navigation light were not recovered. The right main landing gear remained attached to the wing portion by the brake line.

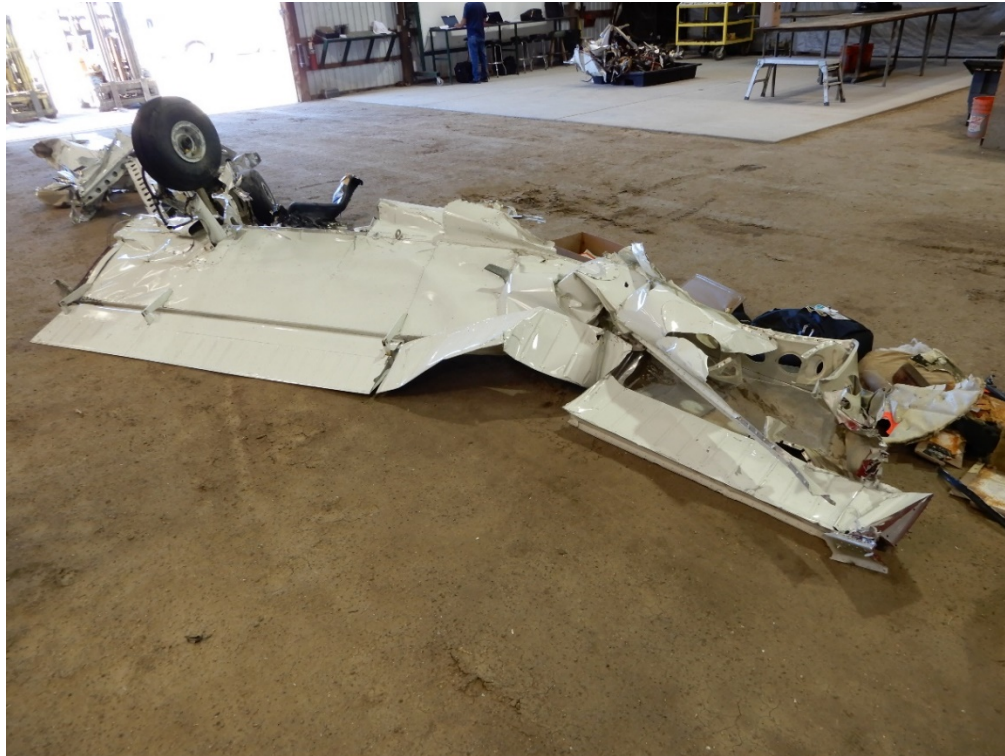
Photo 4. Left Wing

The left wing separated from the fuselage. The spar displayed fractures consistent with overload. The left wing remained mostly intact and retained the aileron, flap and main landing gear. The leading-edge fractured and partially separated from the wing. The portions of the leading edge that remained attached sustained crush damage inwards towards the spar. The tip and outer portion of the wing were crush damaged upwards. The aileron remained attached to the wing at the in-board hinge. The flap remained attached to the wing at the inner and center hinge. The outer hinge was impact separated from the wing. The flap was found in the retracted/up position. The flap was damaged from the outer end to the center hinge. The left-wing fuel cell separated from the wing and received damage deforming the shape. The fuel cap was found secured with the seal soft and pliable. No fuel was found in the fuel cell.

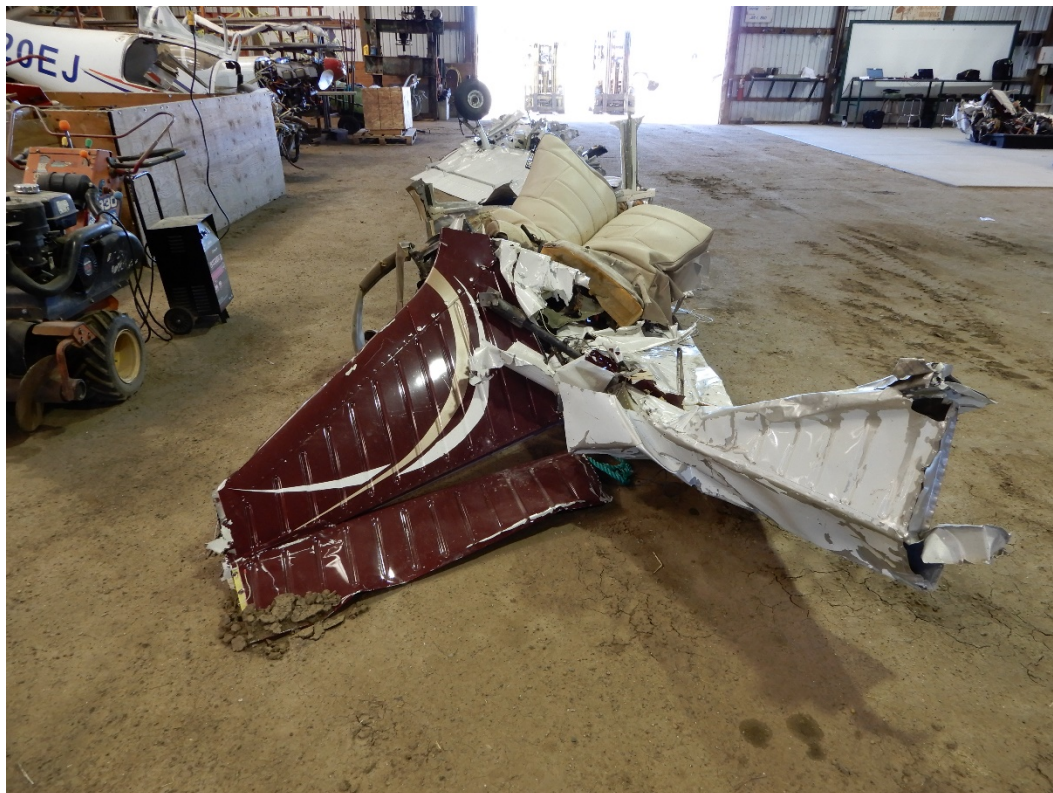
Photo 5. Empennage, Right Side

Empennage. All the major components of the empennage were recovered. The vertical stabilizer was impact damaged and remained attached to a portion of the aft fuselage. The rudder remained attached to the vertical stabilizer at the top hinge and displayed damage throughout. The lower hinge was impact separated. The right side of the stabilator was damaged from the bottom upwards and rearwards. The leading edge was twisted backwards facing 180 degrees. The left side of the stabilator was crushed aft at the leading edge. A tear in the skin was observed on the underside running from the trailing edge to the leading edge. The stabilator counterweight was observed protruding out of the bottom of the assembly.

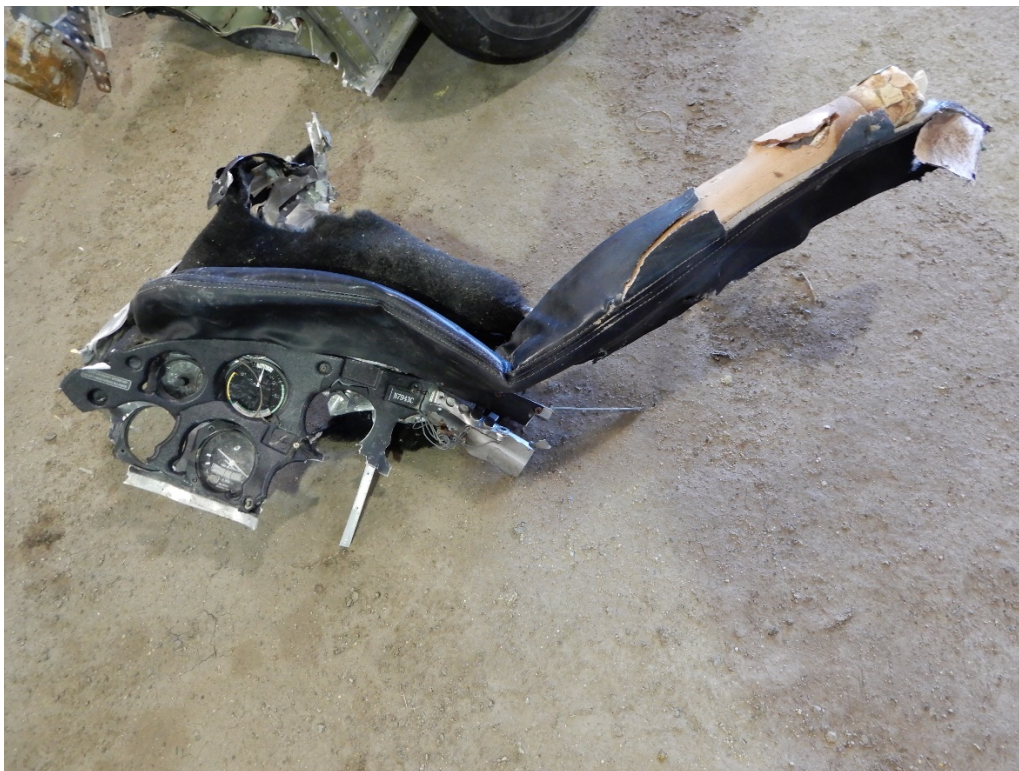
Photo 7. Instrument Panel

INSTRUMENTATION. A small portion of the instrument panel was recovered.

Airspeed indicator: 0 Knots

Clock: 16:30:27

Turn Coordinator: Tumbled

Engine tachometer: Found detached from the instrument panel, damaged and outside of the protective housing. The dial missing.

Circuit Breaker panel. All circuit breakers were missing from the panel.

Throttle: Bent and crushed into the instrument panel.

Mixture: Bent and crushed into the instrument panel

Ignition Key: Bent and found in the "L" magneto position.

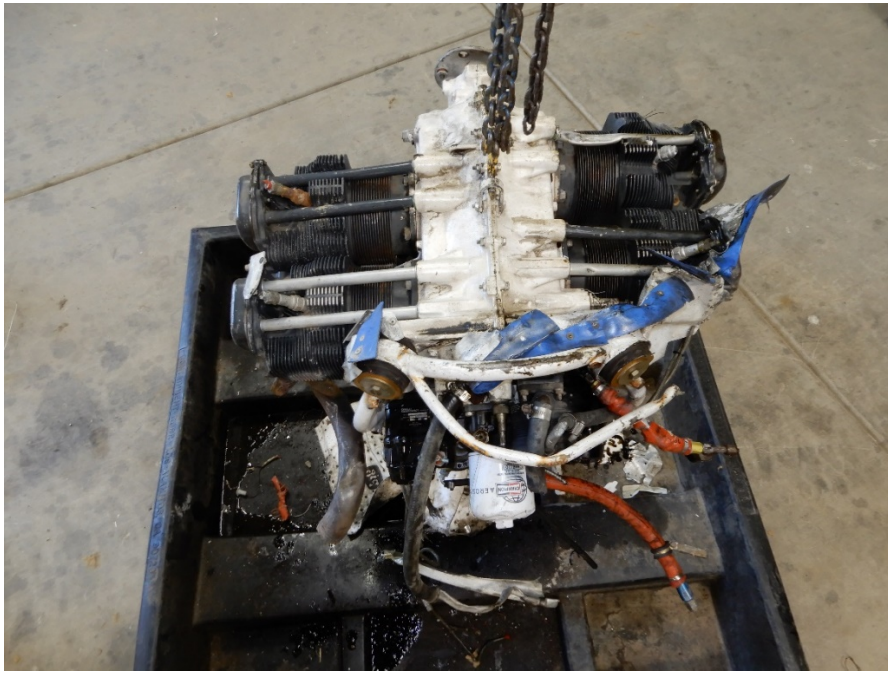
Photo 8. Engine

The engine was recovered after being submerged in the San Joaquin River for four days. Attached to the engine were multiple wires and portions of the engine mounts. The engine appeared intact with all cylinders and heads attached.

A visual inspection revealed the number one-cylinder intake pushrod and push rod tube were absent as was the carburetor. The number one exhaust push rod tube was found damaged and unsealed from the crank case.

Thumb compression was confirmed in all four cylinders. The crankshaft and cam shaft rotated freely. Valve continuity and proper cam lobe shape was established, by monitoring the correct and free movement of all eight rocker arms and, or tappets.

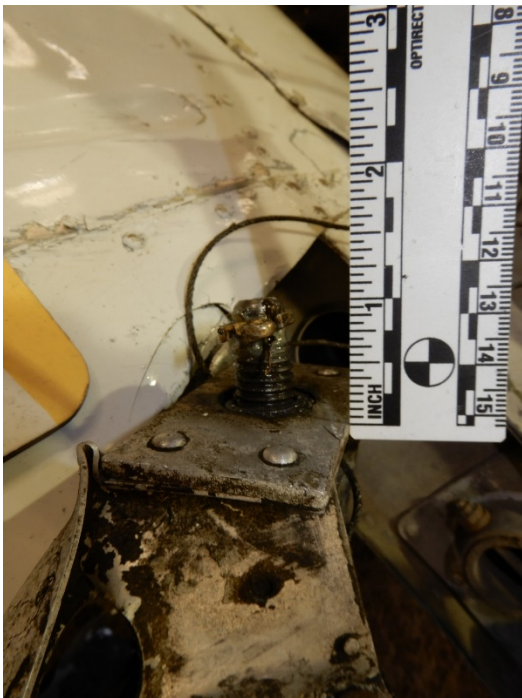
Photo 9. Trim Setting

Flight Controls. The flight controls were recovered. Flight control continuity was established for the ailerons, stabilator, rudder, and trim. The cables of the aileron were removed from the wreckage and laid out. There were two broom straw breaks on the left aileron cable. The chain linking the yokes was impact separated. The right aileron cable had a broom straw break near the right control yoke and a second which resembled a recover cut. Rudder cable continuity was established. The rudder cables remained connected to the ruder horn and traced through the empennage and cabin remnants to the rudder pedals. Stabilator control cable continuity was established from the stabilator to recovery cuts near an attachment clevis. The stabilator trim was set at neutral as verified by five threads exposed or .75" on the trim extension screw. Throttle control continuity was not established due to the carburetor being absent.
