## **NATIONAL TRANSPORTATION SAFETY BOARD**

### **ENGINE EXAMINATION SUMMARY**

**WPR19FA172**

Location: Porter Ranch, California  
Date: June 15, 2019  
Aircraft: Nanchang CJ-6, N269AG  
NTSB Investigator-in-Charge: Tealeye Cornejo

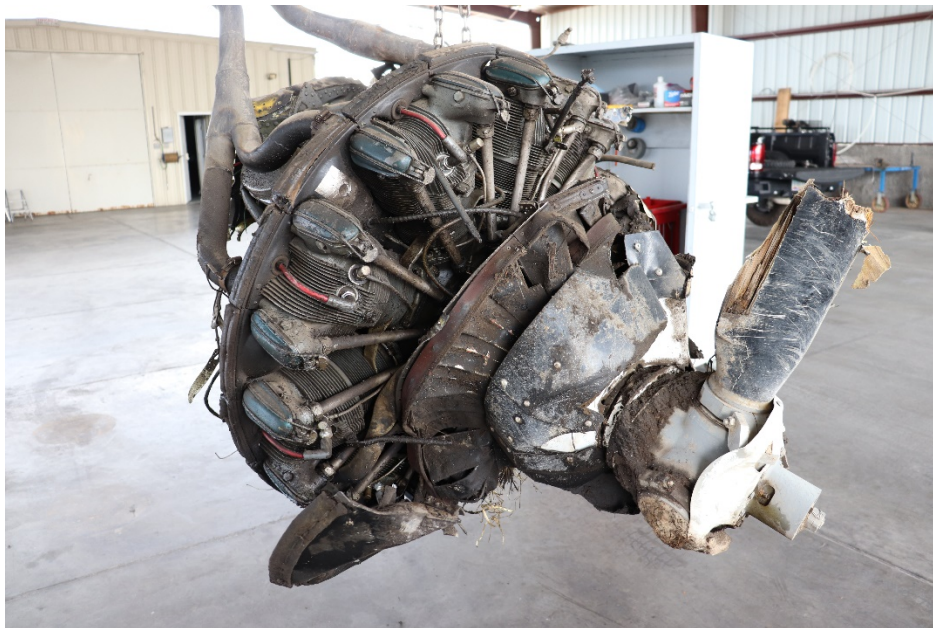
The engine was separated from the airframe. All engine accessories remained attached. Two of the 3 wooden propeller blades were ground down to the propeller hub housing. One wooden propeller blade was impact damaged and about 12 inches of the blade remained attached to the hub. The remaining portion of the blade was splintered in a manner consistent with opposite directional of rotation.

**Figure 1: View of the recovered engine.**

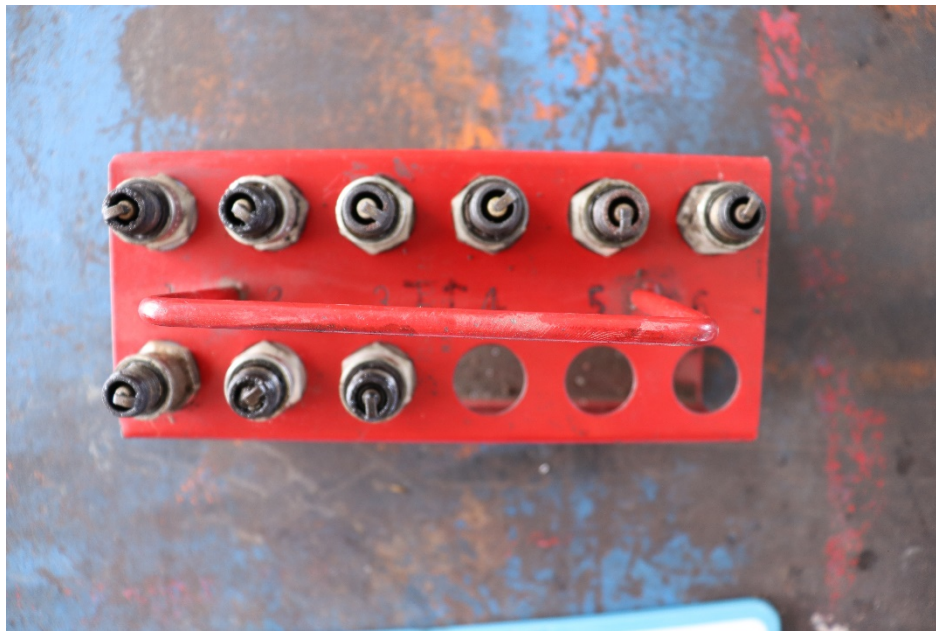
The sparkplugs installed were of an automotive style. The front 4, 5, 6, 7, 8, and 9 were impact damaged. Spark plugs 1, 2, 7, 8, and 9 were oil soaked within the electrode area. Spark plugs 3, 4, 5, and 6 were dark gray within the electrode areas. All spark plugs exhibited normal operational signatures.

**Figure 2: Front spark plugs.**
