**From:** [REDACTED]  
**To:** [REDACTED]  
**Cc:** [REDACTED]  
**Subject:** WPR19FA172 - Porter Ranch, CA Weather  
**Date:** Wednesday, June 26, 2019 7:40:07 AM  
**Attachments:** [image001.png](#)

## **Weather conditions on June 15, 2019 surrounding Porter Ranch, California**

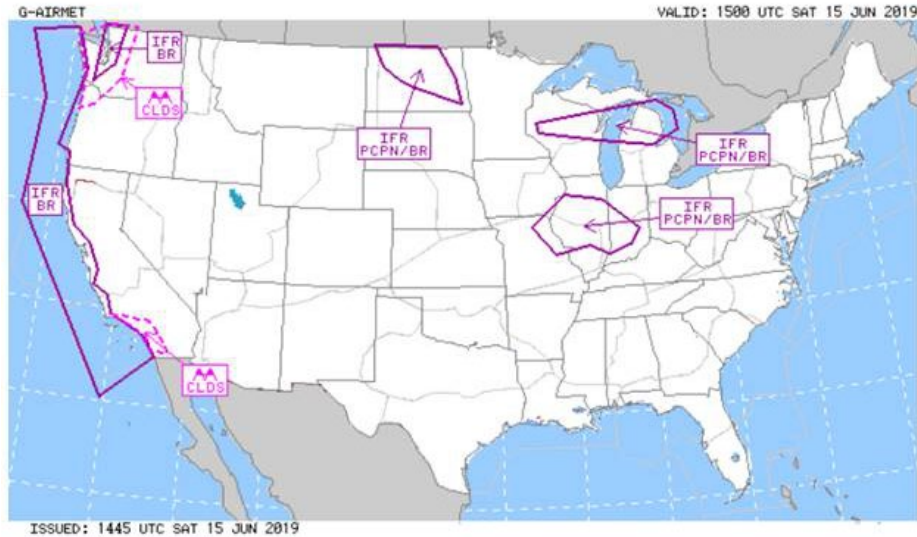
**SIERRA 2019-06-15 15:00:00**

**NWS Inflight Weather Advisories** – The NWS had AIRMET Sierra current for IFR conditions and mountain obscuration along the California coastal region, which bordered the accident site. No

SIGMETs, Convective SIGMETs, or CWA's.
